Castle Hill Hotel Heritage Limited

Castle Hill Huddersfield,  
HD4 6TA

Combined Stage 1 -2 Road Safety  
Audit

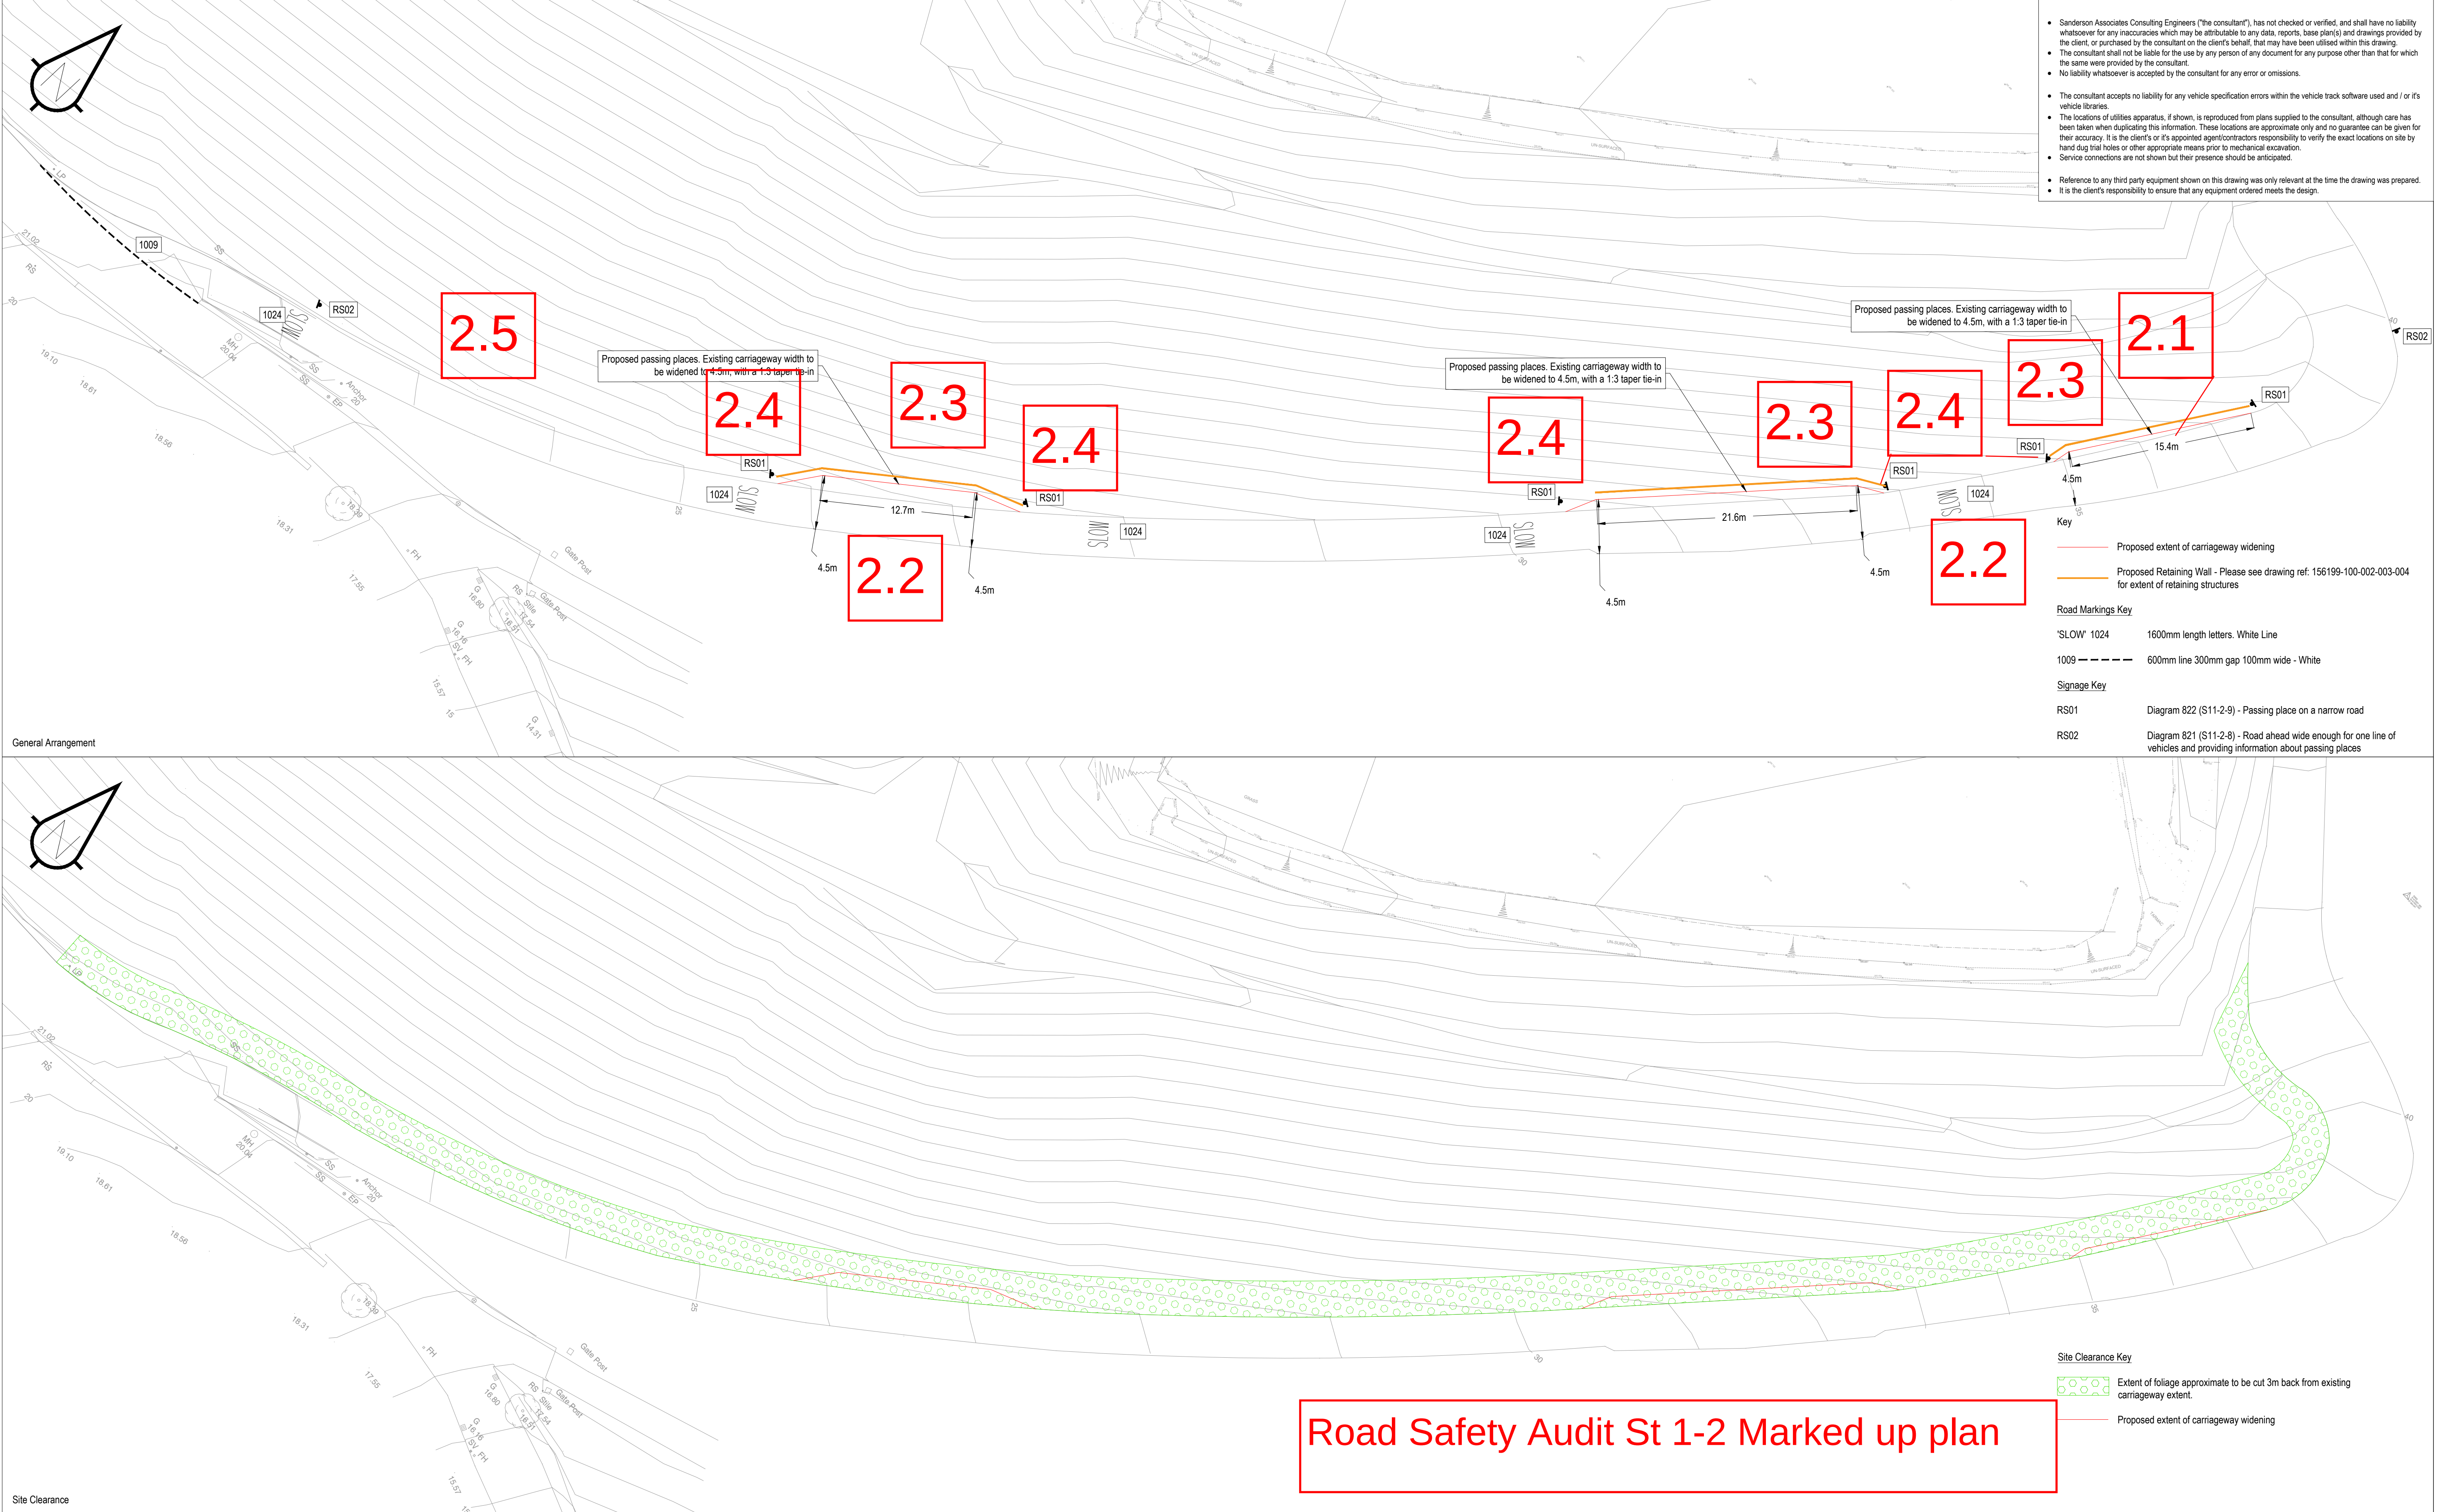
### Marked Up Plan for the combined Stage 1 - 2 RSA

- 1.10 A marked up plan is included in **Appendix A**, which identifies the approximate location of problems that have been raised. General problems or those with multiple locations have not all been shown.

**Location:** Northern most passing place.

**Summary:** Existing gully not shown on drawing adjacent to passing place widening.

There is an existing road gully adjacent to passing place widening which will fall in the wheel track of vehicles and powered two wheelers. The concern is that if adequate drainage is not provided it could lead to skid or loss of control incidents in the carriageway during periods of inclement weather. It is noted that vehicles could also be braking in this area on a downhill approach to the passing place.

**Location:** Areas of carriageway surfacing.

**Summary:** The drawing 156199-700-001 shows to areas of carriageway surfacing and description of the construction materials and thicknesses. However, no details are provided of the PSV value for the surface course aggregate. The concern is that vehicles will be slowing and braking in these areas in conjunction with the gradient of the road. If inappropriate levels of skid resistance are provided this could lead to skidding or loss of control type incidents in conflict with vehicles or pedestrians since they could share the same surface.

**Location:** Areas of proposed 0.45m wide verge between the parking bay and retaining walls.

**Summary:** The drawing 156199-700-001 shows three areas of 0.45 wide verge between the parking bay and retaining walls in conjunction with the placing place width of 4.5m. The concern is if vegetation grows in the verge area, it could lead to drivers providing more clearance against the verge (to avoid their vehicle scratched or damaged) thereby effectively reducing the 4.5m width for passing. The result of this could lead to head-on offside collisions between vehicles and wing mirror clashes.

**Location:** Proposed tapers at the ends of the passing places.

**Summary:** The drawings show 1 in 3 tapers to be provided at the ends of the passing places which may inhibit the manoeuvring of vehicles passed each other particularly the shorter southernmost passing bay. The concern is that two large cars may not have sufficient length to orientate parallel to each other with the 4.5m width and taking into account wing mirrors. The result of this could lead to head-on offside collisions between vehicles and wing mirror clashes. Furthermore, it could lead to the southbound vehicle overriding on the verge. It was also noted that in places the verge was lower, with a vertical drop adjacent to the carriageway, which could lead to damage to vehicle wheels and car bodies.

**Location:** Existing foliage along north western side of Castle Hill Side.

**Summary:** The drawing 156199-100-001 shows the area of existing foliage to be cleared and notes a strip 3m wide from the edge of carriageway. This is needed to assist in providing forward visibility between approaching vehicles and for drivers to use the passing places accordingly. The concern is that without appropriate visibility it could lead to drivers not making use of the passing places resulting in vehicles reversing as another vehicle approaches from behind with consequent rear shunt type incidents or head on offside vehicular collisions whilst vehicles try to pass each other. The drawing provides no details of the maintenance regime or the height to which the foliage should be cut and trimmed.

**Recommendation:** Reposition the gully against the channel line to intercept surface water.

**Recommendation:** Utilise surface course materials with appropriate skid resistant properties.

**Recommendation:** Utilise a surface material that inhibits vegetation growth.

**Recommendation:** Provide appropriate taper lengths to allow vehicles to manoeuvre passed each other and raise verge levels where needed adjacent to the passing places.

**Recommendation:** Provide details of the proposed maintenance regime and heights to which foliage should be cut and trimmed.
