Coal Mining Risk Assessment

40 Bradford Road

Huddersfield

Report No. A6303/24/CMRA

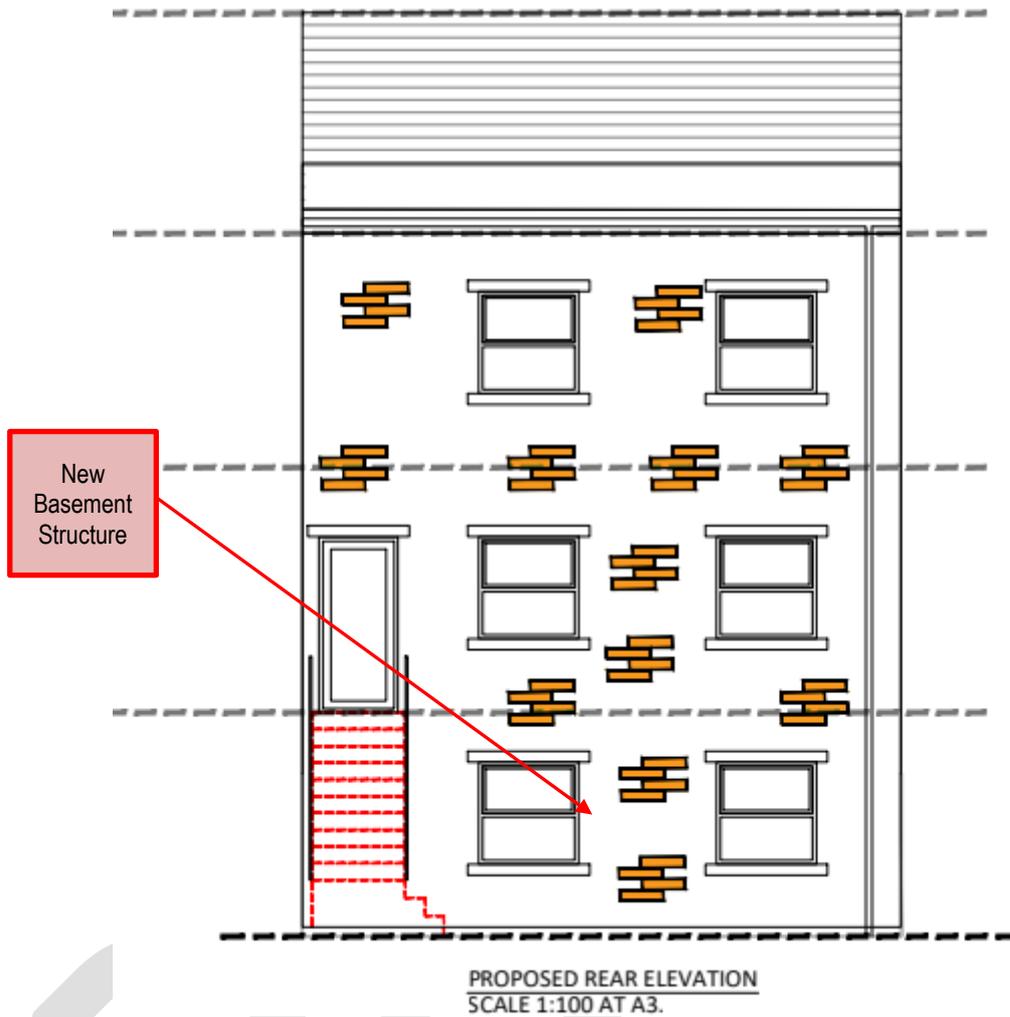
Figure 1: Proposed Development Plan

- 1.1 Earth Environmental & Geotechnical Ltd have been commissioned by Architectural Planning Services on behalf of Mr. Amir (the Client), to undertake a Coal Mining Risk Assessment for a proposed basement for an existing residential structure.
- 1.2 A proposed development plan has been provided shown as Figure 1.

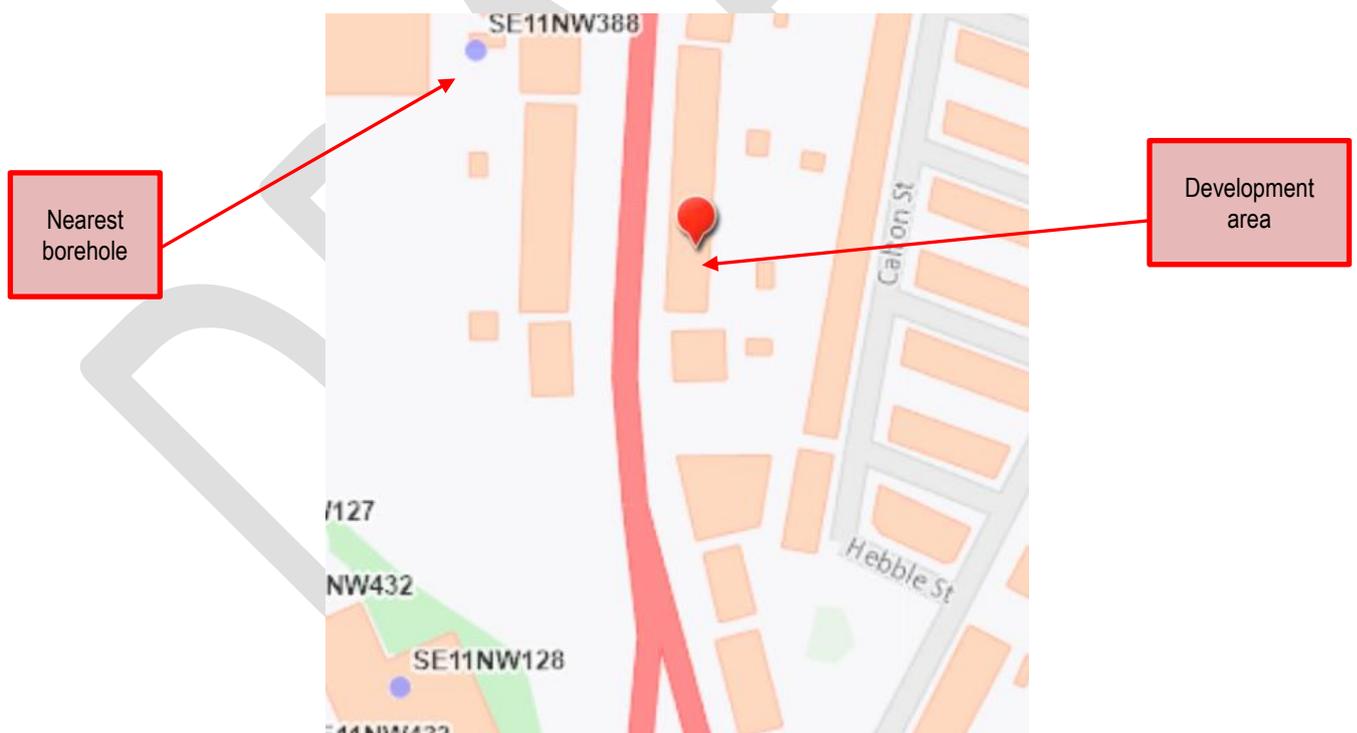
Figure 4: BGS Boreholes

3.4 There are several BGS boreholes within the area which allow for further assessment of the local geology, rockhead depth and shallow coal mining regime.

3.5 Borehole SE11NW388, encountered a rockhead at 3.70m beneath a cover of made ground. There were no coal seams to the base of the borehole at 6.0m.

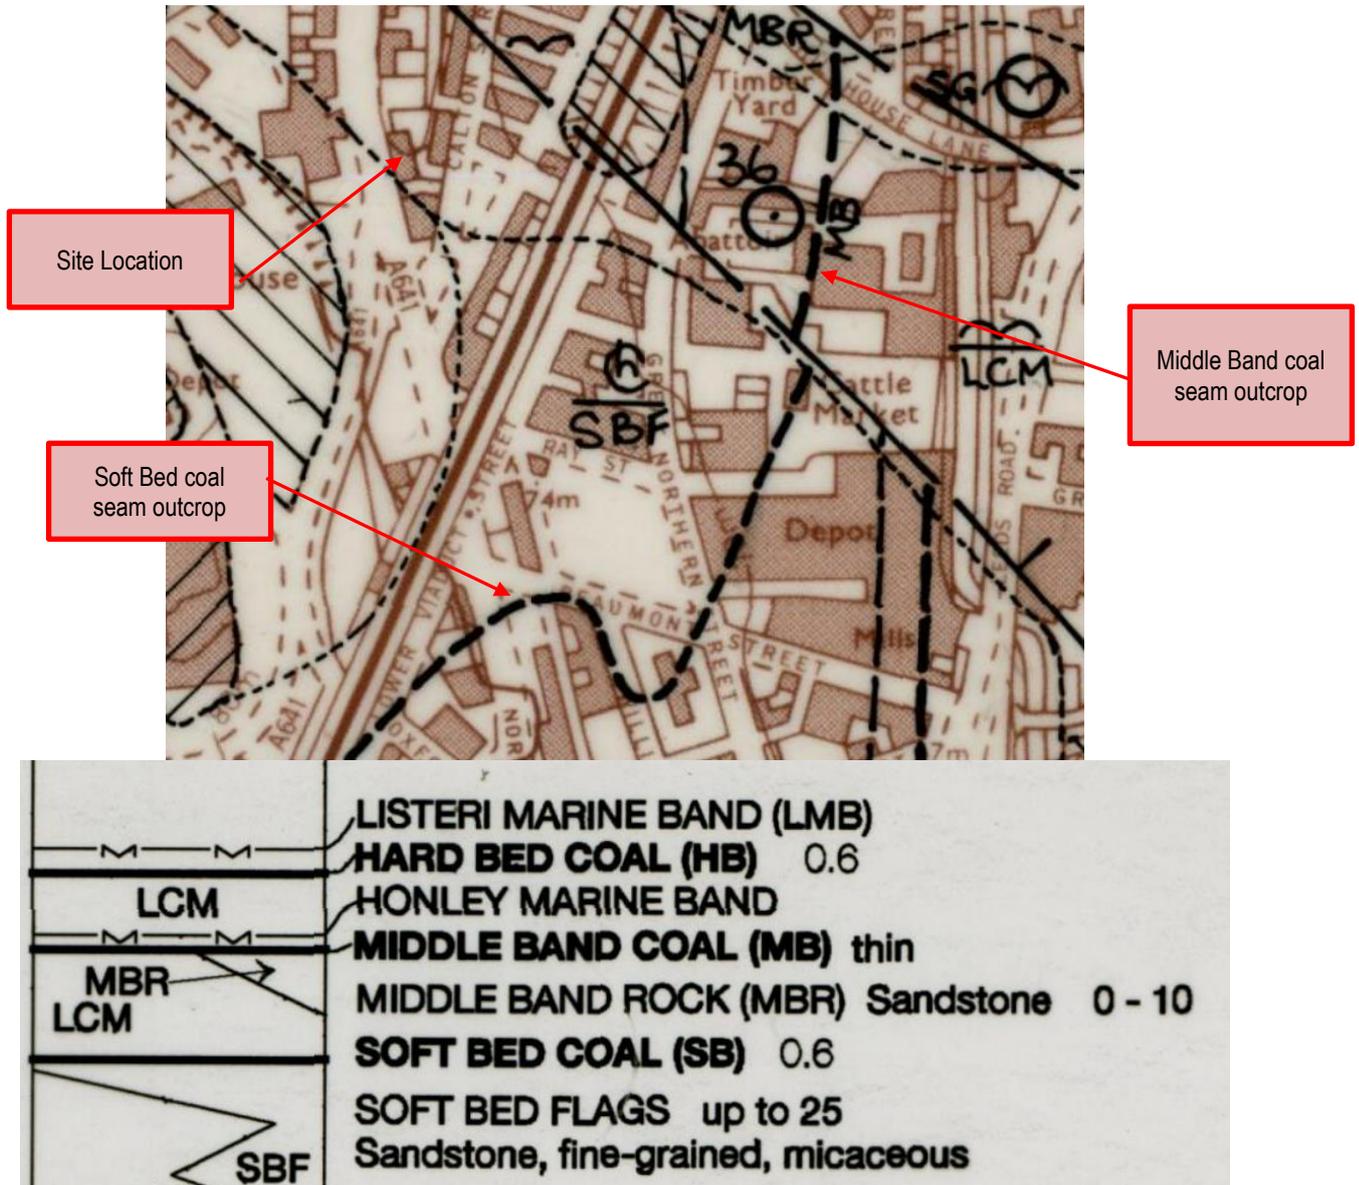
Figure 5: Geology Map Extract

3.6 An extract from the most recently published geological map (1:10,000 scale map) showing the approximate site location and key local geological features is presented in Figure 5.

3.2 The BGS states that superficial deposits consisting of alluvium underlie the site.

3.3 The bedrock geology beneath the site is shown to be the Soft Bed Flags Sandstone of the Pennine Lower Coal Measures Formation.

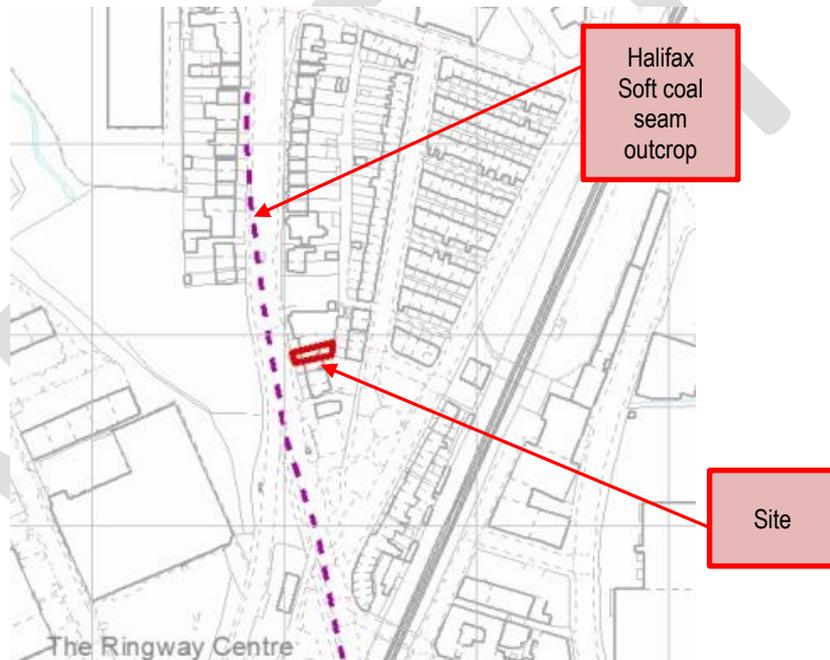
Figure 6: Coal Authority Map Extract

- 3.7 Reference to the Coal Authority Online Interactive viewer shows the site to be located within a Development High Risk Area.
- 3.8 A Coal Authority Mining Report has been acquired for the site and reveals that there are records of past underground mine workings beneath the site.
- 3.9 The worked coal seam was the Halifax Soft (1m thick) which was last worked in 1848 at a depth of 3m. The coal seam dips at 5.2 degrees to the east.
- 3.10 The Coal Authority also report indicates that the site is not located within an area of probable

shallow coal mine workings.

- 3.11 The Halifax Soft coal seam outcrops 10.8m to the west of the site.
- 3.12 There are no spine roadways recorded at shallow depth.
- 3.13 There are no geological faults, fissures or break lines recorded on the site.
- 3.14 There are no records of any opencast mines and managed tips within 500m of the site.
- 3.15 There are no records of claims regarding coal mining subsidence within 50m of the site boundary.
- 3.16 No records of mine gas have been recorded within 500m of the site boundary.
- 3.17 There are no mine water treatment schemes within 500m of the site boundary.

- 4.17 The Coal Authority consider the site area to lie within a Coal Authority Development High Risk Area due to a worked shallow worked coal seam.
- 4.18 The shallowest worked coal seam (Halifax Soft) underlying the site lies at a depth of 3m and dips 5.2 degrees to the east.
- 4.19 Given the depth of the coal seam and the limited thickness of rock cover there is a high risk to any surface structure from mine related subsidence.
