**Blackmoorfoot Road, Huddersfield
Proposed Access Arrangements
Stage 1 Road Safety Audit**

May 2025 (Rev 1)

Miller Homes & Vistry Homes Limited

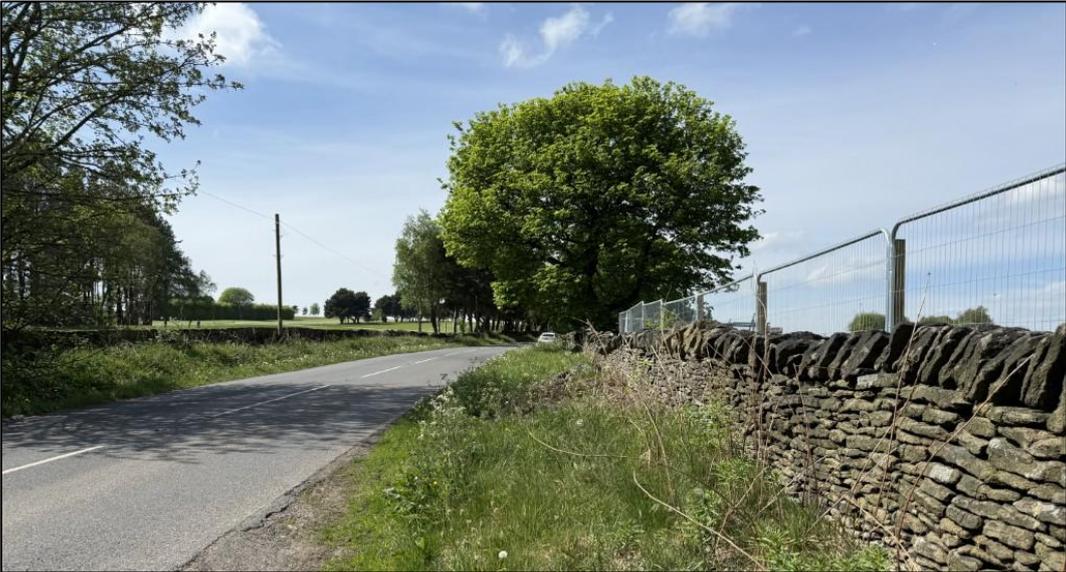
Table 2.5 Problem 5

PROBLEM	
Location	Felks Stile Road access.
Summary	The presence of existing vegetation and a parking layby restricts visibility for emerging vehicles.
<p>Visibility splays of 2.4m x 120m are indicated on drawings provided, however visibility to the northwest of the access may be restricted (particularly during summer months) due to the presence of vegetation and an overhanging tree.</p> <p>In addition, although it is acknowledged that the existing layby to the northwest of the access may not be frequently occupied, when in use (as illustrated in the image below) a parked vehicle may also restrict visibility to/from the junction.</p> <p>Insufficient visibility could lead to a collision between vehicles emerging from the Site and those travelling along Felks Stile Road.</p>

Recommendation	
It is recommended that all vegetation and obstructions within the visibility splay are cleared and appropriately maintained during the lifetime of the development and that the existing layby is removed or relocated outside the visibility splay.

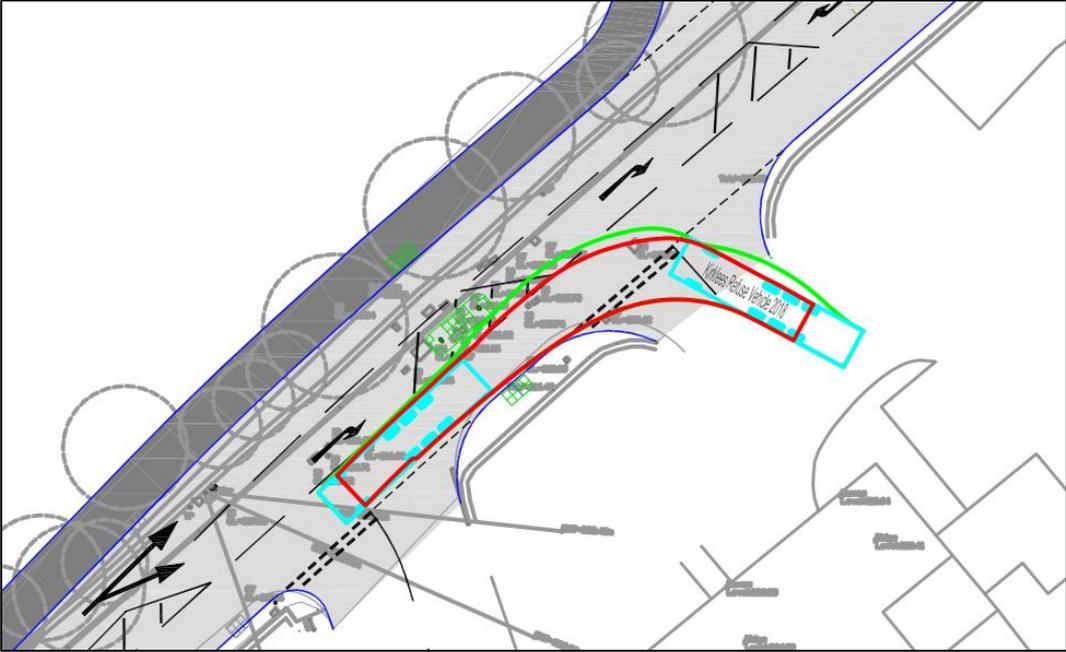
Table 2.6 Problem 6

PROBLEM	
Location	Blackmoorfoot Road – Public House access.
Summary	Potential for refuse/delivery vehicles overrunning the pedestrian refuge island.
<p>A swept path analysis is provided of a Kirklees refuse vehicle turning left out of The Sands House public house onto Blackmoorfoot Road.</p> <p>The analysis indicates that the manoeuvre is extremely tight, with minimal margin for error, due to the proximity of the proposed pedestrian refuge island located between the public house access and Sands House Lane. Based on the analysis presented, there appears to be a risk that larger vehicles could overrun or collide with the refuge island.</p> <p>Furthermore, the assumed starting position and orientation of the vehicle may not be practically achievable when considering the internal layout of the public house and the location of the bin store. In reality, larger vehicles may adopt an alternative exit path, which may increase the likelihood of a vehicle overrunning or striking the refuge island, resulting in a potential vehicle/pedestrian collision or damage to the street furniture.</p> <p>It is worth noting that the analysis adopts an inconsistent approach, with the right turn entry movement showing the vehicle travelling to the western frontage of the site, whereas the exit assumes an origin from the rear of the public house.</p>

Recommendation	
<p>It is recommended that the swept path analysis is revisited to ensure the exiting vehicle is realistically positioned and oriented. Following the revised analysis, should the swept path impact on the proposed refuge island, it is further recommended that the island be repositioned or redesigned to ensure all vehicle movements can be comfortably accommodated.</p>

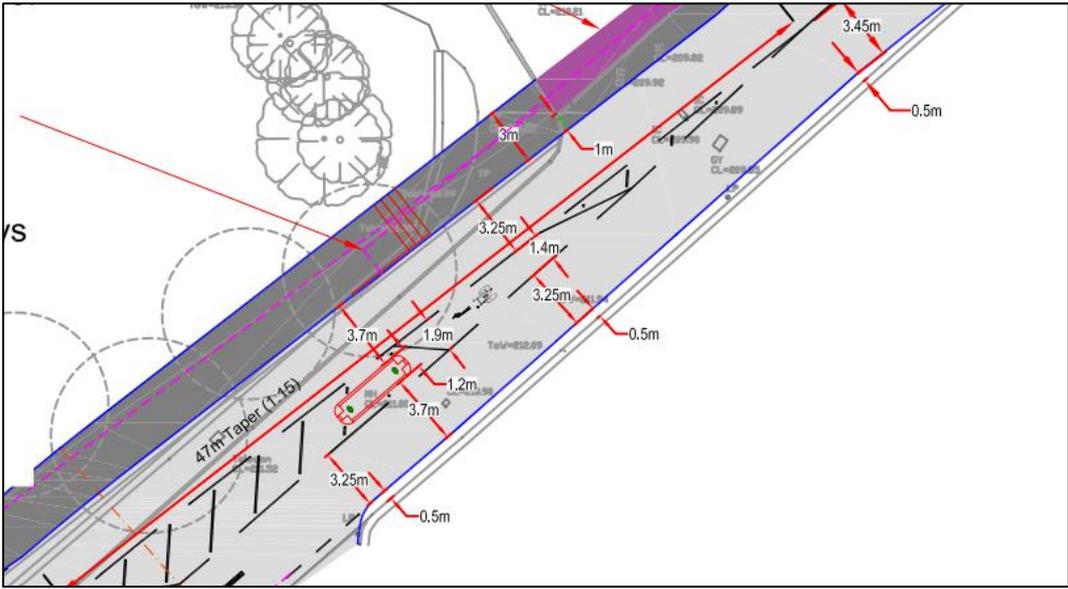
Table 2.7 Problem 7

PROBLEM	
Location	Blackmoorfoot Road access.
Summary	The splitter island may result in vehicle/cyclist collisions.
<p>The proposed design includes a 1.2m wide splitter island intended to protect cyclists turning right from Blackmoorfoot Road into the development. Through lanes of 3.7m are provided adjacent to the splitter island.</p> <p>Guidance contained within LTN 1/20 and Chapter 6 of the Traffic Signs Manual 'Traffic Control' state that lane widths between 3.2m and 3.9m should be avoided as it can encourage drivers to attempt unsafe overtaking of cyclists, when there is insufficient space to do so.</p> <p>Whilst the Road Safety Audit Team agrees that the splitter island is an important feature of the scheme, as a consequence, westbound and eastbound cycle traffic could be 'squeezed' by drivers misjudging the passing clearance, resulting in a potential vehicle/cyclist collisions.</p>

Recommendation	
<p>The Road Safety Audit Team's preferred option would be to provide lane widths of 4.0m past the splitter island, consistent with the pedestrian refuge island opposite the public house. However, the Overseeing Organisation has confirmed that this is not feasible, due to the resultant impacts on either the taper length or the right turn lane length.</p> <p>As such, it is recommended that either the right turn cycle facility and island are removed or additional measures are provided to discourage overtaking such as widening the island, providing red thermoplastic surfacing within the central hatching on both the approach to and around the island (to visually reinforce the through lane width), provide road markings (cycle symbol for example) past the island to indicate a cyclists expected road positioning or whether warning signage could be provided.</p>

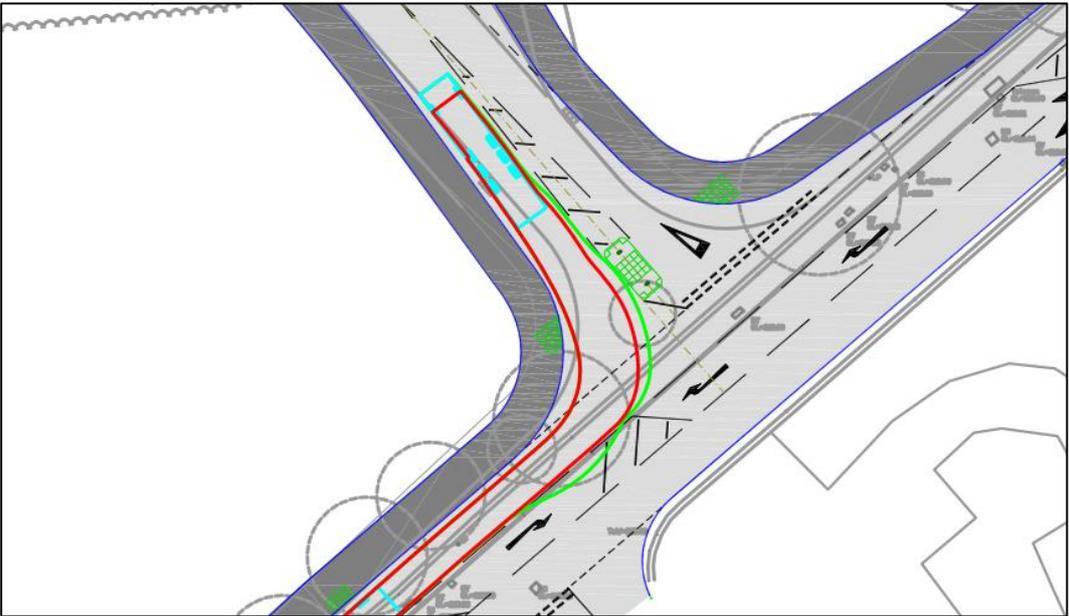
Table 2.8 Problem 8

PROBLEM	
Location	Blackmoorfoot Road access.
Summary	The width of the pedestrian refuge island may result in vehicle/cyclist collisions.
<p>The side arm of the junction includes a 2.0m wide pedestrian refuge island, connecting to a 3.0m wide shared footway/cycleway along Blackmoorfoot Road. The Road Safety Audit Brief states that the reduced width of the island has been provided in order to minimise tree loss.</p> <p>The swept path analysis confirms that both buses and refuse vehicles entering the development require the full width of the lane, with minimal margin for error, passing in very close proximity to the island.</p> <p>Although the Road Safety Audit Team acknowledges that use of the island by larger bicycles may be limited, there is concern that the narrower island width could lead to vehicles encroaching on cyclists using the island, if a cyclist (particularly a less experienced rider) does not position themselves entirely within the island, increasing the risk of a vehicle/cyclist collision.</p>

Recommendation	
It is recommended that the island is increased to 3.0m in accordance with LTN 1/20 guidance.

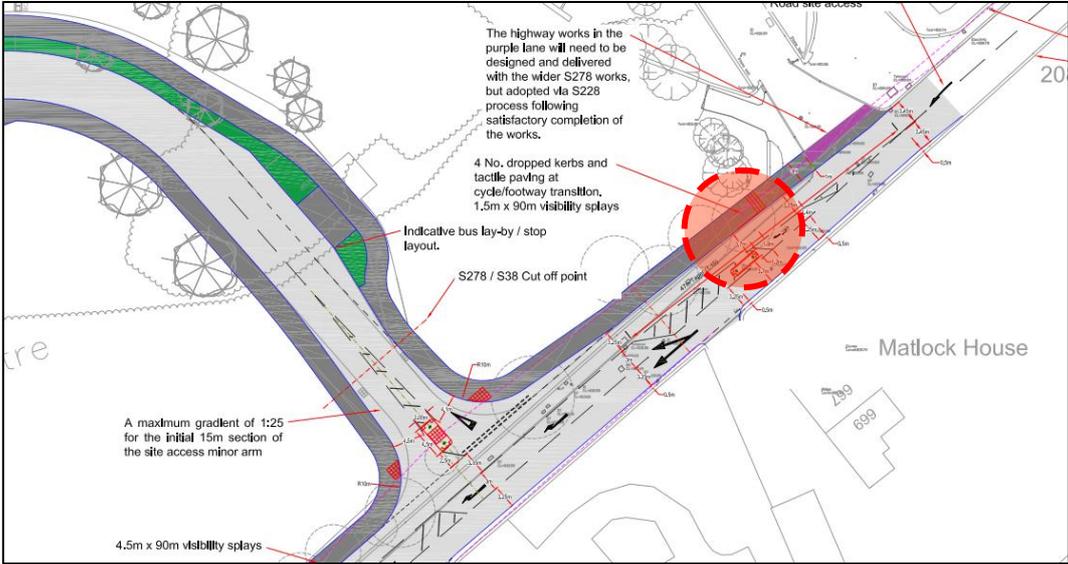
Table 2.9 Problem 9

PROBLEM	
Location	Blackmoorfoot Road access.
Summary	Lack of advisory cycle lane road markings
<p>A dropped kerb, tactile paving and advisory cycle lane road markings are provided to the west of the junction to denote the start of the shared footway/cycle provision. At the end of the shared footway/cycle, dropped kerbs and tactile paving are provided, however the advisory cycle lane markings have not been provided (consistent with the Felks Stile Road junction).</p> <p>The provision of a short length of advisory cycle lane, raises awareness of the likelihood of a cyclist entering the carriageway, therefore the absence of the road markings could increase the potential for a cyclist being struck by an oncoming vehicle, discharging into the carriageway.</p> <p>Although it is acknowledged that this is a preliminary design, the use of tactile paving at the start and end of the shared facility, rather than corduroy, may cause confusion for visually impaired users by failing to distinguish between pedestrian and cycle routes.</p>

Recommendation	
It is recommended that a short length of advisory cycle lane road markings are provided at the end of the shared footway/cycleway and that the tactile paving is stipulated corduroy paving at the detailed design stage.

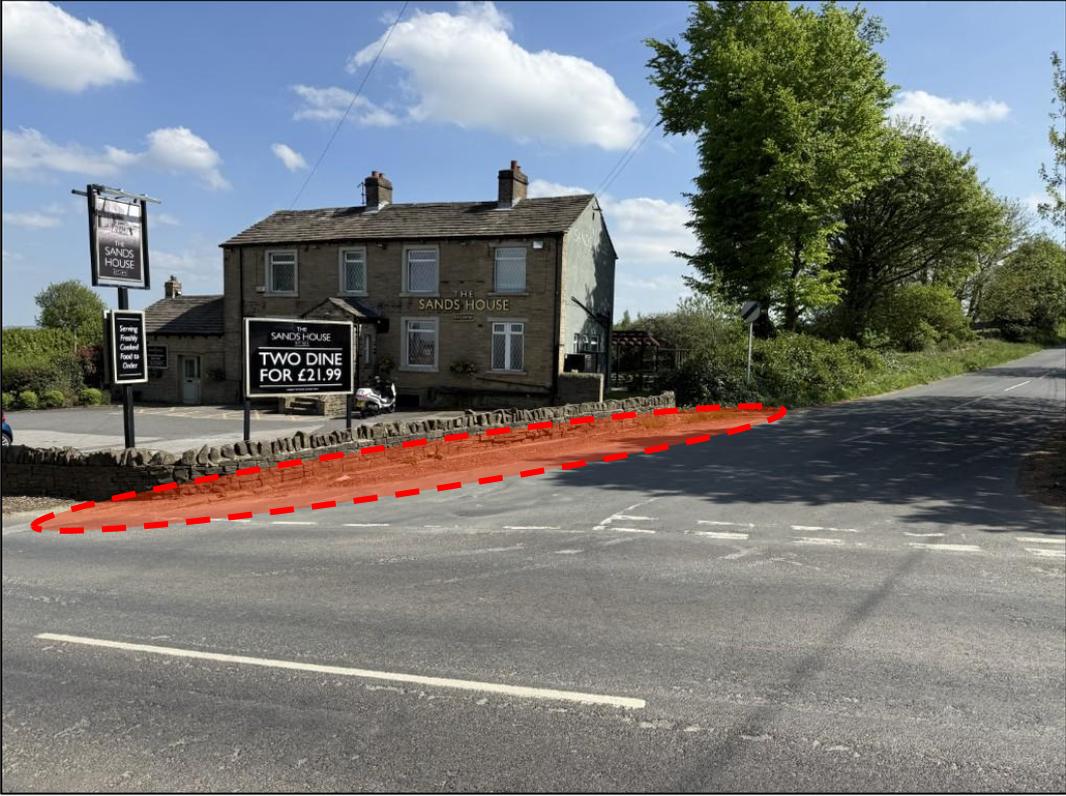
Table 2.10 Problem 10

PROBLEM	
Location	Blackmoorfoot Road pedestrian crossing.
Summary	Pedestrians are encouraged to walk on the carriageway.
<p>A new pedestrian refuge island is proposed between the development and the existing public house. In order to accommodate the crossing, a short length of footway is proposed along the frontage of the public house, however this footway terminates before reaching both the vehicular access to the public house and the Blackmoorfoot Road/Sands House Lane junction. As a result, pedestrians accessing the public house must either walk within the bell mouth of the vehicular access or walk along the edge of the carriageway to reach the pedestrian access located along Sands House Lane. The absence of a suitable pedestrian connection may increase the potential for a pedestrian/vehicle collision.</p>

Recommendation	
<p>It is recommended that the proposed footway is extended around the Blackmoorfoot Road/Sands House Lane junction, using the apparent unused area of the carriageway along the eastern flank of Sands house Lane, in order to connect with the existing pedestrian access to the public house.</p>

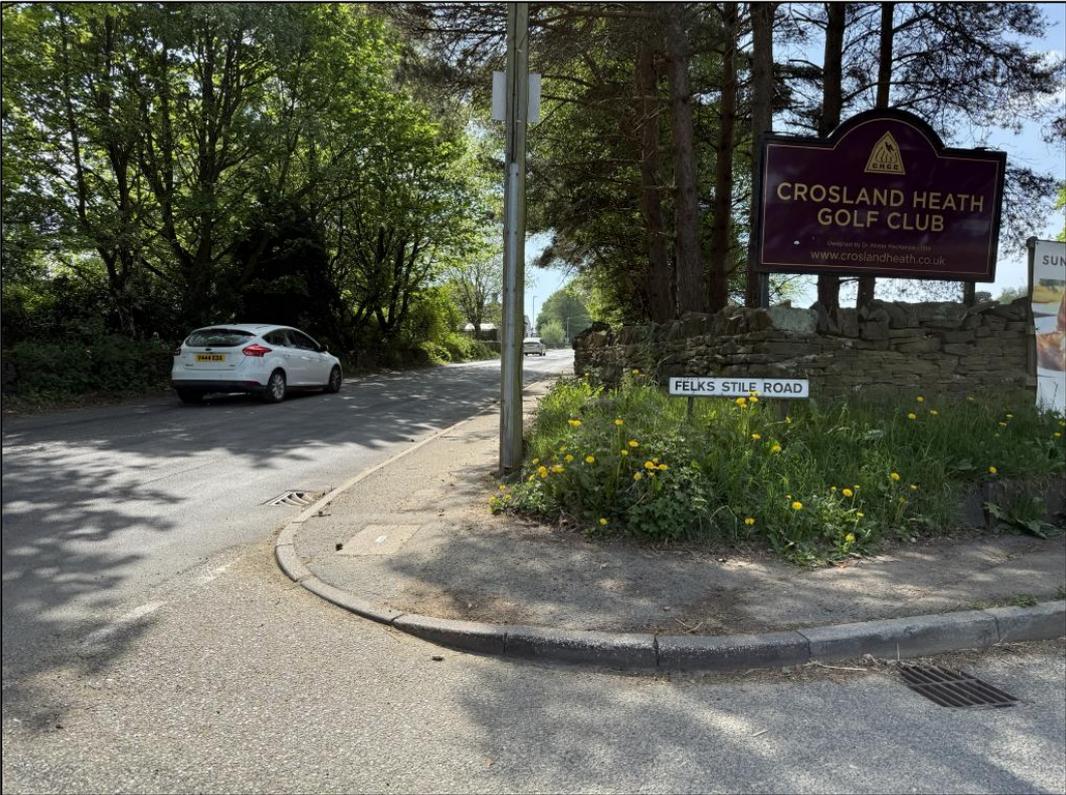
Table 2.11 Problem 11

PROBLEM	
Location	Blackmoorfoot Road/Felks Stile Road access.
Summary	Visibility to the southwest is restricted.
<p>Visibility at the Blackmoorfoot Road/Felks Stile Road junction is restricted in both directions, due to the narrow footway and presence of a stone boundary wall.</p> <p>Visibility to the northeast is restricted to 2.4m x 20.8m (as noted on drawing 425-92-103.01 rev P), but is proposed to be improved to 2.4m x 120m by widening the footway and reconstructing the boundary wall.</p> <p>The existing level of visibility to the southwest is not indicated on the drawing, but was observed to fall well short of 120m. Although it is noted that enhanced speed limit measures are proposed on the approach to the junction, it is considered unlikely that these alone would reduce speeds to align with the level of visibility provided.</p> <p>The restricted visibility and increased use of the junction resulting from the development, may increase the risk of a vehicle/vehicle collision.</p>

Recommendation	
<p>It is recommended that the existing level of visibility is confirmed. If visibility is found to fall short of recommended levels, it is recommended that further speed restraint measures are introduced. The Road Safety Audit Team noted that a substandard ghost island right turn pocket is provided at the junction, which could potentially be removed to allow the footway along Blackmoorfoot Road to be widened. This may allow the giveaway position to be relocated to improve visibility in both directions. This potential solution may also reduce the extent of wall reconstruction identified to the north of the junction.</p>

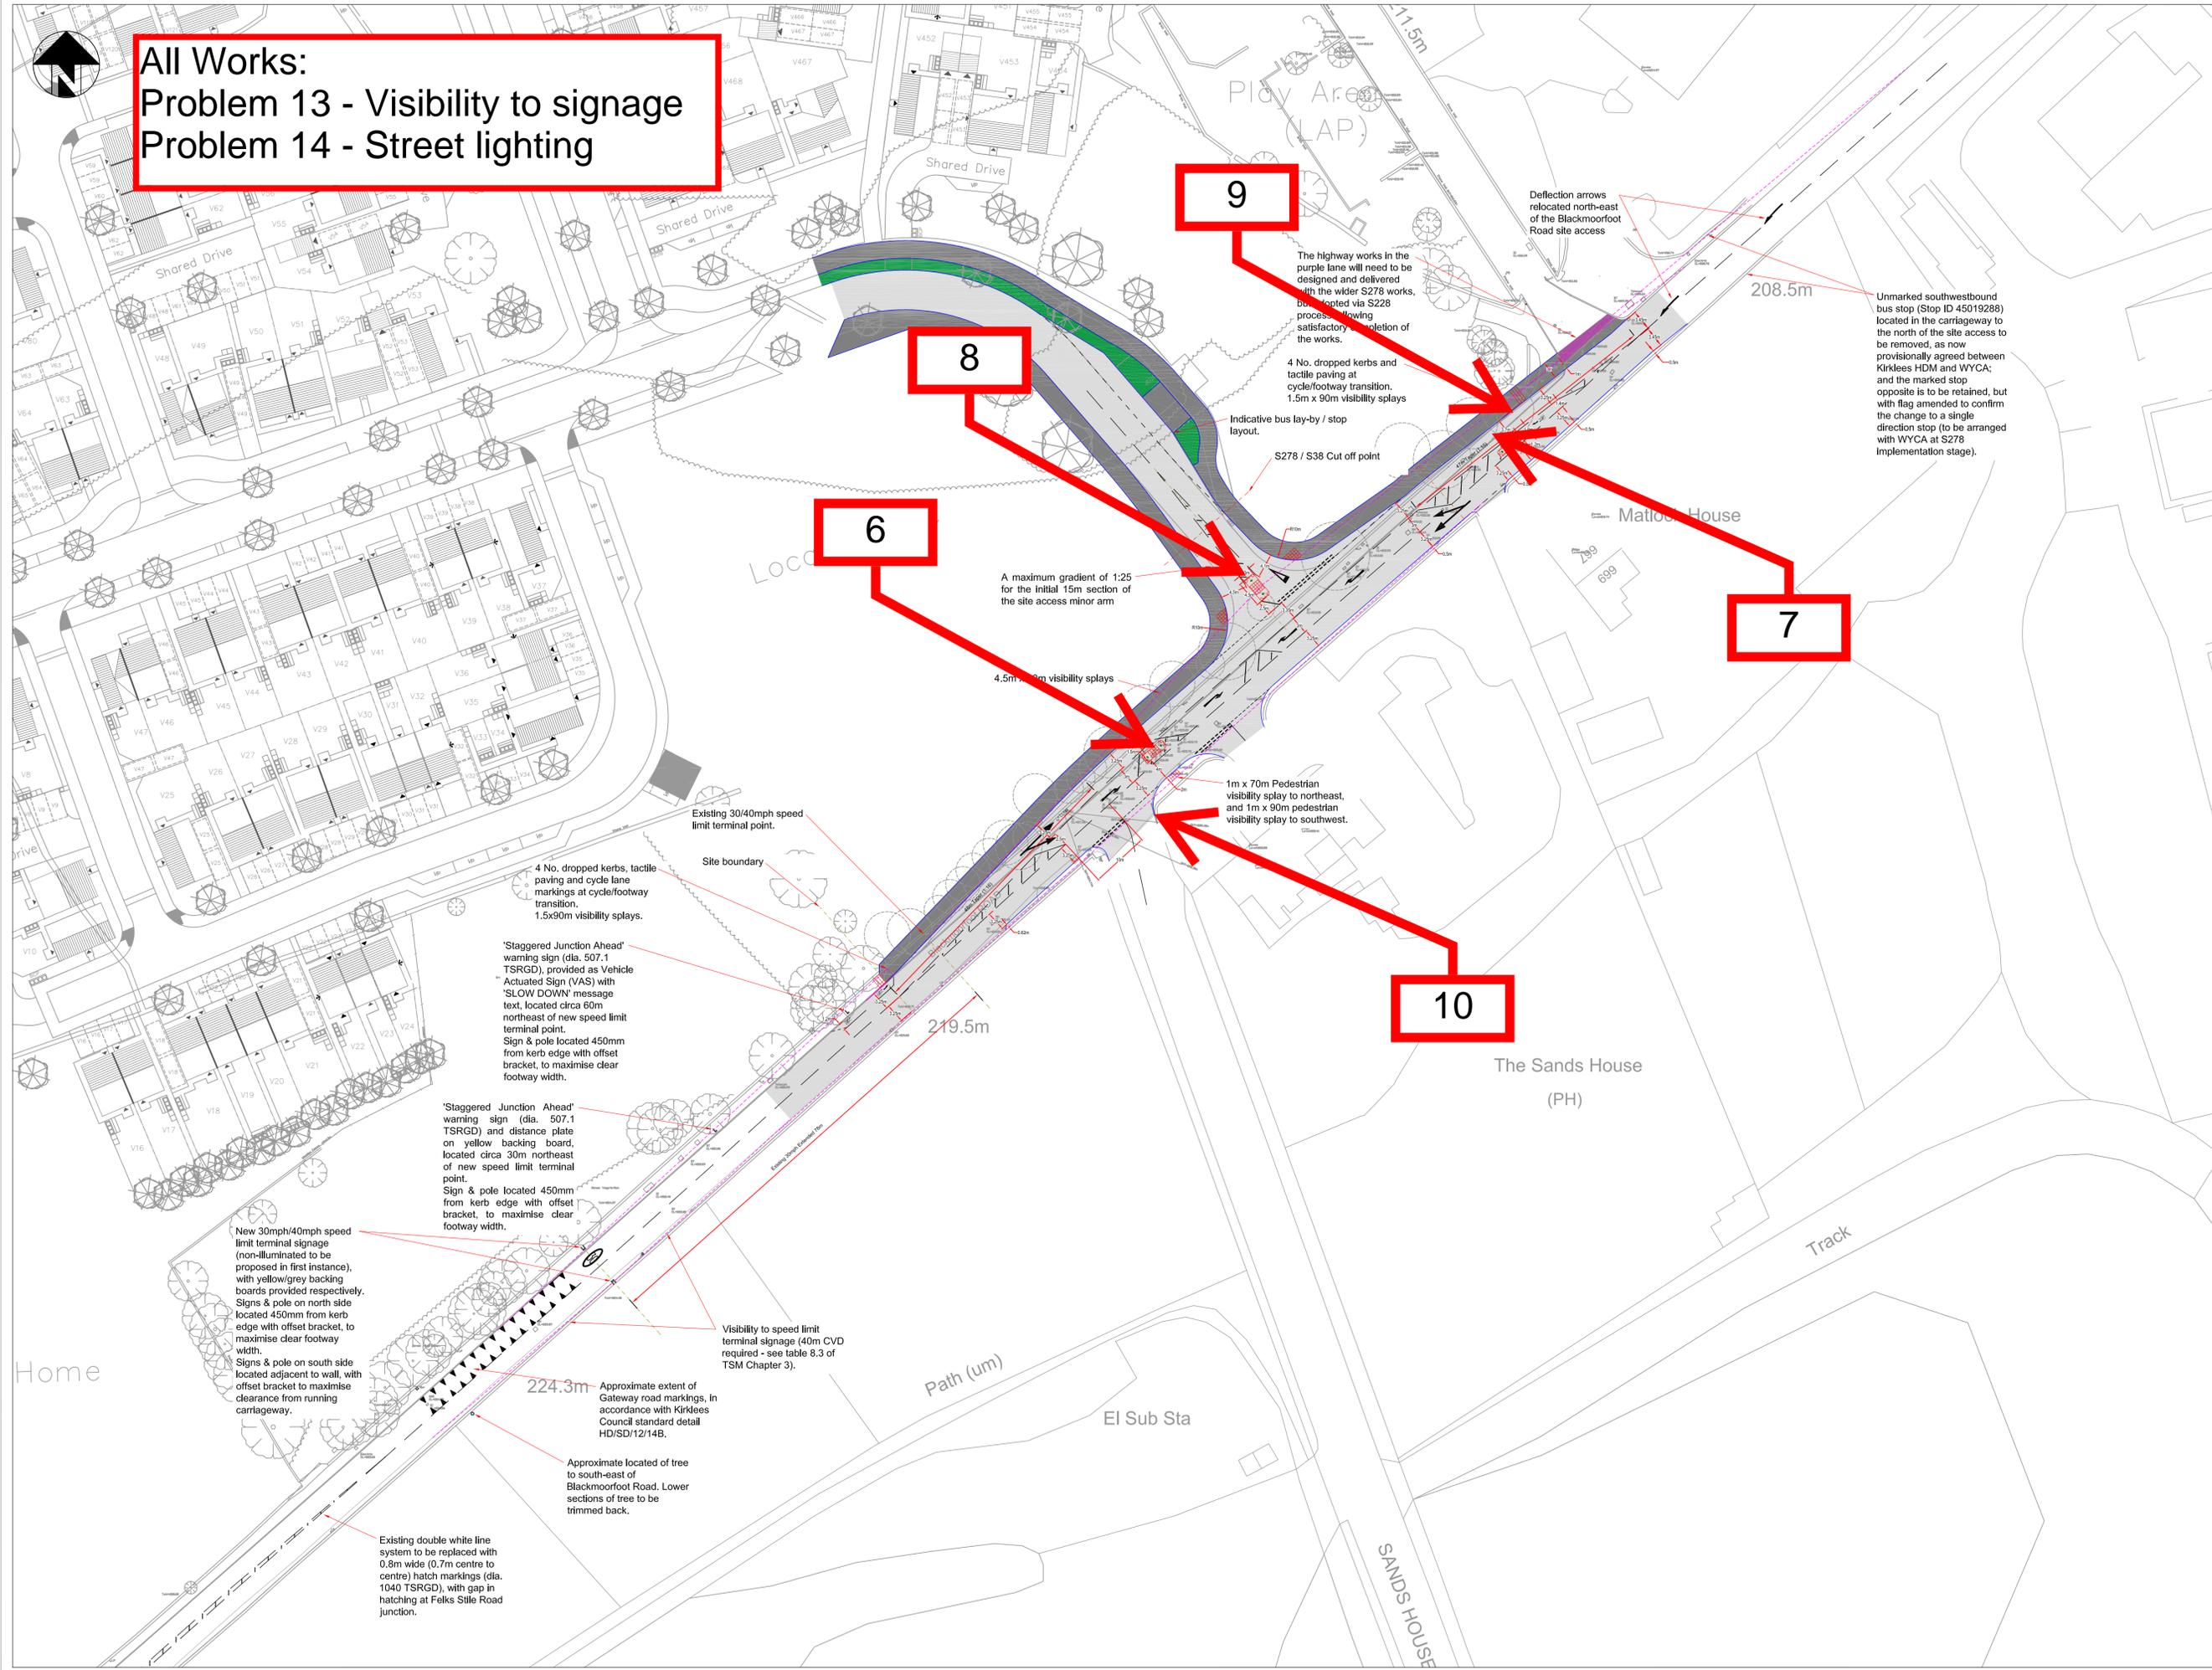
All Works:
Problem 13 - Visibility to signage
Problem 14 - Street lighting

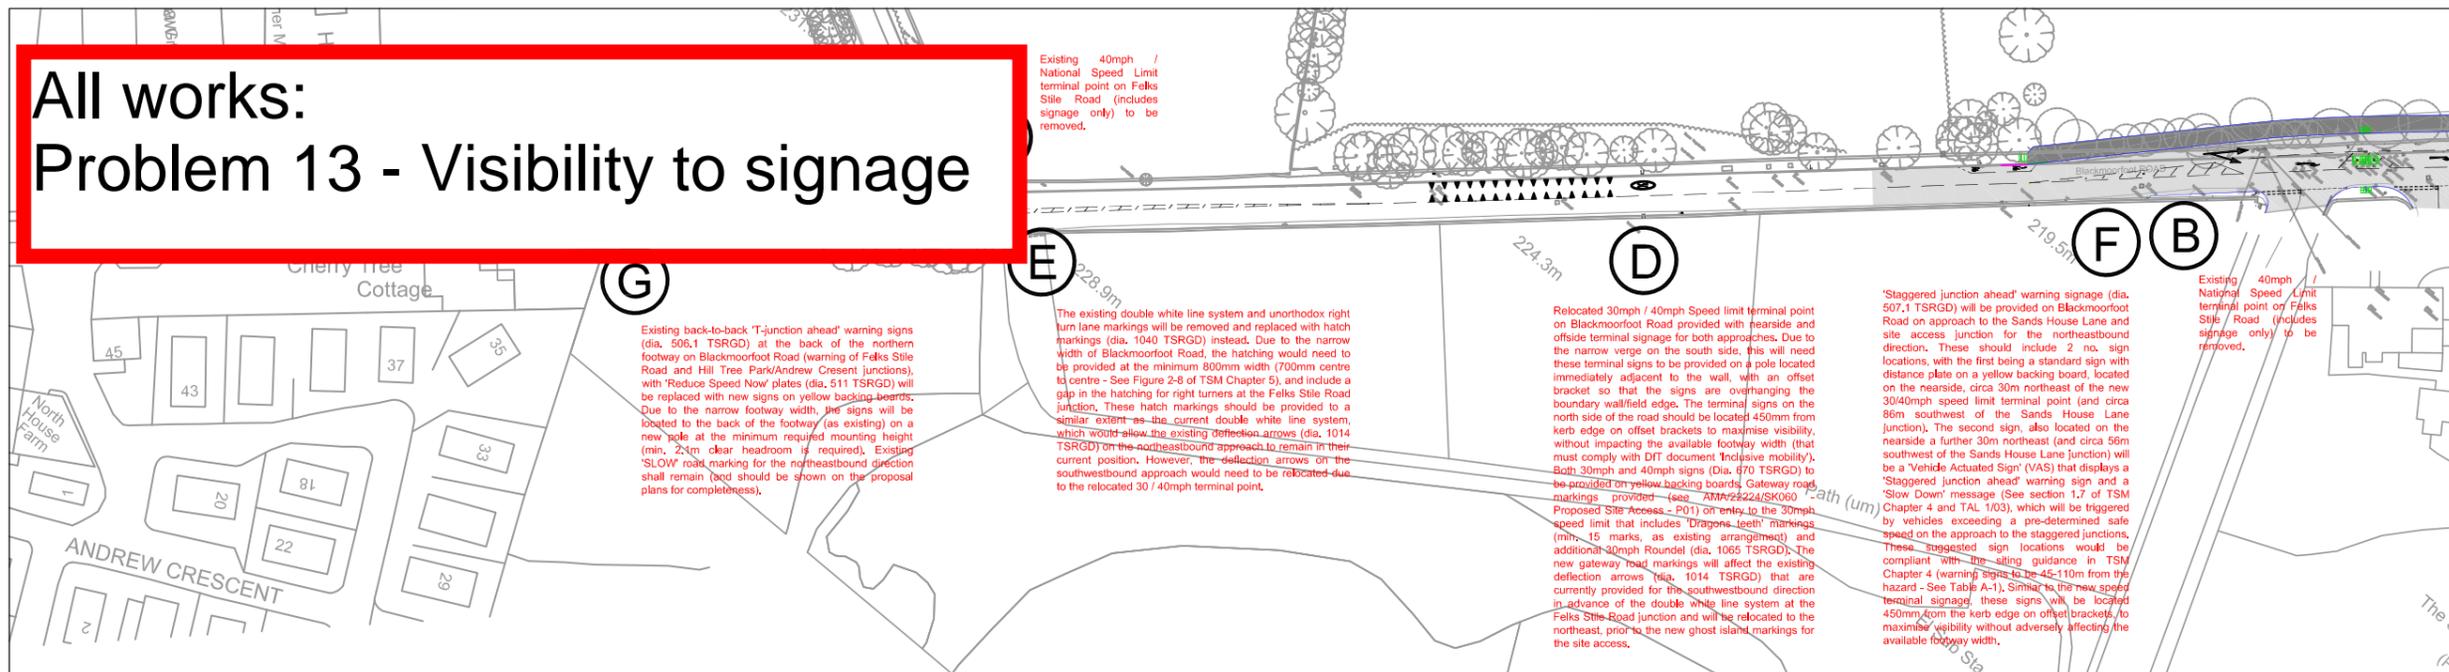
All works: Problem 13 - Visibility to signage

Existing back-to-back 'T-junction ahead' warning signs (dia. 506.1 TSRGD) at the back of the northern footway on Blackmoorfoot Road (warning of Felks Site Road and Hill Tree Park/Andrew Crescent junctions), with 'Reduce Speed Now' plates (dia. 511 TSRGD) will be replaced with new signs on yellow backing boards. Due to the narrow footway width, the signs will be located to the back of the footway (as existing) on a new pole at the minimum required mounting height (min. 2.2m clear headroom is required). Existing 'SLOW' road marking for the northeastbound direction shall remain (and should be shown on the proposal plans for completeness).

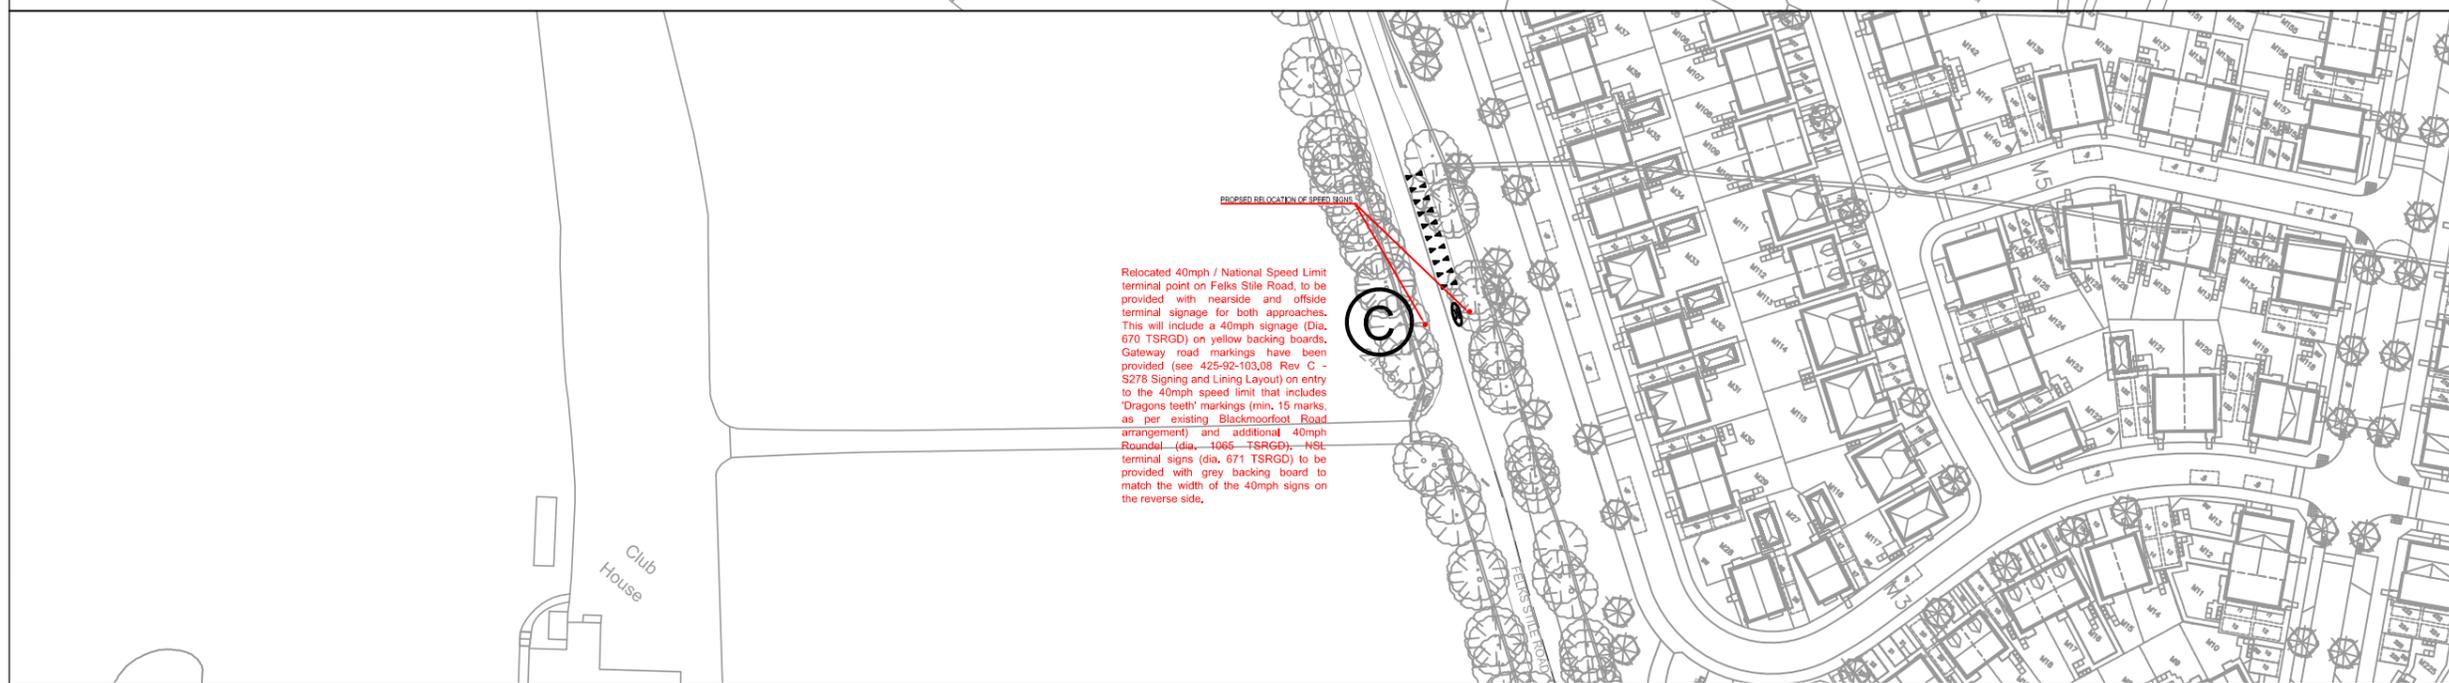
Relocated 40mph / National Speed Limit terminal point on Felks Site Road, to be provided with nearside and offside terminal signage for both approaches. This will include a 40mph signage (Dia. 670 TSRGD) on yellow backing boards. Gateway road markings have been provided (see 425-92-103,08 Rev C - S278 Signing and Lining Layout) on entry to the 40mph speed limit that includes 'Dragons teeth' markings (min. 15 marks, as per existing Blackmoorfoot Road arrangement) and additional 40mph Roundel (dia. 1065 TSRGD). NSL terminal signs (dia. 671 TSRGD) to be provided with grey backing board to match the width of the 40mph signs on the reverse side.

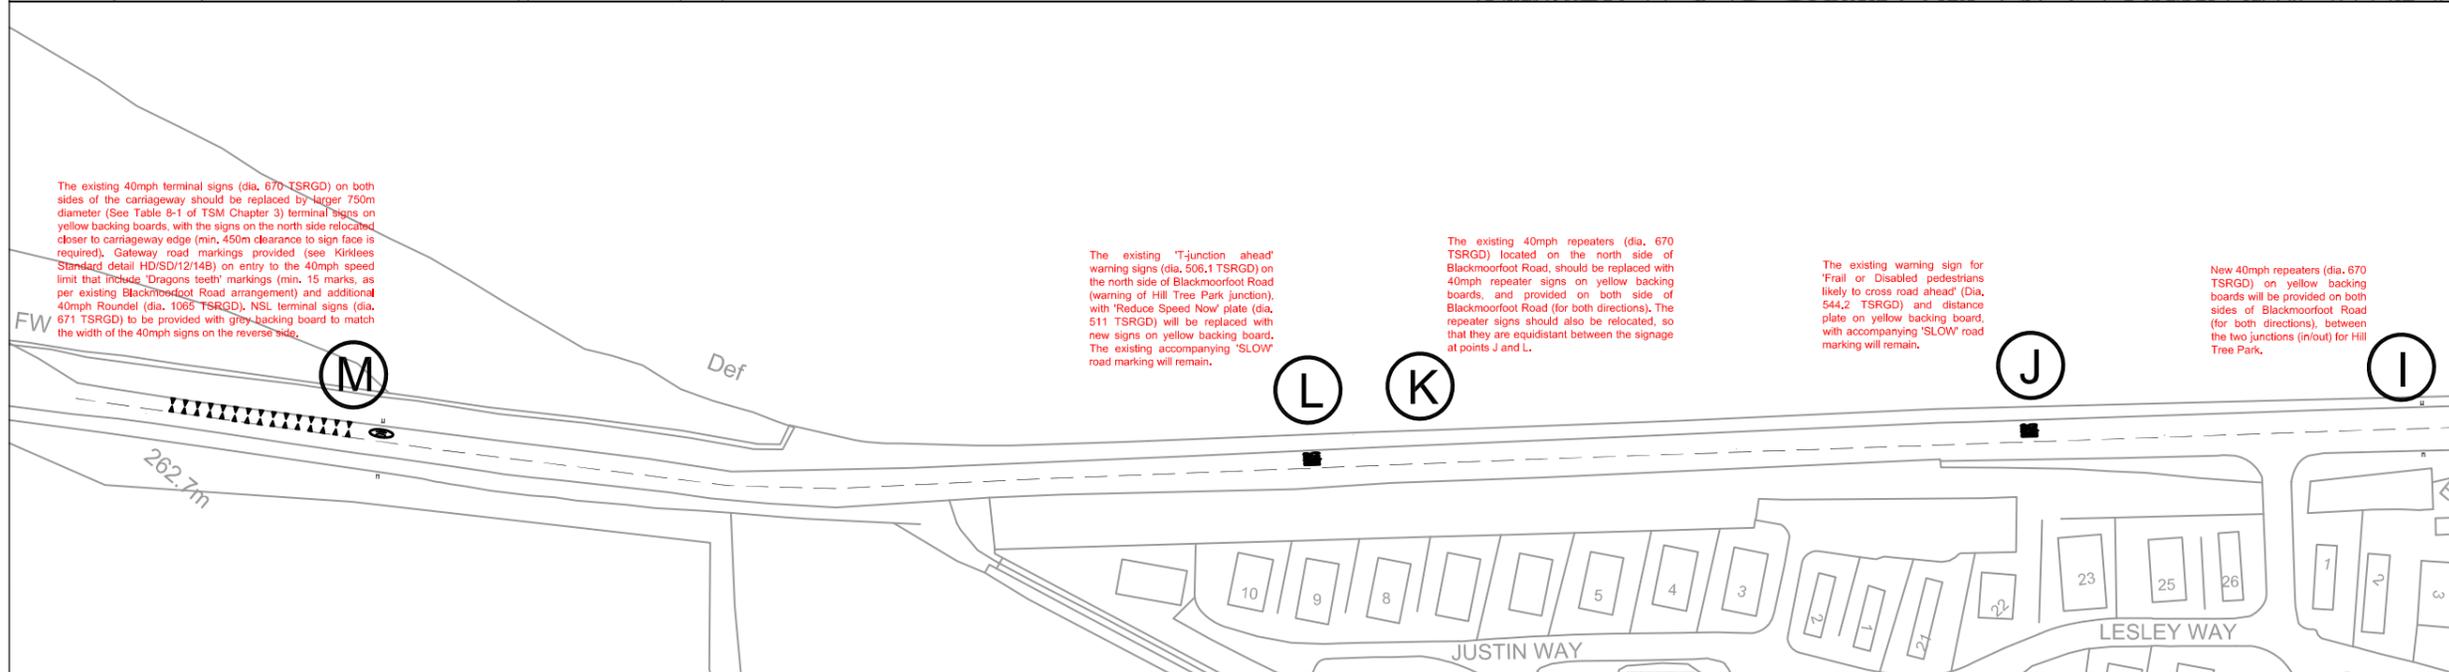
The existing 40mph terminal signs (dia. 670 TSRGD) on both sides of the carriageway should be replaced by larger 750m diameter (See Table 8-1 of TSM Chapter 3) terminal signs on yellow backing boards, with the signs on the north side relocated closer to carriageway edge (min. 450m clearance to sign face is required). Gateway road markings provided (see Kirklees Standard detail HD/SD/12/148) on entry to the 40mph speed limit that includes 'Dragons teeth' markings (min. 15 marks, as per existing Blackmoorfoot Road arrangement) and additional 40mph Roundel (dia. 1065 TSRGD). NSL terminal signs (dia. 671 TSRGD) to be provided with grey backing board to match the width of the 40mph signs on the reverse side.
