Geoenvironmental Appraisal

Land off Ashbourne Drive, Cleckheaton For Newett Homes

Report no: 1462/4

Date: January 2024

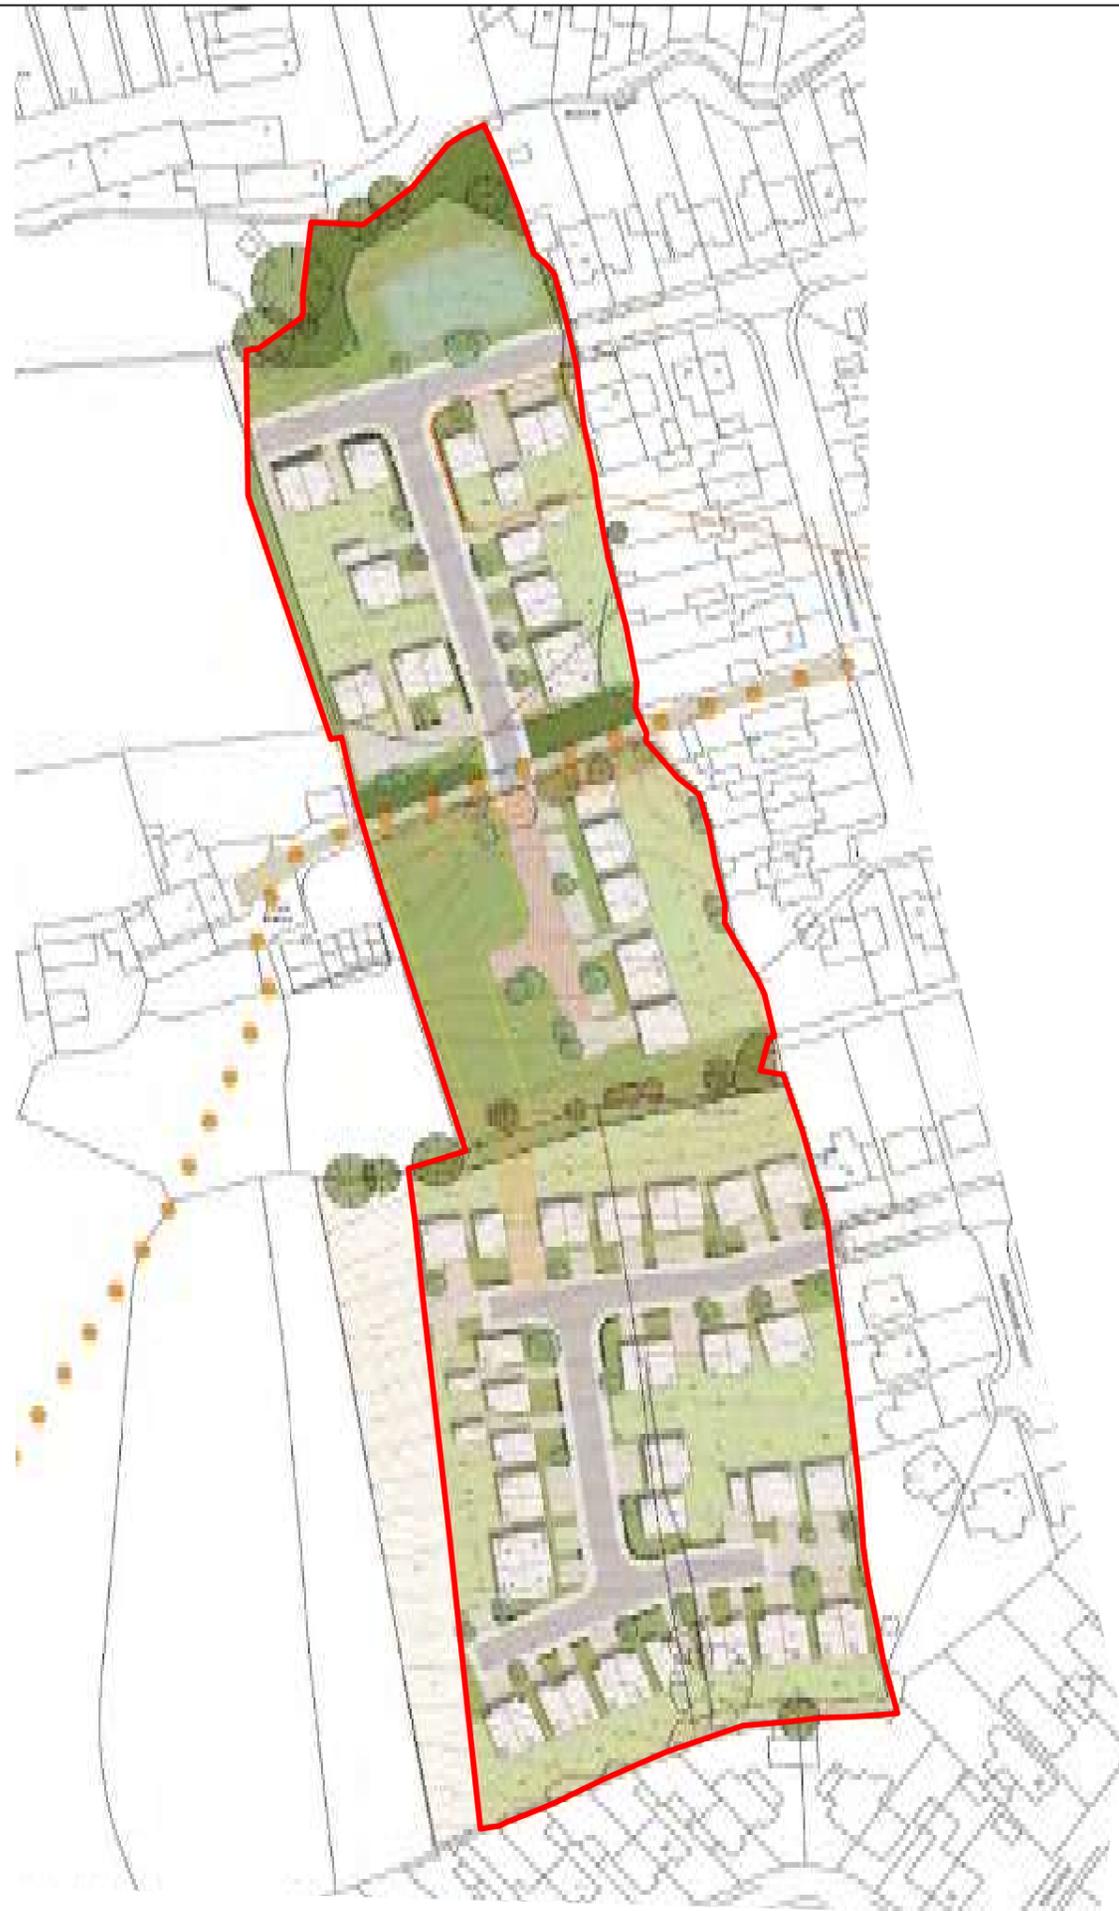
SCALE	1:1500	SHEET	A3	DRAWING NO.	1462/2	REVISION	
-------	--------	-------	----	-------------	--------	----------	--

— APPROXIMATE SITE BOUNDARY

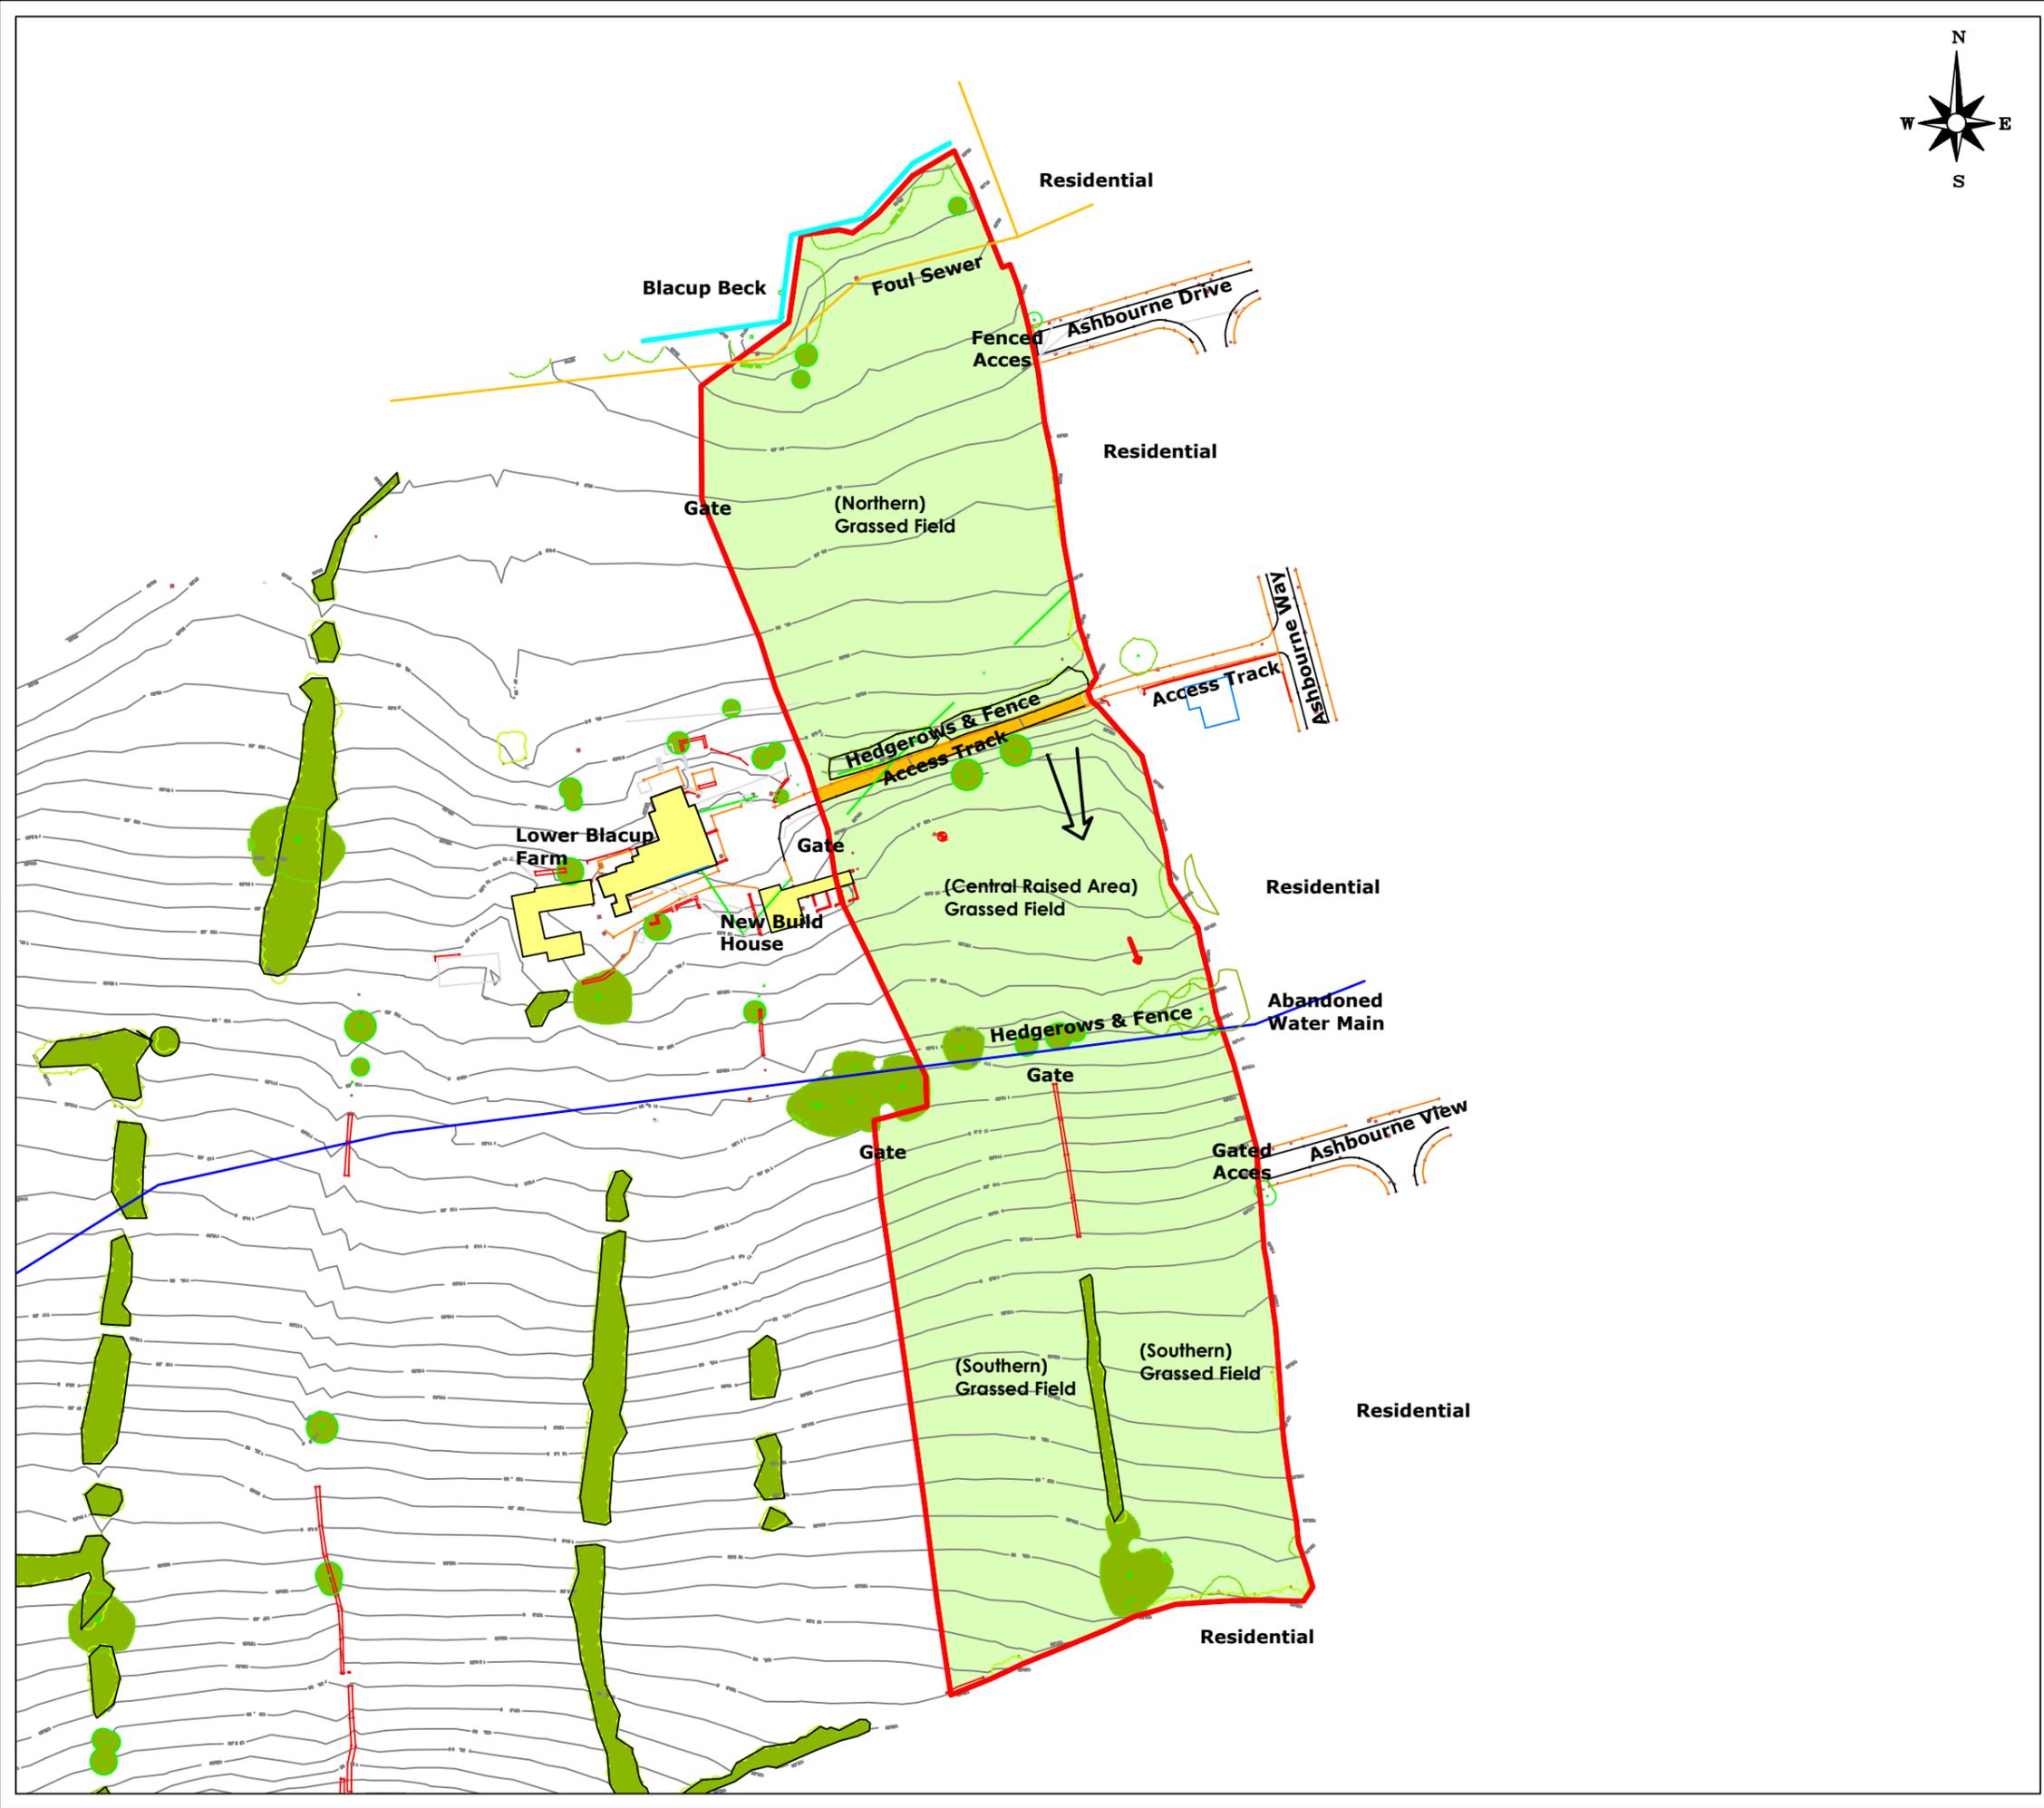
SCALE 1:1500	SHEET A3	DRAWING NO. 1462/3	REVISION
-----------------	-------------	-----------------------	----------

- NOTES
- GRASS & OVERGROWN AREAS
 - BUILDING
 - GRAVEL OR HARDCORE SURFACING
 - APPROXIMATE SITE BOUNDARY
 - EXISTING FOUL SEWER
 - ABANDONED WATER MAIN
 - OVERHEAD TELECOM
- NOTE: LIST OF SERVICES NOT EXTENSIVE, LOCATIONS APPROXIMATE ONLY.

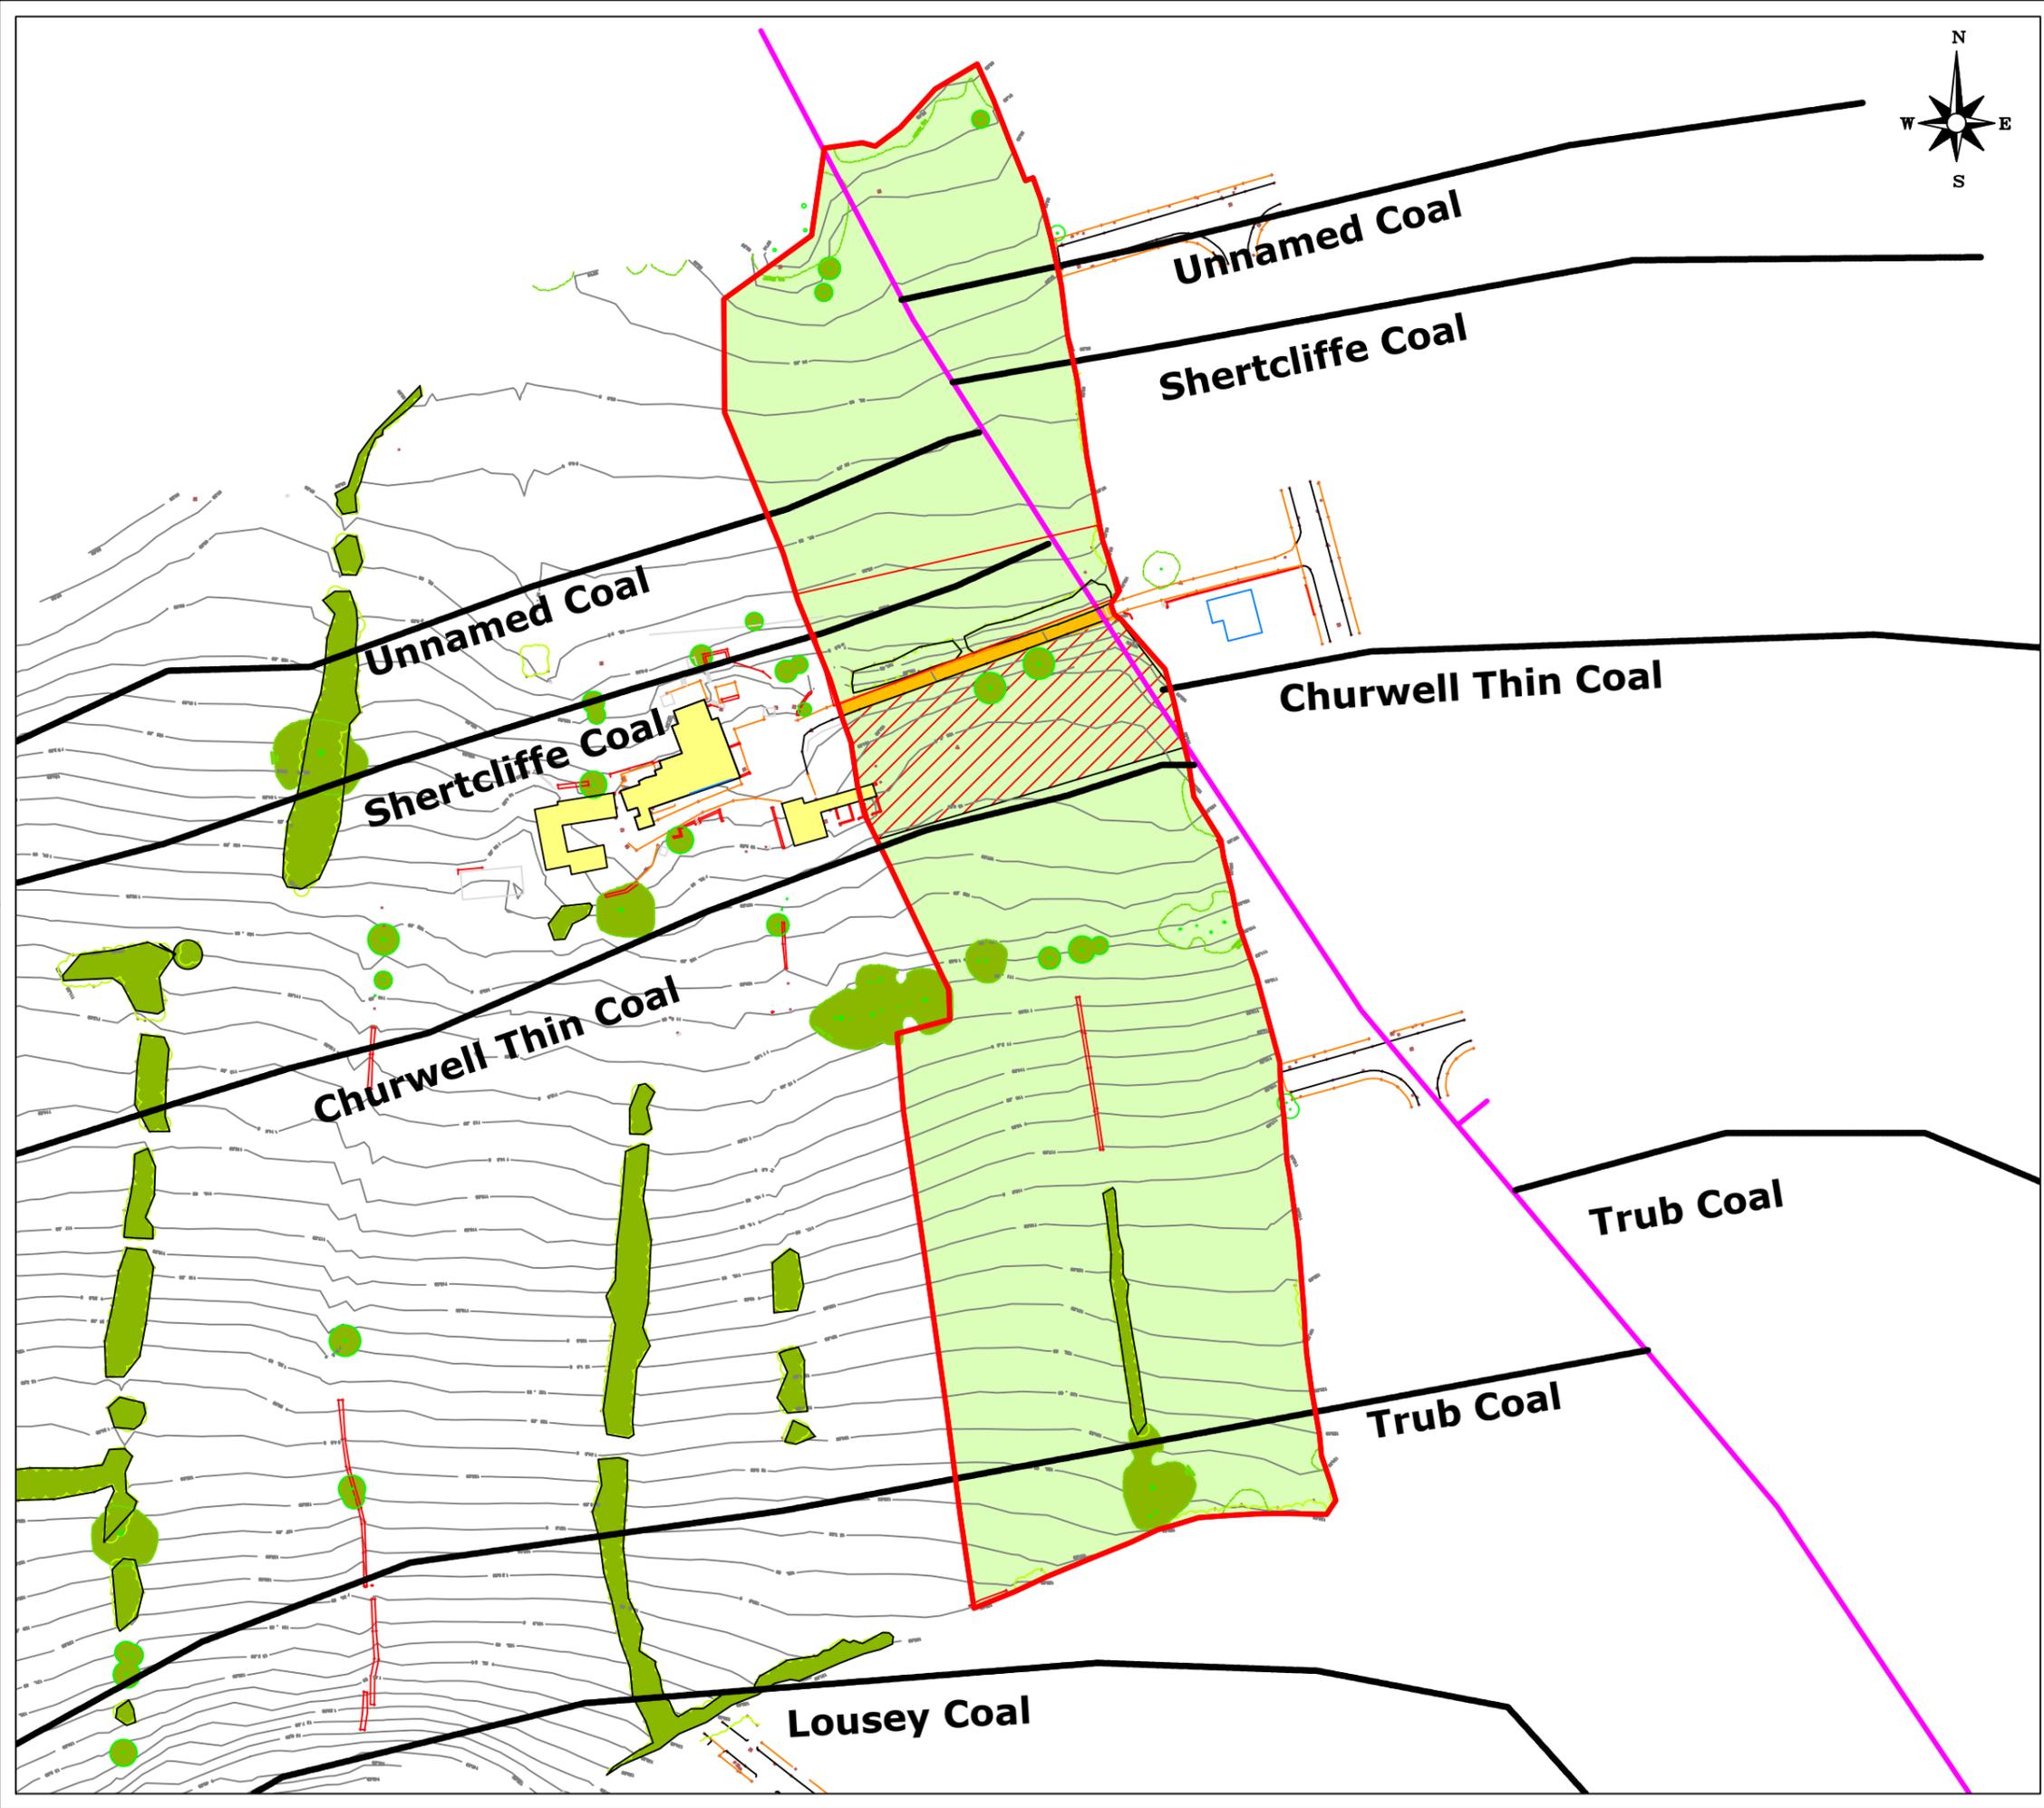
SCALE 1:1500	SHEET A3	DRAWING NO. 1462/5	REVISION
-----------------	-------------	-----------------------	----------

- NOTES
- GRASS & OVERGROWN AREAS
 - BUILDING
 - GRAVEL OR HARDCORE SURFACING
 - APPROXIMATE SITE BOUNDARY
 - APPROXIMATE COAL OUTCROP
 - APPROXIMATE GEOLOGICAL FAULT

NOTES: OUTCROPS AND LINE OF GEOLOGICAL FAULT INFERRED FROM BGS 1:10,000 SCALE PLAN SE 12 SE

- 4.3.7 Faults are usually bordered by a shatter zone where the coal is degraded. The nature and extent of a shatter zone varies according to the intensity of the faulting. Early and modern mining practice was to leave the coal in the shatter zone untouched as it was of little economic value.
- 4.3.8 Thus, there is usually an unworked margin between the workings and the fault, which based on observations elsewhere might be about 60m wide (30m either side of the fault).
- 4.3.9 Approximate outcrops and the line of the geological fault are shown on Drawing 1462/5 in Appendix B.

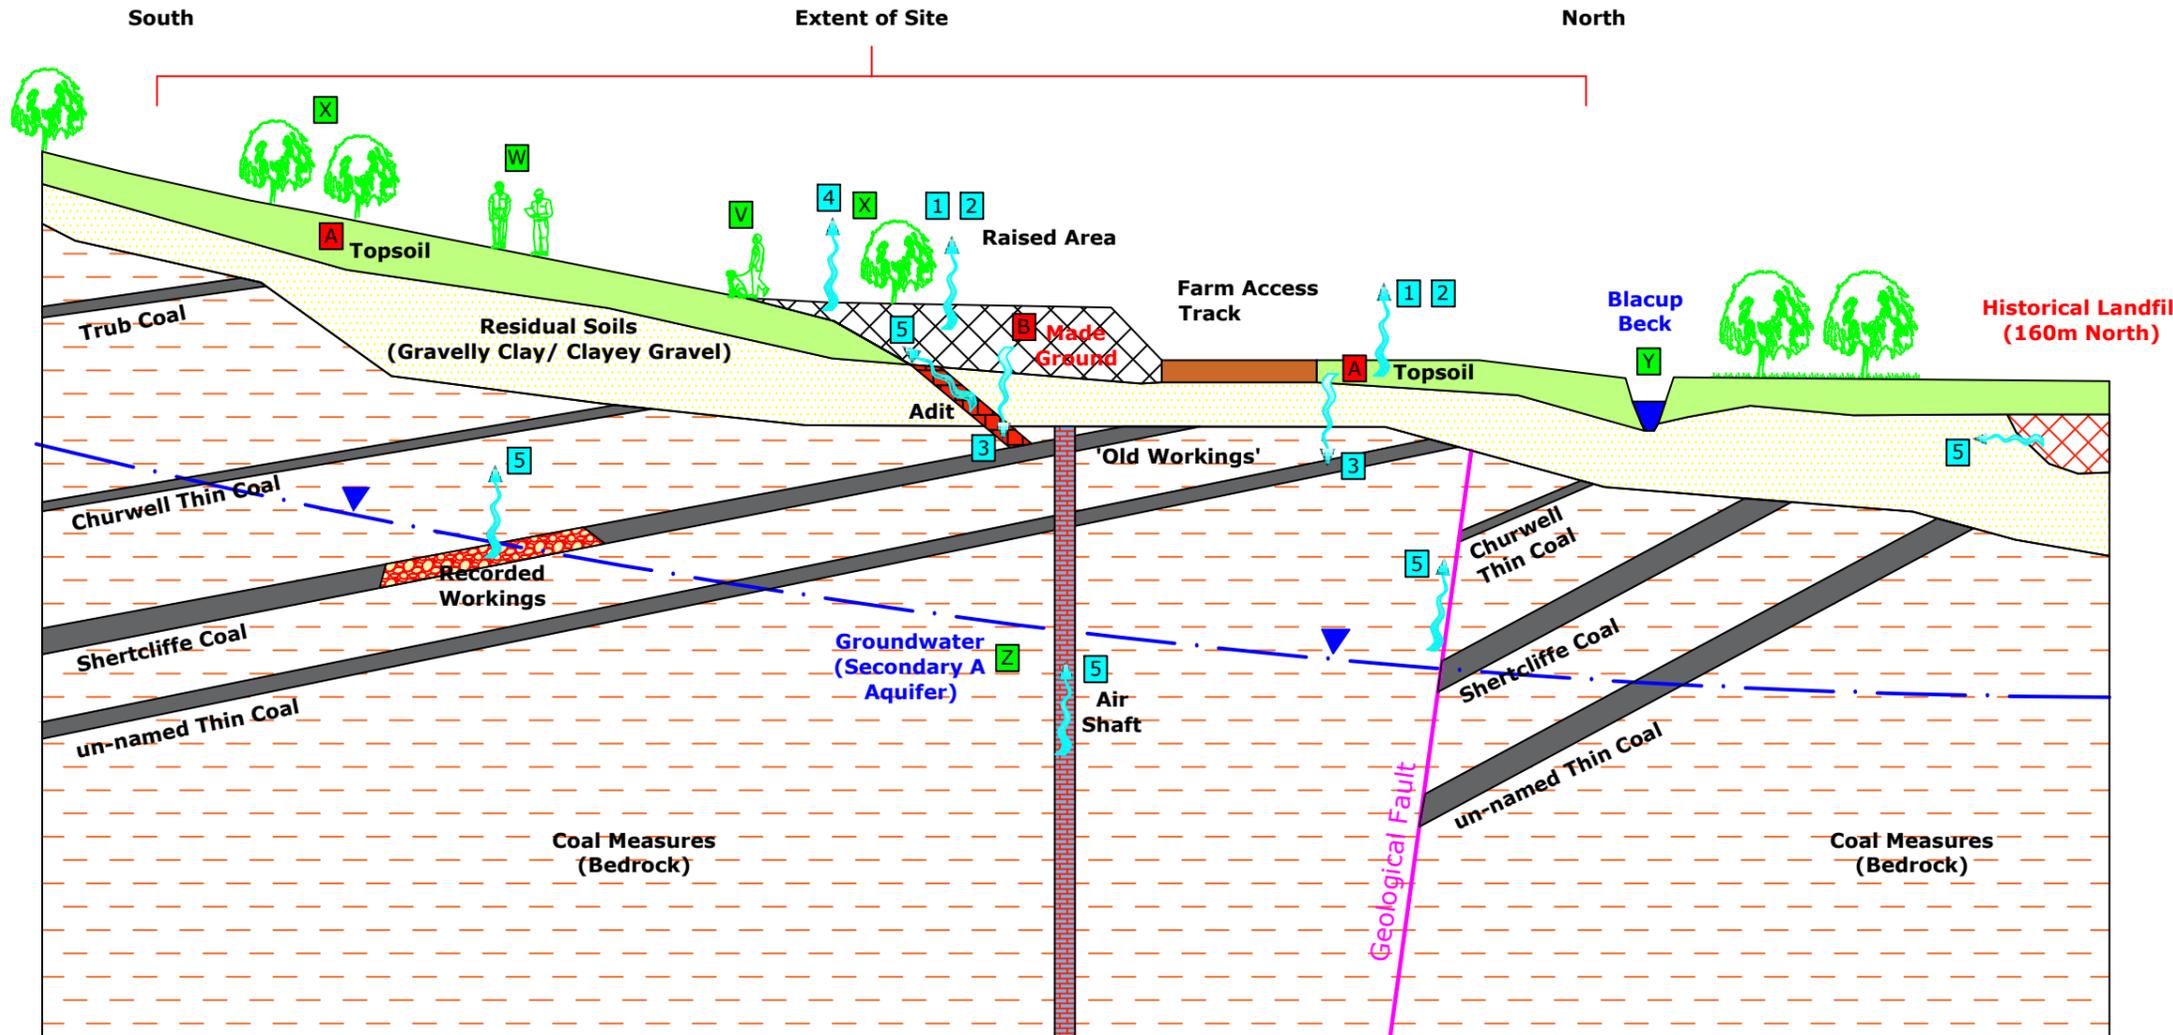
SCALE Not to scale	SHEET A3	DRAWING NO. 1462/6	REVISION
-----------------------	-------------	-----------------------	----------

SOURCES	
A	TOPSOIL (INORGANICS/ ORGANICS)
B	MADE GROUND (INORGANICS/ ORGANICS)

PATHWAYS	
1	DERMAL CONTACT
2	INGESTION/INHALATION
3	LEACHING OF CONTAMINANTS
4	UPTAKE BY PLANTS
5	MIGRATION OF GAS

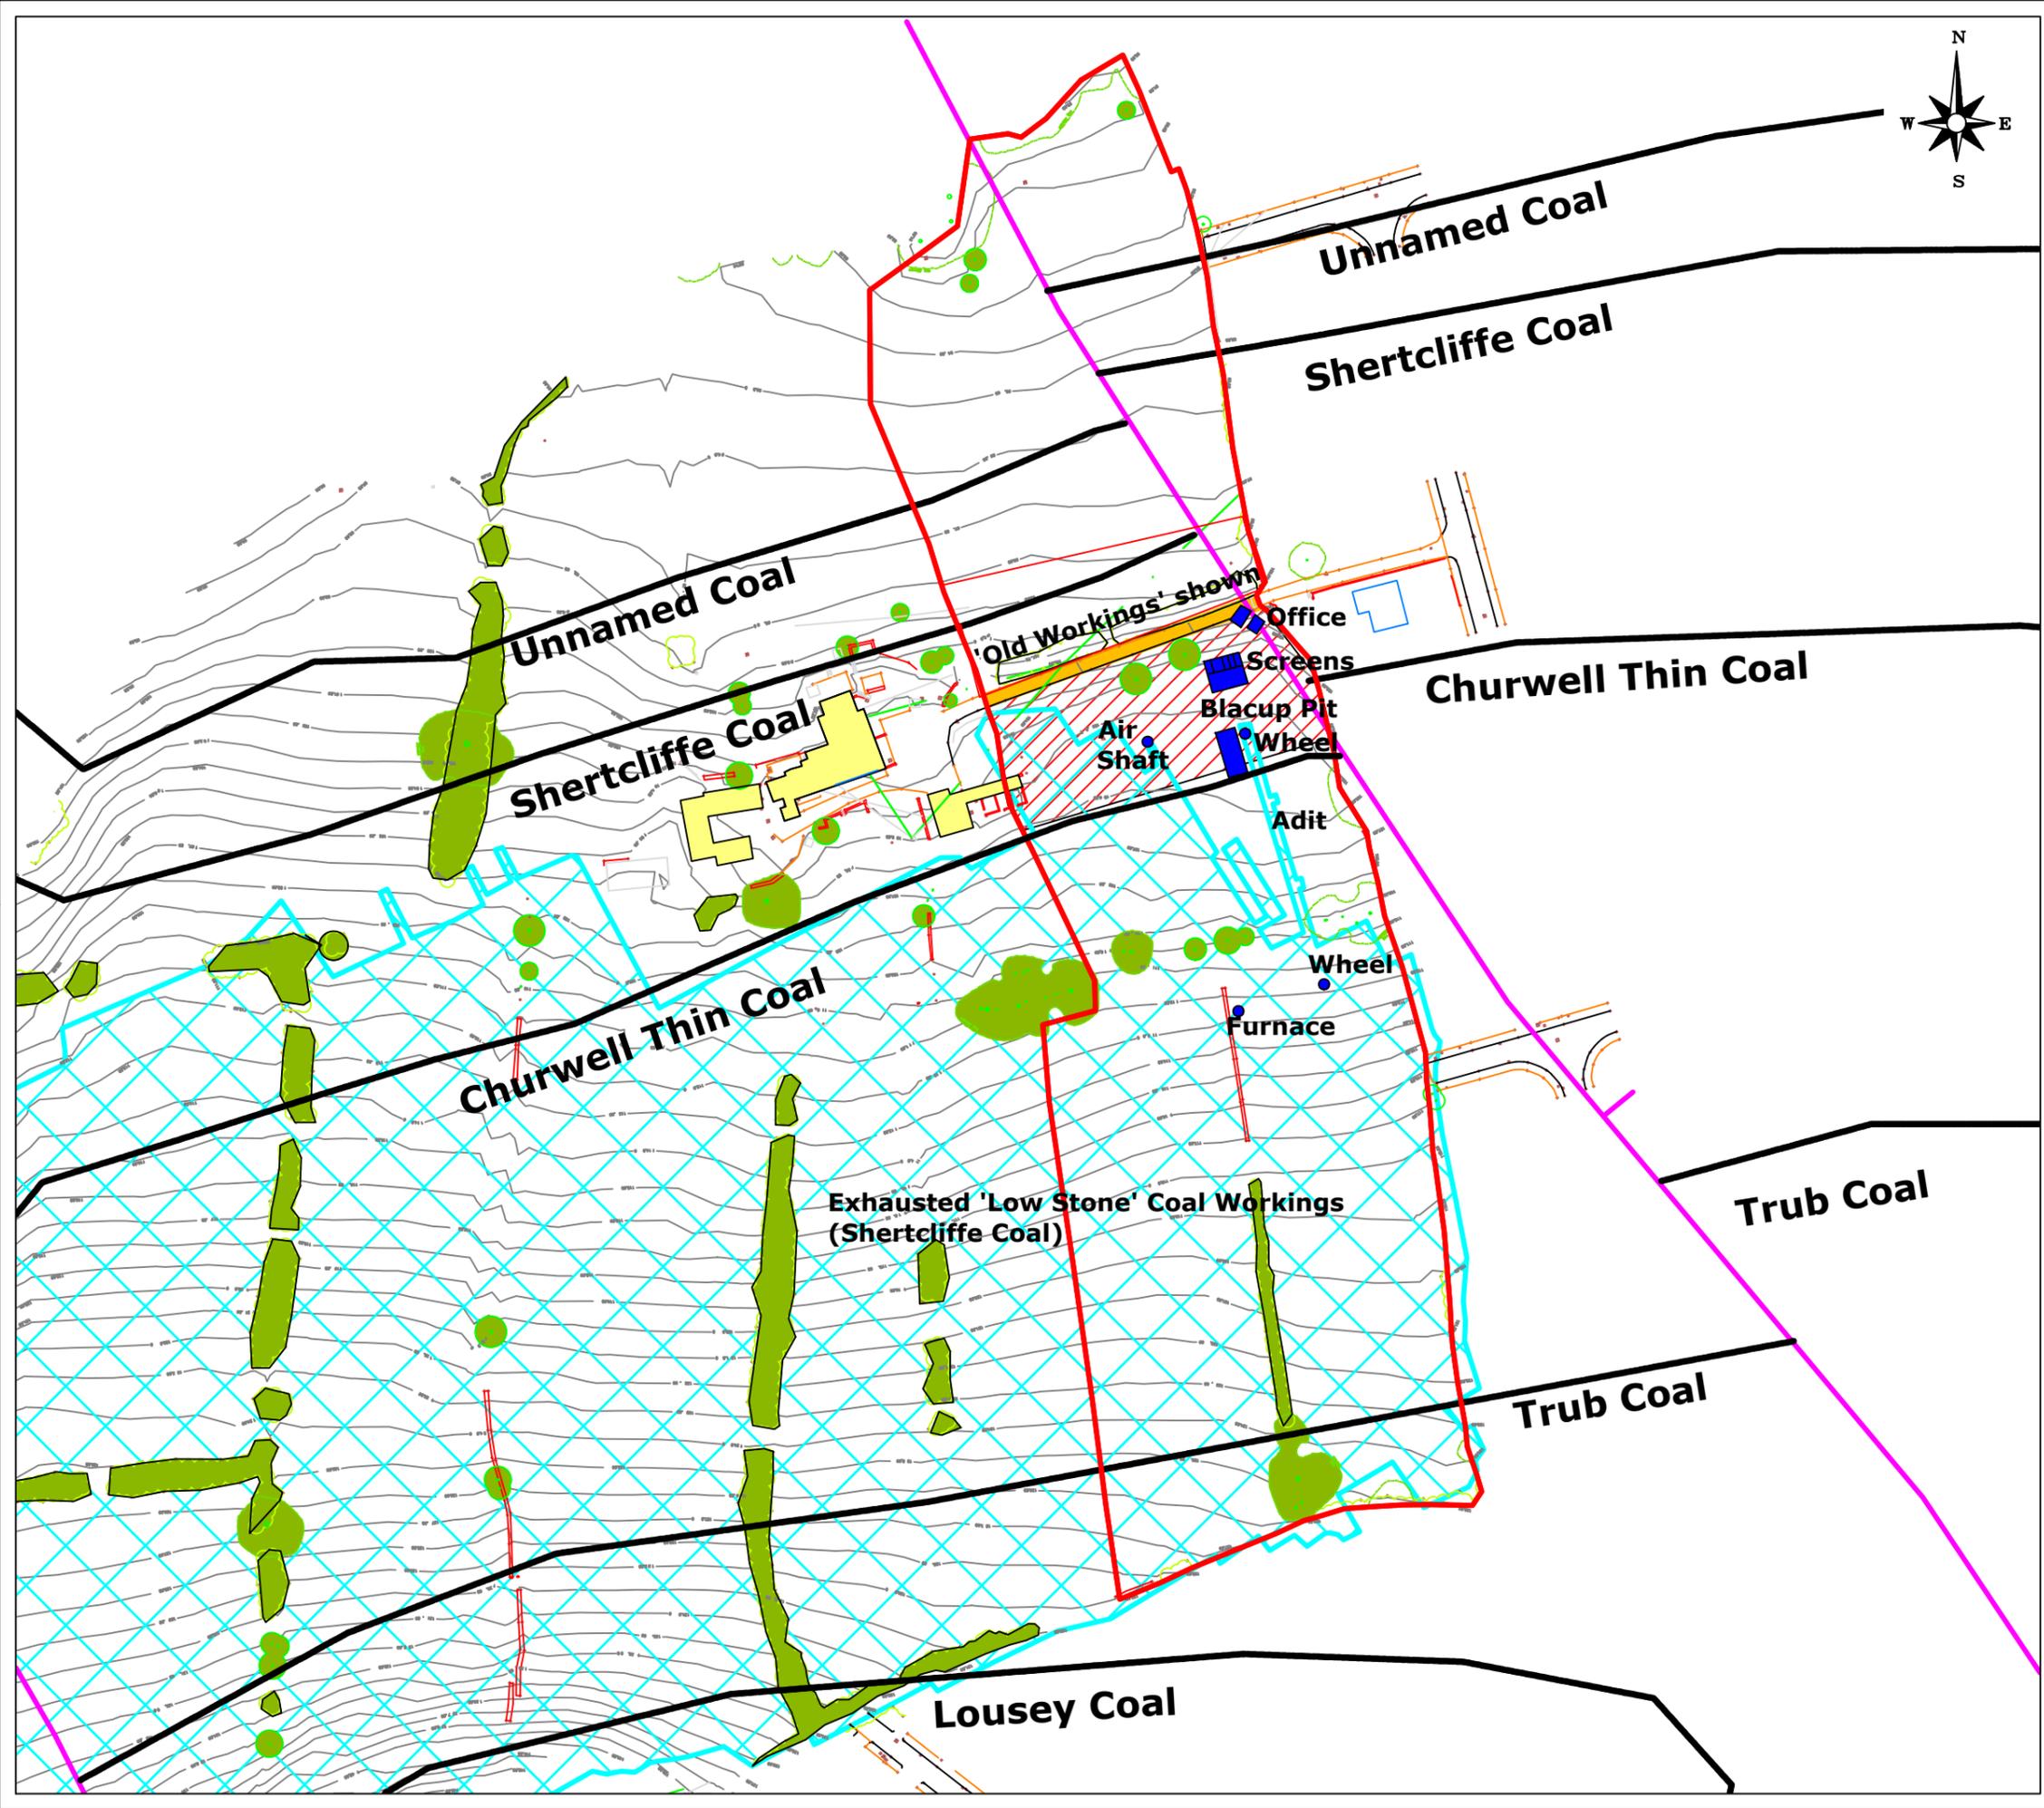
DRAWN	WN	DATE	18 01 2024	STATUS	FOR COMMENT <input type="checkbox"/>
CHECKED	REG	DATE	20 01 2024	FOR APPROVAL	<input type="checkbox"/>
				DRAFT	<input checked="" type="checkbox"/>
				FINAL	<input type="checkbox"/>
SCALE	1:1500	SHEET	A3	DRAWING NO.	1462/7
				REVISION

- FORMER BLACUP COLLIERY FEATURE
- APPROXIMATE EXTENT OF RECORDED WORKINGS IN SHERTCLIFFE COAL

COAL AUTHORITY ABANDONMENT PLAN

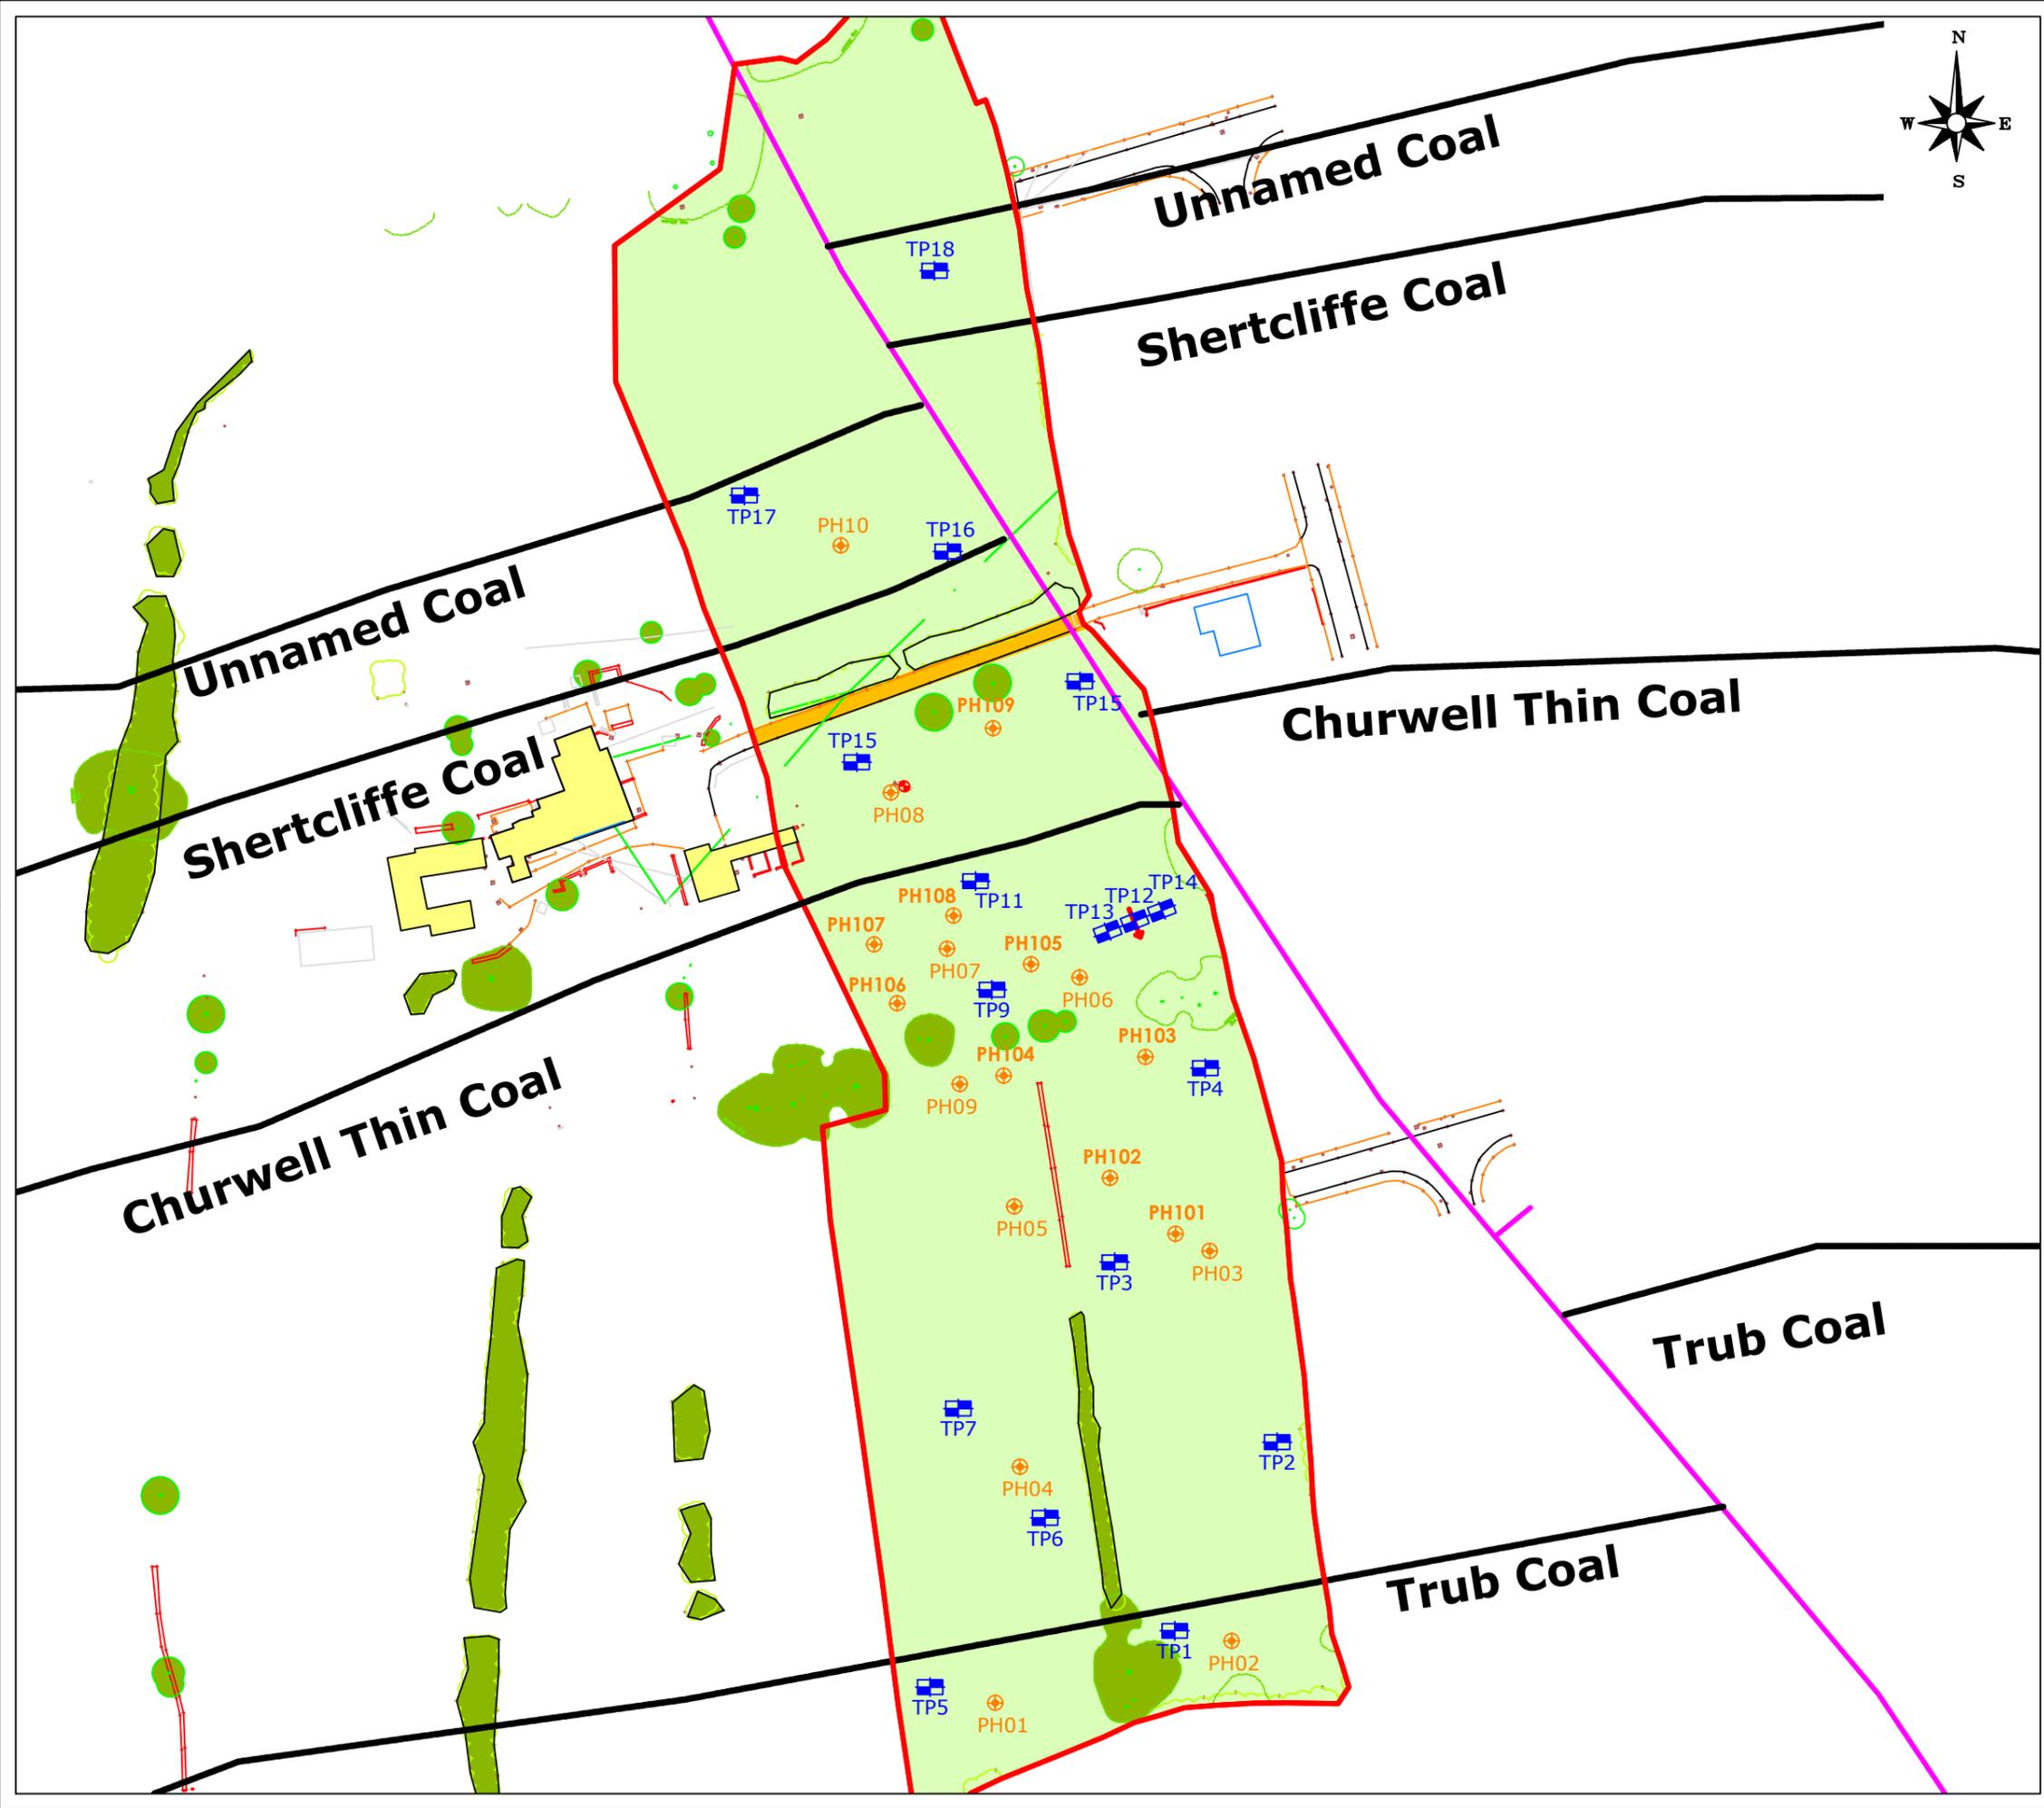
DRAWN	WN	DATE	18 01 2024	STATUS	FOR COMMENT <input type="checkbox"/>
CHECKED	REG	DATE	20 01 2024	FOR APPROVAL	<input type="checkbox"/>
				DRAFT	<input type="checkbox"/>
				FINAL	<input checked="" type="checkbox"/>
SCALE	1:1250	SHEET	A3	DRAWING NO.	1462/8
				REVISION

- 2012 TRIAL PIT LOCATION (TPs 01 TO 18)
- 2012 PROBEHOLE LOCATION (PHs 01 TO 10)
- 2020 PROBEHOLE LOCATION (PHs 101 TO 109)
- APPROXIMATE SITE BOUNDARY
- SHAFT LOCATION (E 418598.91, N 424809.15)
- ADIT LOCATION (E 418639.01, N 424789.66)
- APPROXIMATE LINE OF FAULT (FROM BGS PLANS)
- APPROXIMATE OUTCROP OF COAL SEAM (FROM BGS PLANS)

EXPLORATORY HOLE LOCATIONS
