Geoenvironmental Appraisal

Land off Ashbourne Drive, Cleckheaton For Newett Homes

Report no: 1462/4

Date: January 2024

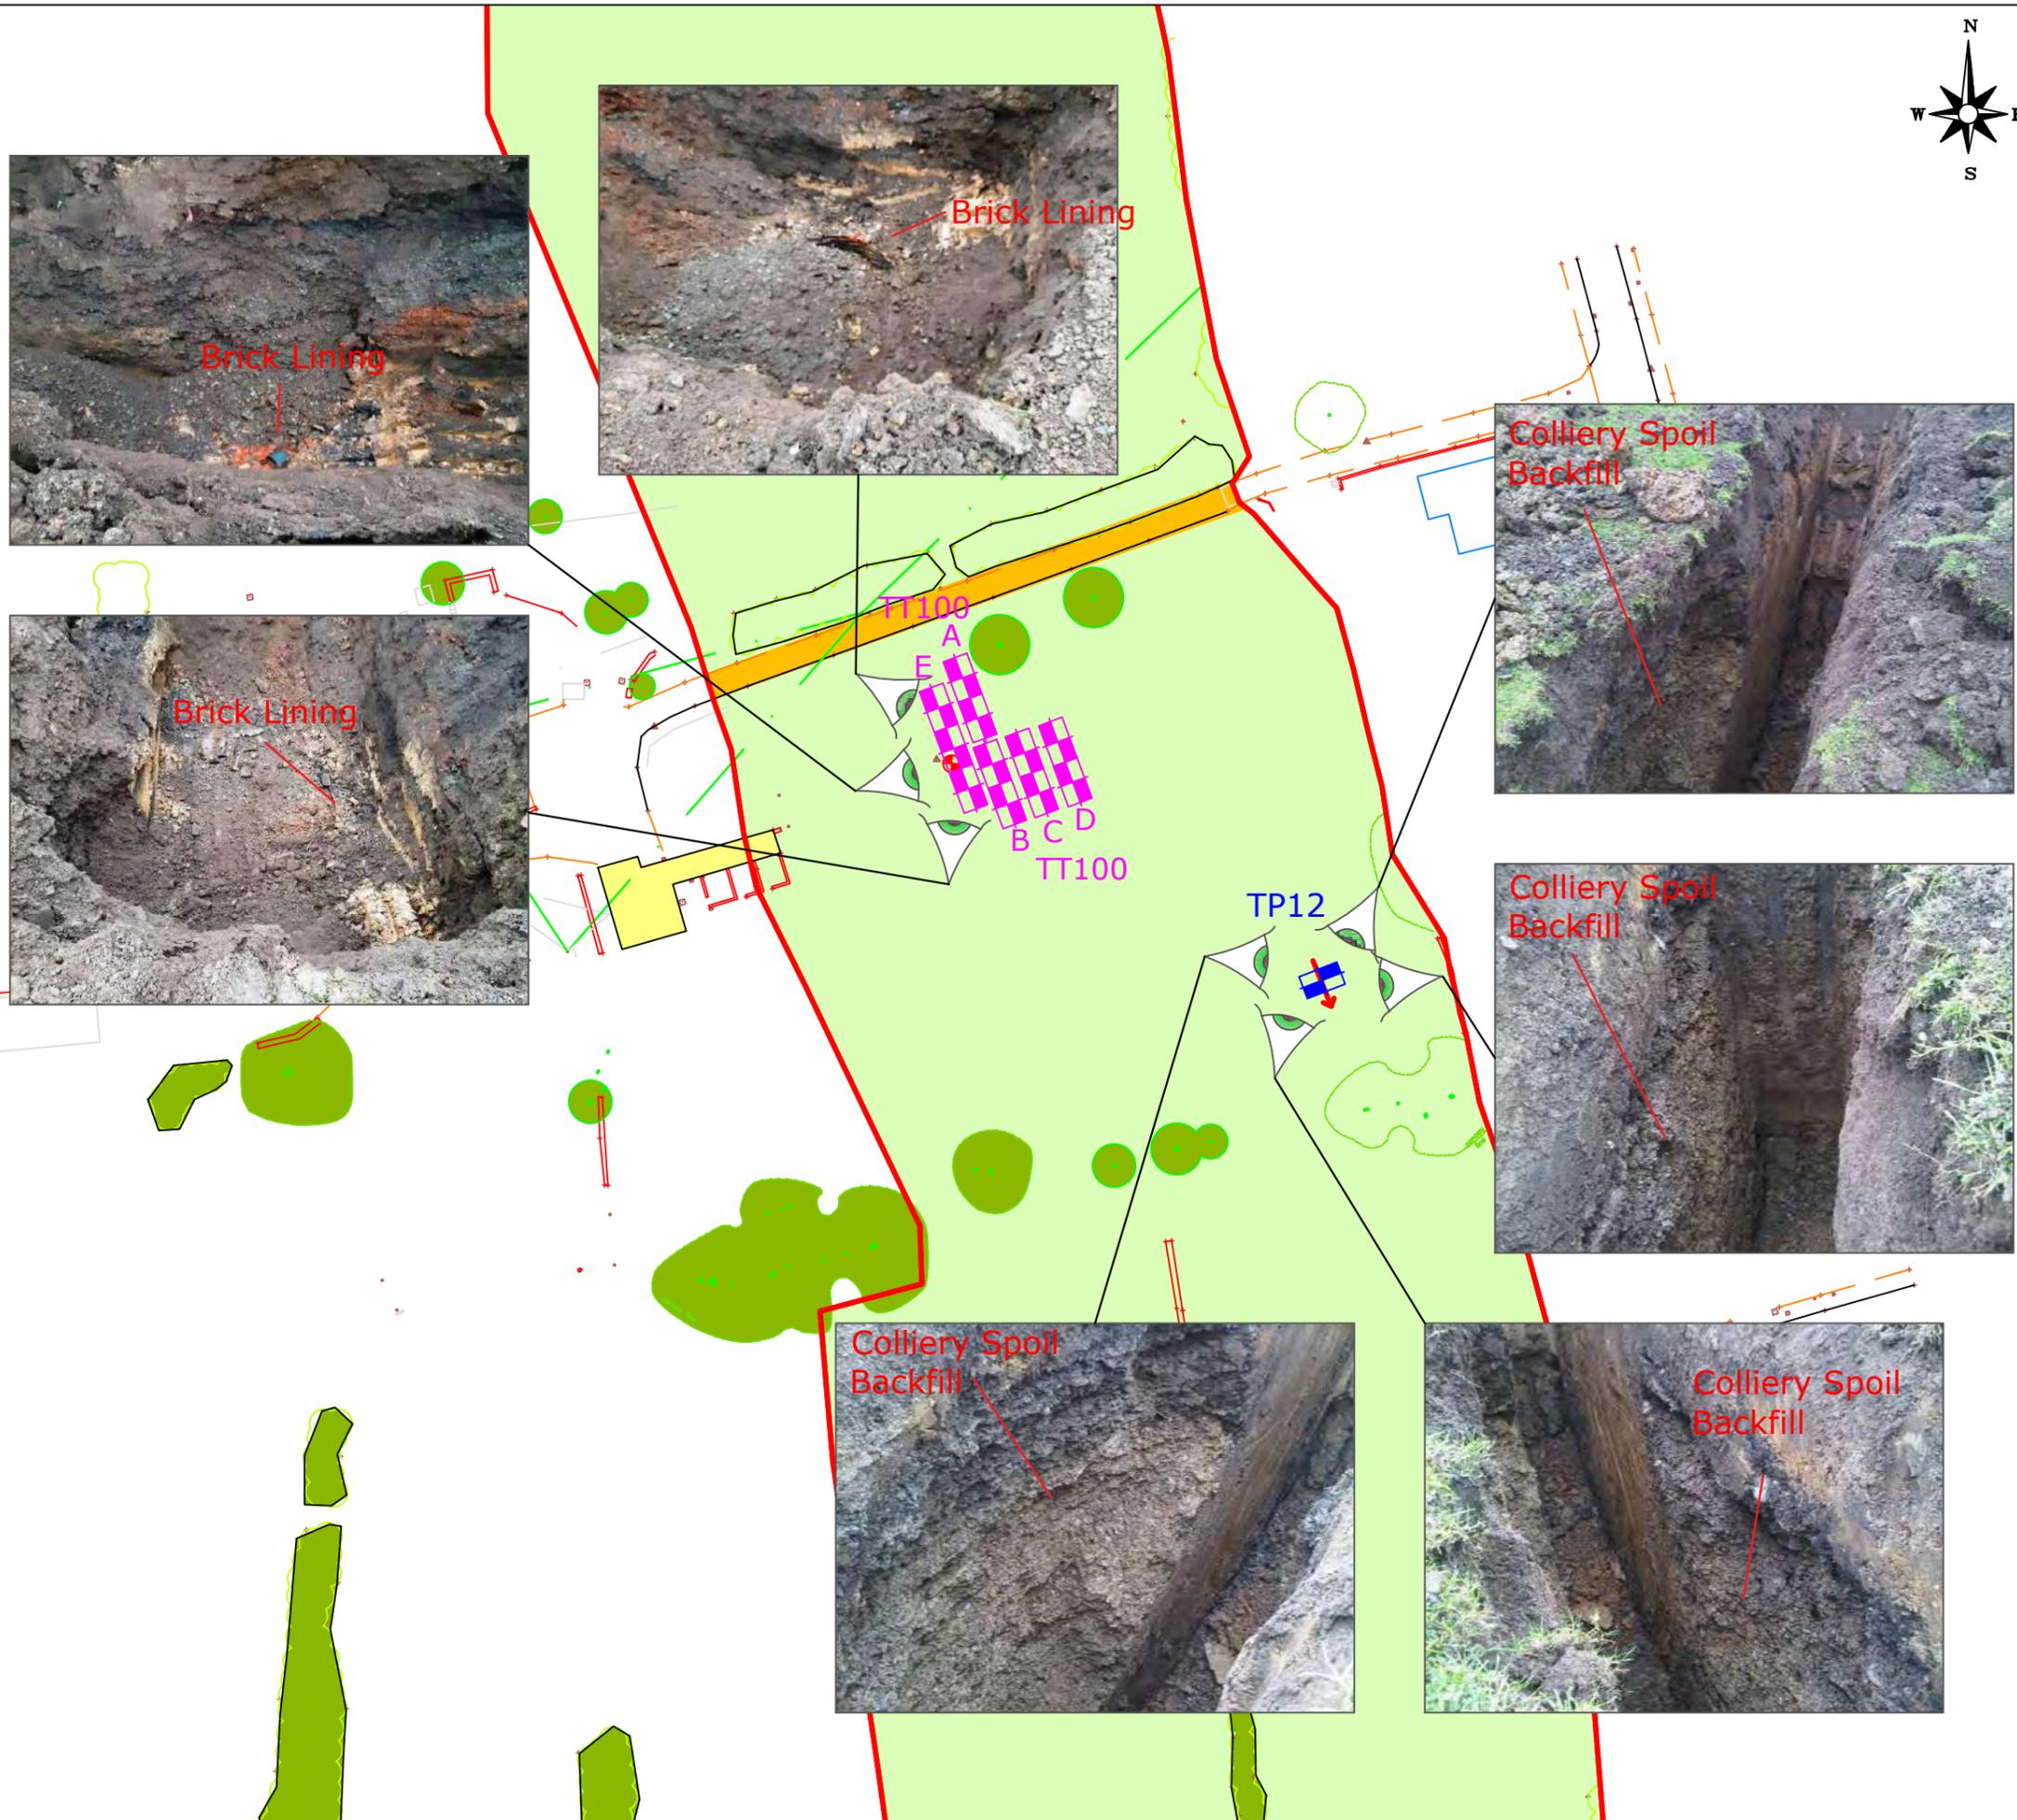
DRAWN	WN	DATE	18 01 2024	STATUS	FOR COMMENT <input type="checkbox"/>
CHECKED	REG	DATE	20 01 2024	FOR APPROVAL	<input type="checkbox"/>
				DRAFT	<input type="checkbox"/>
				FINAL	<input checked="" type="checkbox"/>
SCALE	1:1250	SHEET	A3	DRAWING NO.	1462/8
				REVISION

EXPLORATORY HOLE LOCATIONS

- NOTES
- 2012 TRIAL PIT LOCATION
 - 2020 TRIAL TRENCH LOCATION
 - APPROXIMATE SITE BOUNDARY
 - SHAFT LOCATION
(E 418598.91, N 424809.15)
 - ADIT LOCATION
(E 418639.01, N 424789.66)
 - LOCATION & ORIENTATION OF PHOTOGRAPH

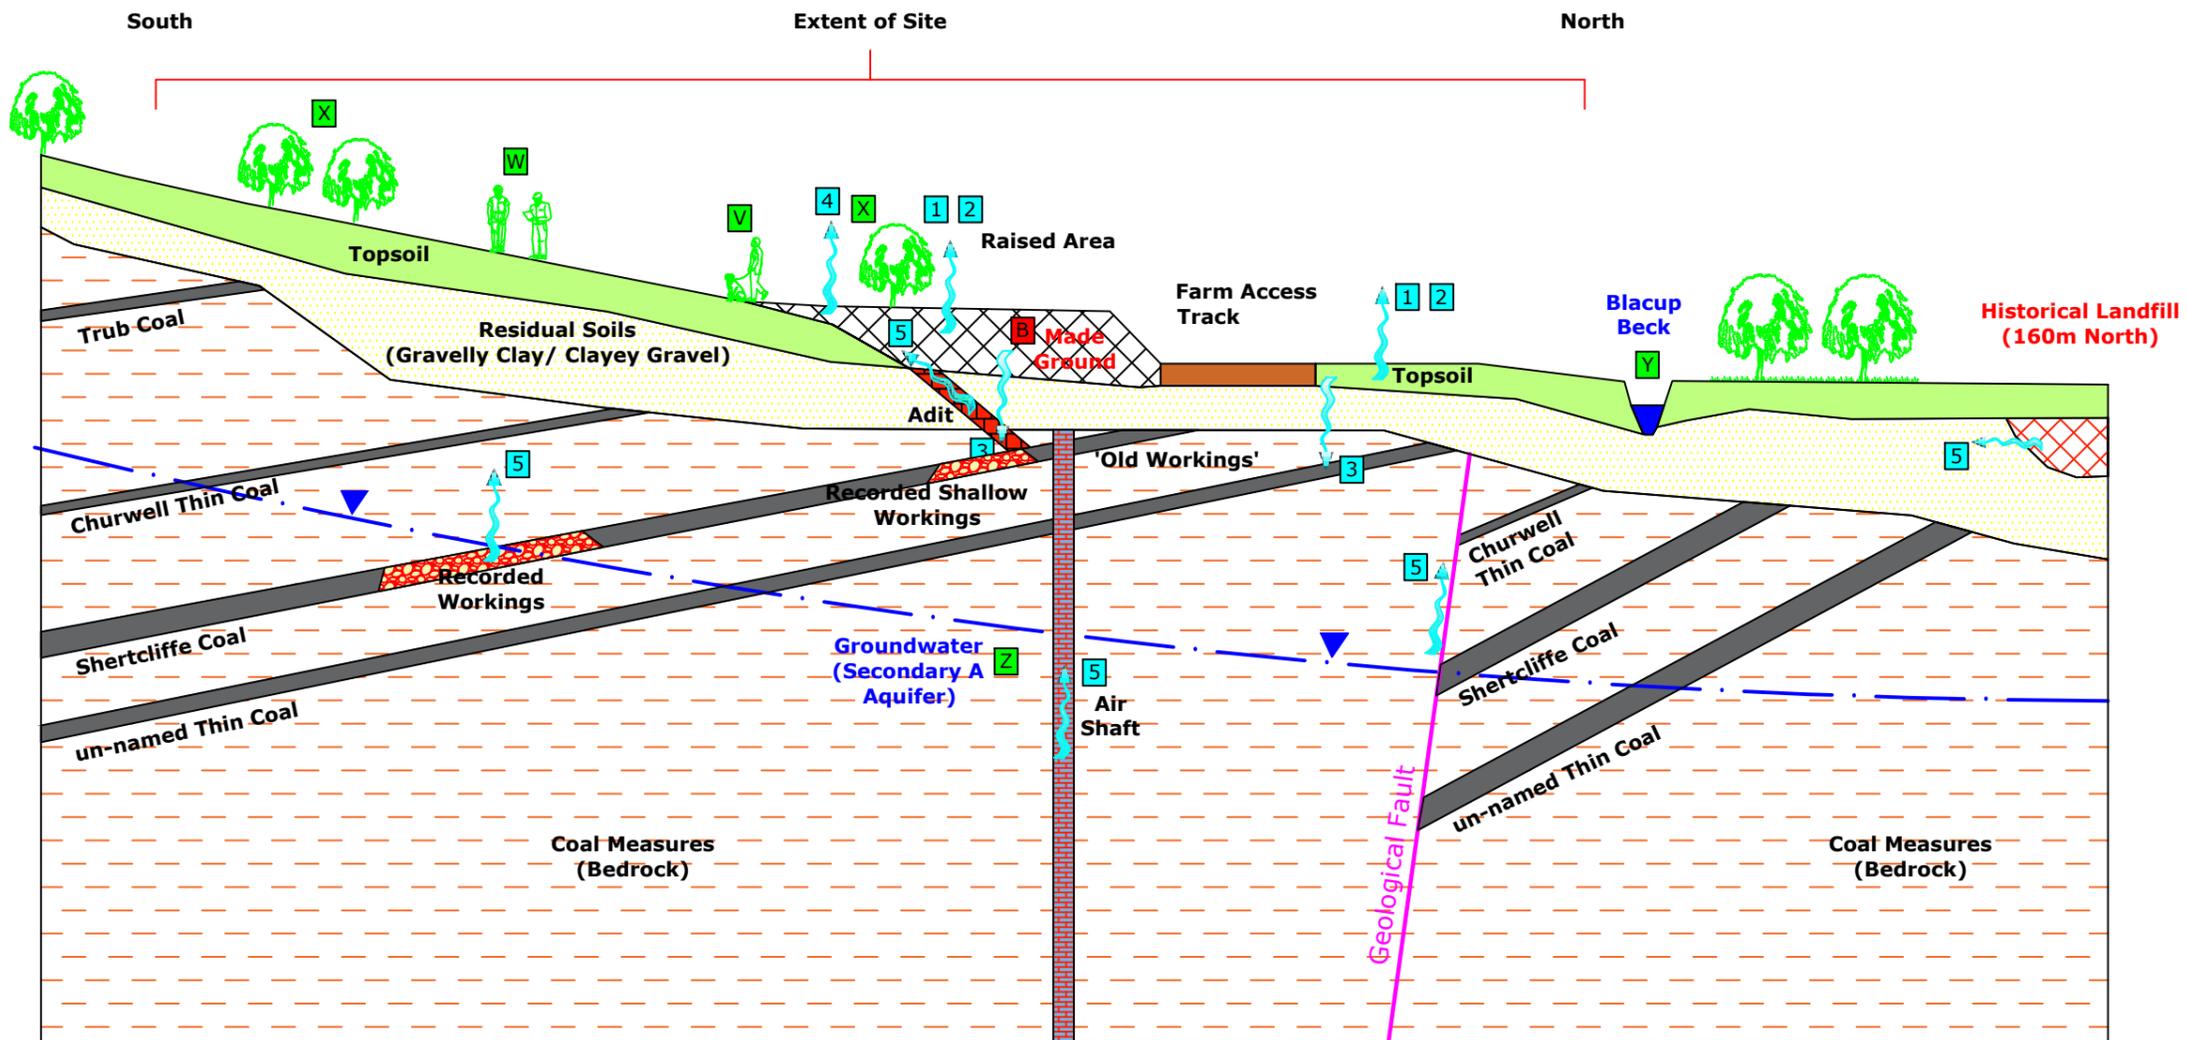
SCALE Not to scale	SHEET A3	DRAWING NO. 1462/10	REVISION
-----------------------	-------------	------------------------	----------

SOURCES	
B	MADE GROUND (INORGANICS)

PATHWAYS	
1	DERMAL CONTACT
2	INGESTION/INHALATION
3	LEACHING OF CONTAMINANTS
4	UPTAKE BY PLANTS
5	MIGRATION OF GAS

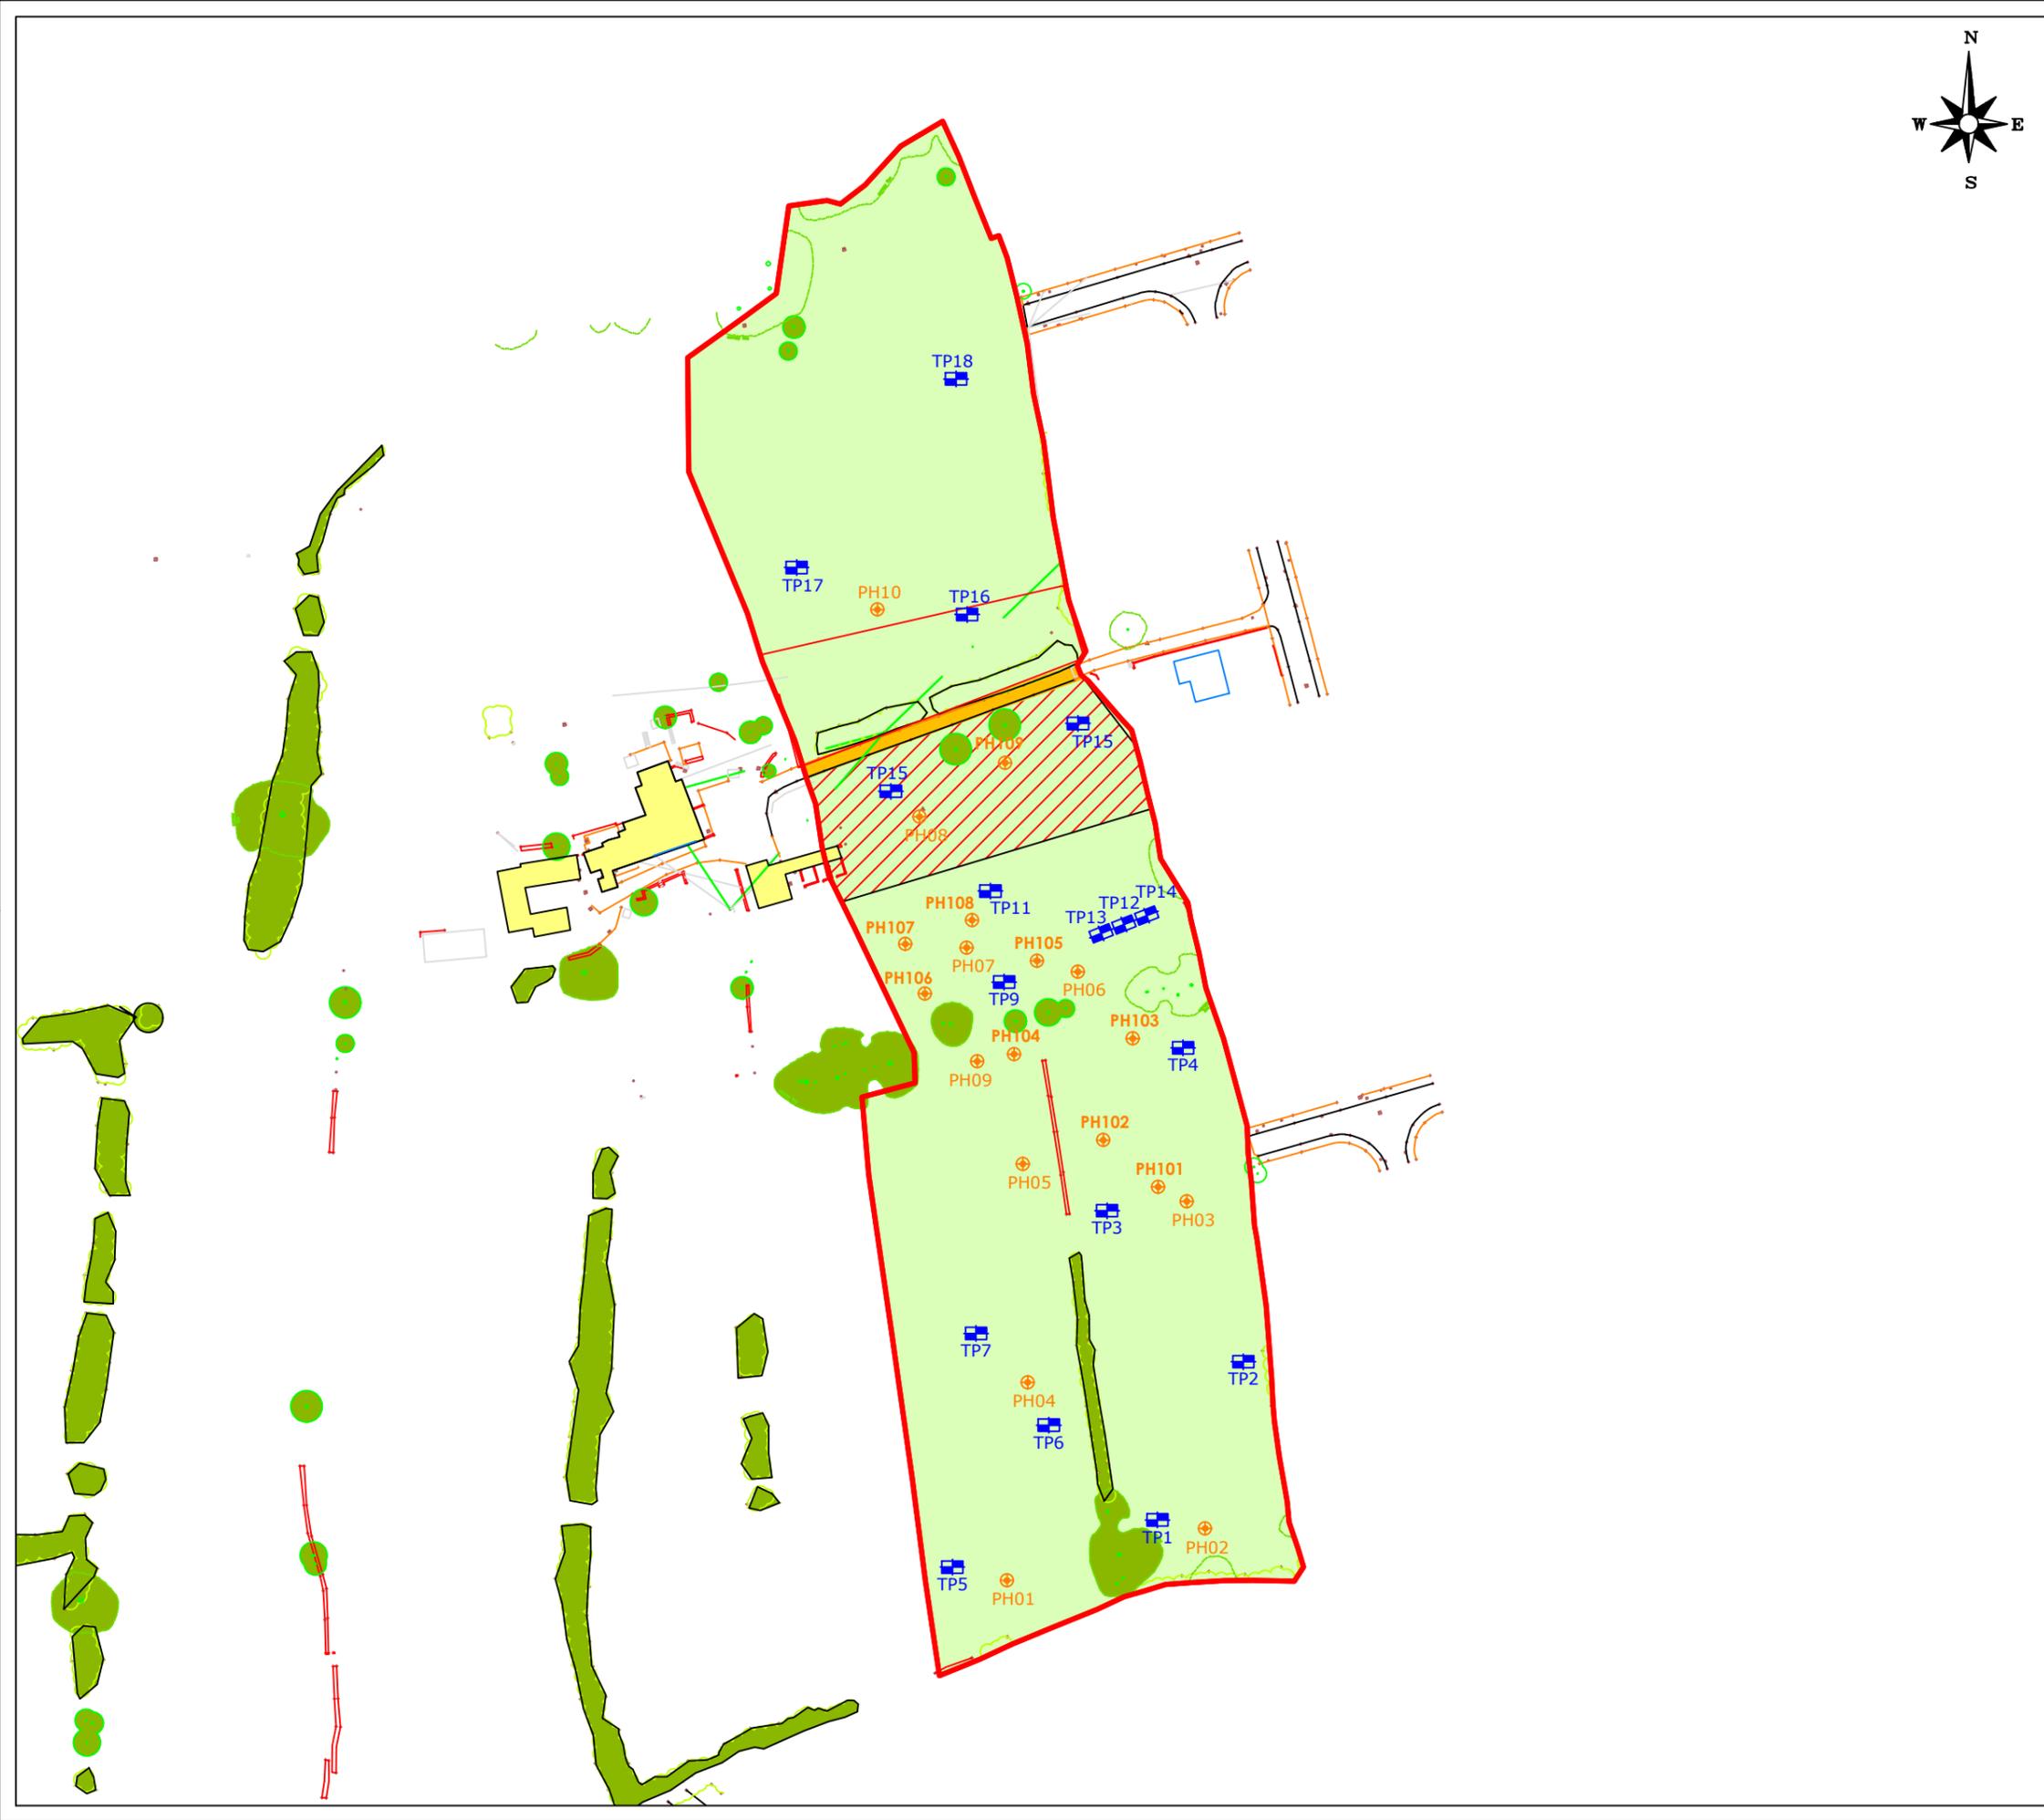
DRAWN	WN	DATE	18 01 2024	STATUS	FOR COMMENT <input type="checkbox"/>
CHECKED	REG	DATE	20 01 2024	FOR APPROVAL	<input type="checkbox"/>
				DRAFT	<input type="checkbox"/>
				FINAL	<input checked="" type="checkbox"/>
SCALE	1:1500	SHEET	A3	DRAWING NO.	1462/11
				REVISION

- NOTES
- 2012 TRIAL PIT LOCATION (TPs 01 TO 18)
 - 2012 PROBEHOLE LOCATION (PHs 01 TO 10)
 - 2020 PROBEHOLE LOCATION (PHs 101 TO 109)
 - APPROXIMATE SITE BOUNDARY
 - APPROXIMATE EXTENT OF MADE GROUND
- MINIMUM 1,000mm CLEAN SOIL COVER REQUIRED IN GARDENS UNDERLAIN BY RESIDUAL MADE GROUND

APPROXIMATE EXTENT OF MADE GROUND

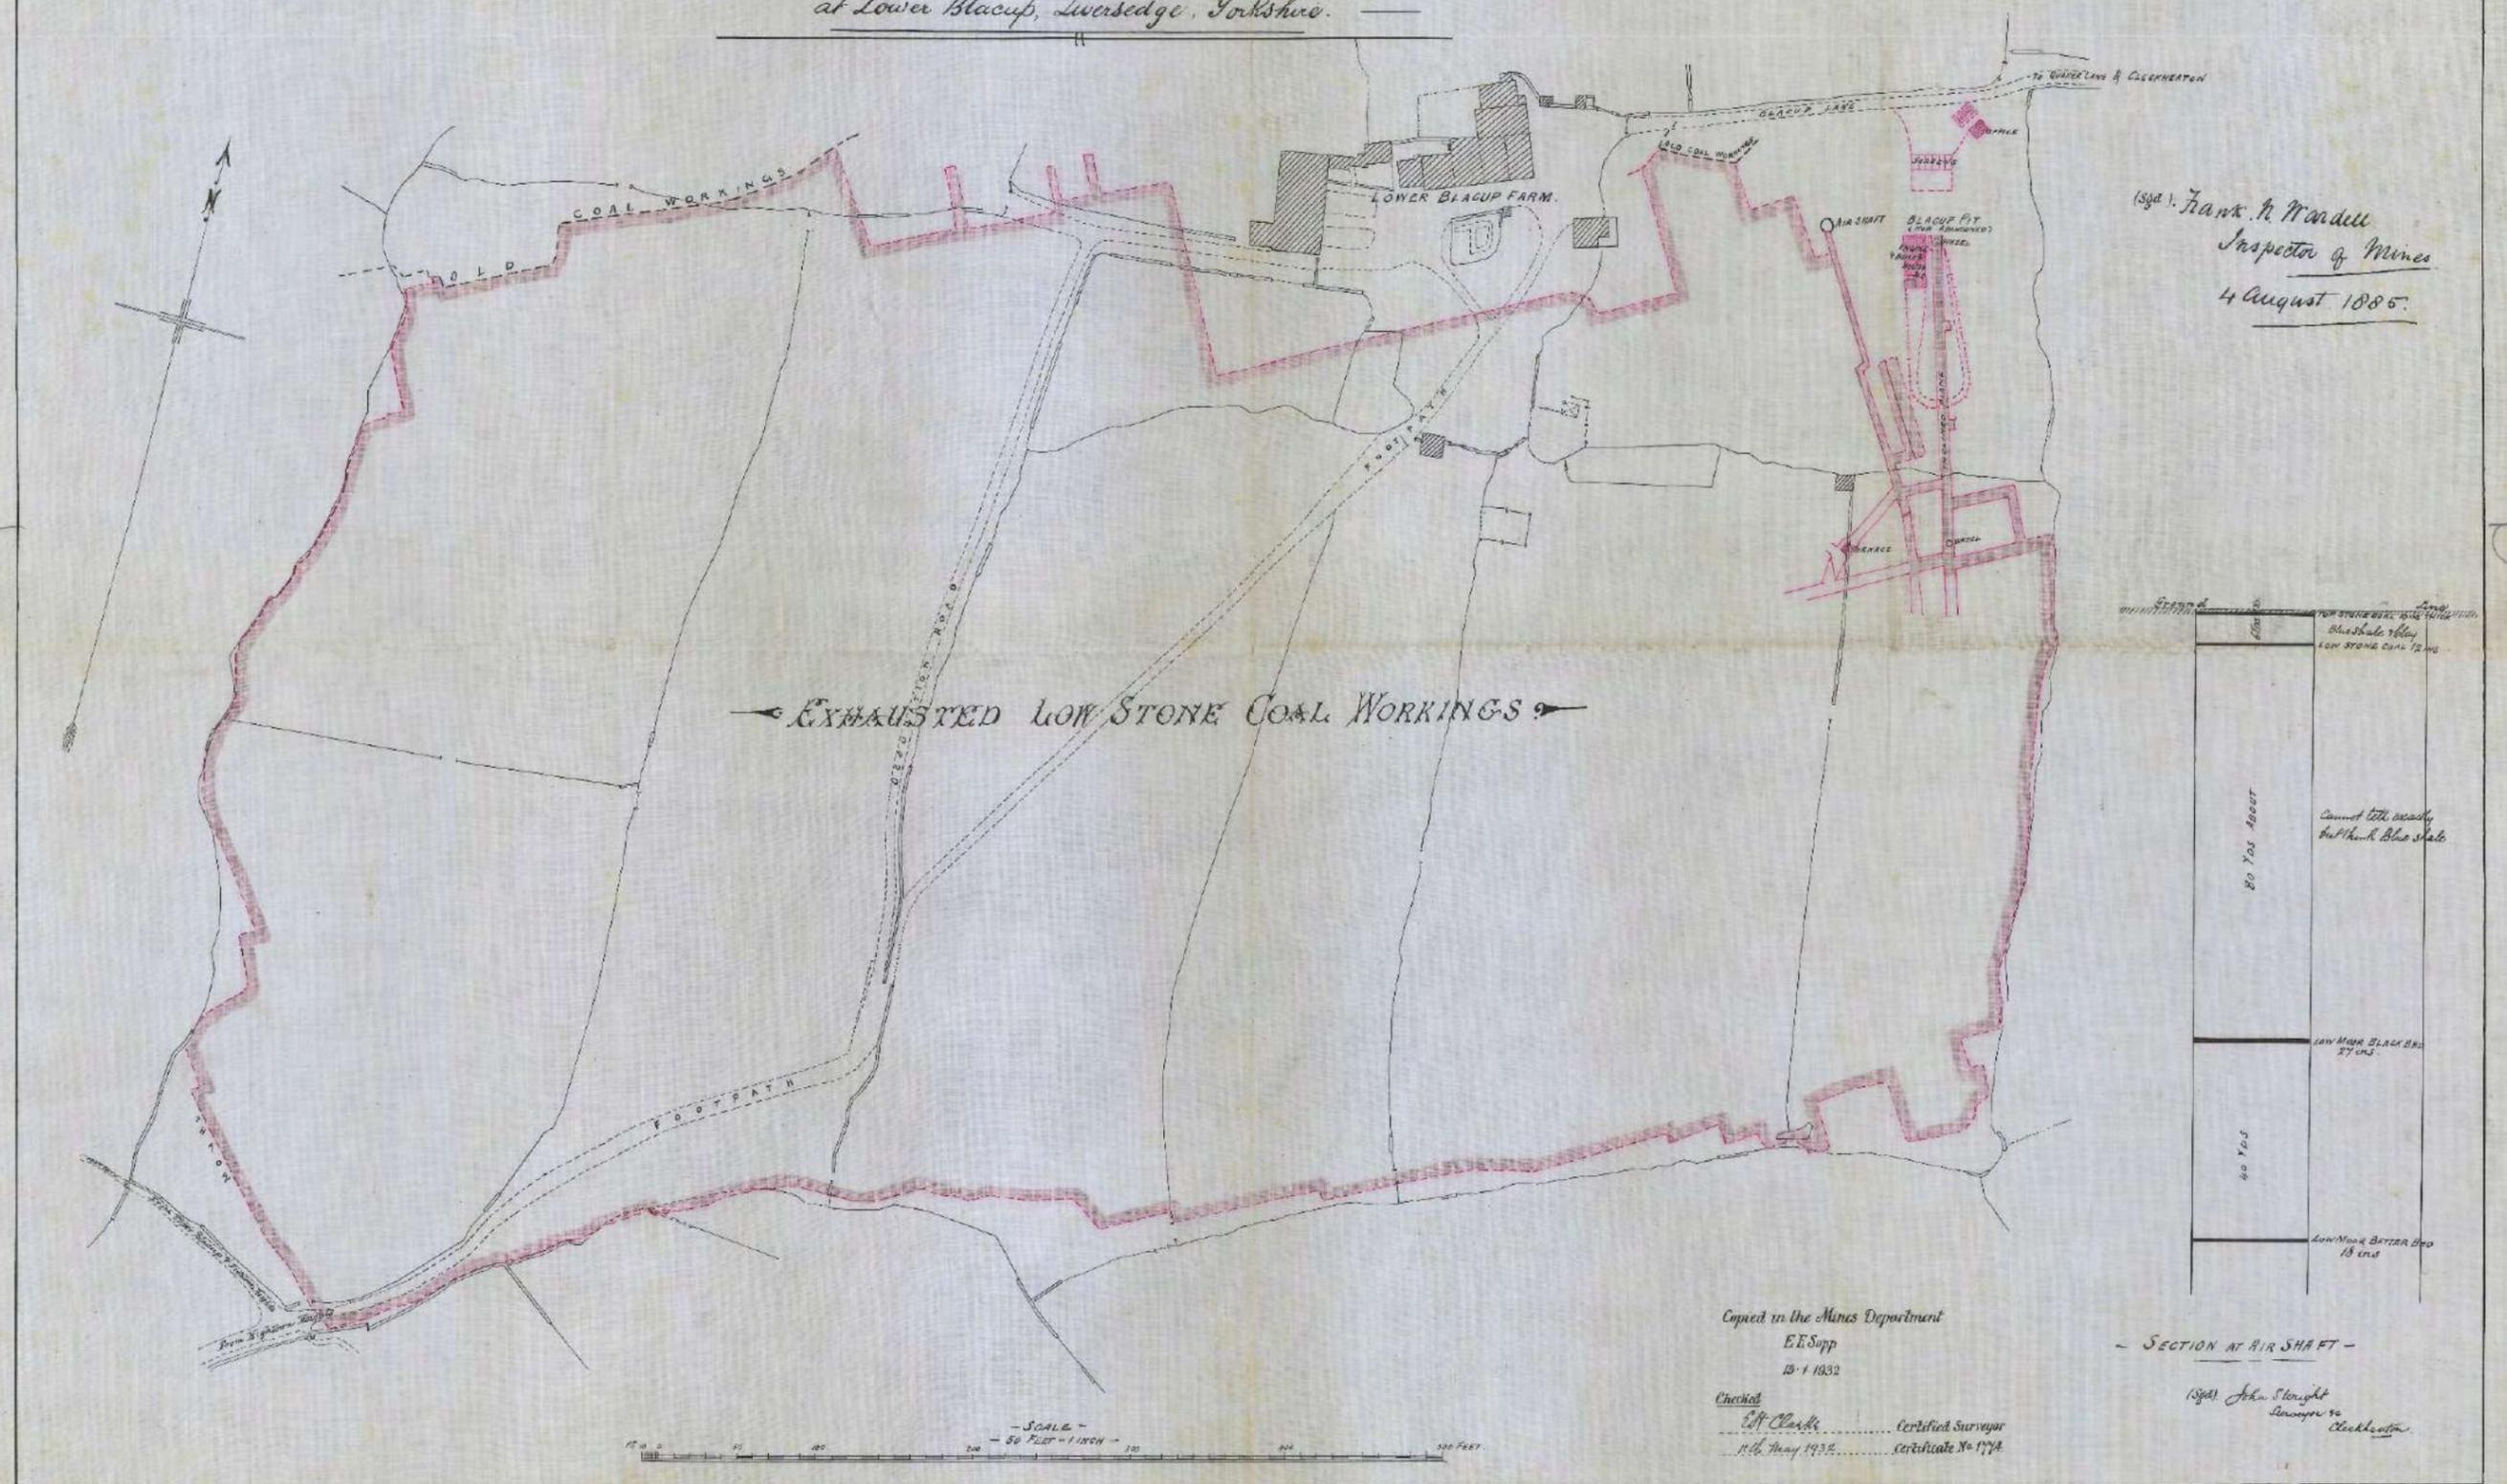
1871 PLAN NO. 1731

*Plan showing exhausted Low Stone Coal workings (as Coloured Pink)
at Lower Blacup, Liversedge, Yorkshire.*

Distance	Description
80 Yds Above	Blue shale 16 in Low stone coal 12 in
40 Yds	Low stone coal 27 in
	Low stone coal 18 in

- 4.3.23 The Top Stone and Low Stone coals are considered to represent the Shertcliffe which is likely present as two leaves within the shaft section.
- 4.3.24 A mining investigation of the entire site will be required to check for the presence of recorded and unrecorded shallow mine workings (voids or broken ground).

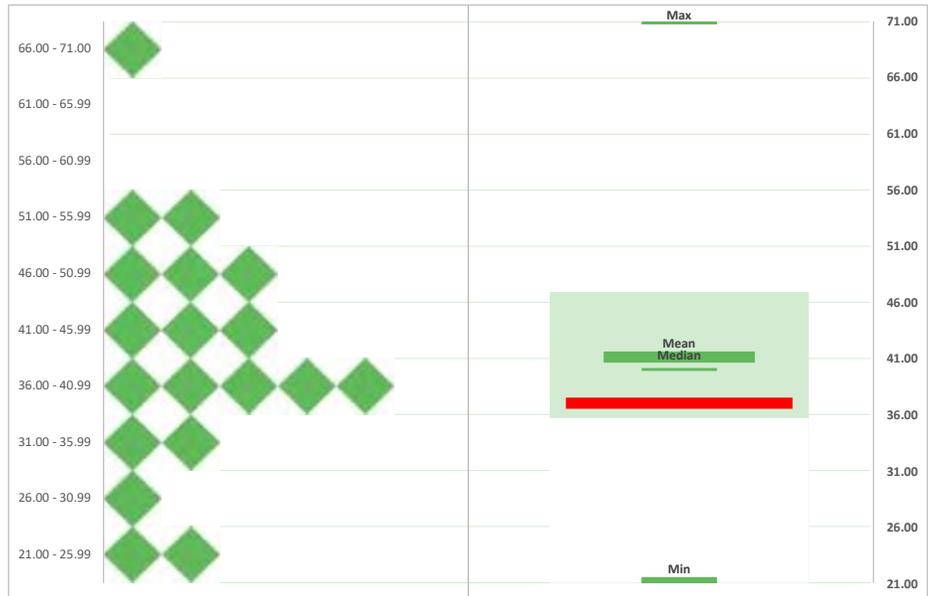
Topsoil: Dataset for As - Dot & Box Plots and Summary Statistics

Determinant	As
Critical concentration	37.00
No. samples	19.00
Max	71.00
Mean	41.11
Min	21.00
Median	40.00
Standard Deviation	12.03
Standard Error	2.76
T value	2.10
Upper Confidence Level (95%)	46.90
Upper Confidence Level (80%)	44.78
Lower Confidence Level (5%)	35.70
Transform data	Normal
Upper Confidence Level for chart	95%

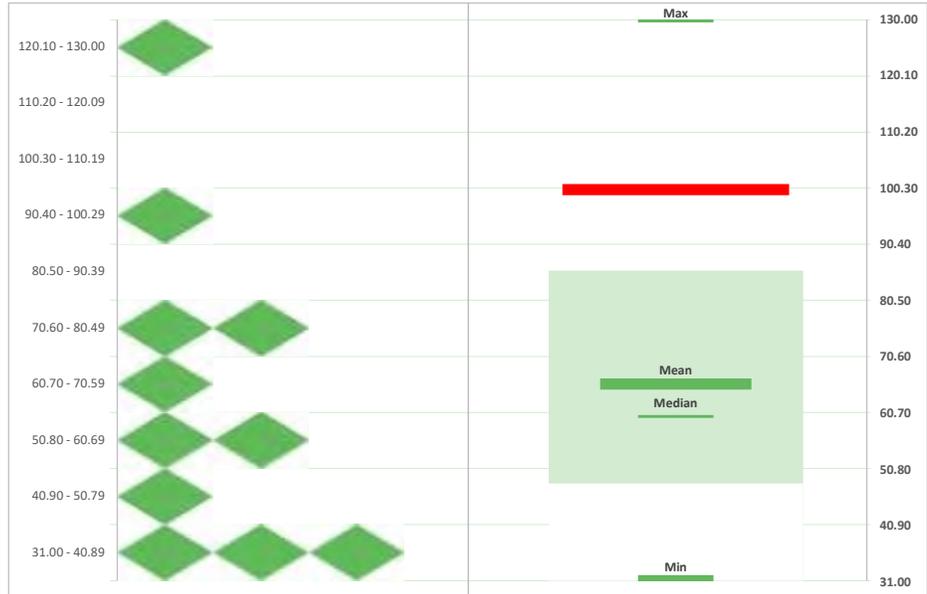
Topsoil: Dataset for Cu - Dot & Box Plots and Summary Statistics

Determinant	Cu
Critical concentration	100.00
No. samples	11.00
Max	130.00
Mean	65.73
Min	31.00
Median	60.00
Standard Deviation	29.74
Standard Error	8.97
T value	2.23
Upper Confidence Level (95%)	85.71
Upper Confidence Level (80%)	78.03
Lower Confidence Level (5%)	48.15
Transform data	Normal
Upper Confidence Level for chart	95%

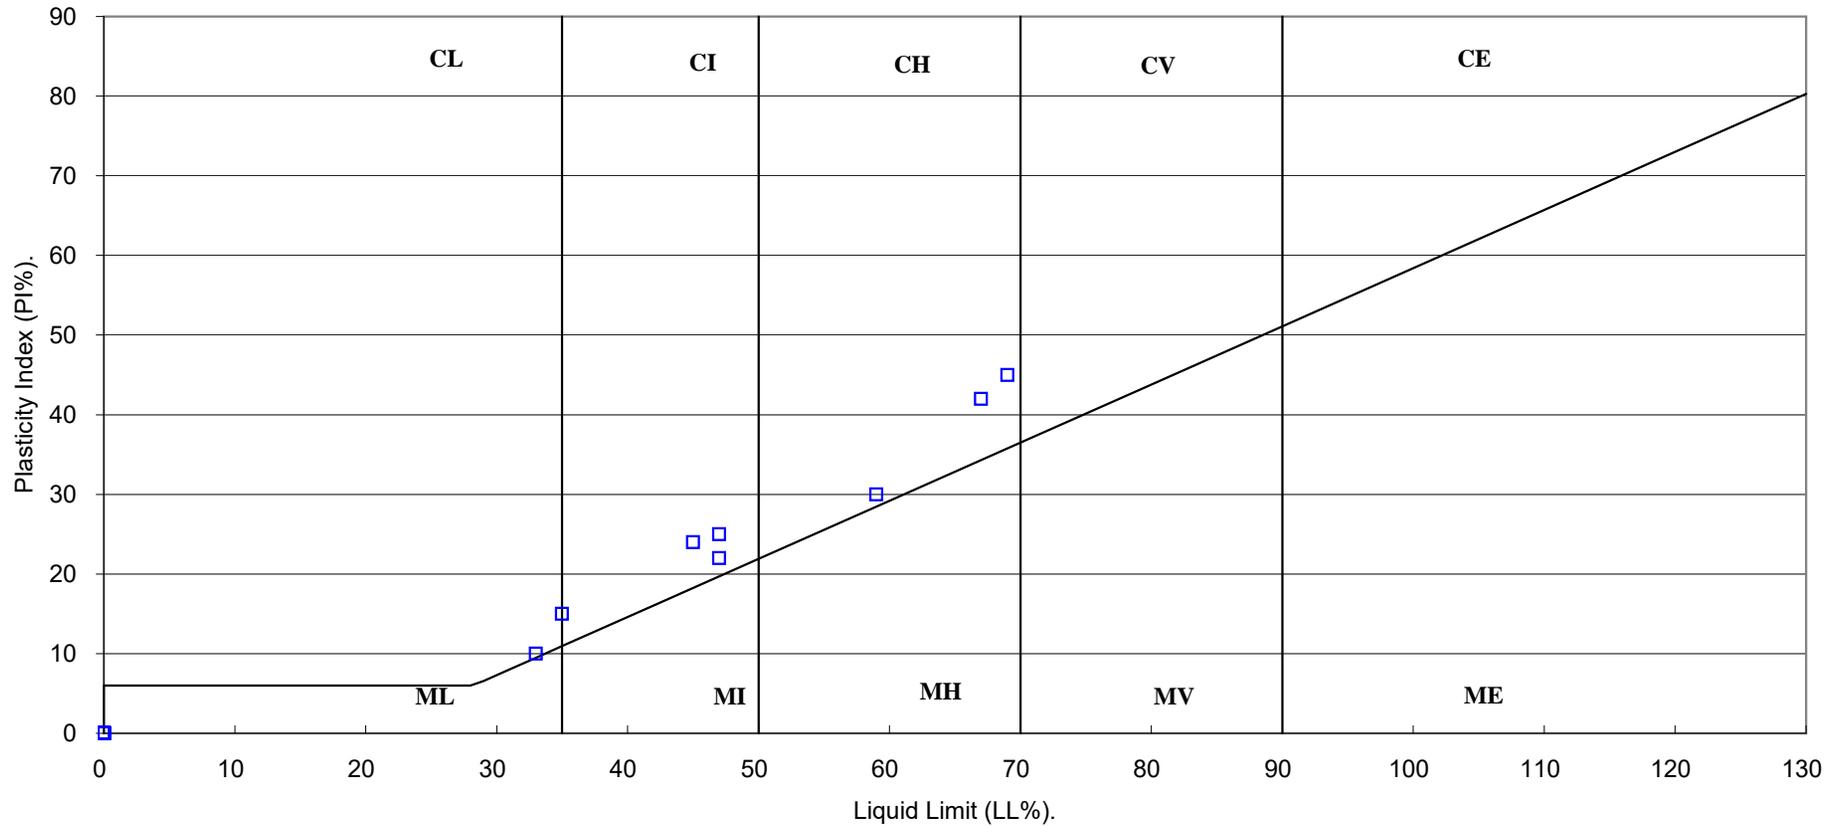
PLASTICITY CHART FOR CASAGRANDE CLASSIFICATION.

(B.S.5930 : 1999)
