**Design & Access Statement**

**Safeguarding Works**

**Heckmondwike Grammar  
School  
High Street,  
Heckmondwike,  
West Yorkshire  
WF16 0AH**

**Existing Boundary Condition/Safeguarding Report**

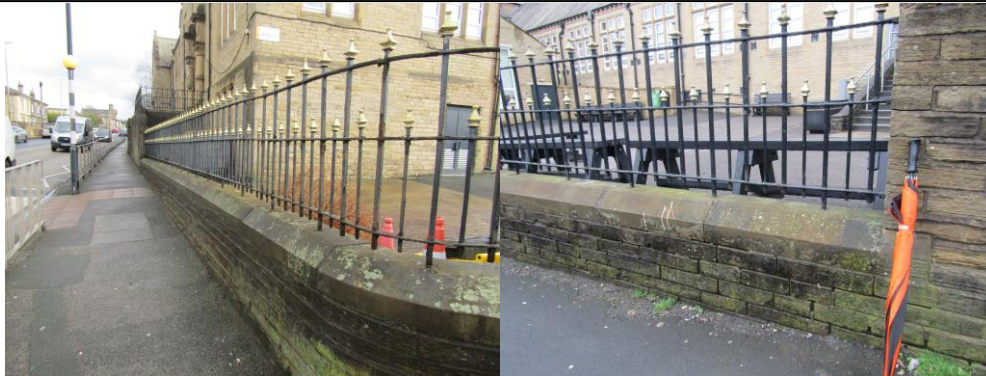
Low boundary stone wall with ornate railings to High Street and North Street on North and West elevations

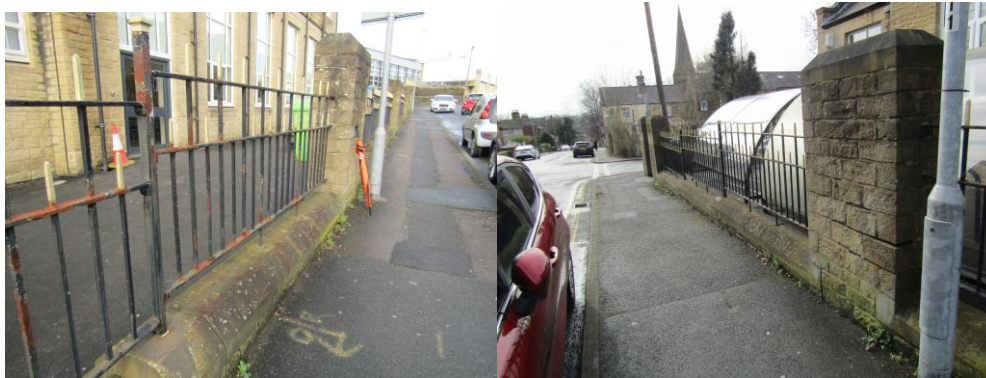
Low boundary stone wall with standard railings to North Street and Church Street on West and South elevations

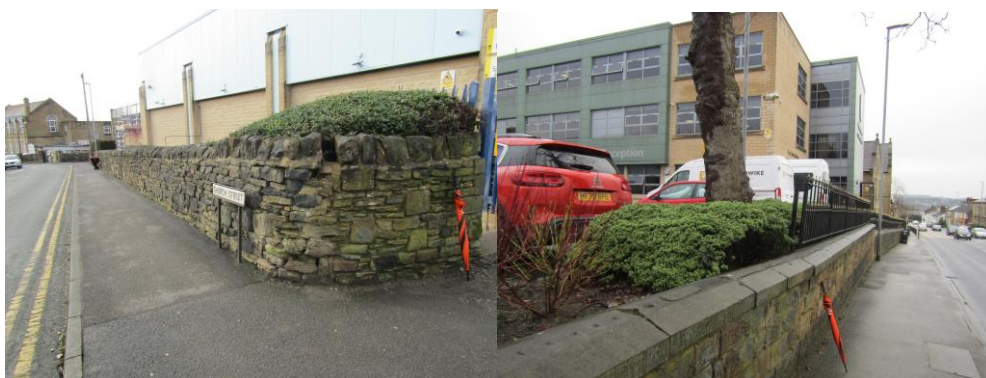
Low stone walls to Church Street, Grove Street and High Street on South, East and North Elevations

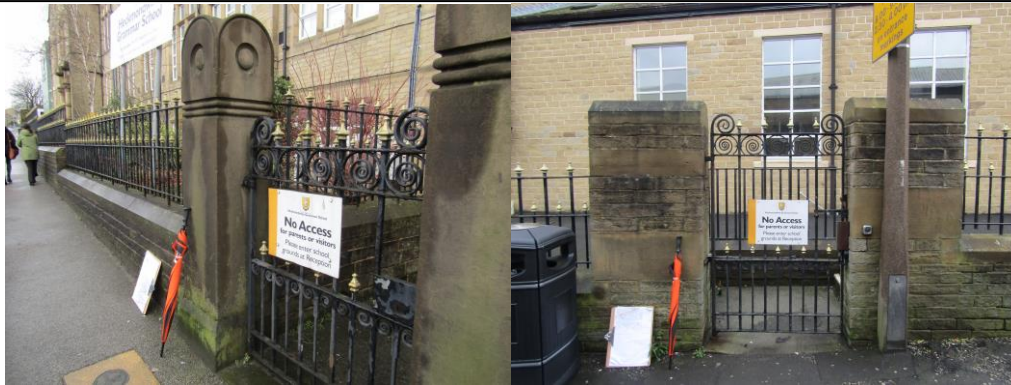
Original ornate pedestrian gates to High Street and North Street on North and West elevations

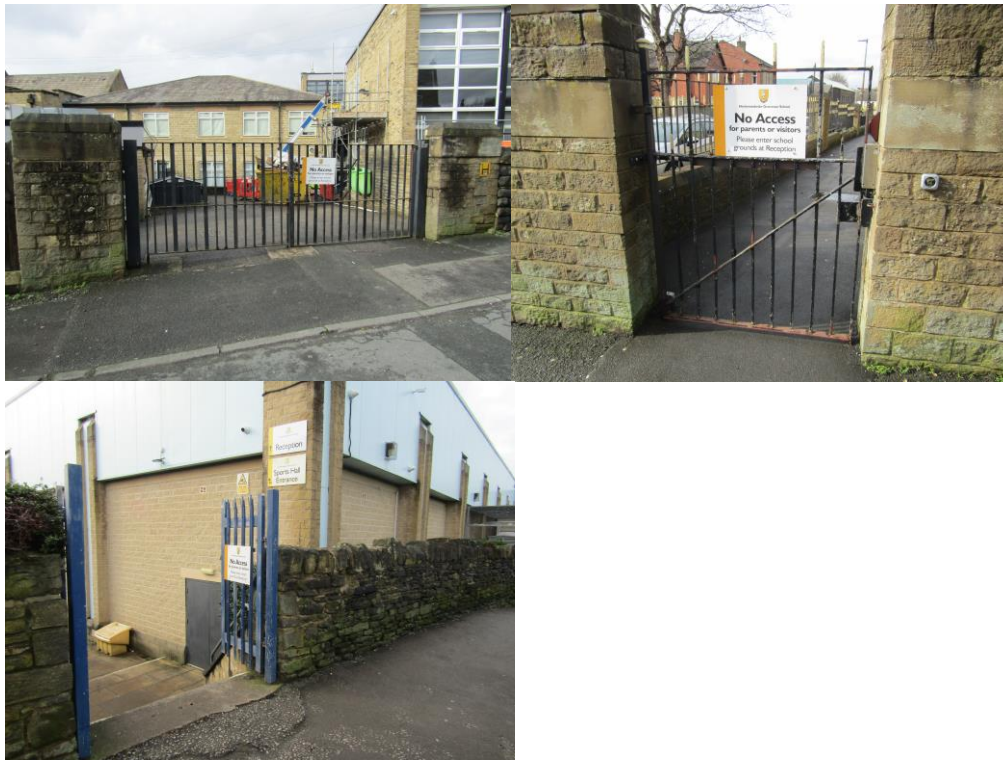
None original vehicular/pedestrian gates to Church Street and Grove Street on South and East elevations.

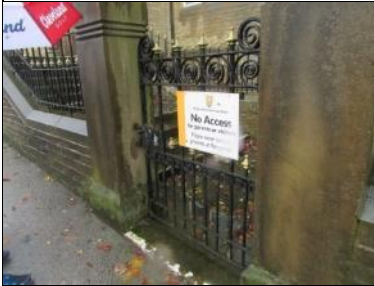
| No.5: Ornate decorative single pedestrian gate, not suitable for boundary to school with no access controls, easily climbed by any intruder. | No.6: Ornate decorative double pedestrian gate, not suitable for boundary to school and is easily climbed by intruders. | No.7: Gap between rails in gate 20cm, small humans could fit through gap with others easily able to use gap as a step for access | No.8: Ornate decorative gates 1.4m high. Too low to comply with DfE Safeguarding Guidance, especially with close proximity to main A road |

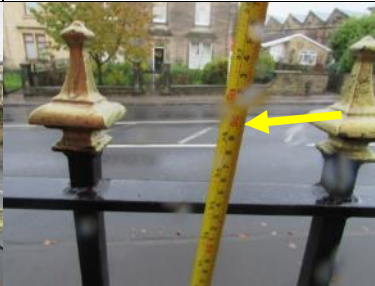
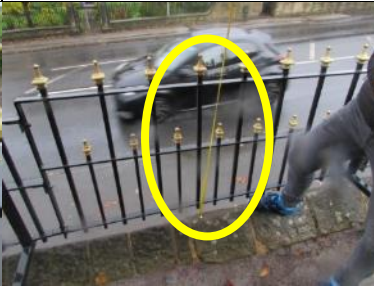
| No.9: General view to railings from inside school. | No.10: Ornate decorative railings less than 90cm high from school side. | No.11: Ornate decorative railings less than 90cm high from school side. | No.12: Fencing design has a central rail that allows a foothold, easily accessible. |

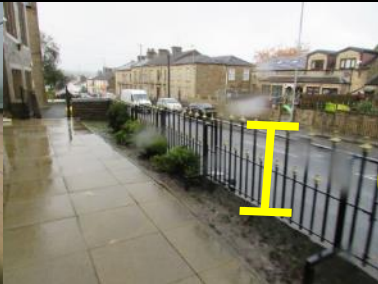
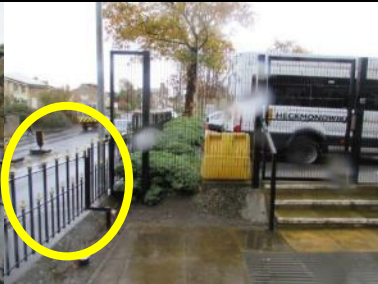
| No.13: General view to railings from inside school. | No.14: Ornate decorative railings less than 90cm high from school side. | No.15: Ornate decorative railings less than 90cm high from school side. | No.16: Could be used as a step up to make climbing over the railings easier. |

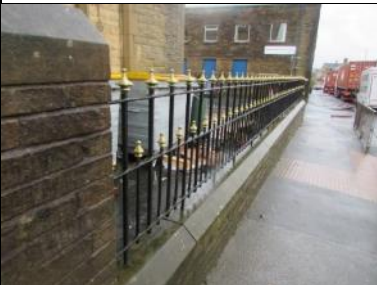
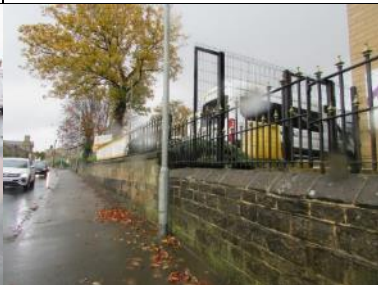
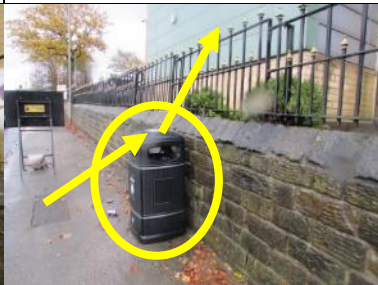
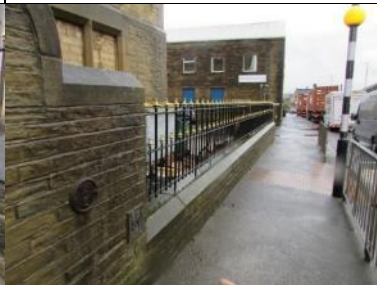
| No.17: View of sloping site, which equates to varying height railings between 0.5/0.9m stone wall with 0.9m railings. | No.18: Current design of railings make for ample hand and foot holds for easy climbing. | No.19: Current design of railings make for ample hand and foot holds for easy climbing. | No.20: Current design of railings make for ample hand and foot holds for easy climbing. |

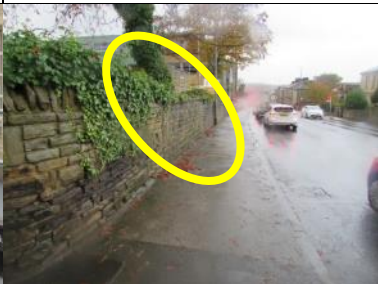
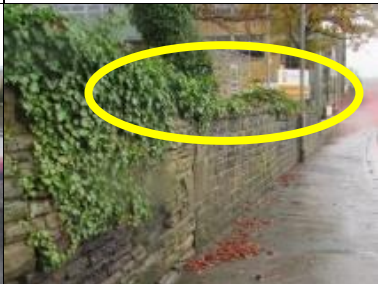
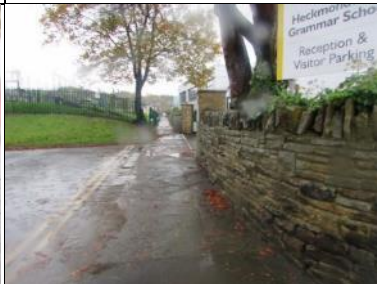
| No.25: Area leading from boundary fence used by many students over break and lunch | No.26: General view of stone wall with no edge protection | No.27: General view of stone wall with no edge protection | No.28: General view of stone wall with no edge protection<br>No.29: |

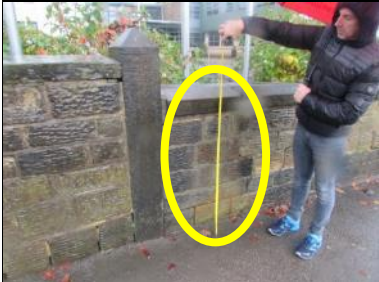
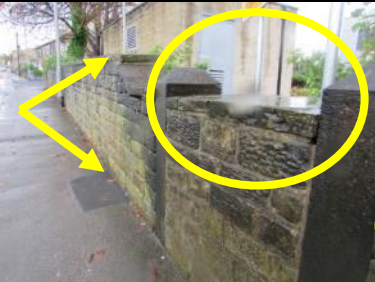
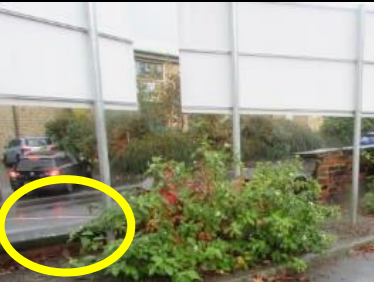
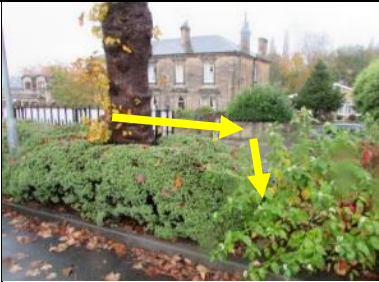
| Location | Element | Description | Photo Ref | Grading |
|---|---|---|---|---|
| North Boundary | Retaining Stone Wall with no Edge Protection<br> | Further along from the above, the retaining stone wall is between 1m and 1.6m high. From the school side, there is no edge protection for pedestrians. | 26-36 | <b>D1</b> |

| No.30: Stone retaining wall between 1/1.6m high, with little/insufficient edge protection. | No.31: Stone retaining wall between 1/1.6m high, with little/insufficient edge protection. | No.32: View from school, inadequate edge protection. | No.33: View from school, inadequate edge protection. |

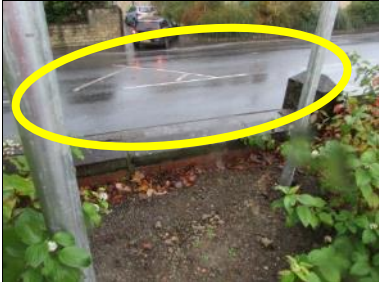
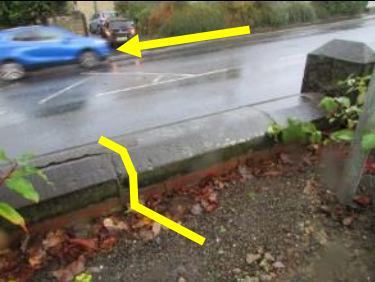
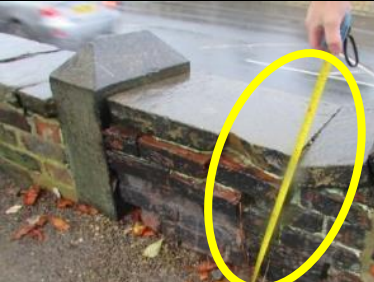
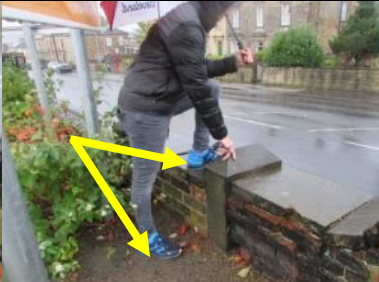
| No.34: View from school, inadequate edge protection. | No.35: View from school, inadequate edge protection and busy A road. | No.36: View from school, inadequate edge protection of up to 40cm high. | No.37: View from school, inadequate edge protection of up to 40cm high. |

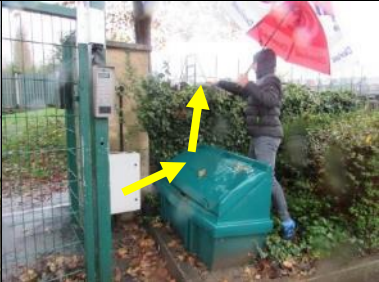
| No.38: General view of East Elevation | No.39: General view of East Elevation from car park. | No.40: General view of East Elevation from car park. | No.41: View from car park, vegetation covering stone wall. Insufficient height for boundary at 1.4m high. Easy step up from grit bin. |

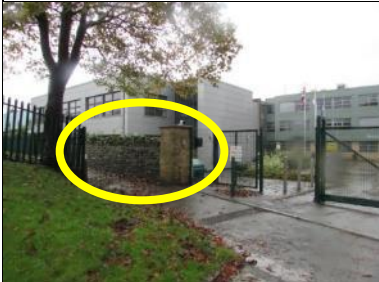
| No.42: New gates installed are considerably | No.43: General view to stone wall adjoining the | No.44: General view to stone wall adjoining the | No.45: General view to stone wall adjoining the |

| higher than the existing stone wall, creating a step up point. | public footpath along East Elevation. | public footpath along East Elevation. | public footpath along East Elevation. |

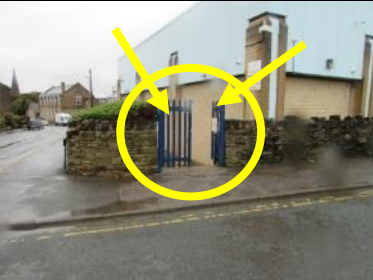
- At the top of steps, there is an inward opening palisade gate, which causes a bottle neck on a major fire escape route from the sports hall. The gates are locked shut with a padlock during school hours to restrict access, however due to the low height this will not prevent unwanted access and creates a fire risk, for evacuation of the building in the event of a fire. **This is in breach of the Education Act 2002.**

| No.46: General view to stone wall adjoining the public footpath along East Elevation. | No.47: 1.8m high palisade gate. NOTE - This gate is inward opening at the top of some steps and is the main fire exit route from the sports hall. Gate is also 50cm higher than the stone wall, making for easier access. | No.48: 1.8m high palisade gate 0.5m higher than stone wall. Fire escape concerns over inward opening gate at the top of steps and crushing. | No.49: 1.8m high palisade gate 0.5m higher than stone wall. This enables easier access for anyone looking to gain access to school grounds. |

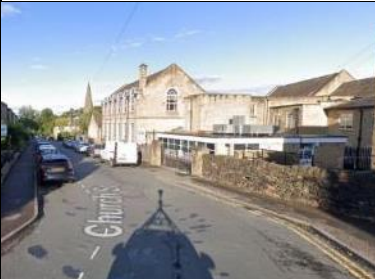
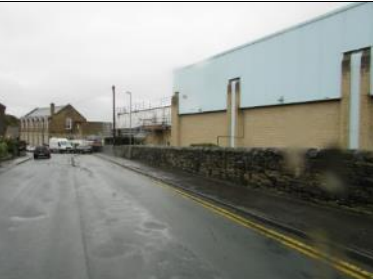
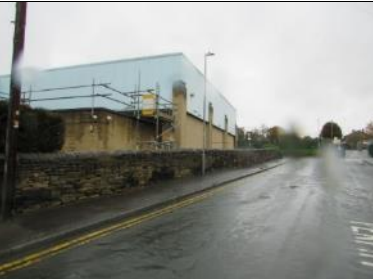
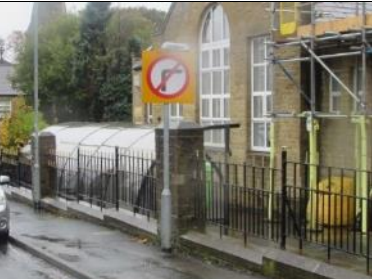
| No.50: General view to South Elevation | No.51: General view to South Elevation | No.52: General view to South Elevation | No.53: General view to South Elevation |

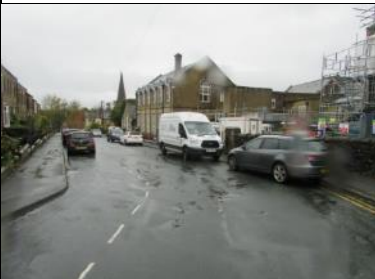
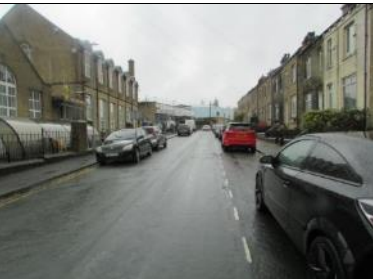
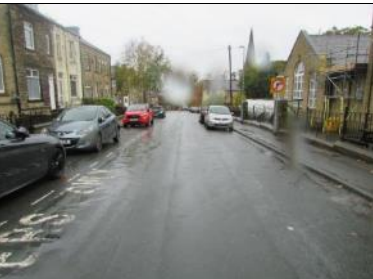
| No.54: General view to South Elevation | No.55: General view to South Elevation | No.56: General view to South Elevation | No.57: 1.3m high stone wall running along south elevation. Insufficient height for perimeter boundary. |

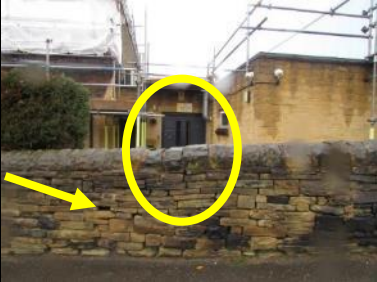
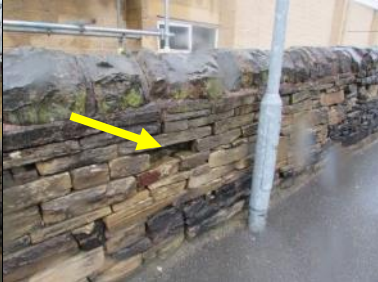
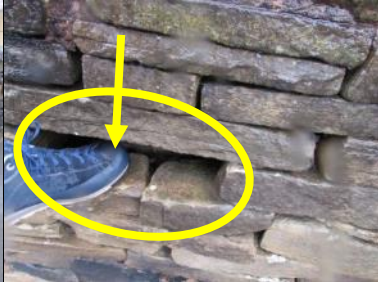
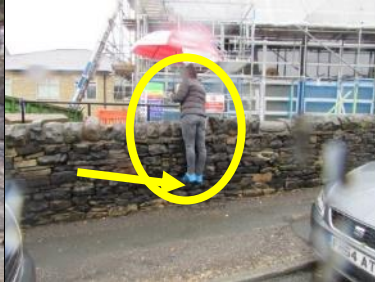
| 3c. South Elevation | General Pictures | | 49-55 | |
|---|---|---|---|---|
| South Boundary | Stone Wall<br> | This wall is approximately 1.3m high and runs along the perimeter of the school along Church Street. There are numerous missing stones to the wall, which act as a step up for any trespassers wanting to utilise this weak boundary as an access point. Directly behind the stone wall, there is some coniferous vegetation, which adds a further 0.7m to the boundary for approximately 15m. This small section is the correct height, but still does not comply with DfE Safeguarding Guidance. There is also some further coniferous vegetation within the school boundary further along the wall, which cannot be seen from the road side and offers no protection. | 56-65 | D1 |

| <p>No.58: Main access doors behind 1.3m high stone wall. Very easily to climb over offering little safeguarding or security for students.</p> | <p>No.59: Stone wall with various stones missing, creating footholds for even easier climbing. Lamp post will also aid any trespassers by offering a hand hold.</p> | <p>No.60: Stone wall with various stones missing, creating footholds for even easier climbing.</p> | <p>No.61: Stone wall with various stones missing, creating footholds for even easier climbing.</p> |

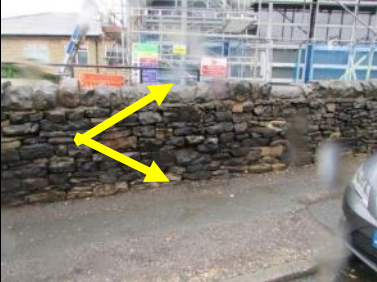
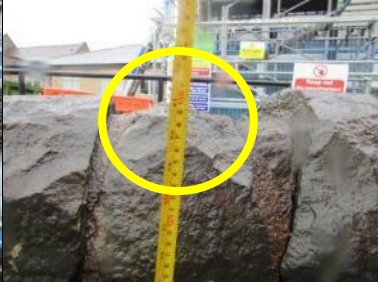
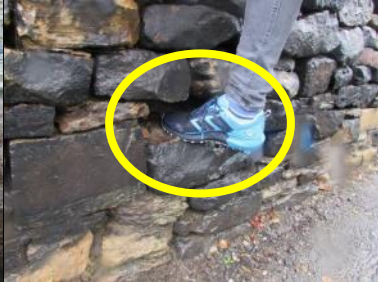
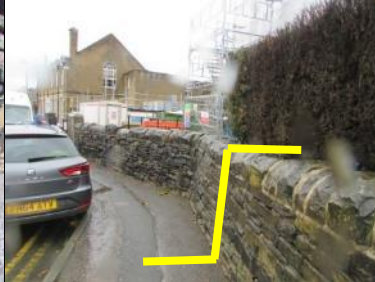
| <p>No.62: Stone wall to South boundary 1.3m high, insufficient for school environment.</p> | <p>No.63: Stone wall to South boundary 1.3m high, insufficient for school environment.</p> | <p>No.64: Stone wall with various stones missing, creating footholds for even easier climbing.</p> | <p>No.65: Stone wall with vegetation adding height to boundary, non-compliant with DfE Safeguarding guidance.</p> |

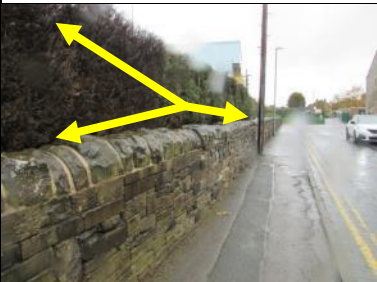
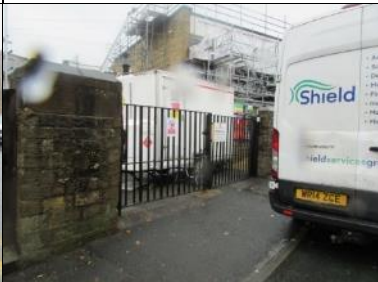
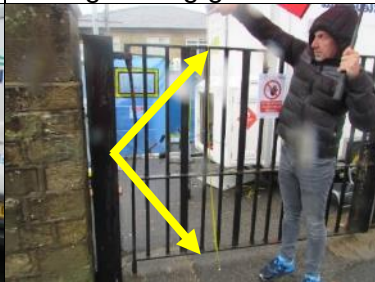
| <p>No.66: Stone wall with vegetation adding height to boundary, non-compliant with DfE Safeguarding guidance.</p> | <p>No.67: General view of vehicular gate to South boundary</p> | <p>No.68: General view of vehicular gate to South boundary 1.3m high. This does not offer appropriate security provisions and leaves the school vulnerable.</p> | <p>No.69: Metal vehicular railings style gate, 1.3m high. This does not offer appropriate security provisions and leaves the school vulnerable.</p> |

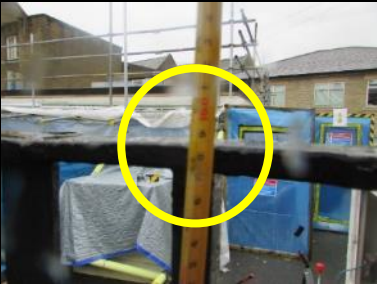
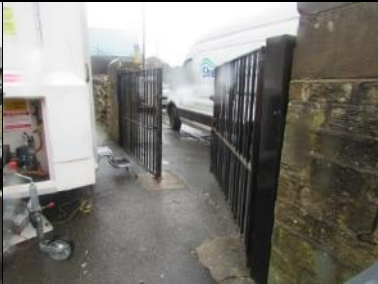
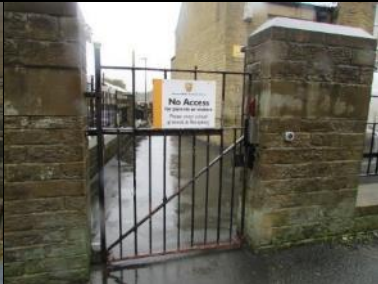
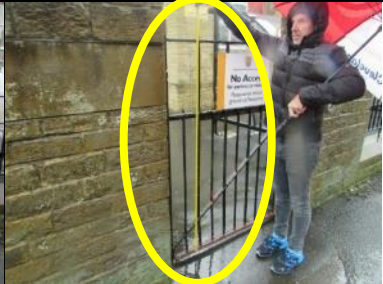
| No.70: Metal vehicular railings style gate, 1.3m high. This does not offer appropriate security provisions and leaves the school vulnerable. | No.71: No access control measures in place to enable the school to control who enters through this gate. | No.72: General view to pedestrian railing style gate to South Elevation. Access control to this gate. | No.73: Decorative railing style gate no adequate height for school boundary. Gate is less than 160cm high and leaves the school vulnerable. |

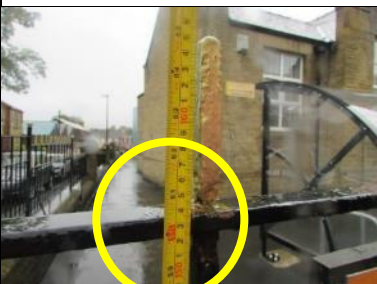
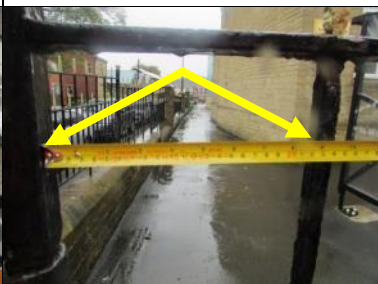
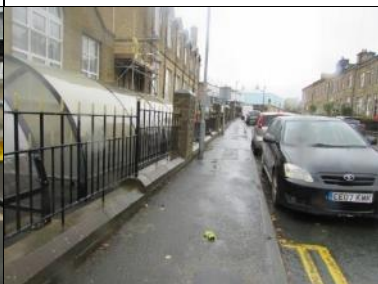
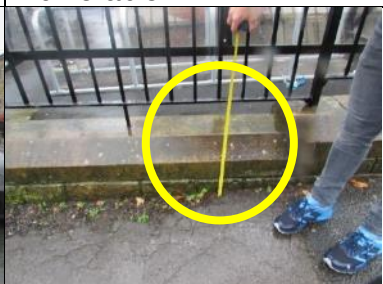
| No.74: Decorative railing style gate no adequate height for school boundary. Gate is less than 160cm high and leaves the school vulnerable. | No.75: Decorative railing style gate no adequate height for school boundary. Gate design has 22cm gaps between rails. This offers a step to enable climbers but also could fit a small person though. | No.76: General view of decorative railings to South boundary. Sloped site varies the railing height slightly, but consistently below 1.6m high. | No.77: Very low wall of 30cm high and railings above (90cm) amounting to less than 1.2m high. |

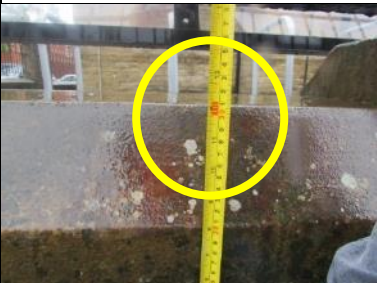
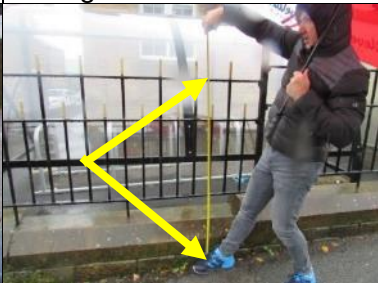
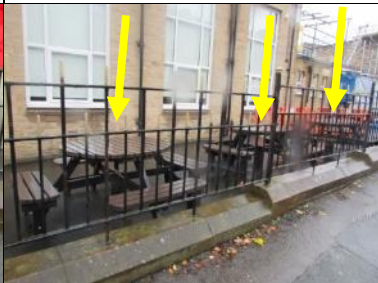
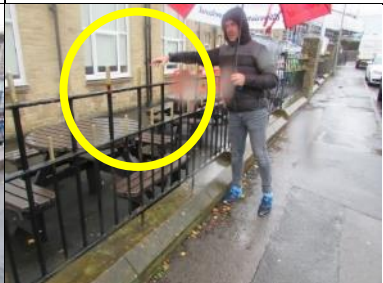
| No.78: Very low wall of 30cm high and railings above (90cm) amounting to less than 1.2m | No.79: Very low wall of 30cm high and railings above (90cm) amounting to 1.2m | No.80: Very low boundary directly next to where students have their lunch and play over break and lunch. | No.81: Taken from public path, but very easy for member of the public to reach into the school grounds. |

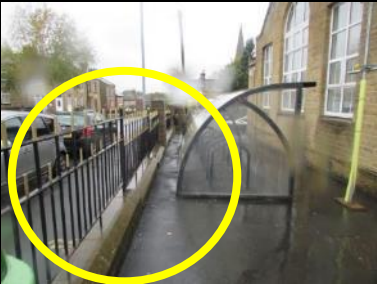
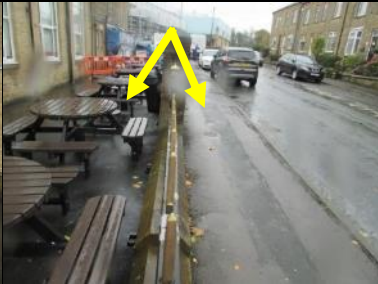
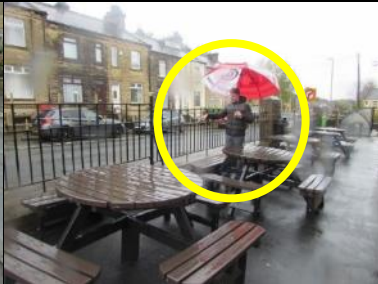
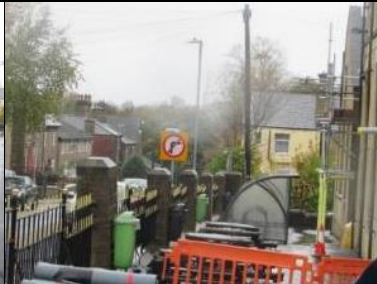
| No.82: Very low boundary directly next to where students have their lunch and play over break and lunch. | No.83: Very low boundary directly next to where students have their lunch and play over break and lunch. | No.84: Very low boundary directly next to where students have their lunch and play over break and lunch. | No.85: Very low boundary directly next to where students have their lunch and play over break and lunch. |

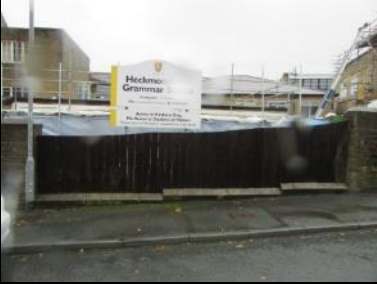
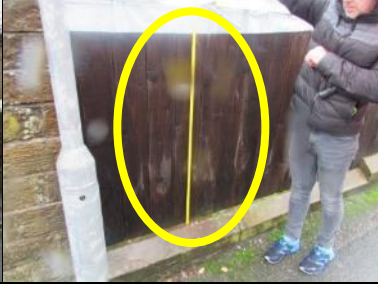
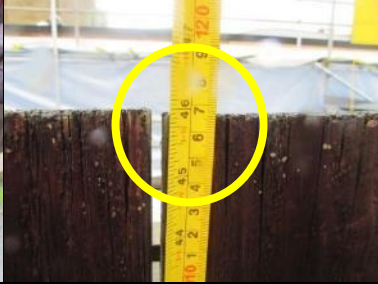
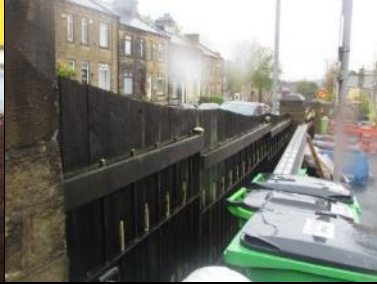
| No.86: General view to timber fence along south boundary. | No.87: Timber fence less than 1.2m high, not suited for school perimeter boundary | No.88: Timber fence less than 1.2m high, not suited for school perimeter boundary | No.89: General view to timber fence along south boundary. |

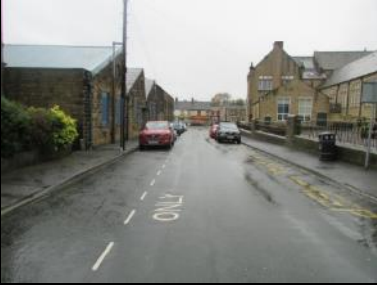
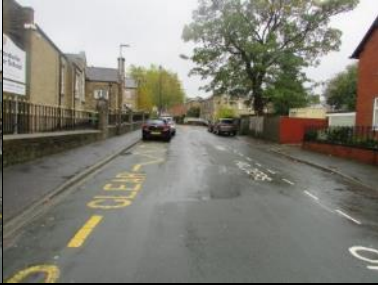
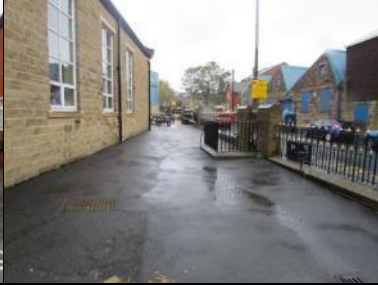
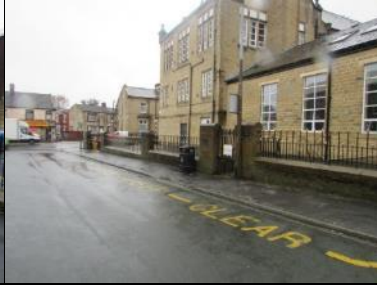
| No.90: General view to West Elevation | No.91: General view to West Elevation | No.92: General view to West Elevation | No.93: General view to West Elevation |

| West Boundary | Pedestrian & Vehicular Access Gates<br>● ● | Along this boundary, there are 3 gates (1 double pedestrian, 1 single pedestrian and 1 vehicular gate) which match the height of the fence a maximum height of 1.6m high. All of these gates are not high enough and can also be easily climbed/traversed. The double pedestrian gate and vehicle access gate have no access controls either, which are inadequate as the double gate is the main student entrance. | 93-97 | D1 |

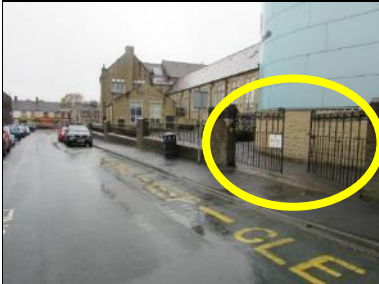
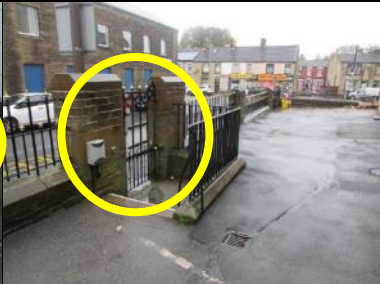
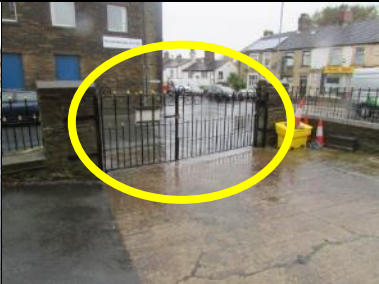
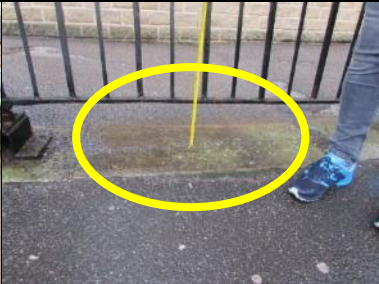
| No.94: Main double gated pedestrian entry to school. No access controls to these ornate decorative gates, 1.6m high | No.95: Decorative ornate single pedestrian gate, 1.6m high. Even though there is access control, the height is not suitable for a perimeter fence to a school. | No.96: Decorative ornate double vehicular gate, 1.6m high, with no access controls. The height is not suitable for a perimeter fence to a school. | No.97: 20cm gap below gate which has been poorly fitted. Children and animals could easily crawl underneath this gate. |

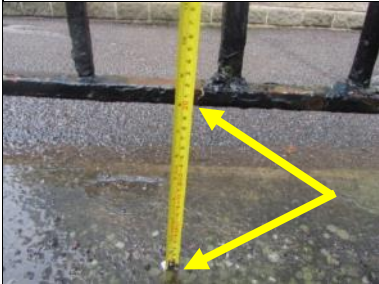
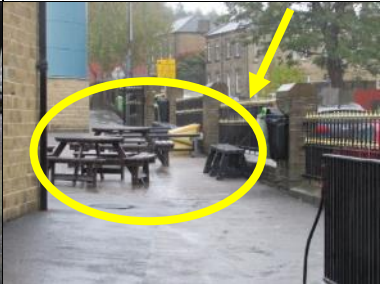
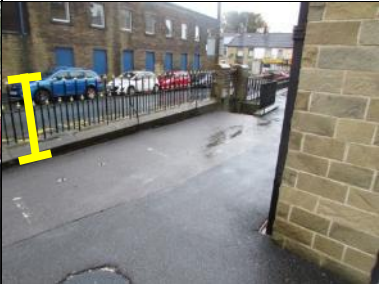
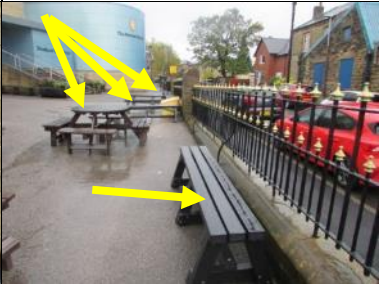
| No.98: 20cm gap below gate which has been poorly fitted. Children and animals could easily crawl underneath this gate. | No.99: General view taken from school grounds of perimeter railings. | No.100: Ornate decorative railings positioned on stone wall, 1.2m high internal. | No.101: Outside area used by students at break and lunch time. The current boundary provision is leaving the school vulnerable. |

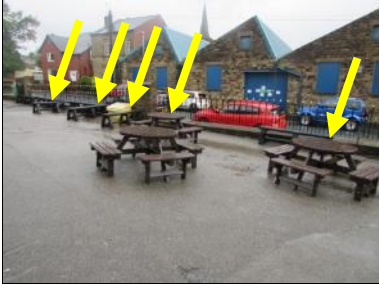
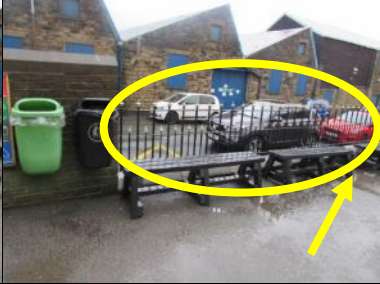
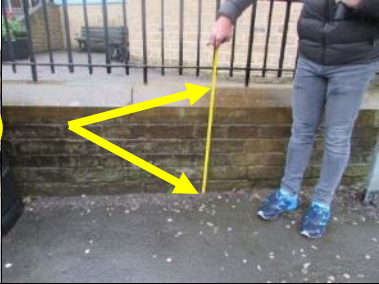
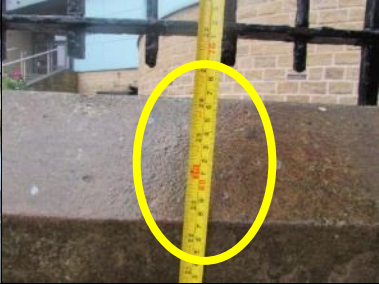
| No.102: Outside area used by students at break and lunch time. The current boundary provision is leaving the school vulnerable. | No.103: Outside area used by students at break and lunch time. The current boundary provision is leaving the school vulnerable. | No.104: Stone wall supporting the railings, less than 70cm high, not appropriate for use as a school boundary. | No.105: Stone wall supporting the railings, less than 70cm high, not appropriate for use as a school boundary. |

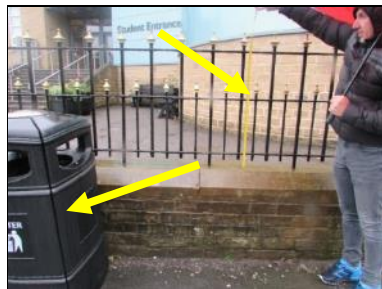
No.106: Decorative ornate metal railings positioned on top of stone. Railing height less than 90cm high. To make access easier, there is a litter bin positioned adjacent to boundary.

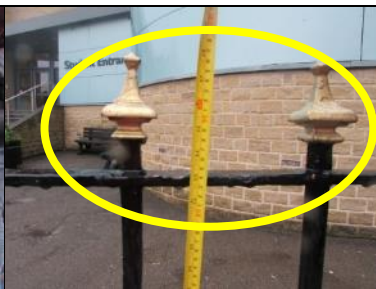
No.107: Decorative ornate metal railings positioned on top of stone. Railing height less than 90cm high.

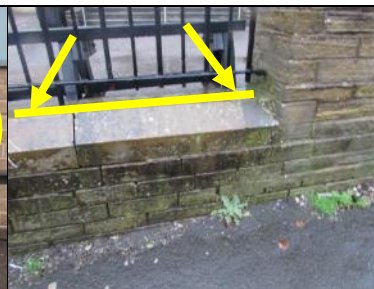
No.108: Entire length of stone wall has a lip which is easy to stand on and climb the 0.9m railings. Inadequate for a school perimeter boundary.

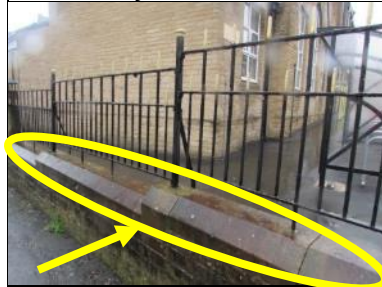
No.110: Entire length of stone wall has a lip which is easy to stand on and climb the 0.9m railings. Inadequate for a school perimeter boundary.

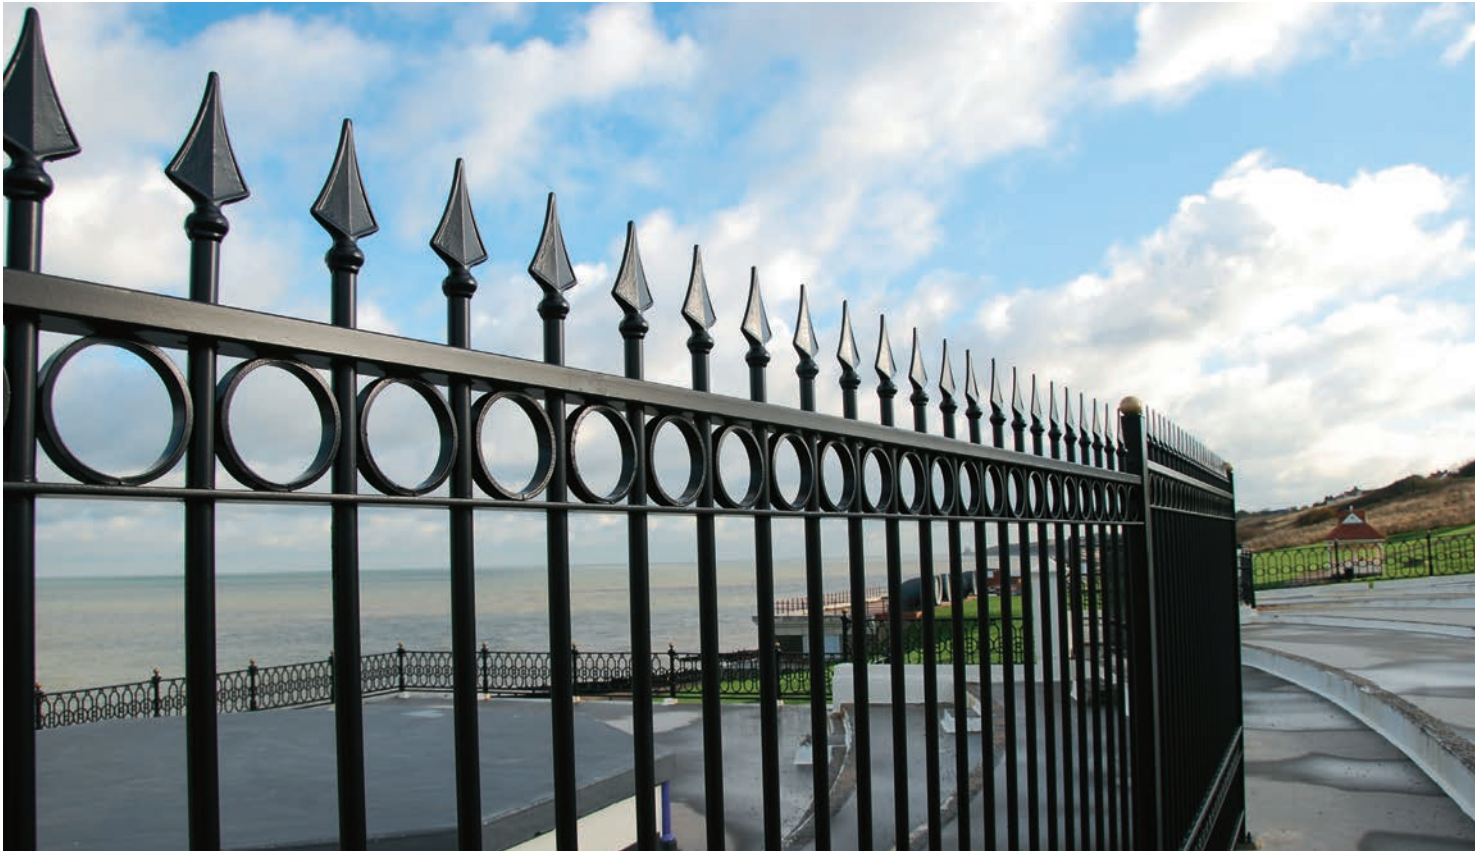
ORNAMENTAL

Our Ornamental fencing is designed to provide the aesthetic grace and form of traditional wrought iron railings with the strength and durability of galvanised or galvanised and powder coated steel. Whether in a parkland, corporate HQ or gated community, our Ornamental fencing adds high levels of security to a classical design.

- Custom designs available
- Pale spacing conforms to Building Regulations for anti-trap
- Various mounting options including on wall, inset or free standing
- Posts can be customised for Barbed wire / Razor wire / Rota Spike® / Alarm-aFence®
- 25-year service life guarantee

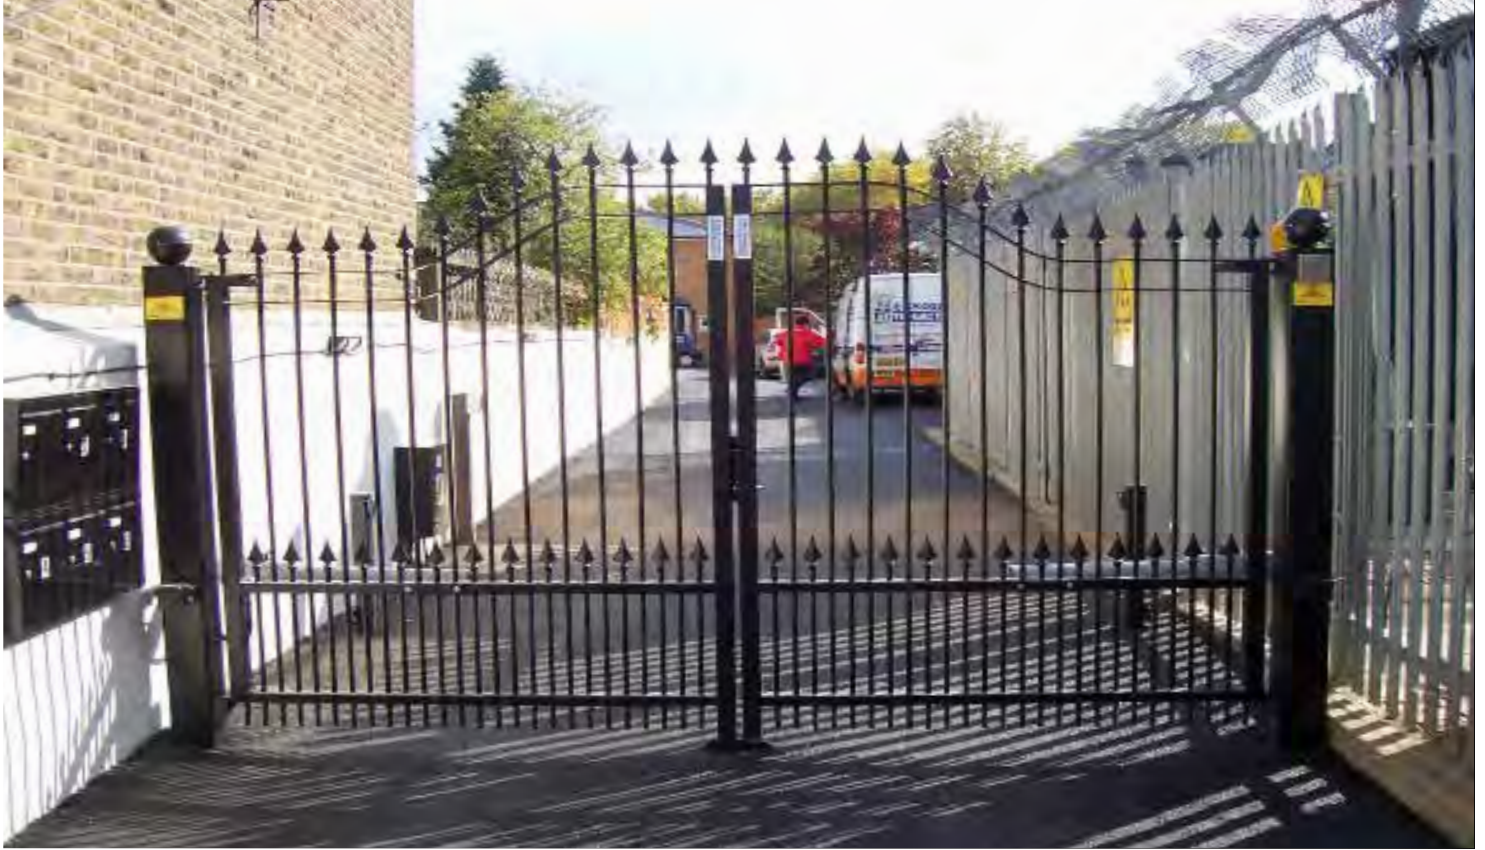
# ORNAMENTAL SWING GATES

- Horizontal rails for all gates are 60x40mm. Hanging and shutting stiles are rectangular hollow section 60x60mm
- Ornamental gates have 60x40mm slam stile unless automated then it is increase to 60x60mm.
- Single or double leaf options available
- Manual or automated operation
- Complete with tamper proof hinges that allow the gate to swing through an angle of up to 180 degrees (manual only)
- Square hollow section gate posts 100mm, 120mm and 150mm depending on the heights and width of gate
- Styles available: Standard, Style A, Style B
