Our Ref: Muffit Lane/BD19 4QD/2023  
Date: 30 November 2023

**POPELEY FARM, MUFFIT LANE, GOMERSAL, CLECKHEATON, BD19 4QS**  
**COAL MINING RISK ASSESSMENT**

# Popeley Farm, Gomersall – Structural inspection for planning

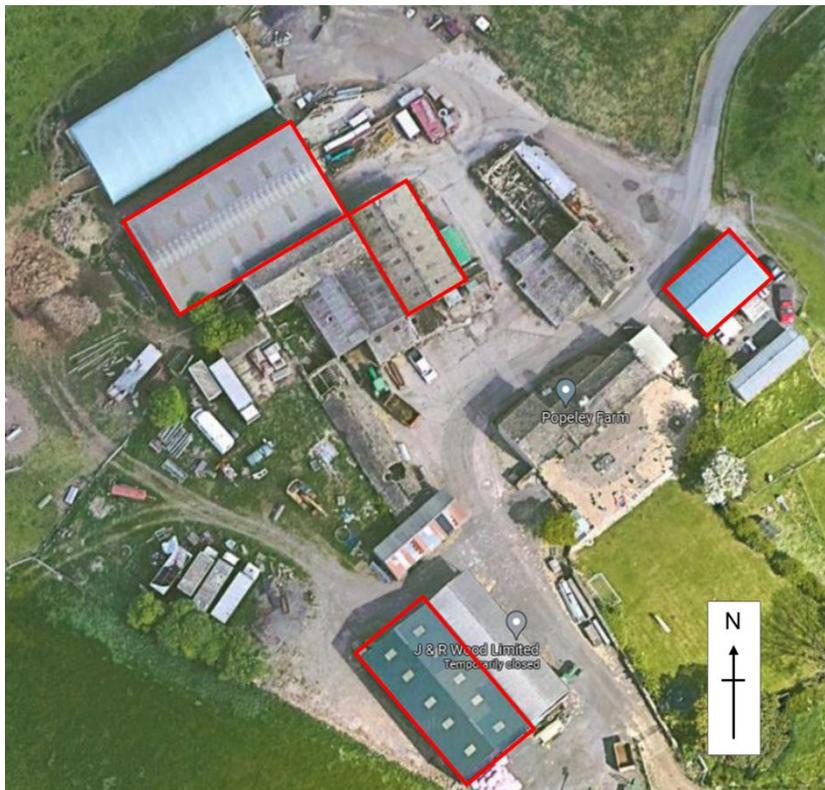
Figure 1: Satellite image of Popeley Farm, with the four structures inspected highlighted red (base image credit: Google Earth Pro.)

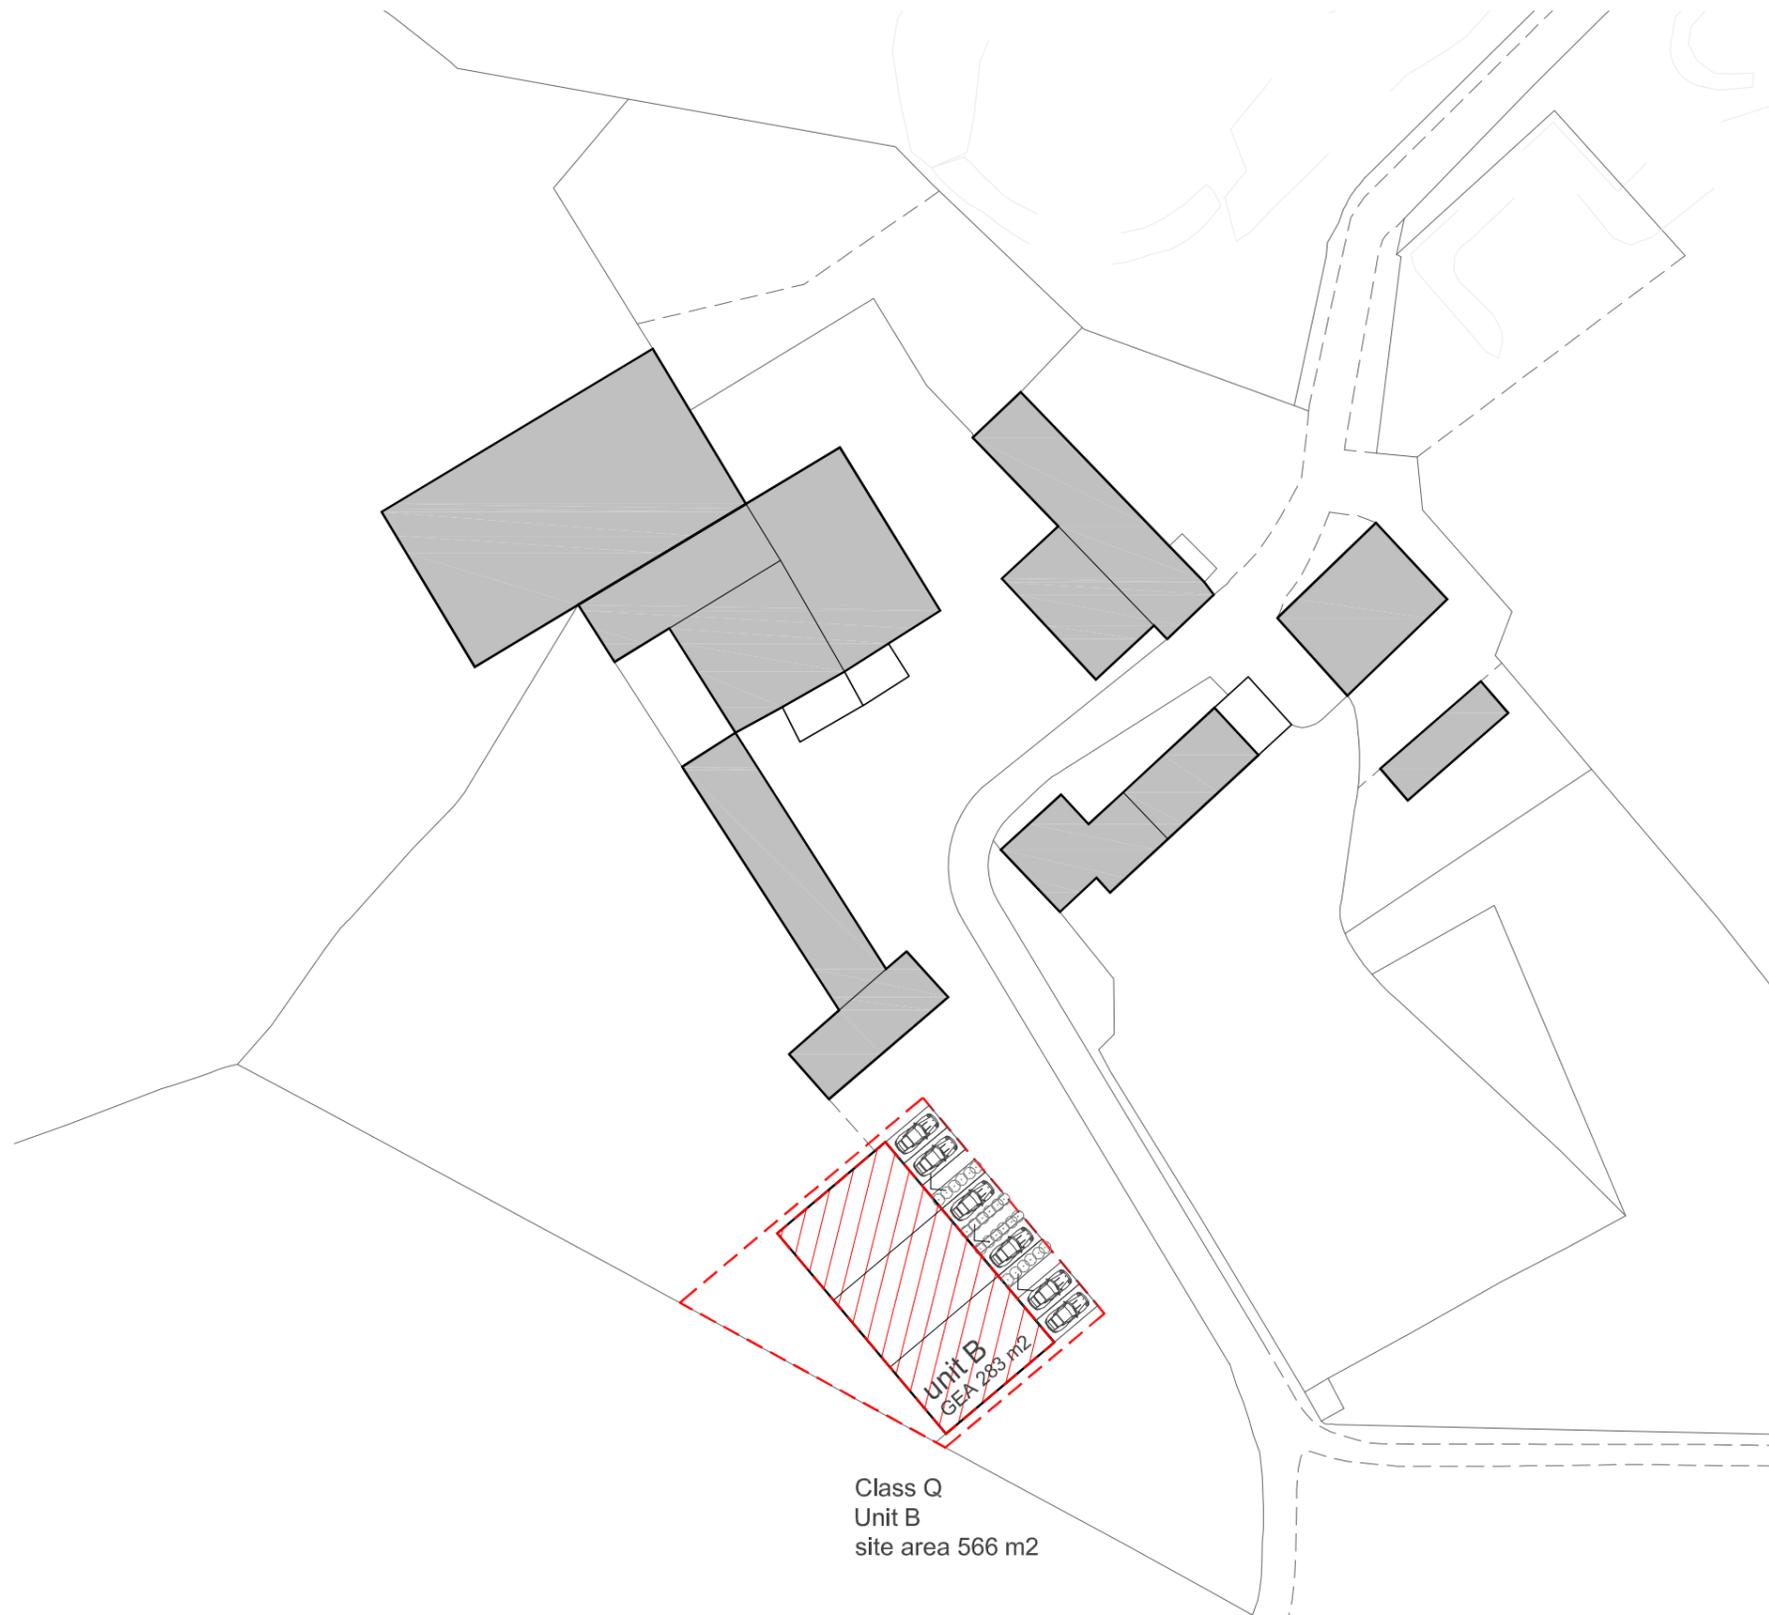
## Unit B (B8) site plan as proposed

Retained buildings
-

Converted building
-

Amenity Space ( area as building footprint)

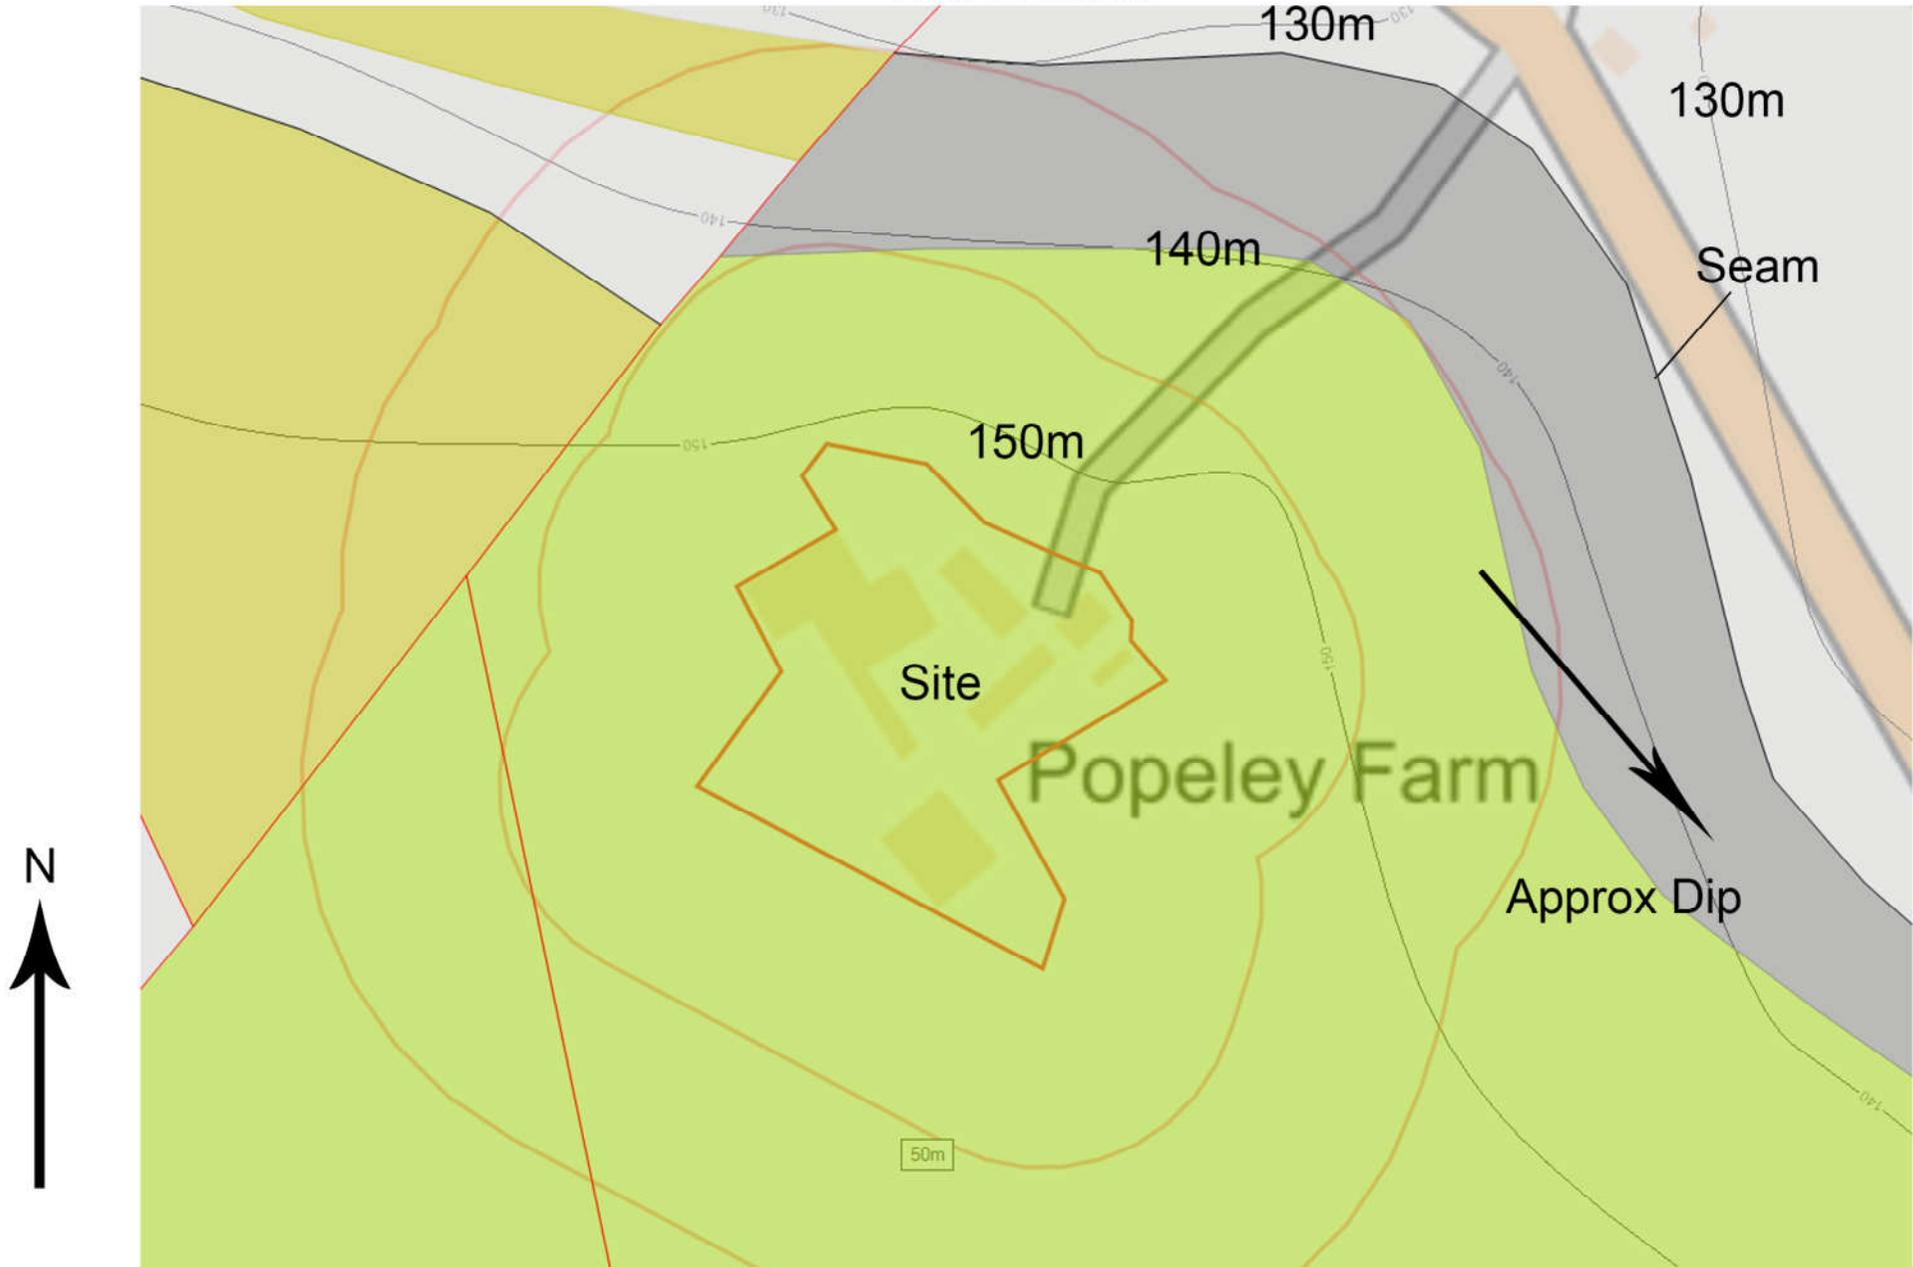
POPELEY FARM, MUFFIT LANE, GOMERSAL, CLECKHEATON, BD19 4QS  
Plan Showing Contours in Metres AOD  
Not to Scale

The Joan coal seam outcrops about 105m northeast and 130m AOD, roughly following the 130m contour around the hillside to the northeast. This is underlain by the Flockton Thick seam, about 15m below the Joan, and the Flockton Thin seam, about 30m below the Joan.

With the site at about 150 AOD this suggests the Joan seam is present at about 18 to 20m below rock below the site, with the Flockton Thick seam at about 35m and the Flockton Thin seam at about 50m below rock head.
