Verification of Remediation Works:

Land at Manor Street, Huddersfield

May 2024

Client: Ramm Construction

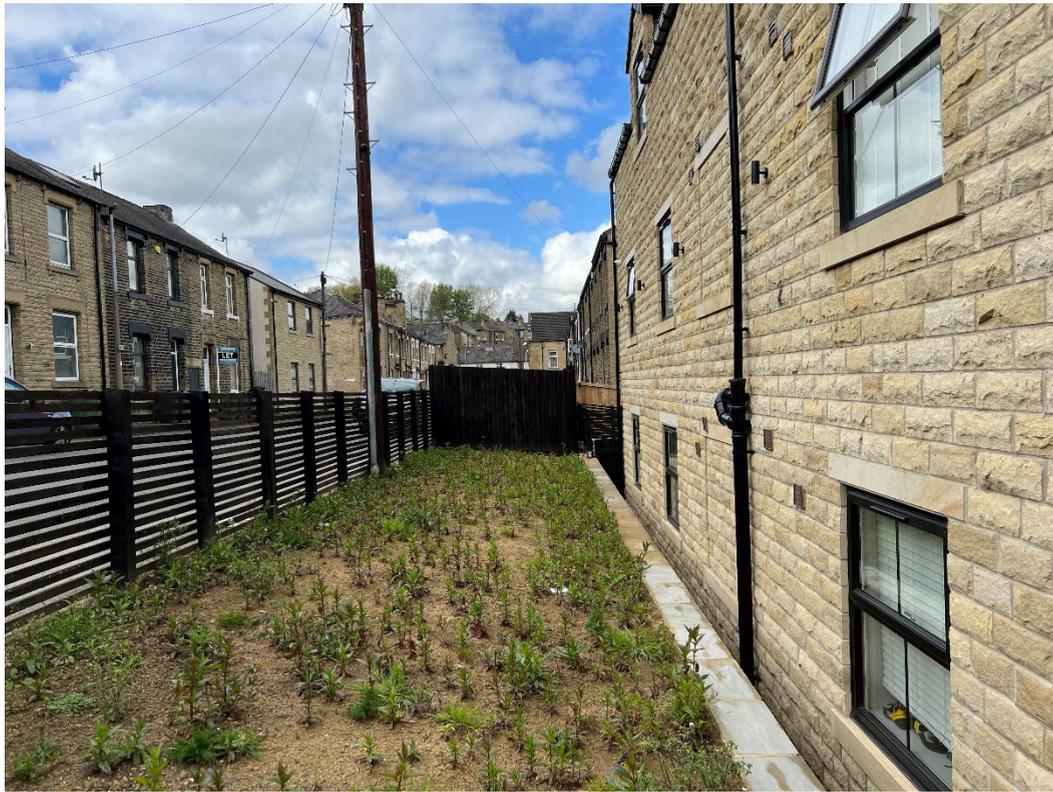
Photograph No.1: View south of southern boundary facing west.

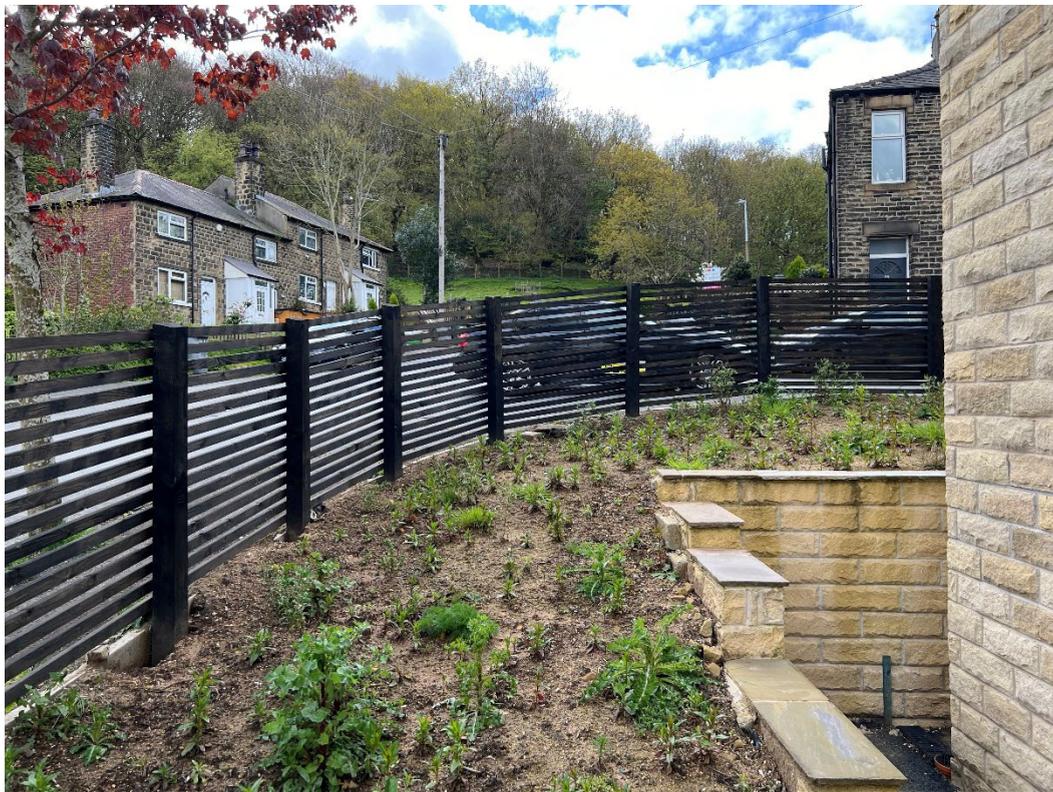
Photograph No.2: View of eastern boundary from side entrance facing south.

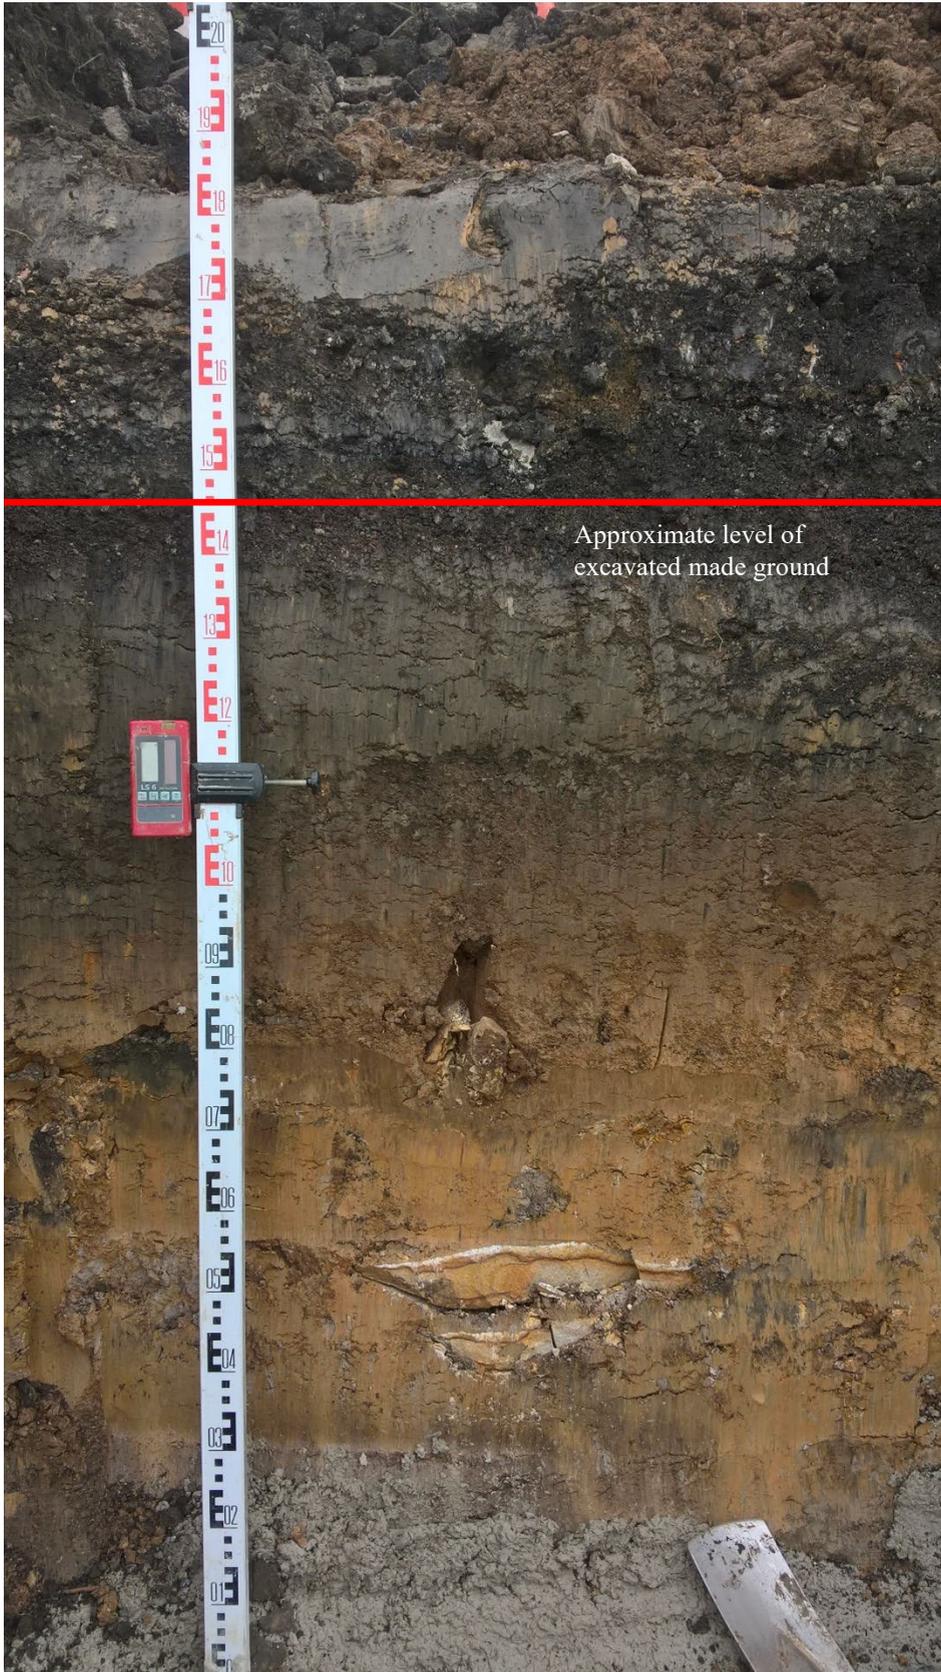
Approximate level of
excavated made ground

Photograph No.5: Pre construction excavation showing soil profile on southern boundary.

It should be noted that the depth of clean cover was confirmed to extend to depths of 500mm and 540mm with no photographic evidence of the excavation prior to it being raised by clean subsoil and topsoil. Whilst the depth of cover differs slightly to that in the remediation strategy the construction of the cover system with a geotextile at the base and use of compacted crushed quarry stone is considered to provide a suitably protective barrier.

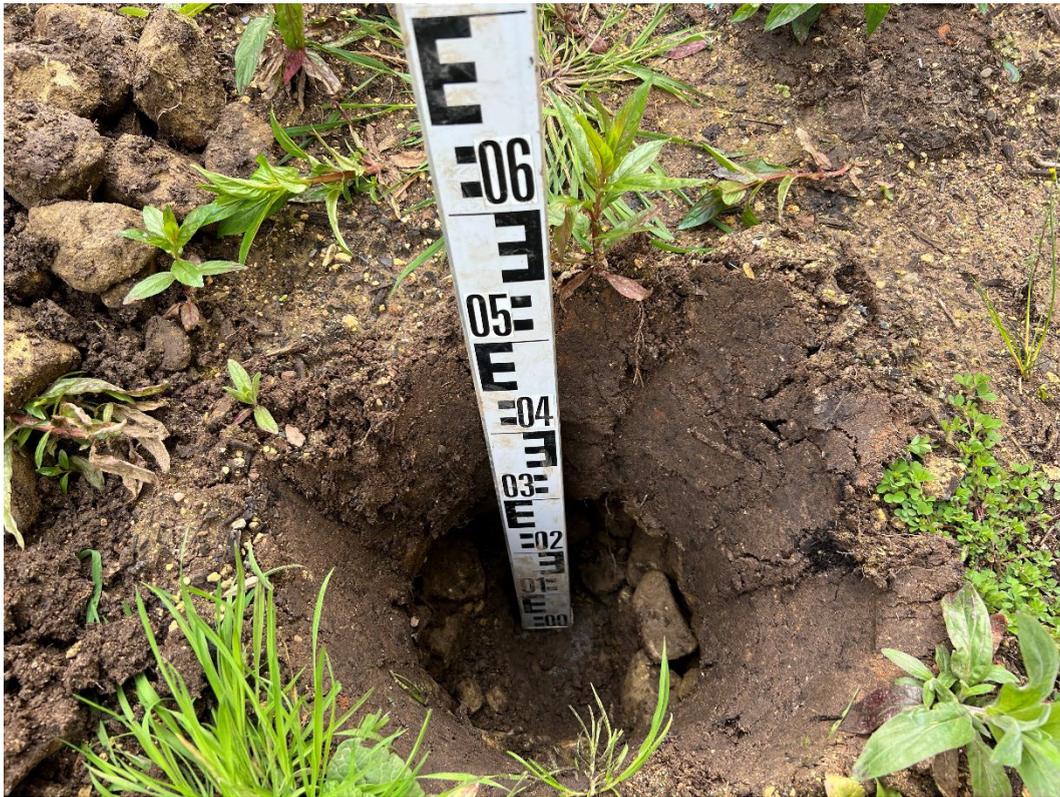
Photograph No.6: IP01.

Brown sandy TOPSOIL with fragments of organic matter. (manufactured)
	0.45	ES		0.50

Yellow coarse gravel size fragments of sandstone with black woven geotextile at base of excavation. (Engineering fill)
							----- End of pit at 0.50 m

Remarks: Geotextile visually confirmed. Backfill with arisings on completion.

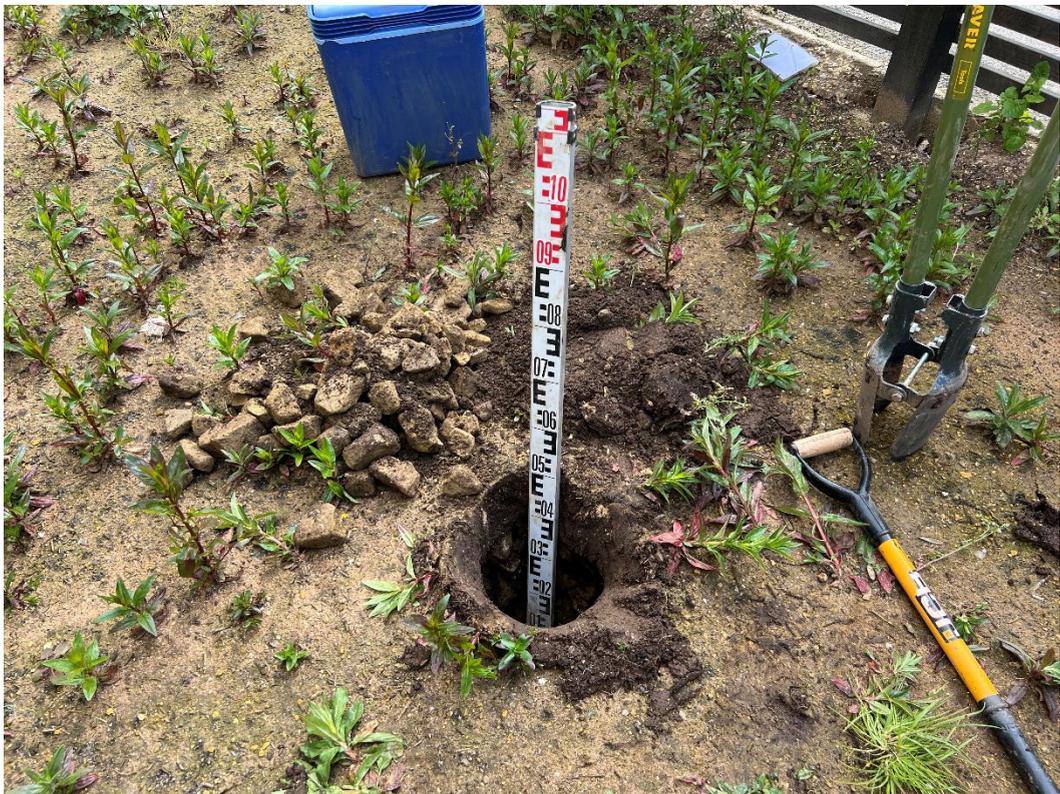
Photograph No.7: IP02.

Brown sandy TOPSOIL with fragments of organic matter. (manufactured)
				0.54

Yellow coarse gravel size fragments of sandstone with black woven geotextile at base of excavation. (Engineering fill)
							End of pit at 0.54 m

Remarks: Geotextile confirmed via hand. Backfill with arisings on completion.

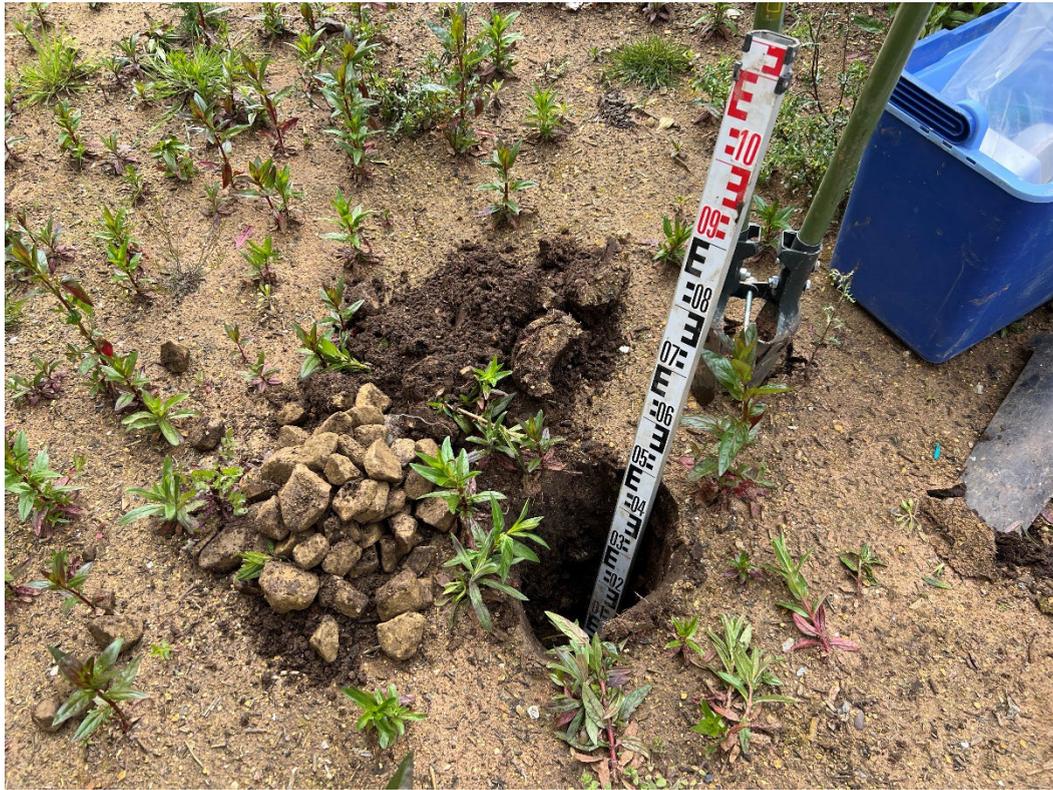
Photograph No.8: IP03.

Brown sandy TOPSOIL with fragments of organic matter. (manufactured)
