Land at Manor Street, Huddersfield

Phase 2 Site Investigation Report

May 2023

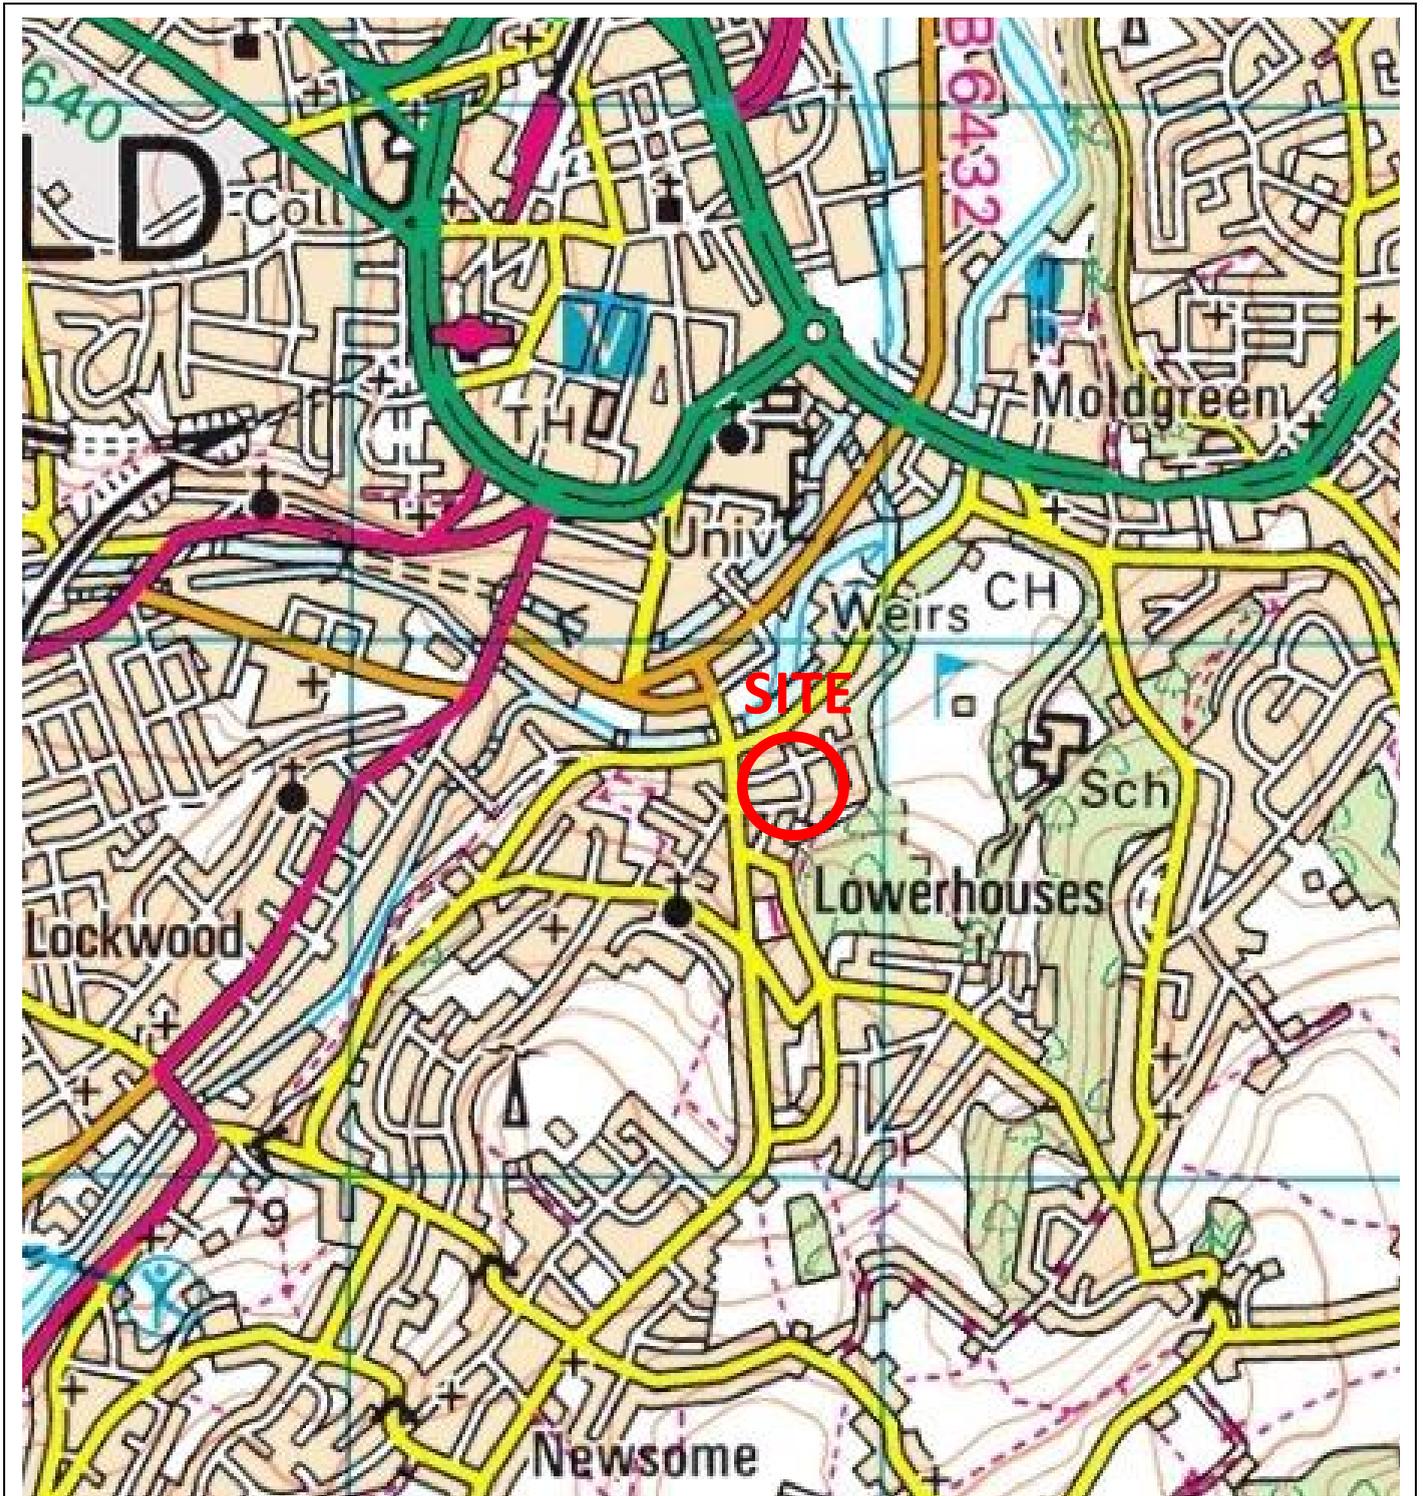
Appendix A – Site Location Plan

The site is located approximately 1.00km south of the centre of Huddersfield. It is approximately 0.04 Ha in size and centred on National Grid Reference 414821, 415700. The site is on the corner of Bell Street and Manor Street.

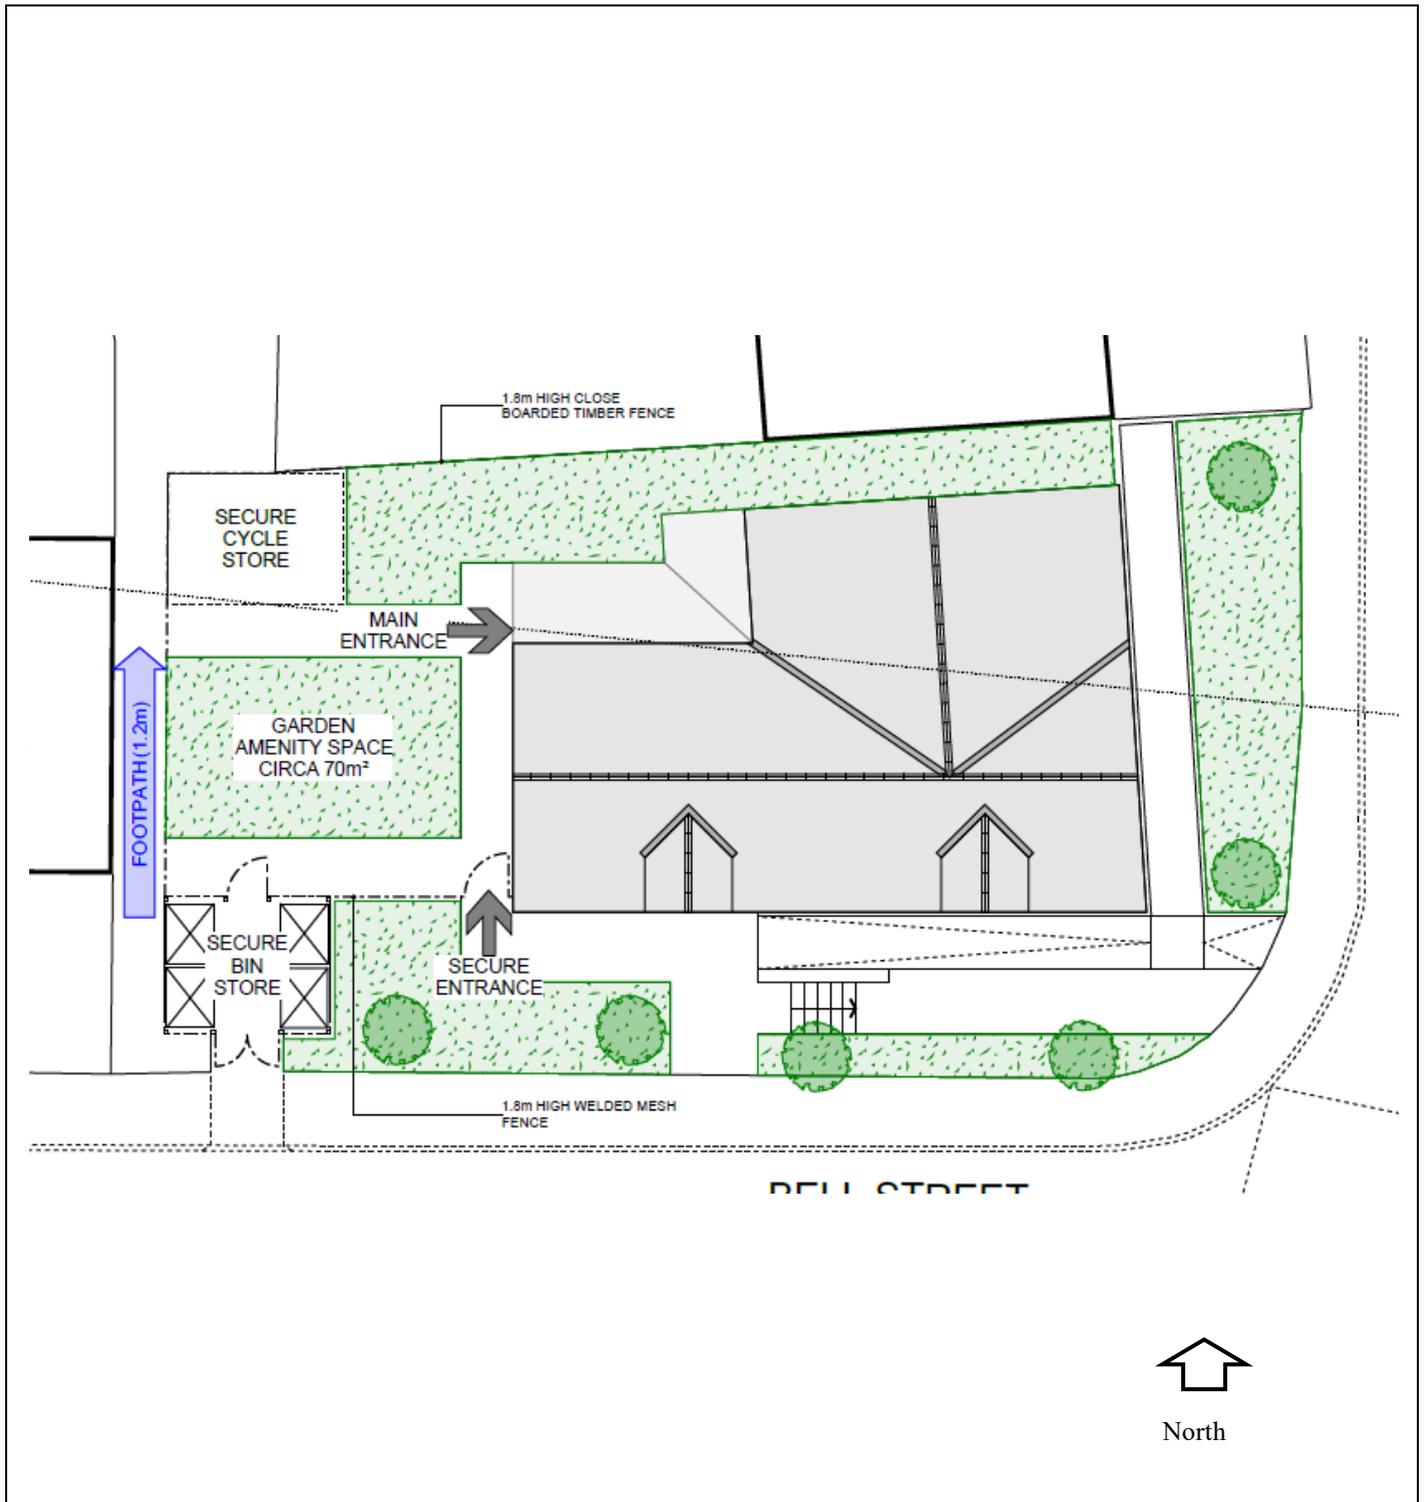
Appendix A – Proposed Site Layout

The proposed development consists of the construction of a single detached dwelling. The proposed site layout plan is presented as Drawing No. C0564-02 in Appendix A. Areas at the top of the retaining wall are proposed to be kept as soft landscape, though not as private gardens.

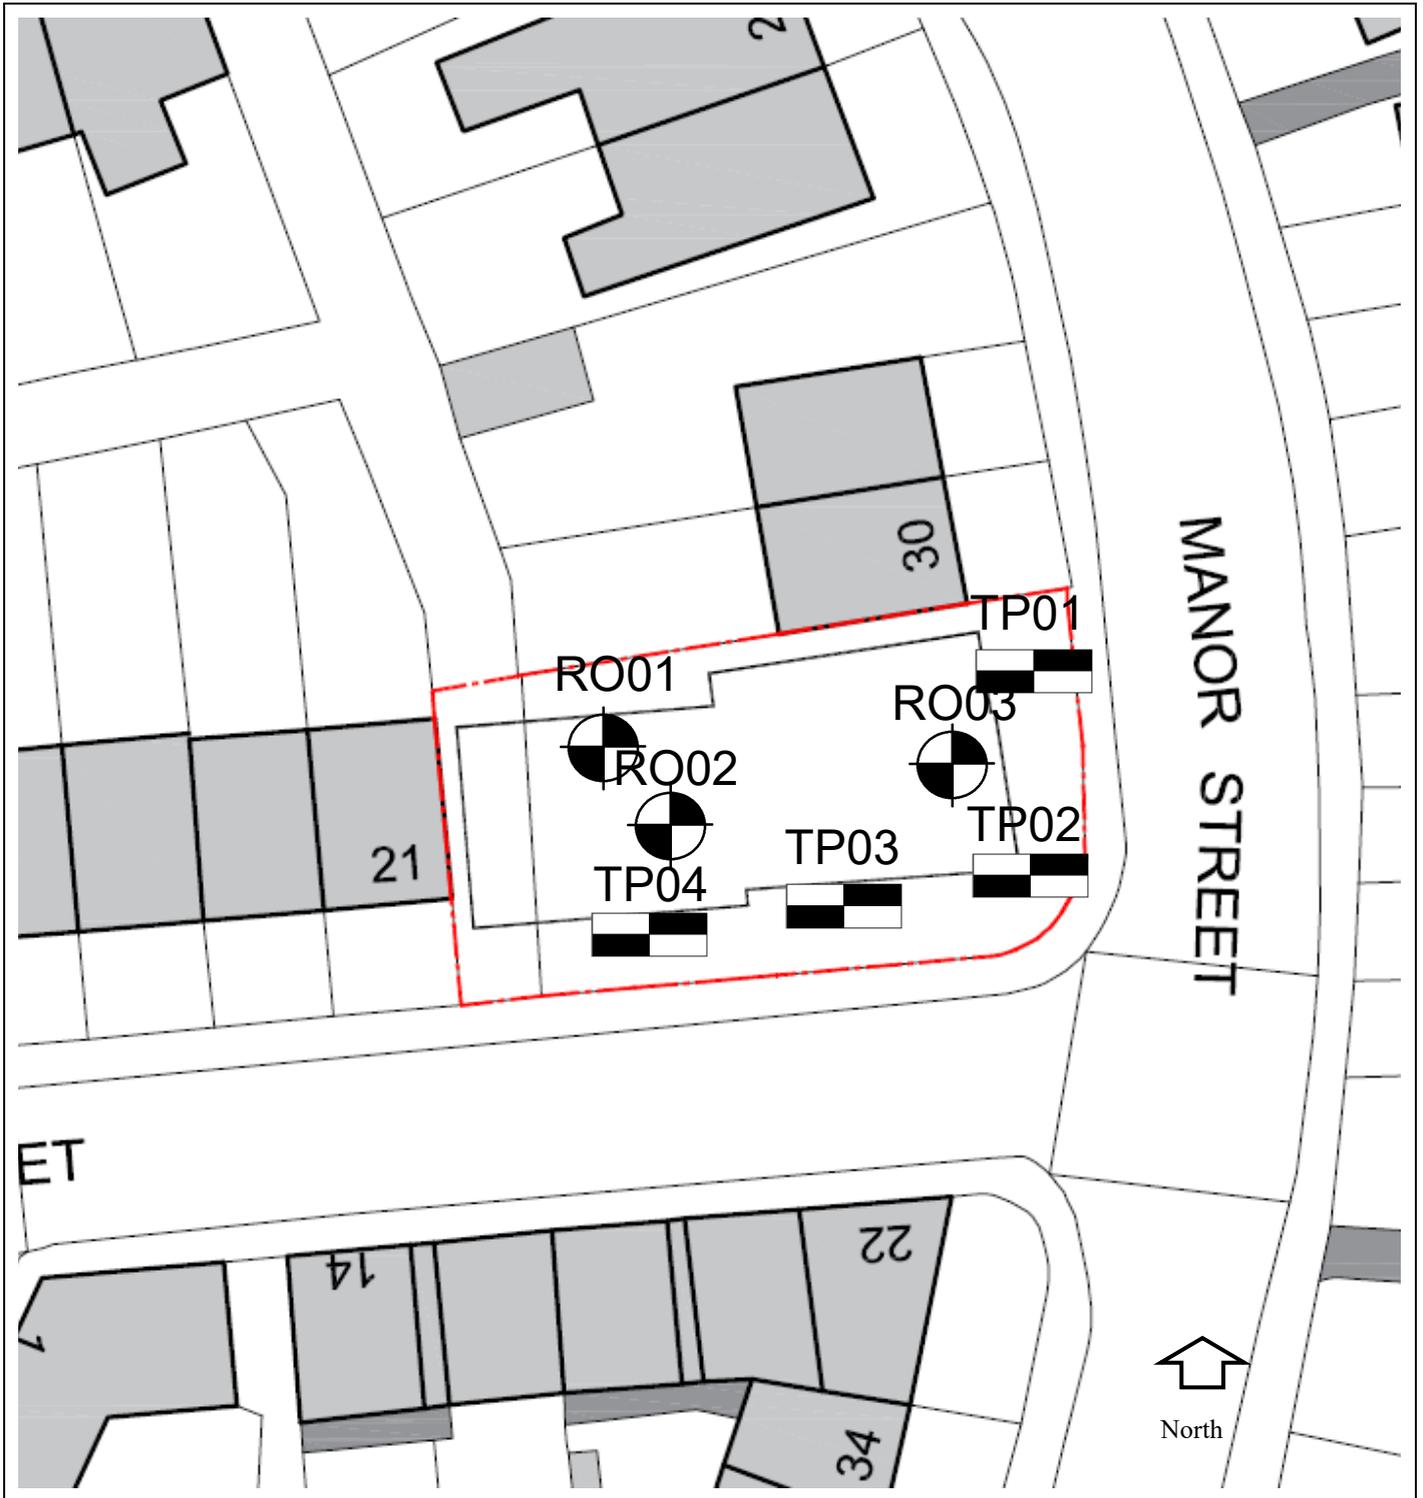
Appendix A – Exploratory Hole Location Plan

A total of four trial pits designated TP01 to TP04 were logged. TP01 was excavated in the side of a stockpile of arisings through to the natural strata beneath, while TP02 to TP04 were logged from the face of the retaining wall cutting. All were located in areas of proposed soft landscape. Between 0.70m and 1.70m of soil was logged by a qualified CGA engineer. Locations are shown on Drawing No. C0564-03 Exploratory Hole Location Plan.

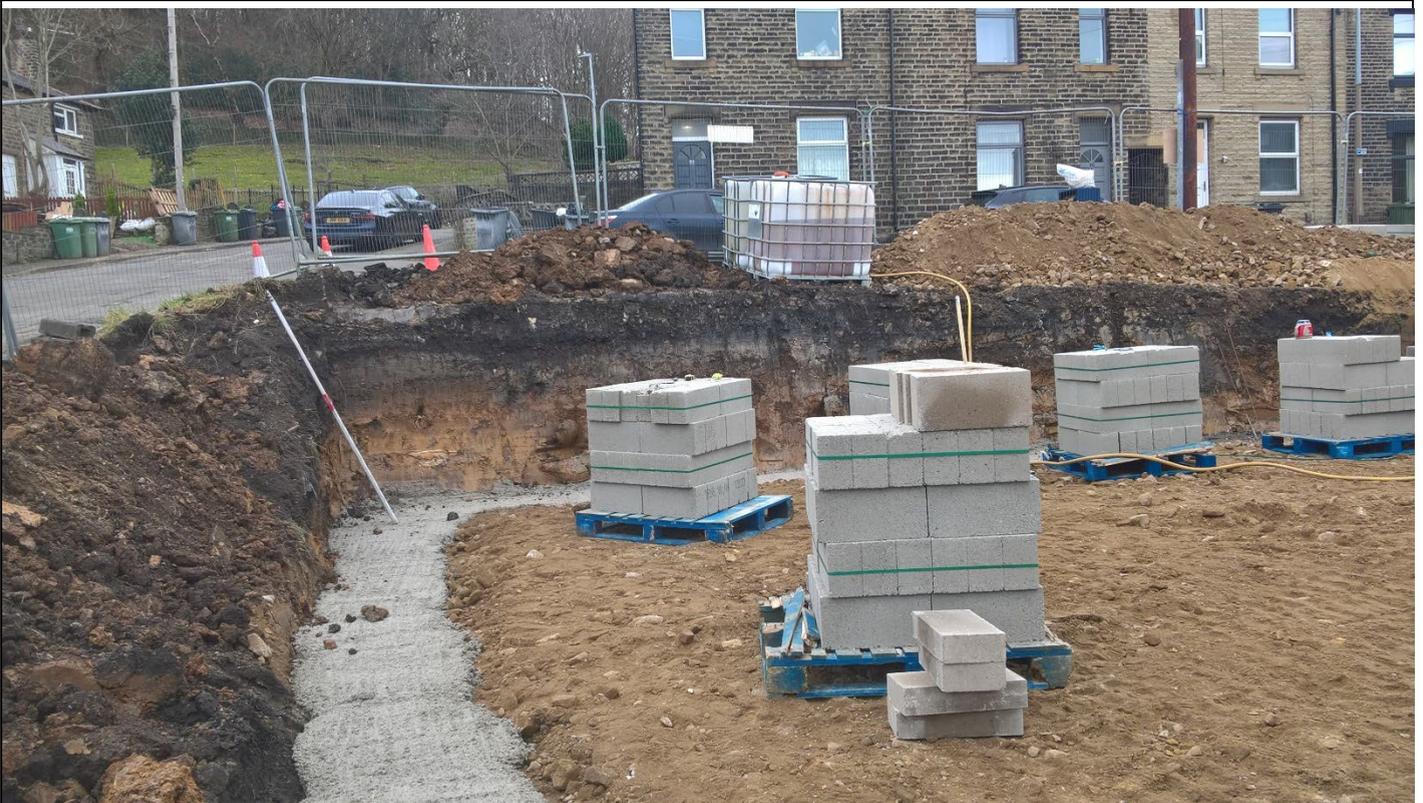
The site is rectangular in shape. On the day of the investigation the site had been largely stripped of topsoil, and levels had been reduced. A retaining wall was being constructed in the south and east of the site, and there were stockpiles of arisings along the southern and eastern site boundaries.

Photograph No.1: View south of cutting on site from site entrance in north east.

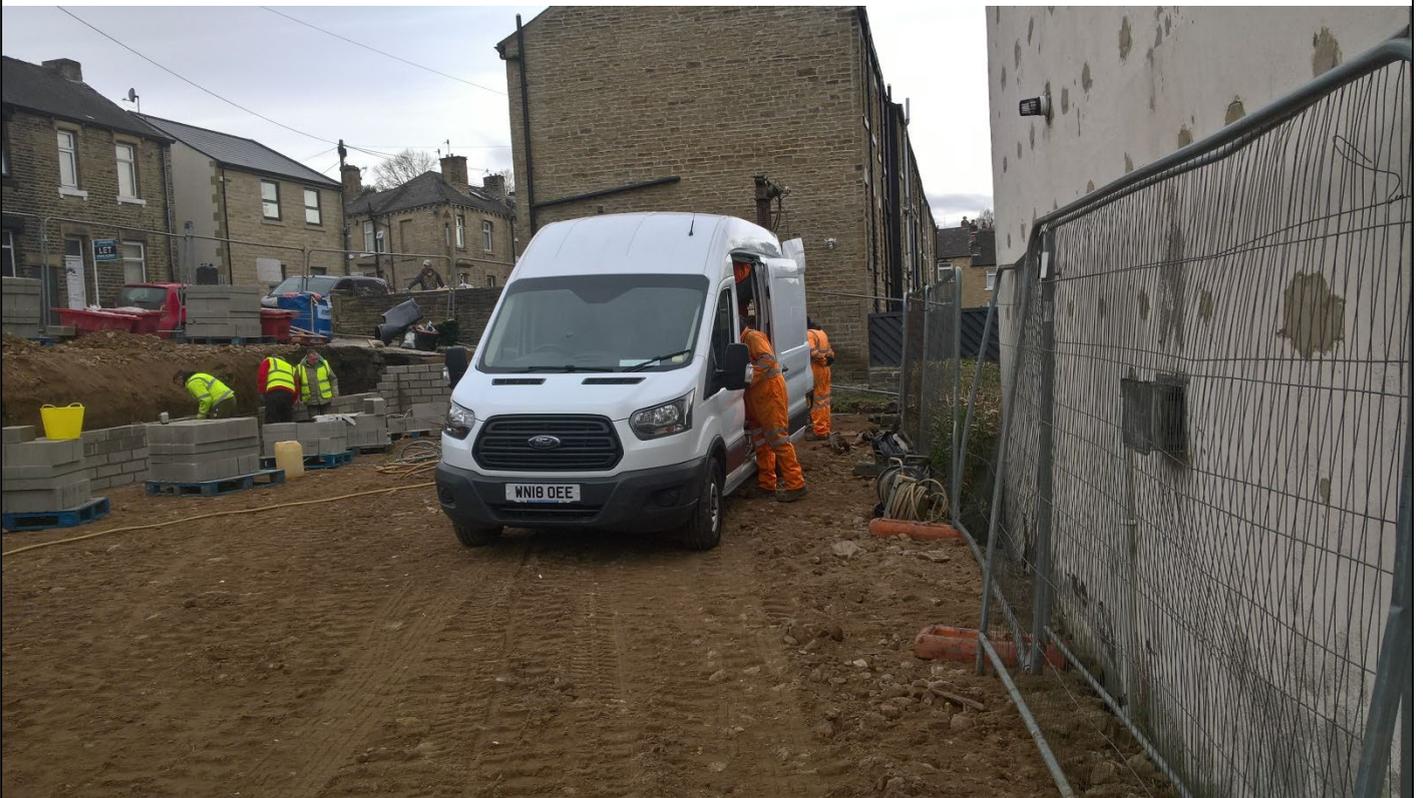
Photograph No.2: View west of site from entrance.

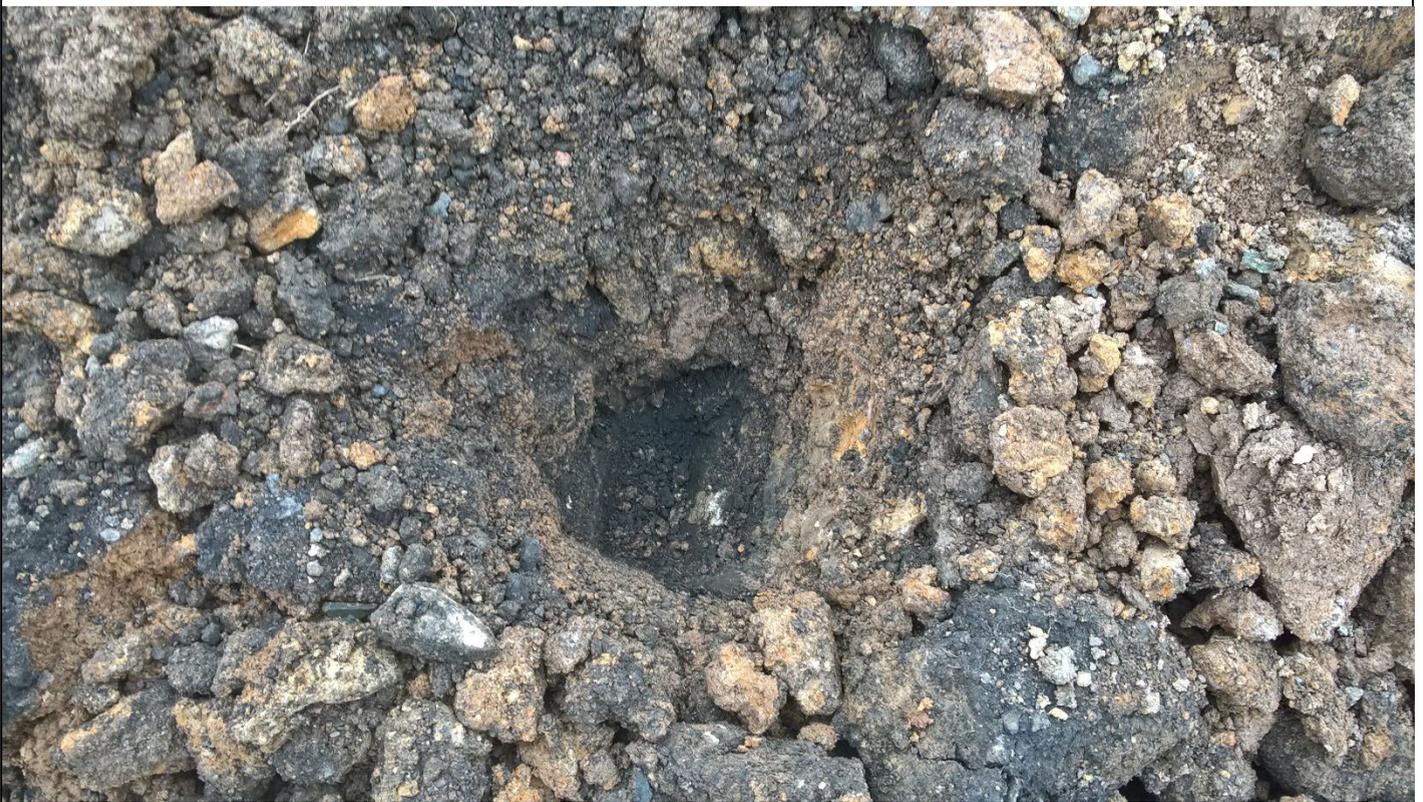
The waste classification for made ground within the western half of the site has been determined to be Hazardous Waste due to the high levels of PAH recorded at the location of TP01. The following waste code can be applied to made ground;

Photograph No.3: TP01 hand pit in north east of site.

Made ground from the location of TP01 is recommended to be segregated for disposal. Due to the variability in the made ground a visual check and segregation of similar made ground to that recorded in TP01 is recommended.

Remediation options for the site include the removal of the contaminated materials and the provision of a verified clean imported cover layer to provide a growing medium for future vegetation. At TPO1 the soils were identified to have elevated concentrations of total PAH, and will require specialist disposal as hazardous waste.

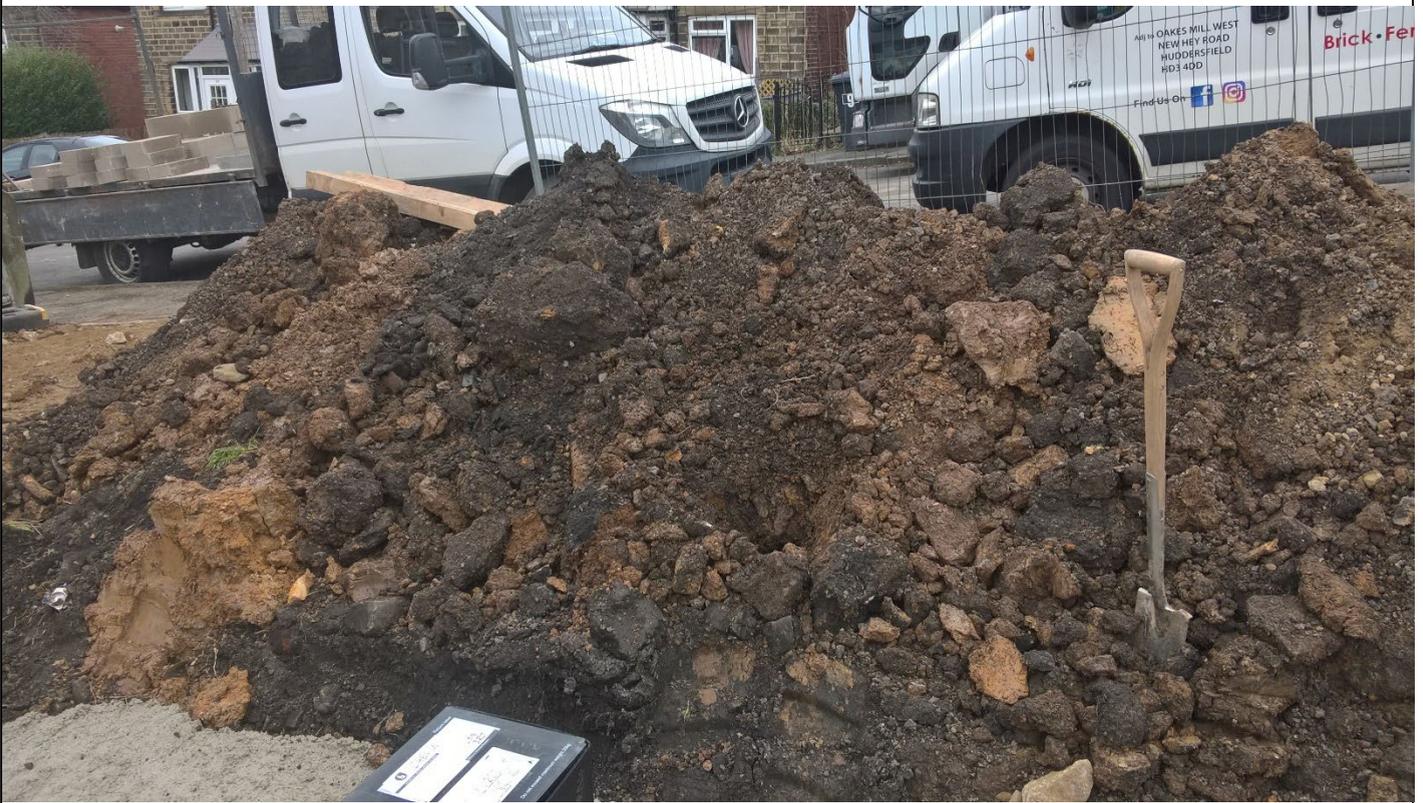
Photograph No.4: Location of TP01.

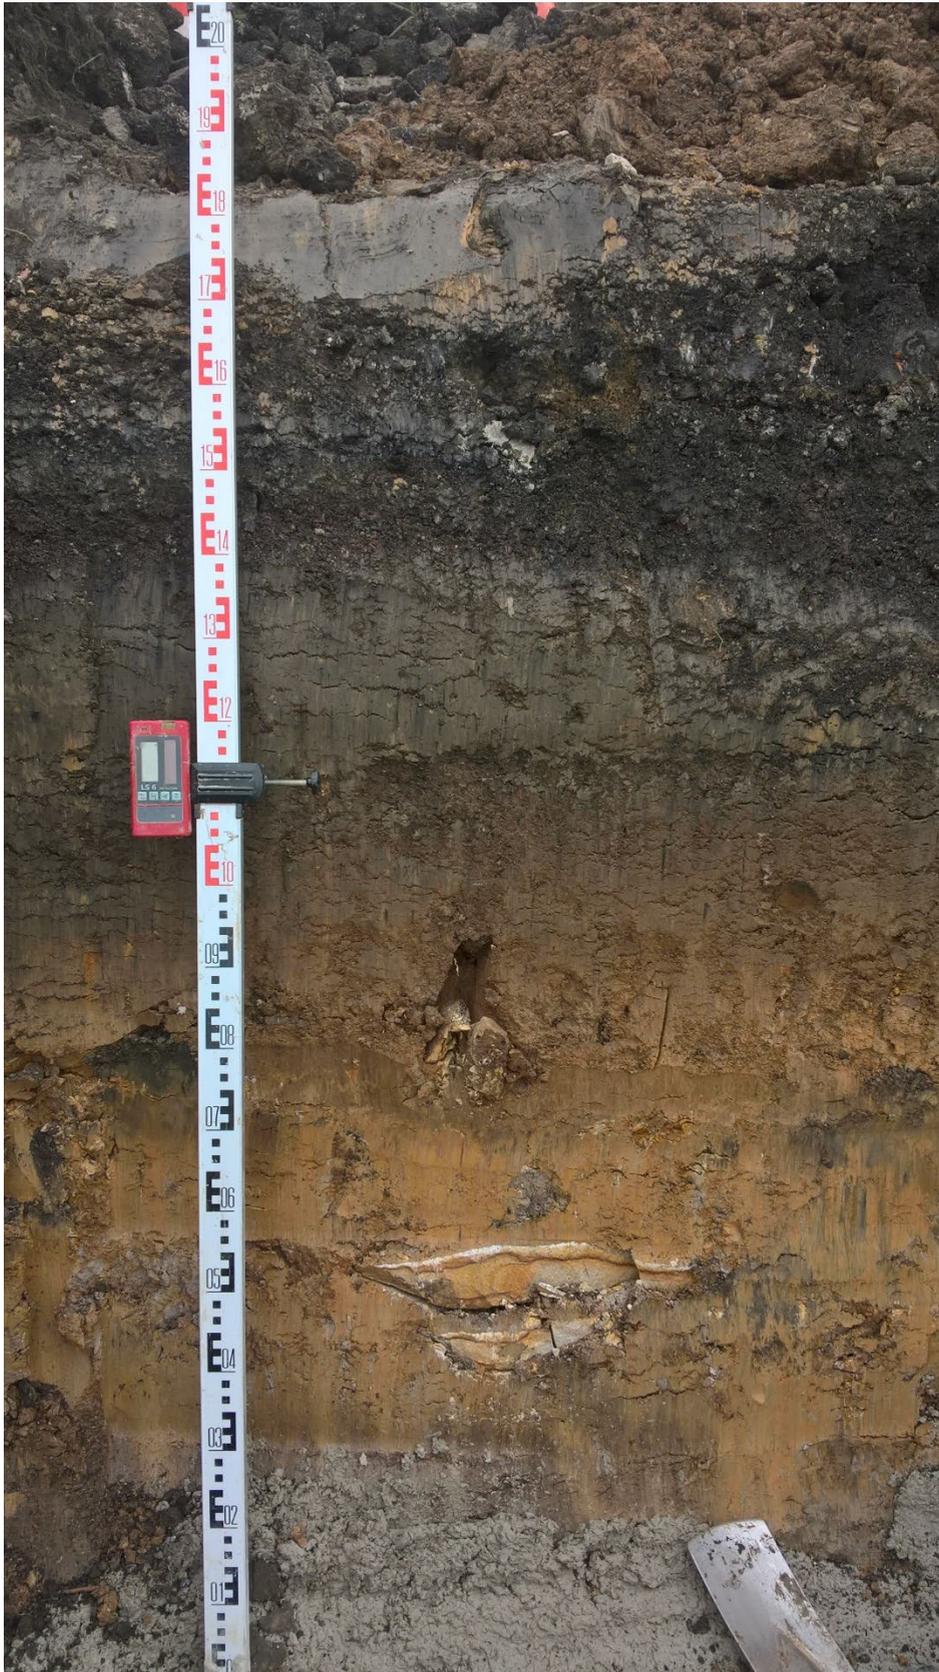
At TP02 made ground between 0.30m and 0.50m was grey and red brown sandy gravel sized fragments of clinker, coal, brick, burned mudstone and glass, with ash. This resembled a layer of burnt poor-quality coal and wood, and domestic waste, possibly originating from a bonfire or waste from a residential fire which had been tipped onto the site.

Photograph No.5: TP02 section.

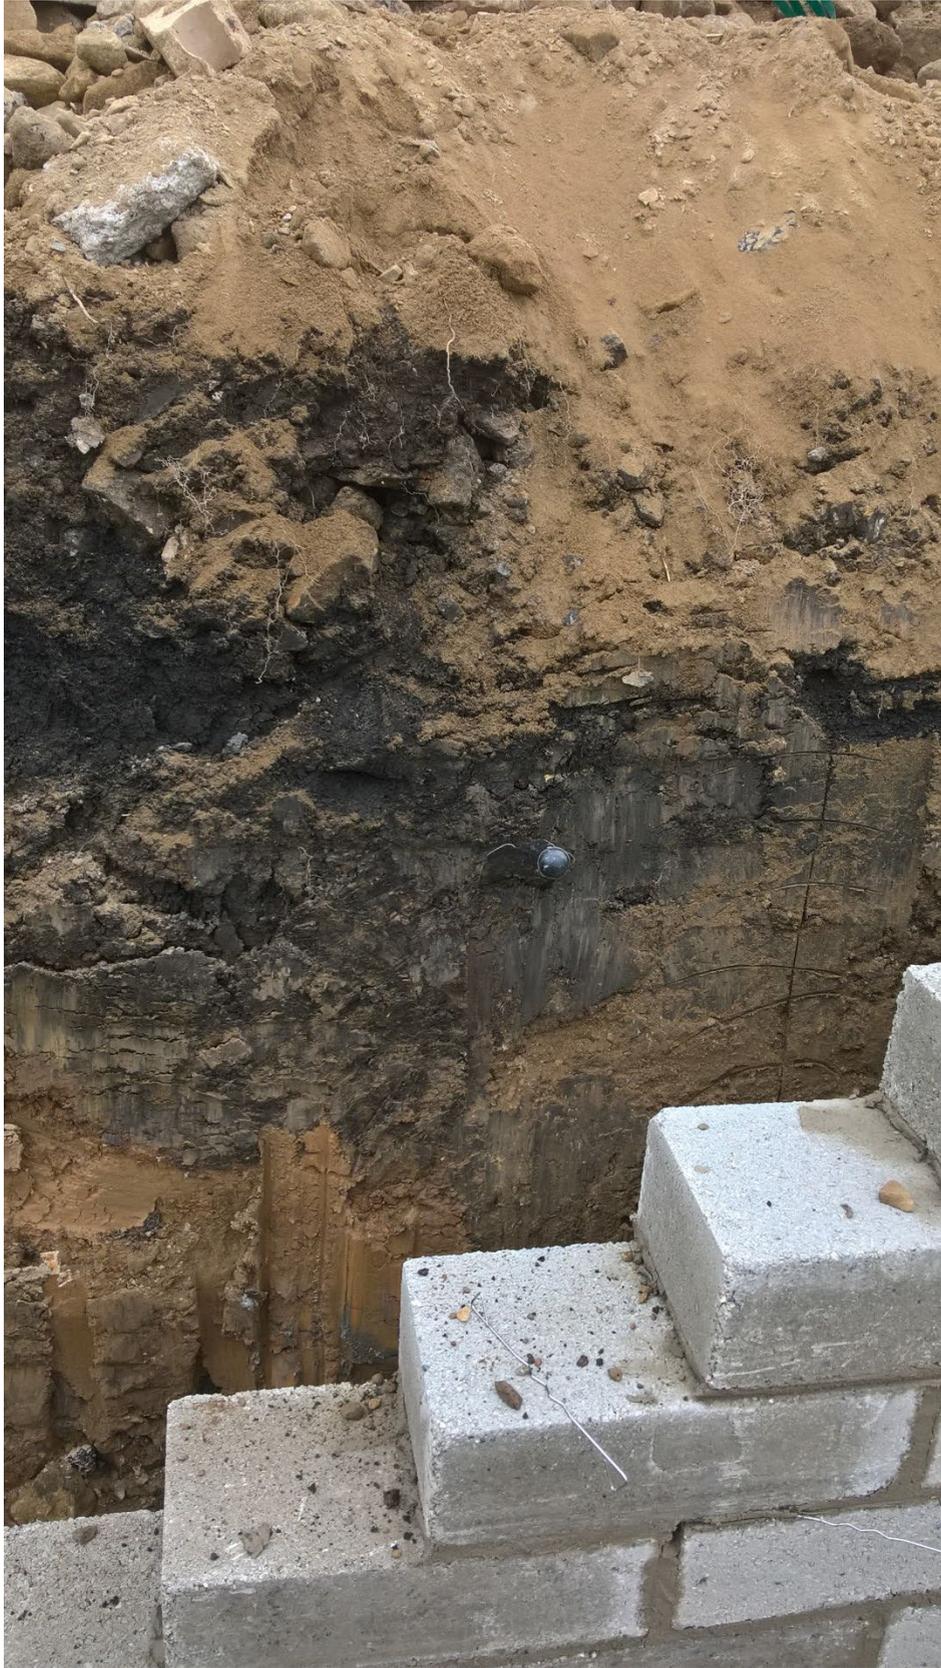
Photograph No.6: TP03 section.

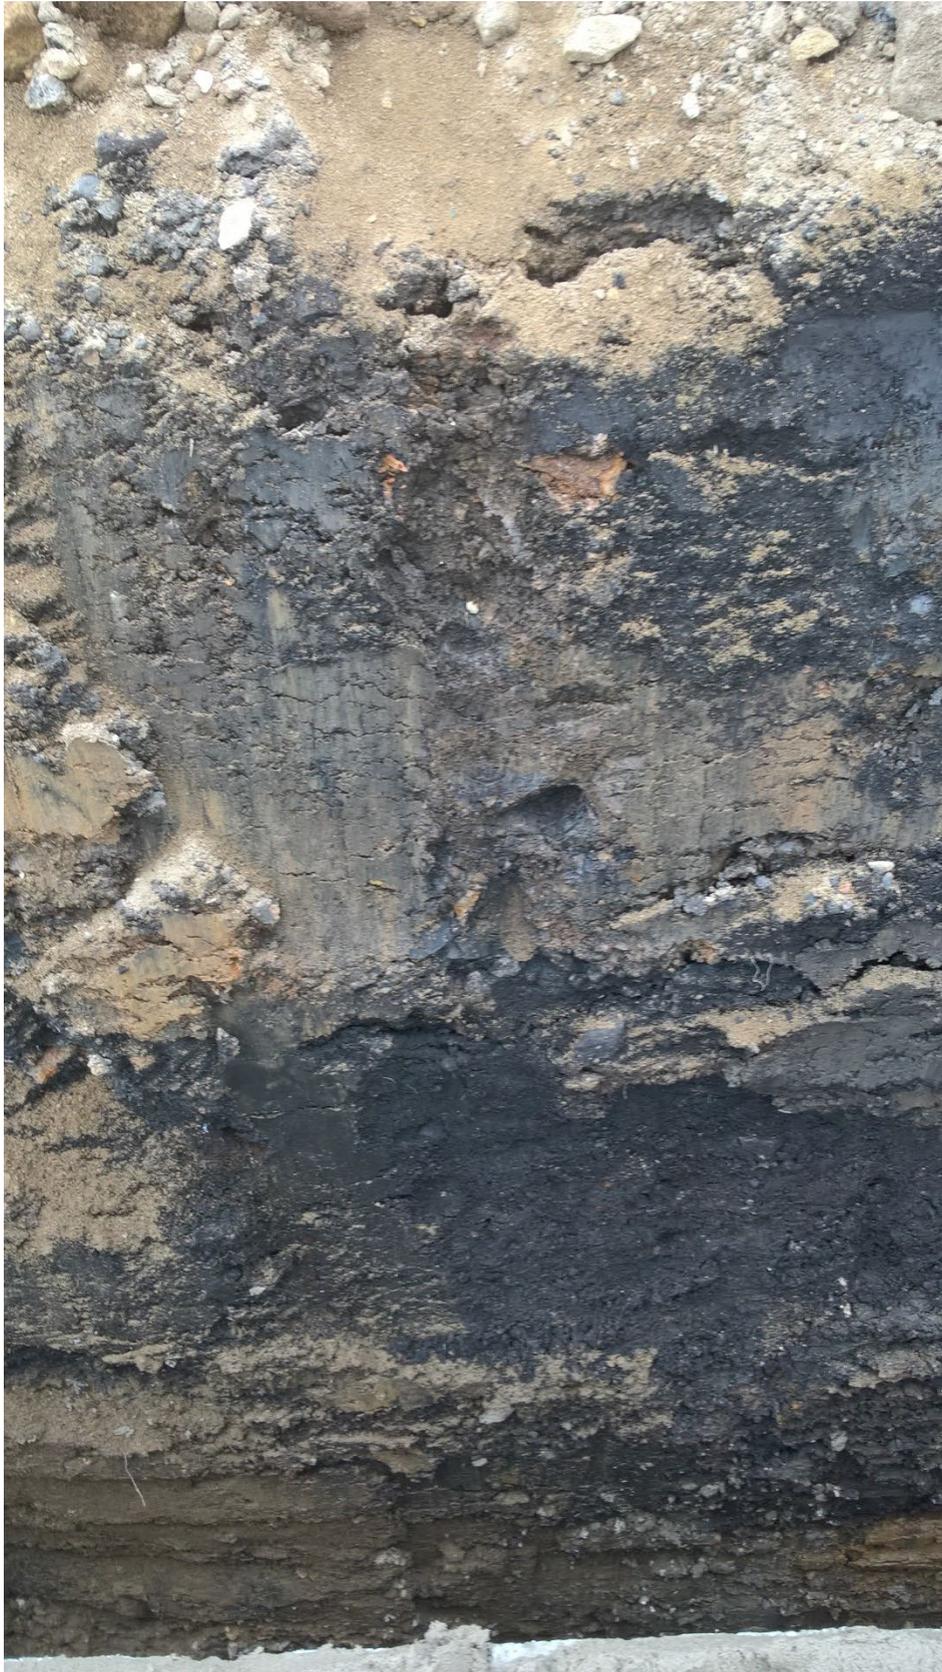
Photograph No.7: TP04 section.
