PHASE 4 VALIDATION REPORT

Phase 4: Validation Report

Location:	New Townhouses, The Old Tannery, 224 Spen Lane, Cleckheaton, West Yorkshire, BD19 4PJ.		
For:	Quarters Development Ltd.	Planning Reference:	2023/92930
Report No.	C3920/24/E/5955	Report date:	September 2024

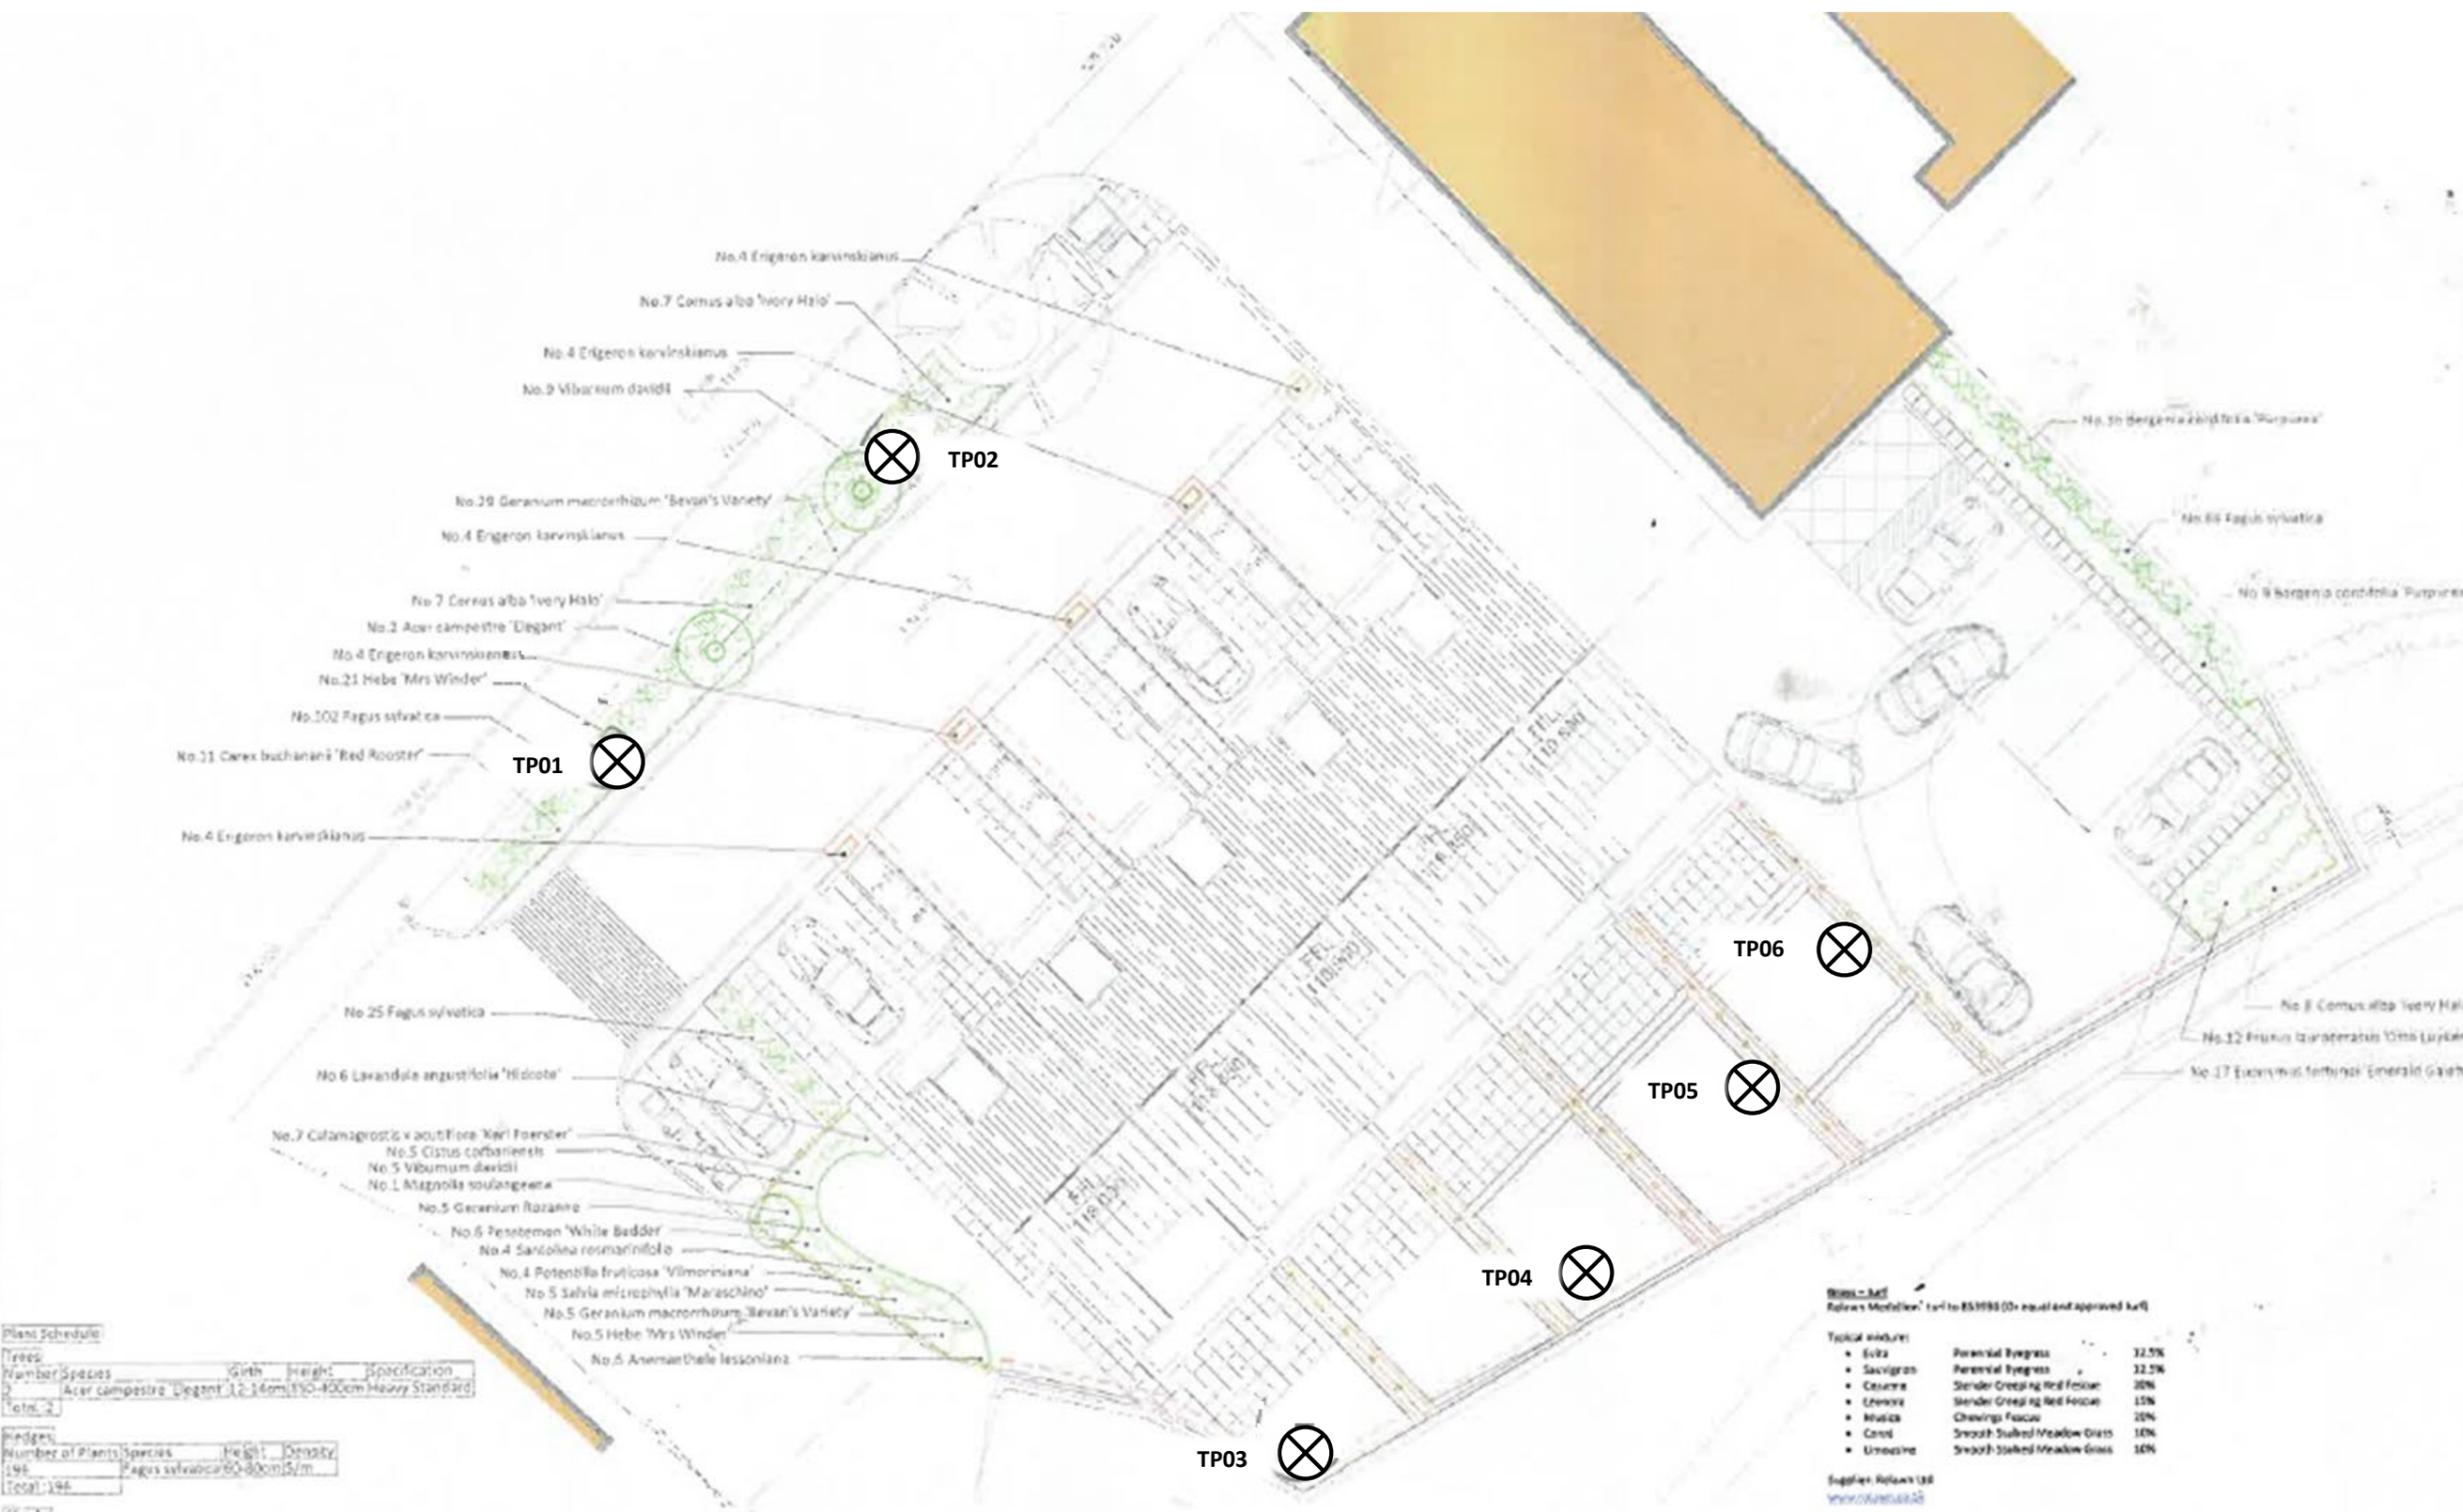
Site Plan

Notes:
Investigation positions approximated from site operative's notes.

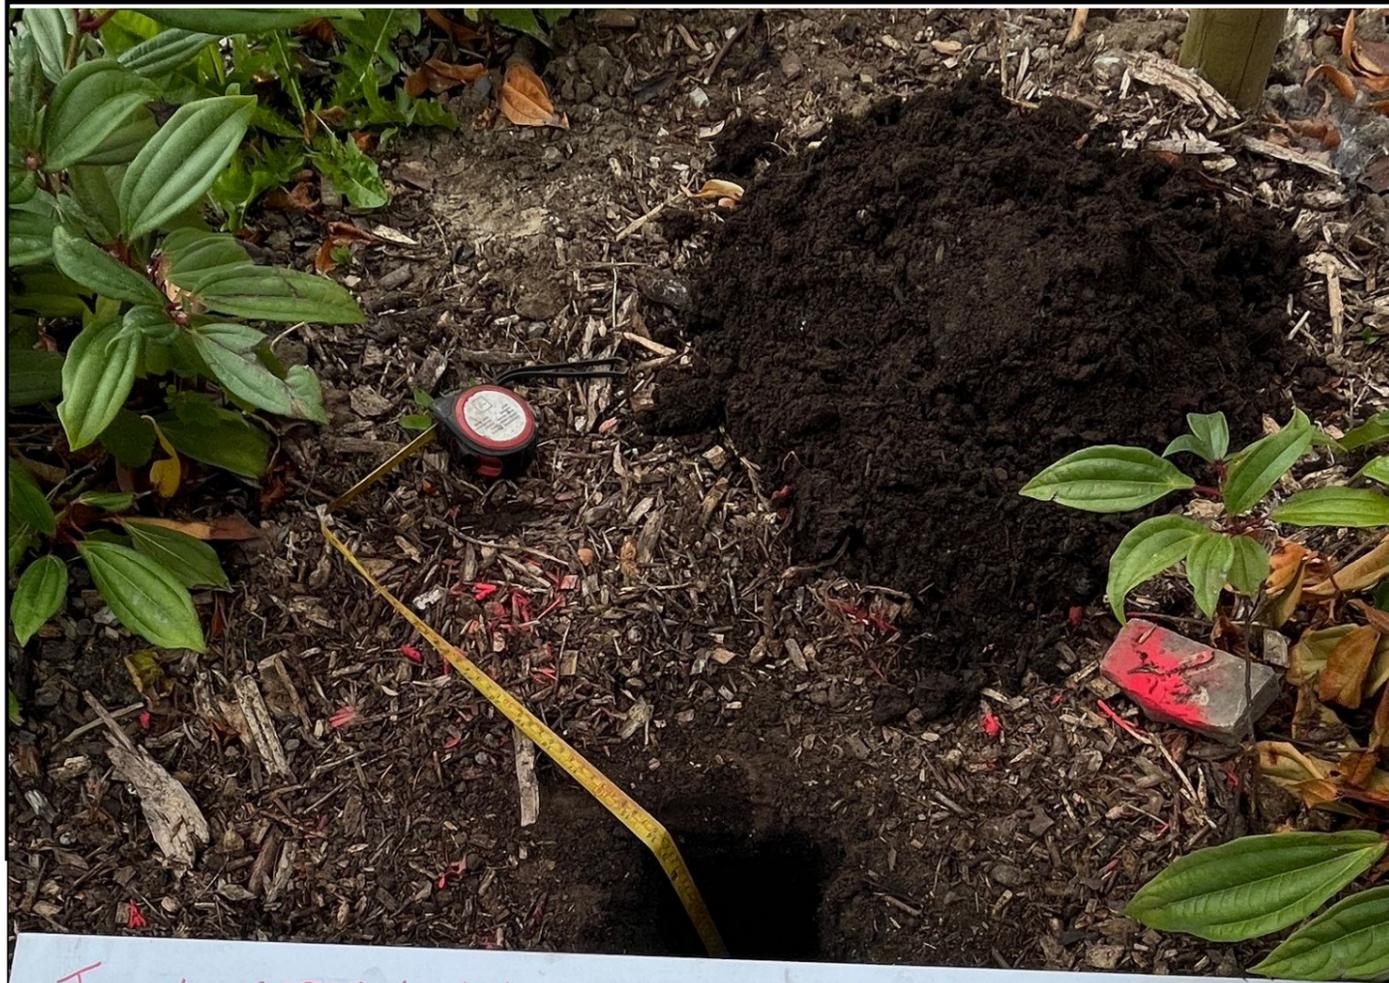
Photo 1: TP01, 0m to 0.3m

JOB No: C3920 /24/E/
 DATE: 05/08/2024
 HOLE No: HDTPO1-
 SITE: THE OLD TANNERY
 224 SPEN LANE
 CLIENT: QUARTERS CONSTRUCTION LTD
 DEPTH: FROM: 0.0 TO: 0.3

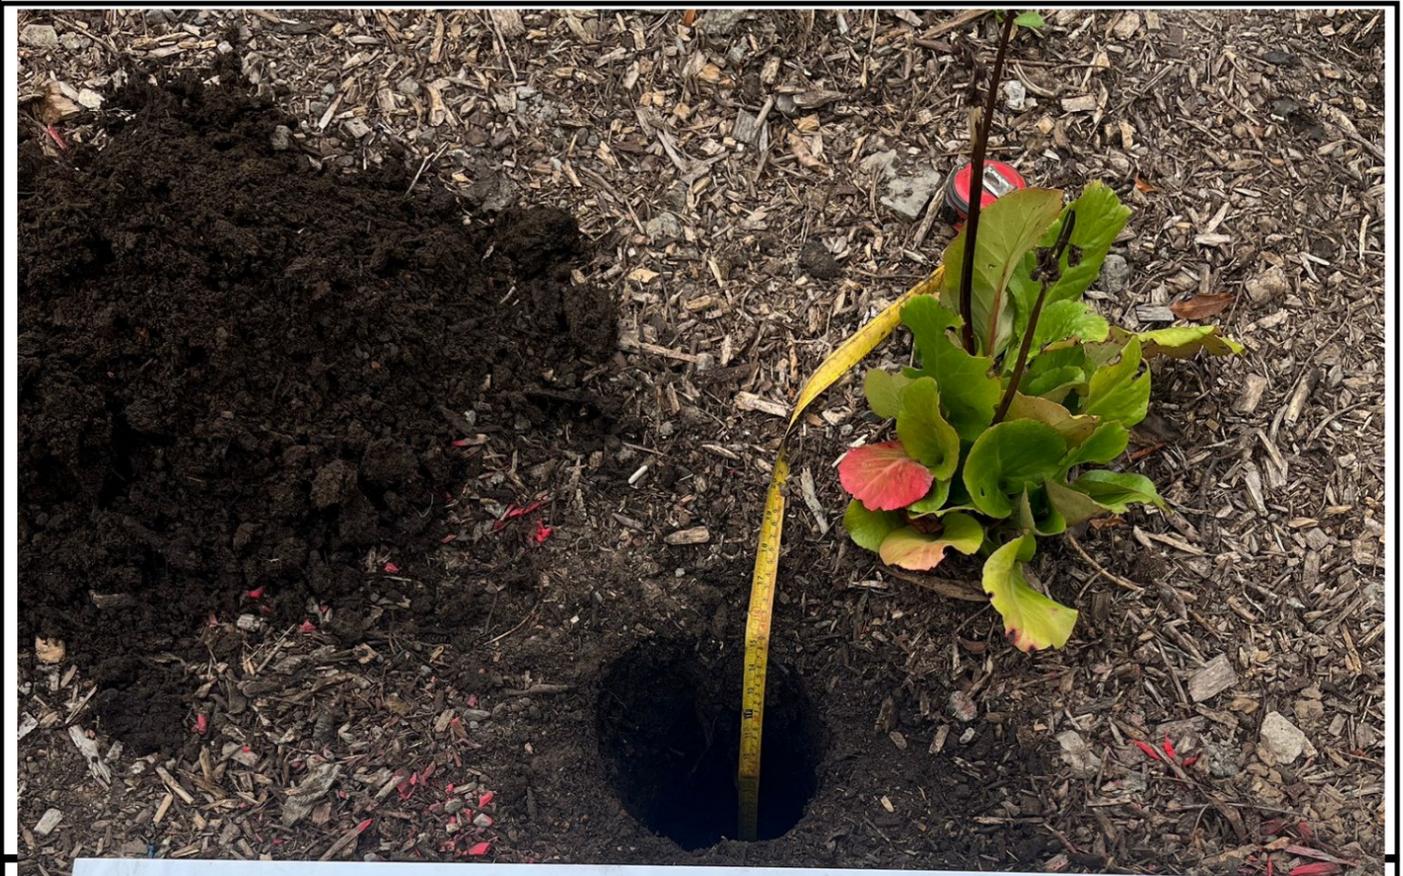
Photo 2: TP02, 0m to 0.3m

JOB No: C3920 /24/E/
 DATE: 05/08/2024
 HOLE No: HDTPO2
 SITE: THE OLD TANNERY
 224 SPEN LANE
 CLIENT: QUARTERS CONSTRUCTION LTD
 DEPTH: FROM: 0.0 TO: 0.3
