Preliminary Bat Roost Assessment	
For:	Healey Islamic Trust
Site:	Building Complex, Healey Lane Mills, Healey Lane, Batley, WF17 7SH
Report Date:	11 th May 2023
Report Reference:	SQ-1040

Client:	Healey Islamic Trust
Site Name:	Building Complex, Healey Lane Mills, Healey Lane, Batley, WF17 7SH
Grid Reference:	SE 23325 24038
Report:	Preliminary Bat Roost Assessment
Date of survey:	12 th April 2023
Surveyed by:	Sam Toon BSc (hons) Natural England Bat Licence Bat Survey Class: 2018-35446-CLS-CLS

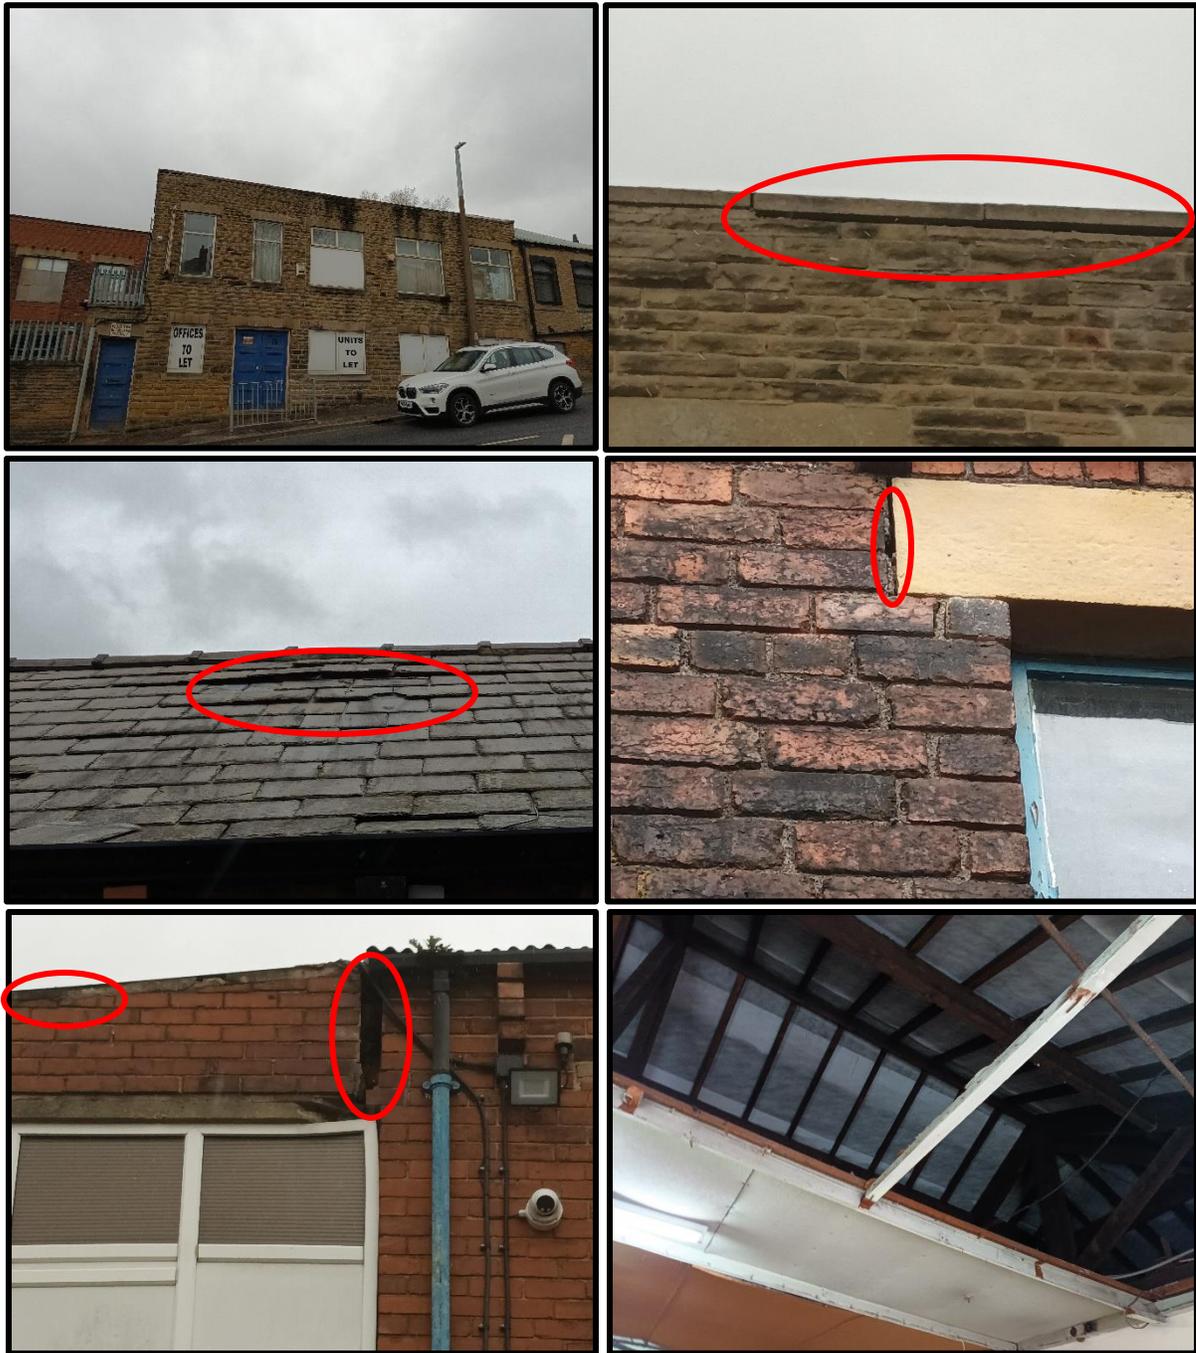
Figure 2: Building Complex, Healey Lane

- 3.3.1 The site at Healey Lane comprises of a building complex, which facilitates small industrial and commercial businesses as well as several residential flats. The buildings comprise of red brick walls with the majority of the buildings recording slate and asbestos roofing material. A small section of the complex

- has recently undergone maintenance on the roof and recorded metal roofing.
- 3.3.2 The walls recorded multiple cracks within the brickwork and missing mortar, however, the majority of the damage was deemed to be superficial, providing no suitability for bats to utilise. Suitable features were present, within the lintels and within the missing mortar to the eave of the roof in which bats could utilise.

- 3.3.3 The roof of the single storey section of the complex to the north, recorded slate tiles. The tiles were considered to be in a poor condition, with multiple tiles recorded as lifted and cracked in which, bats could potentially access for roosting purposes.

- 3.3.4 The windows on the eastern elevation to the complex, were mostly recorded as broken or missing. All windows had been boarded up to prevent access into the internals of the complex.

- 3.3.5 The northern elevation of the complex, recorded a parapet with flat concrete slabs running horizontally. A small section of the slabs were recorded as lifted, which were deemed suitable to provide roosting opportunities for bats to utilise.

9.1 The building complex at Healey Lane was assessed as having low roost suitability due to the presence of potential roost features. Therefore, further survey effort is recommended to ascertain presence/ likely absence of bat use in the form of a single bat activity survey.
