# PHASE 1 DESK STUDY

LAND AT PARKWOOD MILLS,  
GROVE STREET, HUDDERSFIELD

AH DEVELOPMENTS LTD

| SUMMARY TABLE: Phase 1 Desk Study | |
|---|---|
| <b>REFERENCE</b> | PS3657 – V1 |

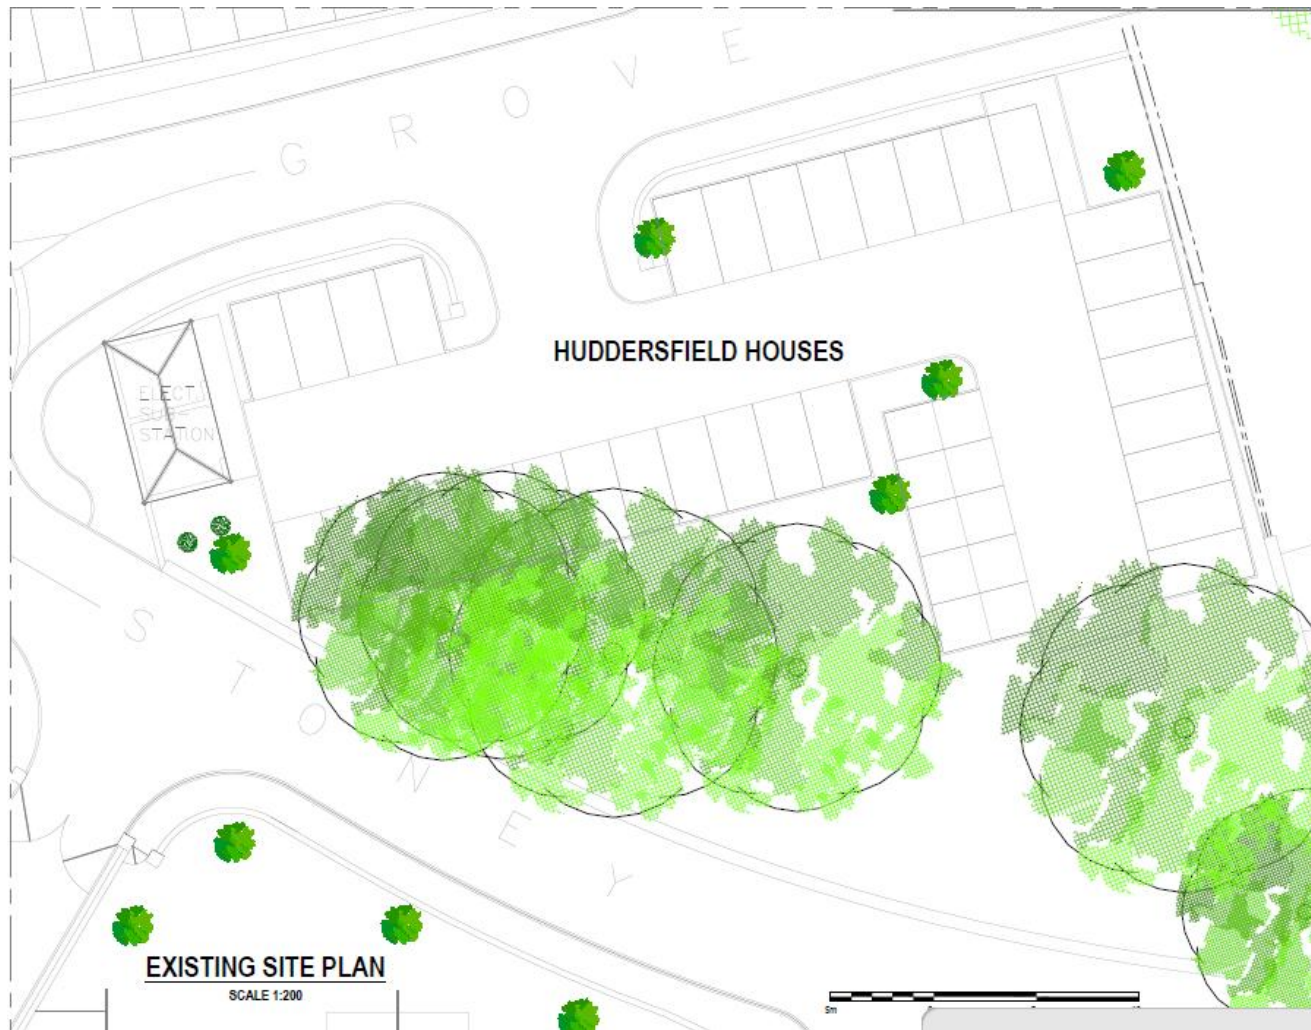
Figure 3

Existing Layout

The northern half of the site is relatively flat, at about the same level as Grove Street (c. 150m aOD), and currently occupied by tarmacked car parking spaces, accessed from Grove Street; while the southern half rises relatively steeply, following the level of Stoney Lane. This section is densely vegetated with semi-mature and mature trees, some of which are understood to be subject to preservation orders. Aerial views of the current site are shown in **Figure 2** in **Appendix A**, and a schematic drawing is shown in **Figure 3** also in **Appendix A**.

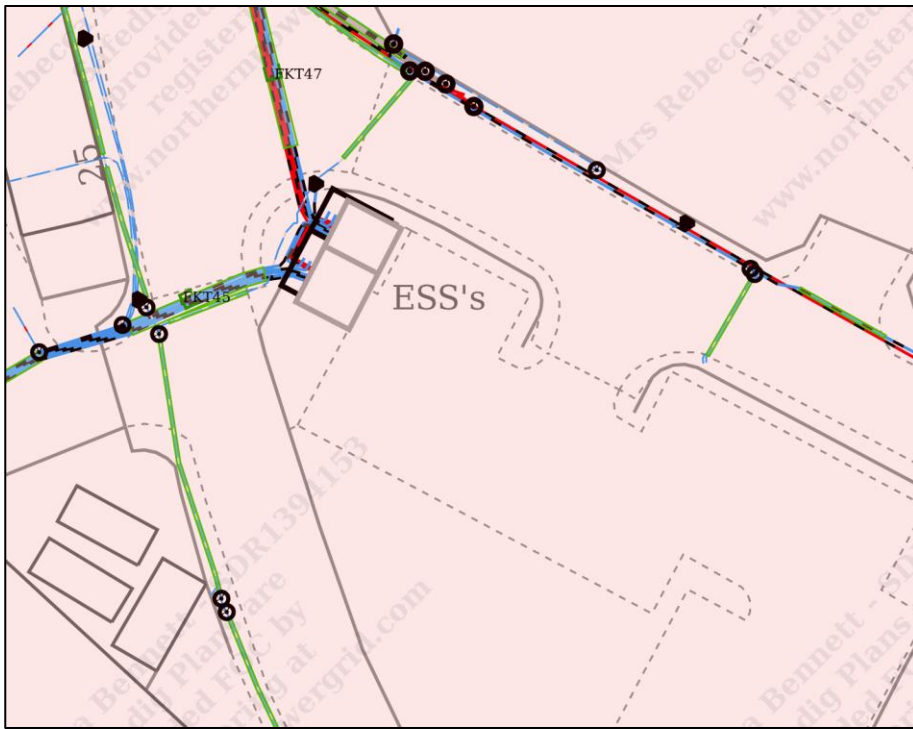
Figure 7

Extracts from Utilities Survey

A comprehensive services/utilities search was commissioned by Rebecca Bennett, 28 March 2024, Ref: Groundwise Searches Ltd, 349 68RB-GWS. Extracts from this are discussed below and included in **Appendix A**. PS Geotech has had access to this document, but has not included it within this report.

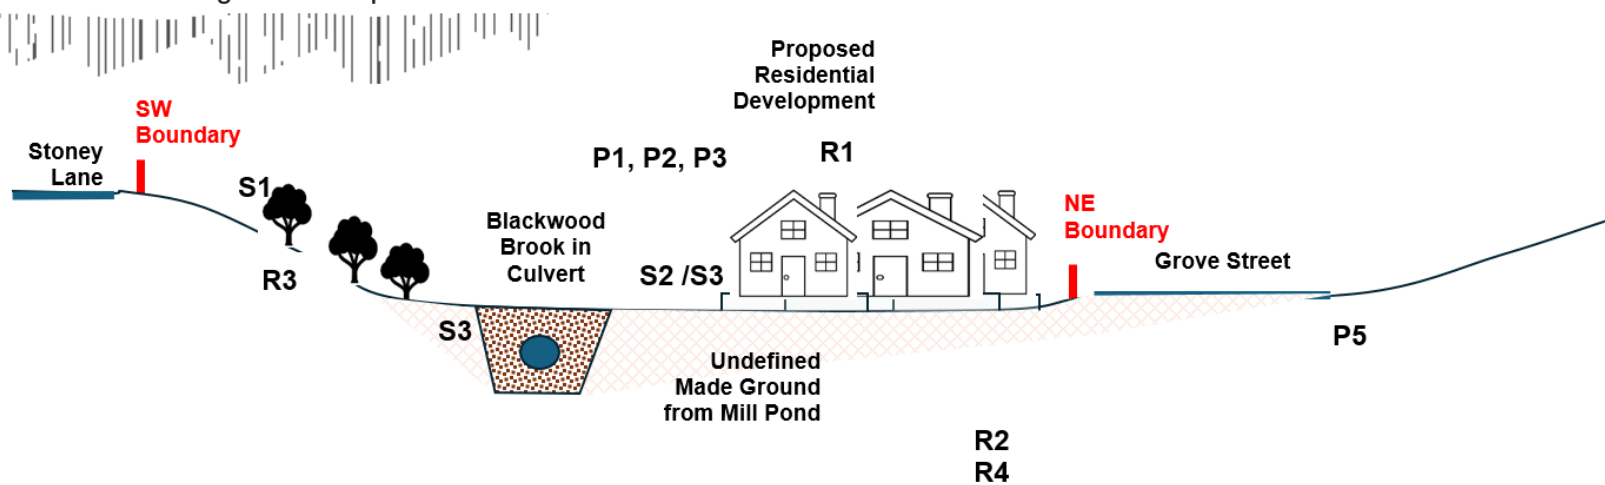
## Appendix C – Conceptual Site Model

| Conceptual Site Model Section | | | | | |

**P5** Infiltration of rain through site grass cover + run off following natural slopes
