SITE INVESTIGATION LAND AT LEES HALL ROAD DEWSBURY

Prepared for: Tarmac Trading Limited

ASL Report No. 203-22-989-09

October 2022

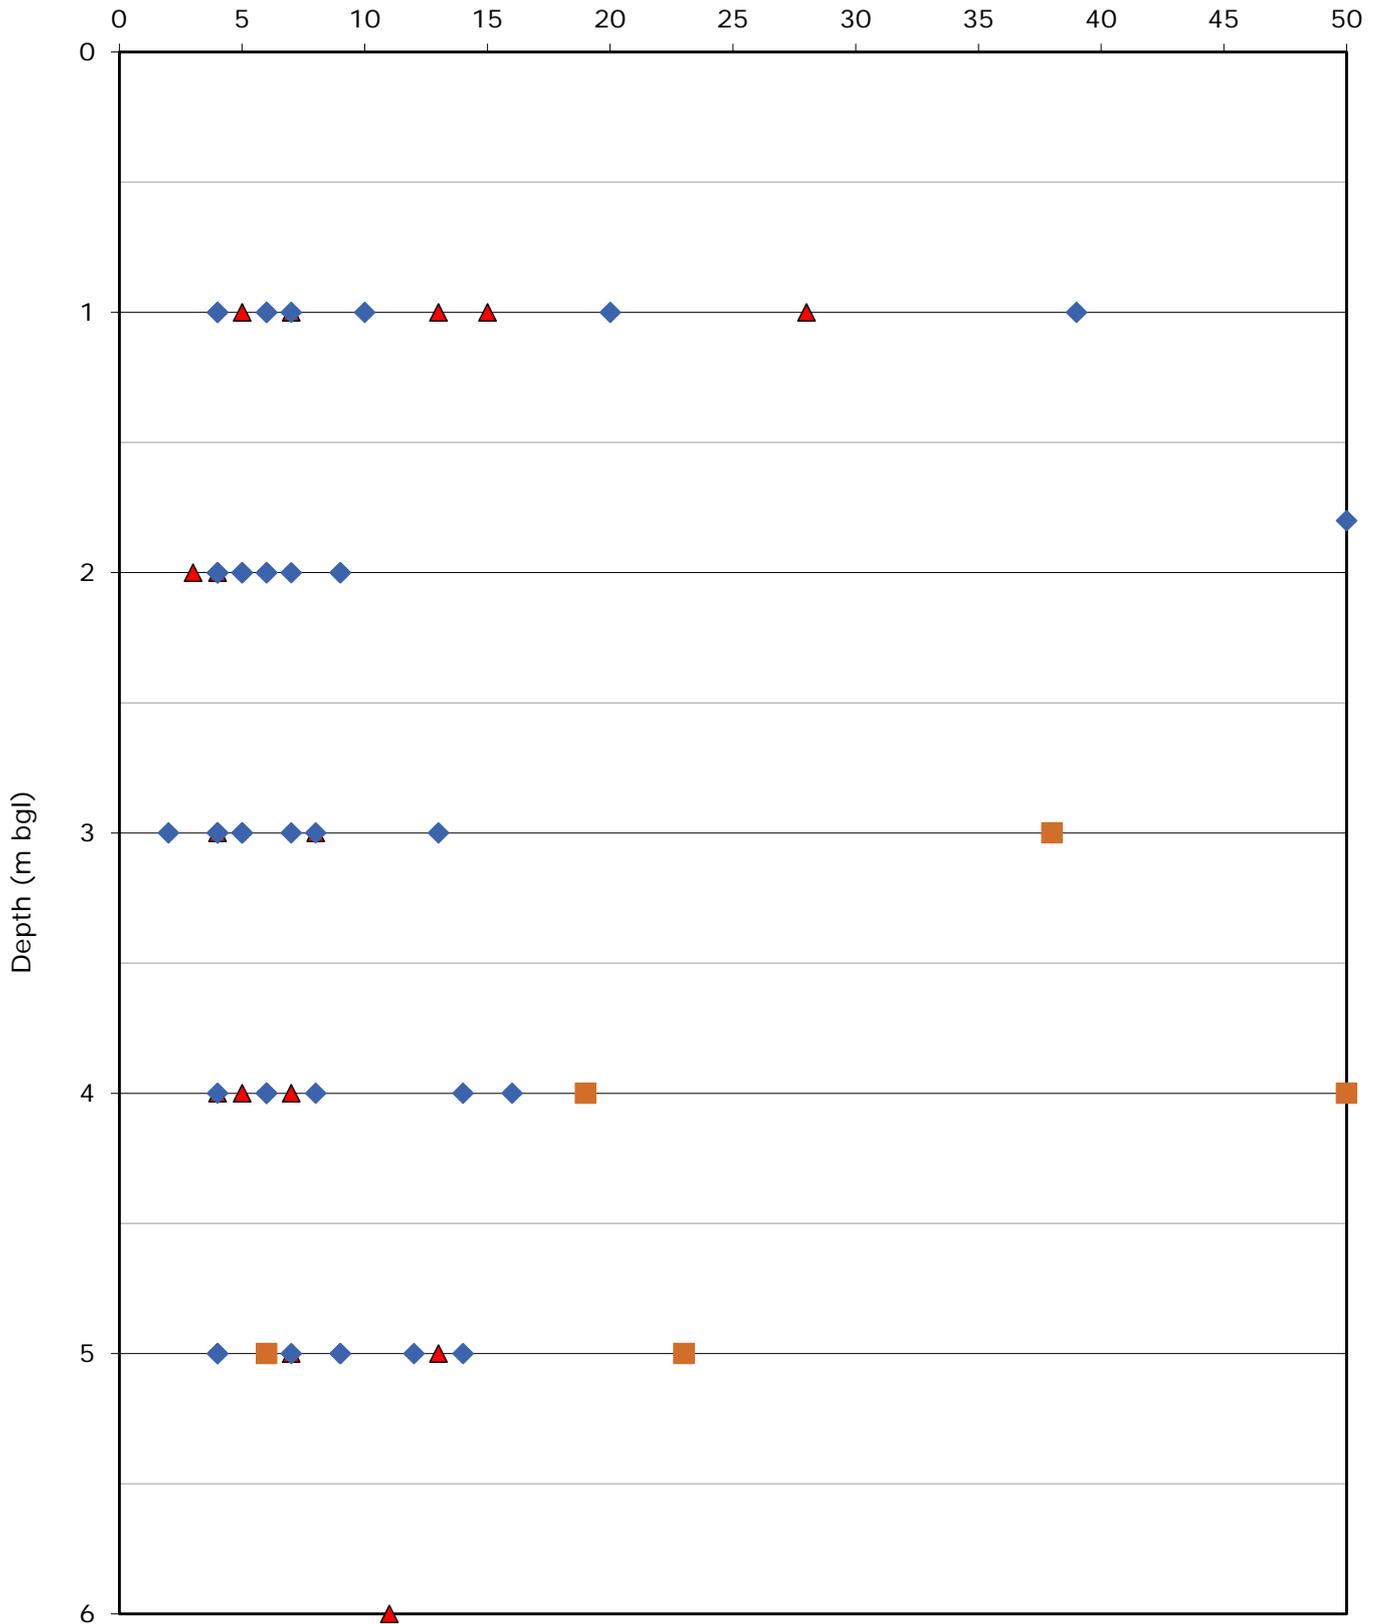
| Drawing No. | Figure 4 |

SPT 'N' Value

| Drawing Name | SPT 'N' Value Versus Depth Below Ground Level |

Forty-two SPTs were completed within typically granular materials interpreted as Made Ground that recorded SPT 'N' values of between 2 and >50 indicating typically very loose

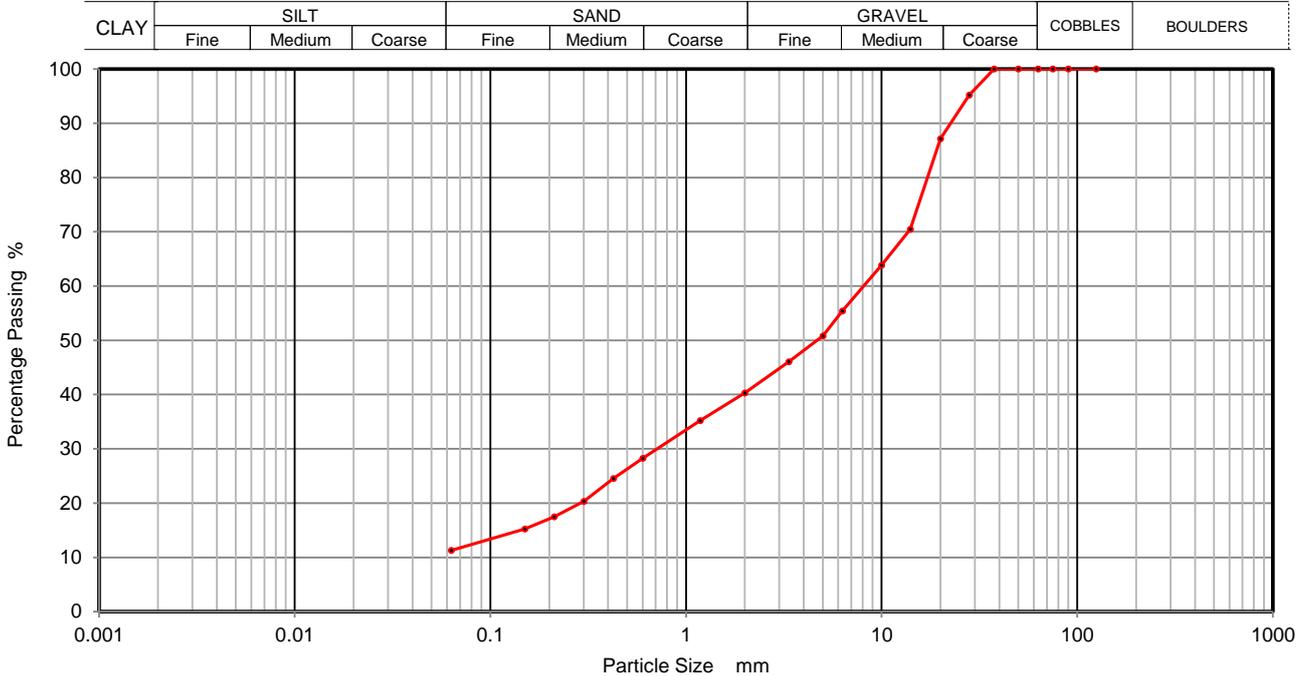
| Sieving | | Sedimentation | |
| Particle Size mm | % Passing | Particle Size mm | % Passing |

Geotechnical laboratory testing was completed on selected soil samples. The samples have been scheduled for moisture content analysis and Atterberg Limit testing to assess volume change potential, sieve analysis to determine the particle size distribution and pH and sulphate testing to assess the concrete classification for the proposed development.

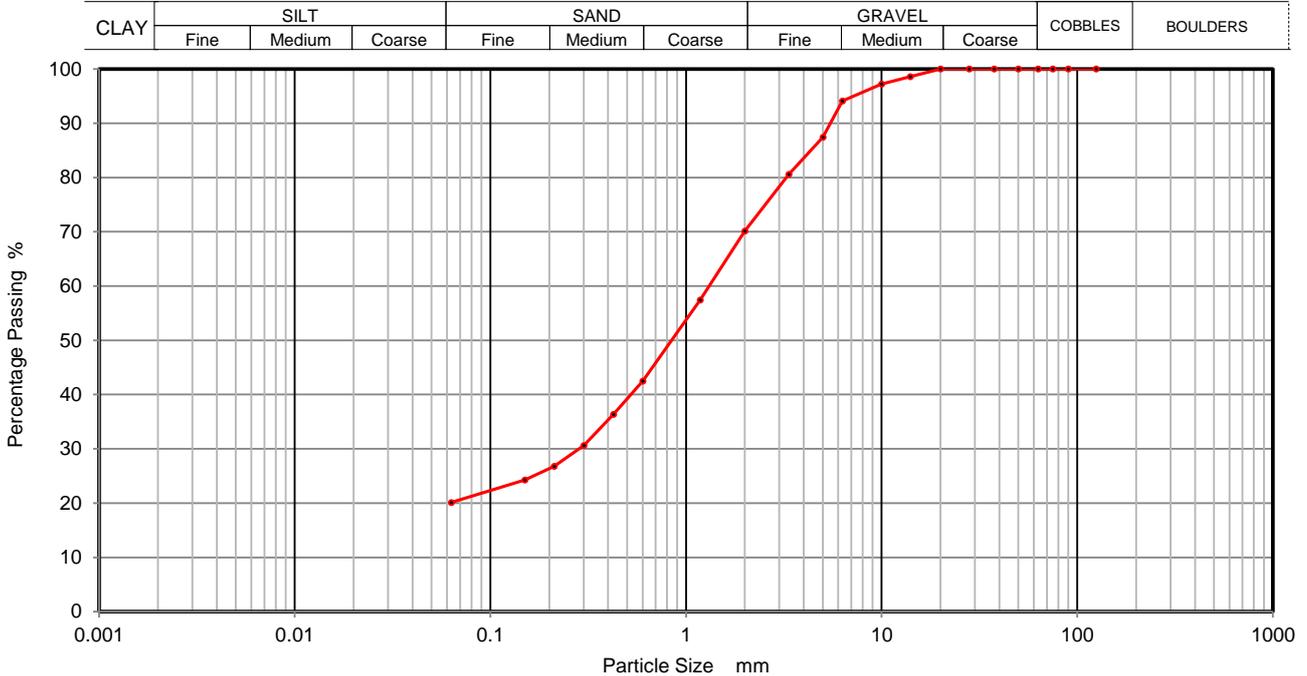
| Sieving | | Sedimentation | |
| Particle Size mm | % Passing | Particle Size mm | % Passing |
