PHASE 2 GEO-ENVIRONMENTAL  
**REPORT**

| job number<br><b>C2206/22/E/3401</b> | date<br><b>25.05.2022</b> |
| site address<br><b>Cliff Hill, Cumberworth Lane,<br/>Denby Dale,<br/>Huddersfield,<br/>HD8 8RZ</b> | |

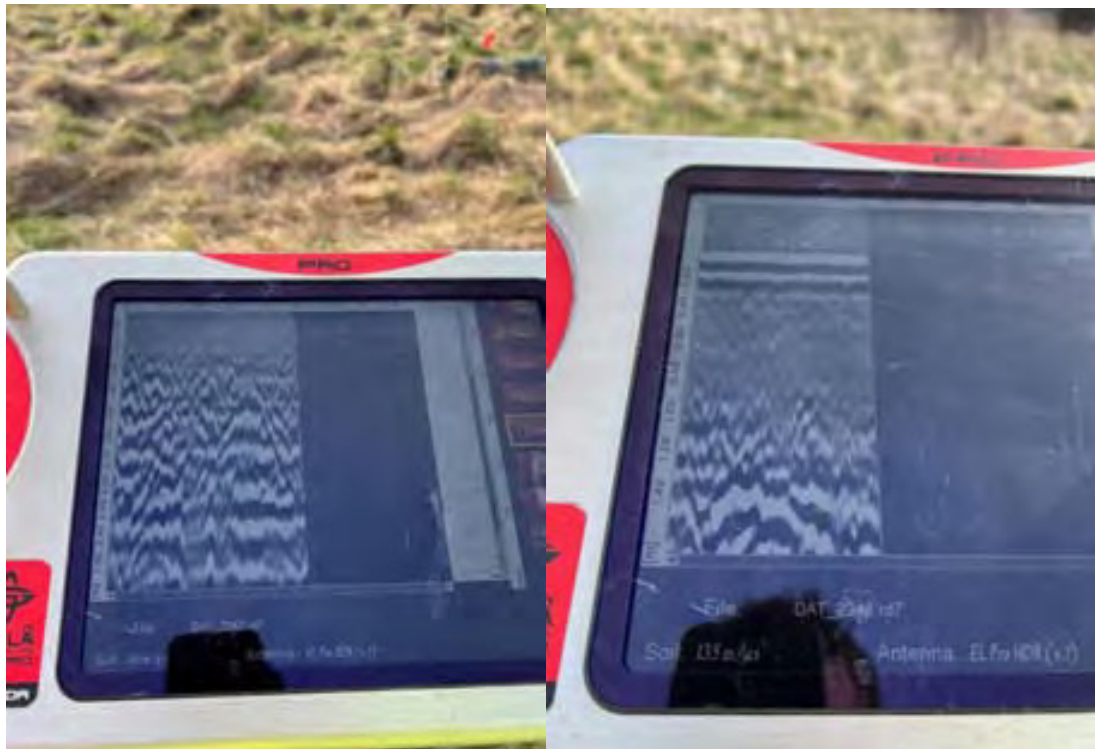
Nothing was detected at the staked-out point using the supplied coordinates.

Coordinates to the GPR trace are - EASTING 422843.598 NORTHING 408655.241.

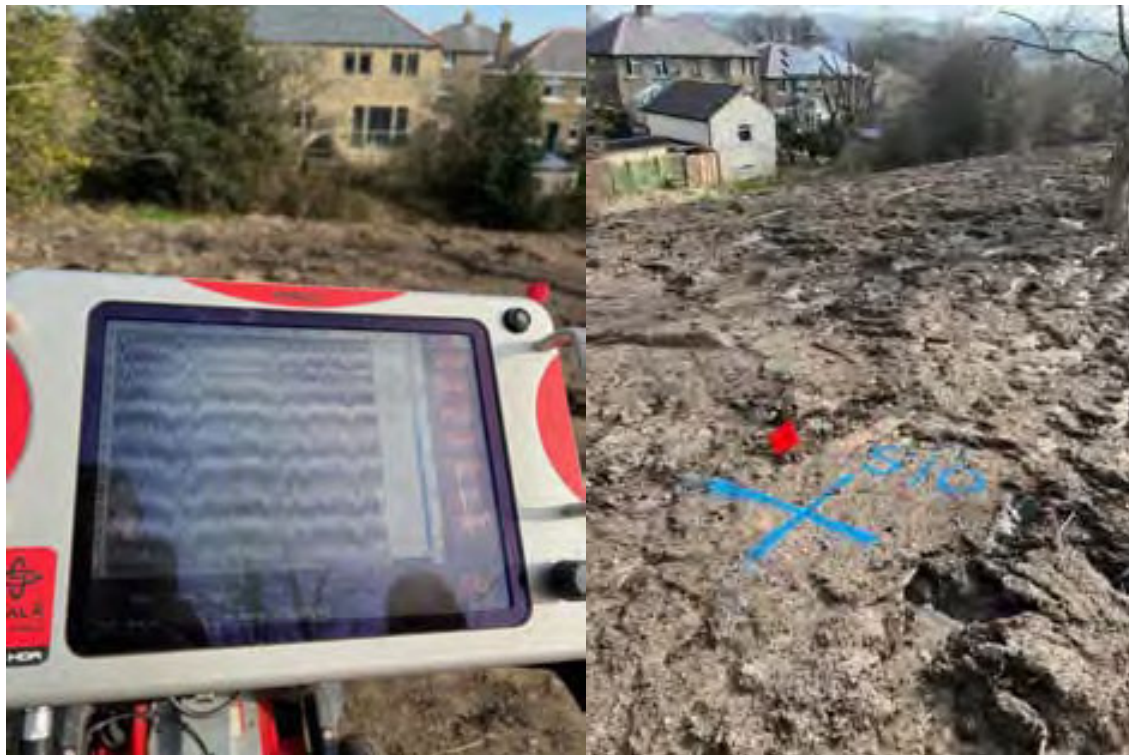
### **MINE 510**

Below images show staked out location of possible mine shaft. No trace of the shaft was detected using GPR techniques. Also below image shows on screen, uniform ground makeup.
