# CLIFF HILL, CUMBERWORTH LANE, DENBY DALE

## GROUND STABILISATION REMEDIAL STRATEGY FOR URBAN GROUP (YORK) Ltd.

**Project Ref:**  
P10350

**Date:**  
July 2023

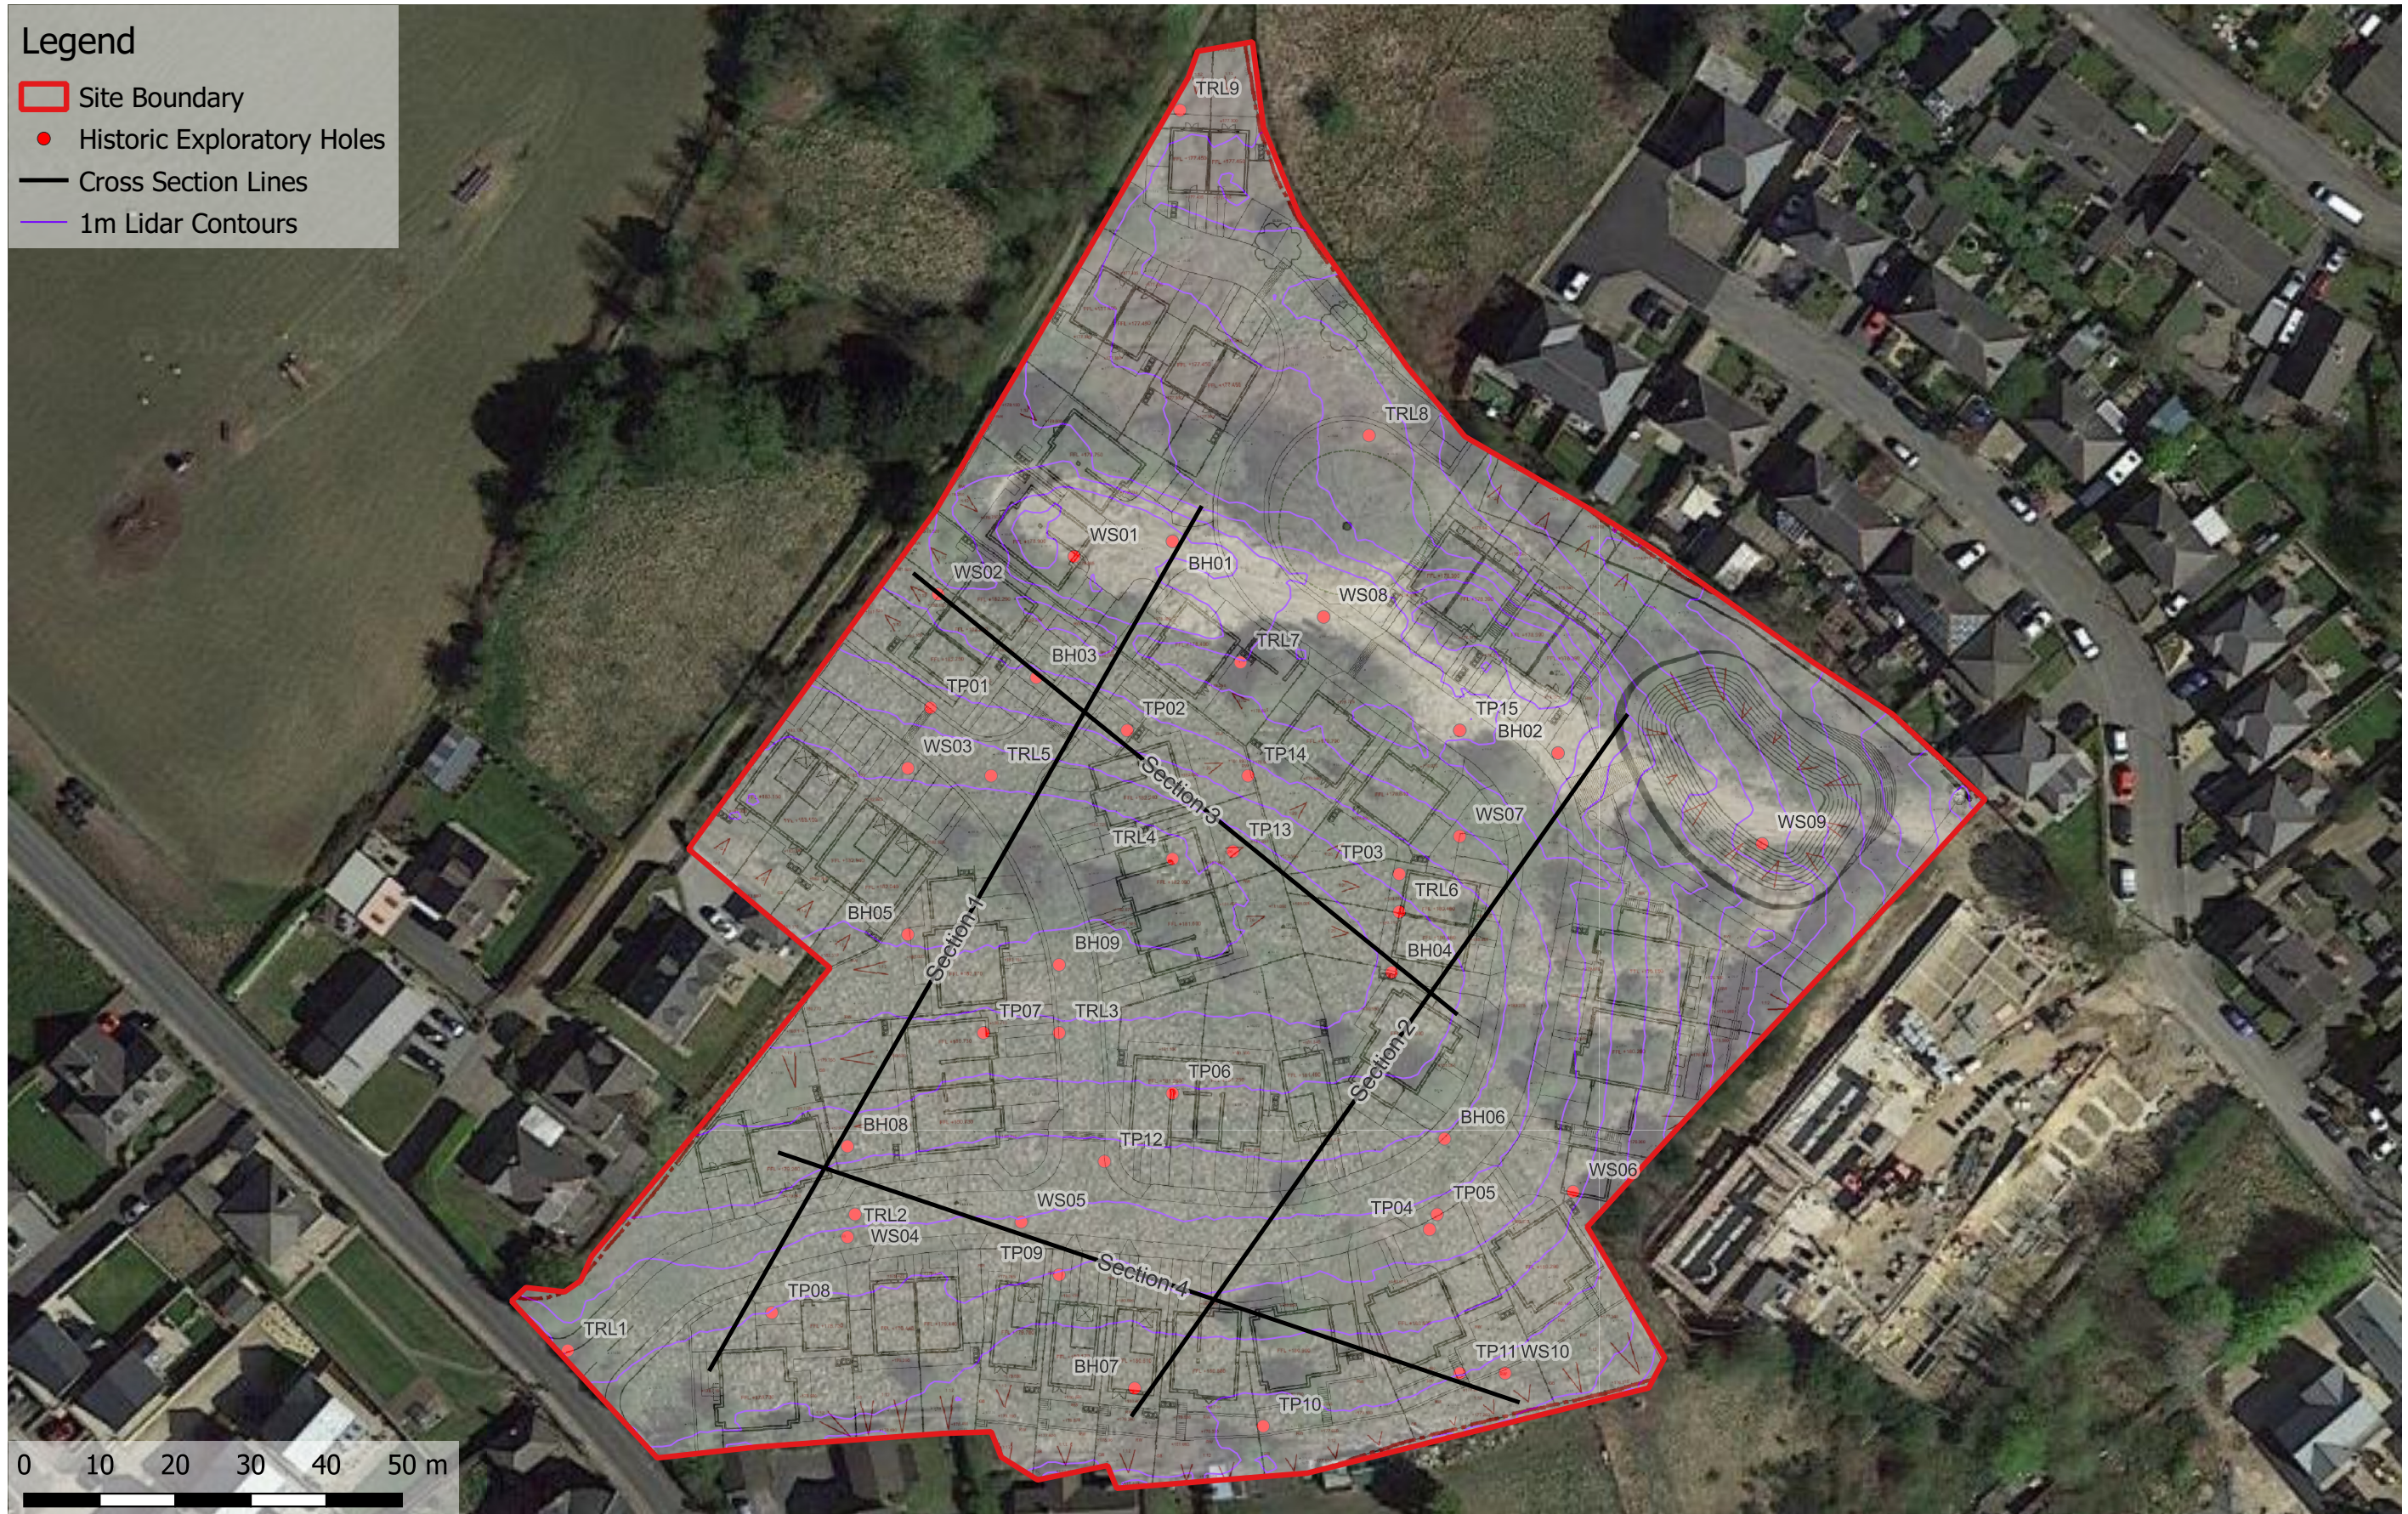
- Site Boundary
- Historic Exploratory Holes
- Cross Section Lines
- 1m Lidar Contours

A section plan and annotated section lines used to interpret the location of coal seams in relation to anticipated finished floor levels are presented in Appendix G.

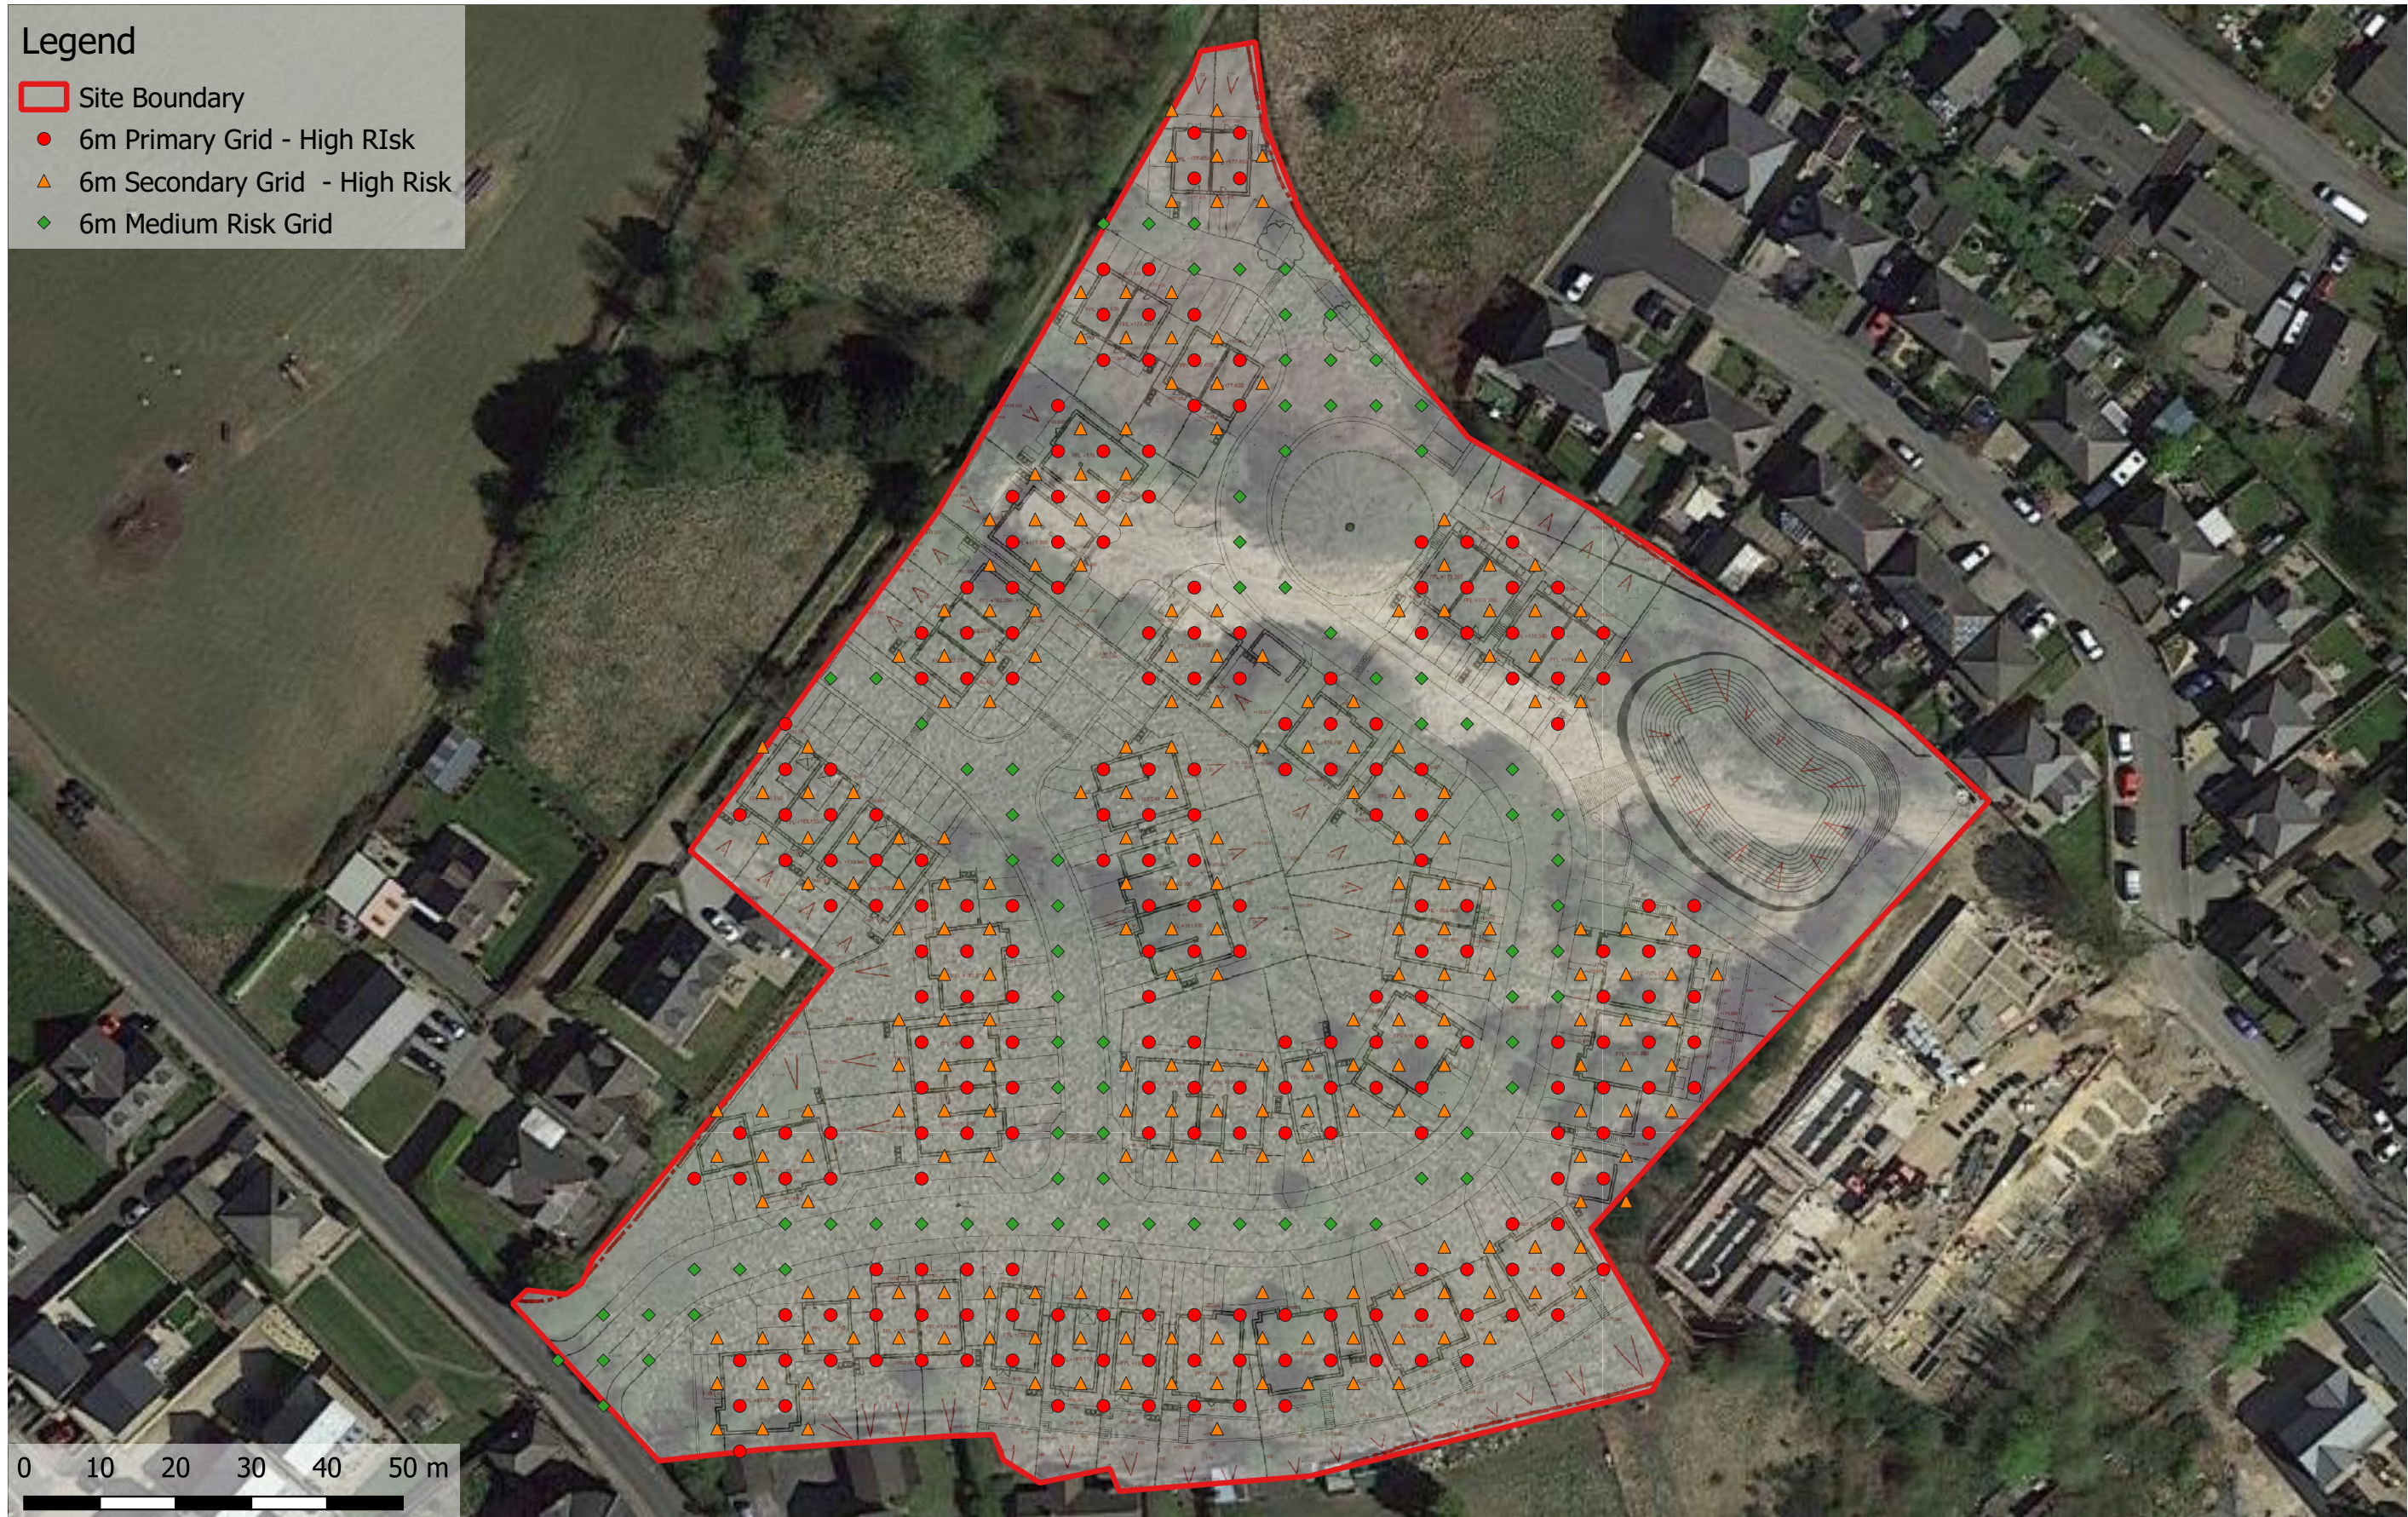
CLIENT:	Urban Group (York) Ltd
PROJECT:	Cliff Hill, Cumberworth Lane, Denby Dale, Huddersf
TITLE:	Proposed Drill and Grout Treatment Grid

6m Medium Risk Grid

NOTES:  
- Based on 6m primary grid with 3m centres under plots

A proposed treatment grid has been provided in Appendix H, based on zoning the development into risk categories. Gardens and areas of public open space are considered to be at low risk. Estate roads are considered to be moderate, and the dwellings are considered as high risk areas.

Risk Designation	Description	Treatment Requirements
Low	Residential gardens and POS	No drilling and grouting required
Moderate	Estate roads	6m primary treatment grid. Localised secondary holes may be required where high grout takes are recorded.
High	Residential properties and immediate curtilage	6m primary grid with 3m secondary holes completed. Additional treatment holes may be required where high grout takes are recorded.

Based on the attached treatment grid, approximately 300no. primary holes are anticipated with an additional 250 secondary holes anticipated below proposed plots. The treatment holes are anticipated to be approximately 20m deep.

- *Primary holes to be drilled on a 6m grid, with centre (secondary) holes beneath and in the immediate areas surrounding proposed new buildings*
- *Check (tertiary) holes may also be required to prove grouting success.*
- *If excessive voiding is encountered, the use of sand will be adopted.*
- *Steel casing to be used in all treatment holes.*
- *Treatment holes to be injected with grout to surface, to ensure full depth reinstatement.*

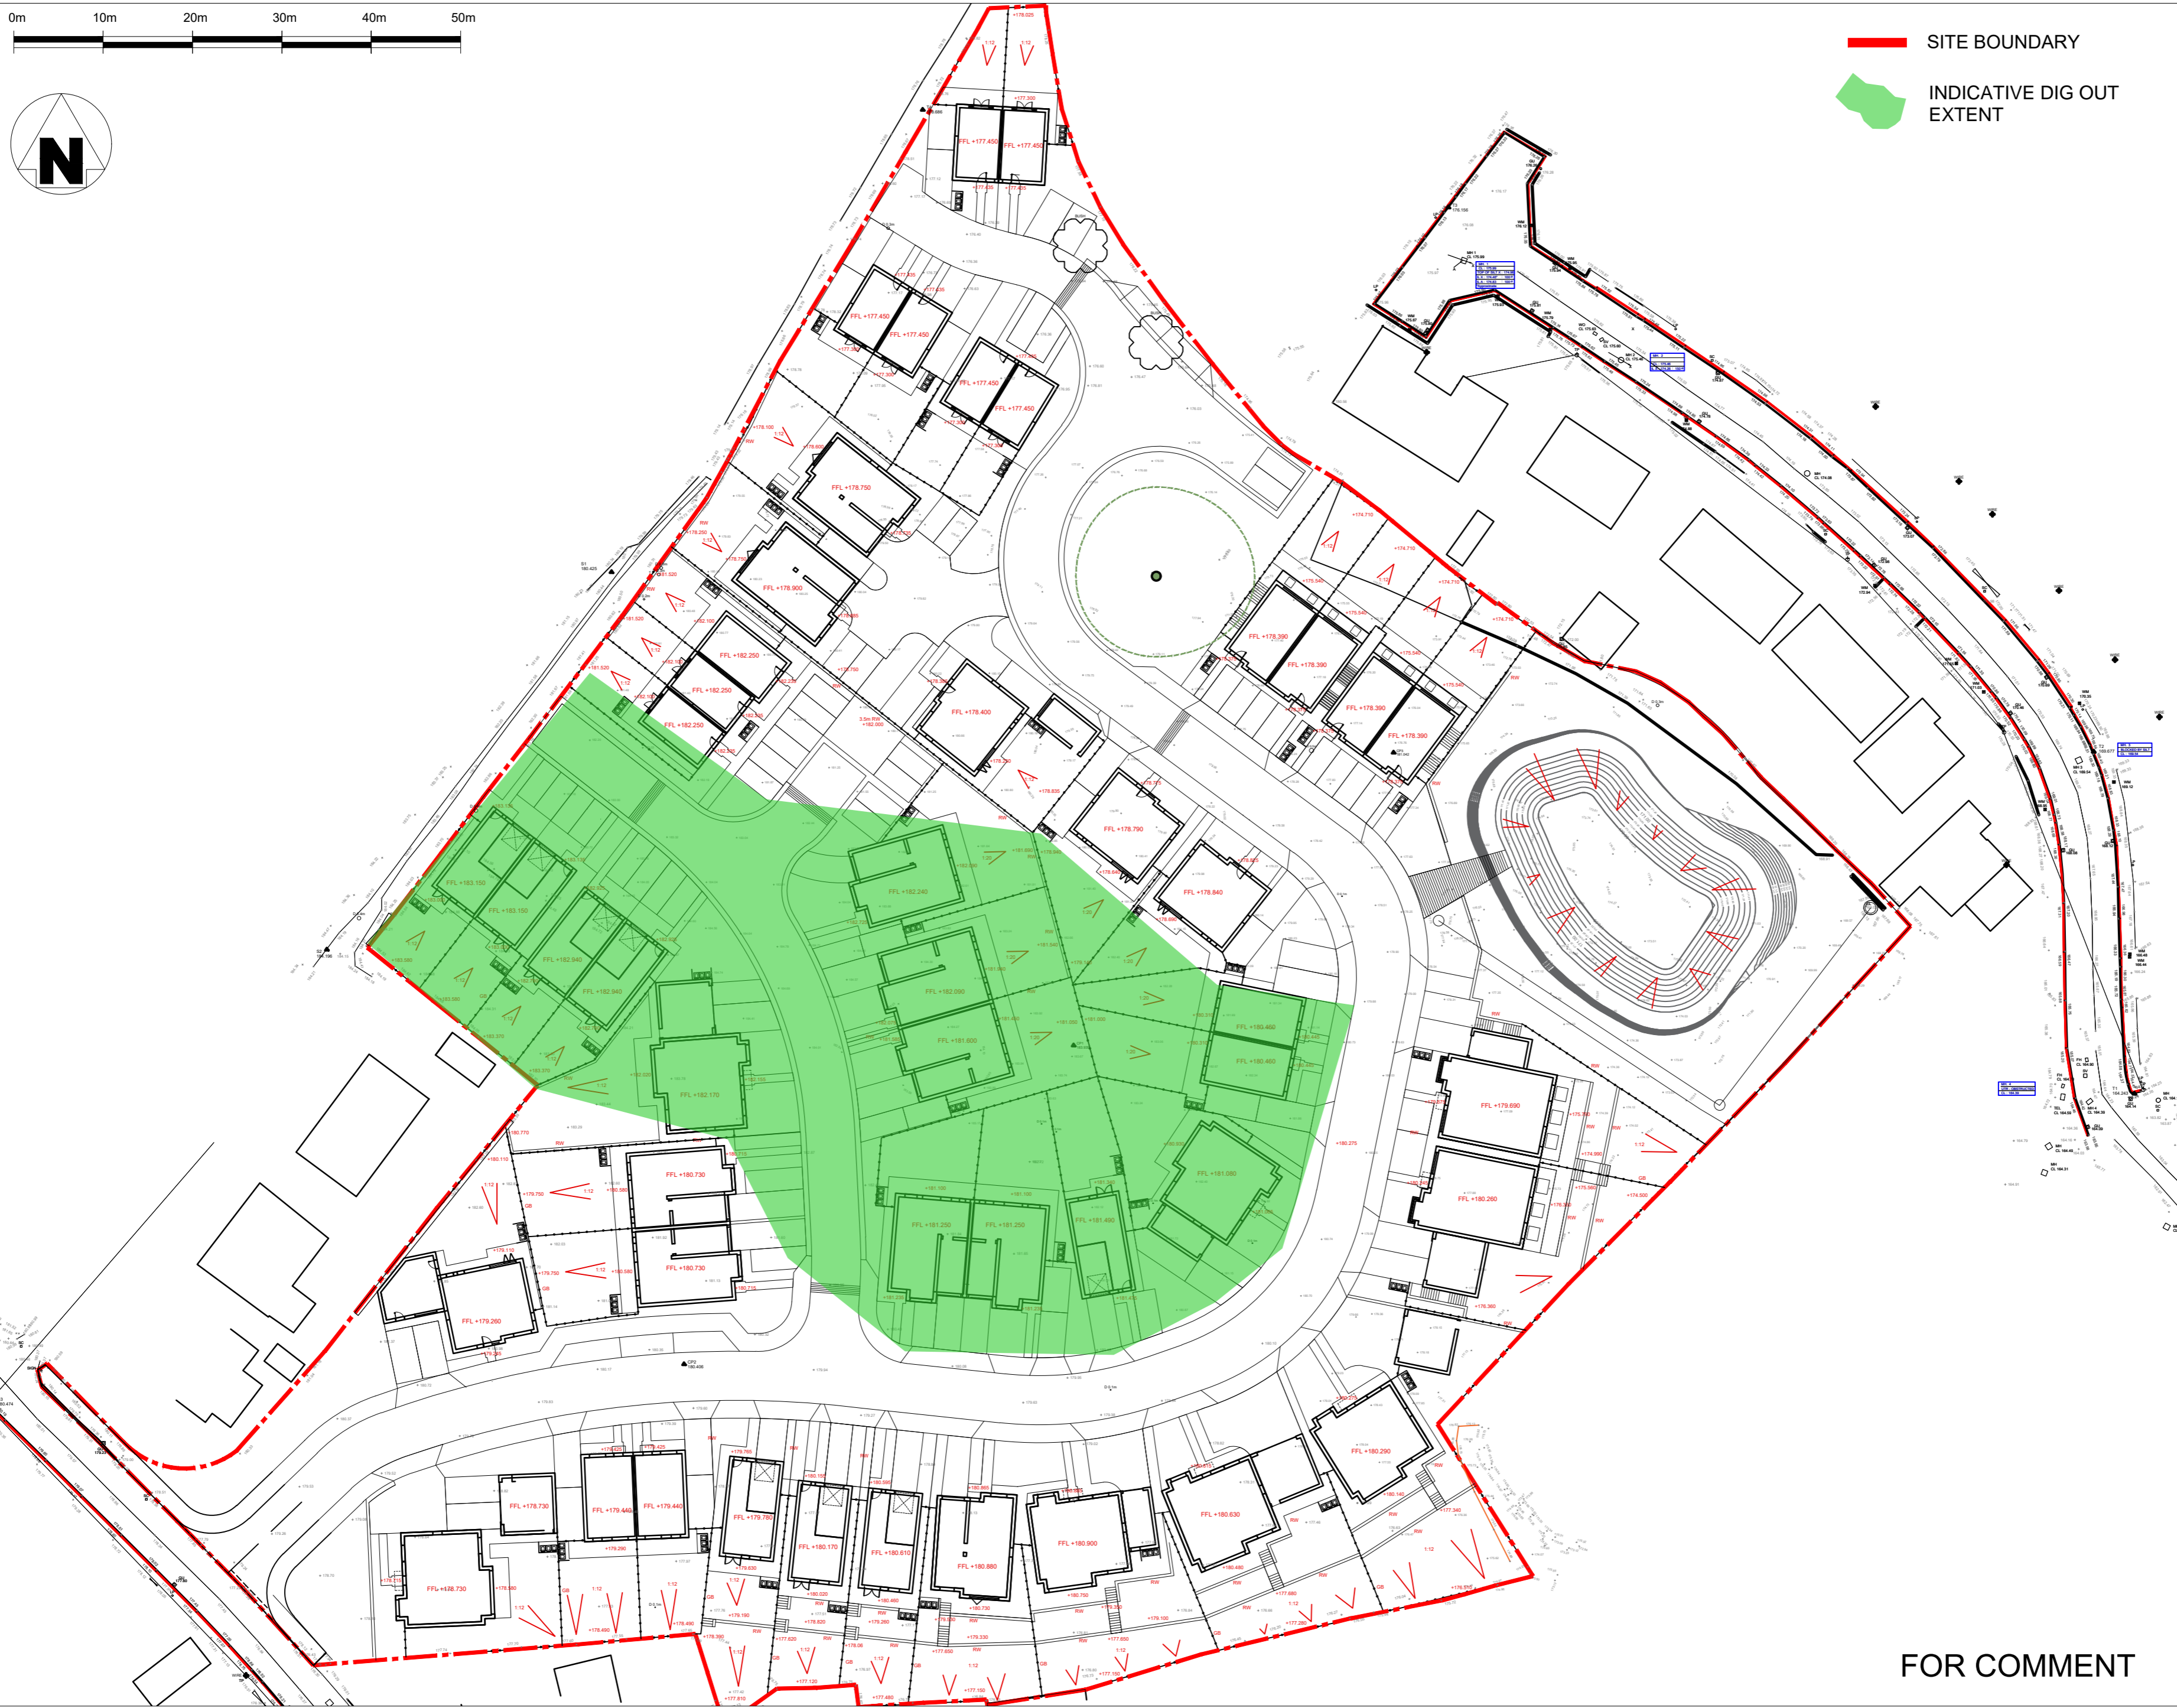
**SITE BOUNDARY**  
**INDICATIVE DIG OUT EXTENT**

Where ground levels are to be reduced during the earthworks, the un-named seam may be within influencing distance of the base of the foundation (<0.5m cover). In this instance, it may be more cost effective to over dig the earthworks and remove the workings/shallow seam in full. Subject to earthworks adjustments and final levels, an excavation plan has been presented in Appendix I.
