Phase 2: Site Investigation

Shawcross Business Park, Dewsbury

Martin Walsh Architectural

S240612

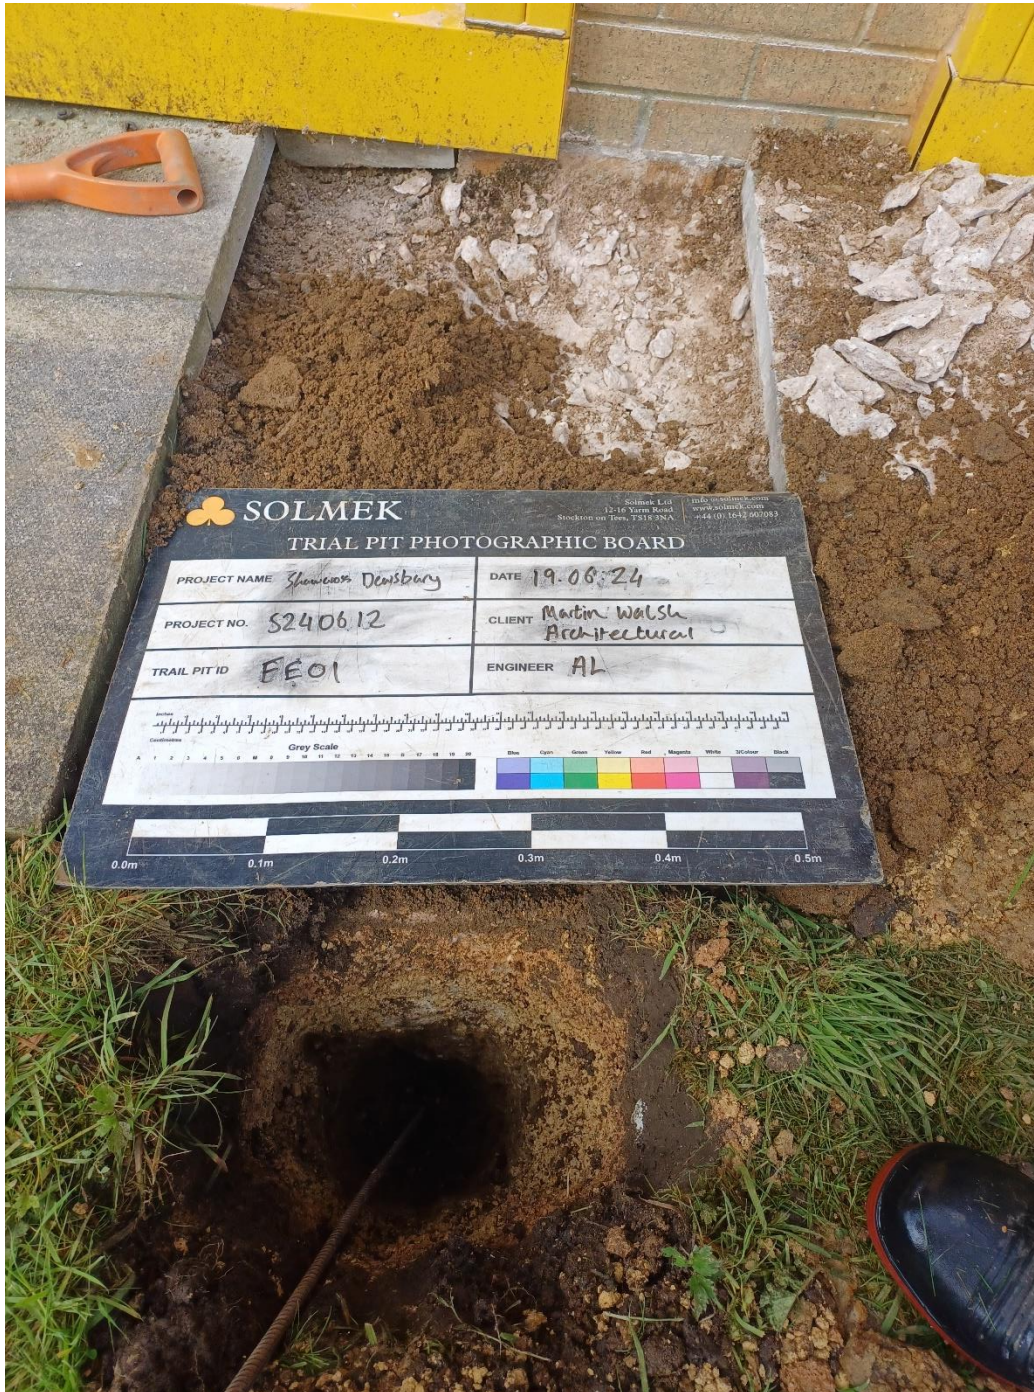
Title
FE01 Foundation Exposure Trial Pit Photograph
Project
Shawcross Business Park, Dewsbury
Client
Martin Walsh Architectural
Date
July 2024
Fig No.
Figure 7
Scale
Do Not Scale
Key

The made ground encountered in the foundation exposure pit (FE01) comprised paving over sand to 0.10mbgl underlain by sandy gravel to 0.30mbgl.
