**PHASE I/II GEO-ENVIRONMENTAL INVESTIGATION REPORT
SCAPEGOAT HILL, GOLCAR, HUDDERSFIELD HD7 4ND**

Brierstone Ltd

Project Reference: **JS/ST/40706-Rp001**

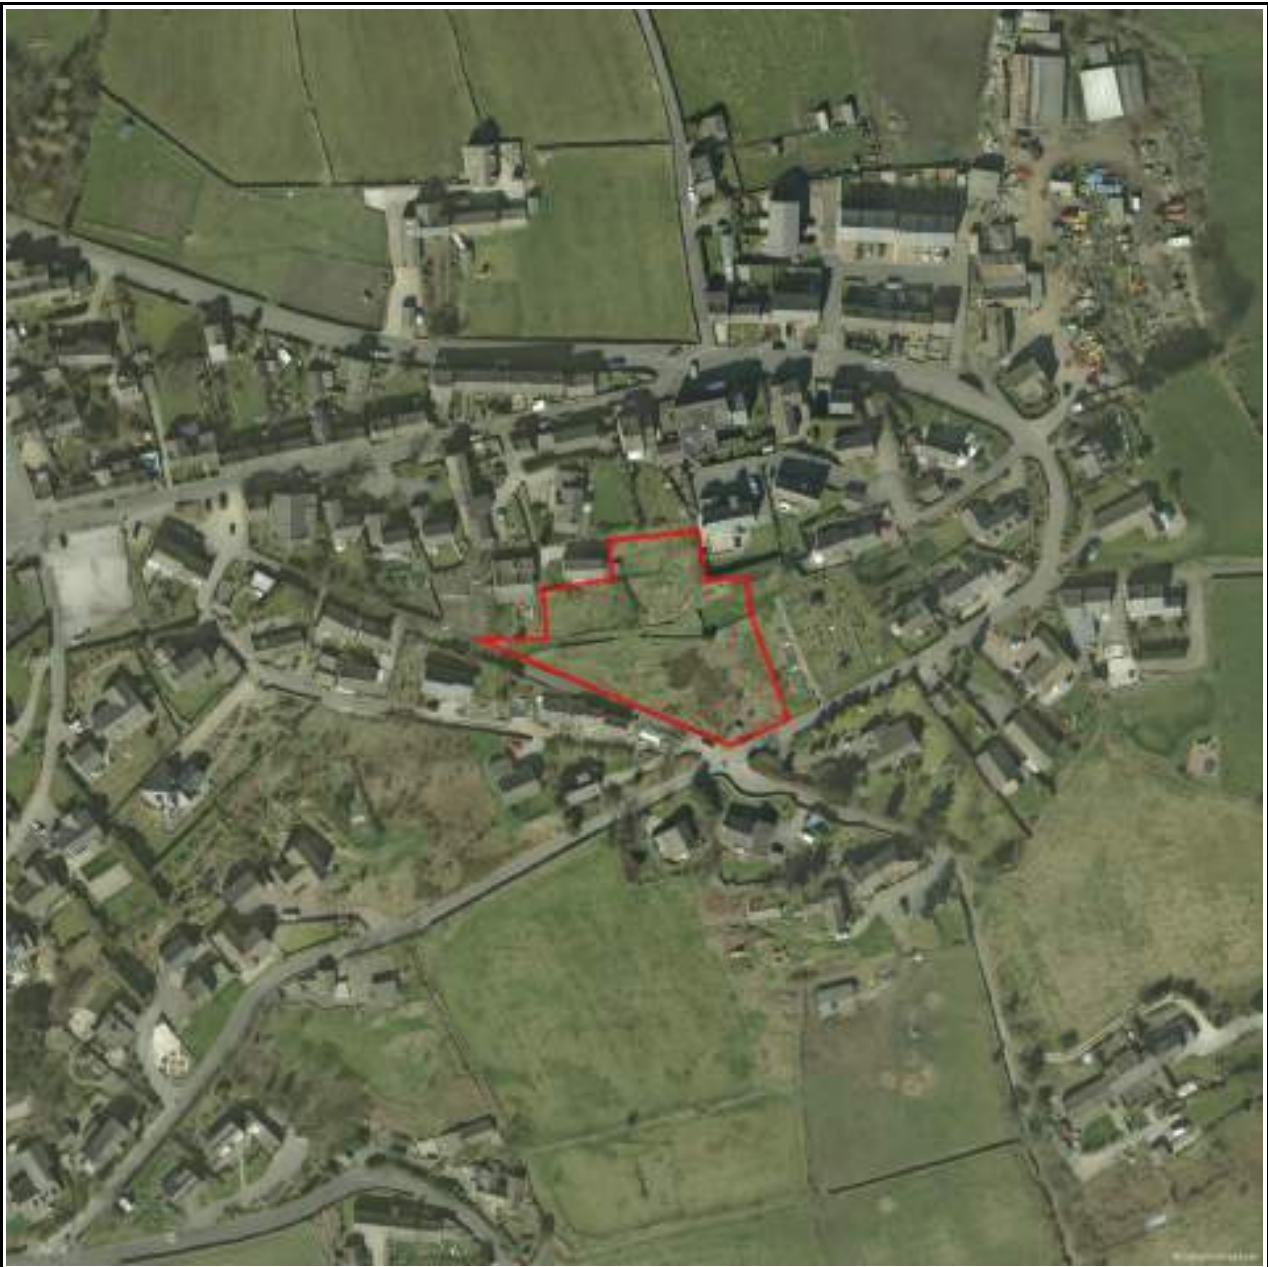
Aerial Photograph Capture date: 26-Mar-2012
Grid Reference: 409007,416372
Site Size: 0.34ha
