### **Our Ref. 25-162**

### **RE: Amendment to Planning Permission 2024/91524 for Erection of Two Detached Dwellings at Old Lane, Scapegoat Hill, Huddersfield, HD7 4ND**

As requested by Violet Homes Ltd and following a consultation response from Kirklees Council Environmental Health (ref. 2024/93506 Dated 24<sup>th</sup> January 2025) regarding the potential risk to end users posed by contamination present within any made ground present on site, as detailed in the Phase 1 / Phase 2 Geoenvironmental Investigation Report previously completed by Alan Wood & Partners (Ref. JS/ST/40706-RP001- May 2018). A site visit was conducted by a suitably qualified geoenvironmental engineer from Arc Environmental Ltd (ARC) on 5th March 2025 to recover samples for laboratory contamination screening to allow for an updated ground contamination risk assessment and Conceptual Site Model to be carried out.

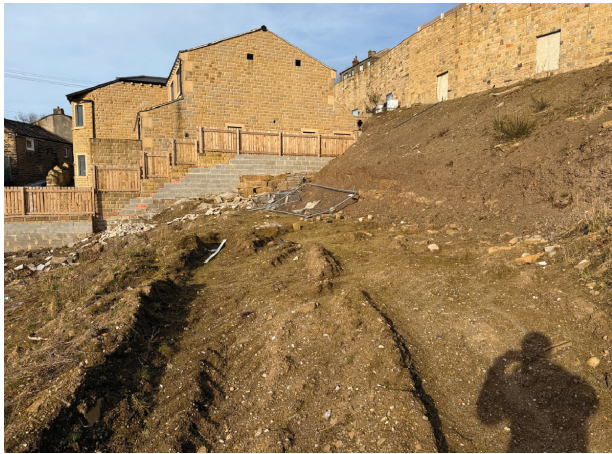
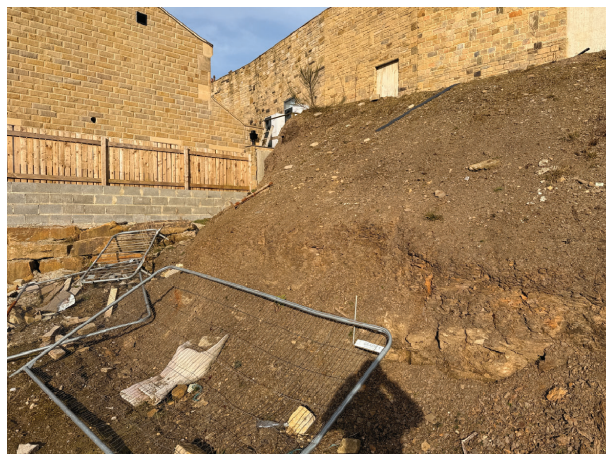
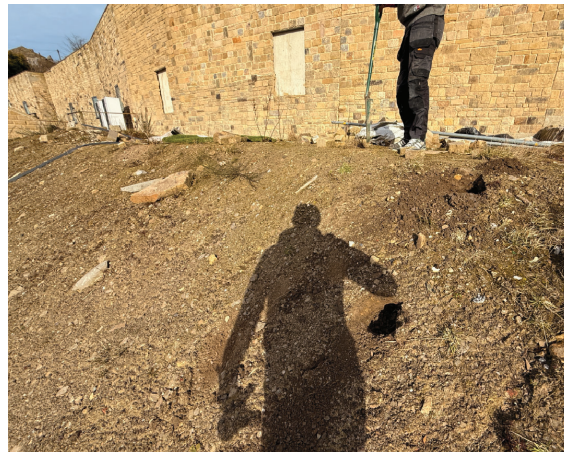
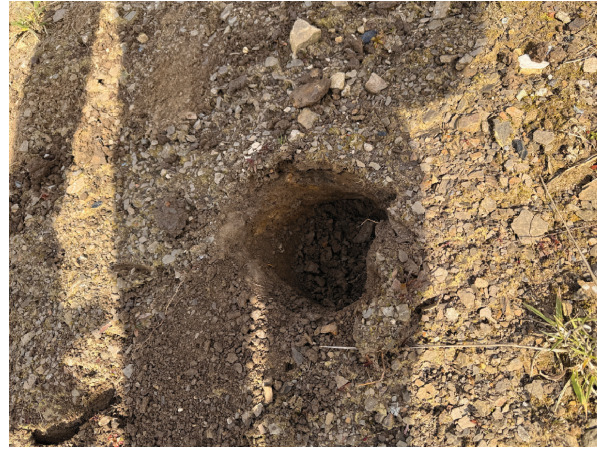
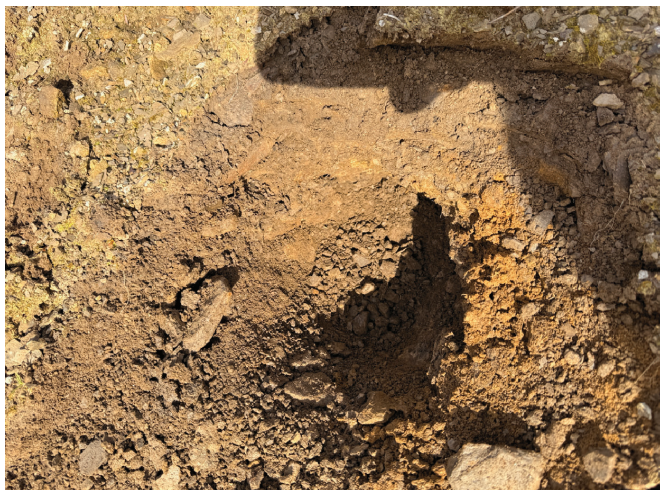
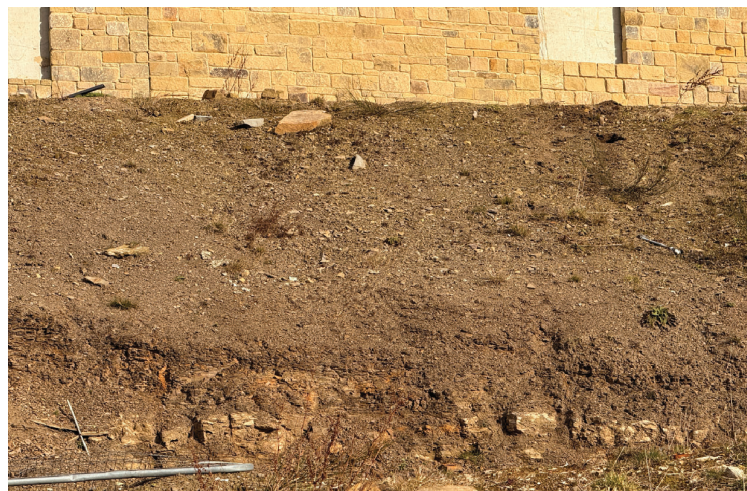
At the time of the site visit, a thin band of topsoil c.0.10m thick overlying natural dark brown weathered mudstone was recorded at the surface in the proposed garden areas with all made ground visibly removed from site. A site photographic record sheet is attached to this report.

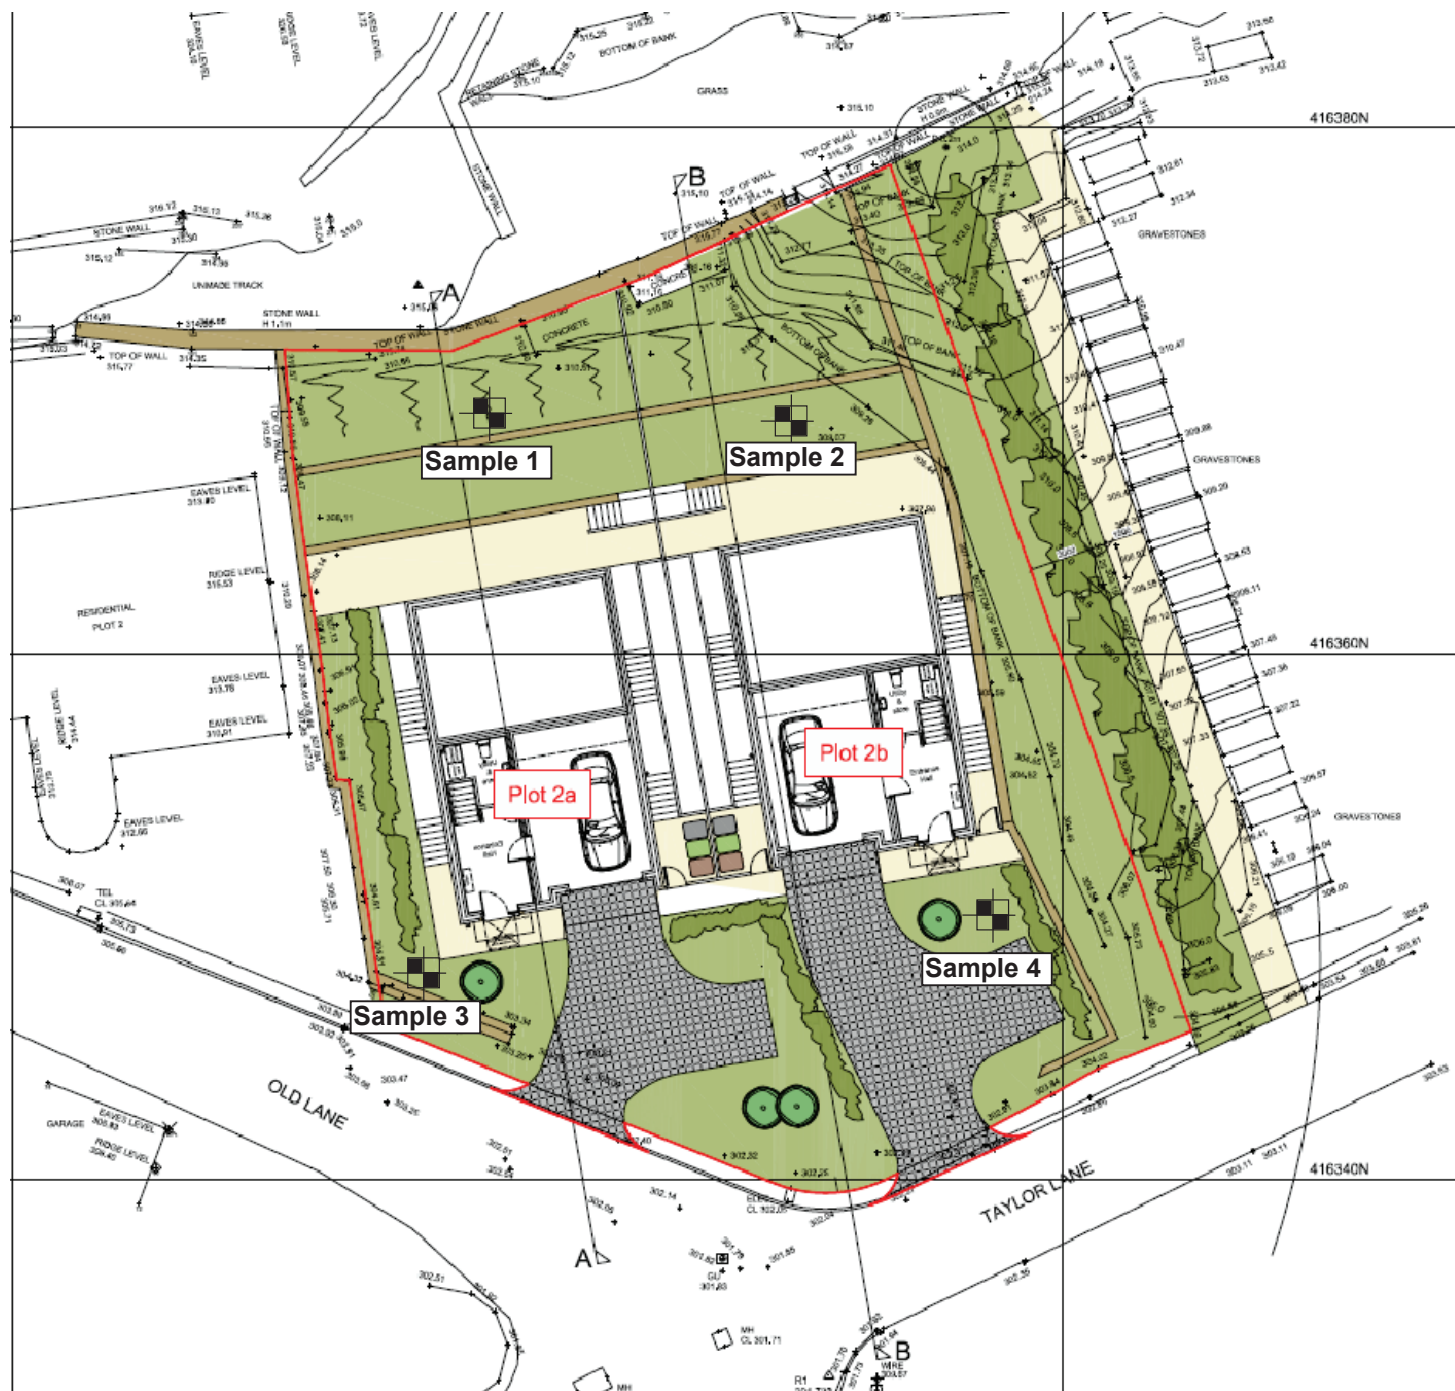
During the site visit, 4 no. samples of the topsoil were recovered from the proposed garden areas and submitted for laboratory analysis.
