**BARN COTTAGE, THUNDERBRIDGE.**

**PRELIMINARY ROOST ASSESSMENT.**

**Ref No: 250208**

**Date: 11<sup>th</sup> February 2025**

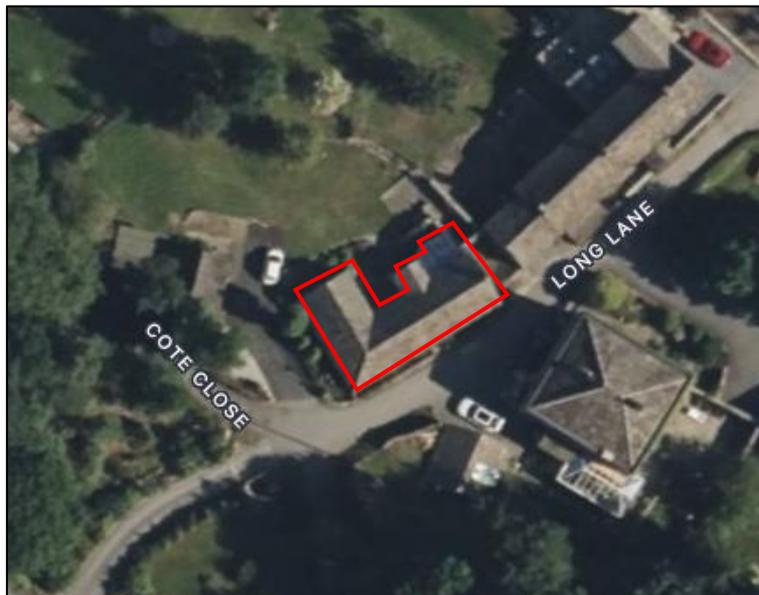
3.2.3. The survey area comprises Barn Cottage on Corn Mill Bottom, which is a two-storey detached property with a loft, and a conservatory extension to the rear of the property facing north. The extent of the property has been defined by the red line boundary in the aerial image below.

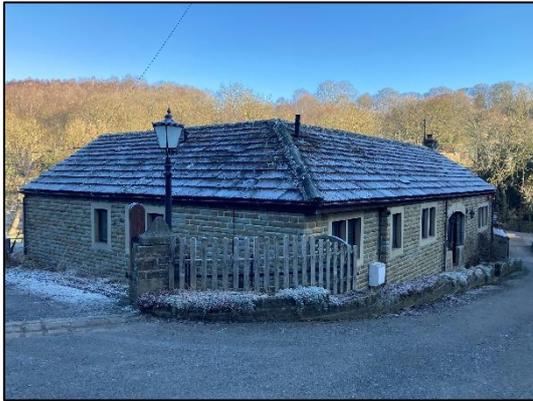
*Southeast facing:*

3.3.1. The building was primarily constructed using stone, including stonework around the window and door surrounds, PVC drainage and rendering. The stonework was in all around

good condition, with no cracks, gaps or crevices suitable for roosting bats. Additionally, all windows and doors were well sealed and no potential access points for bats were identified.

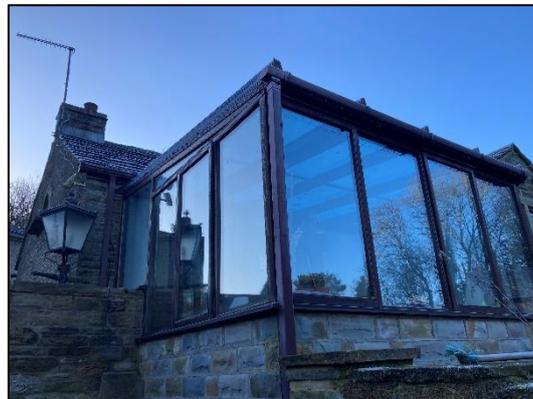
3.3.2. There was a sloping extension to the rear of the property. This was stone based, with timber framed windows and doors. The stonework was, similarly to the rest of the building, in good condition, and there were no identifiable features, which may allow access to roosting bats.

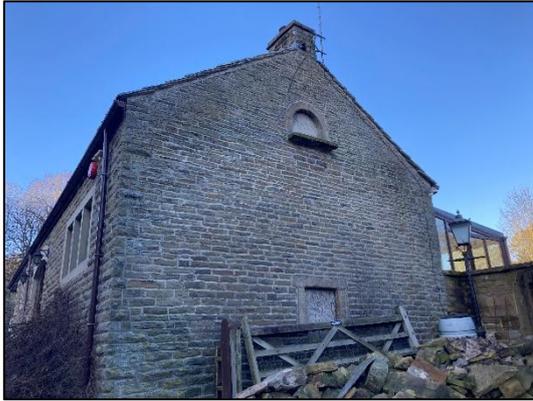
*Northeast facing:*

3.3.3. The roof of the property was pitched and covered with stone tiles with gable ends to the northwest and northeast. The pointing and ridge tiles appeared to be in generally good condition at the gable ends, with no potential features for roosting bats identified. The door to the rear of the property extends outwards and forms a cross gable with a porch, which appears to be in a similar condition.

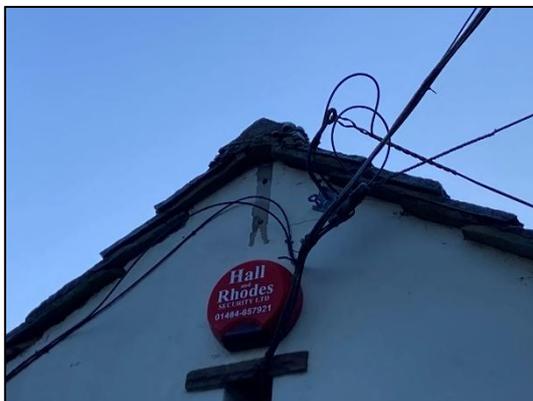
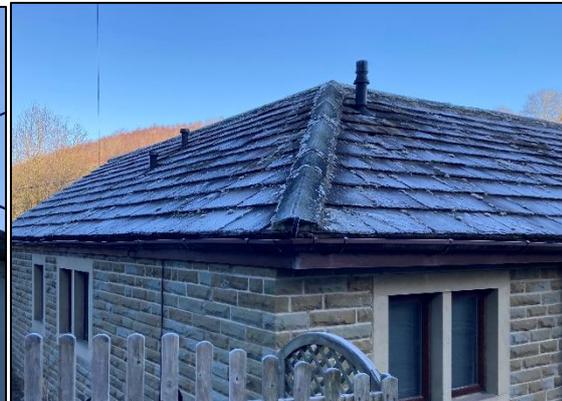
3.3.4. The roof was pitched with overlapping stone tiles, which form a hip at the southwest corner of the property.

3.3.4.1. The ridge tile and pointing appeared to be in relatively good condition from ground level, with no missing mortar identified.

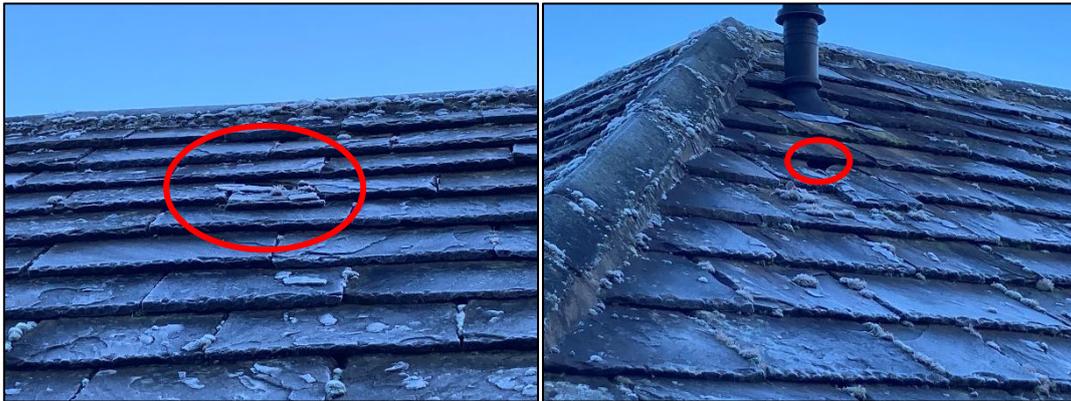
3.3.4.2. The tiling was generally intact and in good condition, although there were occasional slipped, missing or broken tiles, which may provide potential access points for roosting bats.

5.1.1. The building is assessed as having moderate potential for roosting bats according to the Bat Conservation Trust's 'Good Practice Guidelines'. Therefore, it is recommended that two dusk emergence surveys are carried out during the active bat season, which extends from May to August inclusive, to determine whether bats are using the building to roost. The surveys need to be carried out at least three weeks apart.

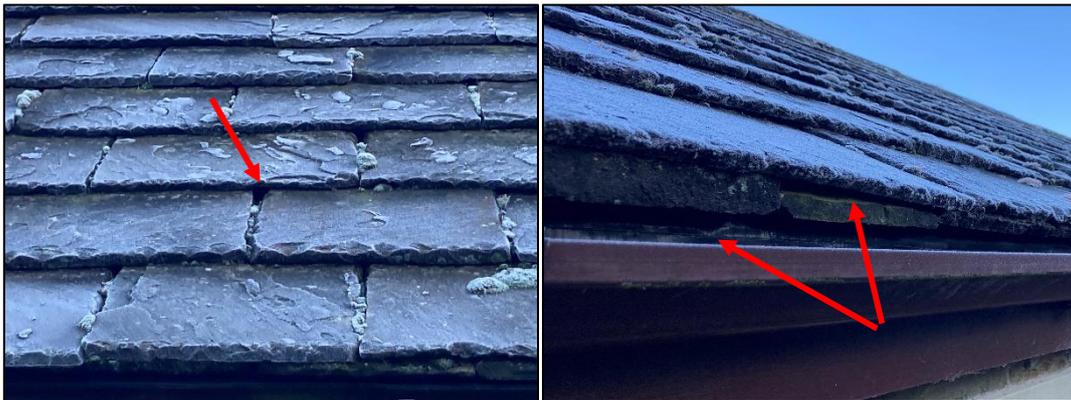
3.3.4.3. The nature of the stone tiles also means that there are gaps present underneath and between the tiles

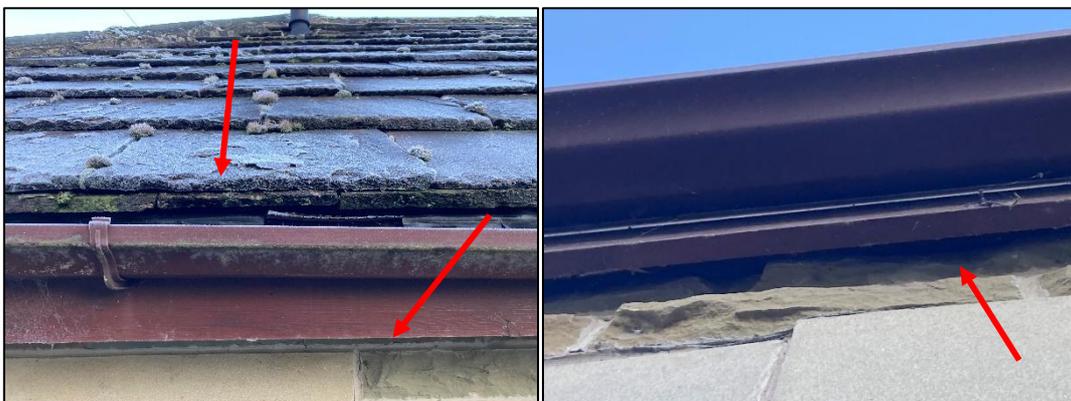
3.3.4.4. Gaps were identified beneath the timber fascia, which underlies the guttering surrounding the building. These gaps appeared to extend into the internal roof void and could be seen internally (see section 3.3.5.1.).

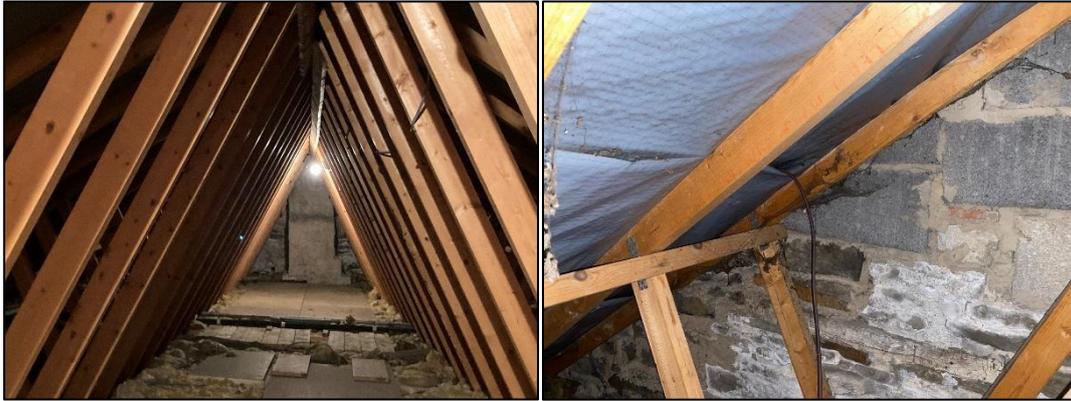
3.3.5. Access to the loft was permitted by the client. The loft was found to comprise two connected areas in an L- formation, as could be seen from the outside of the building. The roof was lined with breathable roofing membrane with exposed timber trusses present throughout.

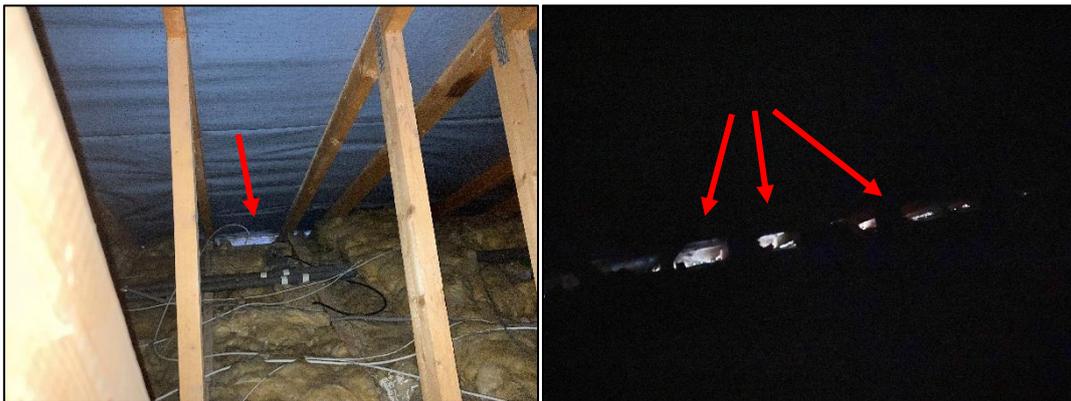
3.3.5.1. The locations of the aforementioned gaps beneath the timber fascia were identified within the loft space, evidenced by the light, which could be seen shining through. No bats were identified within the loft and no definitive field signs were identified at the time of the survey.

3.3.6. The results of this survey found that a number of features that provided potential access into the loft space of the property were present, in addition to potential roosting features beneath slipped and damaged tiles. The gaps identified beneath the timber fascia offer potential access into the loft space for roosting bats, particularly Brown Long-Eared (BLE). Access to the loft is not probable via the external tiles, as the lining is present and in good condition throughout the loft, however the features created by slipped and damaged tiles may offer roosting opportunities for low numbers of bats during the summer months. Furthermore, the relatively rural location of the property within a small residential area means that light levels are likely to be low, and the adjacent woodland to the south offers optimal habitat for foraging and commuting. The building has therefore been assessed as providing **moderate potential for summer roosting bats**.

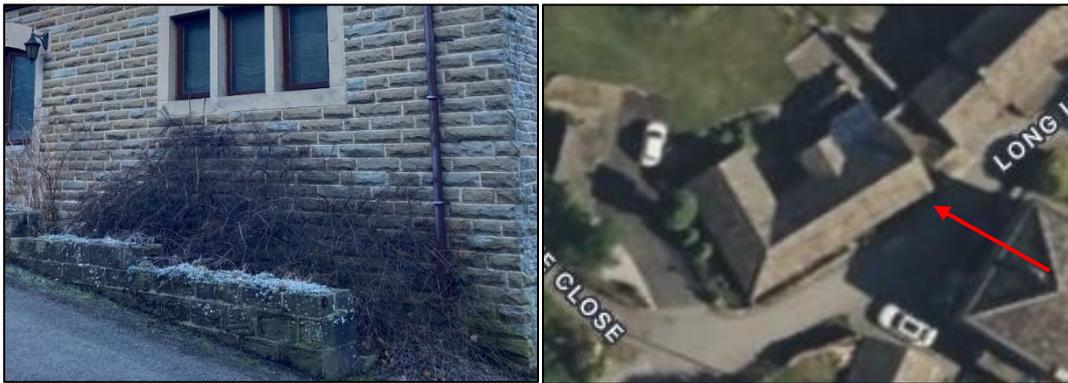
3.4.2. During the initial survey, rockspray cotoneaster (*Cotoneaster horizontalis*), a Schedule 9 invasive non-native species (INNS) listed on the Wildlife and Countryside Act (1981) was identified within the survey area. The approximate location of the plant is indicated by the red arrow on the aerial map below.

4.4.3. *Cotoneaster horizontalis* is a Schedule 9 species listed on Wildlife and Countryside Act (1981) and present in the survey area. This species is spread via long lasting berries, which have the potential to spread into the wider environment during the demolition works. Therefore, without due care, the planned works will potentially have a **Negative Impact** on the spread of this species.

5.2.2. It is recommended that a method statement be drawn up outlining how the *Cotoneaster horizontalis* will be treated, in order to eradicate this plant from the site and avoid causing any further spread into the wild. This will need to consider treatment of soils that will be contaminated by cotoneaster berries. A toolbox talk has been appended to this report to aid with the identification of this species.
