# Ground Appraisal Report

Main Avenue, Kirklees

Client:	Strata Homes and Thirteen Group
Document Type:	Report
Document No.:	1152-GEO-GAR-001
Revision:	001
Date:	2024/08/20

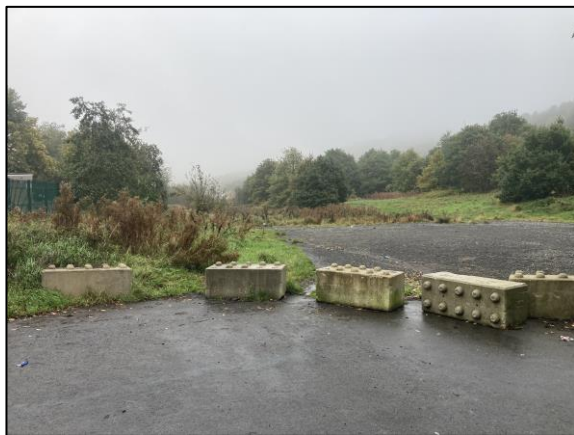
*Photo 1 – Site, off Main Avenue, looking southeast.*

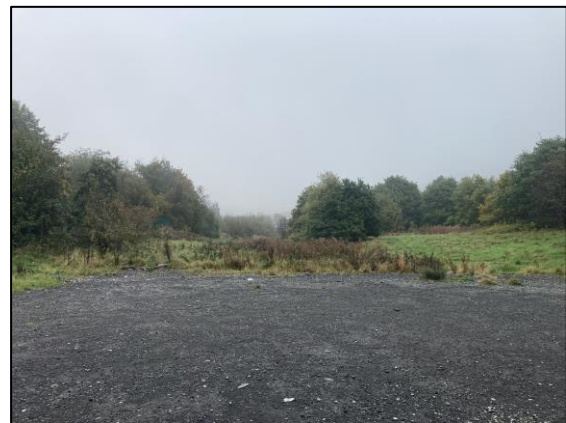
*Photo 2 – Site, facing east, from small surfaced area just off Main Avenue.*

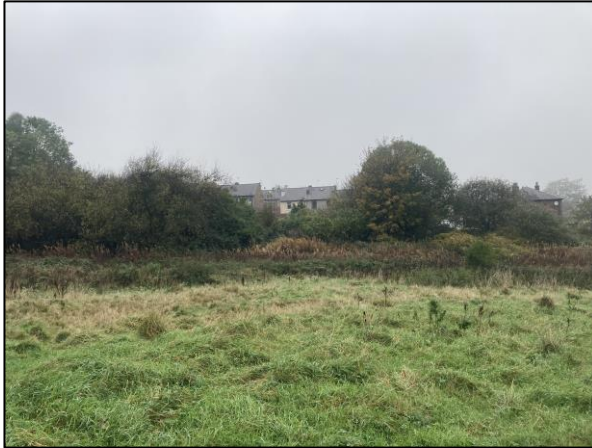
*Photo 3 – Heavily vegetated area in the northeastern corner.*

The northeastern corner of the site is heavily vegetated with shrubs, bushes, and some trees reaching heights of up to c.10m. Throughout the rest of the site, particularly bordering the school playing fields and the steeper slope to the south, there are sporadically located trees and bushes including mature trees up to c. 15m in height.

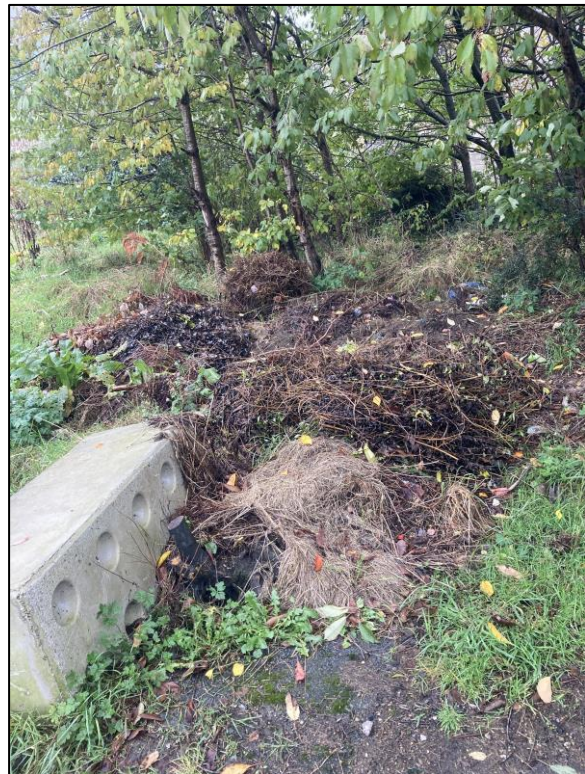
*Photo 6 – Fly-tipped rubbish near the entrance of Main Avenue.*

The site is used frequently by dog walkers and local residents for recreation. Small areas of fly-tipping were noted along with evidence of bonfires.
