Remediation Strategy

Main Avenue, Kirklees

Client:	Strata Homes & Thirteen Group
Document Type:	Report
Document No.:	1152-ACE-GEO-RS-003
Revision:	002
Date:	2025/03/18

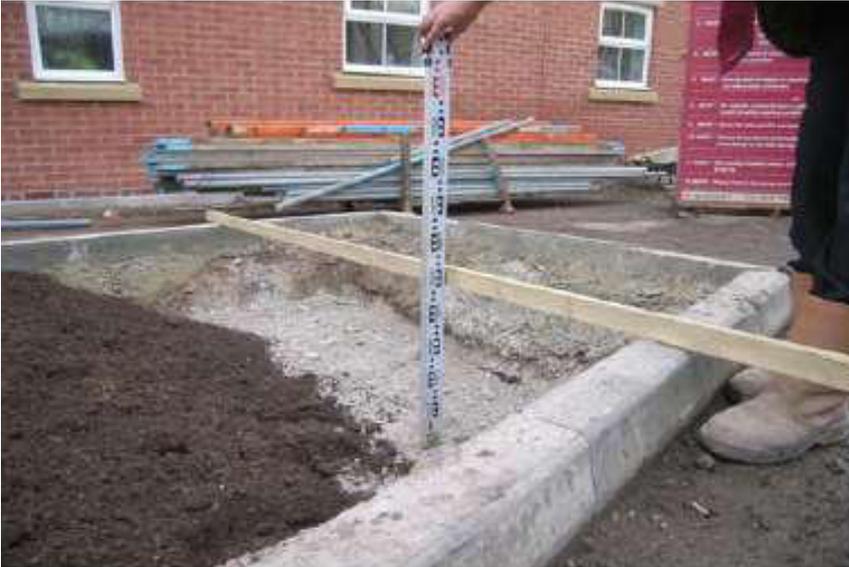
Photograph 1:
Depth check of inert cover within area of public open space. Physical break layer and topsoil visible.

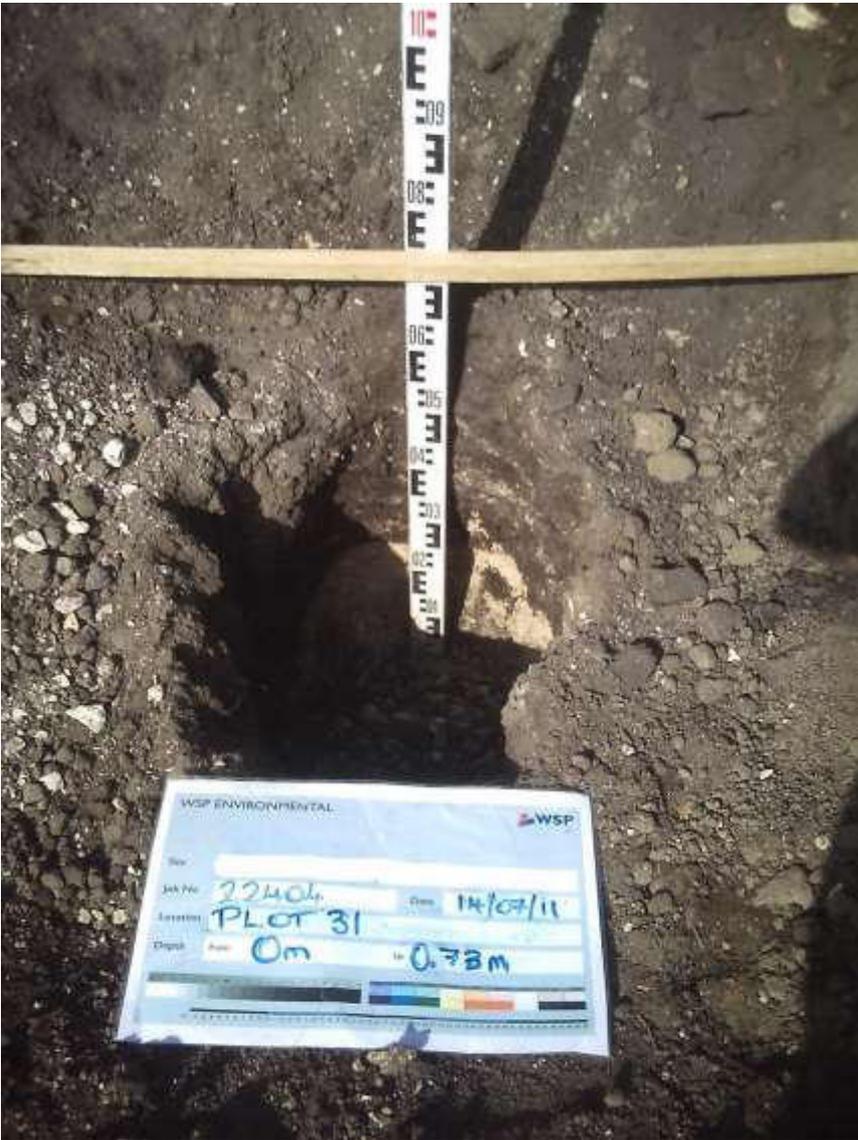
Photograph 2:
Depth check of inert cover with Site & Location Information Board.

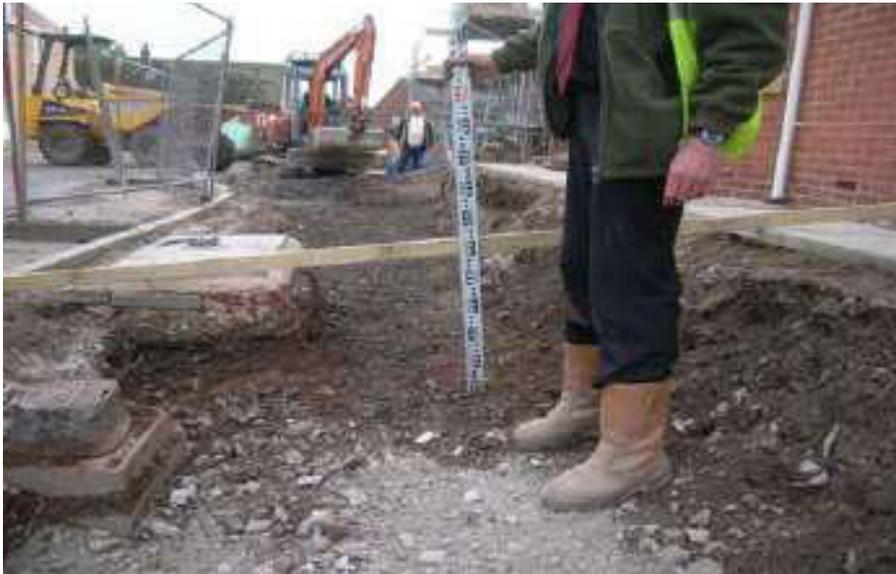
Photograph 3:
Depth check of inert cover within areas of front gardens.

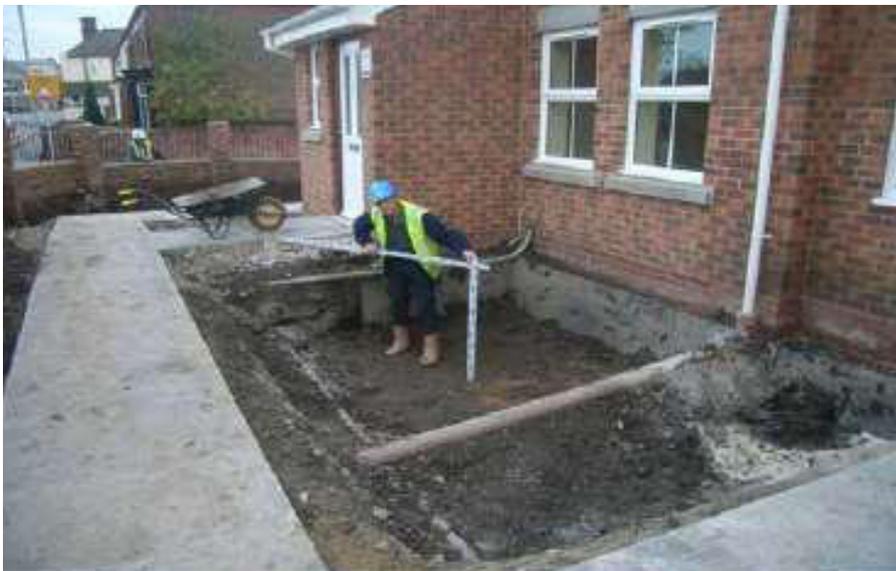
Photograph 4:
Depth check of inert cover within areas of front gardens.

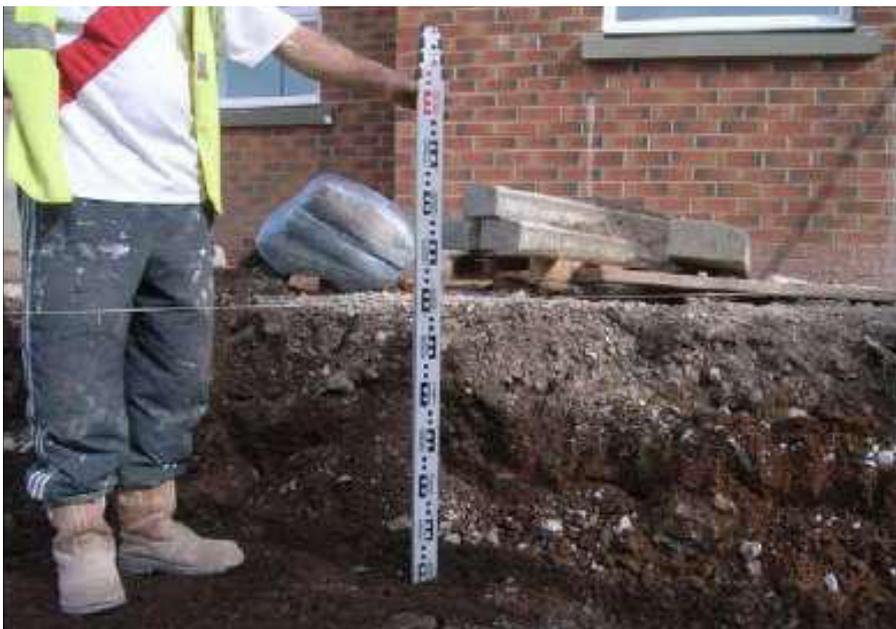
Photograph 5:
Depth check of inert cover within rear gardens. Taut string line spans across excavation.

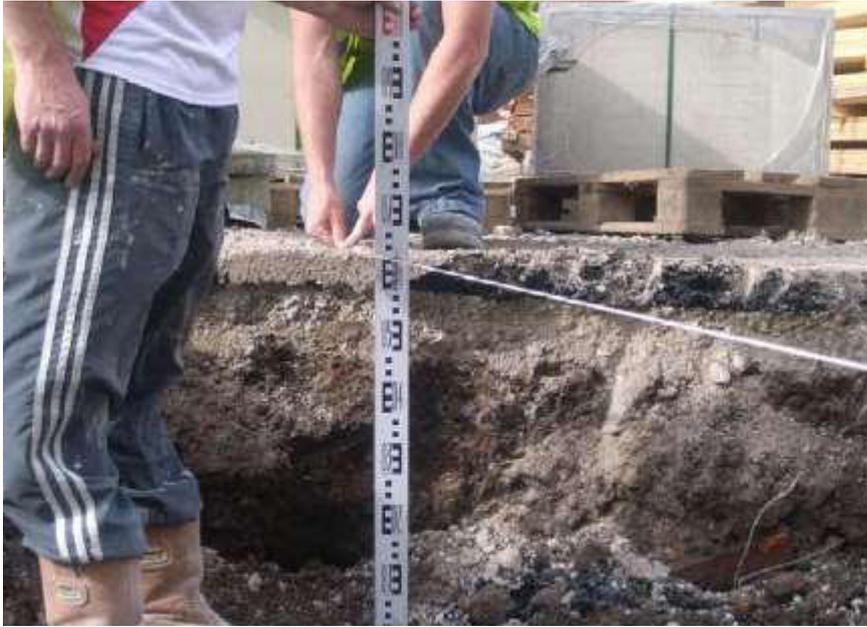
Photograph 6:
Depth check of inert cover within rear gardens. Taut string line spans across excavation.

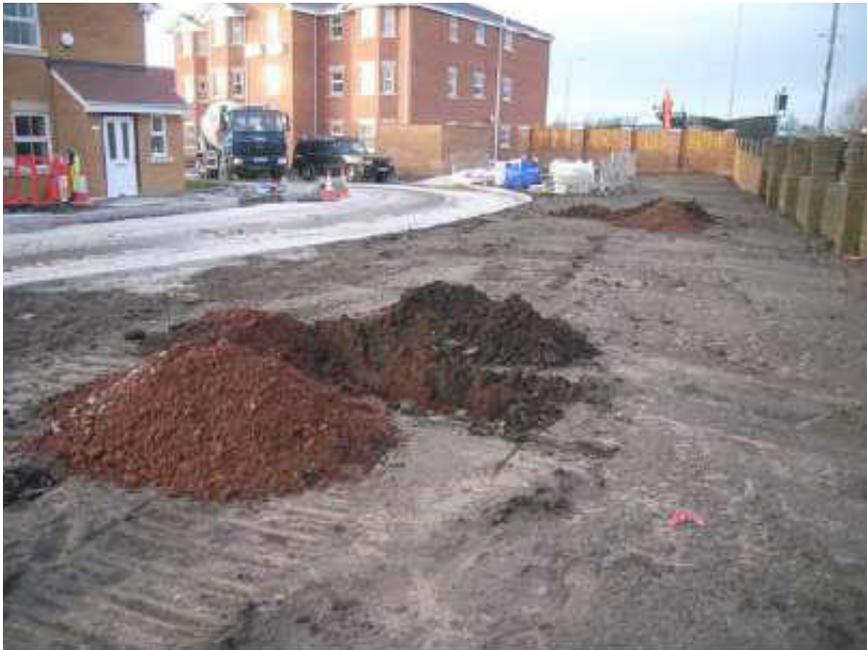
Photograph 7:
Shows the spatial location of the verification pit.

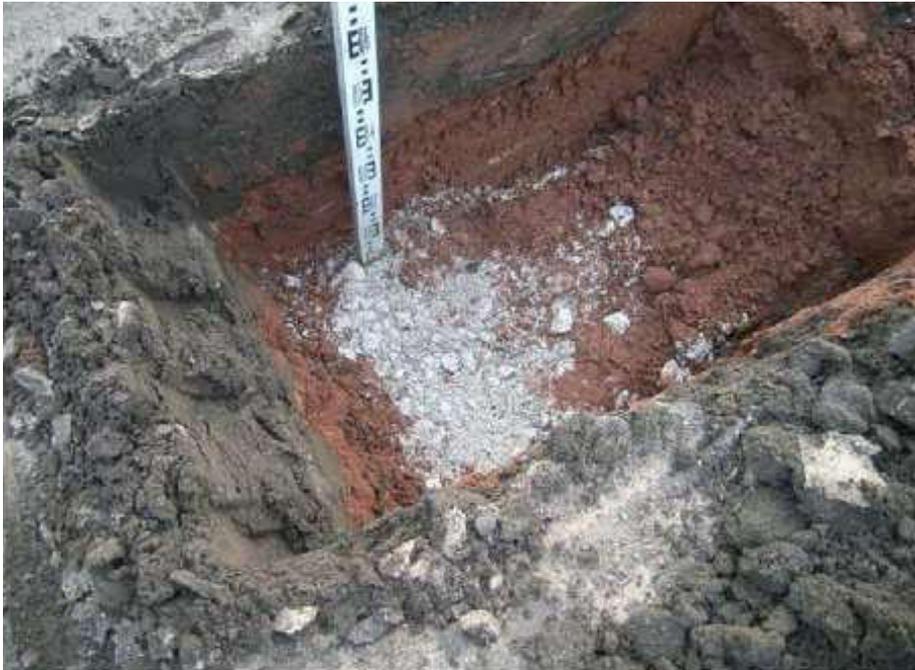
Photograph 8: Excavation within public open space and verification pit showing the presence of a remediation break layer at the base, a crushed sandstone inert fill overlain by topsoil.

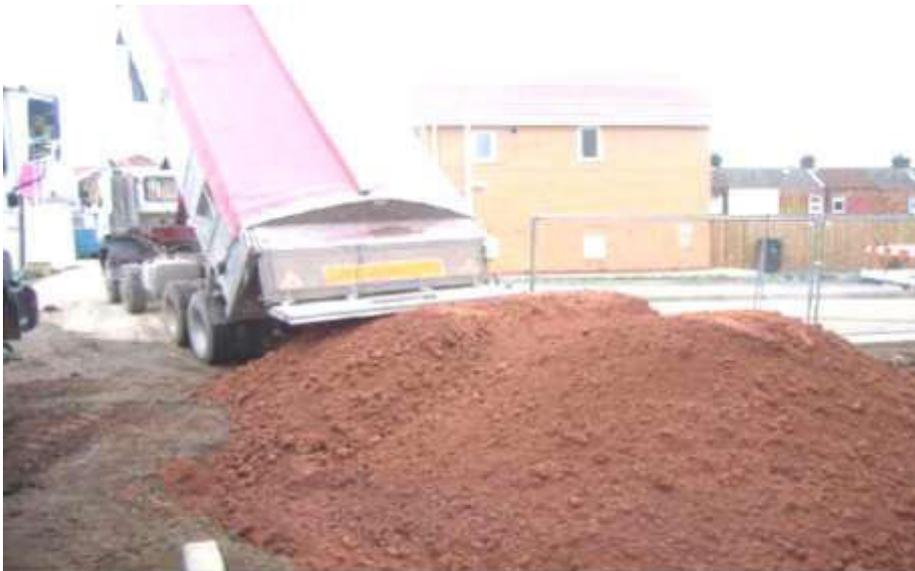
Photograph 9: Inert crushed sandstone being delivered. The spatial area of the remediation can be observed from these photographs (old terrace housing).

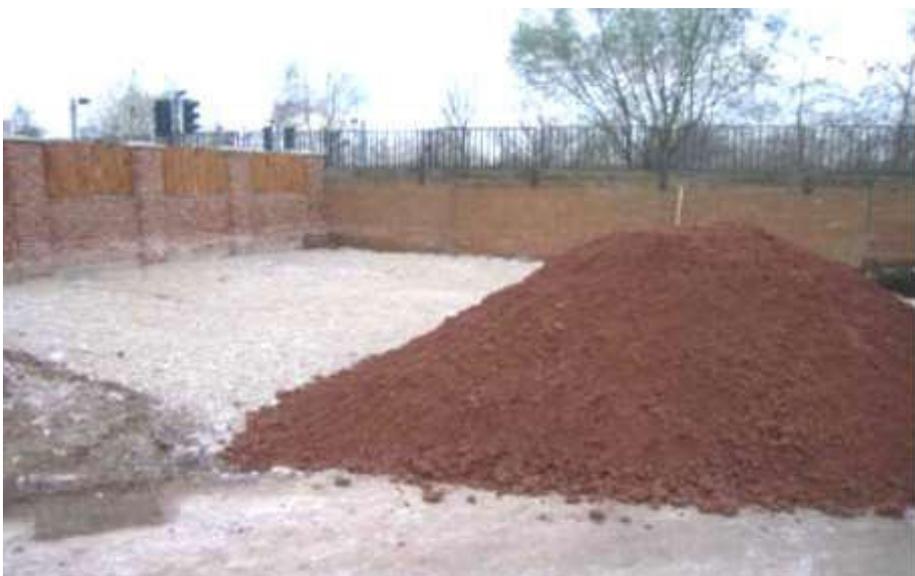
Photograph 10: Inert crushed sandstone being delivered with visible remediation break layer. The spatial area of the remediation can be observed from these photographs (traffic lights).

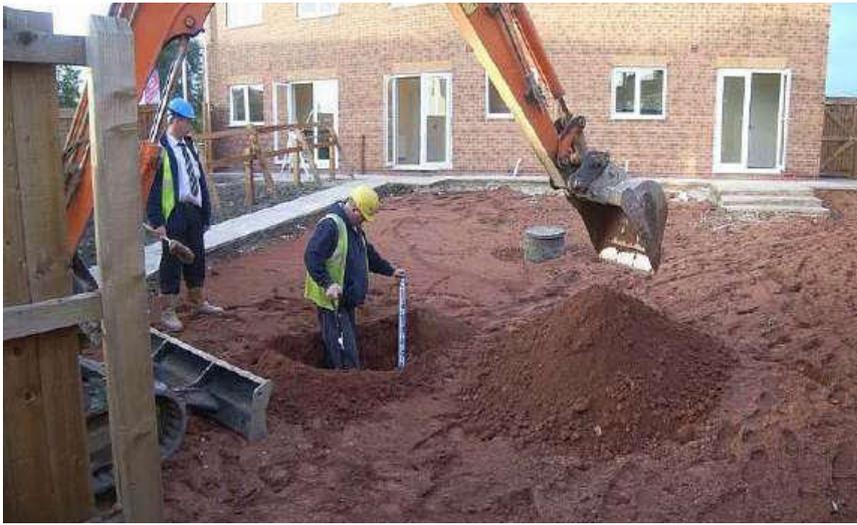
Photograph 11:
Shows the remediation of the rear garden, with a significant depth (1.0m) of inert cover. This photograph has been stitched to form a panoramic photograph and hence there is slight distortion

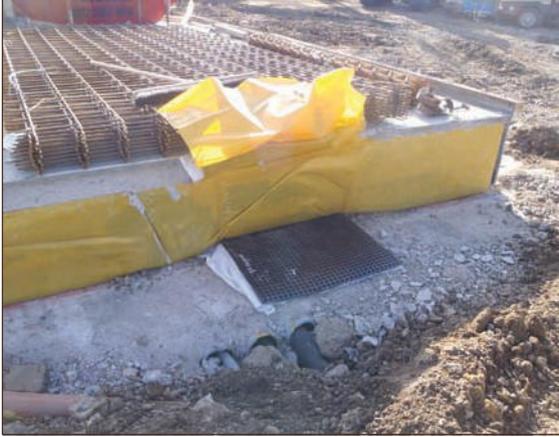
Figure A4.7 Geovent protruding out of the frontage of the unit. Gas membrane along the sides of the slab preventing lateral gas ingress (courtesy Alderburgh Group)

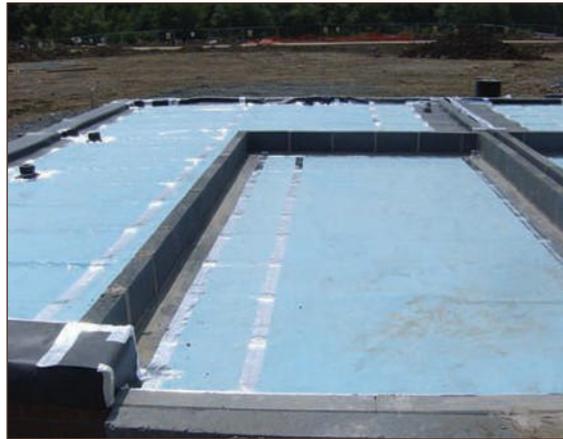
Figure A4.10 Almost complete coverage available for inspection, minimal jointing, service entries suitable distance from walls, light traffic (courtesy Smith Grant)

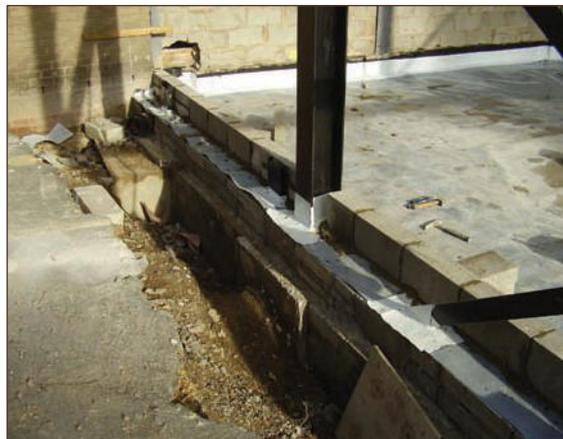
Figure A4.12 Good edge detail across cavity (courtesy PAGEotechnical Ltd)

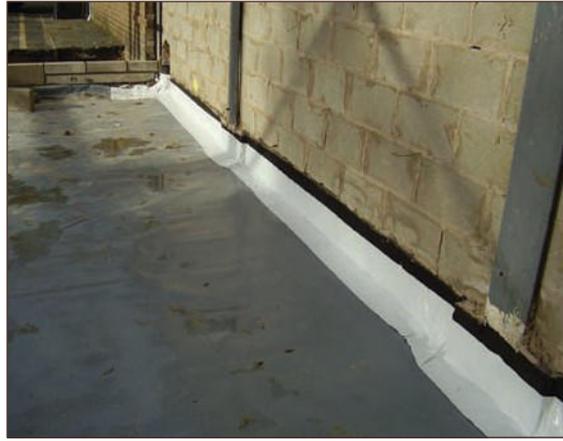
Figure A4.14 Good perimeter seal (courtesy PAGEotechnical Ltd)

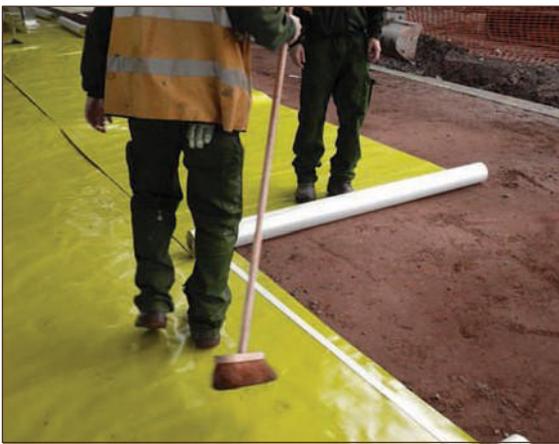
Figure A4.15 LDPE type gas membrane overlap and double sided tape. Sand blinding to protect underside of gas membrane (courtesy A Proctor Group)

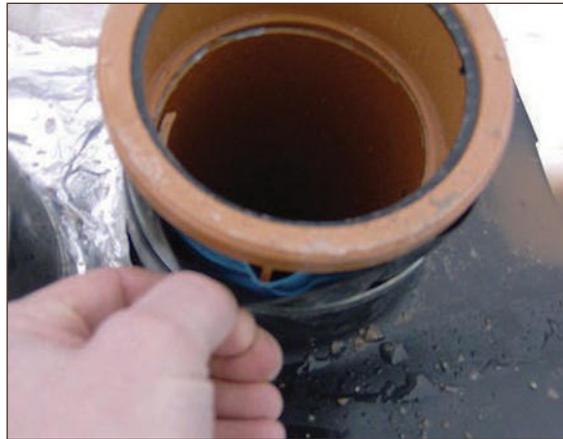
Figure A4.28 Bead of double sided butyl tape provided between interfaces of ID top hat and OD service pipe. When compressed with jubilee clip, forms an effective seal (courtesy Smith Grant)

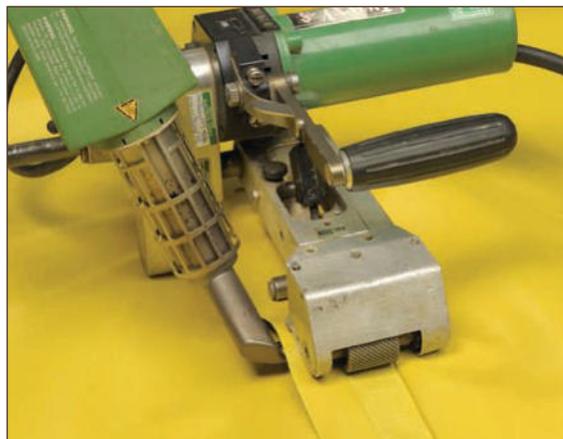
Figure A4.30 Thermal welding technique (courtesy Industrial Textiles & Plastics Ltd)

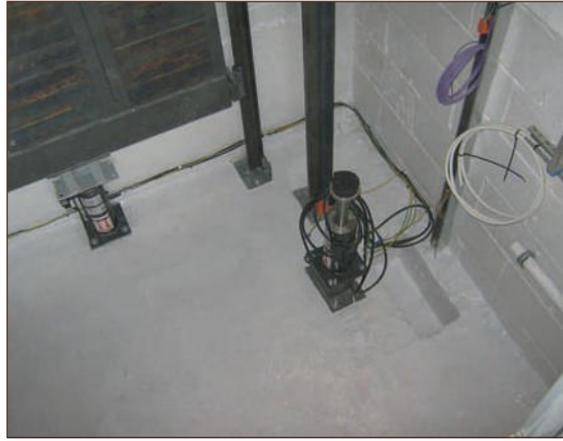
Figure A4.32 High quality installation of liquid gas membrane to lift pits, including resin gas protection on all screw penetrations (courtesy Card Geotechnics Limited)

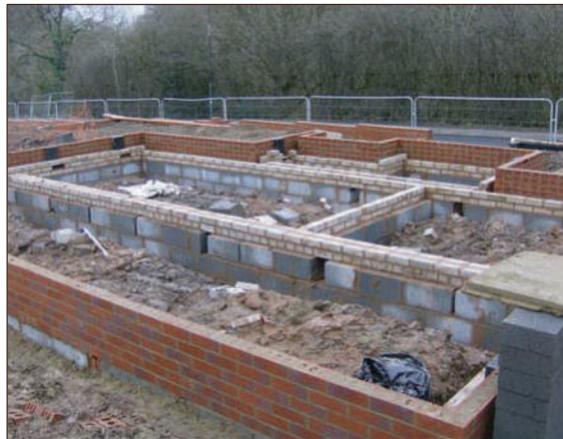
Figure A4.34 Open void >300mm deep, good ventilation through internal sleeper walls (courtesy Smith Grant)

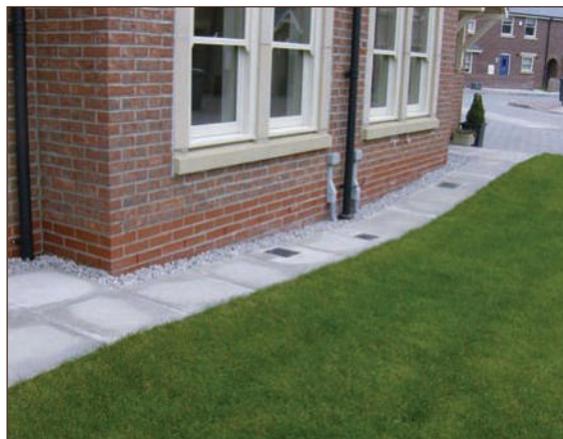
Figure A4.36 Raised air bricks are preferable due to the reduced potential for blockade but the vent trench specified is provided with clean single sized stone (courtesy Smith Grant)

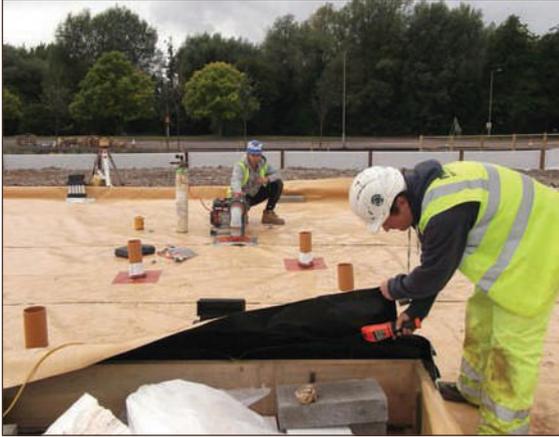
Figure A4.37 Tracer gas testing, whereby gas or smoke is applied under pressure beneath the installed gas membrane and detectors are used to screen for leaks above (courtesy NHBC)

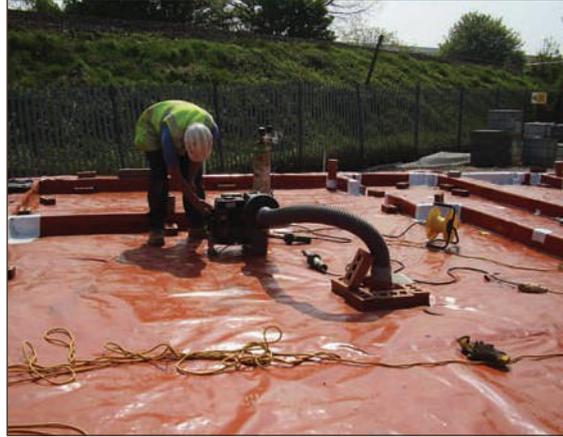
Figure A4.38 Tracer gas testing (courtesy PAGeotechnical Ltd)

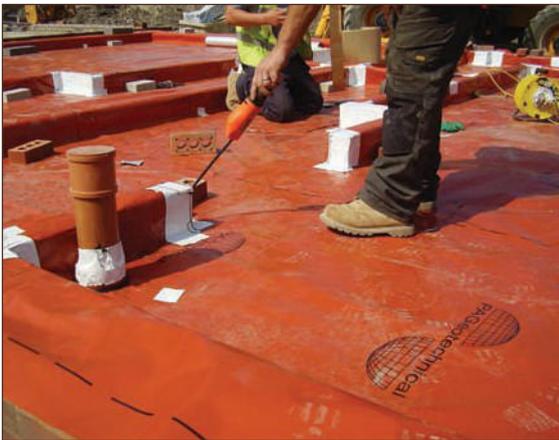
Figure A4.39 Scanning for leaks (courtesy PAGeotechnical Ltd)

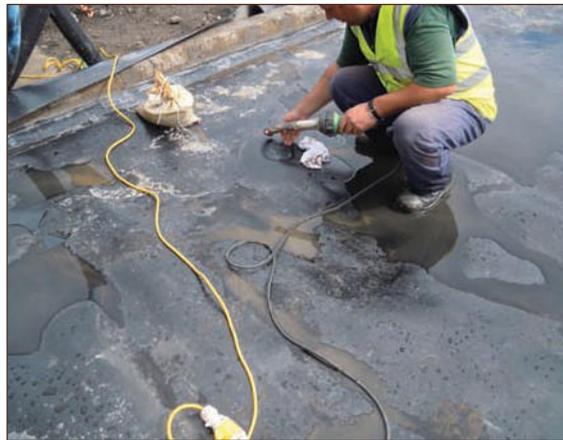
Figure A4.40 CO₂ injection integrity testing (courtesy Landline Ltd)

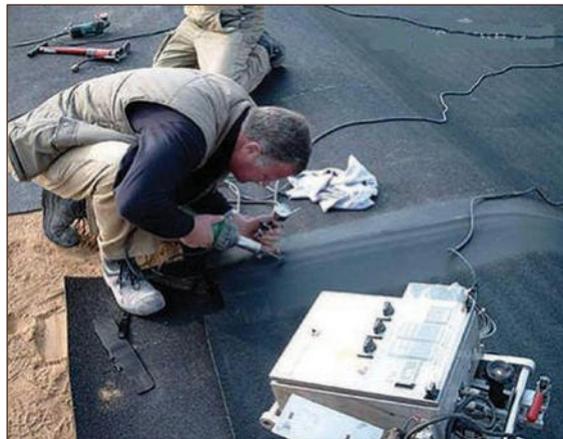
Figure A4.42 Air pressure testing (courtesy GSE Environmental)

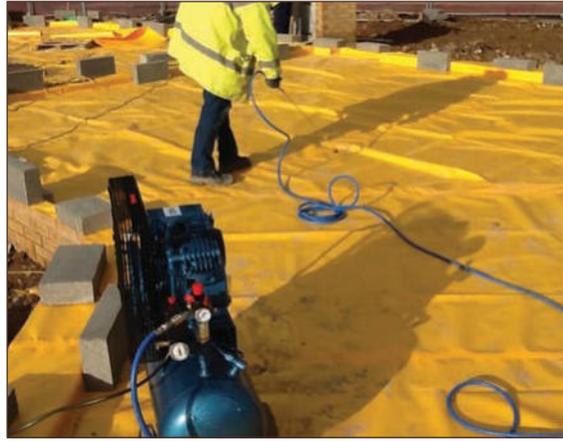
Figure A4.44 Air lance test, used to test the quality of welded seams along gas membrane joints (courtesy MEC Environmental Ltd)

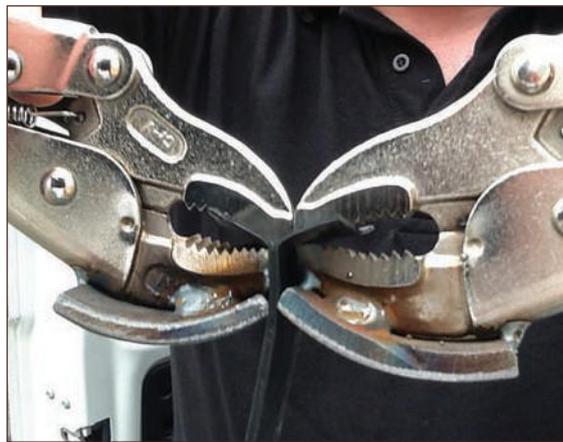
Figure A4.46 Testing a weld with 'dog bone' grips (courtesy MEC Environmental Ltd)

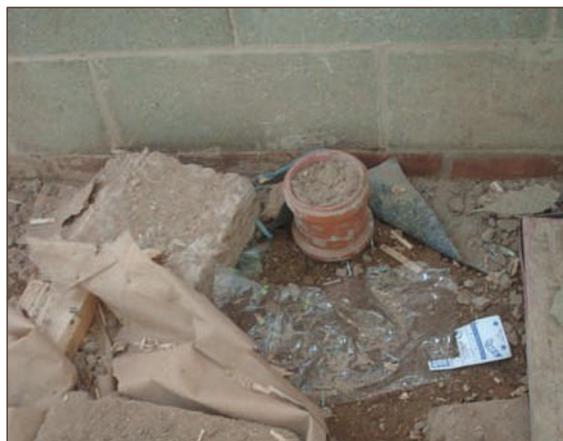
Figure A4.48 Loose nails and over construction debris likely to be left in place beneath gas membrane – poor preparation of gas membrane prior to sealing service penetration (courtesy Card Geotechnics Limited)

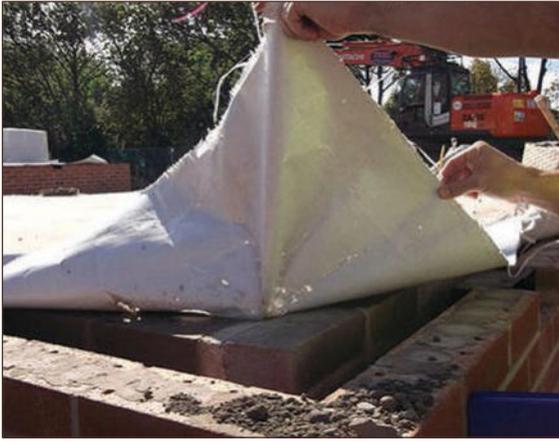
Figure A4.49 *Lifted gas membrane at corner position. Light penetrating through confirms damage to aluminium internal core layer (courtesy NHBC)*

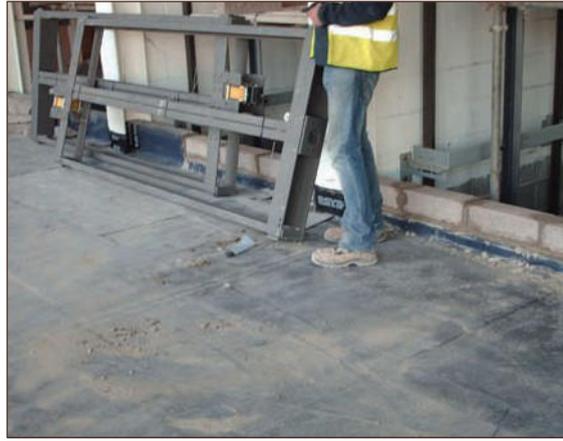
Figure A4.50 *Large/heavy/sharp objects being moved over unprotected gas membrane (courtesy Card Geotechnics Limited)*

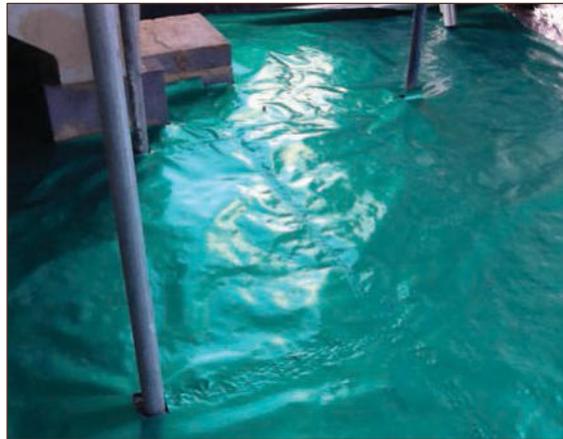
Figure A4.52 *Gas membrane cut by scaffolders and bricklayers after installation (courtesy MEC Environmental Ltd)*

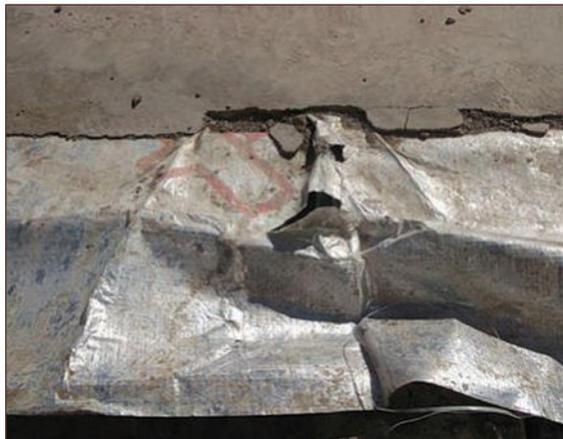
Figure A4.54 *Gas membrane damage/tearing at edge of ground floor slab screed layer where it was left exposed to elements for period of time (courtesy NHBC)*

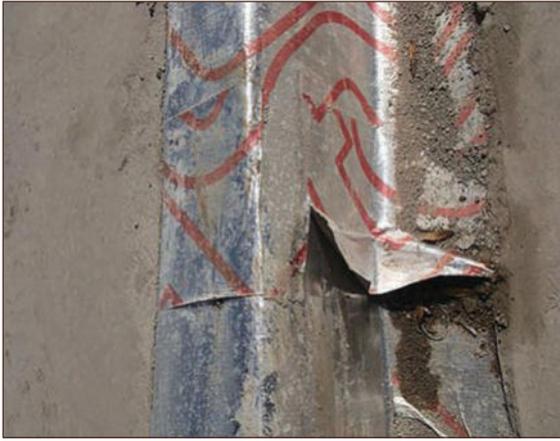
Figure A4.55 Gas membrane at stepped junction of slab to integral garage, appears to be susceptible to tearing when screed is poured. Screed may also weigh down on gas membrane if fitted too tight (courtesy NHBC)

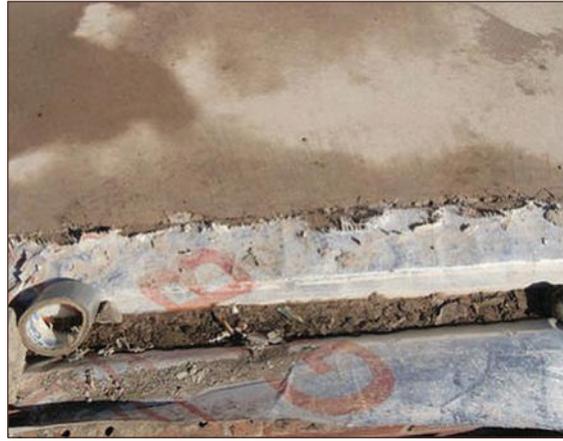
Figure A4.56 Gas membrane at edge of concrete screed. Screed has been grinded to achieve desired levels, gas membrane shows extreme wear and damage as a result (courtesy NHBC)

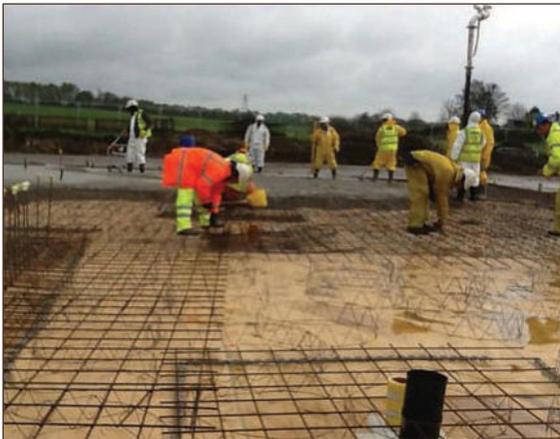
Figure A4.57 Unprotected gas membrane damaged by heavy traffic (courtesy MEC Environmental Ltd)

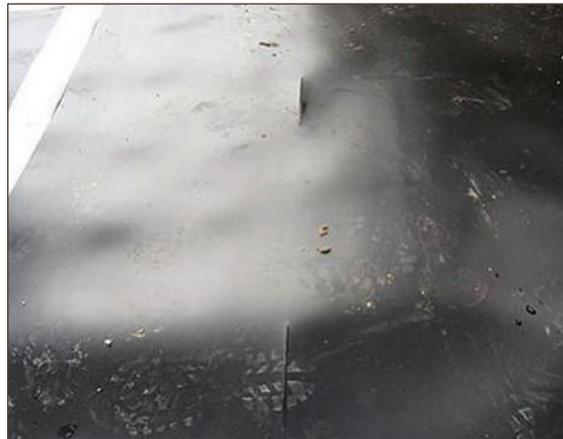
Figure A4.58 Damage caused to gas membrane by follow-on trade who cut/shaped the dry lining board directly on the unprotected installed gas membrane (courtesy NHBC)

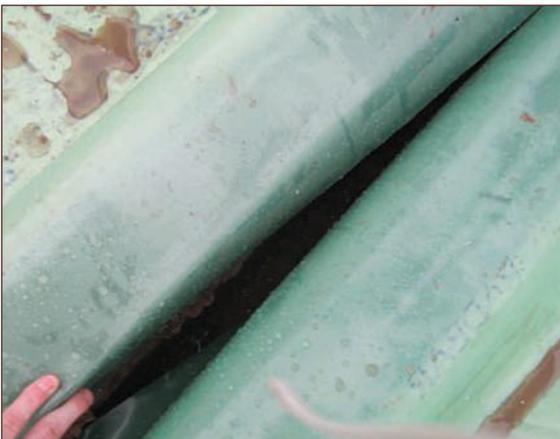
Figure A4.59 Gas membrane slit at the bottom of a cavity tray to enable water to drain away (courtesy Smith Grant)

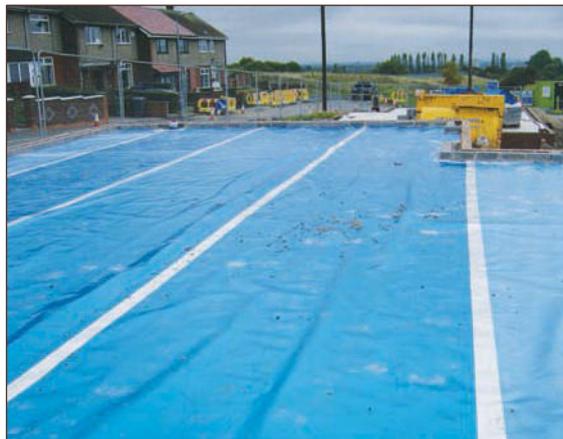
Figure A4.60 Some stones could penetrate gas membrane if sufficient force is applied (courtesy Smith Grant)

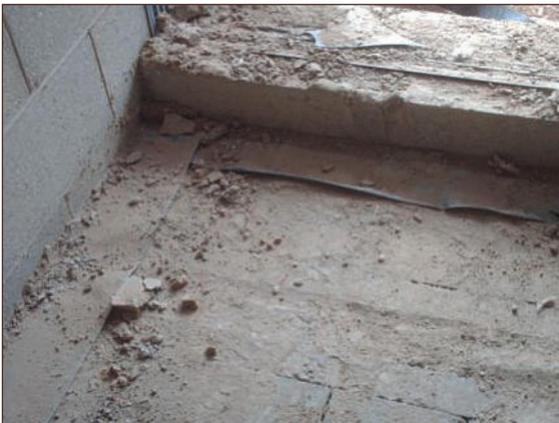
Figure A4.63 Absence of surface preparation prior to laying of gas membrane, debris likely to pierce gas membrane (courtesy Card Geotechnics Limited)

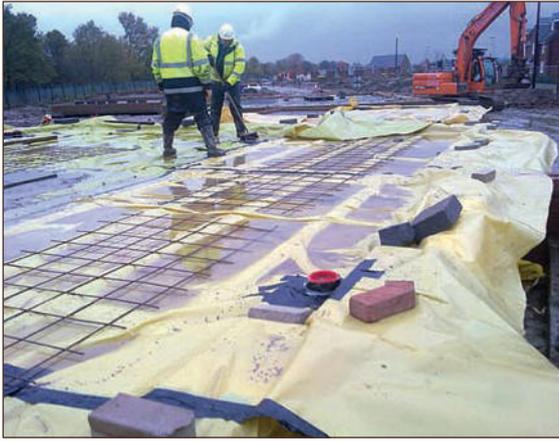
Figure A4.67 Traffic over mesh resulted in several punctures, in addition most joints were found to be poorly constructed. Taped joints are difficult to construct in adverse weather (courtesy Smith Grant)

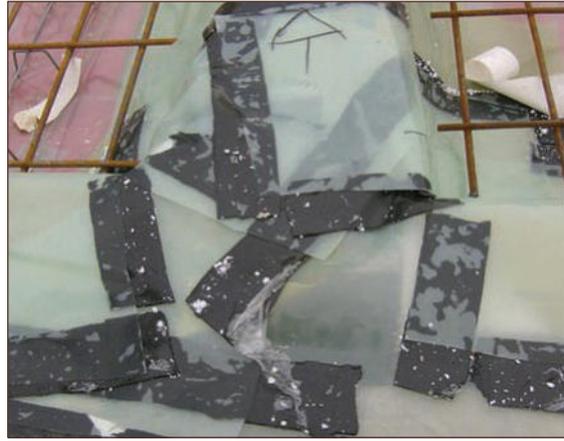
Figure A4.68 A pre-formed corner unit would have been preferable. The installer could not produce sufficient quality despite the amount of tape applied (courtesy Smith Grant)

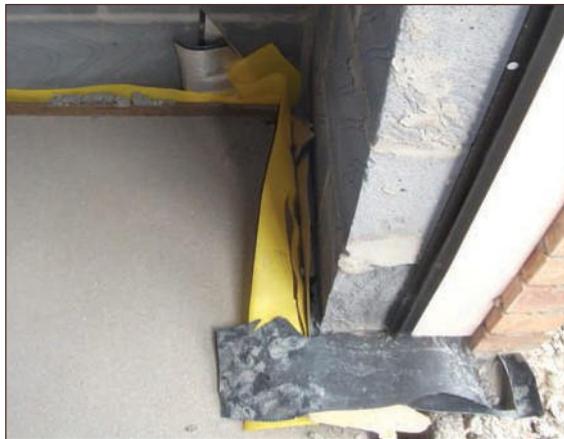
Figure A4.70 Inadequate corner detailing. The use of preformed proprietary products would have avoided such bad practice (courtesy NHBC)

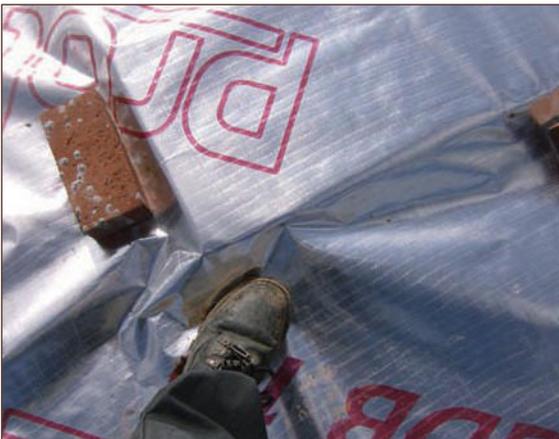
Figure A4.71 No corner detailing leading to stress point on gas membrane (courtesy Smith Grant)

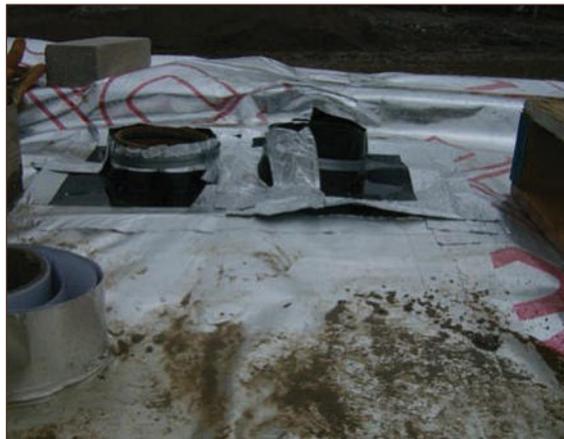
Figure A4.72 Joint between top hat and gas membrane has lifted due to poor fit and attempt to construct in very wet conditions (courtesy Smith Grant)

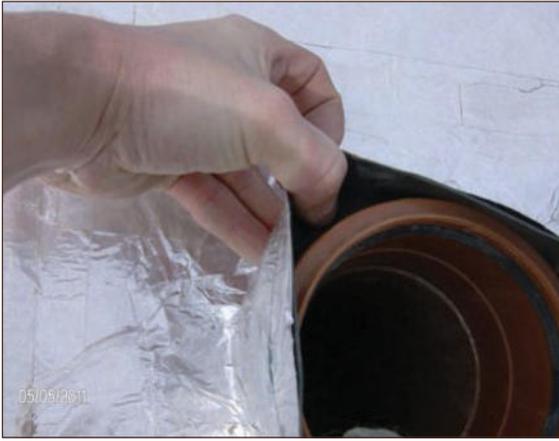
Figure A4.73 No bead of double sided butyl tape provided between interfaces of ID top hat and OD service pipe: cannot be compressed enough to form seal (courtesy Smith Grant)

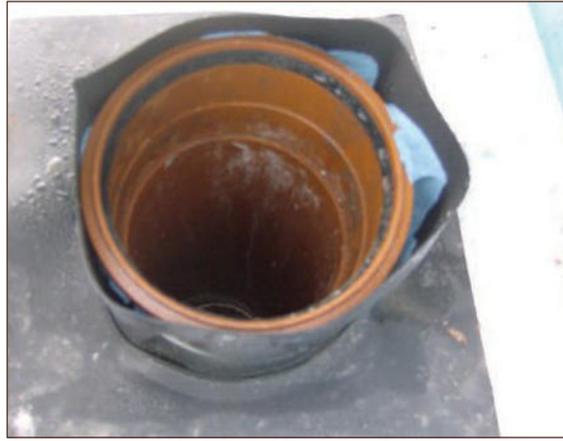
Figure A4.74 Gap between OD of service pipe and ID of top hat too large: cannot be compressed enough to form seal, even with the application of additional tape (courtesy Smith Grant)

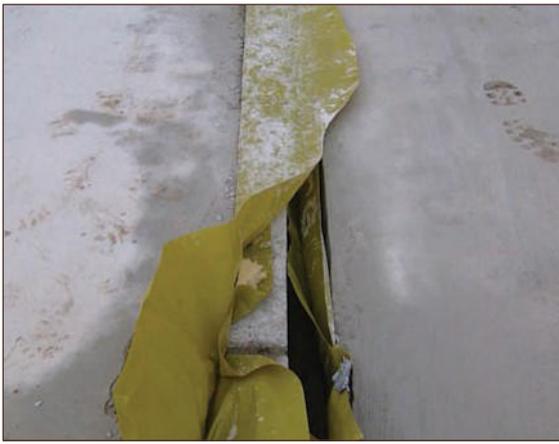
Figure A4.79 Gas membrane not continuous over internal wall. It had been deliberately cut open for unknown purpose (courtesy Smith Grant)

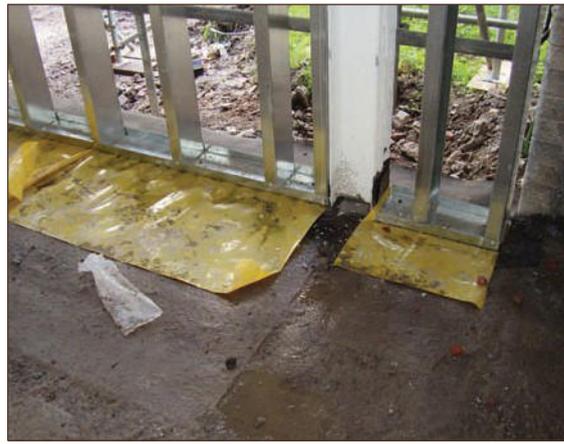
Figure A4.80 Column left unsealed (courtesy PAGEotechnical Ltd)

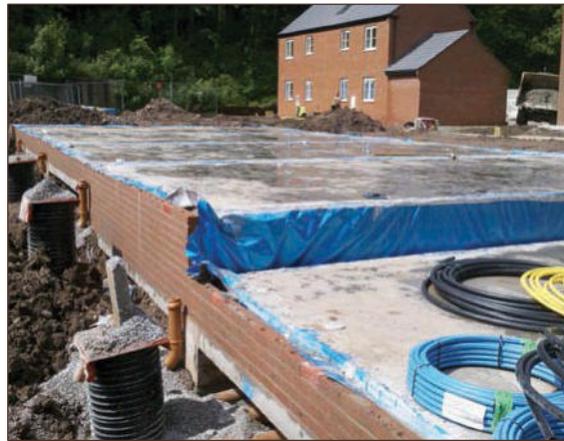
Figure A4.82 Gas membrane used to bridge cavity wall instead of DPC, leaving it exposed to damage by follow-on trades (courtesy Smith Grant)

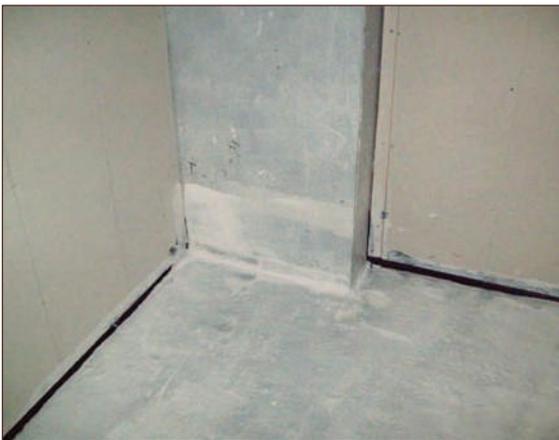
Figure A4.83 Poor quality installation of liquid gas membrane. Liquid gas membranes come in two colours (black and white) allowing coverage of each coat to be easily assessed. Here the gas membrane has been spread too thinly and inconsistently. In addition, it appears to have been applied to a damp surface, causing blistering (courtesy Card Geotechnics Limited)

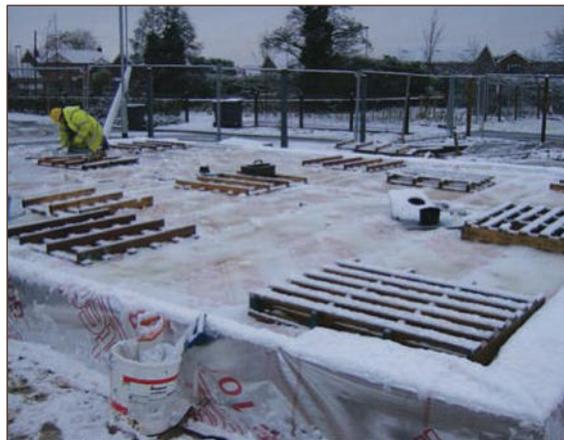
Figure A4.84 Taped joints are difficult to construct in adverse weather. Also difficult to inspect if covered with snow (courtesy Smith Grant)
