Ground Appraisal Report

Main Avenue, Kirklees

Client:	Strata Homes and Thirteen Group
Document Type:	Report
Document No.:	1152-GEO-GAR-001
Revision:	002
Date:	2025/03/18

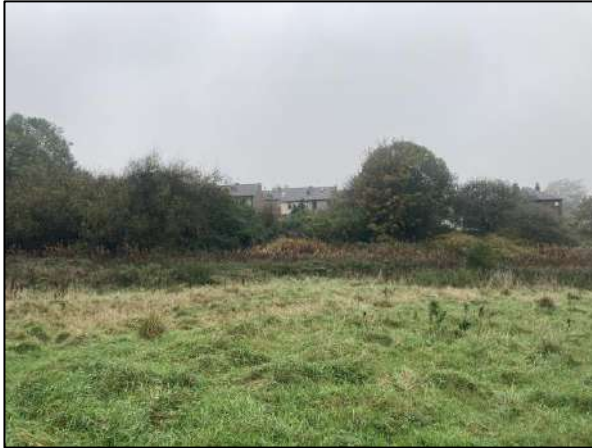
Photo 3 – Heavily vegetated area in the northeastern corner.

The northeastern corner of the site is heavily vegetated with shrubs, bushes, and some trees reaching heights of up to c.10m. Throughout the rest of the site, particularly bordering the school playing fields and the steeper slope to the south, there are sporadically located trees and bushes including mature trees up to c. 15m in height.

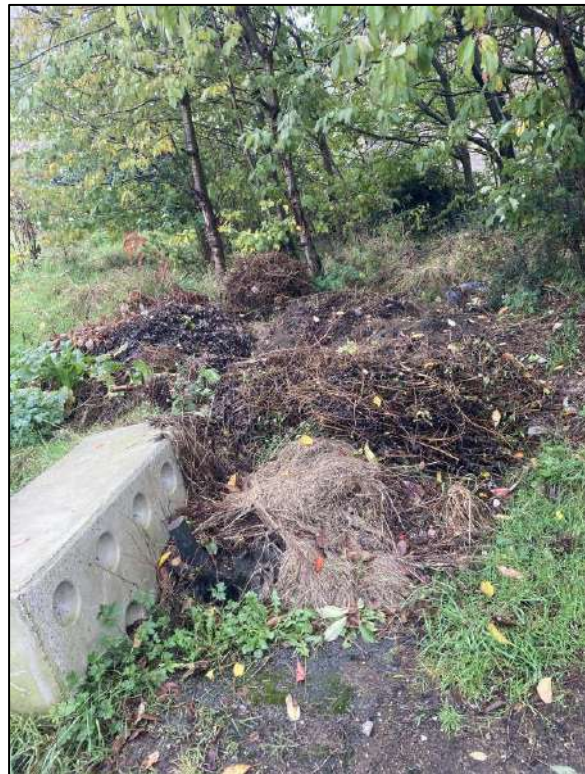
Photo 6 – Fly-tipped rubbish near the entrance of Main Avenue.

The site is used frequently by dog walkers and local residents for recreation. Small areas of fly-tipping were noted along with evidence of bonfires.
