# Remediation Strategy

Main Avenue, Kirklees

| Document No.: | 1152-ACE-GEO-RS-003 |

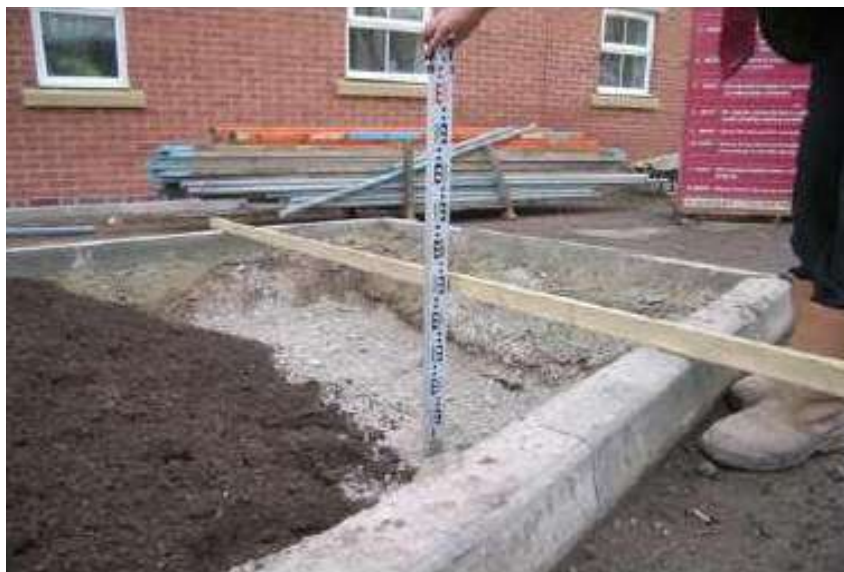
Photograph 1:  
Depth check of inert  
cover within area of  
public open space.  
Physical break layer  
and topsoil visible.

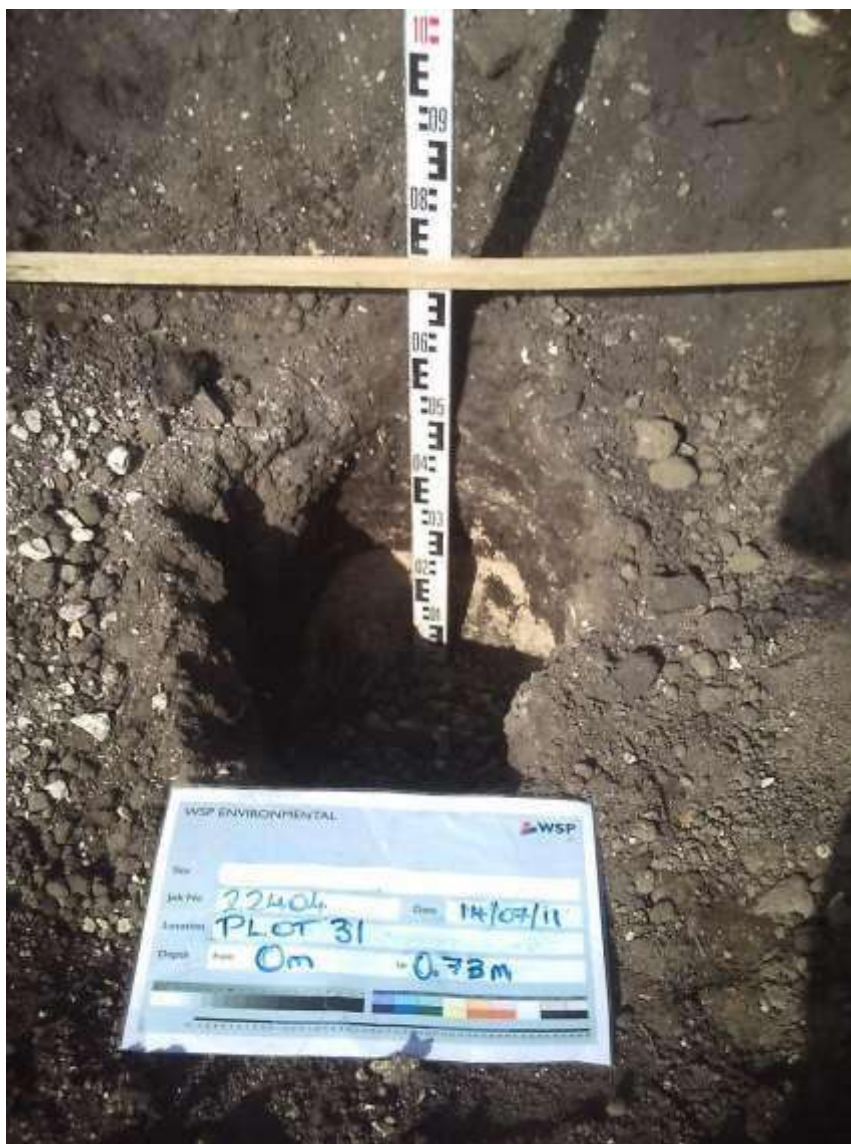
Photograph 2:  
Depth check of inert  
cover with Site &  
Location Information  
Board.

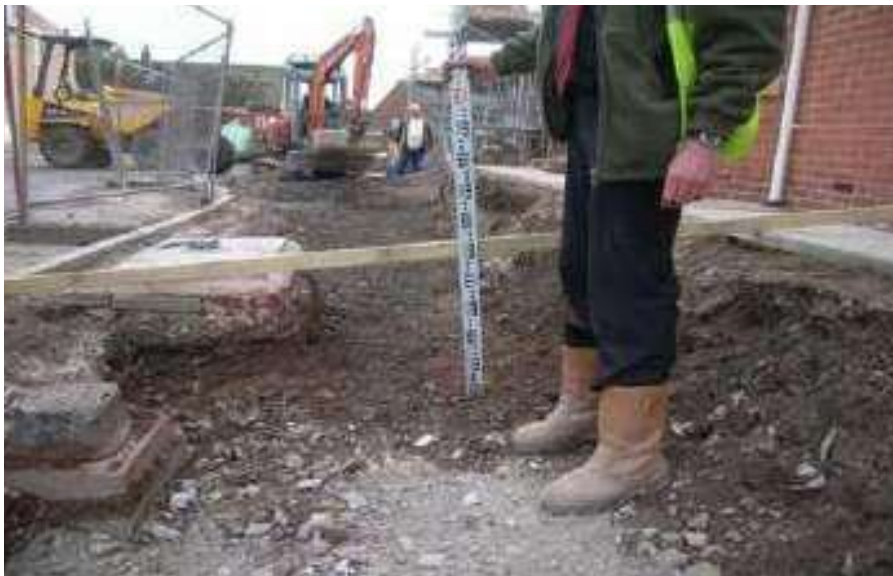
Photograph 3:  
Depth check of inert  
cover within areas of  
front gardens.

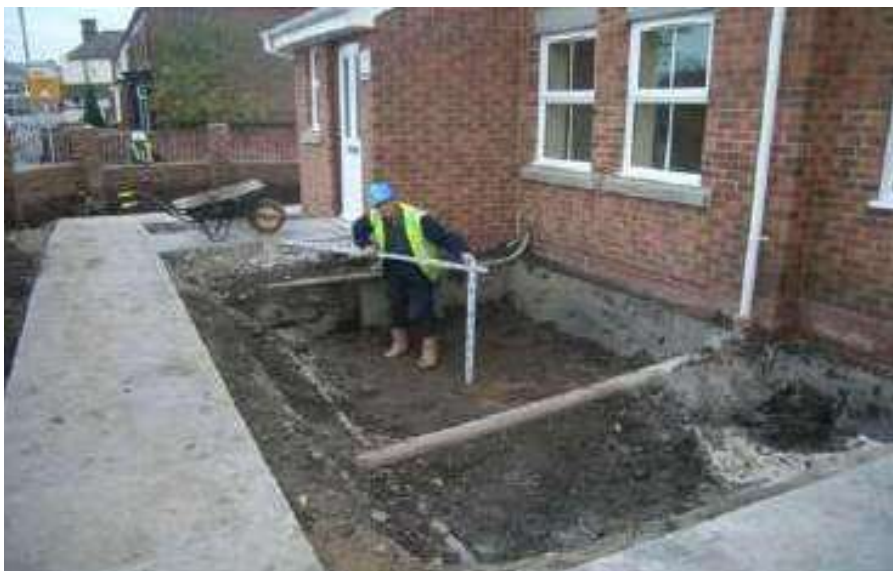
Photograph 4:  
Depth check of inert  
cover within areas of  
front gardens.

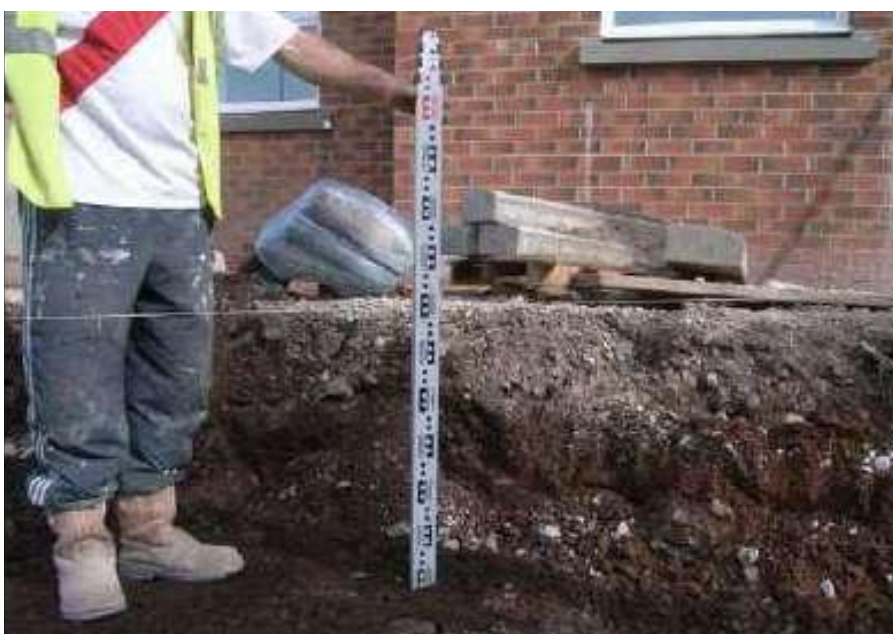
Photograph 5:  
Depth check of inert  
cover within rear  
gardens. Taut string  
line spans across  
excavation.

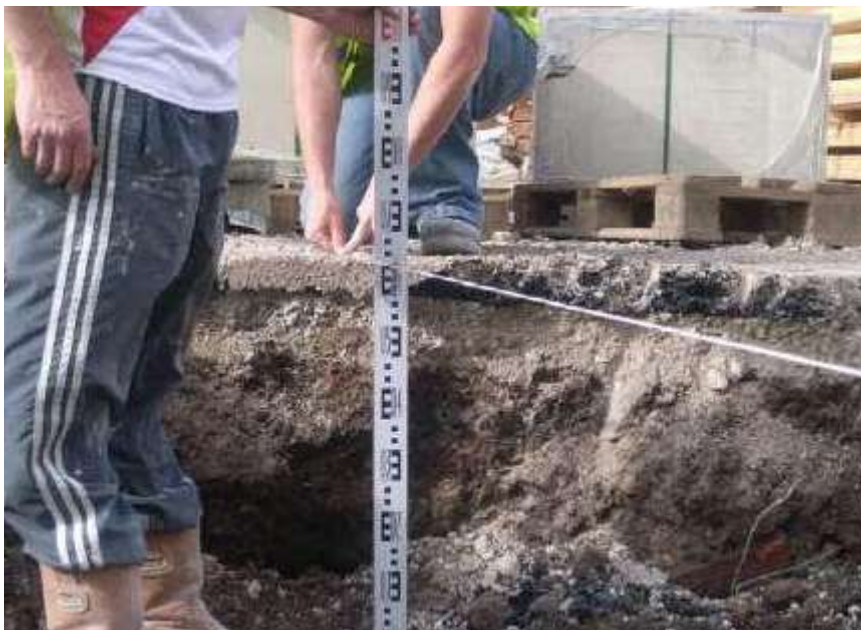
Photograph 6:  
Depth check of inert  
cover within rear  
gardens. Taut string  
line spans across  
excavation.

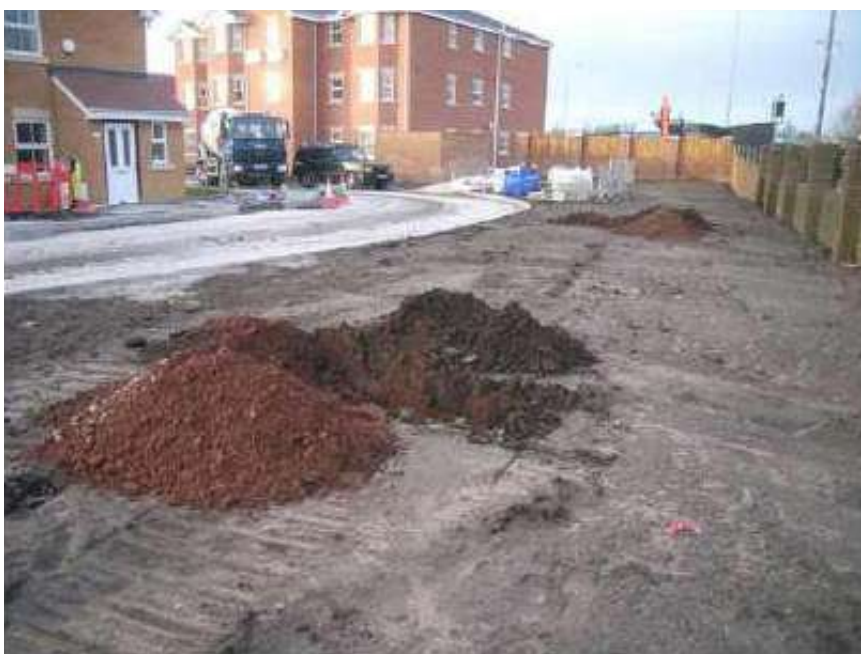
Photograph 7:  
Shows the spatial  
location of the  
verification pit.

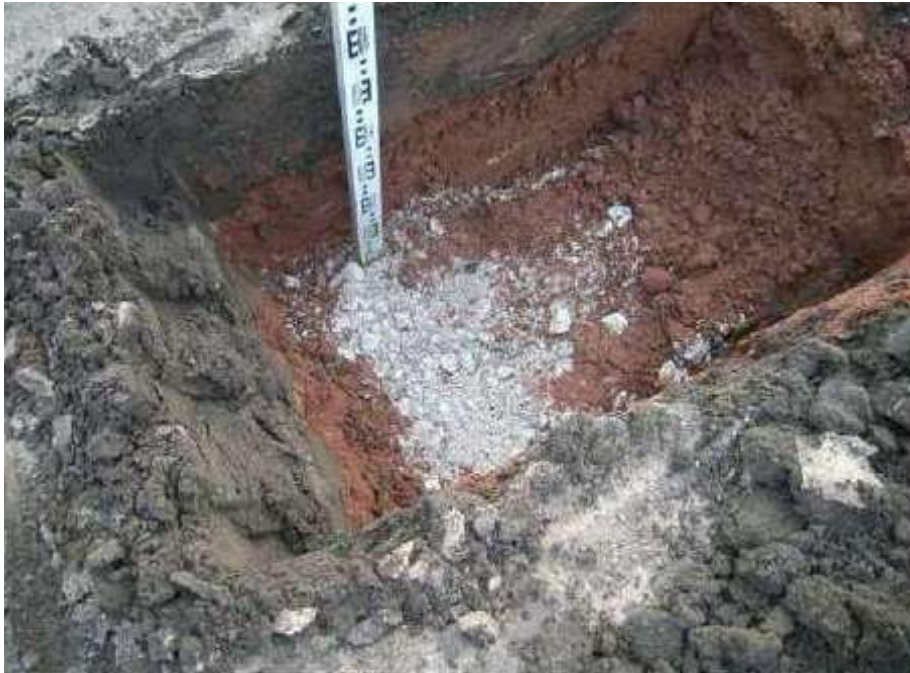
Photograph 8:  
Excavation within  
public open space  
and verification pit  
showing the presence  
of a remediation  
break layer at the  
base, a crushed  
sandstone inert fill  
overlain by topsoil.

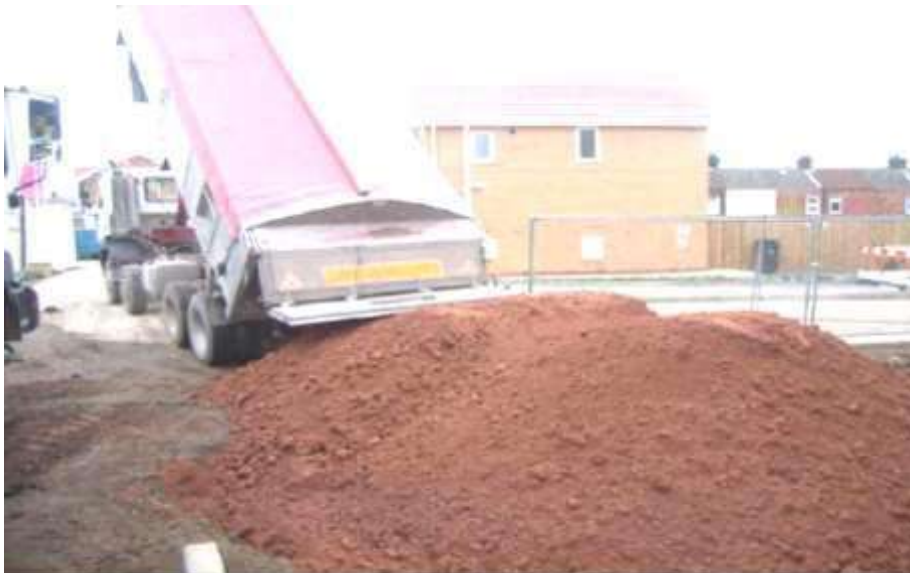
Photograph 9:  
Inert crushed  
sandstone being  
delivered. The spatial  
area of the  
remediation can be  
observed from these  
photographs (old  
terrace housing).

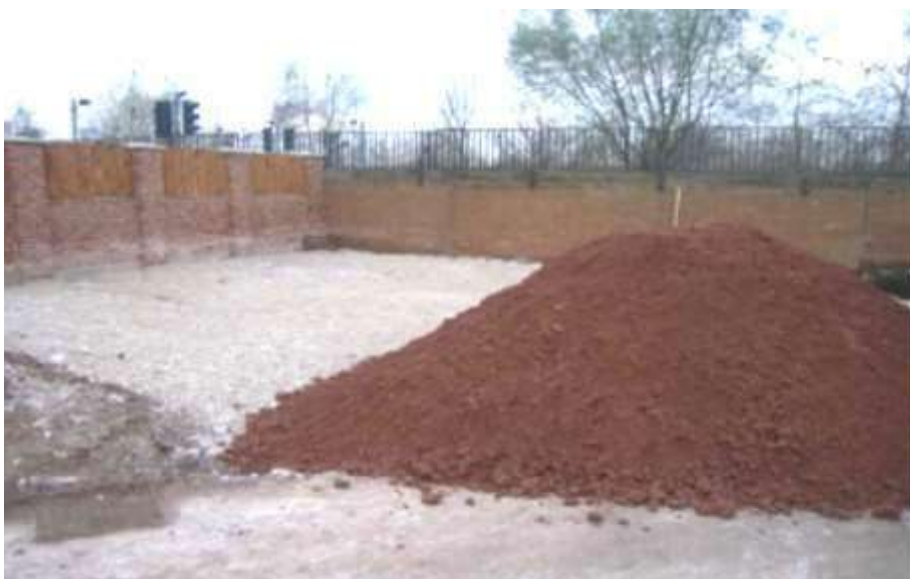
Photograph 10: Inert  
crushed sandstone  
being delivered with  
visible remediation  
break layer. The  
spatial area of the  
remediation can be  
observed from these  
photographs (traffic  
lights).

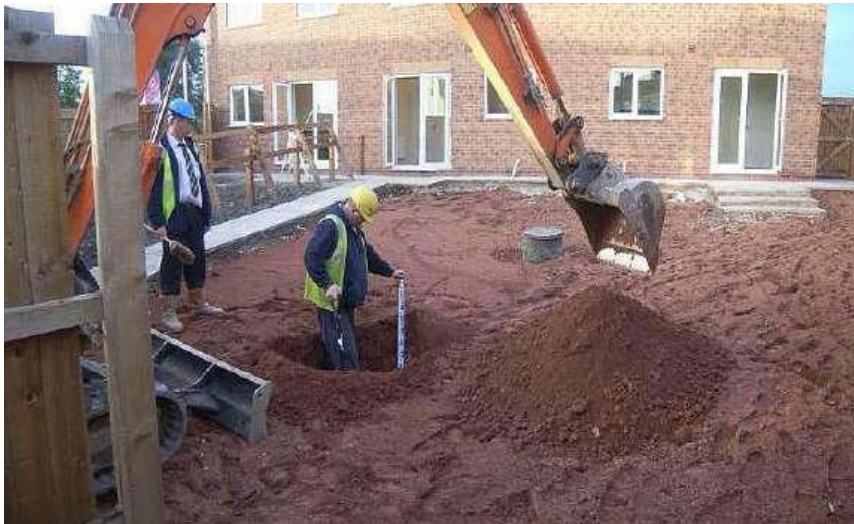
Photograph 11:  
Shows the  
remediation of the  
rear garden, with a  
significant depth  
(1.0m) of inert cover.  
This photograph has  
been stitched to form  
a panoramic  
photograph and  
hence there is slight  
distortion

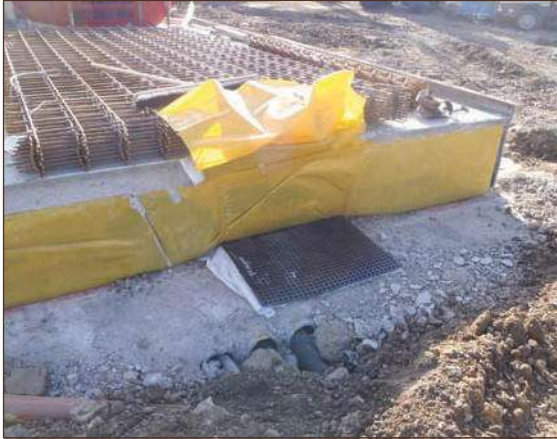
**Figure A4.7** Geovent protruding out of the frontage of the unit. Gas membrane along the sides of the slab preventing lateral gas ingress (courtesy Alderburgh Group)

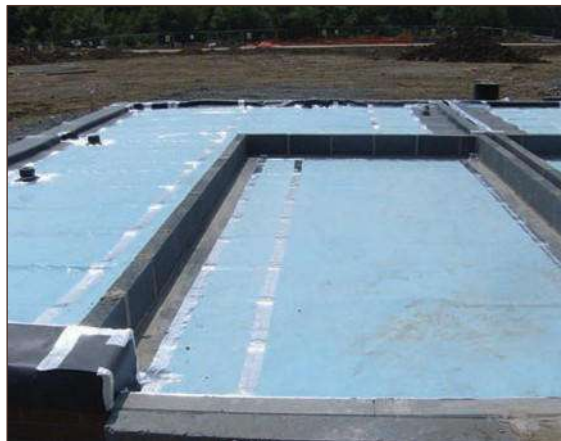
**Figure A4.10** Almost complete coverage available for inspection, minimal jointing, service entries suitable distance from walls, light traffic (courtesy Smith Grant)

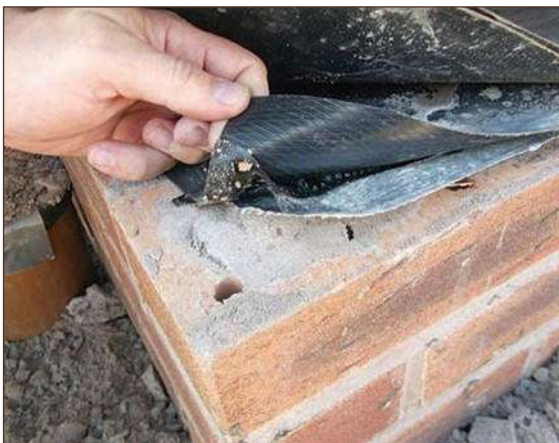
**Figure A4.13** Gas proof DPC adhered on top of gas membrane using butyl strips across cavity space (courtesy NHBC)

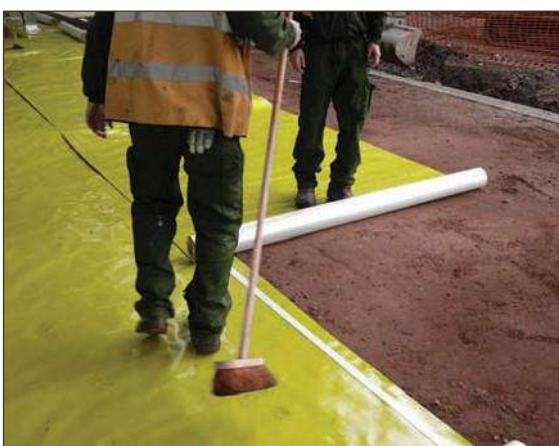
**Figure A4.15** LDPE type gas membrane overlap and double sided tape. Sand blinding to protect underside of gas membrane (courtesy A Proctor Group)

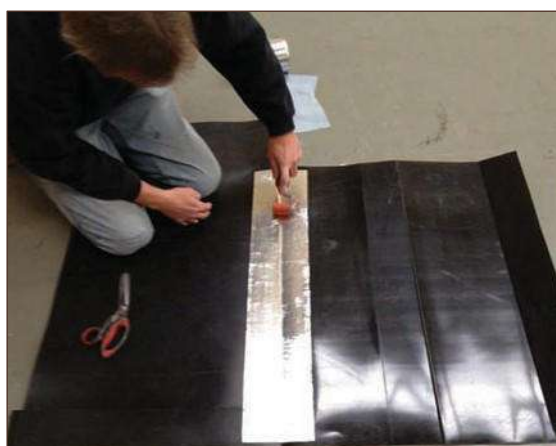
**Figure A4.16** Example HDPE type gas membrane and steam roller used to ensure self-adhesive tape is correctly installed (courtesy A Proctor Group)

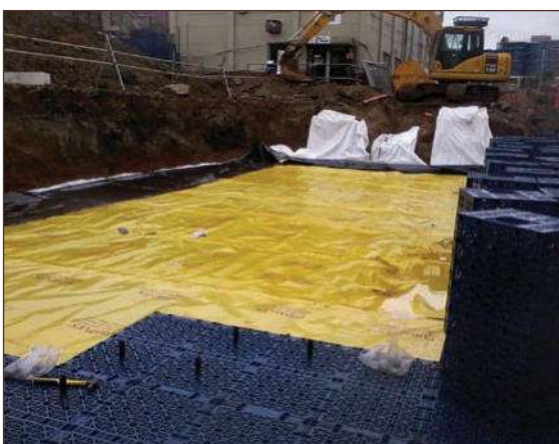
**Figure A4.17** Gas membrane installed in attenuation tank (courtesy Industrial Textiles & Plastics Ltd)

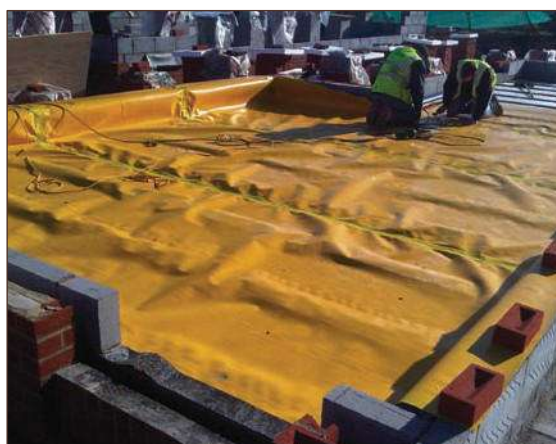
**Figure A4.18** Gas membrane installed as part of foundation barrier (courtesy Industrial Textiles & Plastics Ltd)

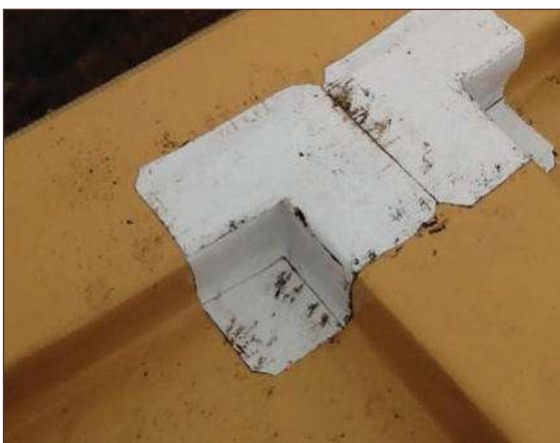
**Figure A4.21** Good prefabricated corner detail (courtesy MEC Environmental Ltd)

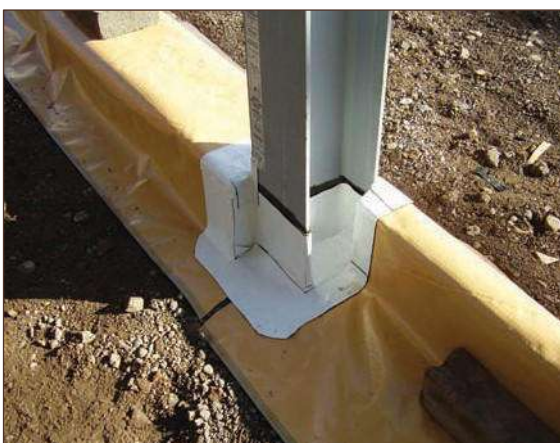
**Figure A4.23** Complex column seal (courtesy PAGeotechnical Ltd)

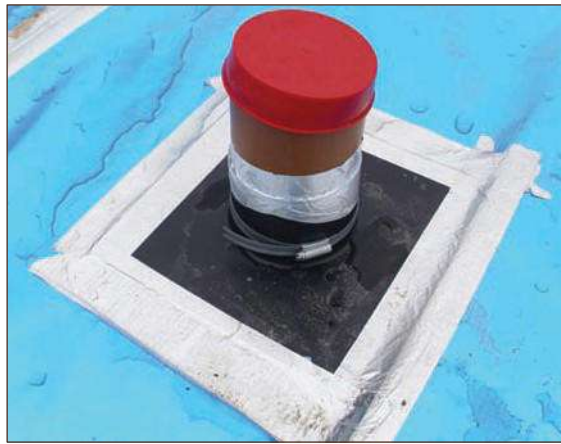
**Figure A4.26** Well-constructed service entry: top hat fits well with service pipe and taped down to gas membrane, secondary seal with proprietary single sided tape (courtesy Smith Grant)

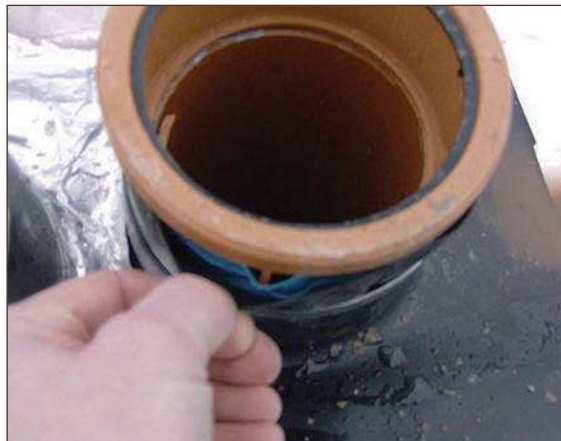
**Figure A4.28** Bead of double sided butyl tape provided between interfaces of ID top hat and OD service pipe. When compressed with jubilee clip, forms an effective seal (courtesy Smith Grant)

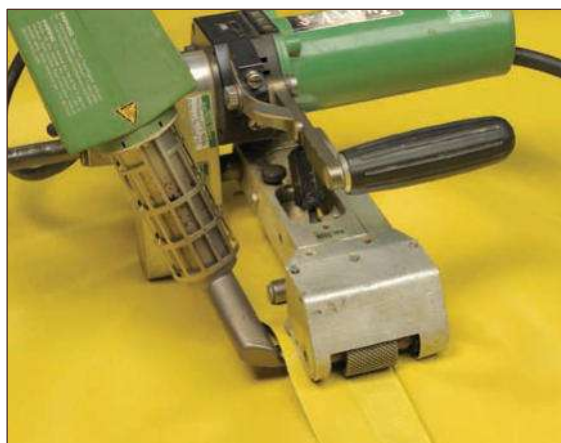
**Figure A4.30** Thermal welding technique (courtesy Industrial Textiles & Plastics Ltd)

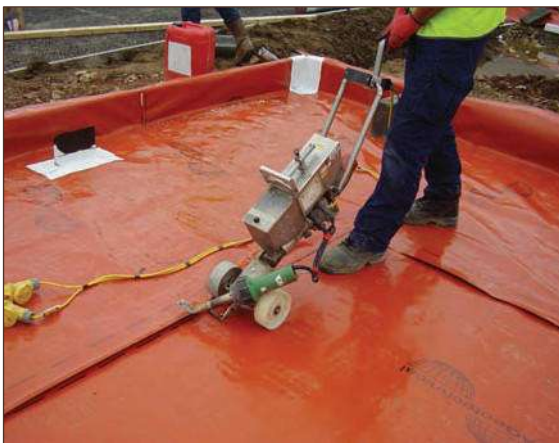
**Figure A4.31** Extrusion welding (courtesy PAGeotechnical Ltd)

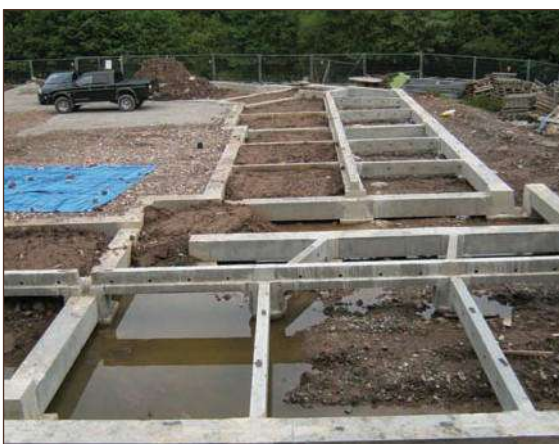
**Figure A4.33** Good ventilation in internal sleeper walls, cast into prefabricated beams (courtesy Smith Grant)

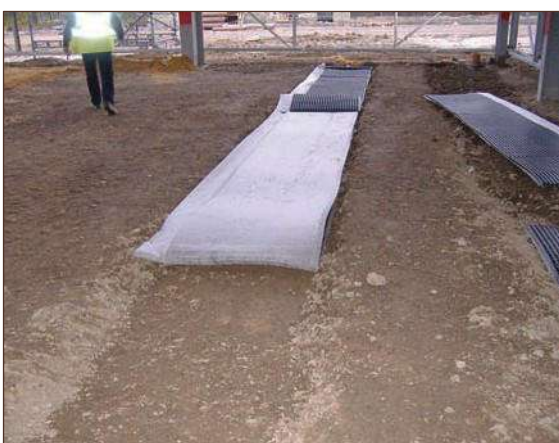
**Figure A4.35** Good installation of passive gas venting trenches and 'egg-crate' (courtesy Card Geotechnics Limited)

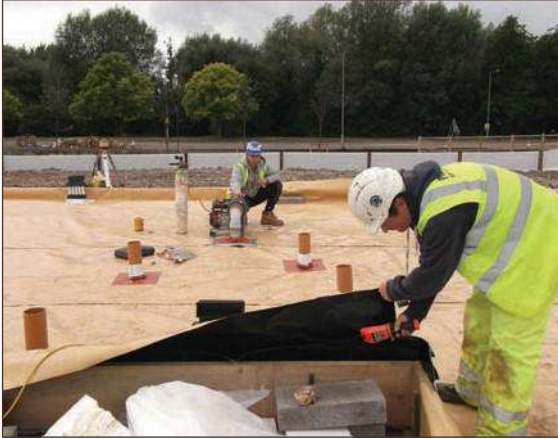
**Figure A4.37** Tracer gas testing, whereby gas or smoke is applied under pressure beneath the installed gas membrane and detectors are used to screen for leaks above (courtesy NHBC)

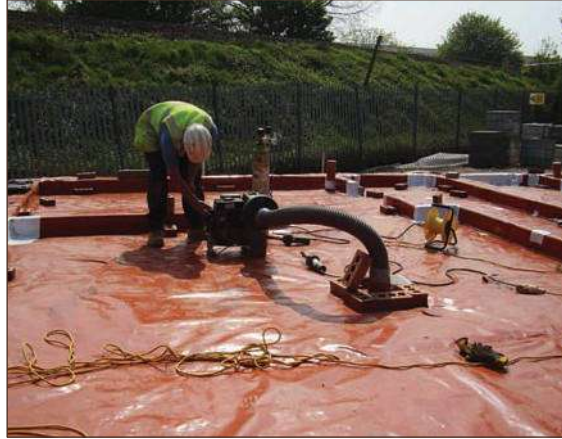
**Figure A4.38** Tracer gas testing (courtesy PAGEotechnical Ltd)

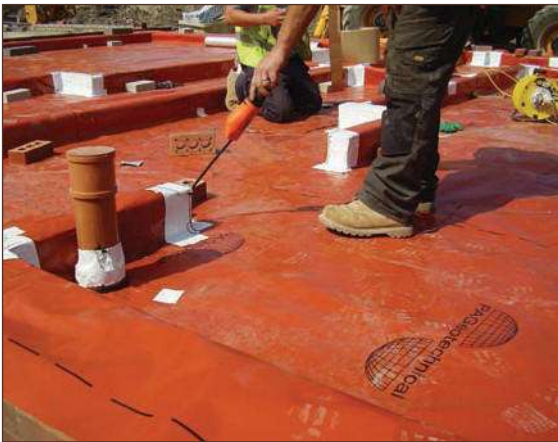
**Figure A4.39** Scanning for leaks (courtesy PAGEotechnical Ltd)

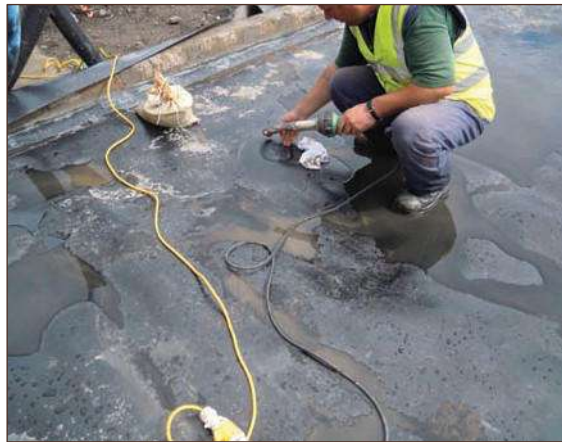
**Figure A4.40** CO<sub>2</sub> injection integrity testing (courtesy Landline Ltd)

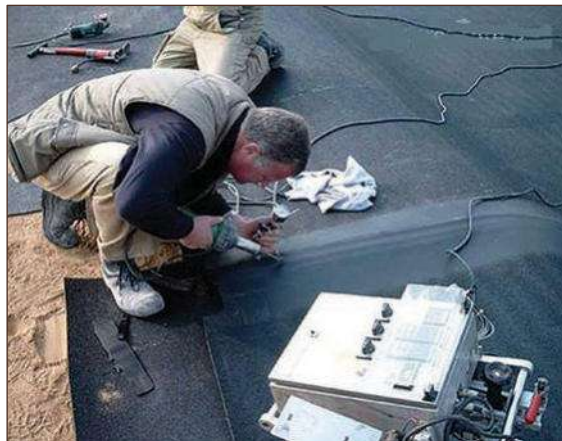
**Figure A4.42** Air pressure testing (courtesy GSE Environmental)

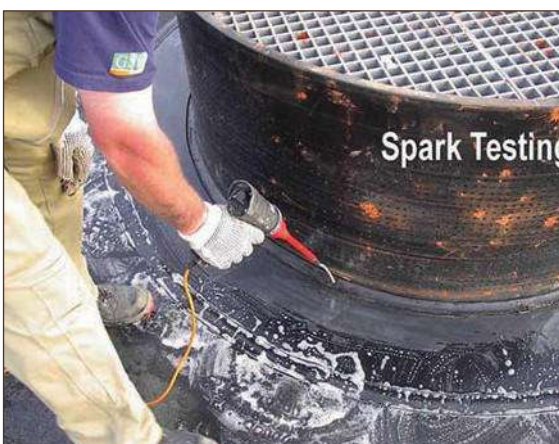
**Figure A4.45** Spark testing (courtesy GSE Environmental)

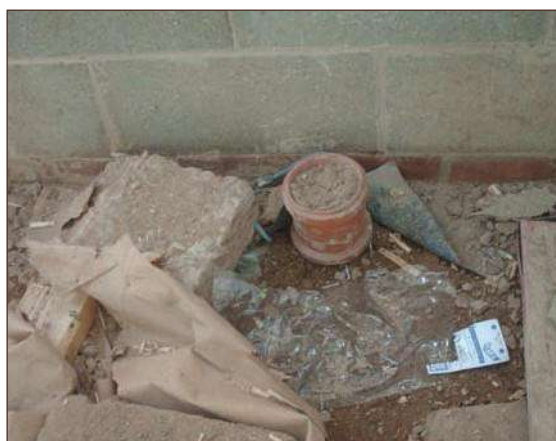
**Figure A4.48** Loose nails and over construction debris likely to be left in place beneath gas membrane – poor preparation of gas membrane prior to sealing service penetration (courtesy Card Geotechnics Limited)

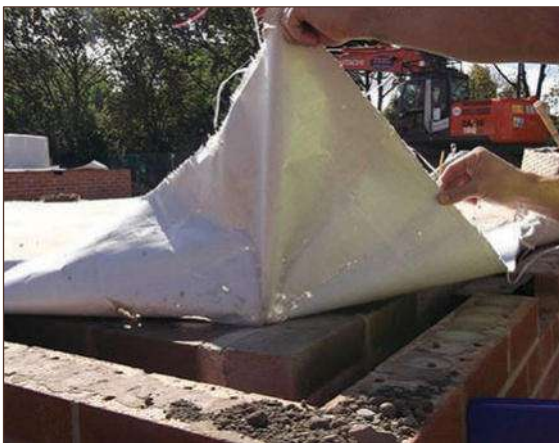
**Figure A4.49** *Lifted gas membrane at corner position. Light penetrating through confirms damage to aluminium internal core layer (courtesy NHBC)*

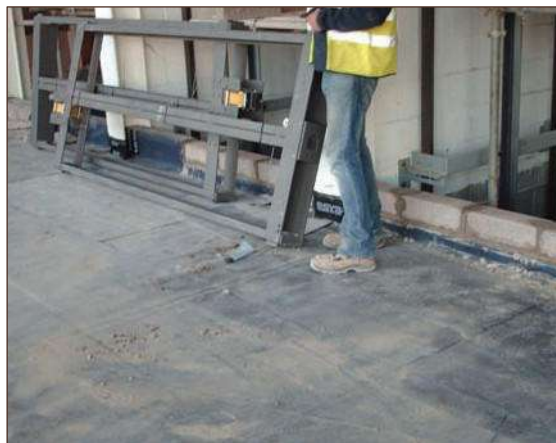
**Figure A4.50** *Large/heavy/sharp objects being moved over unprotected gas membrane (courtesy Card Geotechnics Limited)*

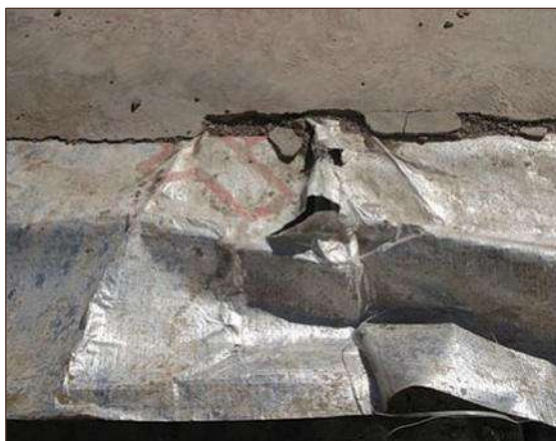
**Figure A4.54** *Gas membrane damage/tearing at edge of ground floor slab screed layer where it was left exposed to elements for period of time (courtesy NHBC)*

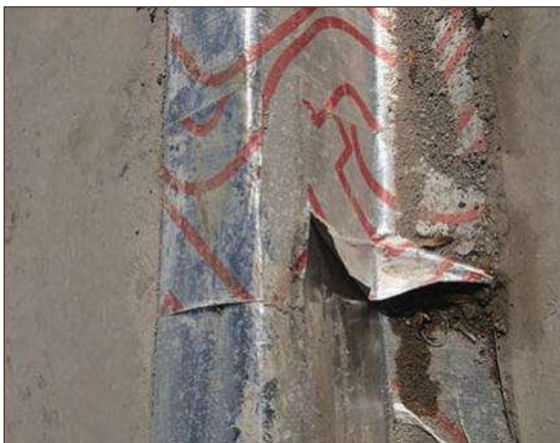
**Figure A4.55** Gas membrane at stepped junction of slab to integral garage, appears to be susceptible to tearing when screed is poured. Screed may also weigh down on gas membrane if fitted too tight (courtesy NHBC)

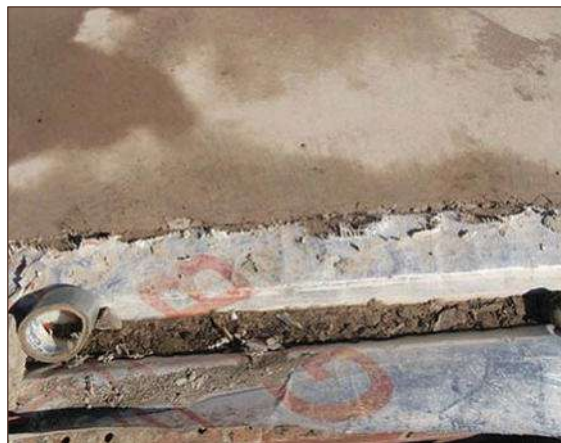
**Figure A4.56** Gas membrane at edge of concrete screed. Screed has been grinded to achieve desired levels, gas membrane shows extreme wear and damage as a result (courtesy NHBC)

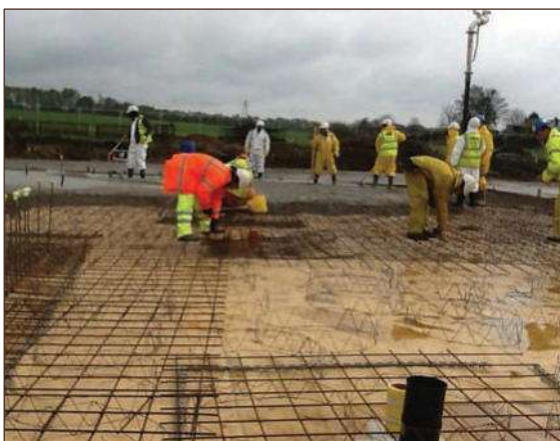
**Figure A4.57** Unprotected gas membrane damaged by heavy traffic (courtesy MEC Environmental Ltd)

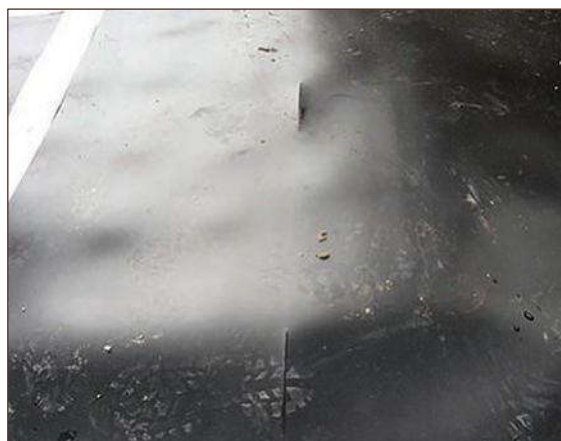
**Figure A4.58** Damage caused to gas membrane by follow-on trade who cut/shaped the dry lining board directly on the unprotected installed gas membrane (courtesy NHBC)

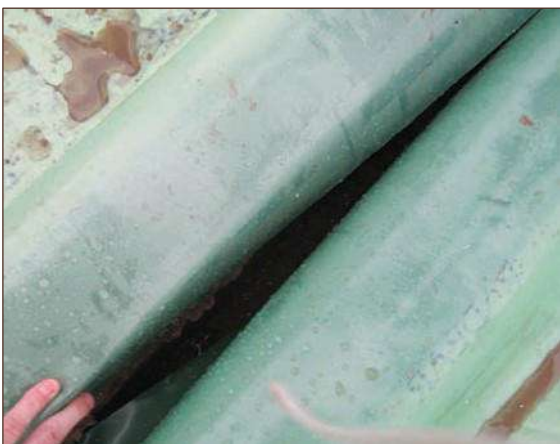
**Figure A4.59** Gas membrane slit at the bottom of a cavity tray to enable water to drain away (courtesy Smith Grant)

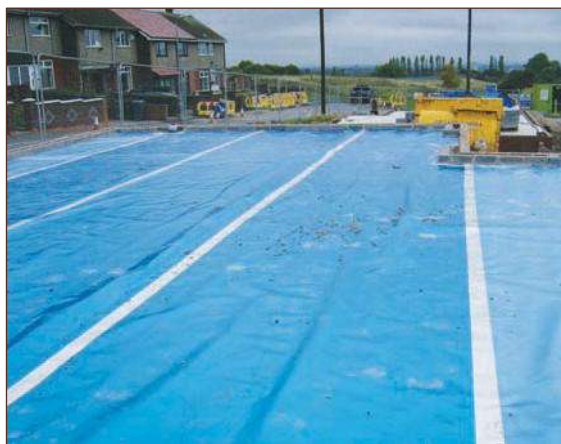
**Figure A4.60** Some stones could penetrate gas membrane if sufficient force is applied (courtesy Smith Grant)

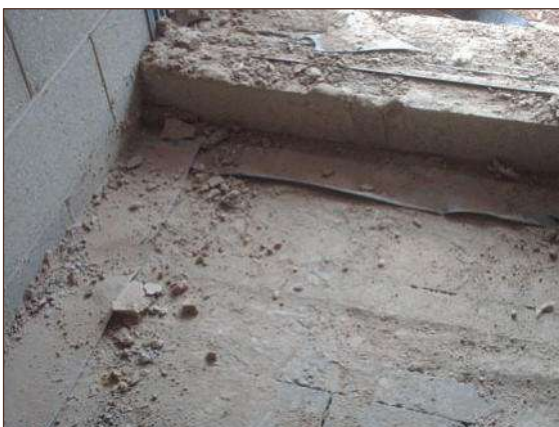
**Figure A4.63** Absence of surface preparation prior to laying of gas membrane, debris likely to pierce gas membrane (courtesy Card Geotechnics Limited)

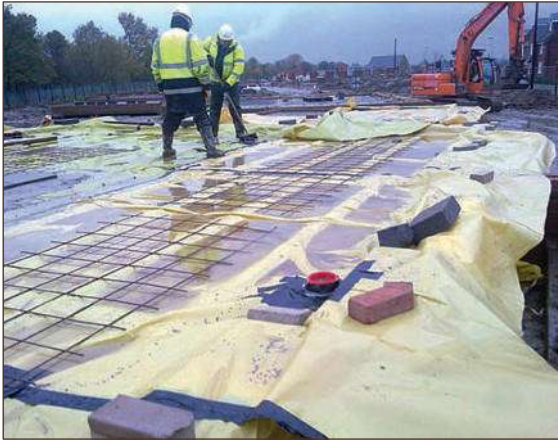
**Figure A4.67** Traffic over mesh resulted in several punctures, in addition most joints were found to be poorly constructed. Taped joints are difficult to construct in adverse weather (courtesy Smith Grant)

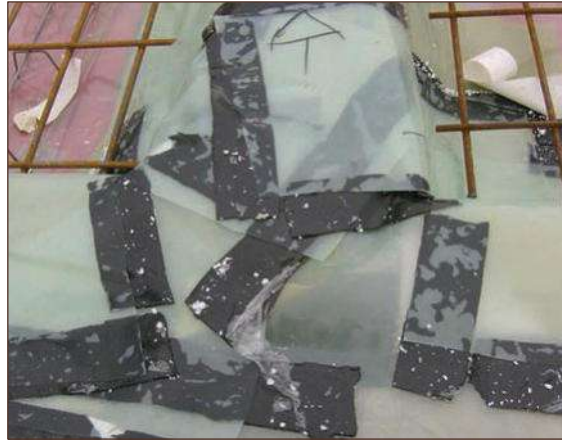
**Figure A4.68** A pre-formed corner unit would have been preferable. The installer could not produce sufficient quality despite the amount of tape applied (courtesy Smith Grant)

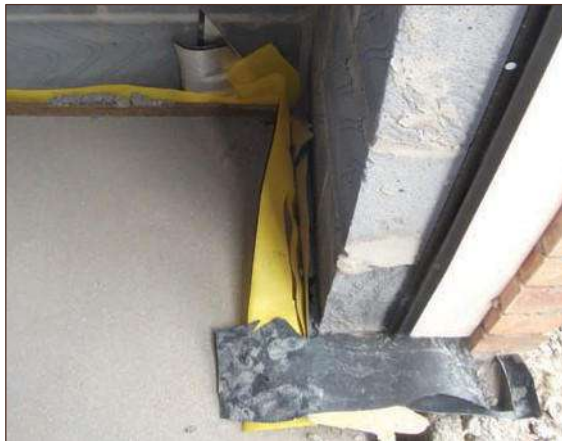
**Figure A4.70** Inadequate corner detailing. The use of preformed proprietary products would have avoided such bad practice (courtesy NHBC)

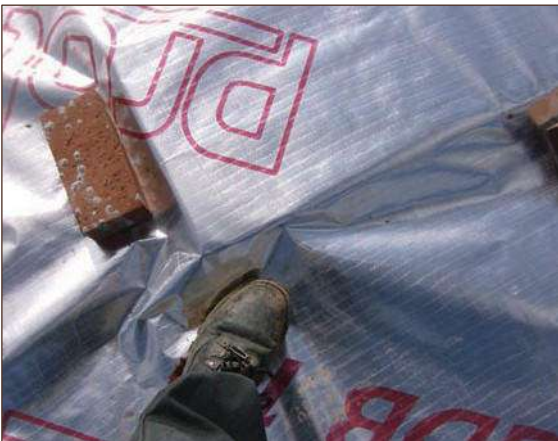
**Figure A4.71** No corner detailing leading to stress point on gas membrane (courtesy Smith Grant)

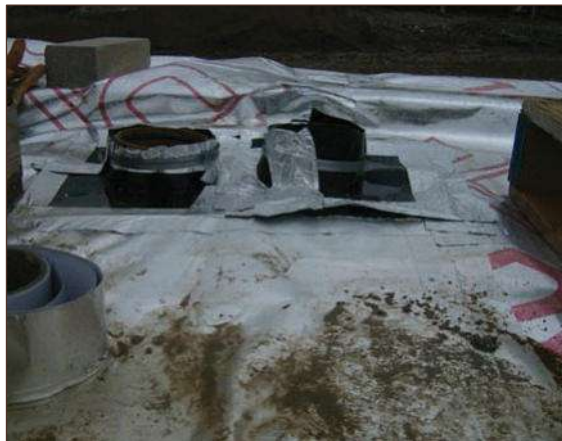
**Figure A4.72** Joint between top hat and gas membrane has lifted due to poor fit and attempt to construct in very wet conditions (courtesy Smith Grant)

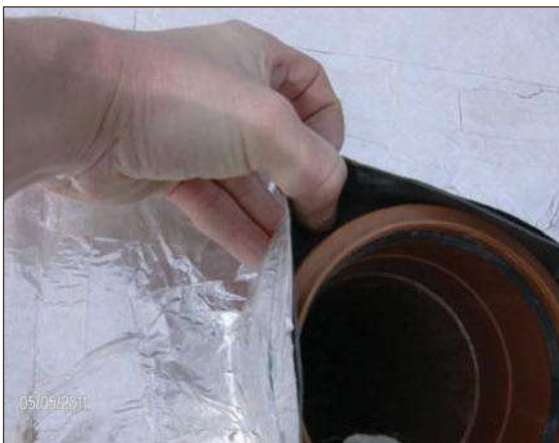
**Figure A4.73** No bead of double sided butyl tape provided between interfaces of ID top hat and OD service pipe: cannot be compressed enough to form seal (courtesy Smith Grant)

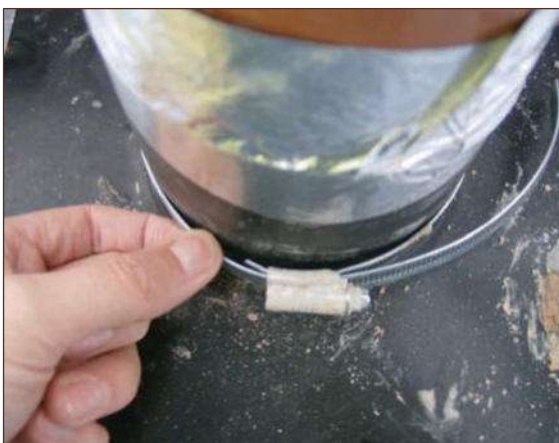
**Figure A4.75** Jubilee clip on service entry insufficiently tightened so joint is uncompressed (courtesy Smith Grant)

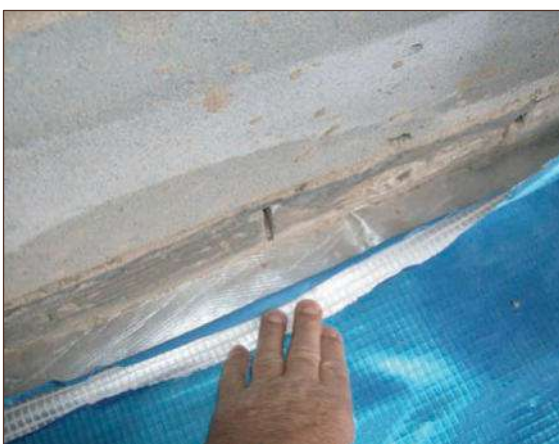
**Figure A4.77** Small lap and no single sided tape used to achieve secondary seal (courtesy Smith Grant)

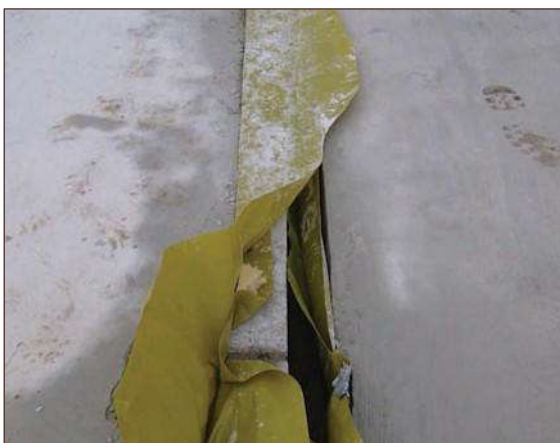
**Figure A4.79** Gas membrane not continuous over internal wall. It had been deliberately cut open for unknown purpose (courtesy Smith Grant)

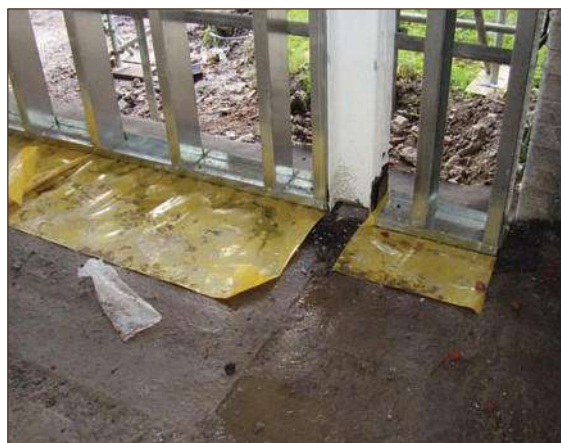
**Figure A4.80** Column left unsealed (courtesy PAGEotechnical Ltd)

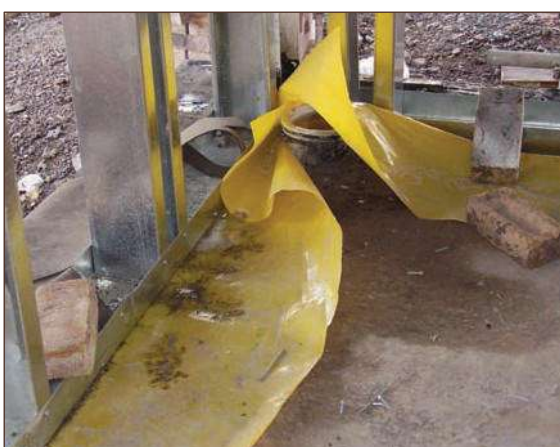
**Figure A4.81** No seal to perimeter pipe (courtesy PAGEotechnical Ltd)

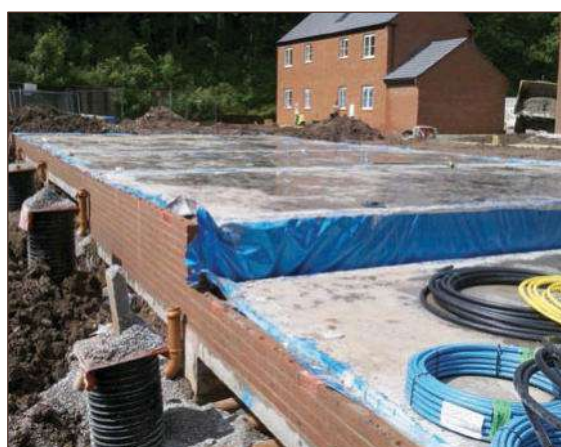
**Figure A4.82** Gas membrane used to bridge cavity wall instead of DPC, leaving it exposed to damage by follow-on trades (courtesy Smith Grant)

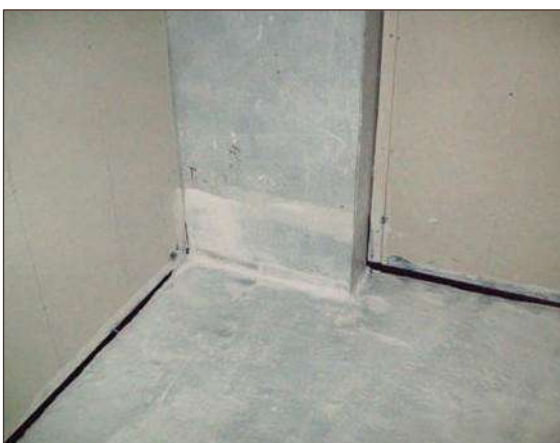
**Figure A4.83** Poor quality installation of liquid gas membrane. Liquid gas membranes come in two colours (black and white) allowing coverage of each coat to be easily assessed. Here the gas membrane has been spread too thinly and inconsistently. In addition, it appears to have been applied to a damp surface, causing blistering (courtesy Card Geotechnics Limited)

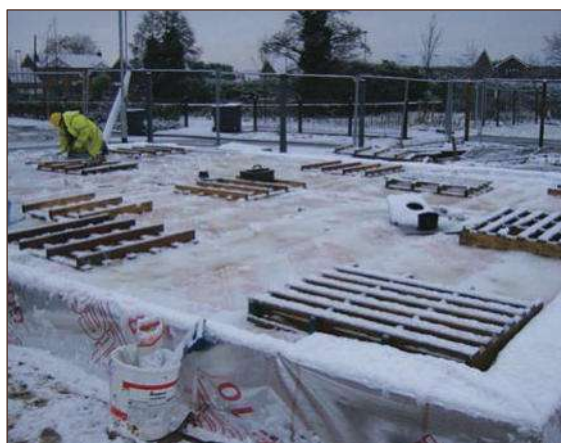
**Figure A4.84** Taped joints are difficult to construct in adverse weather. Also difficult to inspect if covered with snow (courtesy Smith Grant)

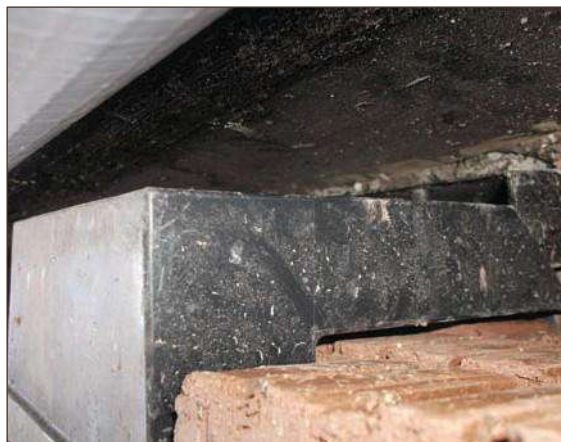
**Figure A4.88** Ventilator becoming detached to fit to external block work. This is due to builders requiring increased cavity widths to achieve thermal properties expected by Building Regulations (courtesy NHBC)
