**Strata and Thirteen Group**

**Land at Main Avenue, Cowlersley, Huddersfield**

**FLOOD RISK ASSESSMENT AND DRAINAGE STRATEGY**

September 2024

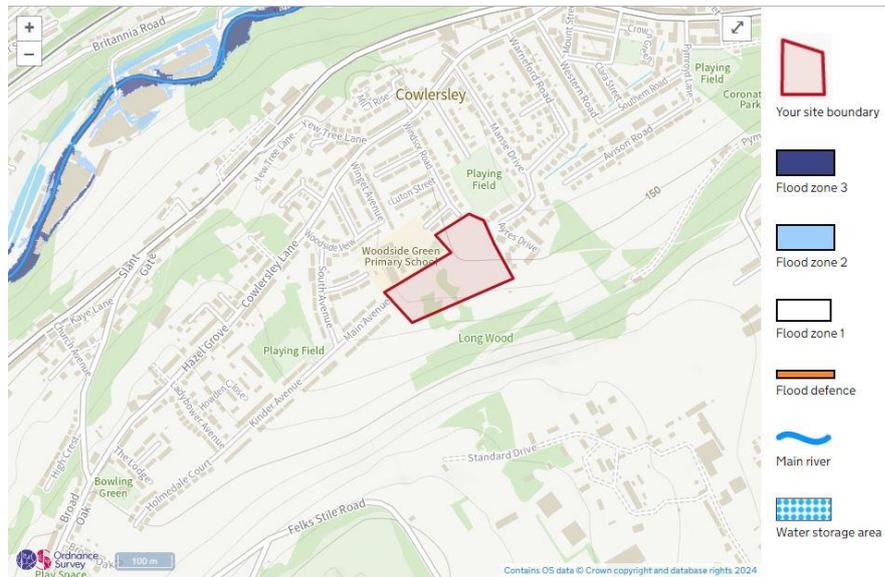
4.8 *Figure 4.1 – Environment Agency Flooding from Rivers and Sea Flood Map*

- 4.7 The Environment Agency 'Flood Map for Planning' map in figure 4.1, indicates the site is located entirely within Flood Zone 1 and so is considered to have the lowest probability of flooding from rivers and the sea, of 1 in 1000 in any one year (0.1%).

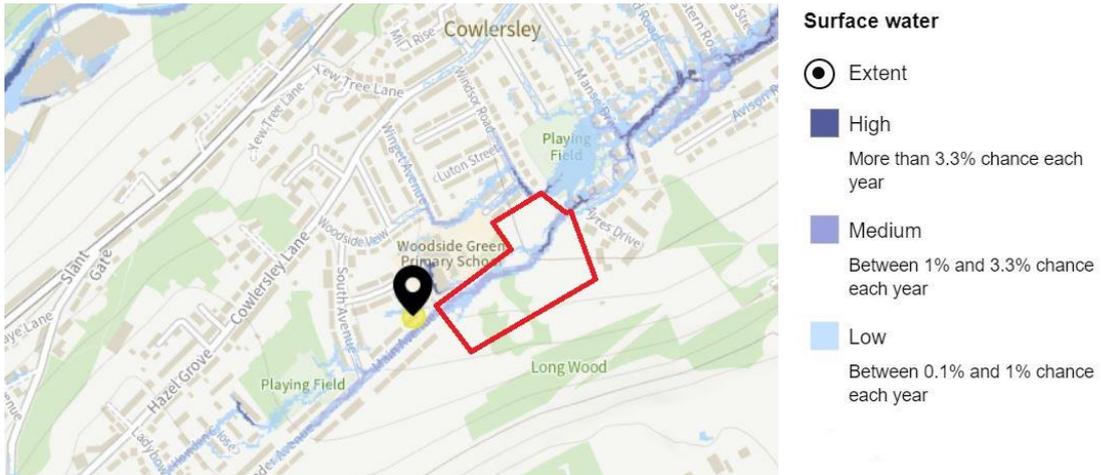
4.25 Figure 4.2 – Environmental Agency Surface Water Flood Risk Map

4.24 Based on the available information flood risk from this source is considered HIGH.

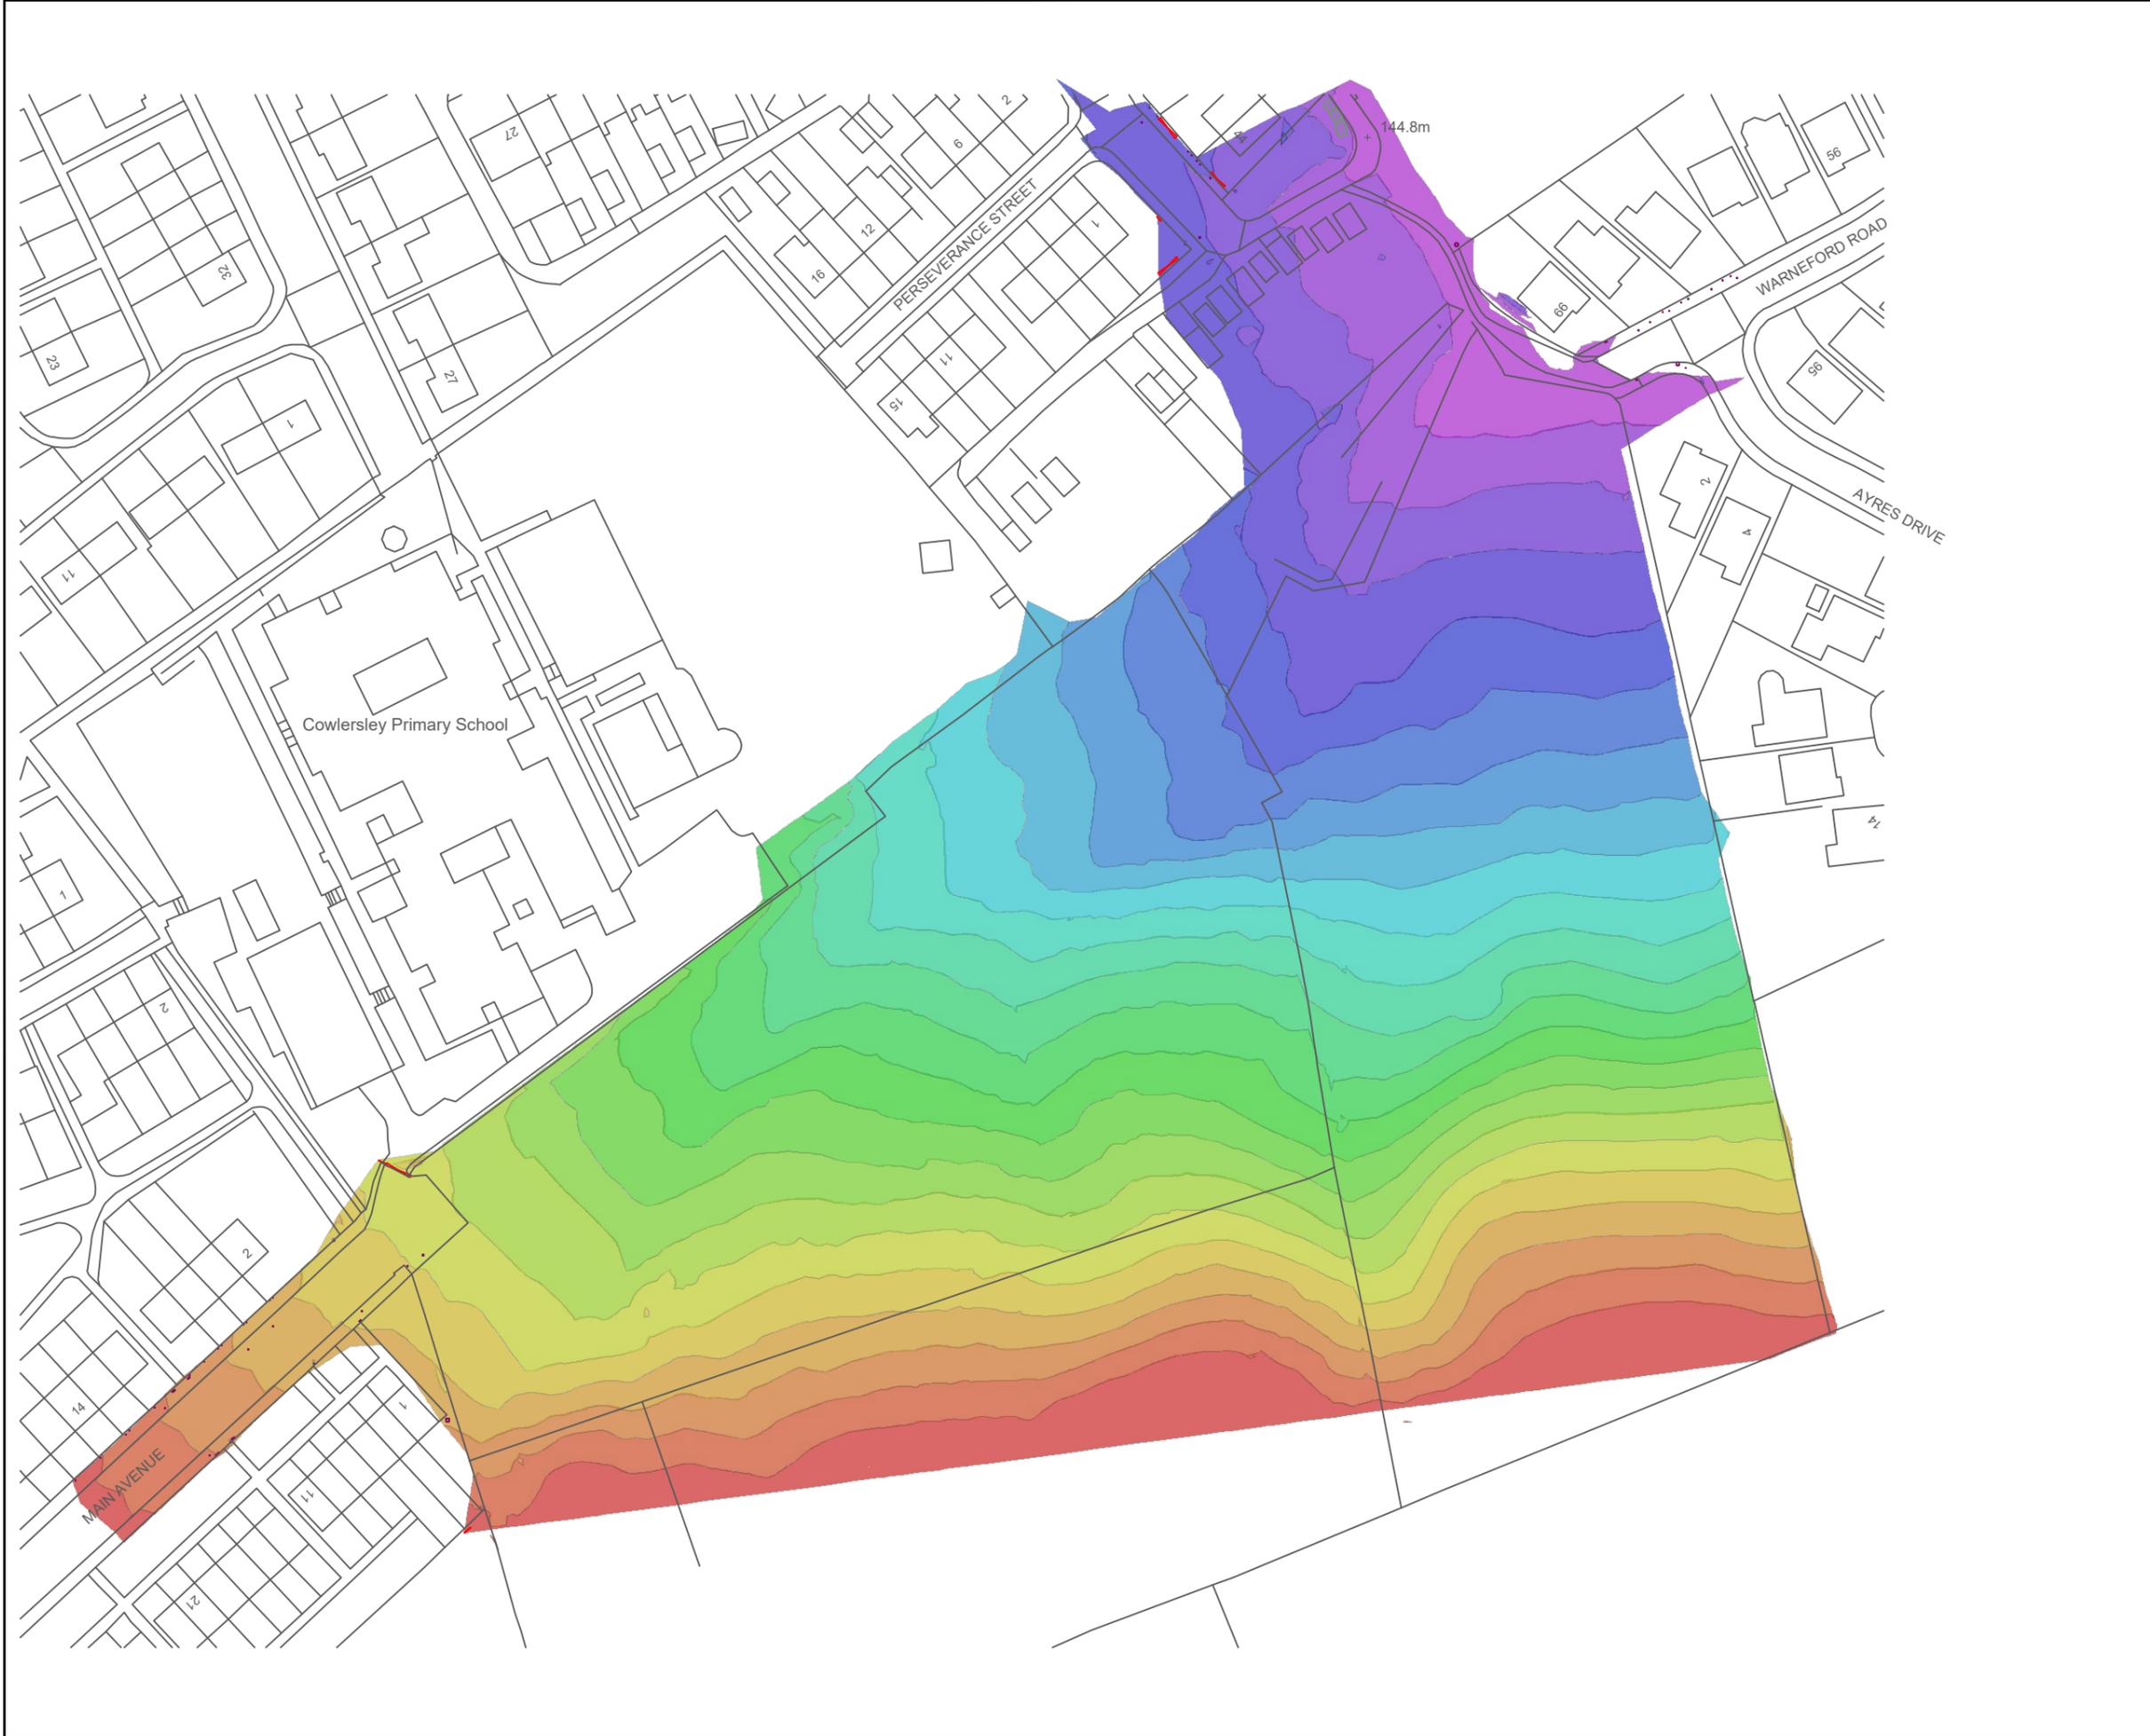
## Appendix 2 – Site Fall Diagram

- 2.5 A topographical survey was carried out during May 2024 and can be viewed in Appendix 1. Site levels generally fall from the north-west towards the south-east. The existing topography is steep with gradients up to 1 in 4.
- 2.6 Existing levels fall centrally forming a channel through the site, falling from west to east.
- 2.7 Appendix 2 provides a coloured plan showing how the existing topography falls.

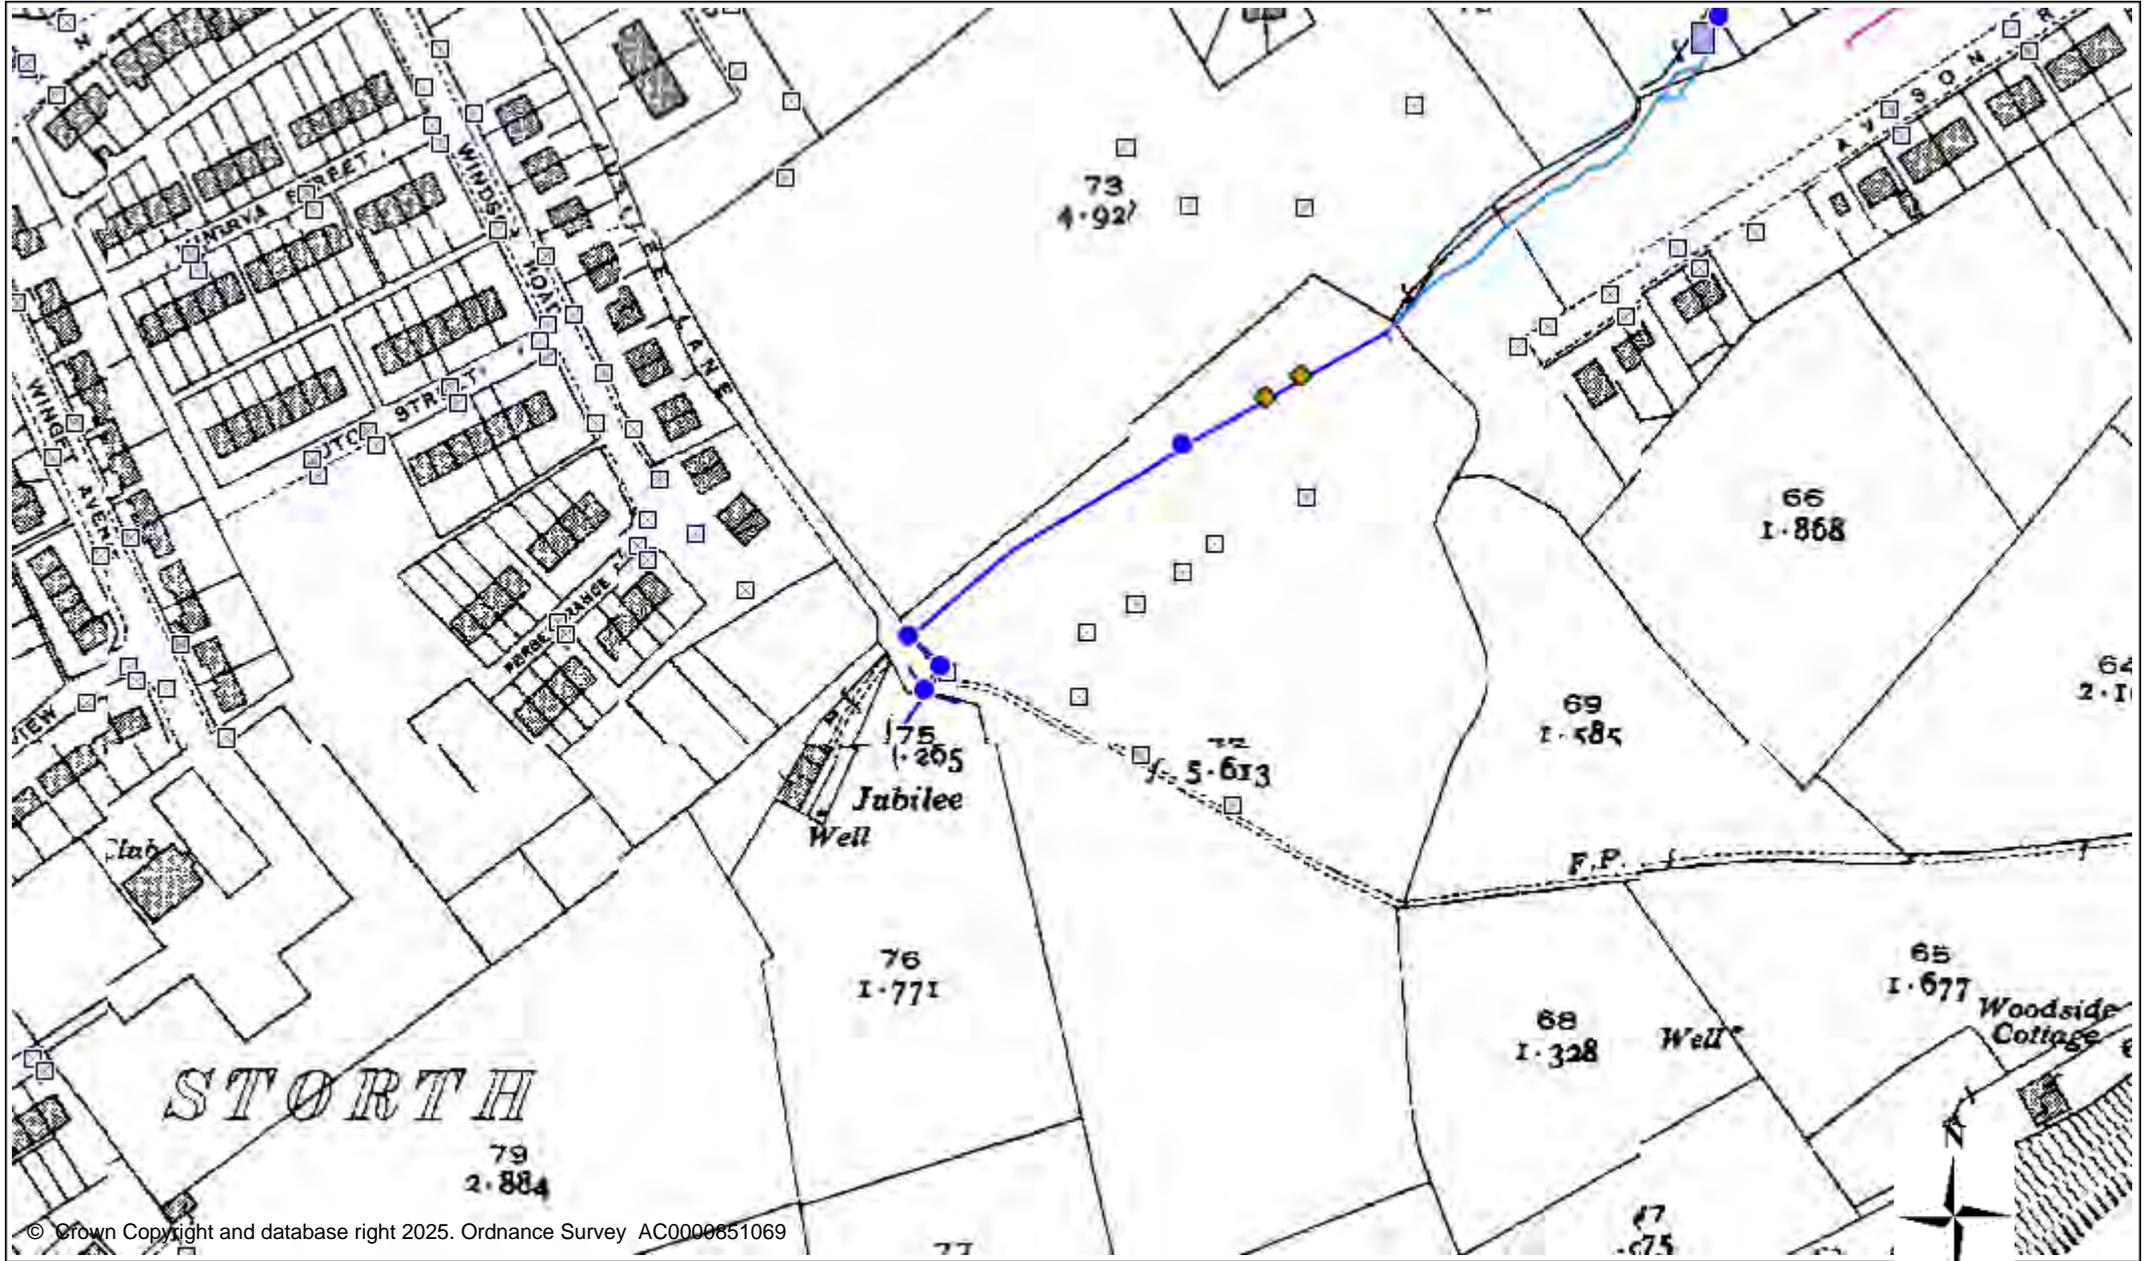
1933 Map - -Well

An examination of historical OS Maps shows a cluster of buildings toward the eastern boundary named 'Jubilee'. A well is clearly shown and in line with the downstream watercourse. The 1933 map is included as an example. Kirklees would like the applicant to determine the depth of the system as it leaves site and perform the excavation of slip trenches at the well location and upstream at several intervals including the western boundary with Main Avenue. Kirklees Council has previously noted overland flows (flows escaping?) along this low valley within the site in addition to water running south to north. The presence of existing systems must be fully investigated.

- 2.19 Consultation with the LLFA and a review of historic mapping have identified the likely presence of a well associated with the former Jubilee Properties. However, its exact location, dimensions, and depth remain unknown. If encountered during construction, the well should be decommissioned in accordance with the Environment Agency's guidance document: "Good Practice for Decommissioning Redundant Boreholes and Wells" (EA, 2012).

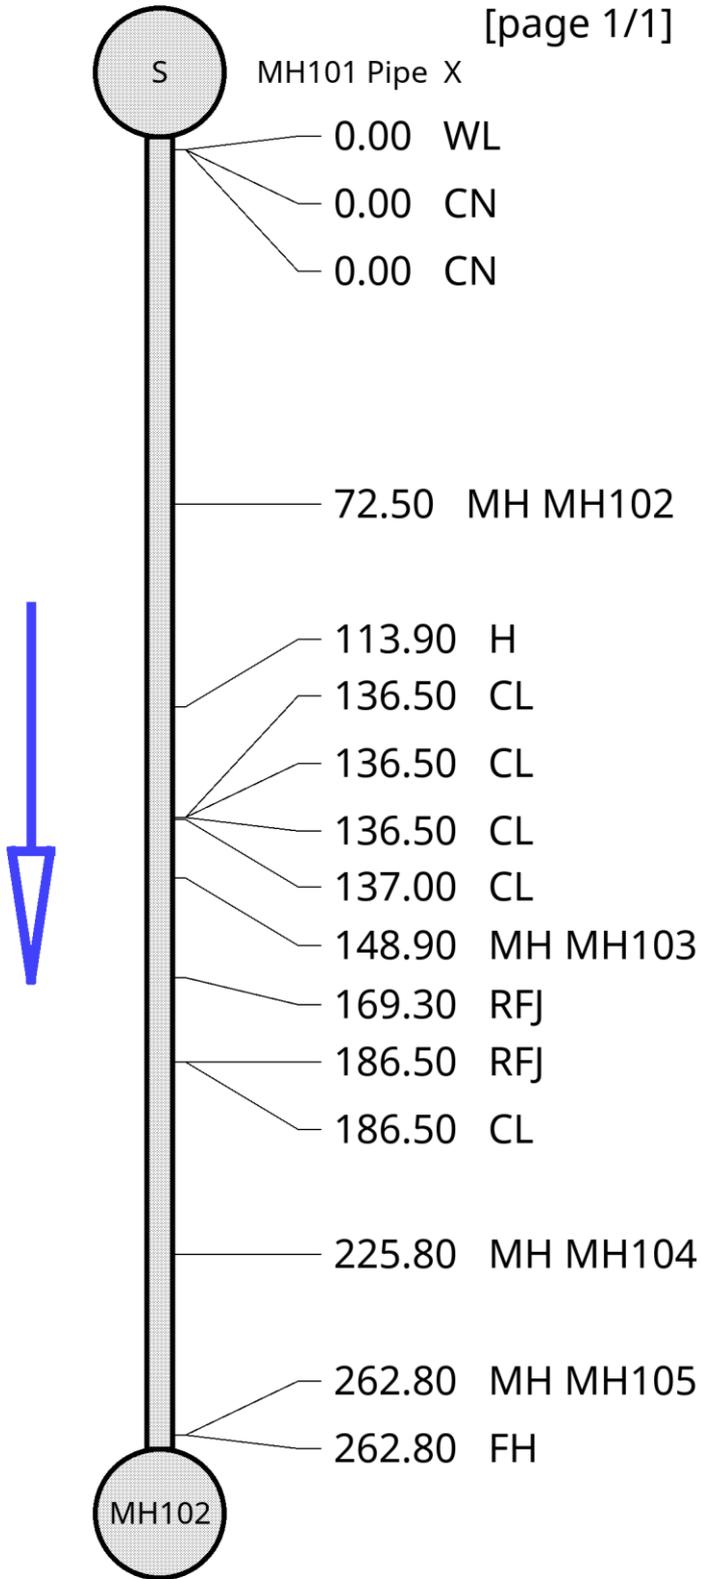
1.2 Diagram

Distance	Condition code and attributes	Photo Ref
Cont. Defect		
Clock (At - To)		
Junta	Remarks	Video Ref
0.0	(WL) Water level ...% height/diameter Percentage: 10%	./MH101-Pipe---X/MH101-Pipe---X_2024_06_20-09_45_18_839.jpg

136.5	(CL) Crack longitudinal at ... o'clock Clock At/From: 12	./MH101-Pipe---X/MH101-Pipe---X_2024_06_20-09_55_39_319.jpg

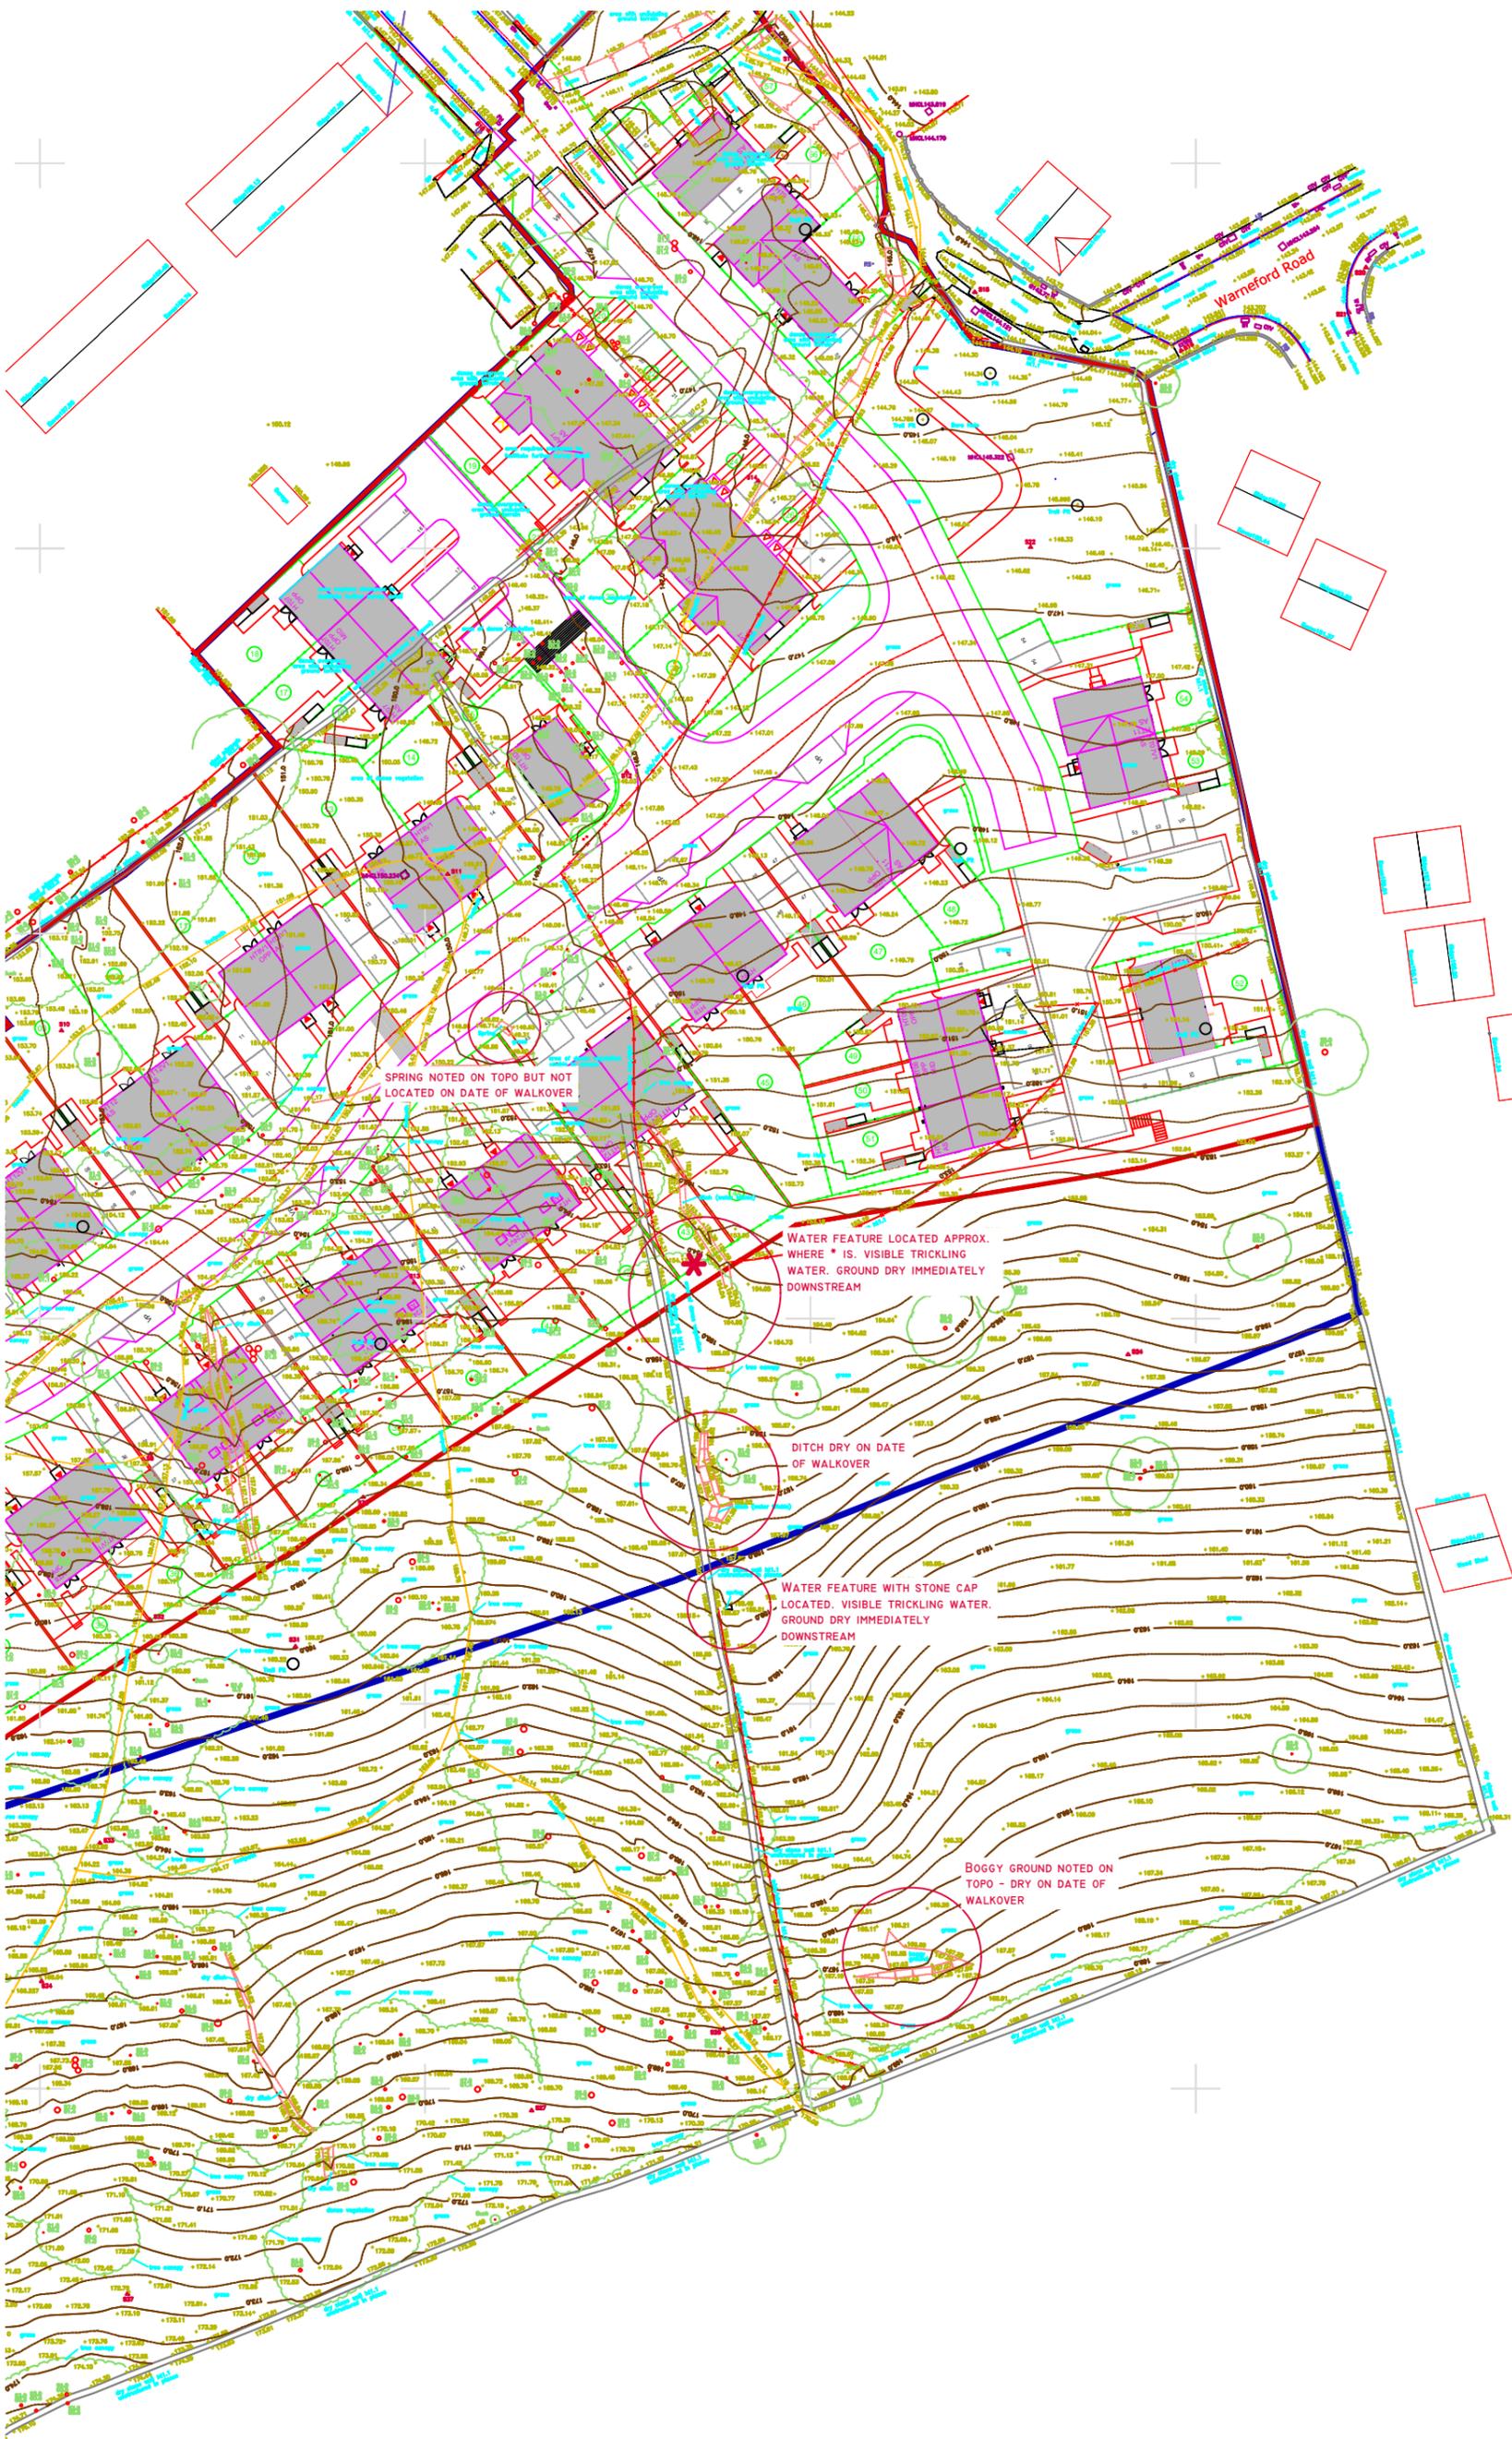
Stone Culvert located here  
 Dye tested Green, waited 35 minutes but no dye  
 appeared in manhole located on culvert downstream.  
 Area in field very wet and boggy at this location

- 2.16 A stone culvert is located adjacent to a dry stone wall on the hillside to the south of the development site. During the site walkover, trickling water was observed within the culvert, although a ditch located further downslope was found to be dry at the time of inspection.

- 2.17 Consultation with the Lead Local Flood Authority (LLFA) and trial trenching have so far been unable to locate the outfall of the culvert. However, based on the local topography and site levels, it is anticipated that runoff from this feature is directed into the culvert to the rear of Warneford Road.

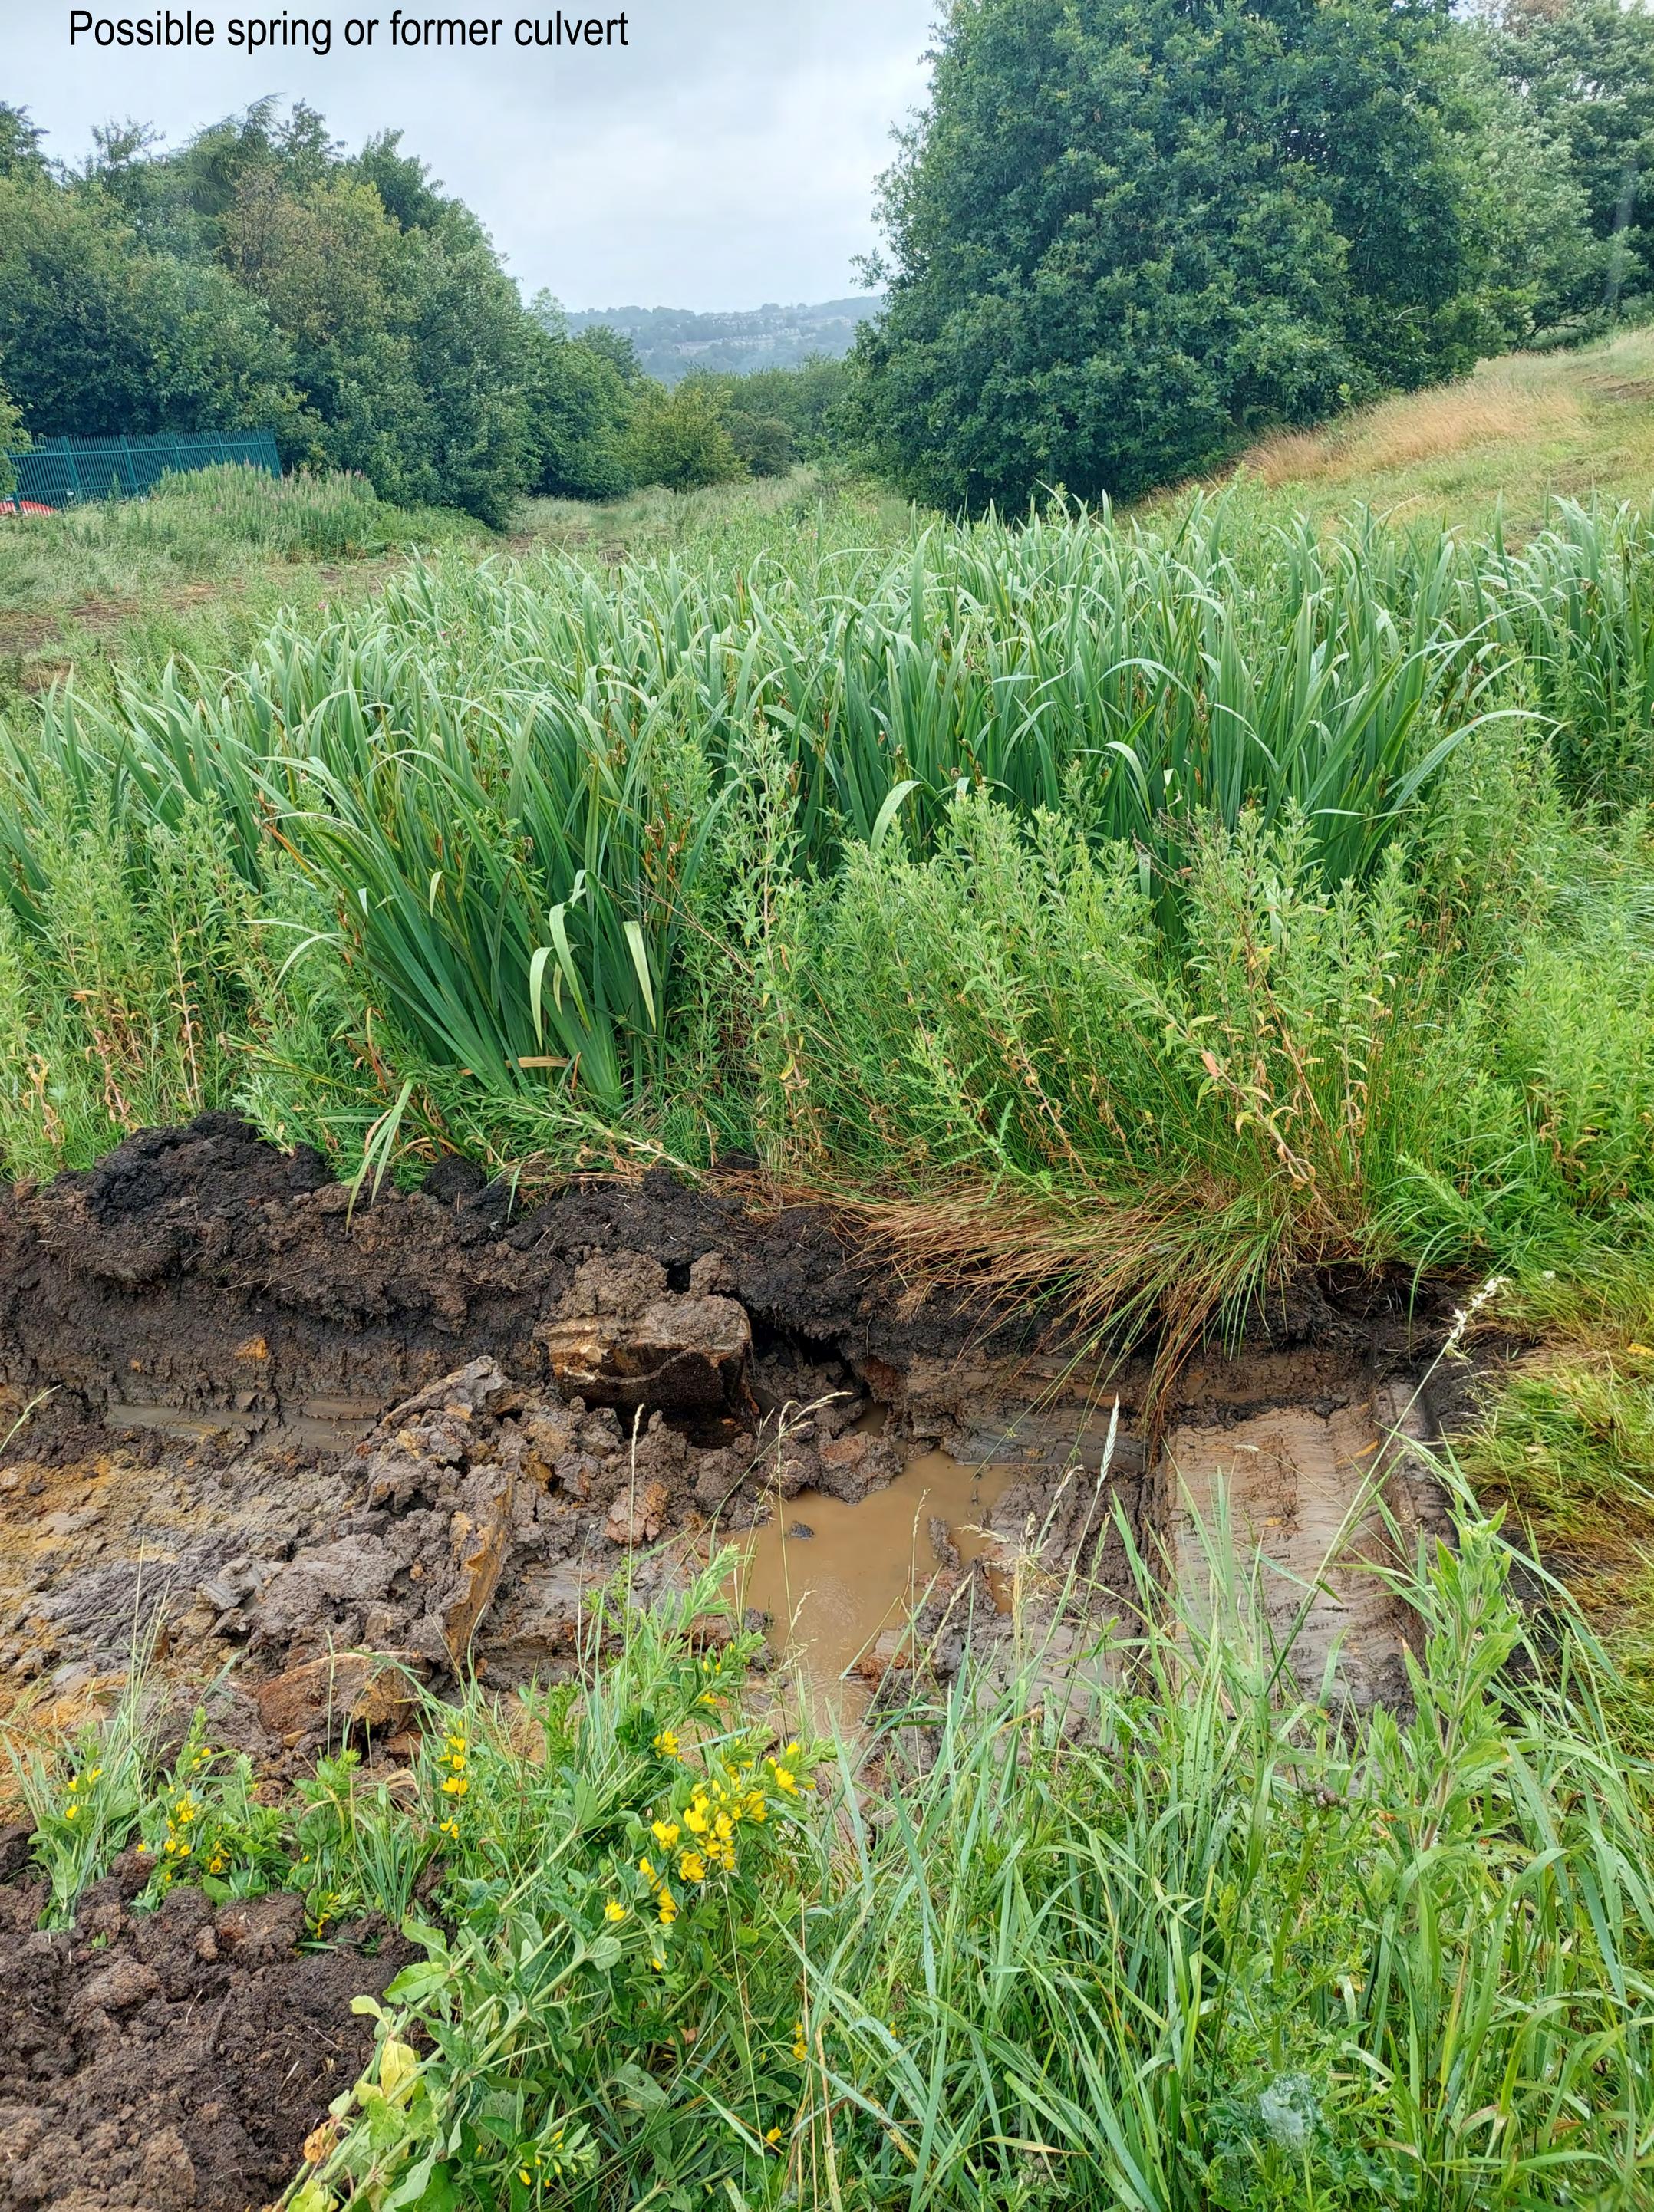
Possible spring or former culvert

- 2.18 A saturated area was observed adjacent to the existing hardstanding. This area is densely vegetated with reed and wetland-type species, suggesting a persistently moist environment. Trial trenching in this location uncovered a subsurface void at a shallow depth, with continued ground saturation. It is therefore assumed this may represent a former culverted watercourse or a natural spring.

- 9.18 A spring or former culvert was observed adjacent to the existing car park in the western area of the site. Further trial pitting and trenching have not identified any active or continuous drainage feature in this location.
