**ARBORICULTURAL REPORT  
AND  
ARBORICULTURAL IMPACT ASSESSMENT  
to BS 5837:2012  
at  
916 Halifax Road  
Cleckheaton  
West Yorkshire  
BD19 6LR**

**Client:**  
Barnes Homes

**JCA Ref:**  
22692/AJB

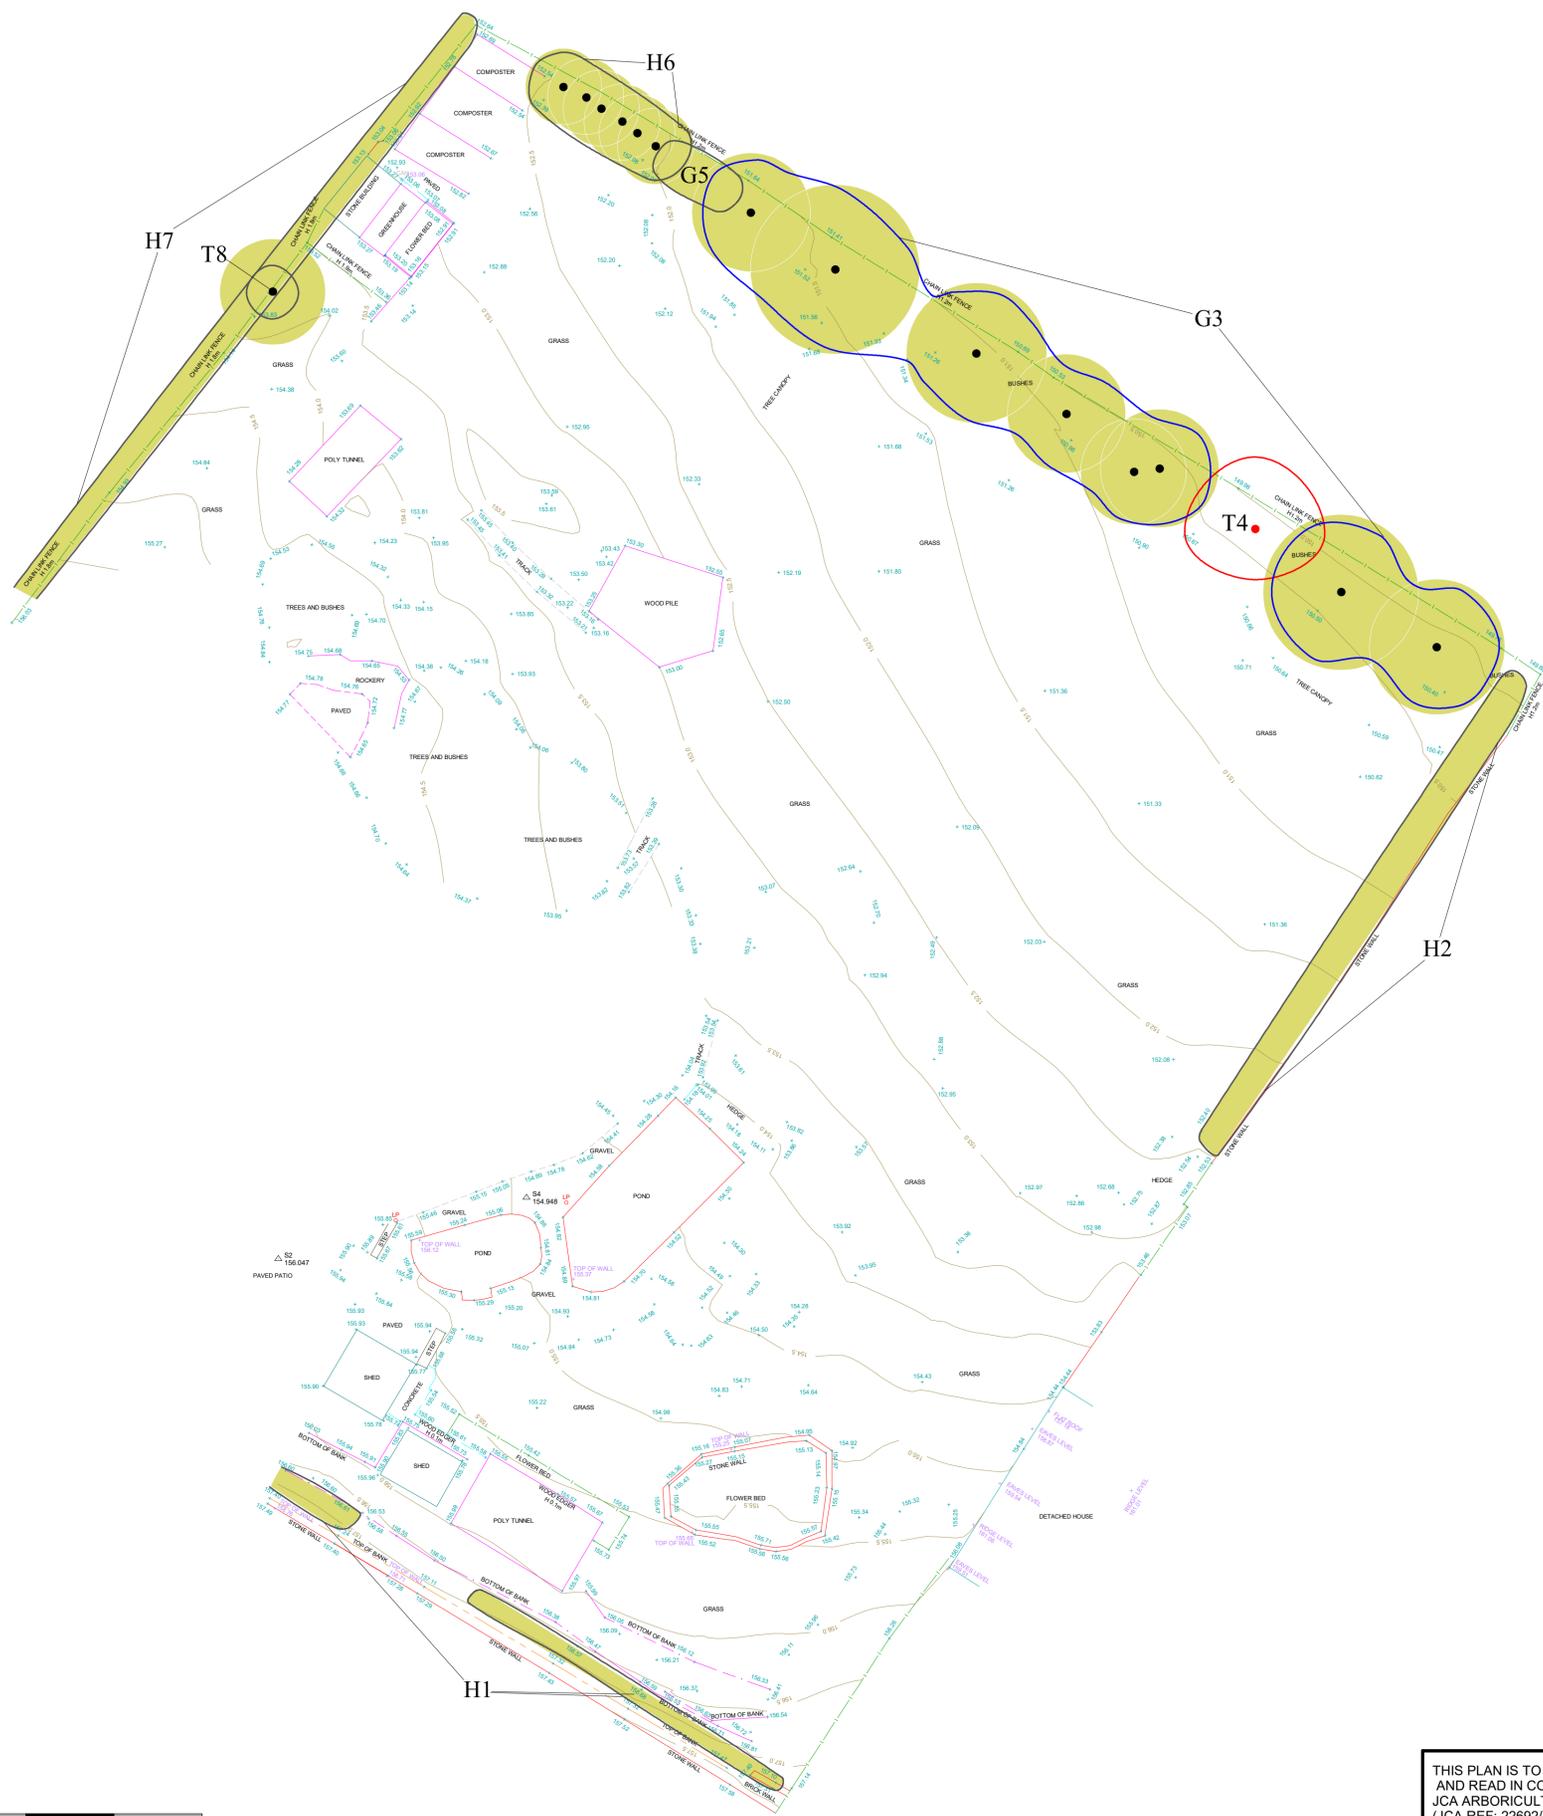
**Appendix 5:  
Tree Constraints Plan**

**Root Protection Area: RPA**

THE ROOT PROTECTION AREA SHOULD IDEALLY REMAIN UNDISTURBED IF THE TREE IS TO BE RETAINED.

THE DEVELOPMENT PROPOSALS SHOULD THEREFORE BE DESIGNED TO AVOID THE RPA OF ANY TREE WHICH IS TO BE RETAINED.

IF IT IS NECESSARY FOR THE DEVELOPMENT TO ENCR OACH INTO THE RPA OF A TREE WHICH IS TO BE RETAINED THEN SPECIALIST CONSTRUCTION TECHNIQUES AND MATERIALS MUST BE CONSIDERED.

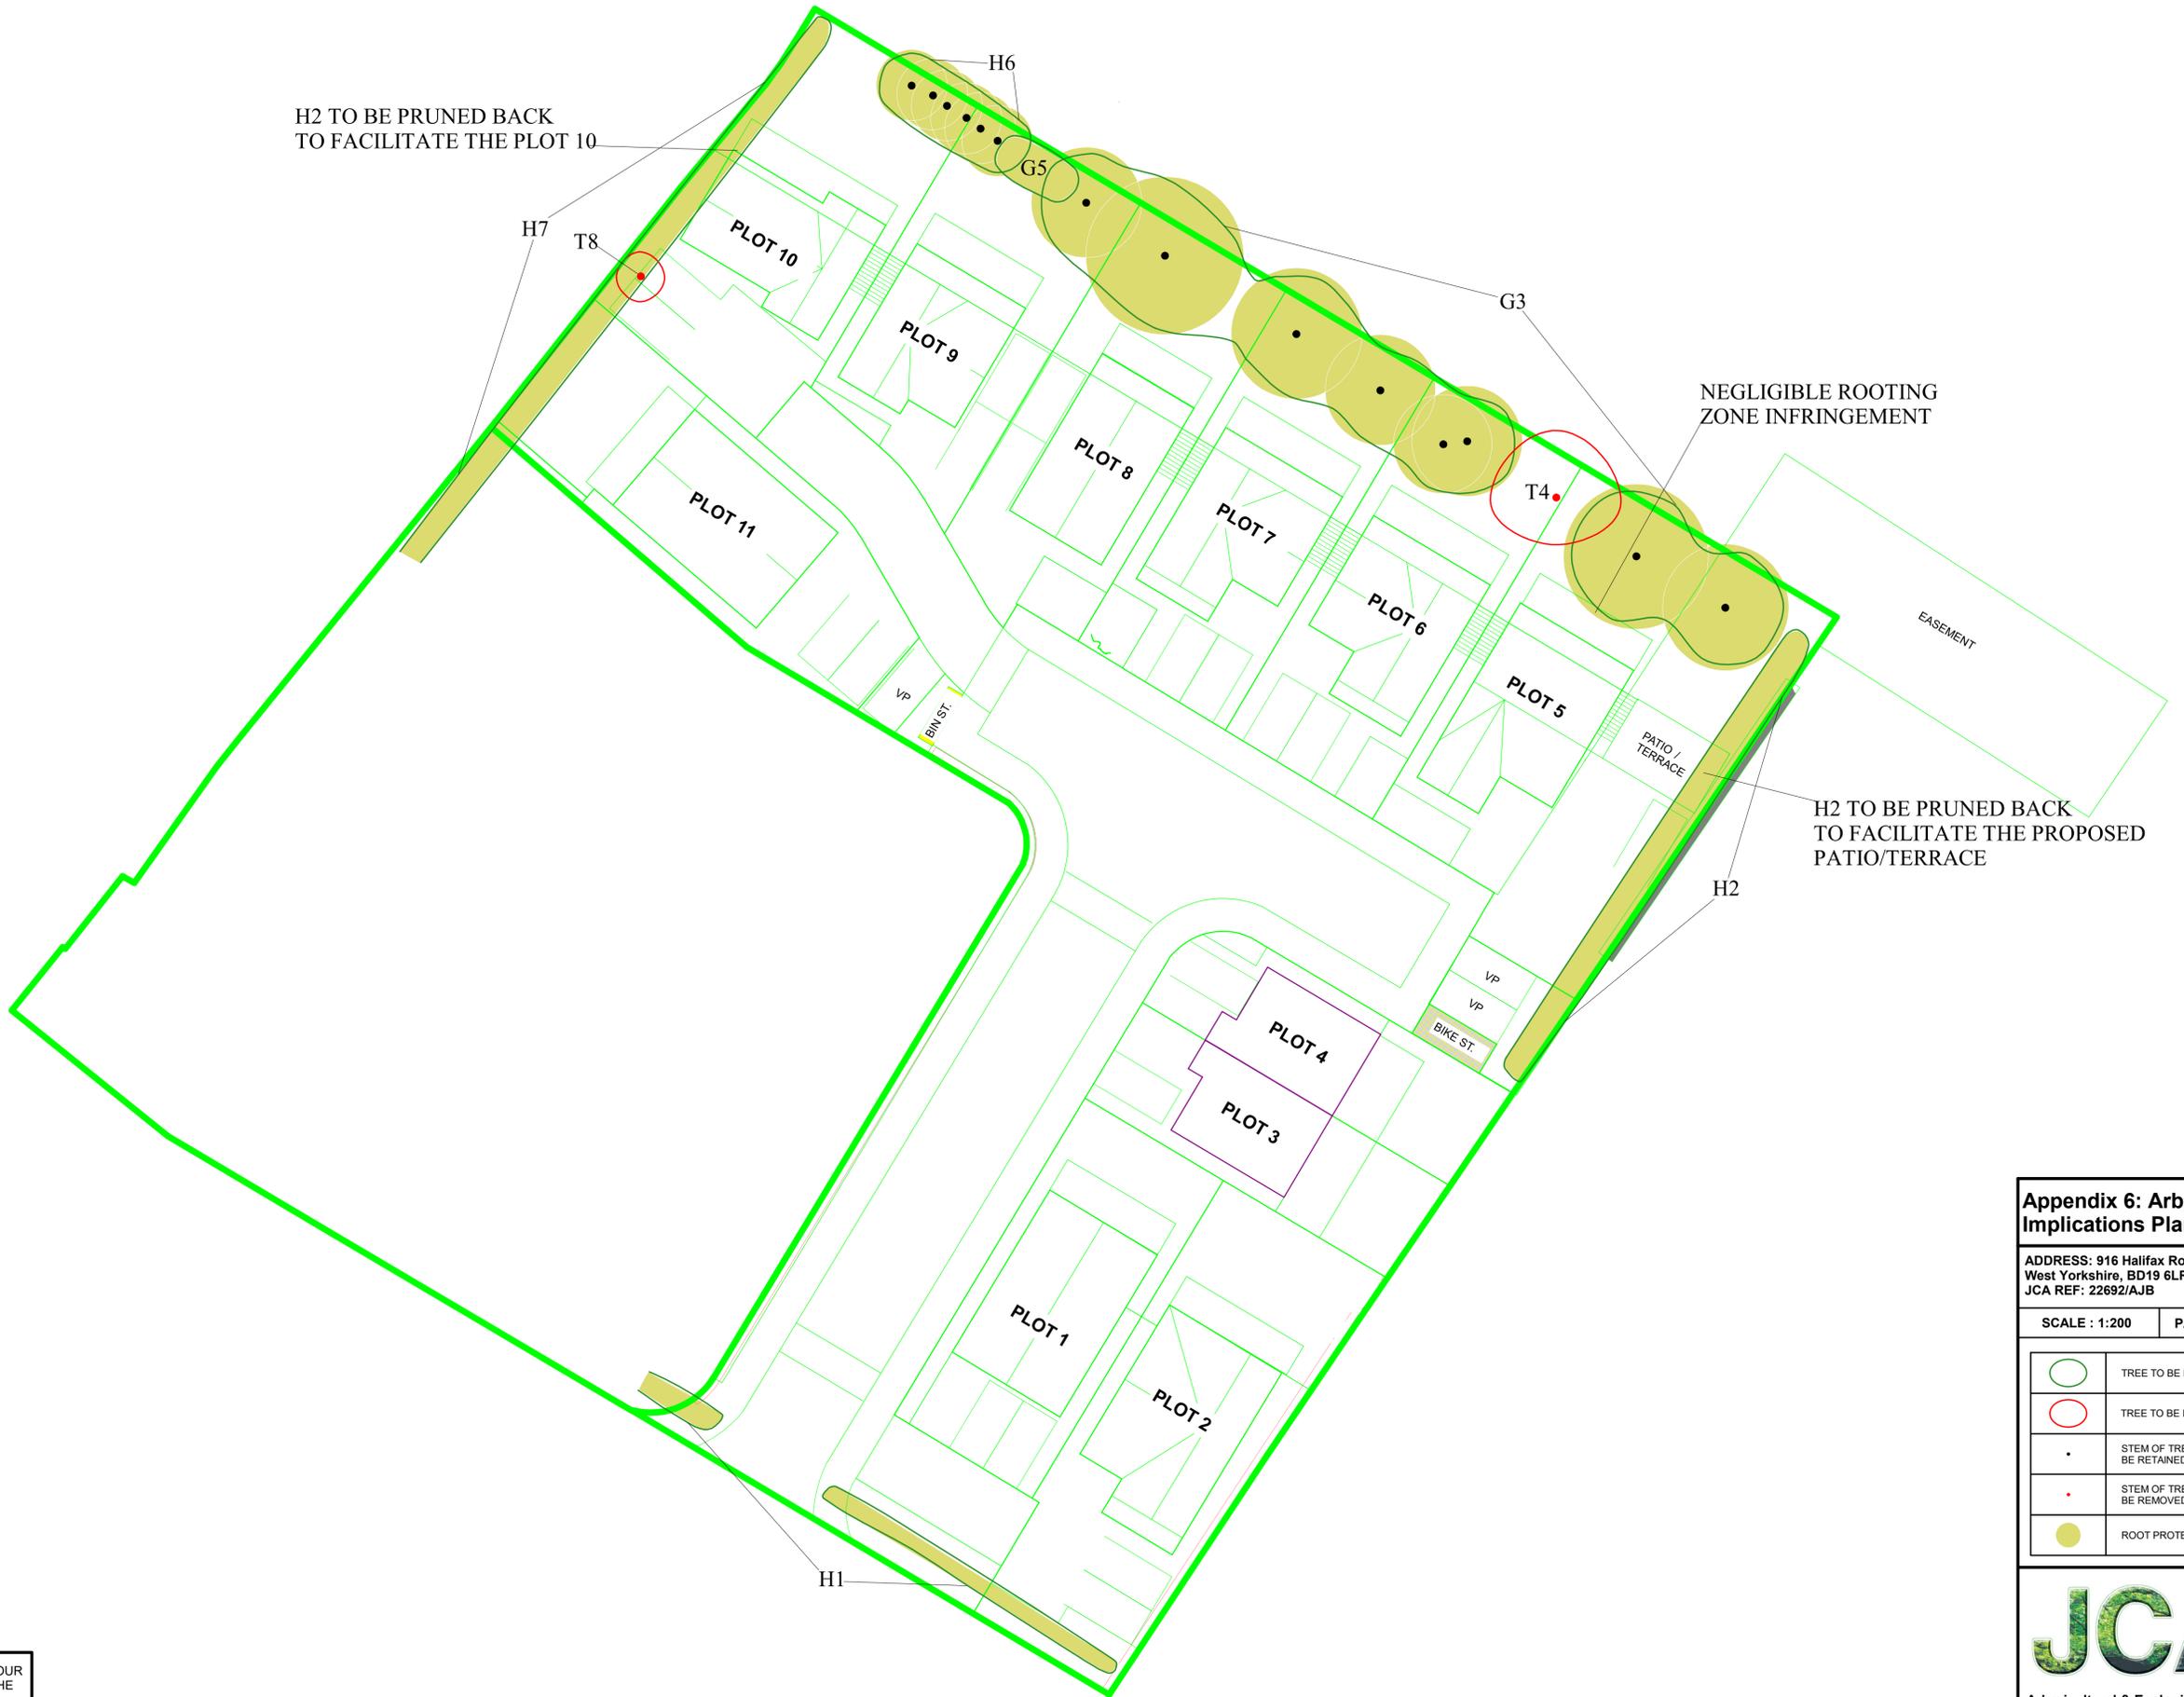
**Appendix 6: Arboricultural Implications Plan**

H2 TO BE PRUNED BACK  
TO FACILITATE THE PLOT 10

NEGLIGIBLE ROOTING  
ZONE INFRINGEMENT

H2 TO BE PRUNED BACK  
TO FACILITATE THE PROPOSED  
PATIO/TERRACE

4.5.1.1 Other than negligible encroachments (as annotated on the plan at **Appendix 6**), no construction activities are required within the root protection areas of trees to be retained at this site.

4.5.3.1 Other than a negligible encroachment within the RPA's of **H2** and **G3** (as annotated on the plan at **Appendix 6**), the proposed scheme does not require the construction of hard surfaces within the RPA of retained trees. As such no specialised construction techniques/surface treatments will be required for this purpose.

4.5.4.1 Other than a negligible encroachment within the RPA of **H7** (as annotated on the plan at **Appendix 6**), the footprints of the proposed buildings do not encroach into the RPA of retained trees. As such no specialist construction or foundation methods are considered necessary for the sole purpose of preventing damage to trees.

- 5.5 **T8** requires removal and **H2** and **H7** require pruning in order to facilitate the proposed development. These are discussed in **Section 4.2** and detailed on the Arboricultural Implications Plan at **Appendix 6**.
