178 Marsh Lane, Shepley

Preliminary Bat Roost Assessment

*15<sup>th</sup> November 2024*

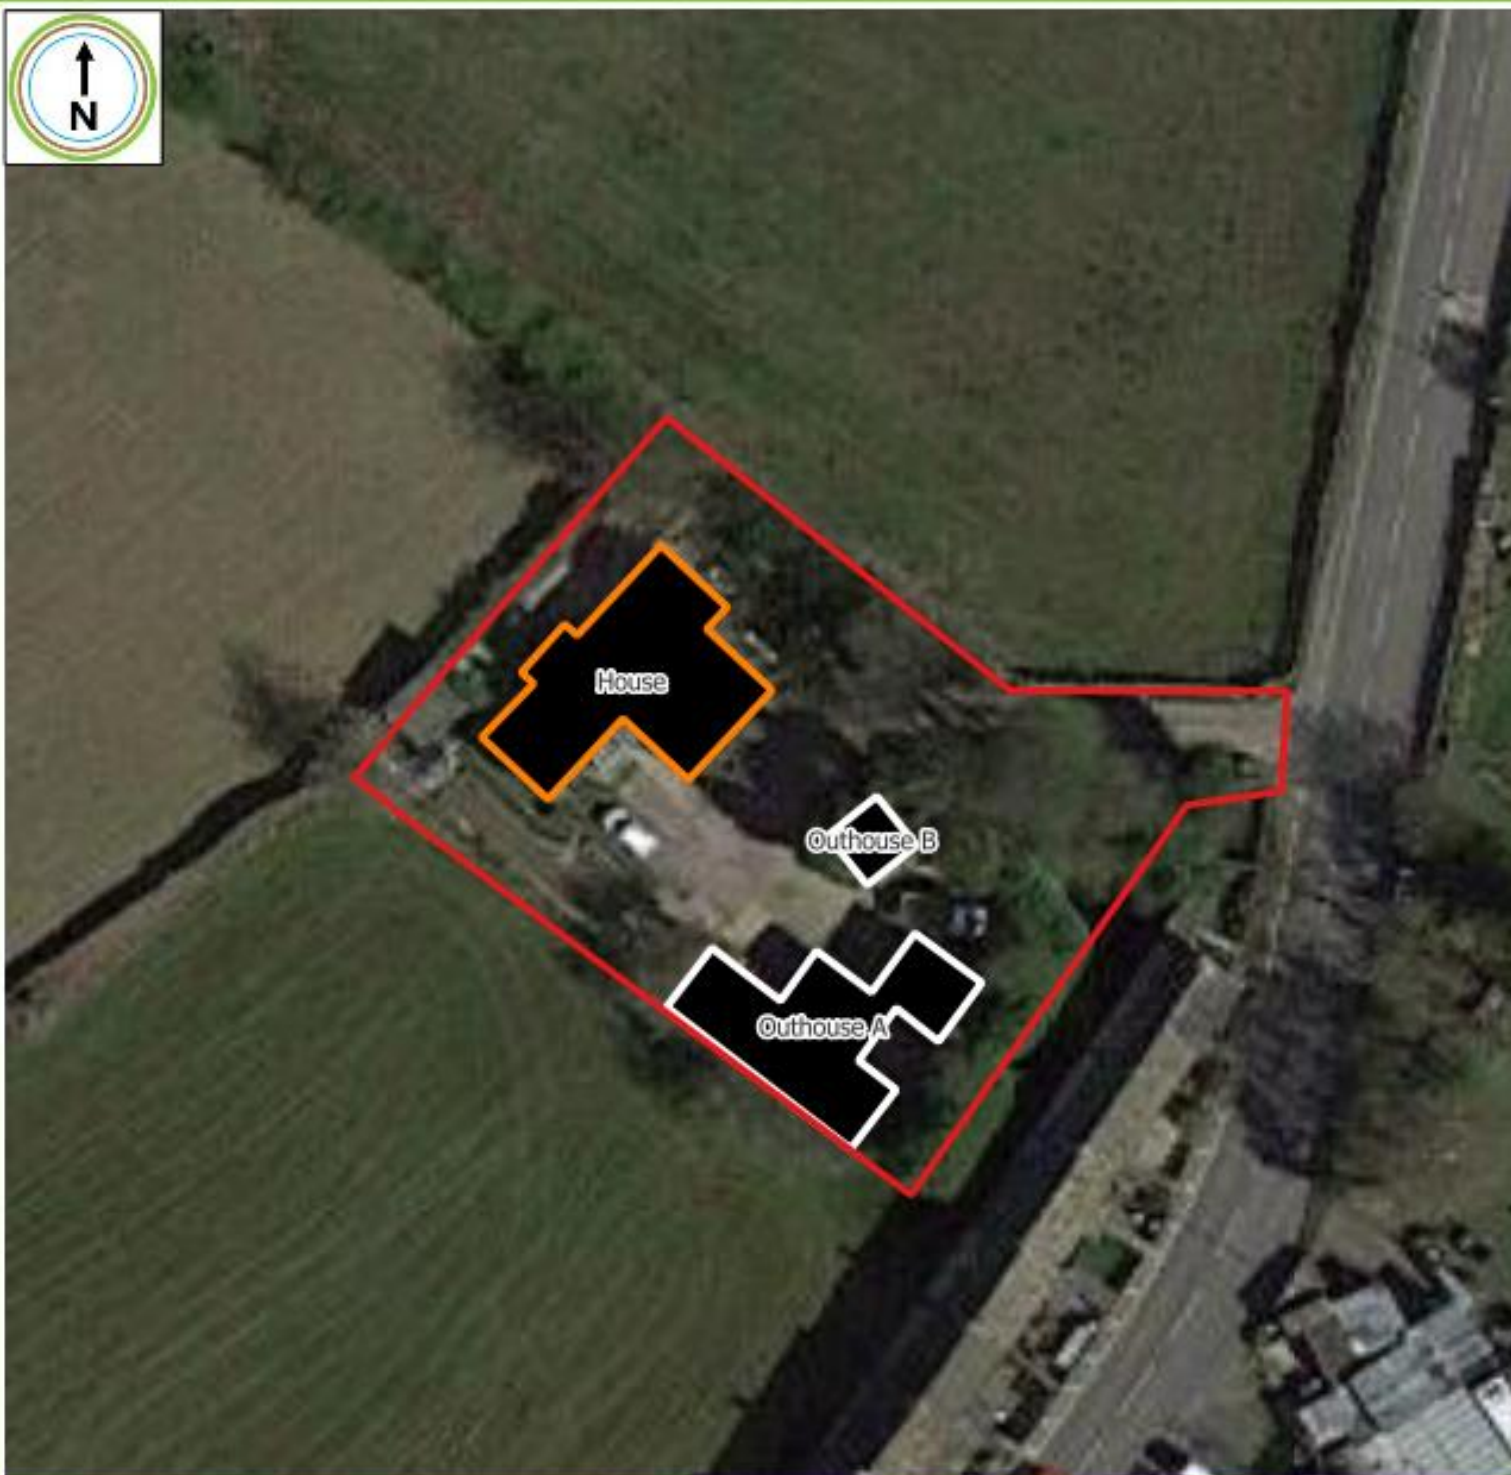
Figure 1  
Building Suitability Map

- 3.3.11 In line with good practice guidance (Collins, 2023) given the absence of suitable PRFs, it is considered that both Outhouse A and Outhouse B are of 'Negligible' suitability for roosting bats. However, The House offers a range of PRFs suitable for roosting bats, and as such, is considered to be of 'Moderate' suitability for roosting bats (Collins, 2023).

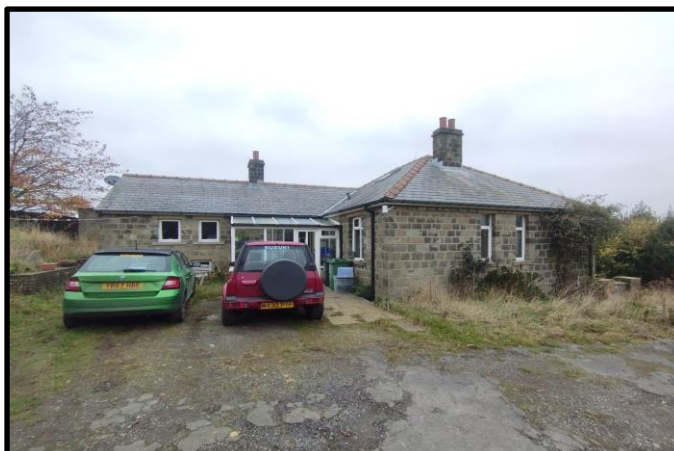
- 3.3.2 The House is a single storey, stone-built bungalow with a pitched slate roof. The roof contains a series of gable ends, with an additional section that is hipped. The ridges of the roof are constructed with clay ridge tiles. The House contains PVC window and door frames, in addition to a glass porch on the southeastern aspect. The House contains wooden soffit boxes beneath the eaves.
- 3.3.3 The roof void of the building has been converted, with the void within the main pitch having been removed to add height to the ceilings beneath, while the section within the hipped area of the roof has undergone a loft conversion, including the installation of VELUX windows. Some sections within this conversion have been kept as a void for storage, in which these areas are fitted with roofing felt. A swallow nesting cup was recorded on the eastern entrance of the building.

Photograph 1. 178 Marsh Lane, Shepley

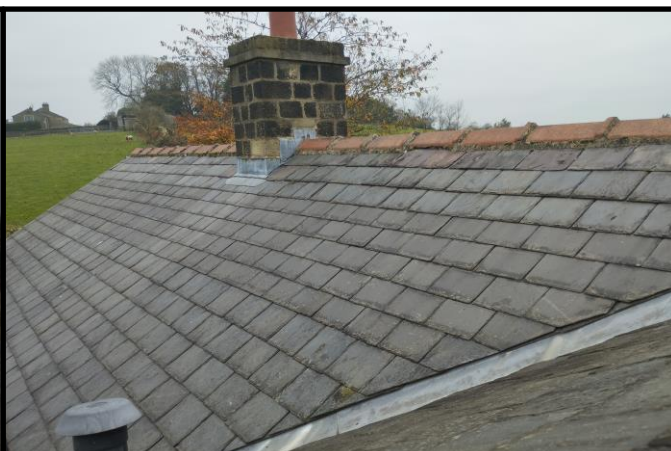
- 3.3.4 The slate tiles on the house are mostly in good condition, however there are some small areas of damaged/lifted tiles which create small crevices which are suitable Potential Roosting Features (PRFs) for bats. There are areas of missing mortar below the ridge tiles, again creating further PRFs for bats. The soffit boxes are damaged in some places, creating entry opportunities for bats into the soffit boxes and potentially into the small roof voids present around the edges of the roof.
- 3.3.5 Given the variety of PRFs, in addition to their presence on a variety of aspects of the building, it is considered that the building is of 'Moderate' suitability for roosting bats, in line with good practice guidelines (Collins, 2023).

Photograph 2. Example of roof

- 4.3.6 As compensation for the loss of PRFs across the Site, it is recommended that integrated bat boxes or bat access roof tiles should be incorporated into the House as part of the proposals. The model of boxes used should be suitable for crevice dwelling bat species, such as the Schwegler 1FR Bat Tube. The bat boxes should be placed as high as possible on the House, facing southern aspects to maximise chances of occupation.

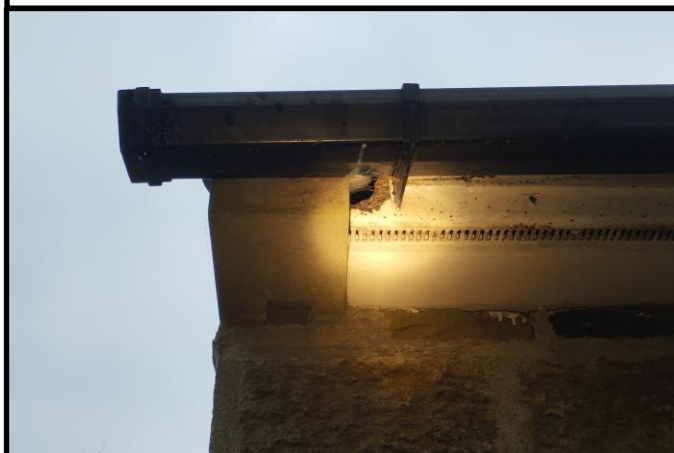
Photograph 3. Example of damage to soffit box allowing access to the voids of the property

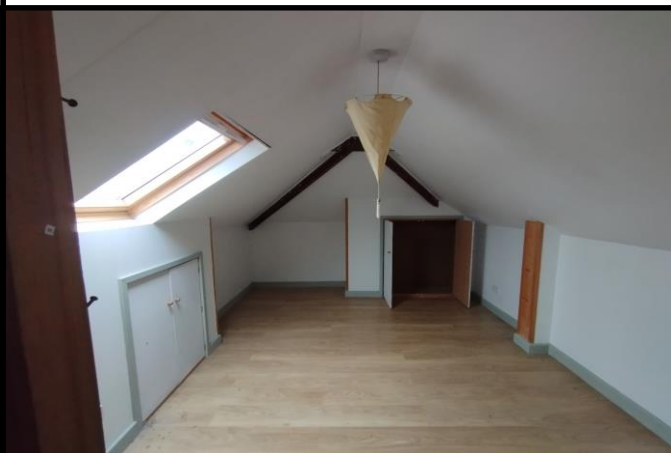
Photograph 4. Example of roof void conversion

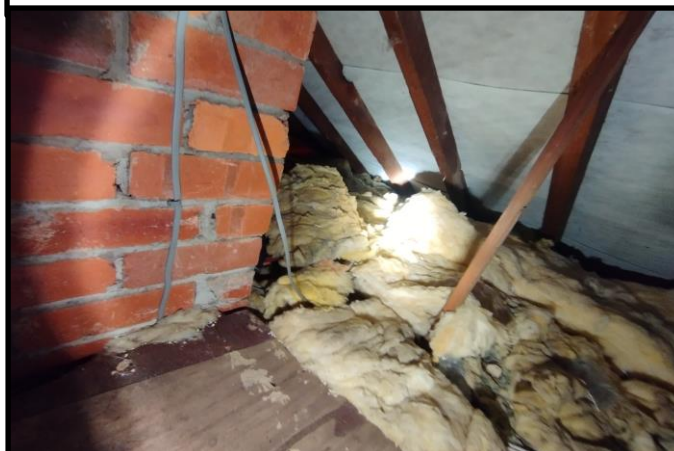
Photograph 5. Example of small sections of roof voids not converted

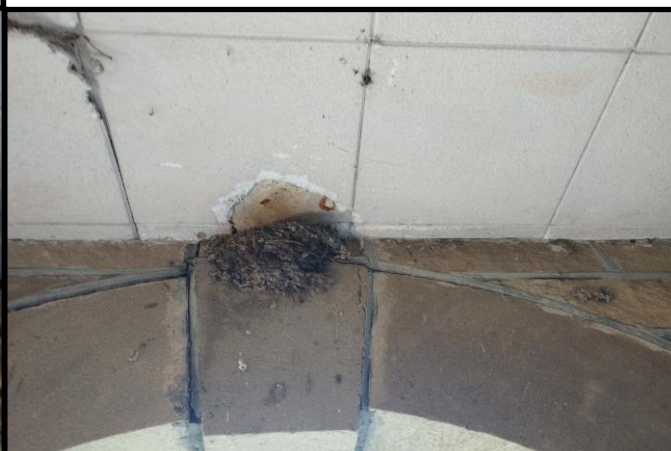
Photograph 6. Remnants of swallow cup

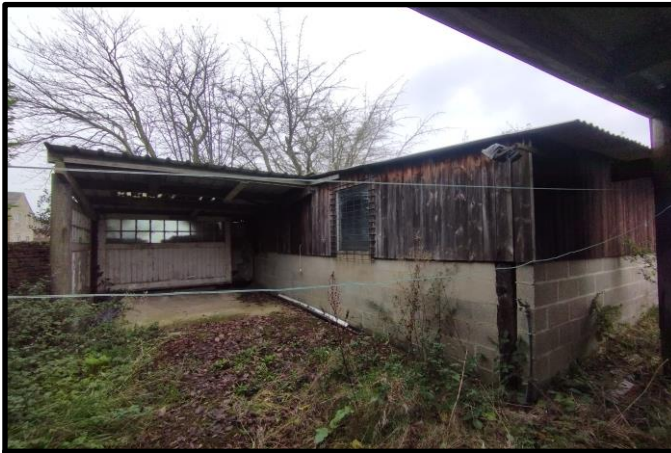
- 3.3.6 Outhouse A is single storey, breezeblock and timber constructed building supporting a corrugated metal sloping roof. The building contains some small, timber framed windows. No roof void is present, with the roof visible from the internal of the building, supported by timber frames.
- 3.3.7 The building offers no crevices across its construction that are suitable for roosting bats, and as such, supports no PRFs for local bats and consequently, the building is considered to offer 'Negligible' suitability for roosting bats (Collins, 2023).

Photograph 7. Outhouse A

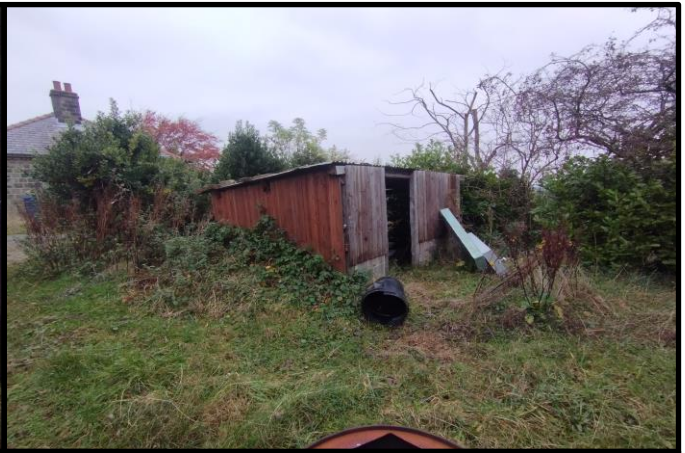
- 3.3.8 Outhouse B is as Outhouse A, only with a much smaller footprint and no windows present.
- 3.3.9 As with Outhouse A, the building offers no crevices across its construction that are suitable for roosting bats, and as such, no PRFs are present and consequently, the building is considered to offer 'Negligible' suitability for roosting bats (Collins, 2023).

Photograph 8. Outhouse B
