CHURCH LANE, LINTHWAITE

EARTHWORKS SPECIFICATION FOR CASEY GROUP LTD

Project Ref:
P8985

Date:
May 2020

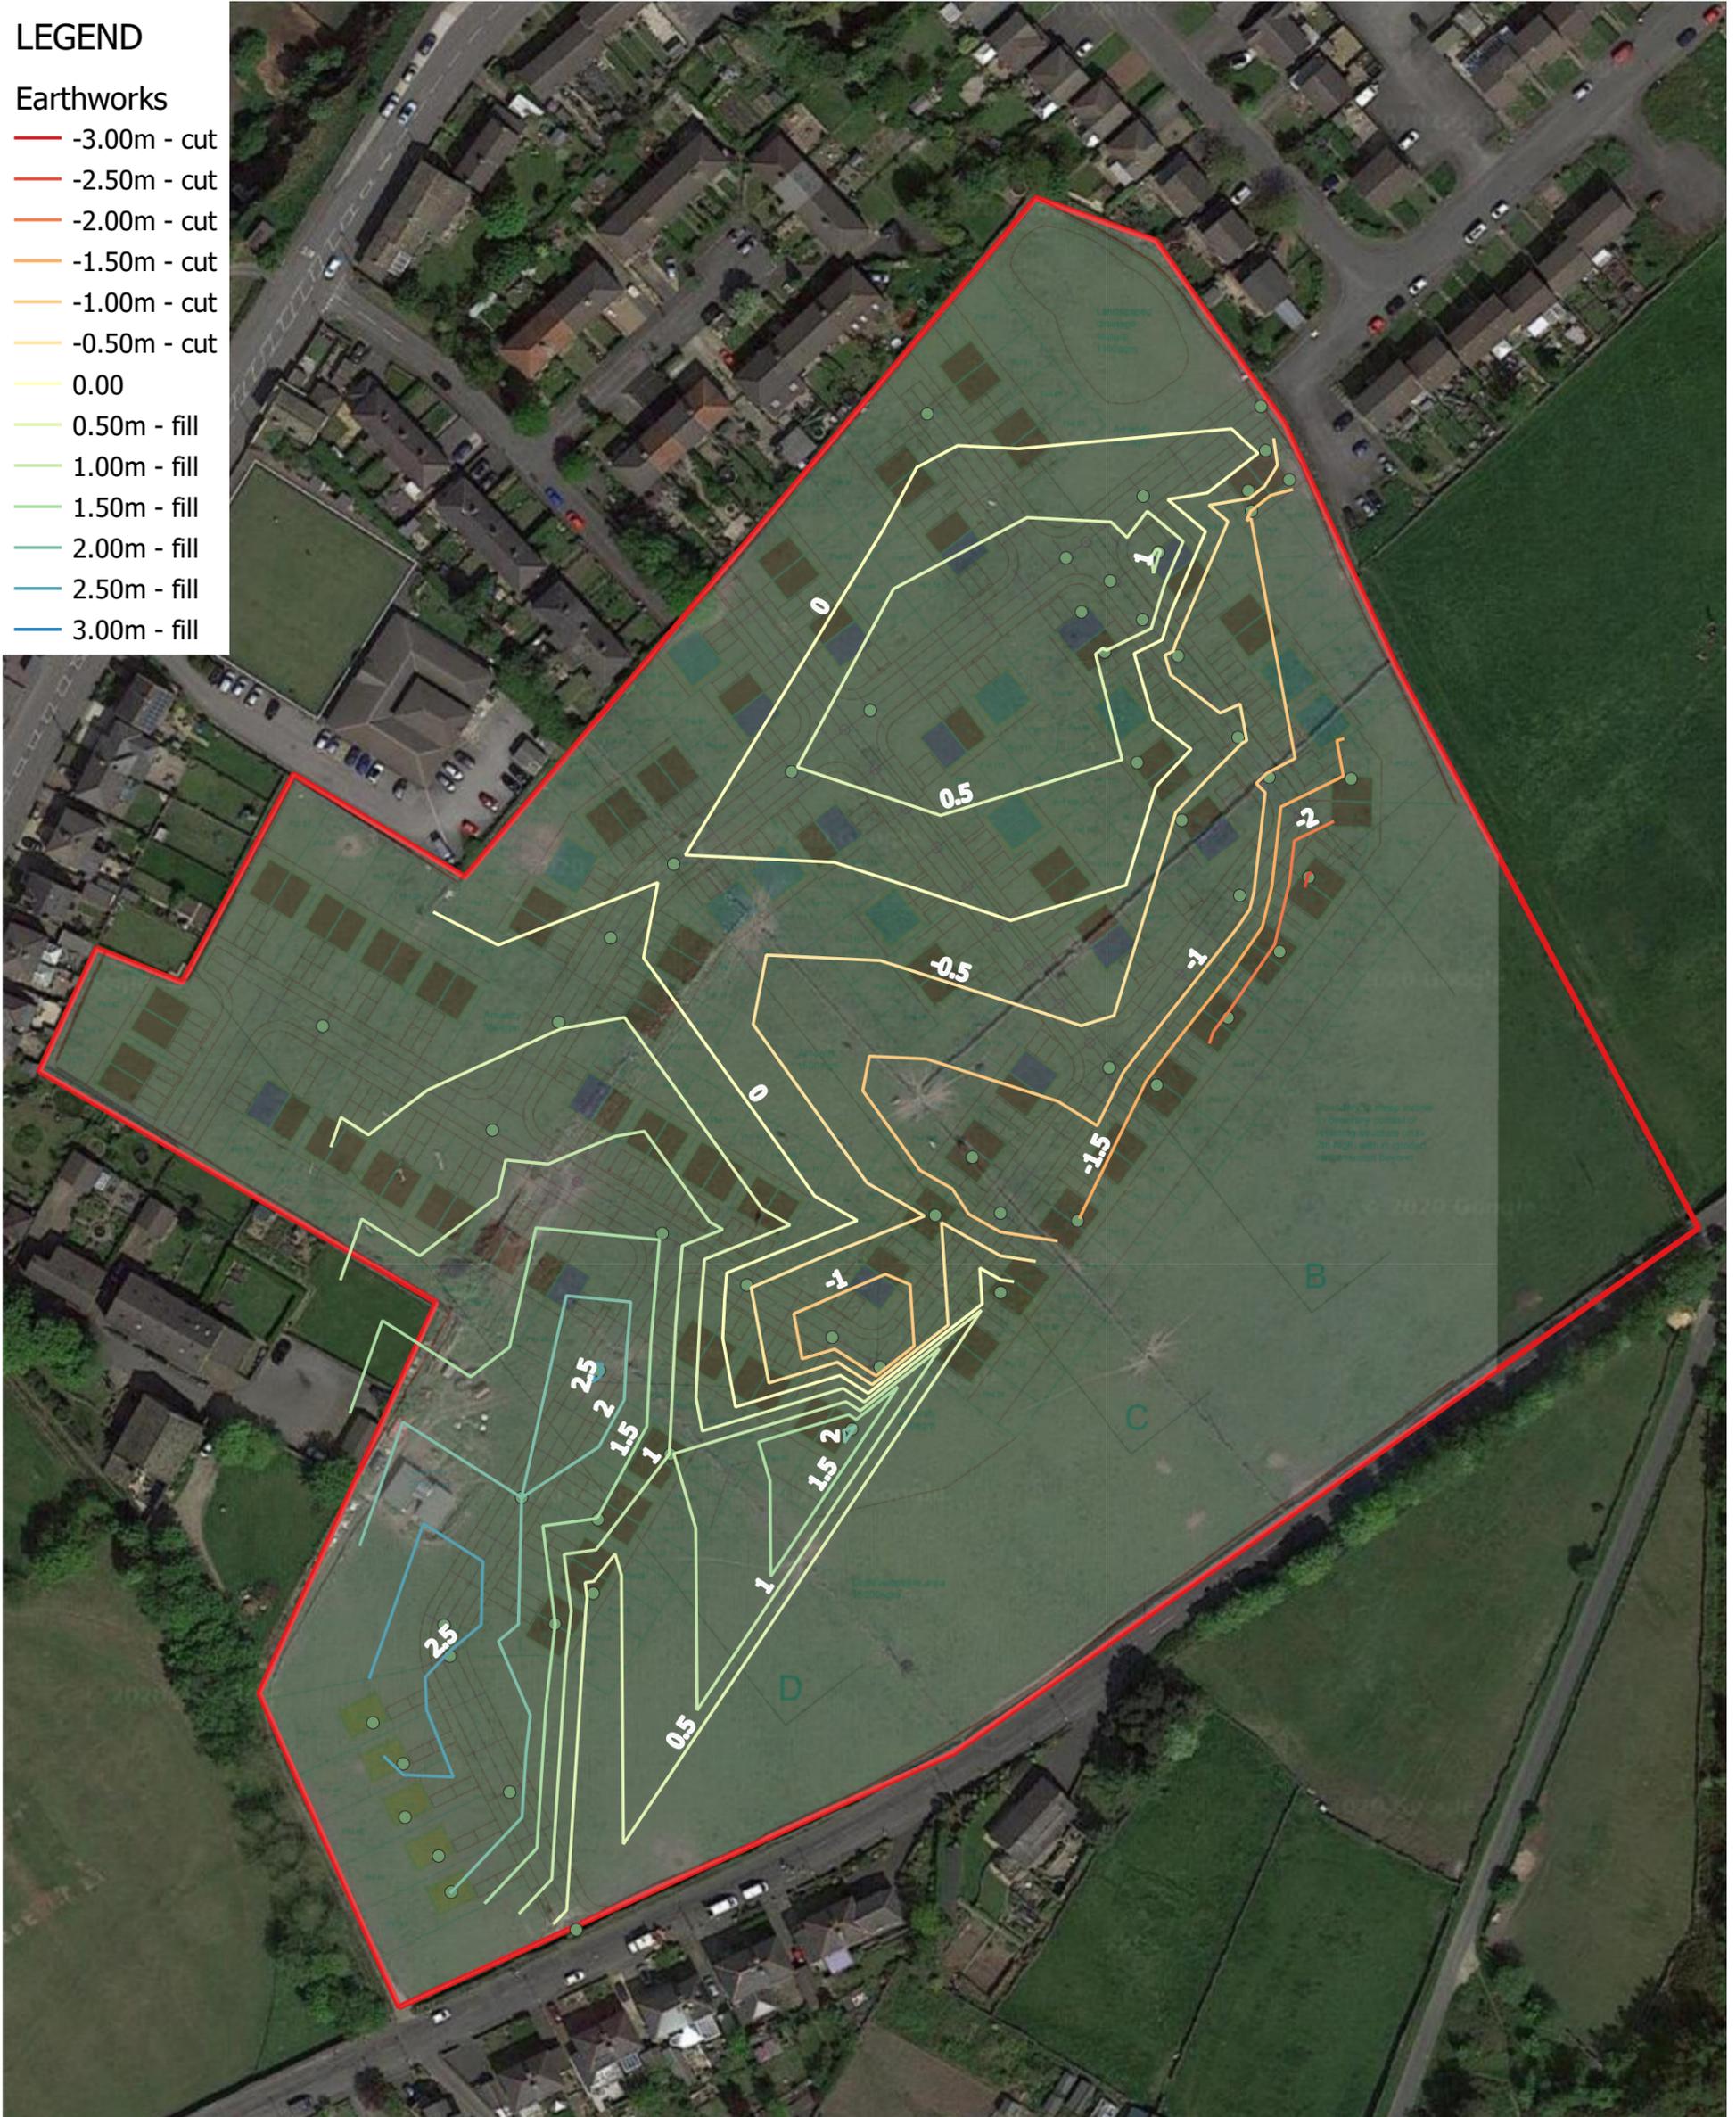
Earthworks

- -3.00m - cut
- -2.50m - cut
- -2.00m - cut
- -1.50m - cut
- -1.00m - cut
- -0.50m - cut
- 0.00
- 0.50m - fill
- 1.00m - fill
- 1.50m - fill
- 2.00m - fill
- 2.50m - fill
- 3.00m - fill

1. Earthwork levels based upon FFL on Tadw Architects drawing 911277 drwg no. 2, issue P2, dated 25/04/19.
2. Existing ground levels based on Latitude Surveys Topographical Survey drawing, reference TW1026-002, dated 17/06/15.
3. Contour lines are automatically generated. Local earthwork profiles likely to change due to proposed development requirements.

The existing topography ranges from 212m AOD in the south western corner to 200m AOD in the north western corner, and from 230m AOD in the south eastern corner to 194m AOD in the north eastern corner. It is inferred by cross referencing the proposed development plan with the topographical plan that up to around 3.0m of fill will take place in the south western corner of the site, whilst up to 2.50m of cut will take place around the eastern part of the site. Minor amounts of cut and fill are to take place elsewhere around the site. An earthwork cut and fill drawing inferred from the aforementioned plans is presented in Appendix C. An allowance for an attenuation pond is included within the proposed development plan however levels haven't been provided for this structure. Therefore the earthwork levels advocated in this specification and within the plan presented in Appendix C are likely to change.

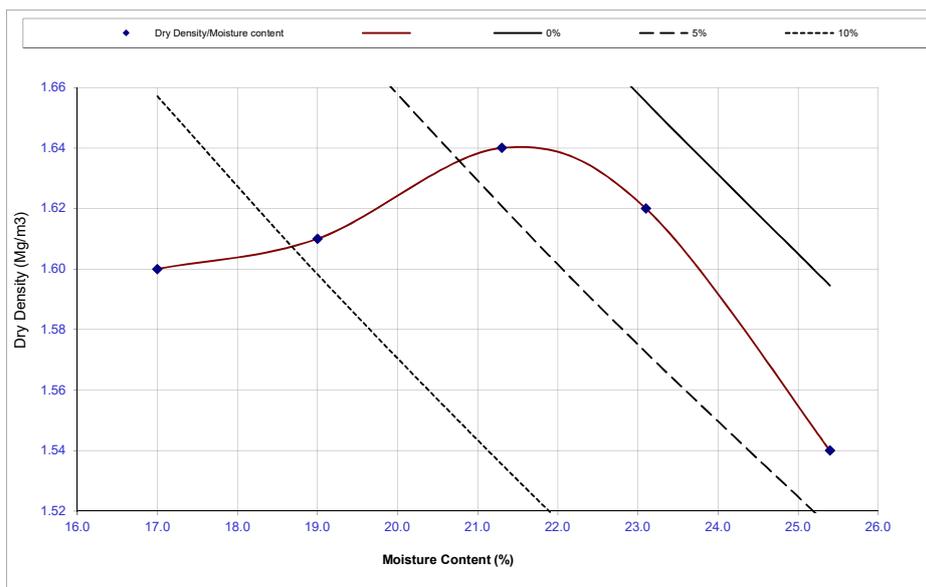
BS 1377 Dry Density / Moisture Content Relationship - 4.5 Kg Rammer

Maximum Dry Density (Mg/m³) : 1.64

Optimum Moisture Content % : 22

1. Samples were prepared in accordance with BS1377:Part 4:1990 Clause 3.2.6.1 using separate batches
2. Testing was in accordance with BS1377:Part 4:1990 Clause 3.5

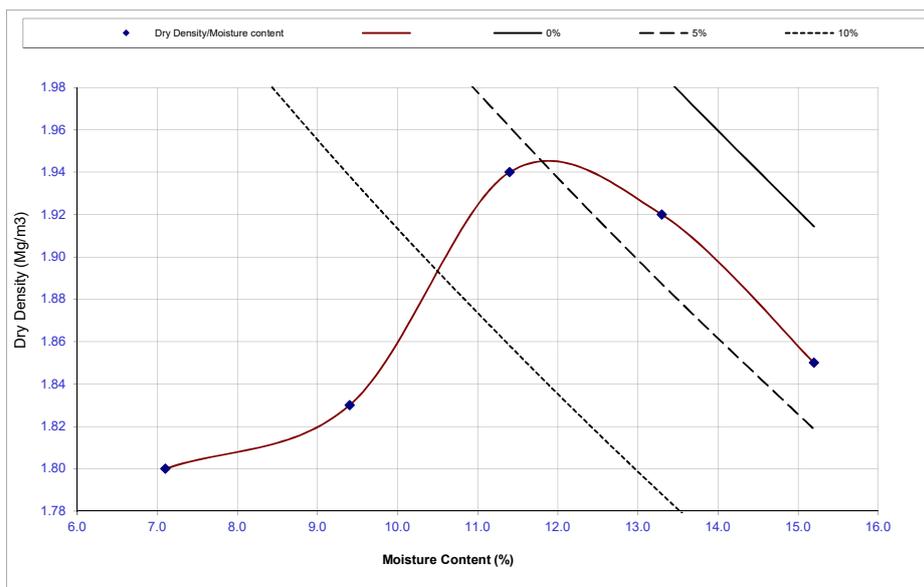
BS 1377 Dry Density / Moisture Content Relationship - 4.5 Kg Rammer

Maximum Dry Density (Mg/m³) : 1.95

Optimum Moisture Content % : 12

1. Samples were prepared in accordance with BS1377:Part 4:1990 Clause 3.2.6.2 using separate batches
2. Testing was in accordance with BS1377:Part 4:1990 Clause Clause 3.5

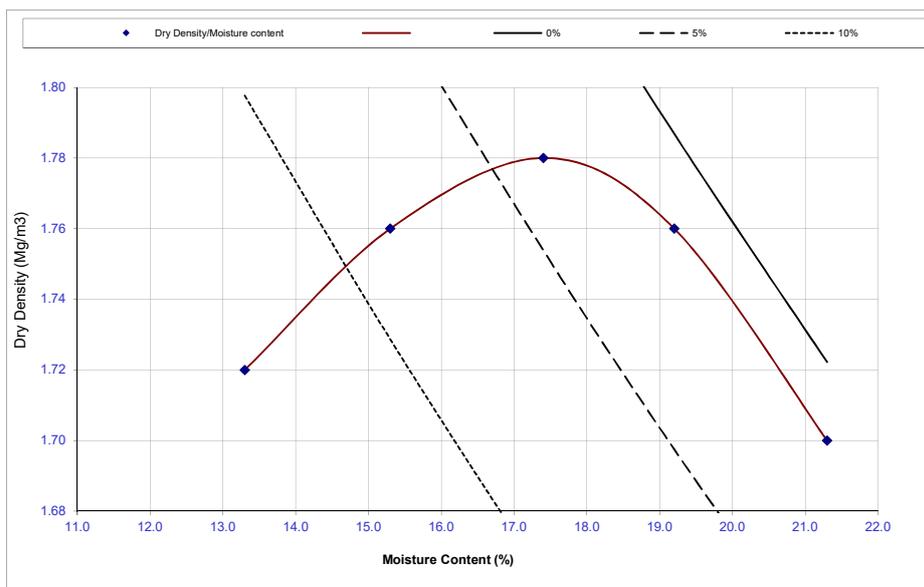
BS 1377 Dry Density / Moisture Content Relationship - 4.5 Kg Rammer

Maximum Dry Density (Mg/m³) : 1.78

Optimum Moisture Content % : 17

1. Samples were prepared in accordance with BS1377:Part 4:1990 Clause 3.2.6.2 using separate batches
2. Testing was in accordance with BS1377:Part 4:1990 Clause 3.5

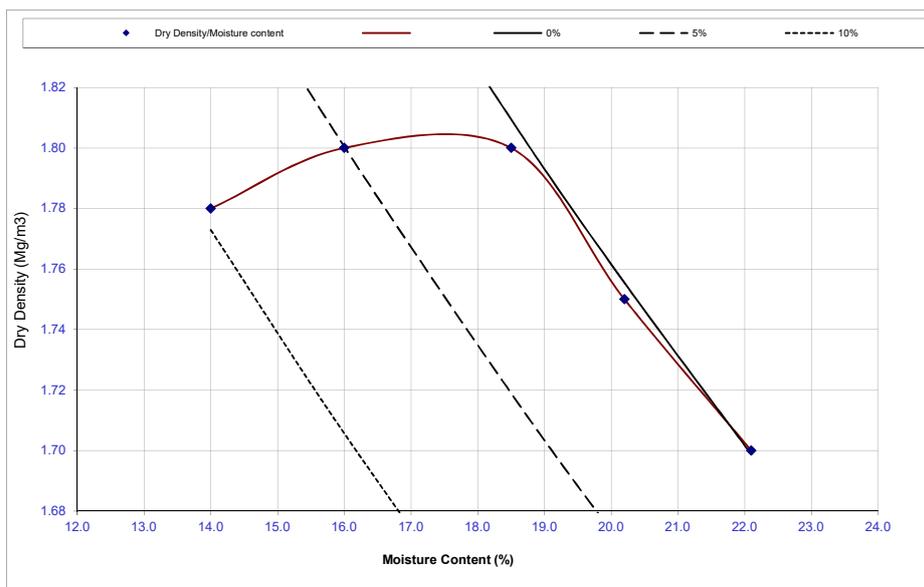
BS 1377 Dry Density / Moisture Content Relationship - 4.5 Kg Rammer

Maximum Dry Density (Mg/m³) : 1.80

Optimum Moisture Content % : 18

1. Samples were prepared in accordance with BS1377:Part 4:1990 Clause 3.2.7.1 using separate batches
2. Testing was in accordance with BS1377:Part 4:1990 Clause 3.6

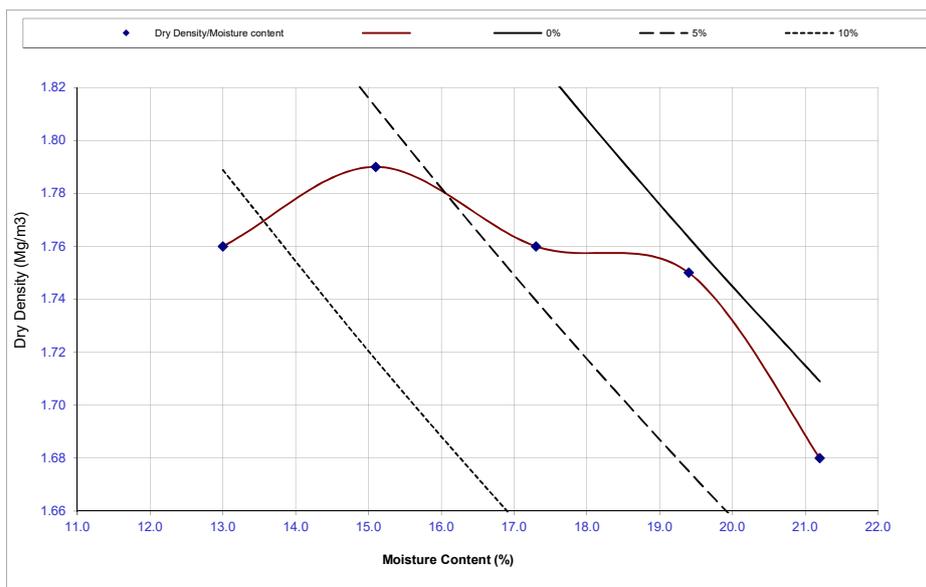
BS 1377 Dry Density / Moisture Content Relationship - 4.5 Kg Rammer

Maximum Dry Density (Mg/m³) : 1.79

Optimum Moisture Content % : 15

1. Samples were prepared in accordance with BS1377:Part 4:1990 Clause 3.2.6.1 using separate batches
2. Testing was in accordance with BS1377:Part 4:1990 Clause 3.5

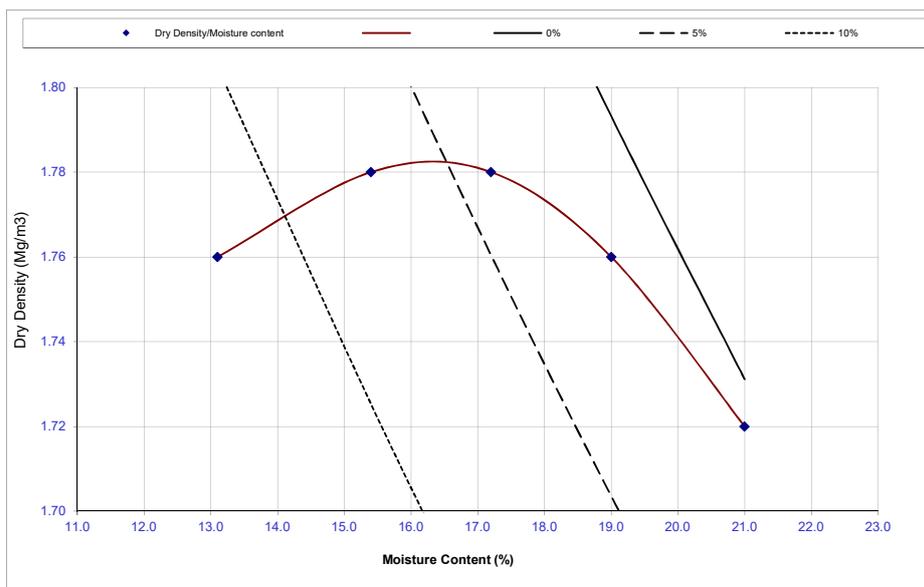
BS 1377 Dry Density / Moisture Content Relationship - 4.5 Kg Rammer

Maximum Dry Density (Mg/m³) : 1.78

Optimum Moisture Content % : 16

1. Samples were prepared in accordance with BS1377:Part 4:1990 Clause 3.2.6.1 using separate batches
2. Testing was in accordance with BS1377:Part 4:1990 Clause 3.5

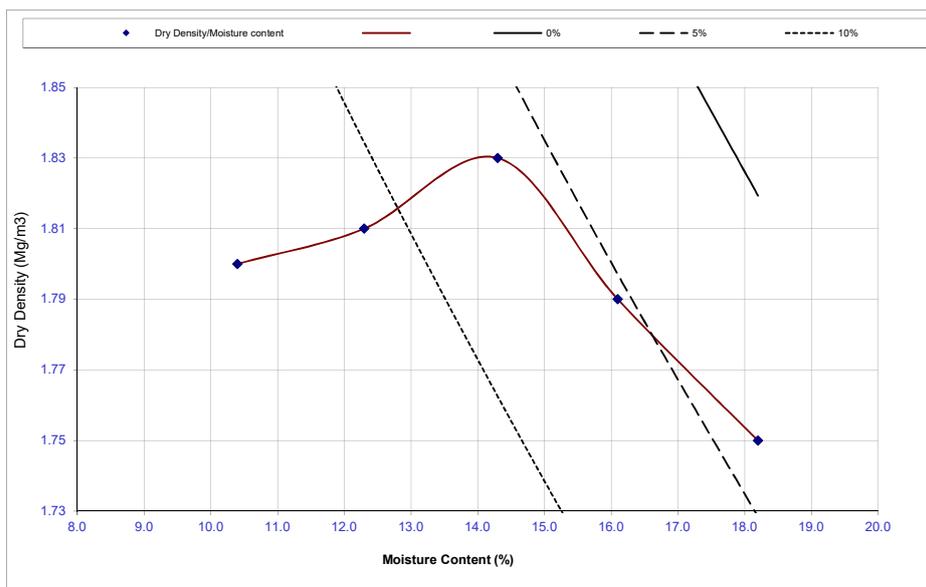
BS 1377 Dry Density / Moisture Content Relationship - 4.5 Kg Rammer

Maximum Dry Density (Mg/m³) : 1.83

Optimum Moisture Content % : 14

1. Samples were prepared in accordance with BS1377:Part 4:1990 Clause 3.2.7.2 using separate batches
2. Testing was in accordance with BS1377:Part 4:1990 Clause 3.6

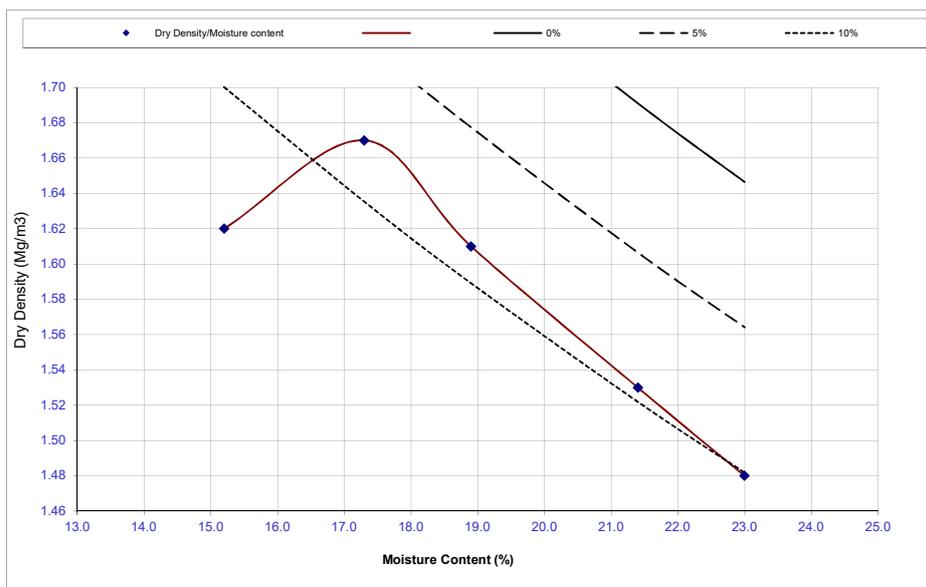
BS 1377 Dry Density / Moisture Content Relationship - 4.5 Kg Rammer

Maximum Dry Density (Mg/m³) : 1.67

Optimum Moisture Content % : 17

1. Samples were prepared in accordance with BS1377:Part 4:1990 Clause 3.2.6.1 using separate batches
2. Testing was in accordance with BS1377:Part 4:1990 Clause 3.5

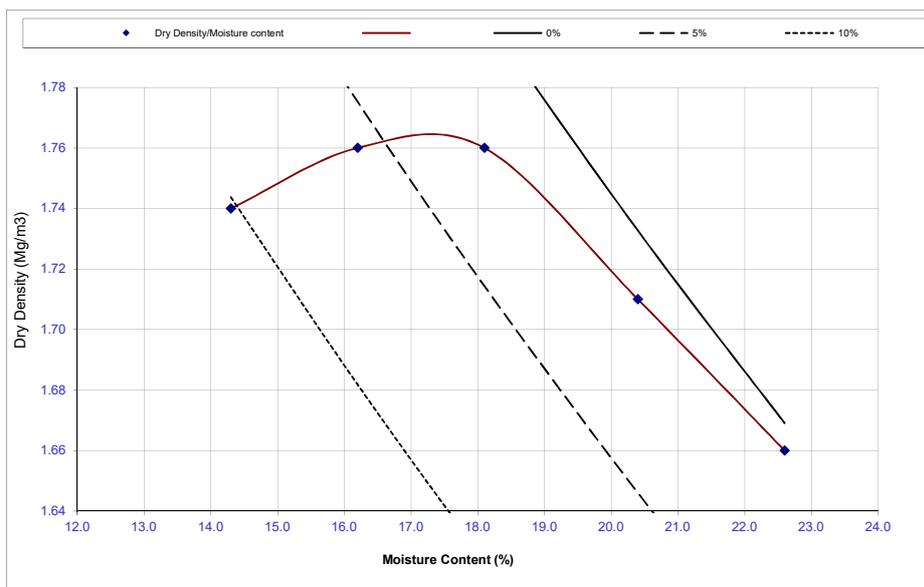
BS 1377 Dry Density / Moisture Content Relationship - 4.5 Kg Rammer

Maximum Dry Density (Mg/m³) : 1.76

Optimum Moisture Content % : 17

1. Samples were prepared in accordance with BS1377:Part 4:1990 Clause 3.2.6.1 using separate batches
2. Testing was in accordance with BS1377:Part 4:1990 Clause 3.5

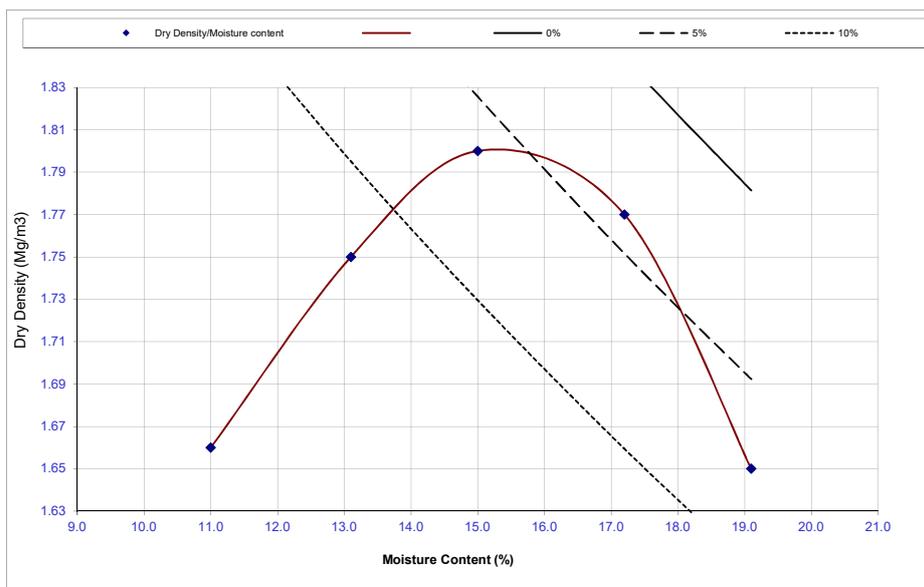
BS 1377 Dry Density / Moisture Content Relationship - 4.5 Kg Rammer

Maximum Dry Density (Mg/m³) : 1.80

Optimum Moisture Content % : 15

1. Samples were prepared in accordance with BS1377:Part 4:1990 Clause 3.2.6.1 using separate batches
2. Testing was in accordance with BS1377:Part 4:1990 Clause 3.5

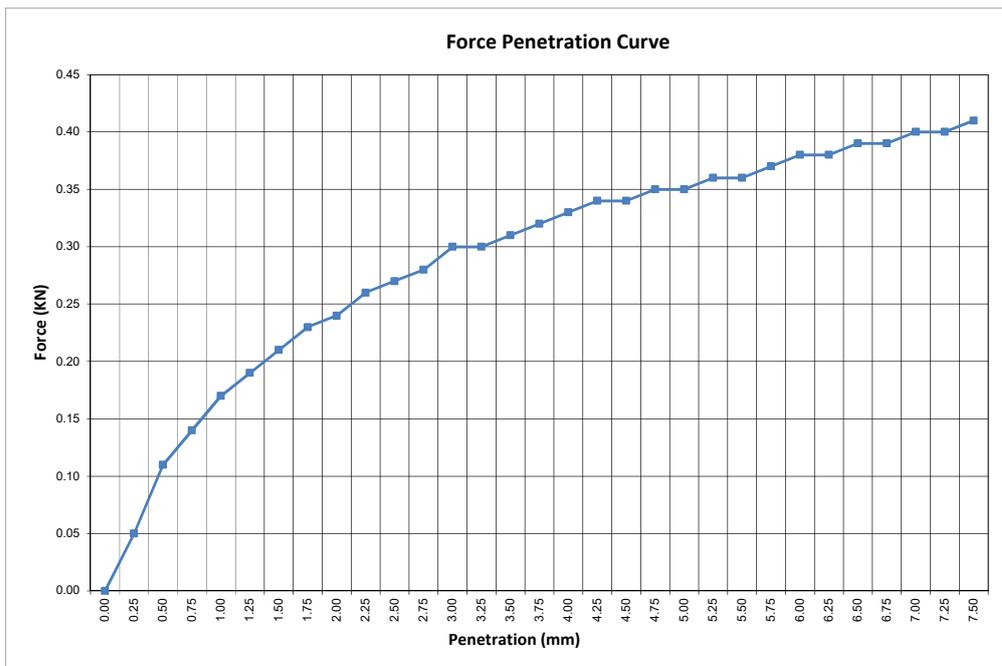
NC Reference	84680
---------------------	--------------

Client reference :	TP101	Location:	TP101
Sample Depth - Top (m):	0.5	Sample Depth - Bottom (m):	0.6
Visual description :	Brown slightly silty clay		
Sample type:	Disturbed		
Initial Bulk Density (Mg/m3) :	1.83	Initial Dry Density (Mg/m3) :	1.35
Material retained on 20mm test sieve (%) :	0	Moisture content (%) :	35
California Bearing Ratio (CBR) % :	2.0

1. Testing was in accordance with BS 1377 : Part 4 : 1990 : Clause 7.
2. Sample preparation was in accordance with cl.7.2.4.4 method 5 4.5kg rammer
3. The test specimen was not soaked prior to testing

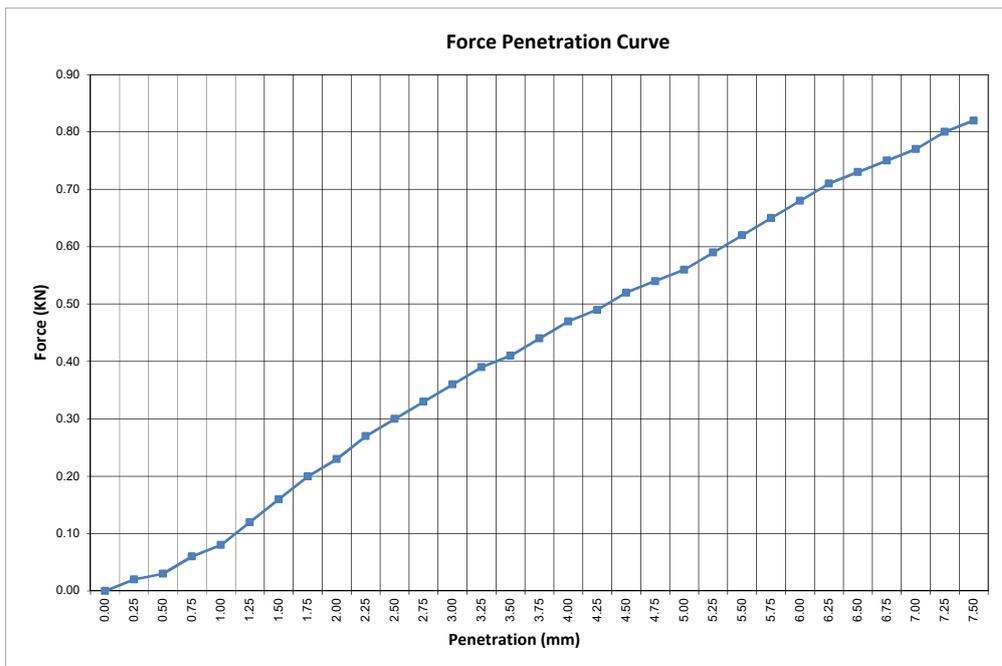
NC Reference	84682
---------------------	--------------

Client reference :	TP107	Location:	TP107
Sample Depth - Top (m):	0.7	Sample Depth - Bottom (m):	0.8
Visual description :	Brown silty clay with occasional sandstone		
Sample type:	Disturbed		
Initial Bulk Density (Mg/m3) :	2.15	Initial Dry Density (Mg/m3) :	1.84
Material retained on 20mm test sieve (%) :	3	Moisture content (%) :	17
California Bearing Ratio (CBR) % :	2.8

1. Testing was in accordance with BS 1377 : Part 4 : 1990 : Clause 7.
2. Sample preparation was in accordance with cl.7.2.4.4 method 5 4.5kg rammer
3. The test specimen was not soaked prior to testing

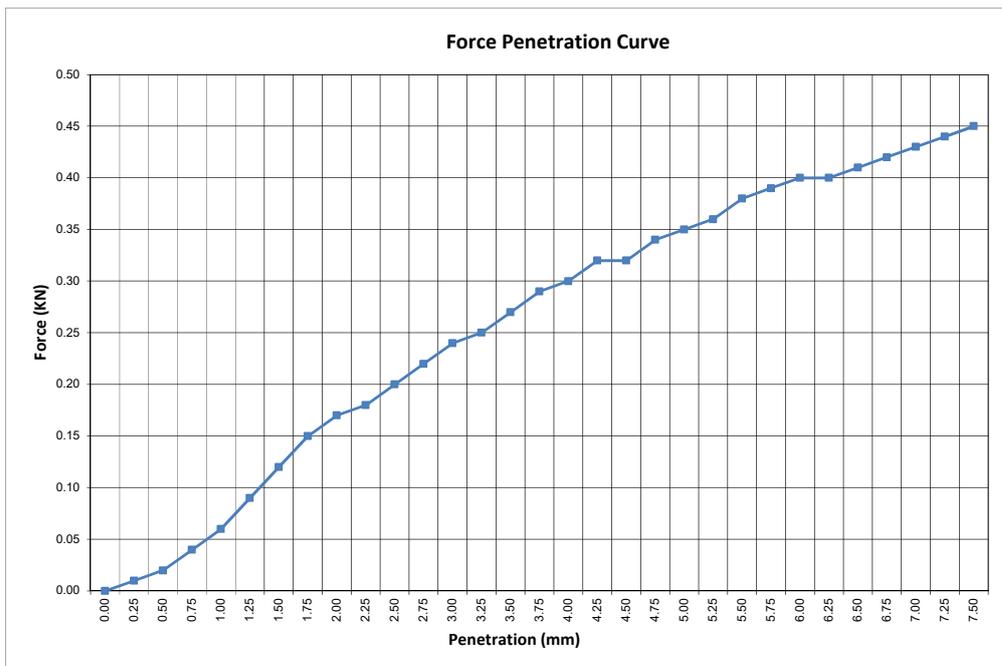
NC Reference **84683**

Client reference :	TP108	Location:	TP108
Sample Depth - Top (m):	0.6	Sample Depth - Bottom (m):	0.7
Visual description :	Brown slightly silty clay		
Sample type:	Disturbed		
Initial Bulk Density (Mg/m3) :	1.98	Initial Dry Density (Mg/m3) :	1.58
Material retained on 20mm test sieve (%) :	2	Moisture content (%) :	25
California Bearing Ratio (CBR) % :	1.8

1. Testing was in accordance with BS 1377 : Part 4 : 1990 : Clause 7.
2. Sample preparation was in accordance with cl.7.2.4.4 method 5 4.5kg rammer
3. The test specimen was not soaked prior to testing

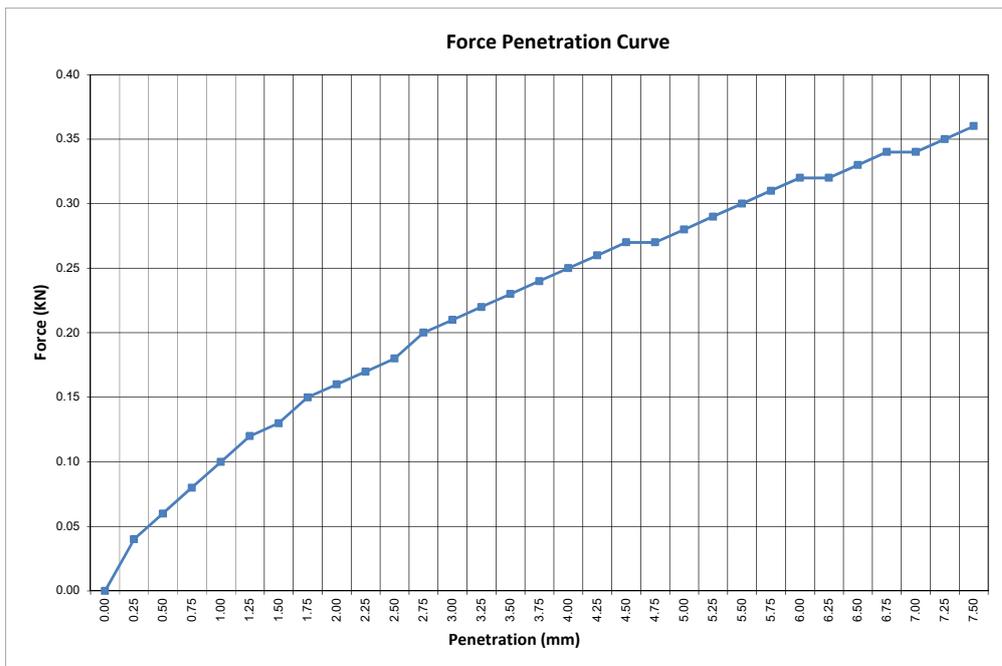
NC Reference **84684**

Client reference :	TTP109	Location:	TP109
Sample Depth - Top (m):	0.7	Sample Depth - Bottom (m):	0.8
Visual description :	Brown slightly silty clay with mudstone		
Sample type:	Disturbed		
Initial Bulk Density (Mg/m3) :	2.04	Initial Dry Density (Mg/m3) :	1.65
Material retained on 20mm test sieve (%) :	8	Moisture content (%) :	24
California Bearing Ratio (CBR) % :	1.4

1. Testing was in accordance with BS 1377 : Part 4 : 1990 : Clause 7.
2. Sample preparation was in accordance with cl.7.2.4.4 method 5 4.5kg rammer
3. The test specimen was not soaked prior to testing

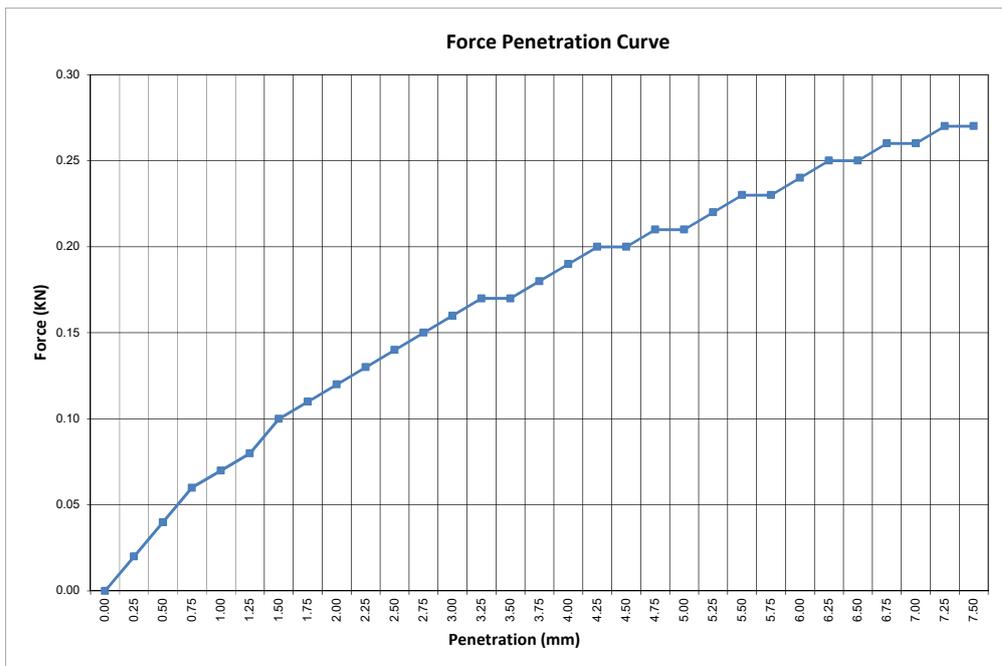
NC Reference	84685
---------------------	--------------

Client reference :	TP110	Location:	TP110
Sample Depth - Top (m):	0.8	Sample Depth - Bottom (m):	0.9
Visual description :	Light brown sandy silt		
Sample type:	Disturbed		
Initial Bulk Density (Mg/m3) :	1.93	Initial Dry Density (Mg/m3) :	1.49
Material retained on 20mm test sieve (%) :	0	Moisture content (%) :	29
California Bearing Ratio (CBR) % :	1.1

1. Testing was in accordance with BS 1377 : Part 4 : 1990 : Clause 7.
2. Sample preparation was in accordance with cl.7.2.4.4 method 5 4.5kg rammer
3. The test specimen was not soaked prior to testing

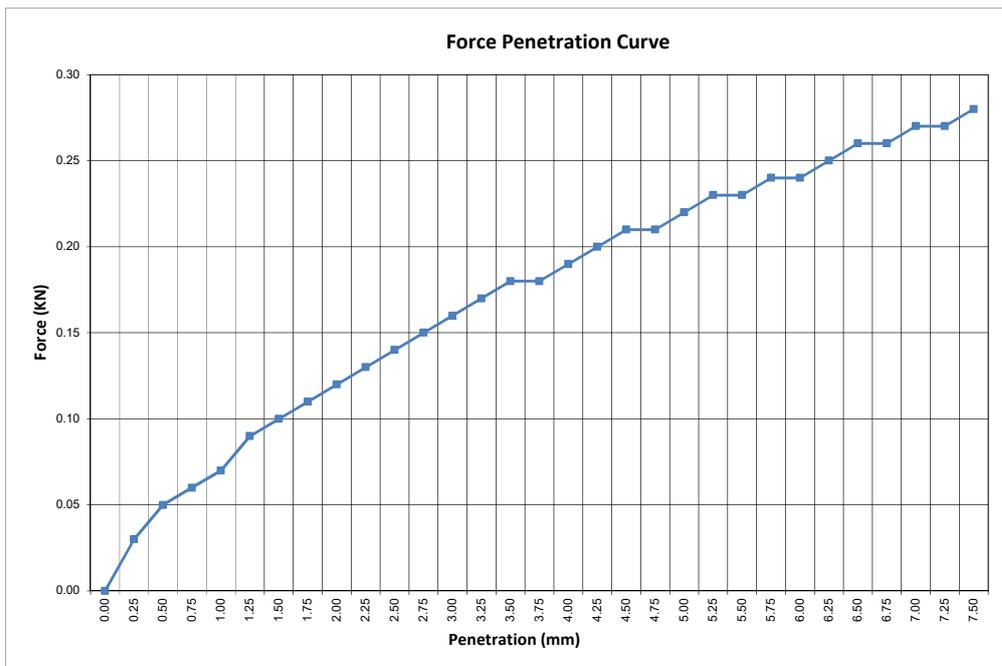
NC Reference	84686
---------------------	--------------

Client reference :	TP111	Location:	TP111
Sample Depth - Top (m):	0.4	Sample Depth - Bottom (m):	0.5
Visual description :	Light brown sandy silt		
Sample type:	Disturbed		
Initial Bulk Density (Mg/m3) :	1.95	Initial Dry Density (Mg/m3) :	1.51
Material retained on 20mm test sieve (%) :	0	Moisture content (%) :	29
California Bearing Ratio (CBR) % :	1.1

1. Testing was in accordance with BS 1377 : Part 4 : 1990 : Clause 7.
2. Sample preparation was in accordance with cl.7.2.4.4 method 5 4.5kg rammer
3. The test specimen was not soaked prior to testing

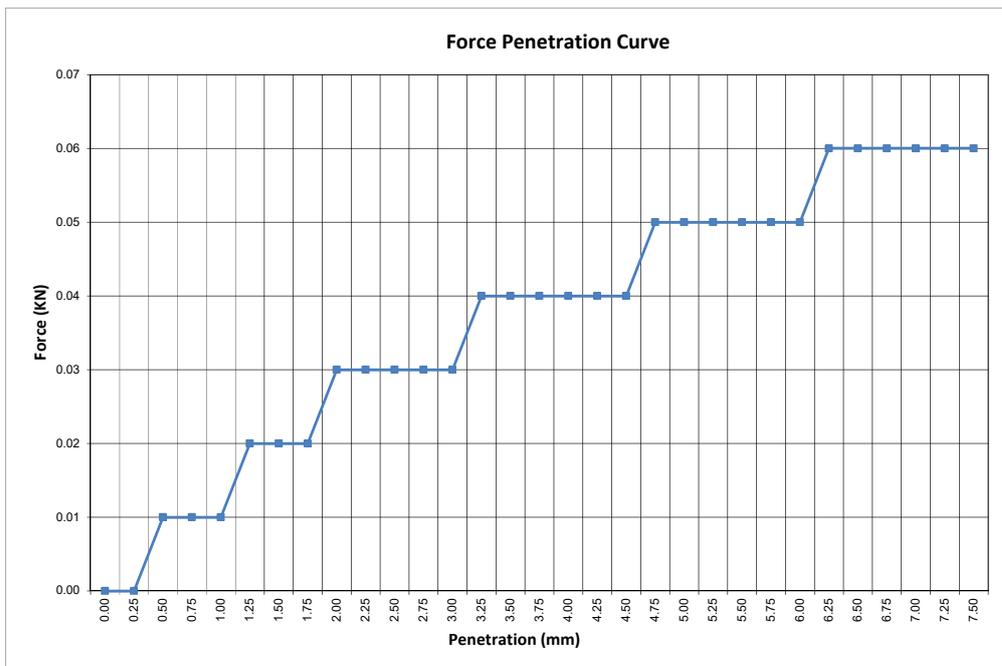
NC Reference	84687
---------------------	--------------

Client reference :	TP112	Location:	TP112
Sample Depth - Top (m):	0.4	Sample Depth - Bottom (m):	0.5
Visual description :	Brown silty clay with mudstone		
Sample type:	Disturbed		
Initial Bulk Density (Mg/m3) :	1.93	Initial Dry Density (Mg/m3) :	1.55
Material retained on 20mm test sieve (%) :	13	Moisture content (%) :	25
California Bearing Ratio (CBR) % :	0.3

1. Testing was in accordance with BS 1377 : Part 4 : 1990 : Clause 7.
2. Sample preparation was in accordance with cl.7.2.4.4 method 5 4.5kg rammer
3. The test specimen was not soaked prior to testing

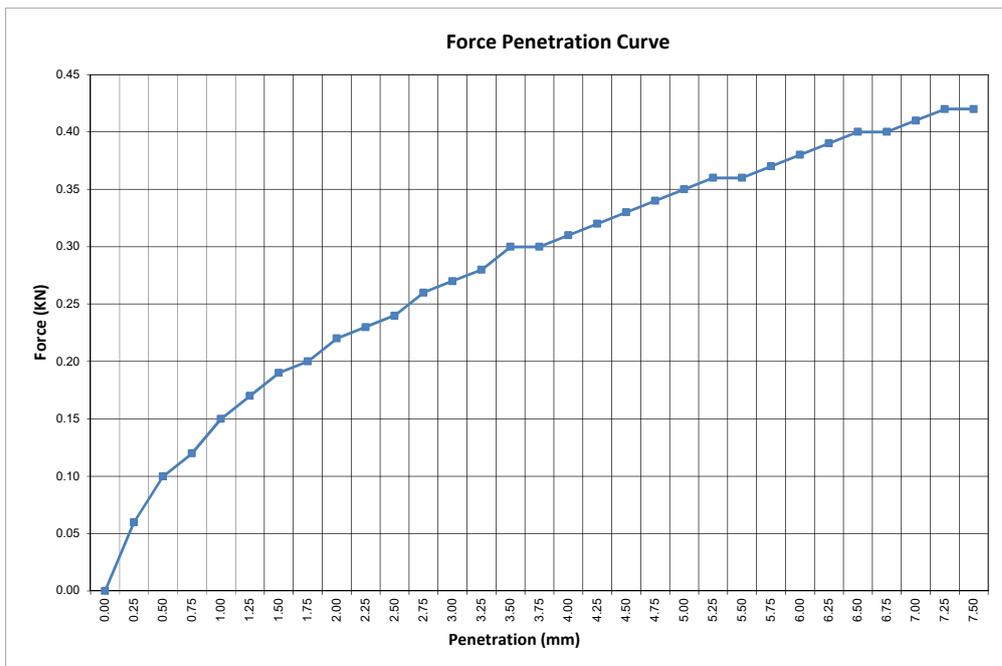
NC Reference	84688
---------------------	--------------

Client reference :	TP113	Location:	TP113
Sample Depth - Top (m):	0.5	Sample Depth - Bottom (m):	0.6
Visual description :	Light brown silty clay		
Sample type:	Disturbed		
Initial Bulk Density (Mg/m3) :	1.92	Initial Dry Density (Mg/m3) :	1.49
Material retained on 20mm test sieve (%) :	0	Moisture content (%) :	29
California Bearing Ratio (CBR) % :	1.8

1. Testing was in accordance with BS 1377 : Part 4 : 1990 : Clause 7.
2. Sample preparation was in accordance with cl.7.2.4.4 method 5 4.5kg rammer
3. The test specimen was not soaked prior to testing

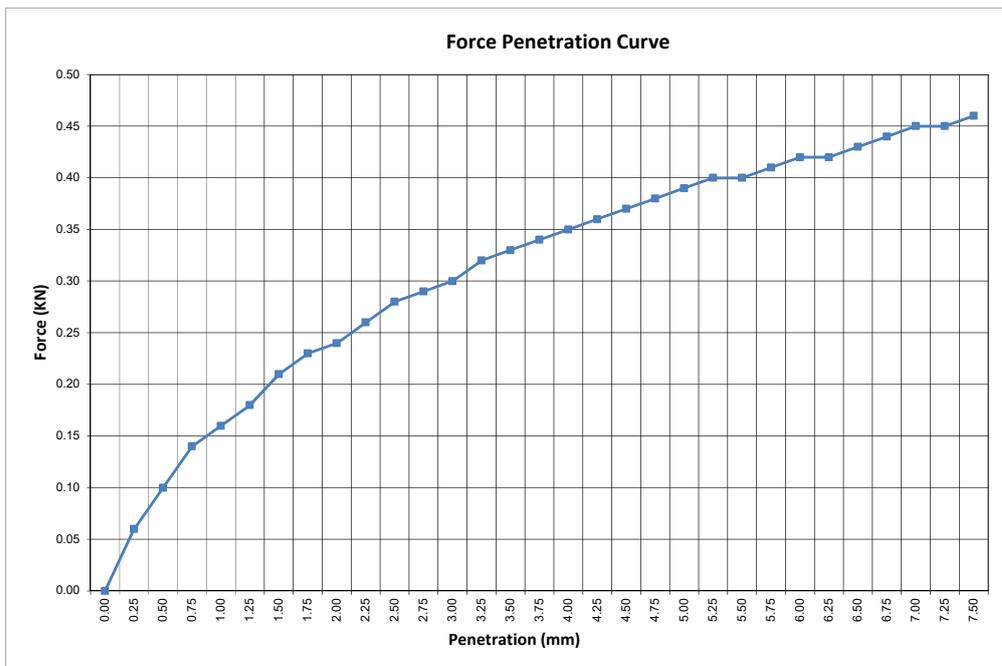
NC Reference	84689
---------------------	--------------

Client reference :	TP115	Location:	TP115
Sample Depth - Top (m):	0.8	Sample Depth - Bottom (m):	0.9
Visual description :	Brown silty clay		
Sample type:	Disturbed		
Initial Bulk Density (Mg/m3) :	1.92	Initial Dry Density (Mg/m3) :	1.48
Material retained on 20mm test sieve (%) :	0	Moisture content (%) :	30
California Bearing Ratio (CBR) % :	2.1

1. Testing was in accordance with BS 1377 : Part 4 : 1990 : Clause 7.
2. Sample preparation was in accordance with cl.7.2.4.4 method 5 4.5kg rammer
3. The test specimen was not soaked prior to testing

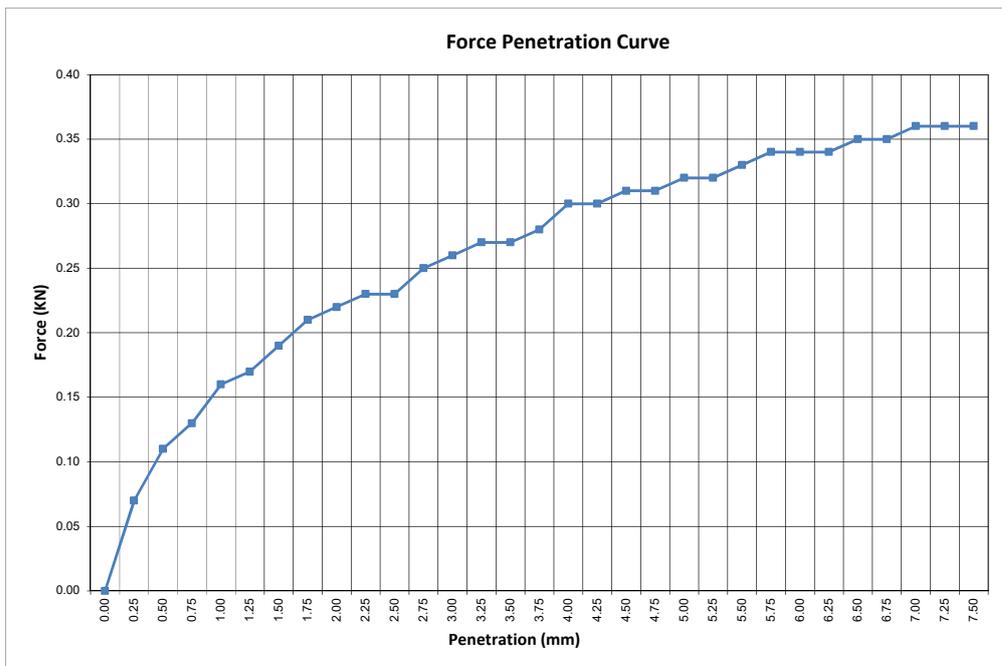
NC Reference	84690
---------------------	--------------

Client reference :	TP116	Location:	TP116
Sample Depth - Top (m):	0.8	Sample Depth - Bottom (m):	0.9
Visual description :	Brown slightly gravelly silty clay		
Sample type:	Disturbed		
Initial Bulk Density (Mg/m3) :	1.72	Initial Dry Density (Mg/m3) :	1.16
Material retained on 20mm test sieve (%) :	0	Moisture content (%) :	49
California Bearing Ratio (CBR) % :	1.7

1. Testing was in accordance with BS 1377 : Part 4 : 1990 : Clause 7.
2. Sample preparation was in accordance with cl.7.2.4.4 method 5 4.5kg rammer
3. The test specimen was not soaked prior to testing
