**CCTV REPORT FOR: 5 WESTFIELD COURT  
MIRFIELD  
WEST YORKSHIRE  
WF14 9PT**

**CONTENTS:** SITE LAYOUT  
FOUNDATION RECORD  
PHOTOGRAPHS  
LABORATORY TESTING RESULTS  
ROOT IDENTIFICATION

**Insured:** Mr Paul Moorhouse  
**Reference:** DLG-SN-22-005272 Ins Ref: 084495365

**Site Visit:** 25-Nov-24  
**Report Date:** 02-Jan-25

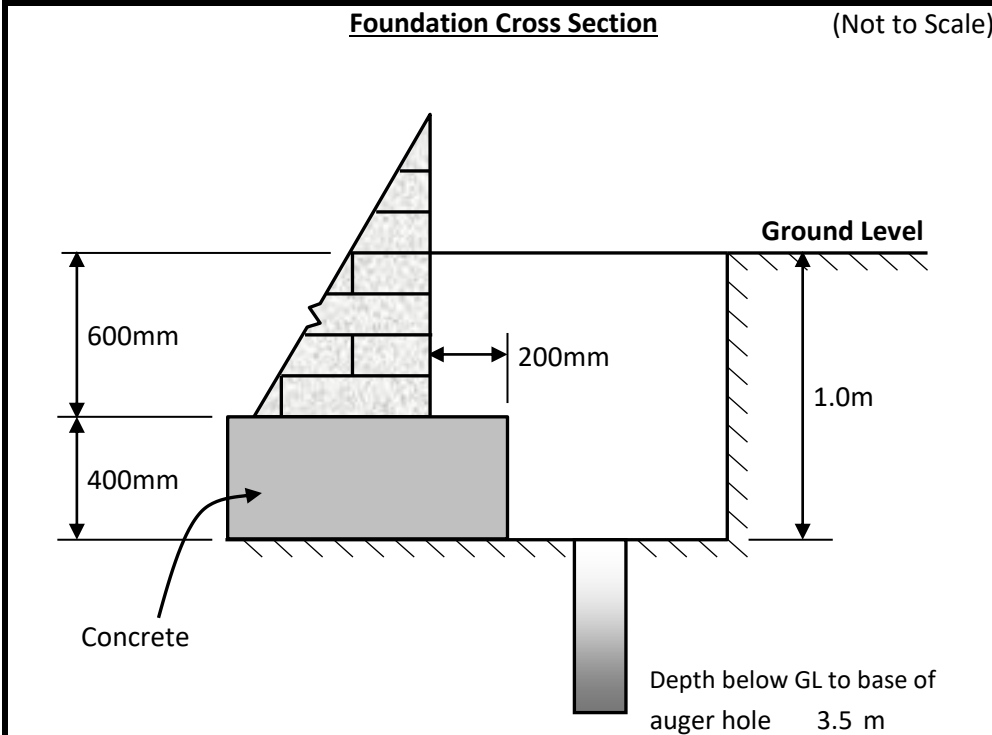
Location: <b>Rear Left Hand Corner</b>	T/H No. <b>1</b>
Ground Surface: <b>Dry</b>	Weather: <b>Dry</b>
	Date: <b>25-Nov-24</b>

Roots Depth & Diameter:
From 1.0m
Down to 2.0m
up to 2mm diameter
Water Depth Hit & Rise:
None observed on site
Reason for Termination :
Encountered obstruction
Bedrock

Depth (m)	Soil Descriptions <i>(NB: Field crew description only)</i>	Test Type	Depth (m)	
			From	To
G.L.				
1.00	Firm light grey/dark brown slightly sandy/silty CLAY with some medium gravel & rare rootlets	V(n) 45	1.000	
1.50	Firm light grey/brown slightly sandy/silty CLAY with some medium gravel	V(n) 53	1.500	
2.00	Firm/stiff friable light grey/brown slightly sandy/silty CLAY with some medium gravel	V(n) 67	2.000	
2.50	Firm/stiff friable grey/brown slightly sandy/silty CLAY with some medium gravel	V(n) 70	2.500	
3.50	End of Borehole	V(n) 72	3.000	
		Mac 50+	3.500	3.575

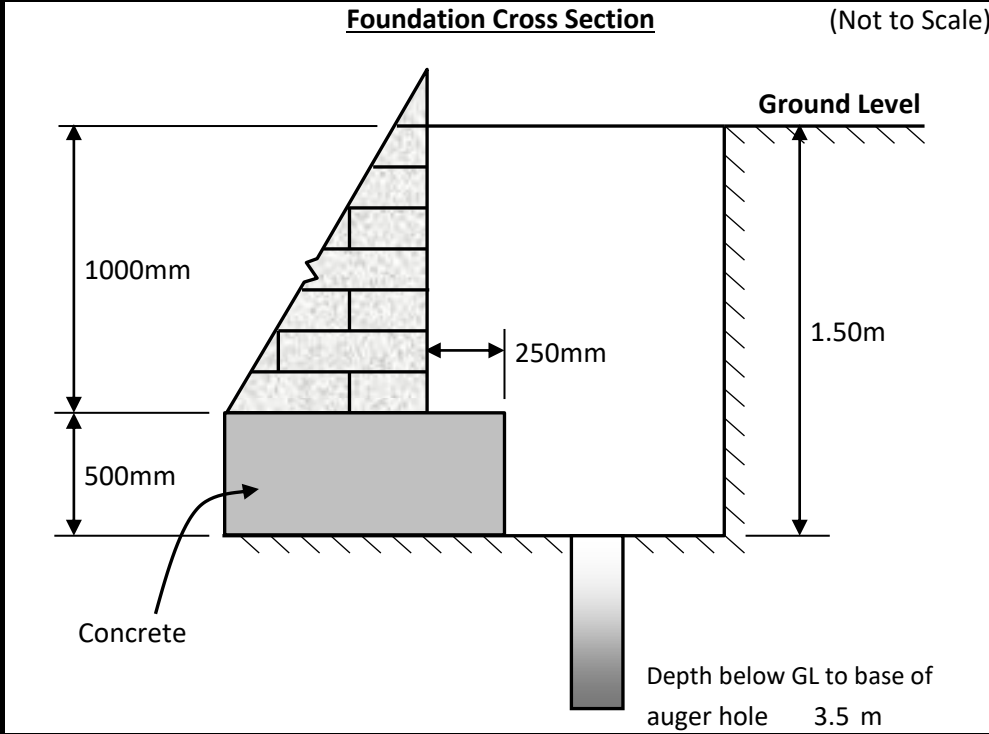
Location: **Middle of Rear of Original House** T/H No. **2**  
 Ground Surface: **Dry** Weather: **Dry** Date: **25-Nov-24**

**Roots Depth & Diameter:**  
 From 1.5m  
 Down to 2.0m  
 up to 2mm diameter

**Water Depth Hit & Rise:**  
 None observed on site

**Reason for Termination :**  
 Encountered obstruction  
 Bedrock

Depth (m)	Soil Descriptions <i>(NB: Field crew description only)</i>	Test Type	Depth (m)	
			From	To
G.L.				
1.50	Soft/firm grey/brown slightly sandy/silty CLAY with some medium gravel & rare rootlets	V(n) 57	1.500	
2.00	Firm grey/brown slightly sandy/silty CLAY with some medium gravel	V(n) 54	2.000	
2.50	Firm/stiff friable grey/brown slightly sandy/silty CLAY with some medium gravel	V(n) 71	2.500	
3.50	End of Borehole	V(n) 71	3.000	
		Mac 50+	3.500	3.575
<b>Photograph</b>

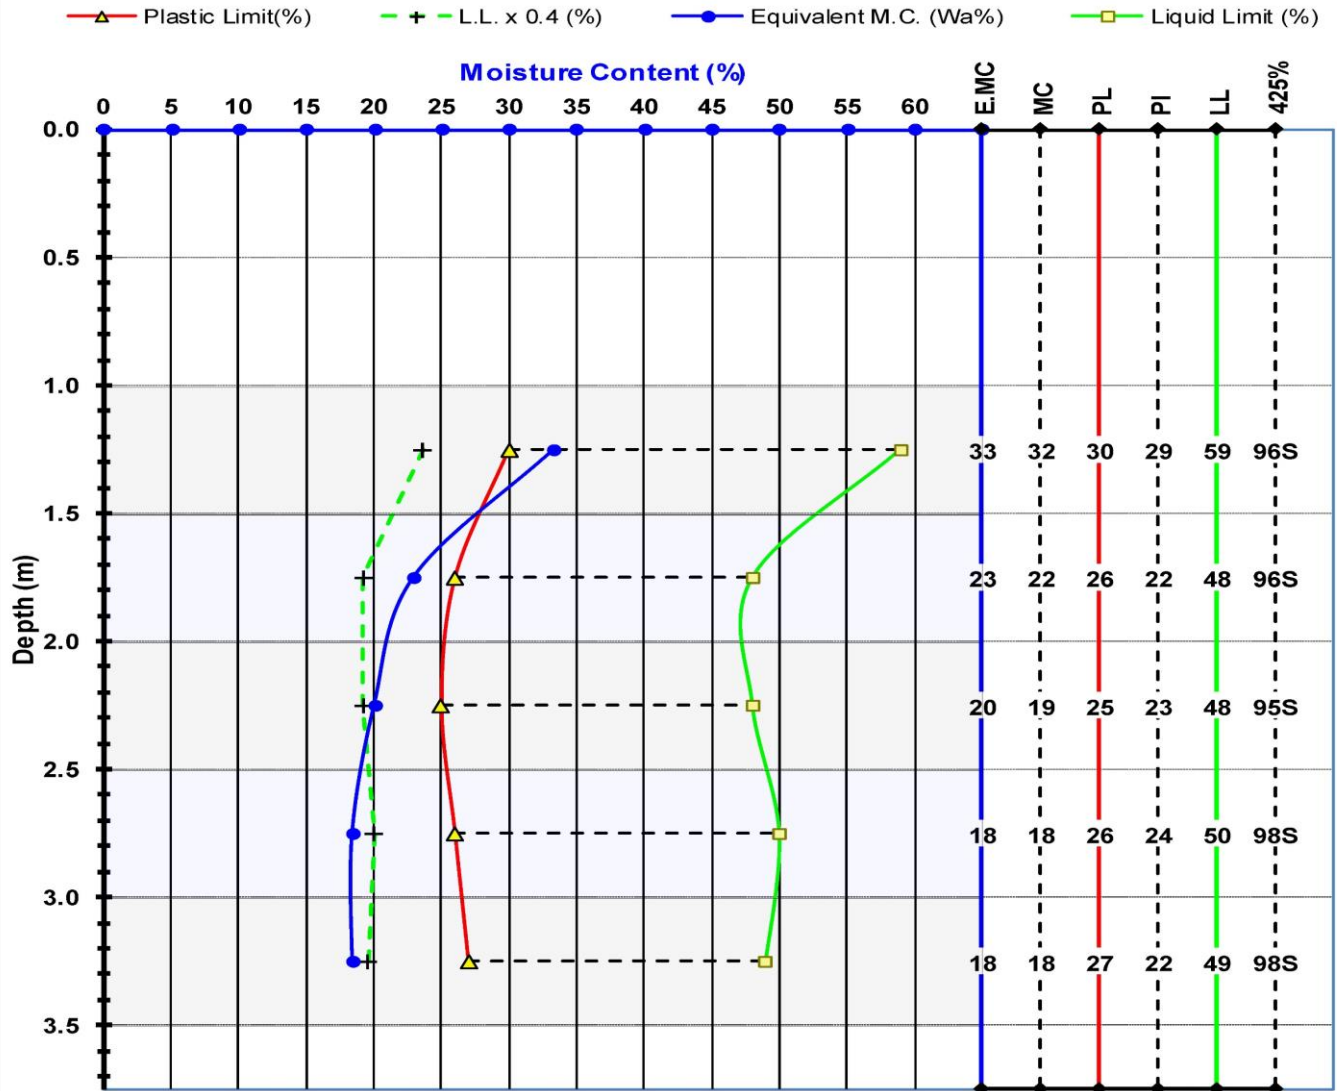
Depth T (m)	Depth B (m)	1 - Rear LHC of extension	Plasticity (BS 5930)	Volume Change (BRE 240)	
		Brief Soil Description		M.PI	(%)
1	1.5	Firm light grey/dark brown slightly sandy/silty CLAY with some medium gravel & rare rootlets	High CH	28%	Medium
1.5	2	Firm light grey/brown slightly sandy/silty CLAY with some medium gravel	Intmd. CI	21%	Medium
2	2.5	Firm/stiff friable light grey/brown slightly sandy/silty CLAY with some medium gravel	Intmd. CI	22%	Medium
2.5	3	Firm/stiff friable grey/brown slightly sandy/silty CLAY with some medium gravel	Intmd. CI	24%	Medium
3	3.5	Firm/stiff friable grey/brown slightly sandy/silty CLAY with some medium gravel	Intmd. CI	22%	Medium

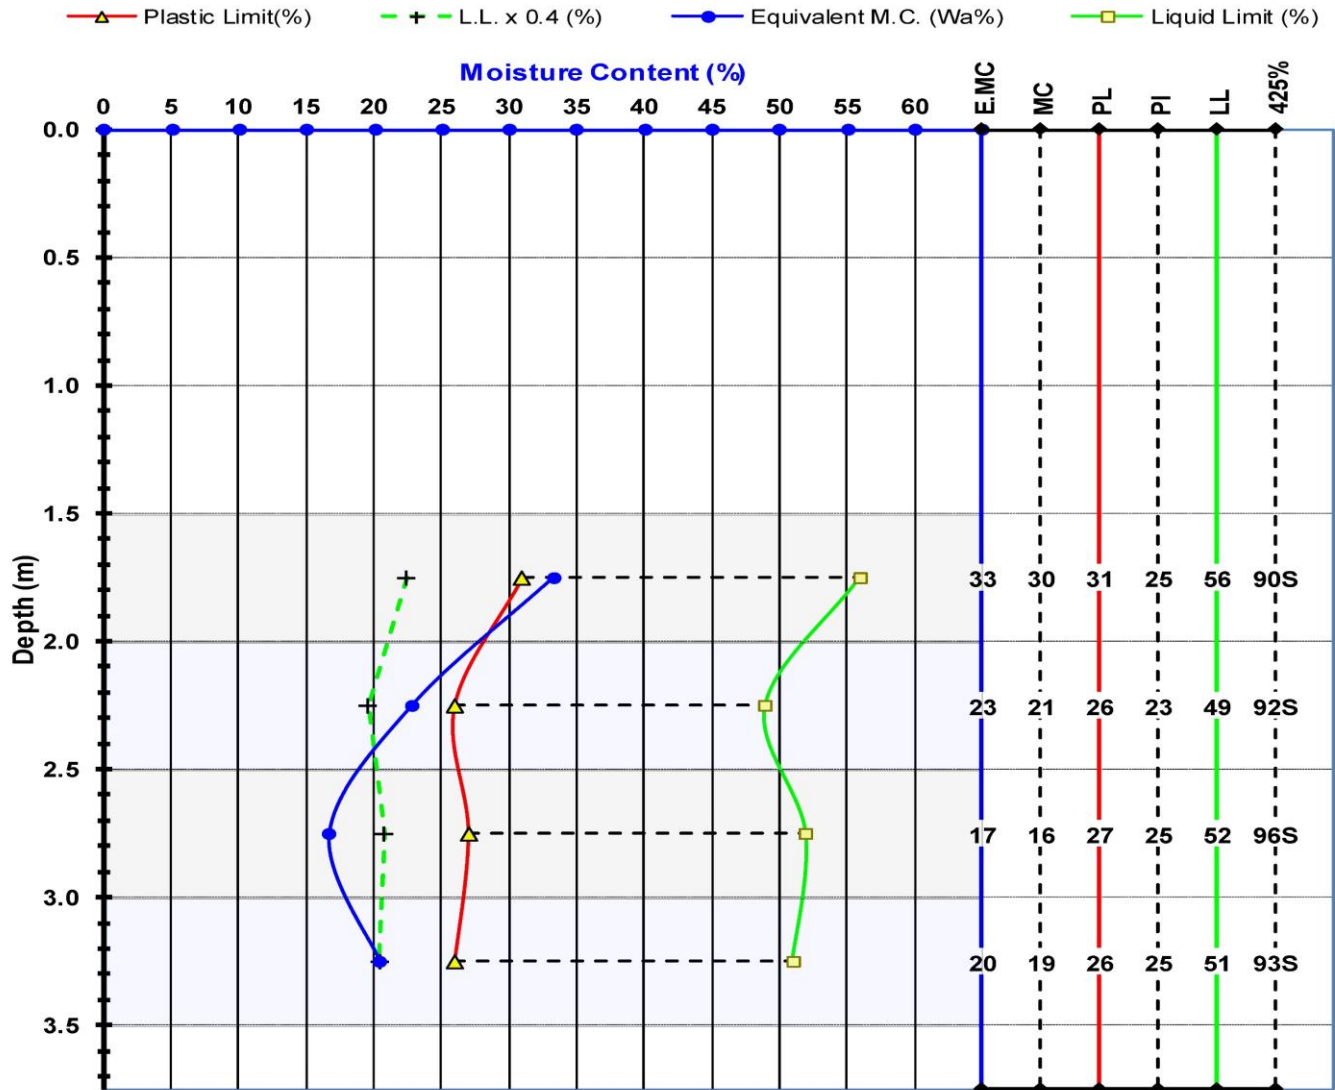
Depth T (m)	Depth B (m)	2 - Midway original house		Plasticity (BS 5930)	Volume Change (BRE 240)	
		Brief Soil Description			M.PI	(BRE 240)
1.5	2	Soft/firm grey/brown slightly sandy/silty CLAY with some medium gravel & rare rootlets		High MH	23%	Medium
2	2.5	Firm grey/brown slightly sandy/silty CLAY with some medium gravel		Intmd. CI	21%	Medium
2.5	3	Firm/stiff friable grey/brown slightly sandy/silty CLAY with some medium gravel		High CH	24%	Medium
3	3.5	Firm/stiff friable grey/brown slightly sandy/silty CLAY with some medium gravel		High CH	23%	Medium
