# Bat Scoping Survey to

Hopton Cricket Club

3<sup>rd</sup> April 2025

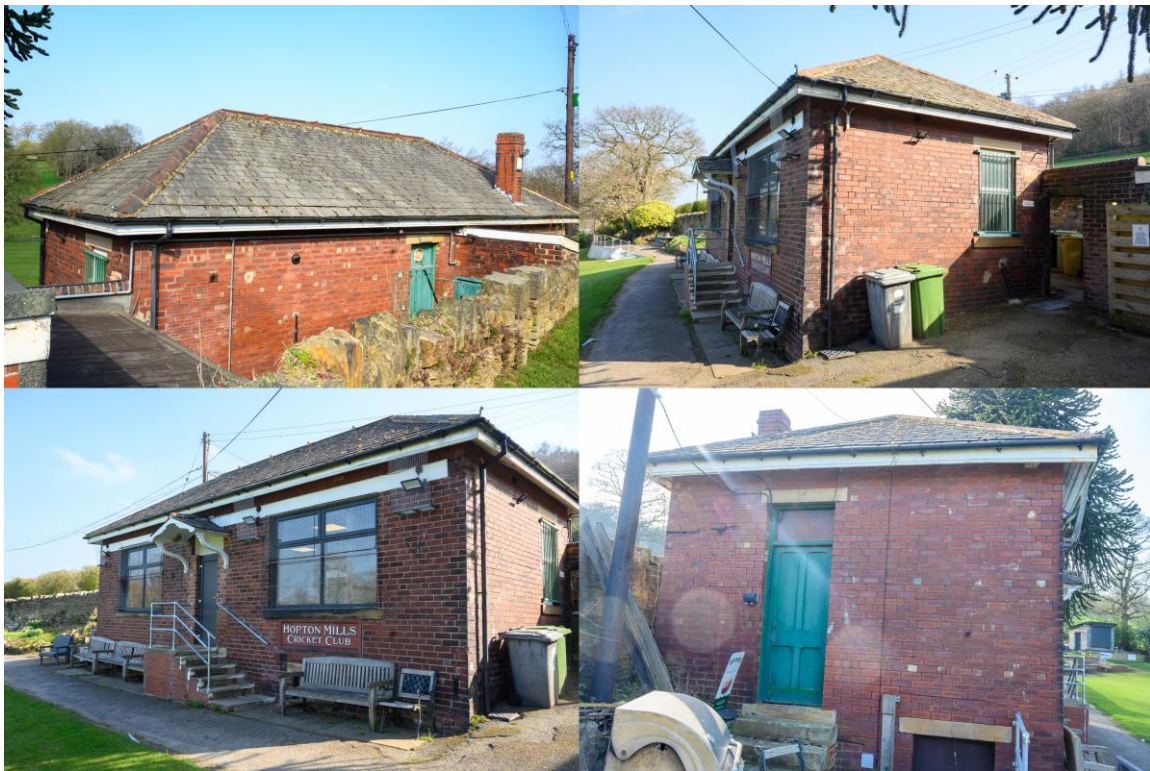
Photo 1 showing all elevations

The site comprises a small clubhouse located in a rural area close to Wheatley Park and its extensive mature woodland. The cricket fields have scattered mature trees to the boundary. The walls are constructed from brick and are English bond and therefore have no wall cavity. The walls are sound and in good condition and have no structural cracks or other features that would allow bats to roost.

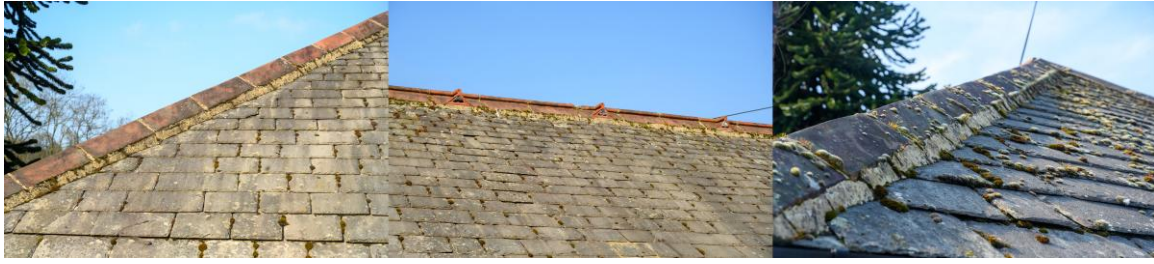
The hipped roof is constructed from large blue slate and is in very good condition without any slipped or missing tiles. All ridge and hip-ridges are present and well bedded and there were no gaps or sections of failed mortar. The internal section is lined with wooden planks and there is no light ingress at the ridge. The lightweight false ceiling prevented access to look for scattered droppings or discarded prey remains, but it seems unlikely that bats would access the roof void given the condition of the roof.

Photo 2. Showing roof and very sound ridge sections.

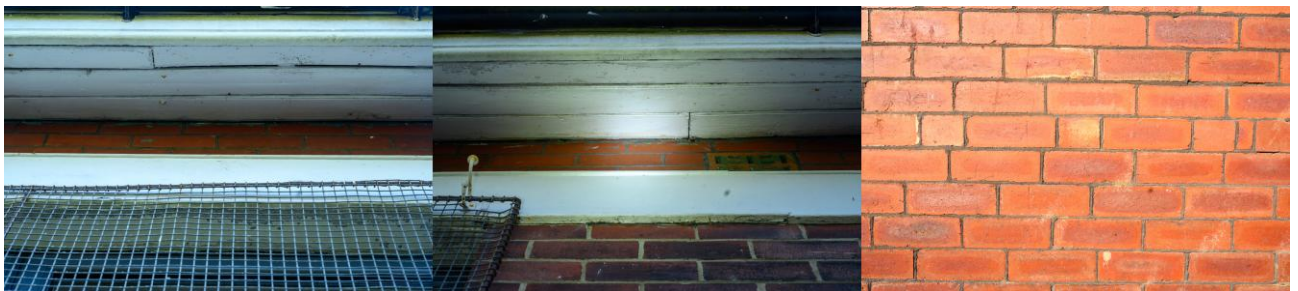
The deep soffits fit close to the walls and offer little in the way of entry points. All soffits were searched easily with a powerful lamp and there was no evidence of use by bats and very few points which offer roost sites.

Photo 3 showing the soffits and English bond walls

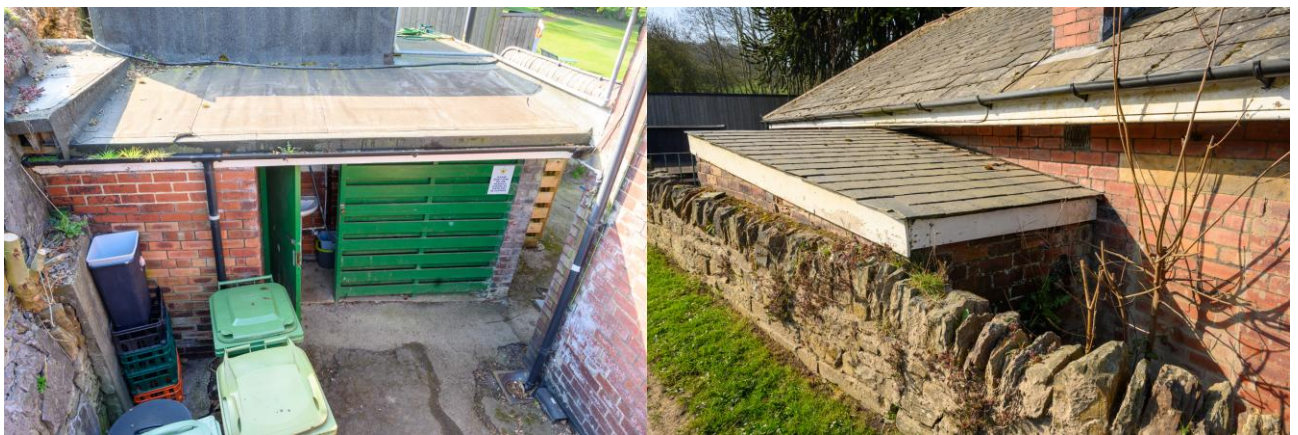
There are two small outbuildings that will be taken down as part of the project and these are considered to have no value to bats.

Photo 4 Showing small external buildings

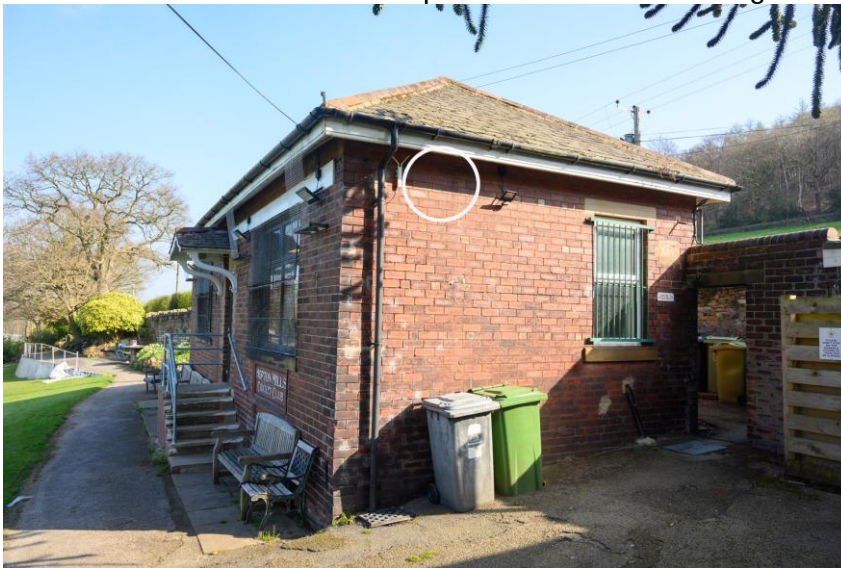
Photo 4: Possible location of a bat box

There will be no loss of potential roosting sites from the works and the building is regarded as being of negligible interest to bats. Consequently, there is no requirement for a European Protected Species Mitigation Licence (EPSML). The addition of a permanent roosting feature just below the eaves should be considered and will create a biodiversity net gain. A Schwegler 1FTH summer bat box could be placed on the south facing elevation (indicated below).
