Our Ref C4182/24/E/CSM&RS  
6<sup>th</sup> August 2025

Ref: Revised Conceptual Site Model and Remediation Strategy

672 Bradford Rd

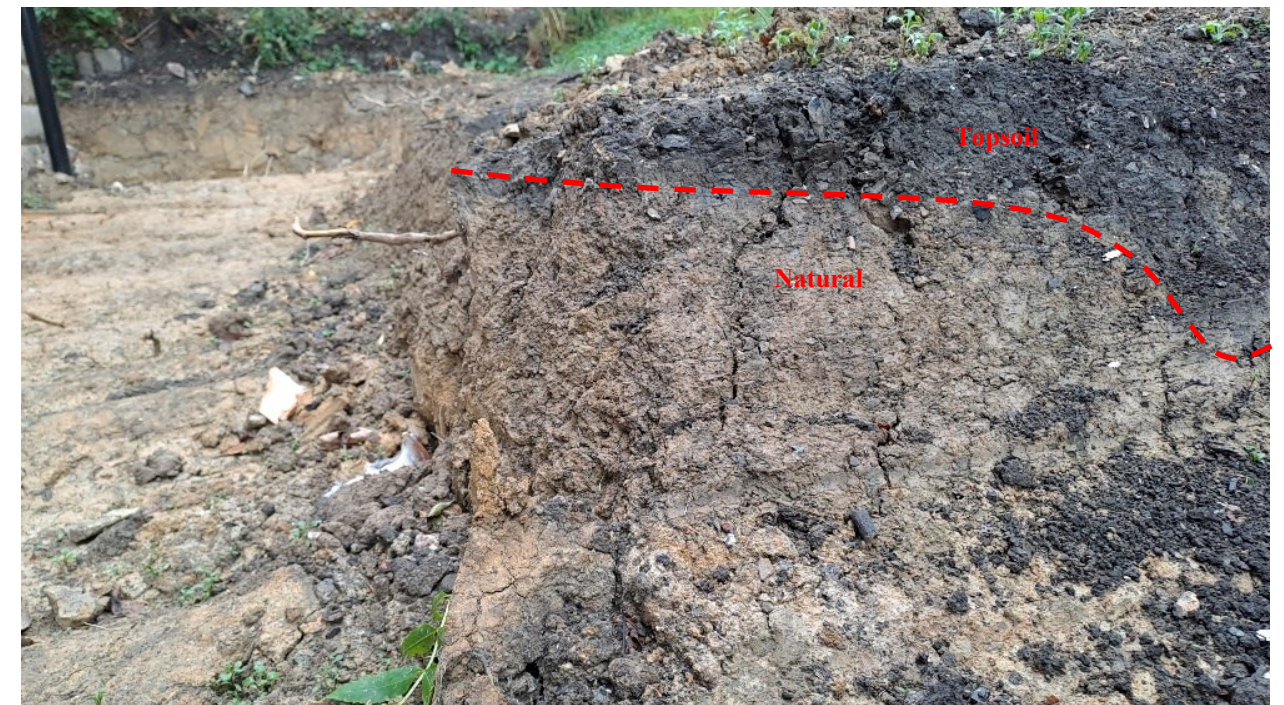
Photo 2: Cross section near building which shows nominal thickness of topsoil above natural soil.

In light of the sample labelling error, RGS visited site on the 2<sup>nd</sup> July 2025 to confirm the topsoil thicknesses in the RAZ. In the excavations observed, topsoil was found to vary between 100mm and 200mm depth, prior to the underlying natural clays being encountered. This topsoil thickness appears to be slightly less than that identified at BH04. To confirm that the underlying clay was uncontaminated, an environmental sample was collected and subjected to Greenfield Suite testing. The tests revealed that all PAHs fell below screening levels, no asbestos was present and all metals fell below screening thresholds for a residential with plant uptake end use. As such, it is considered that the natural clays beneath the topsoil are suitable for the intended end use and can be left insitu where appropriate.

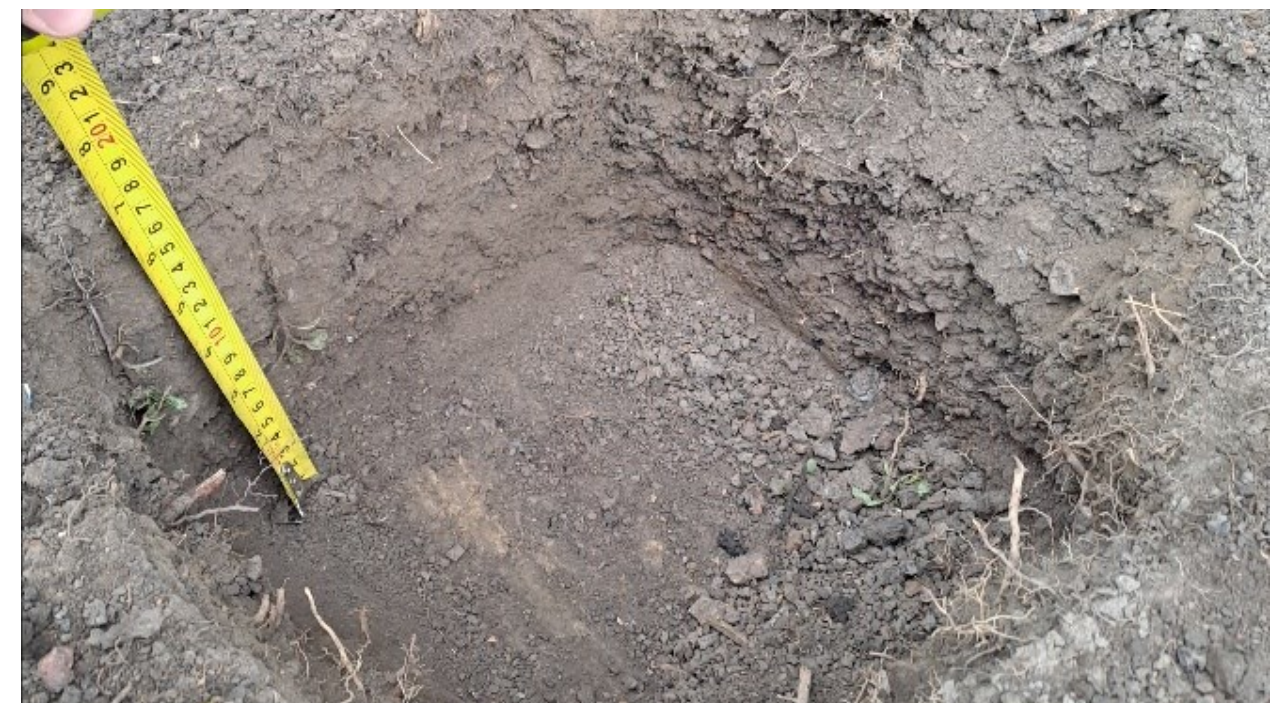
Photo 3: Trial pit dug to show level of natural clay below topsoil. Topsoil 170mm thick at this location.

It should be appreciated that the client's arboricultural consultant has stated that up to 200mm of soil can be removed around the protected tree (subject to following the arboricultural consultant's method statement). If conditions are true to the recent RGS visit, however, then only 200mm of topsoil may be prevalent in the majority of the RAZ.

If removing this recommended thickness of soil, such works would remove the existing topsoil. This would thereby remove the 'source' of contamination in the RAZ, as the underlying clays are proven to be clean. Notwithstanding the above, any proposed landscaped areas outside of the RAZ will still be subject to the previous remediation strategy and shall require a clean cover system of up to 600mm. This is because those areas could be readily opened up by the client and end user to allow the planting of plants and bushes.
