## Phase 2 Intrusive Site Investigation Report

LOCATION	33a Church Lane, Clayton West, Huddersfield HD8 9LY
ISSUE DATE	December 2024
FOR	Byram Construction Ltd
CLIENT REF.	
OUR REF.	G24327

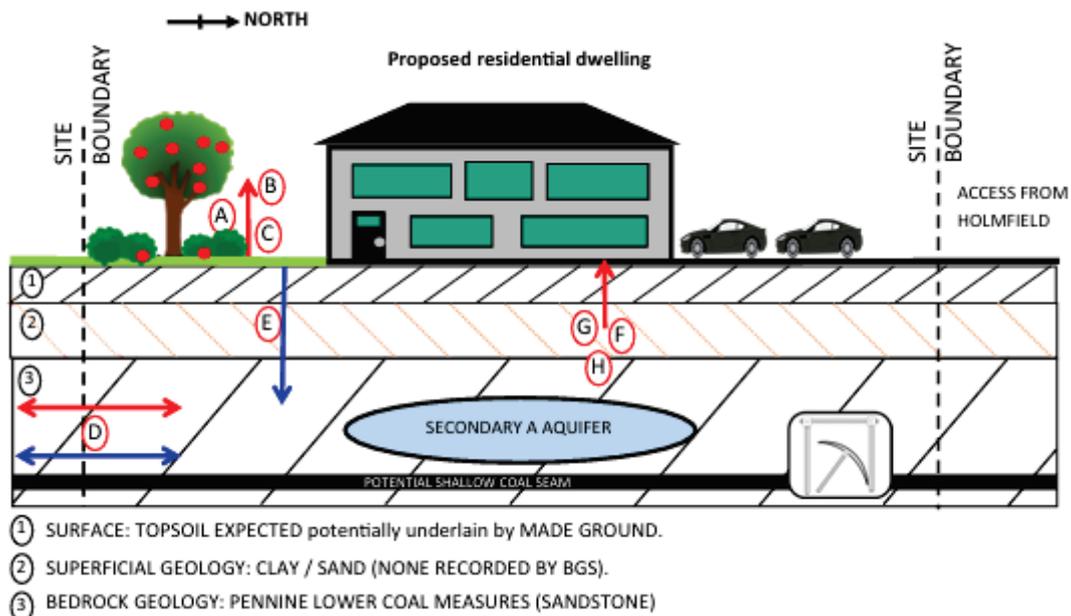
**Figure 1:** CGHM – Conceptual cross section of site including a Source, Pathway and Receptor Model

The conceptual ground hazard model (CGHM) presented below shows the potential hazards and pollutant linkages which have been considered at the site, all of which are considered to have been satisfactorily disproven.

- Possible presence of made ground and historical contamination thereof by past land use and development and/or demolition works at the site.
- Potentially contaminative historical land uses on nearby/adjacent sites including; former onsite and adjacent buildings and two quarries.
- Potential for made or infilled ground to generate hazardous gases either within the study site or on adjacent/nearby sites.
- Possible hazardous gas risk from shallow historical coal mining.
- Potential ground stability issues associated with; vegetation influence and shrink-swell clays, potentially weak and compressible made ground, compressible natural deposits and shallow historical coal mining.

- F— Buildings and services through direct contact.**
- See Report Section 7.5 for appropriate concrete design advice.
- Barrier type water supply pipe not recommended given no elevated petroleum hydrocarbon levels detected in soils. Pipe line risk assessment is still suggested.

- See report sections 7.3 and 7.4 for appropriate foundation and mining advice.

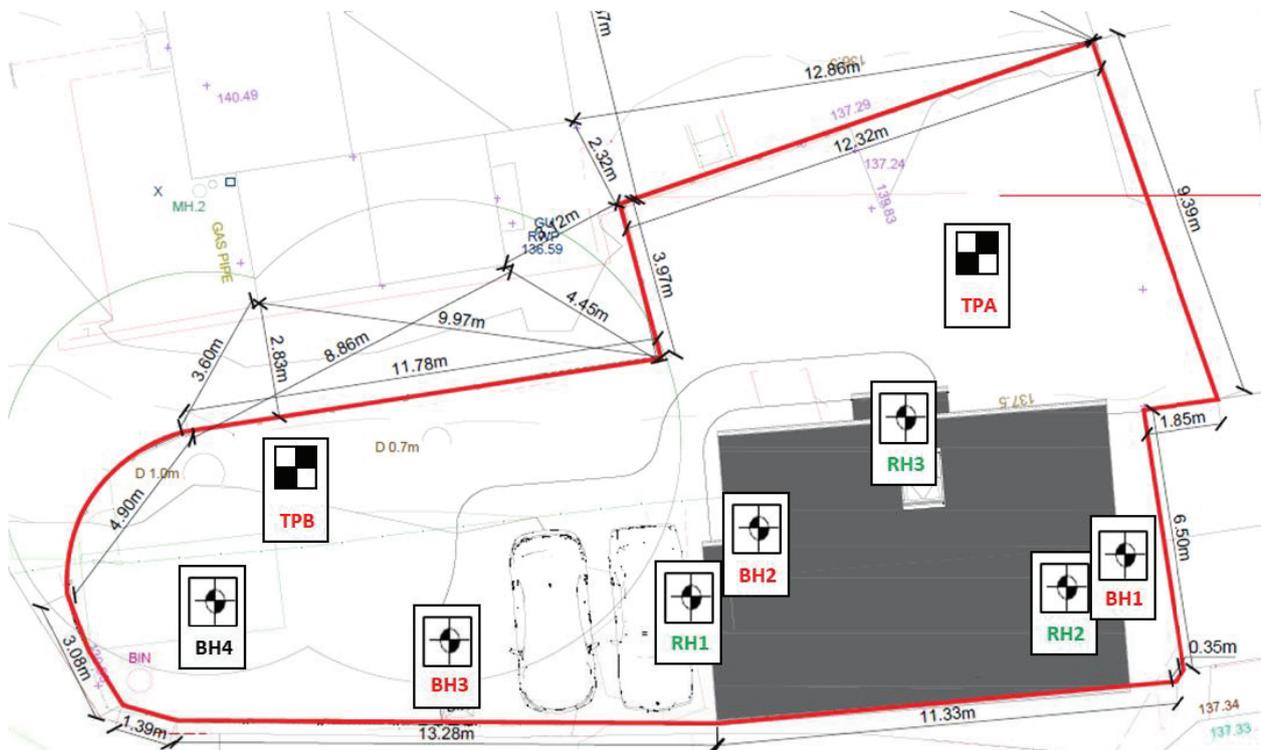
Site Plan  
and  
Exploratory Hole Logs

OUR REF: G24327	YOUR REF:	SITE PLAN (NOT TO SCALE)
DATE: 07/11/24	LOCATION: 35a Church Road, Holmfild HD8 9LY

The trial pit and borehole positions are shown on the plan provided in Appendix 1.

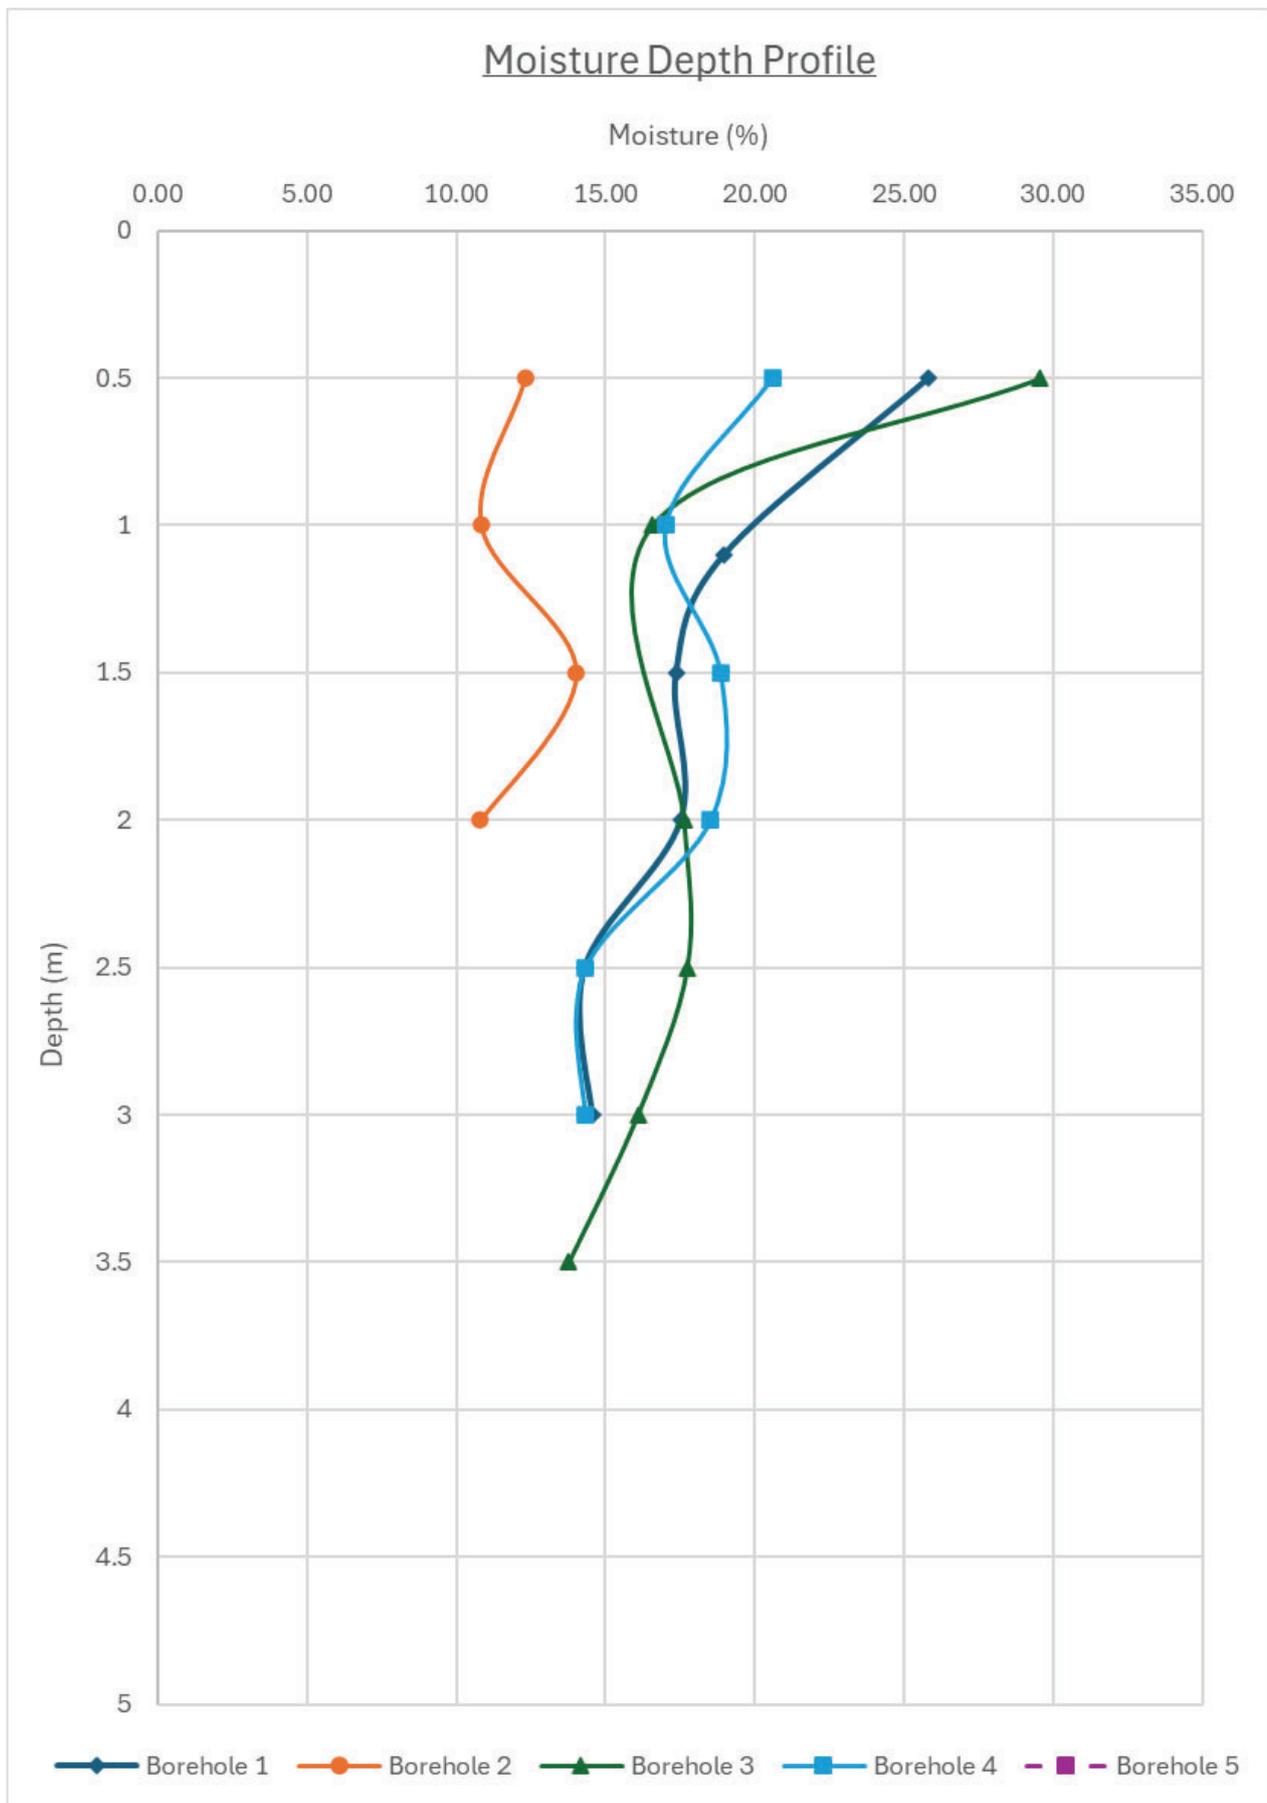
TP / BH No.	Sample Depth (m)	Insitu Moisture Content (%)	% Passing BS 425 Micron Sieve	Corrected Moisture Content (%)	Plastic Limit (%)	Liquid Limit (%)	Plasticity Index (%)	Soil Classification BS5930 [1999]
4	0.50	20.6						
	1.00	17.0						
	1.50	18.9						
	2.00	18.5						
	2.50	14.3						
	3.00	14.3

Borehole moisture profiles are presented in Appendix 2. Moisture contents between 12.3% and 25.8% were reported within the made ground. The natural strata recorded moisture contents between 10.8% and 29.6%.
