Contaminated Land Phase One Desk
Study for proposed conversion and
extension of barn to residential
dwelling at
Lower Crawshaw,
Stringer House Lane,
Emley Moor,
Huddersfield,
Kirklees,
HD8 9SU.

January 2025

Summary

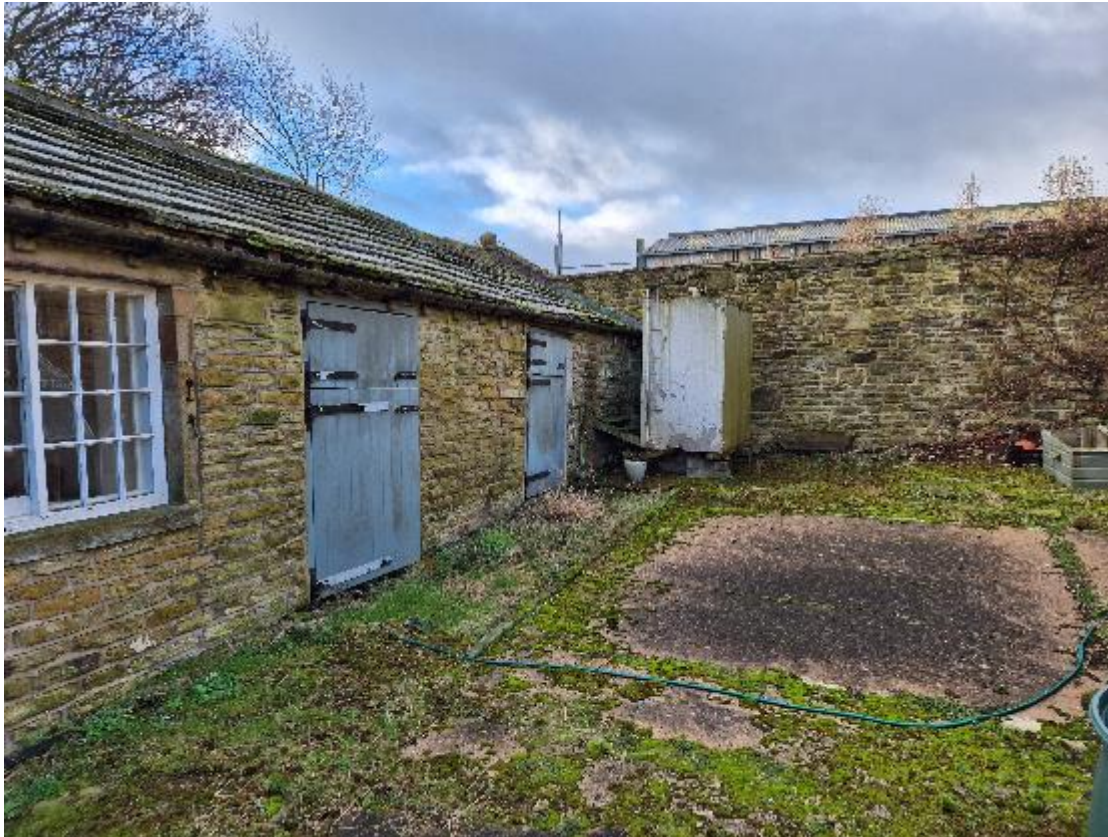
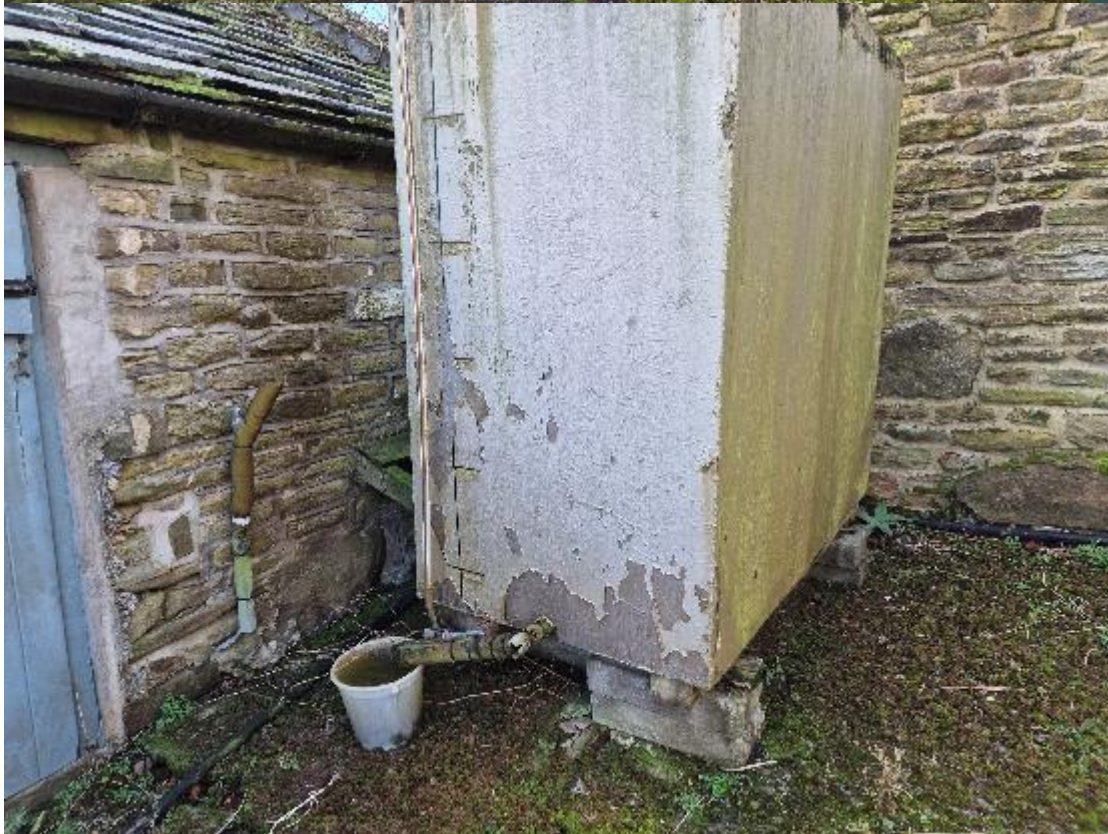
A historic fuel storage tank was identified to the northeast of the site, this has reportedly remained unused for years, consists of a double skinned metal tank elevated from the ground and no signs of any leakage were present.

The fuel tank

As a result of the investigation into the historical use of the site and surrounding area it is recommended that a phase II intrusive investigation is undertaken to establish the presence of any contamination from the historic fuel tank, following its removal.

Soil samples from below the tank should be taken and analysed for the presence of petroleum hydrocarbons to determine whether any risk to the identified receptors exists.

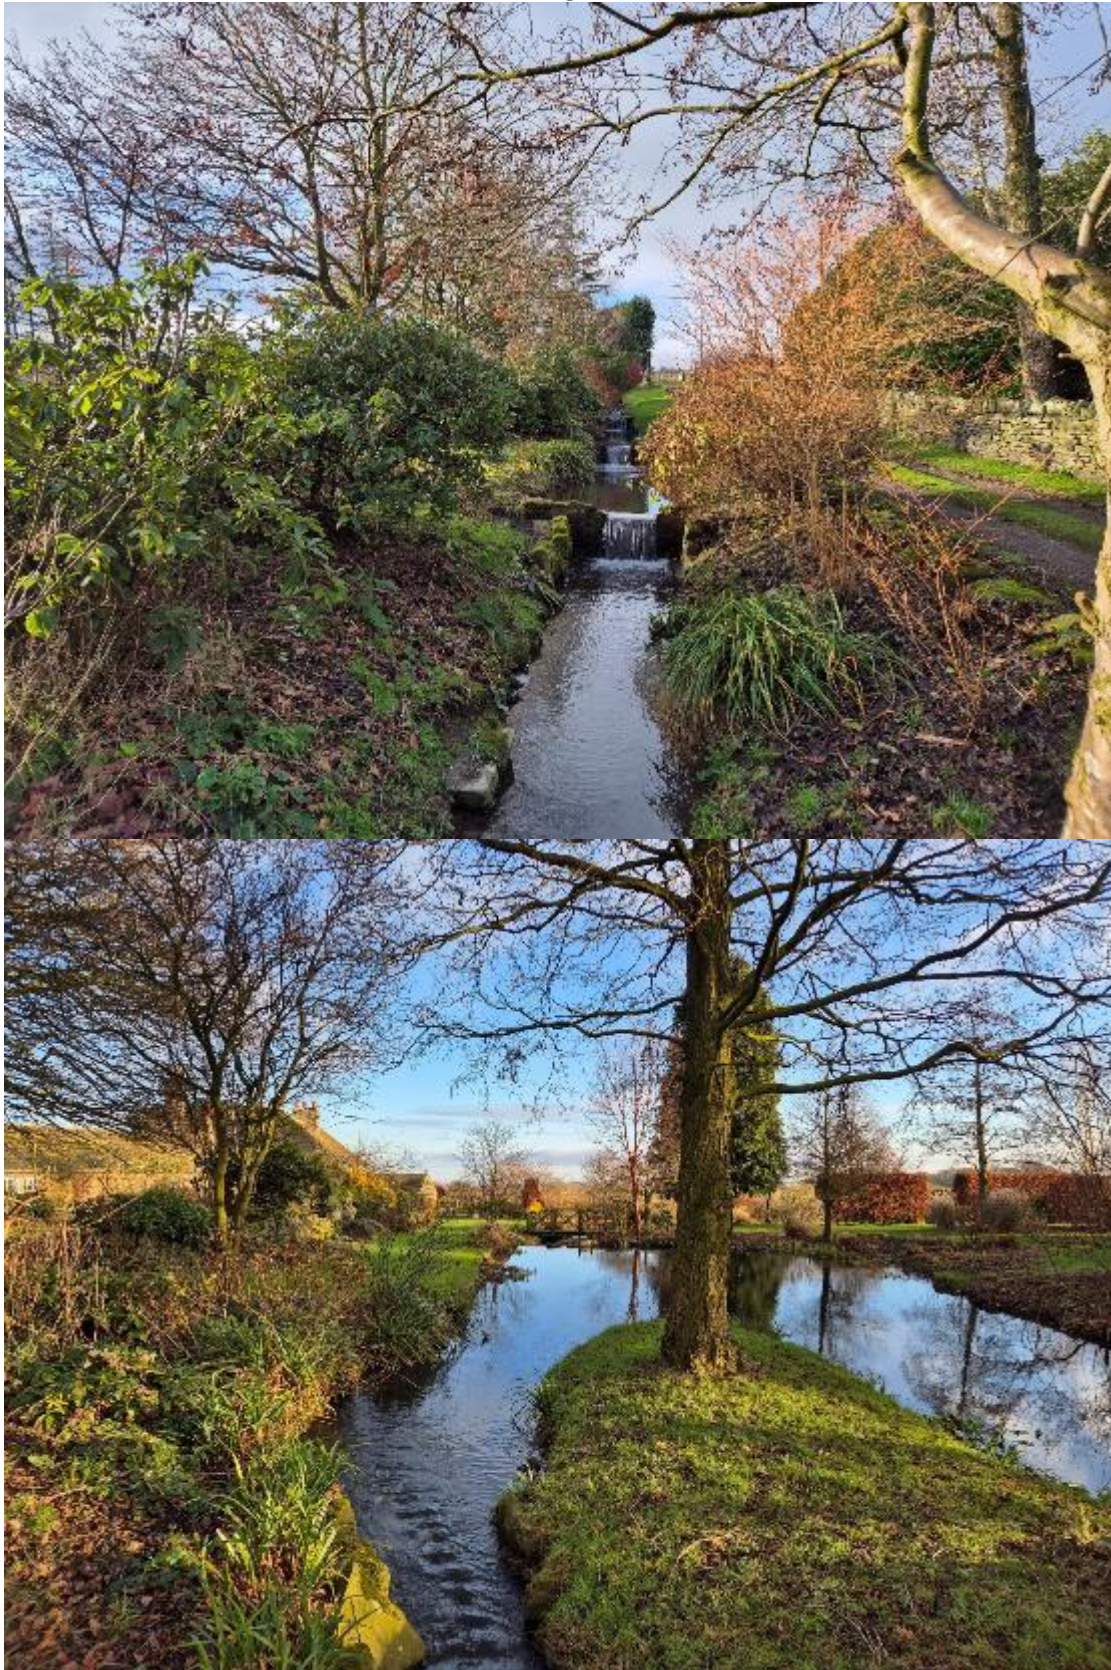
The nearest watercourse runs along the southern boundary of the site, into a sink which then reappears to the southeast and runs east. The watercourse is identified as Mouse House Dyke.

The watercourse to the south of the site looking west then east

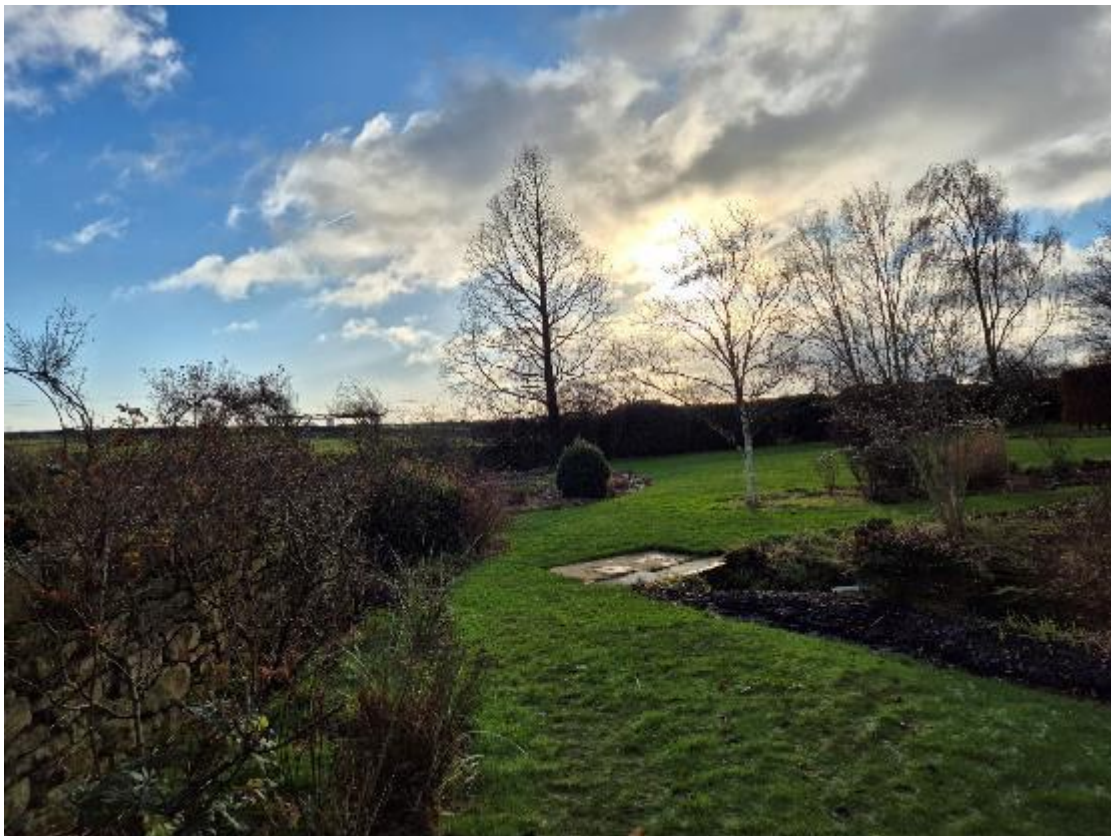
The sink

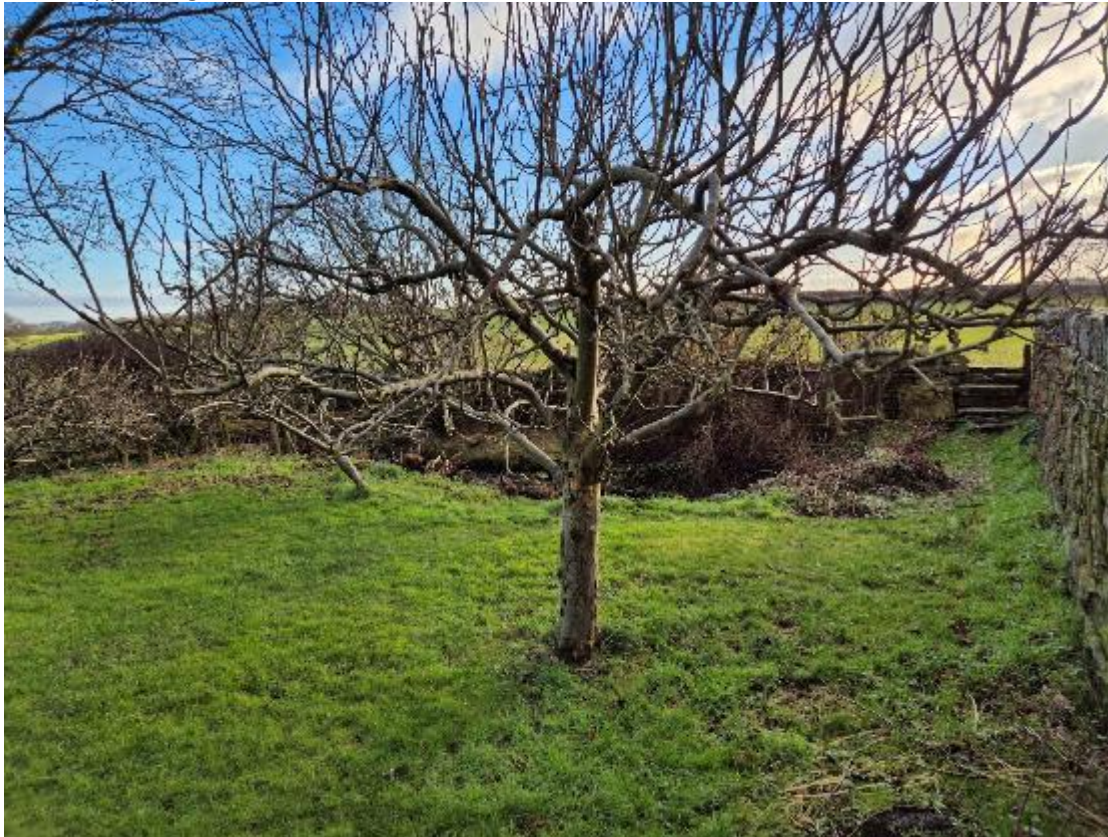
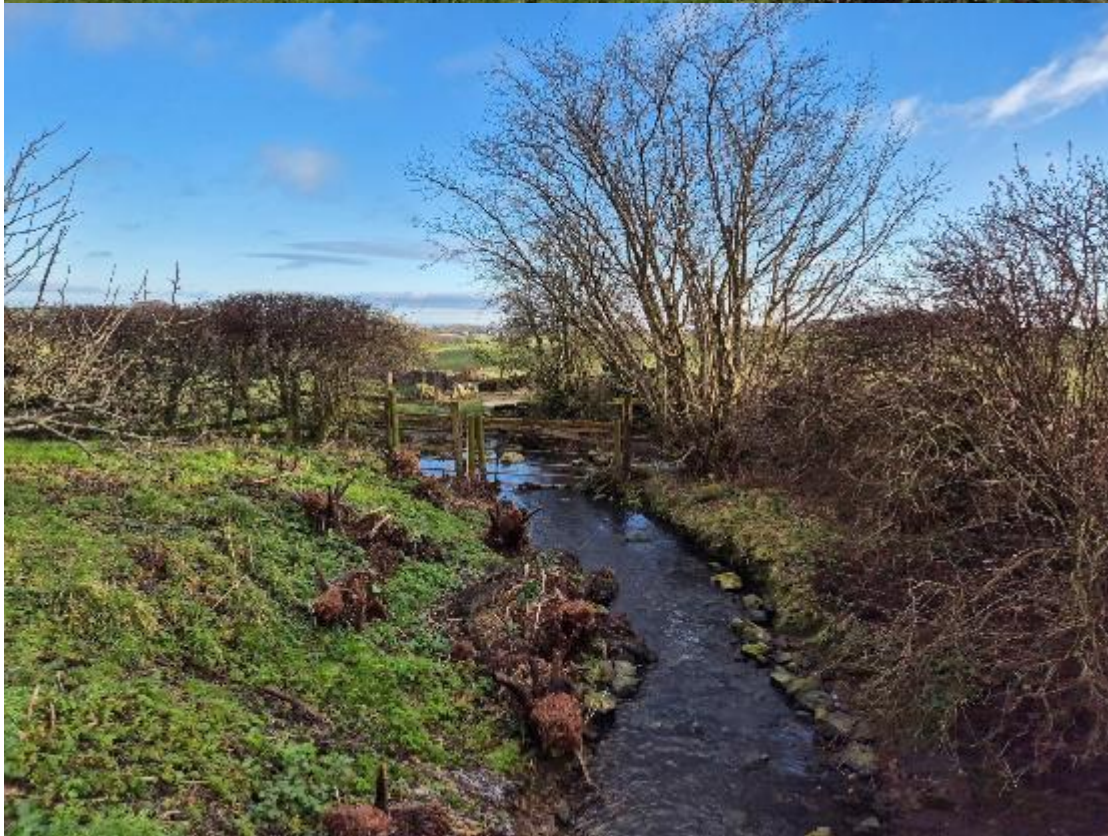
To the south of the development are well maintained gardens and a stream running off to the east, this disappears at the end of the site and reappears to the southeast running down the side of the adjacent field.

The reappearing stream to the southeast

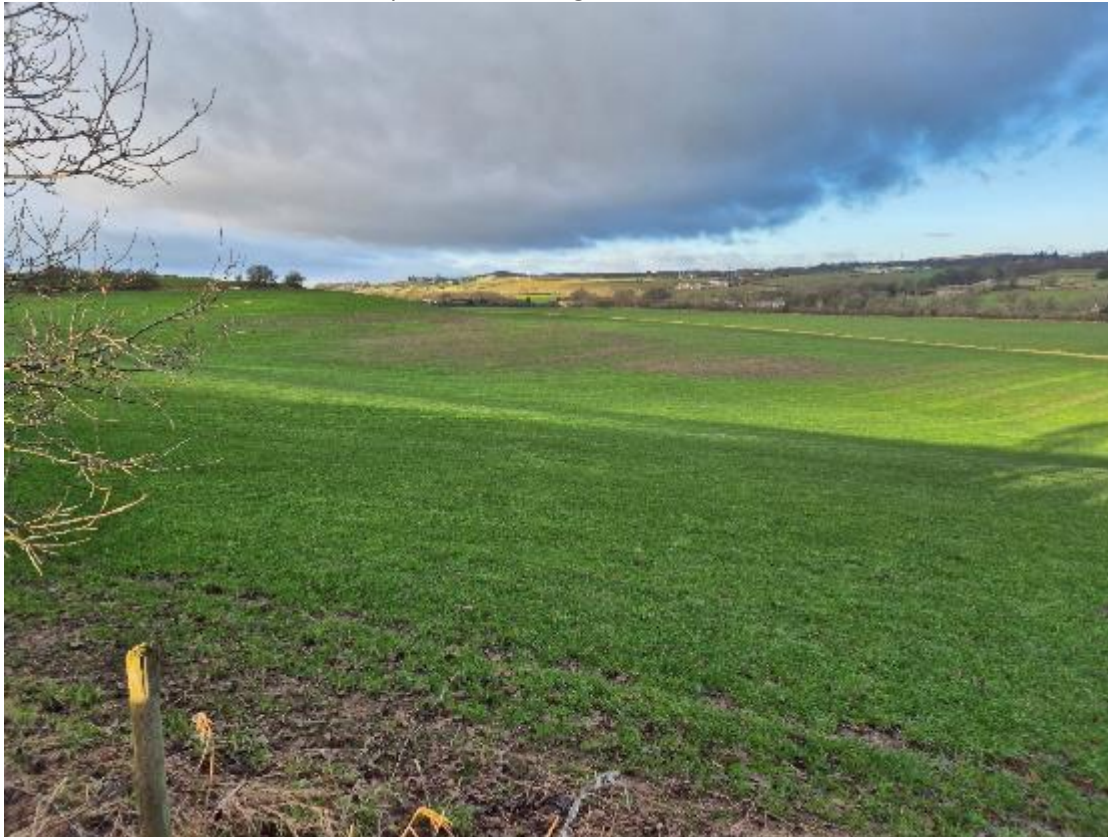
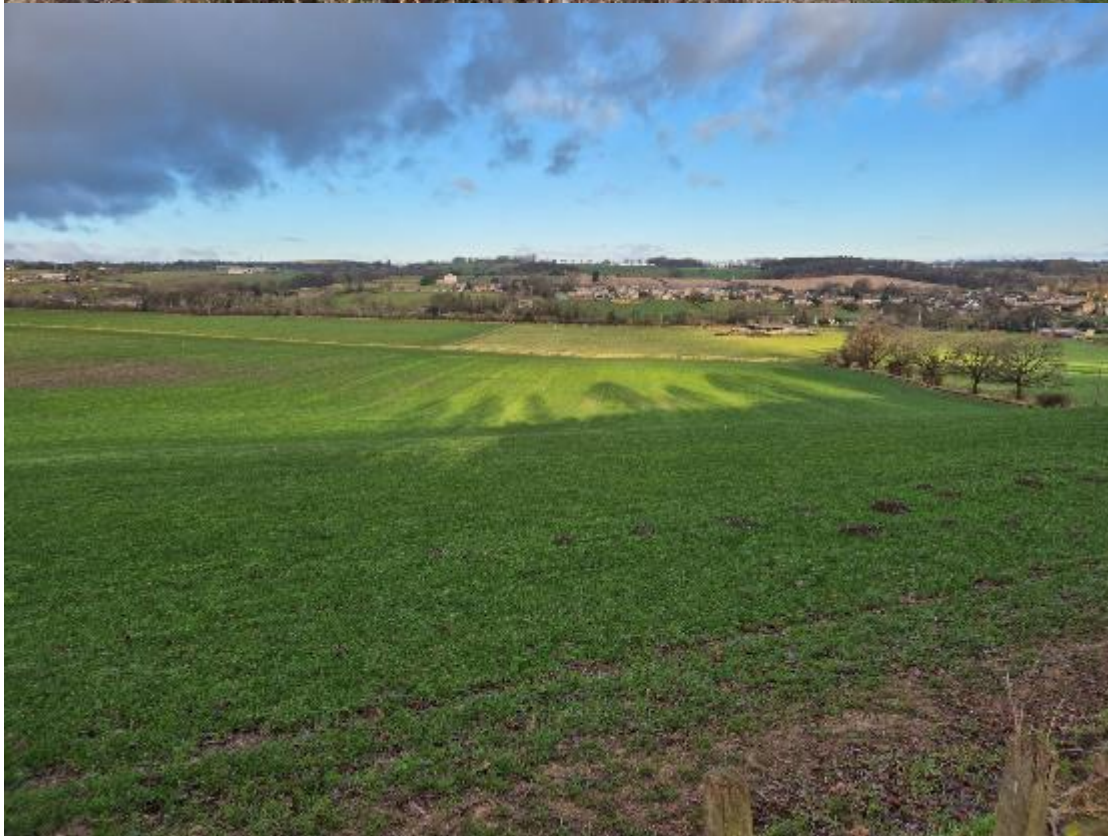
The area identified as the opencast workings to the north is also a ploughed field used for crops and animal grazing. It slopes down towards the road in the north and further investigation and discussions with locals has not identified any fill to the area with the hillside known locally as a great sledging site.

The fields to the north and the opencast workings area

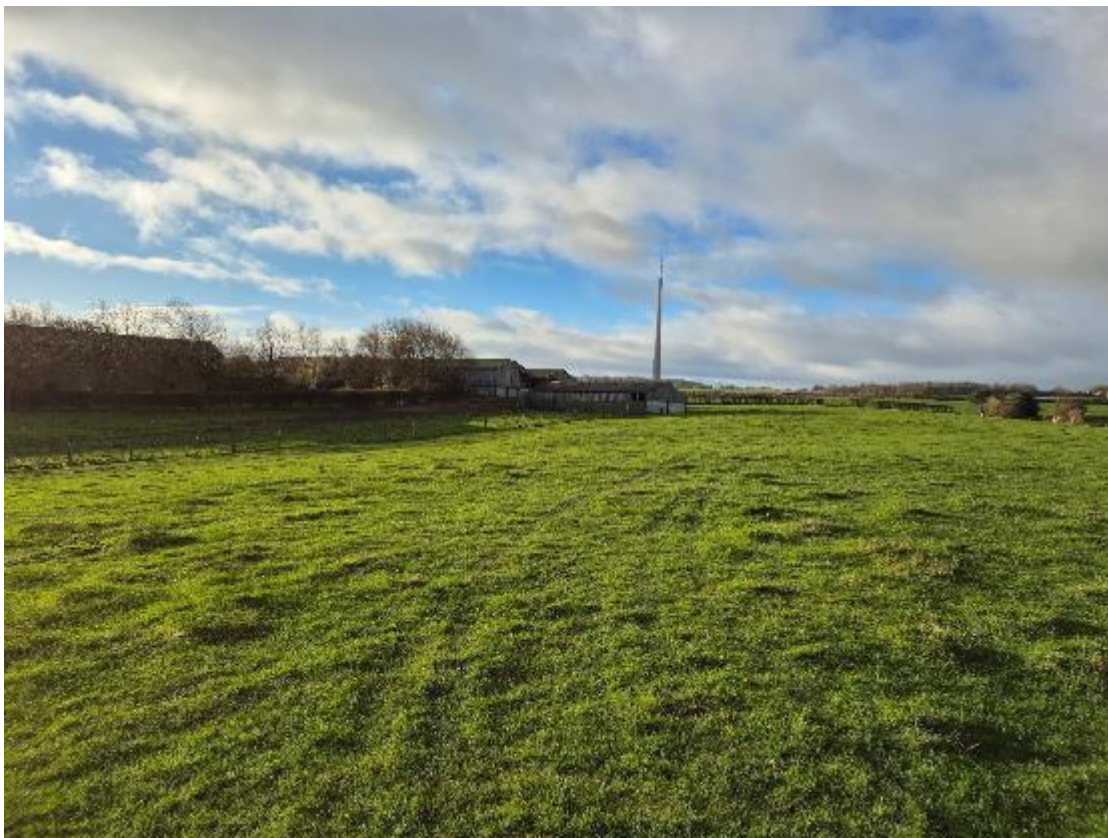
The field housing the historic quarries has a watercourse running through it, which according to historically aerial photographs comes and goes depending on the weather. The field has been used for crops in the past.

The fields to the east and southeast
