# PERCOLATION REPORT

St Andrew Roads, Huddersfield

Arrow Self Drive

24466-FP-001

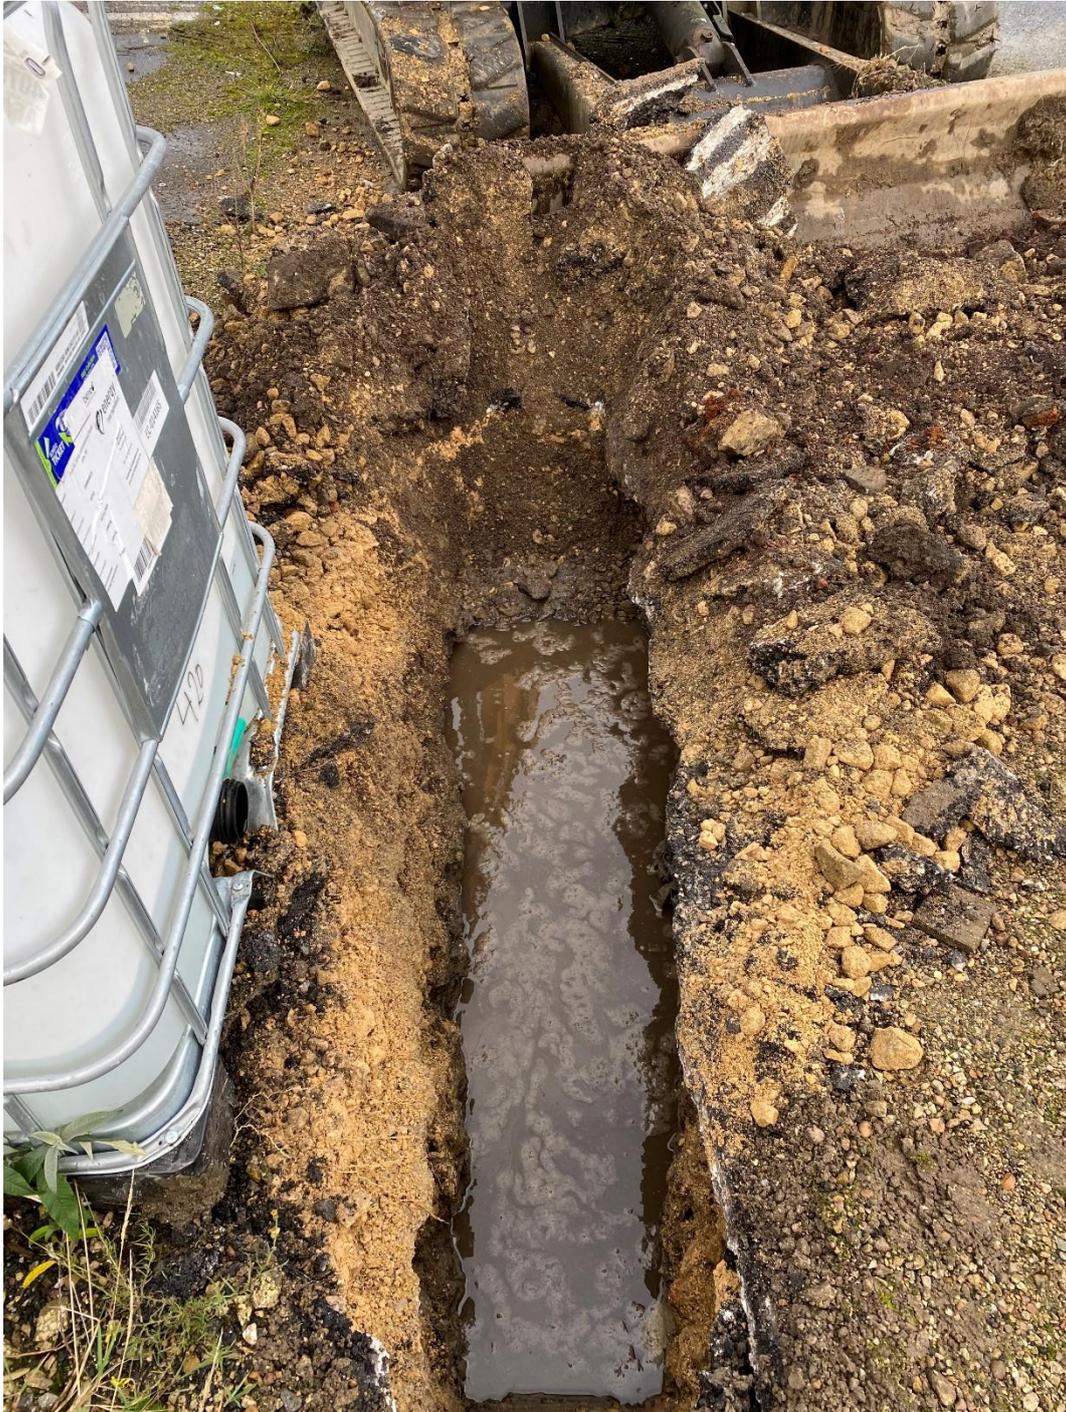
**Appendix B**  
**Percolation photograph**

For Test 1 (Test Pit 1), water was filled to a depth of 800mm, the water level dropped 160mm after 2 hours of testing.

**Calculation sheet 1 shows that the infiltration rates are not high enough and do not satisfy BRE 365 requirements. Therefore, Infiltration methods of drainage will not be viable for this site and strategy.**

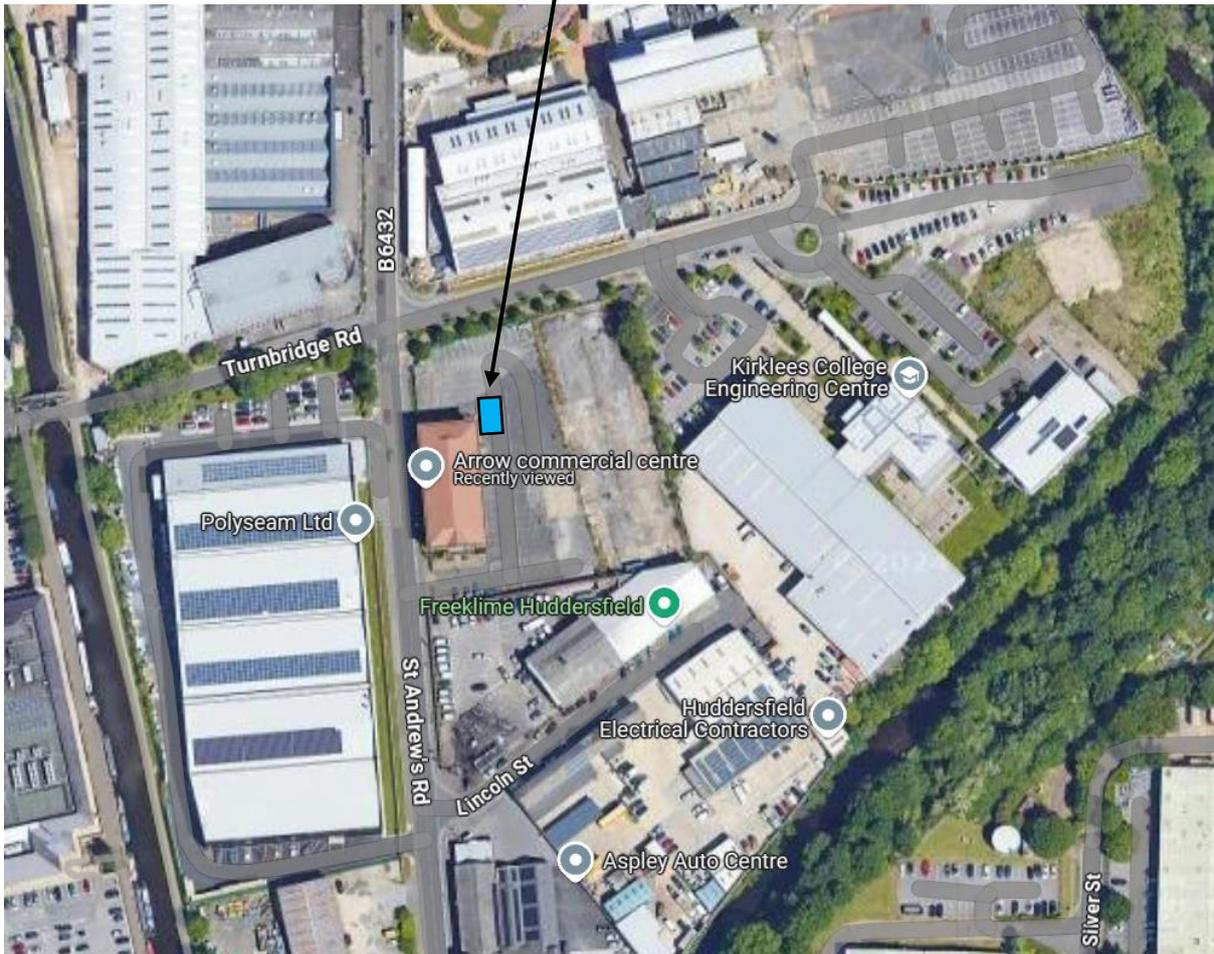
Test Pit 1      500mm x 1200mm x 1300mm deep
