PHASE 2

GEO-ENVIRONMENTAL REPORT

Report on a Phase 2 Geo-environmental Investigation

Location:	Site of Former Perseverance House St Andrew's Road, Huddersfield HD1 6RZ	
For:	Arrow Commercial Centre (Huddersfield) Ltd	
Consultants:	Northern Design Partnership	
Report No.	C4483/24/E/6941	Report date: February 2025

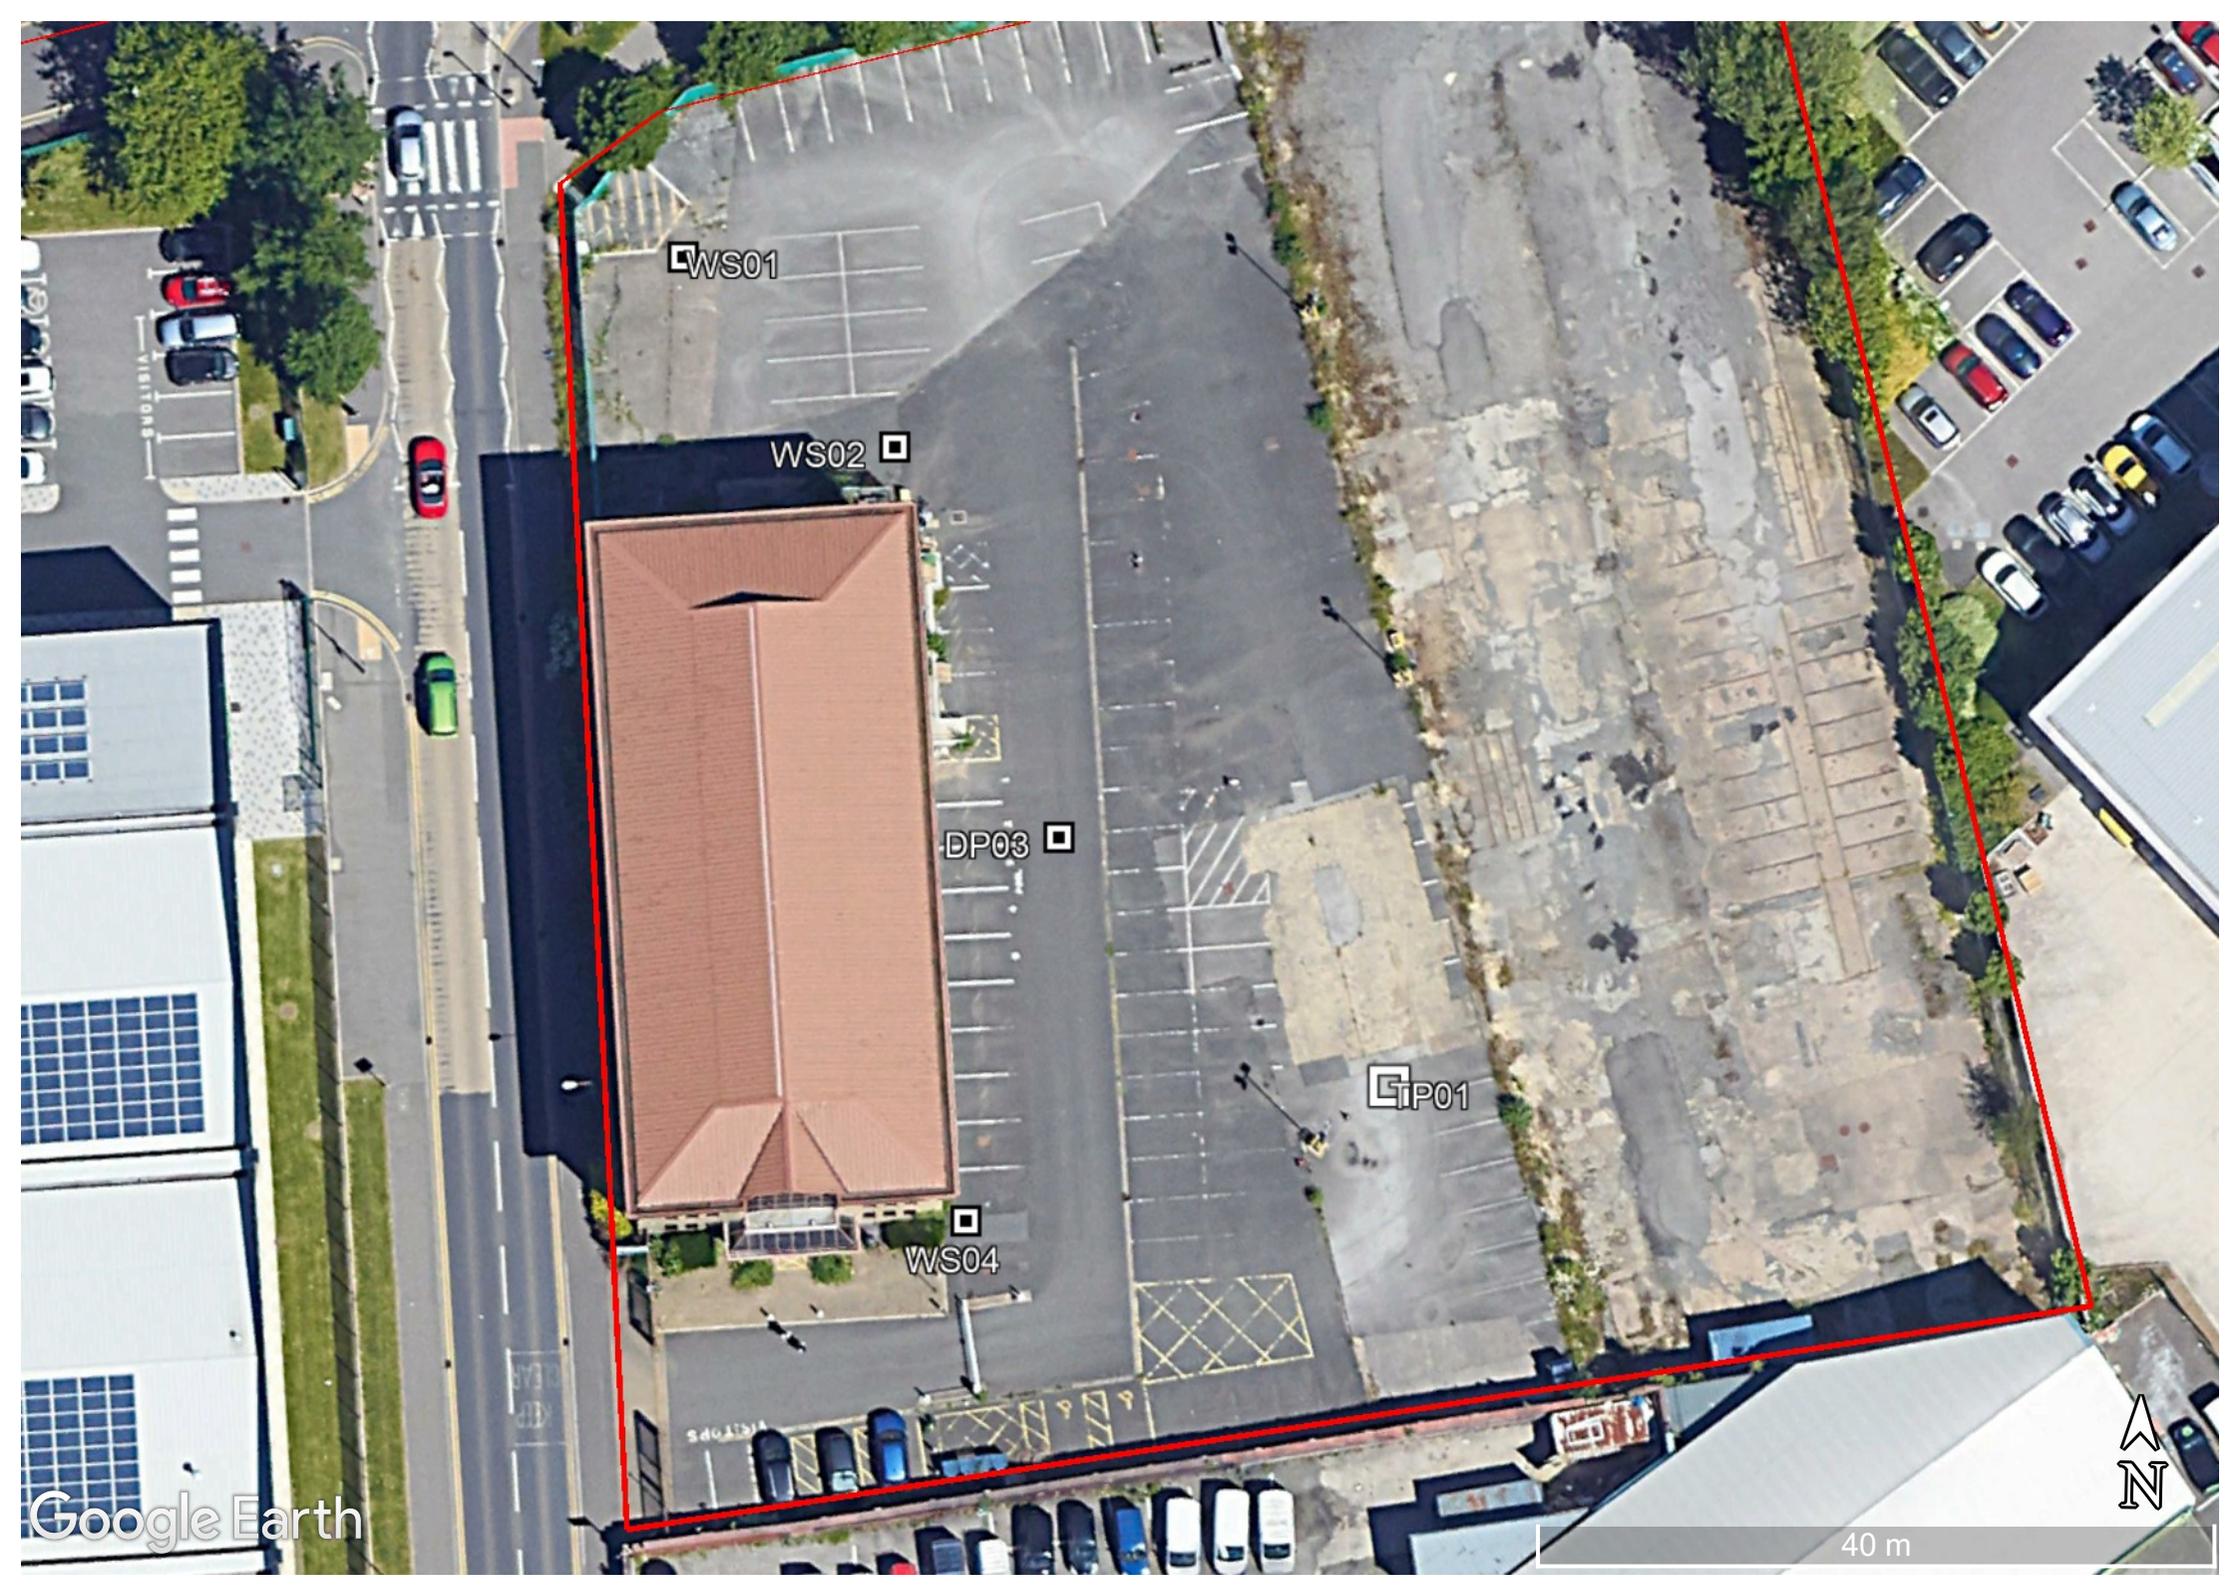
Site Plan

The investigatory locations are shown on the site plan which is presented in Appendix 1 to this report.

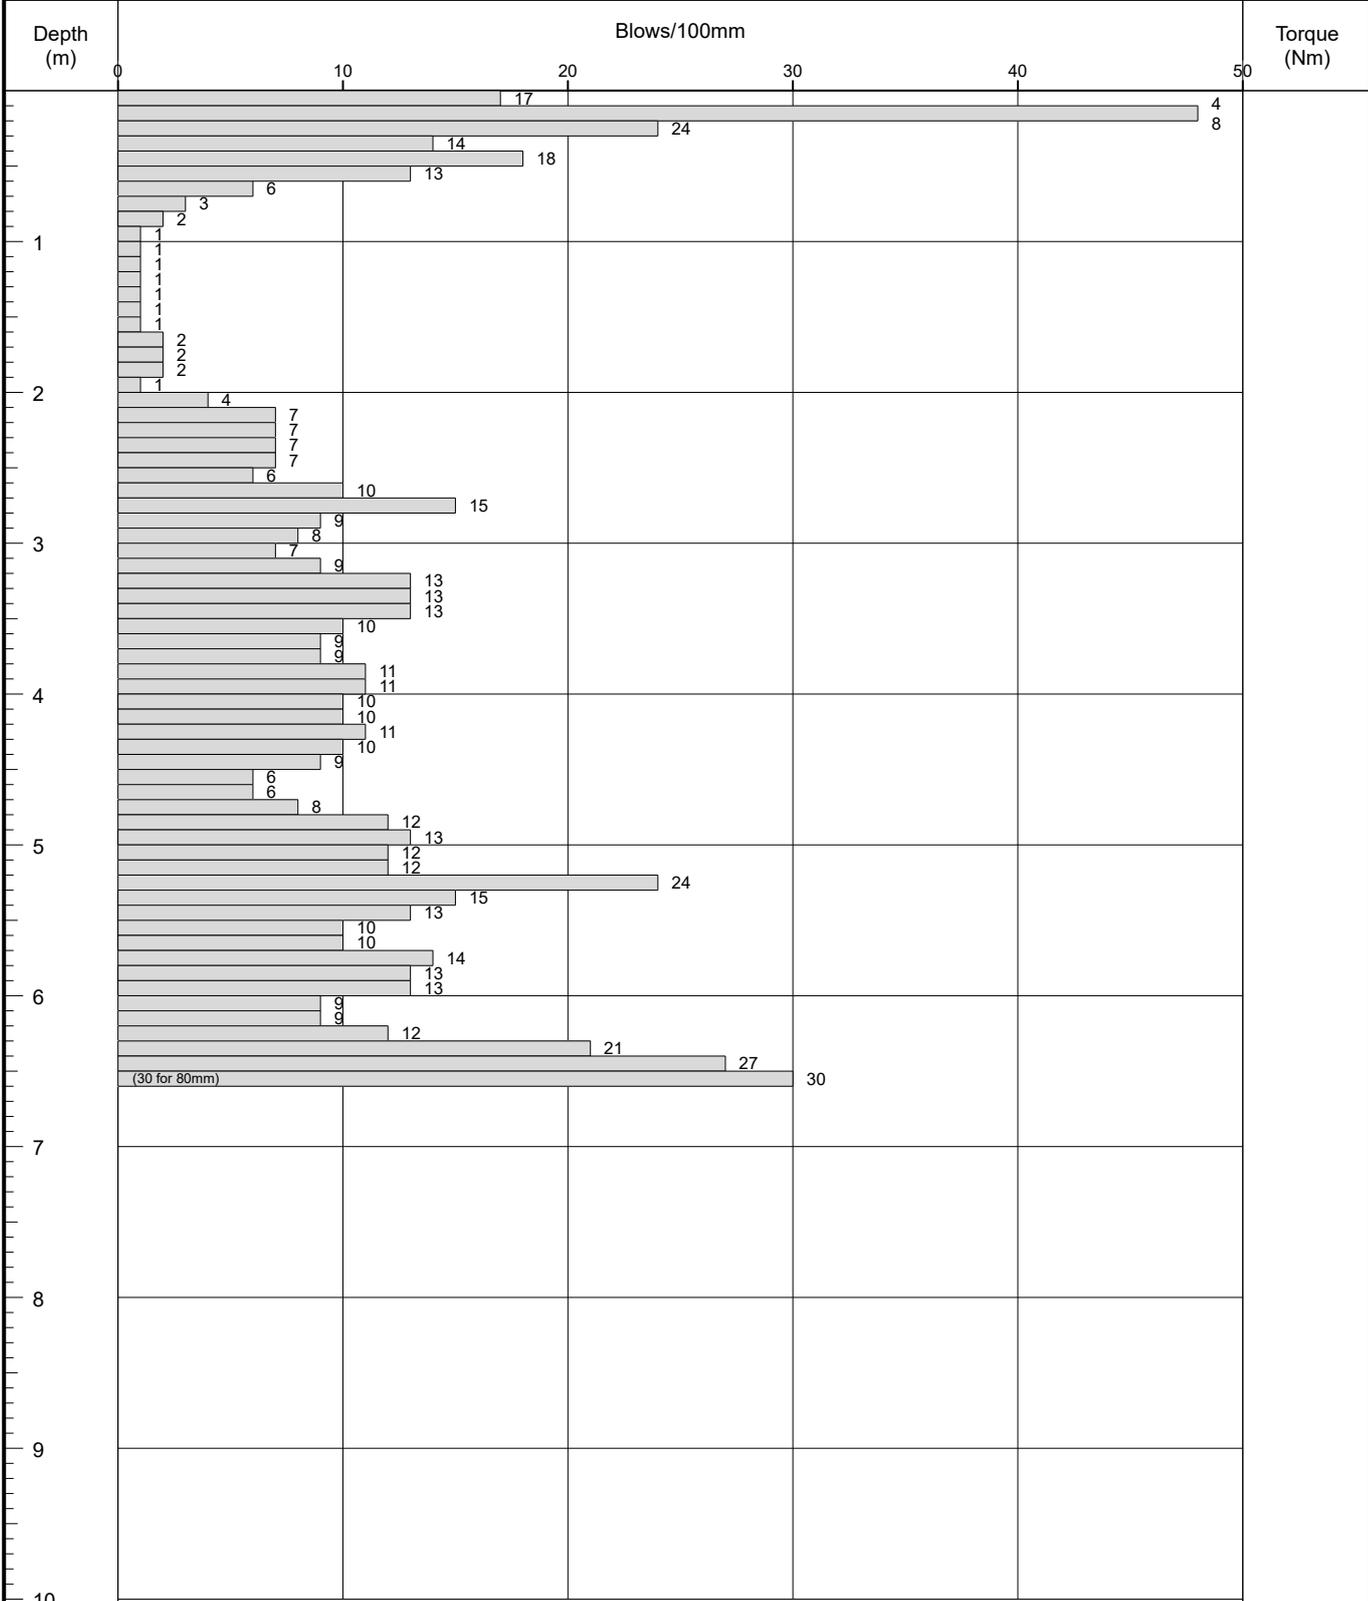
Project Name: St. Andrew's Road	Project No. C4483/24/E/6941	Co-ords:	Hole Type DCP
Location: Huddersfield HD1 6RZ	Level:		Scale 1:50
Client: Arrow Commercial Centre	Dates: 27/11/2024		Logged By AB

Table 4: Summary of Dynamic Penetration Tests					
Position	Blows/100mm			Refusal type (Effective/ Abrupt) ⁵	Comments
	0 - 2	3 - 10	10+		
	Depth to which blow count range was observed (m)				
DP03	2.0	4.8	0.6 6.6	Abrupt	Initial high blow counts associated with coarse particles present within the granular made ground at the near surface.

Remarks:	Fall Height	750mm	Cone Base Diameter	50.5mm
	Hammer Wt	63.5kg	Final Depth	6.58m
	Probe Type	DPSH-B

As an alternative to the above, a piled foundation could be adopted. In order to formulate a suitable design it is recommended that the advice of specialist piling contractors be sought. It is anticipated that further ground investigation will likely be required to complete a pile design. However, for preliminary design and estimating purposes it is considered that driven piles could prove suitable. It should be noted that RGS have completed ground investigation locally on similar geological deposits and the granular river deposits from 2m to 3m depth have been consistent in composition and density to approximately 10m depth, whereupon the bedrock is typically present. This typical soil profile would appear to have been confirmed by the dynamic probe log which had consistent high blow counts beyond 2.0m depth.

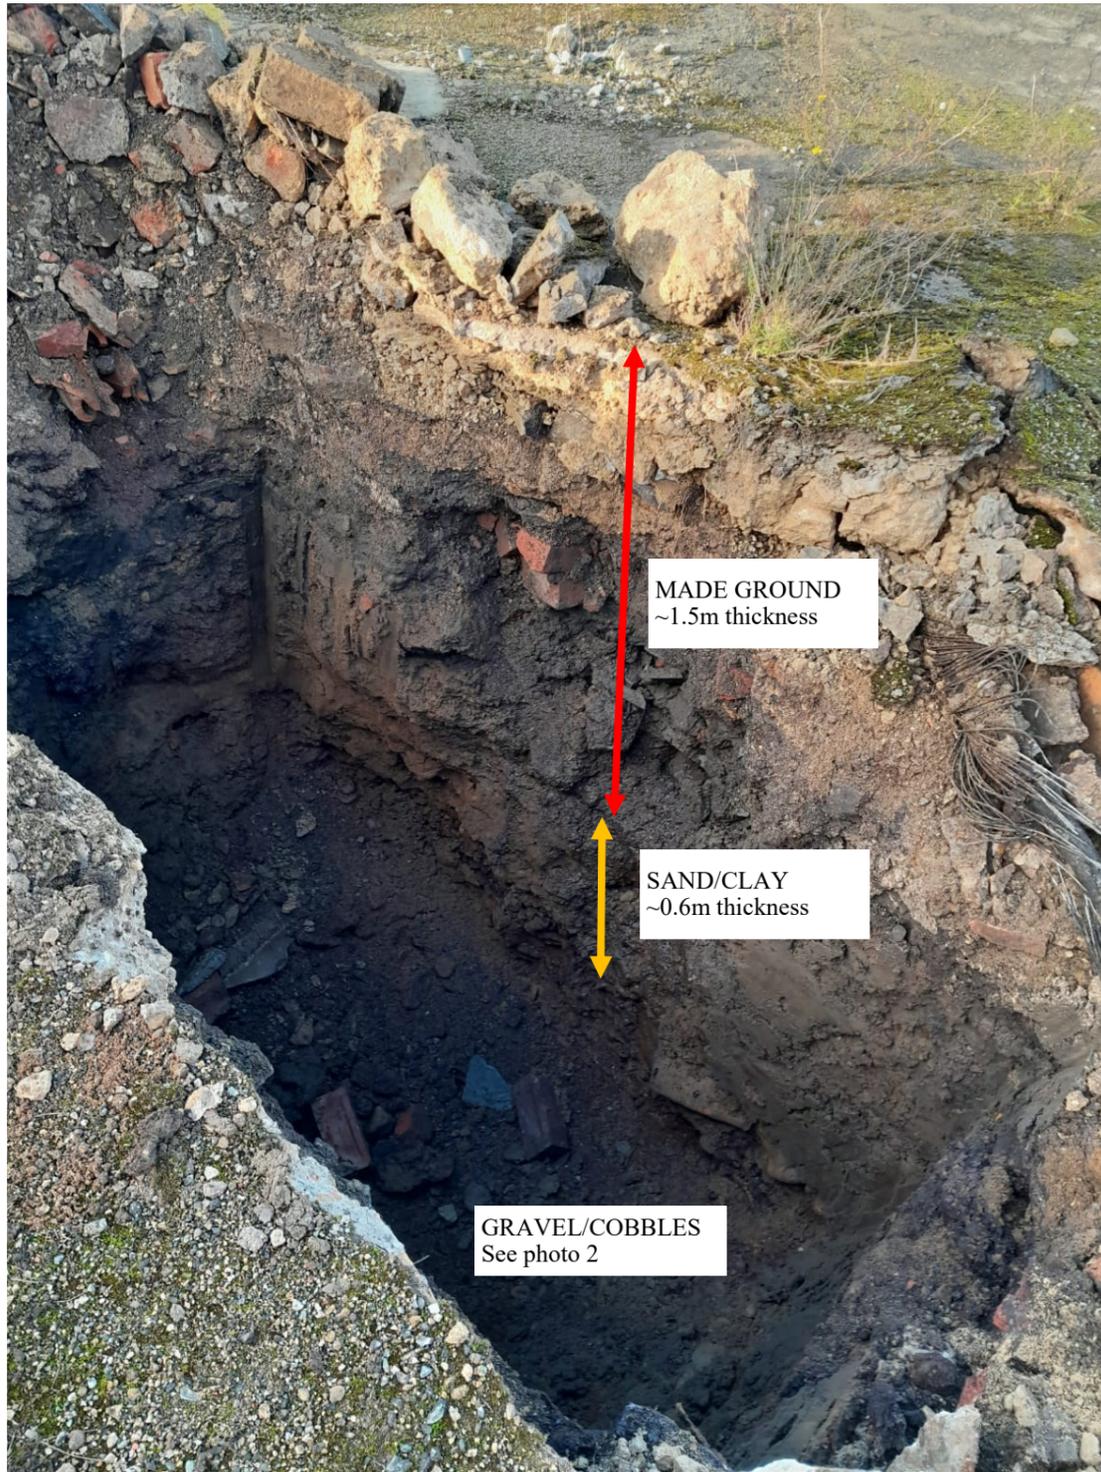
Photo 1: Trial Pit TP01

In view of the shallow refusal of the boreholes, a trial pit was excavated by the client in order to reveal the nature of the near surface soils using a 13 ton tracked 360° excavator. The soils were examined on site by the windowless sample drillers and their descriptions are given on the trial pit photographs which are presented in Appendix 4.

Beneath the fill at 2.0m depth, granular alluvial deposits were revealed comprising variably graded sands and gravels. These soils appear to be river bed deposits and are present in a medium dense to dense insitu condition. With reference to the trial pit photographs, cobbles and boulders are also present in the granular layer at 2.0m depth.
