QUALITY MANAGEMENT FOR REPORT

Project	Land adjacent 2 Poplar Avenue, Thongsbridge, HD9 7TL	Phase I Desk Study	
Client	Holme Valley Estates Ltd		
Date	February 2025		
Version	Issue 1		
Prepared by	Frances A Bennett	BSc (Hons), CGeol, FGS, FIMMM, MCIWEM, MIEEnvSci	Director Ashton Bennett Ltd

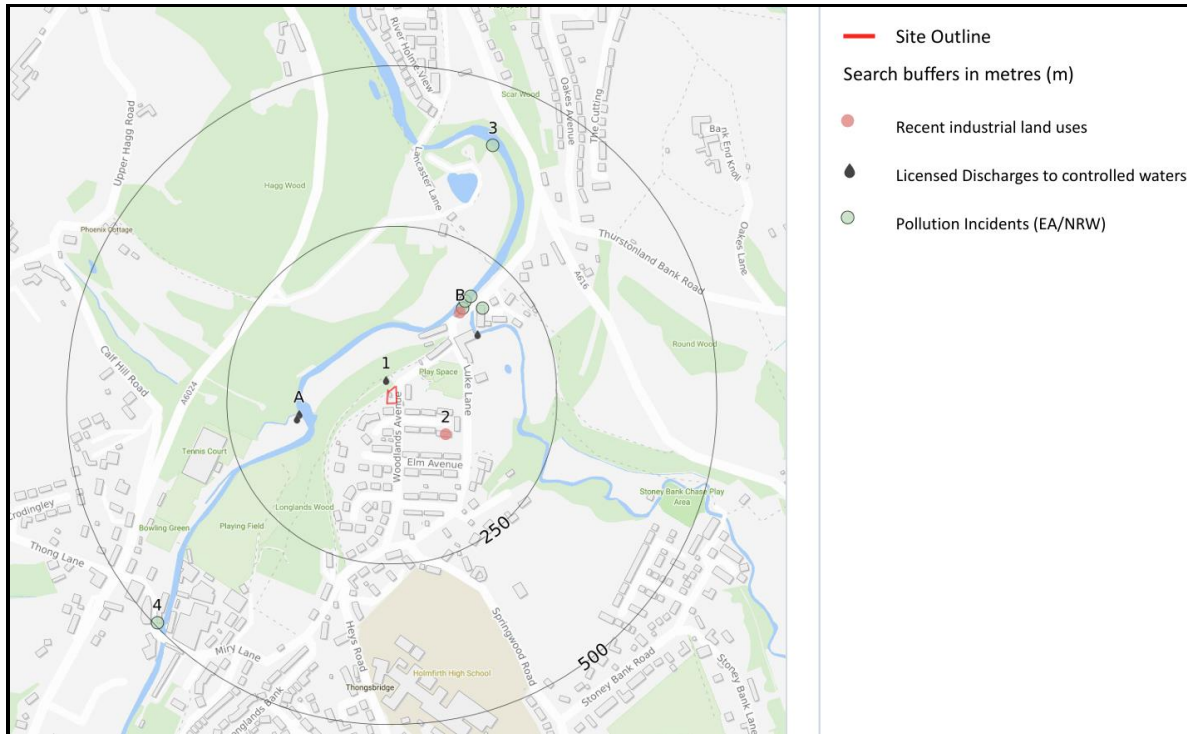
Figure 6 Current Industrial Land Use Plan

Potentially contaminating industrial land use within 250m of the site are noted as the site of the former Upper Mytholm Bridge Mill.

Current industrial land uses beyond 100m are unlikely to detrimentally affect the site.

There are no sites determined as contaminated land, National Grid High Voltage underground electricity transmission cables or high pressure gas transmission pipelines on, or within 500m of the site.
