Our ref: 24-054.01L

Re: Land at Blue Hills Farm, Whitehall Road West, Birkenshaw, Bradford, Kirklees, BD11 2DU

1.0 Introduction: -

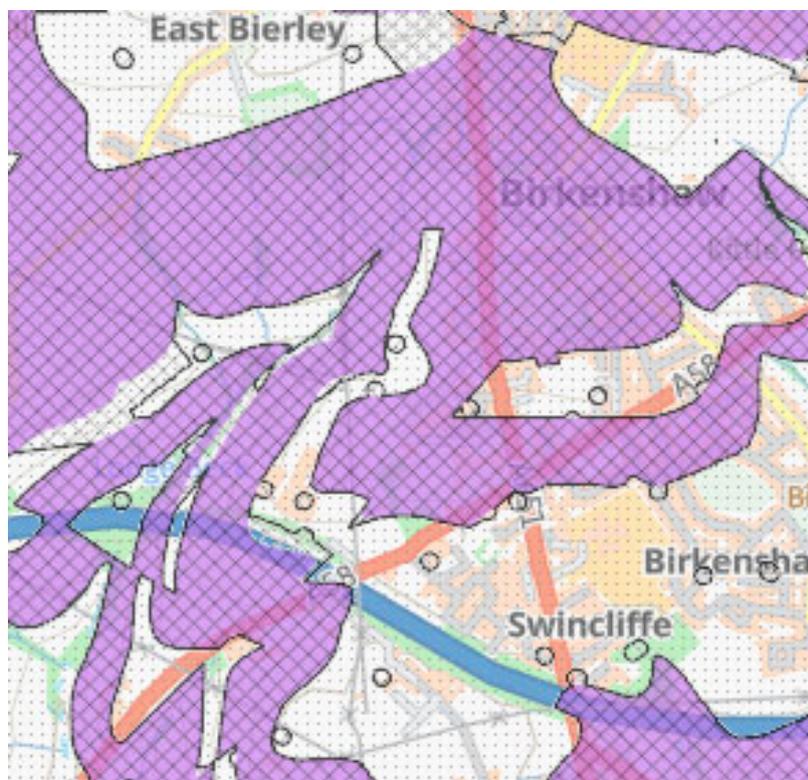
Figure 1 - Coal Authority Interactive Map Viewer Extract (Development High Risk Area & Probable Shallow Coal Mine Workings)

In accordance with the Coal Authority Online Map Viewer, parts the site (northeast of coal outcrop positions) are shown to lie within a 'Coal Mining Reporting Area' a defined 'Development High Risk Area' and area of Probable Shallow Coal Mine Workings (See Figure 1 below).

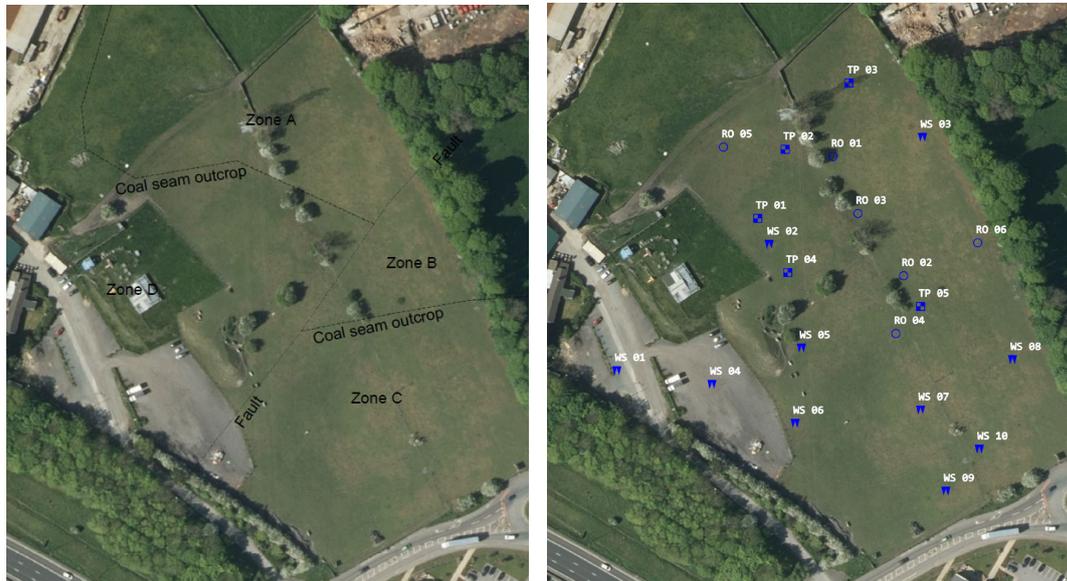
Figures 2 & 3– Extract from IFA Ground Investigation Report (Coal Risk Features & Exploratory Hole Location Plan)

When comparing Figure 2 with Figure 3 the rotary boreholes labelled RO 02, RO04 and RO 06 all appear to be positioned south of the inferred fault line with no coal seams or evidence of historic coal / ironstone mining both sides of the fault.

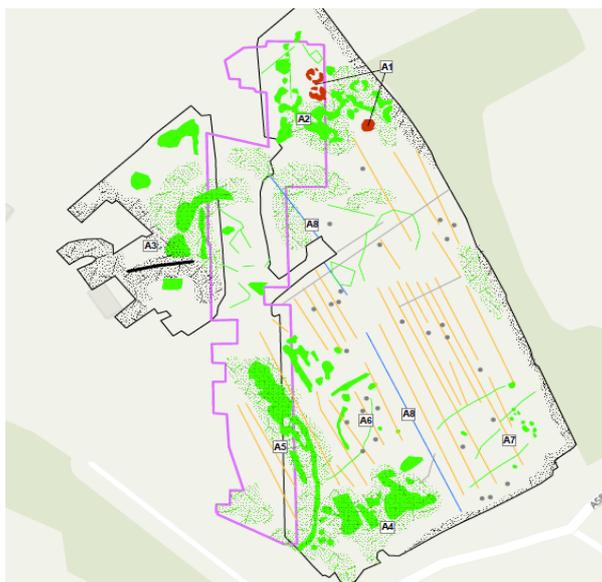
Figure 4 - Interpretation of Gradiometer Survey Results (Extract from Report)

- A3** Area containing the earthworks and the farm buildings occupying the former colliery site west and north of the survey area (**A3**). These may relate to more intact building remains such as foundations or floors, or other structures, as discussed below.

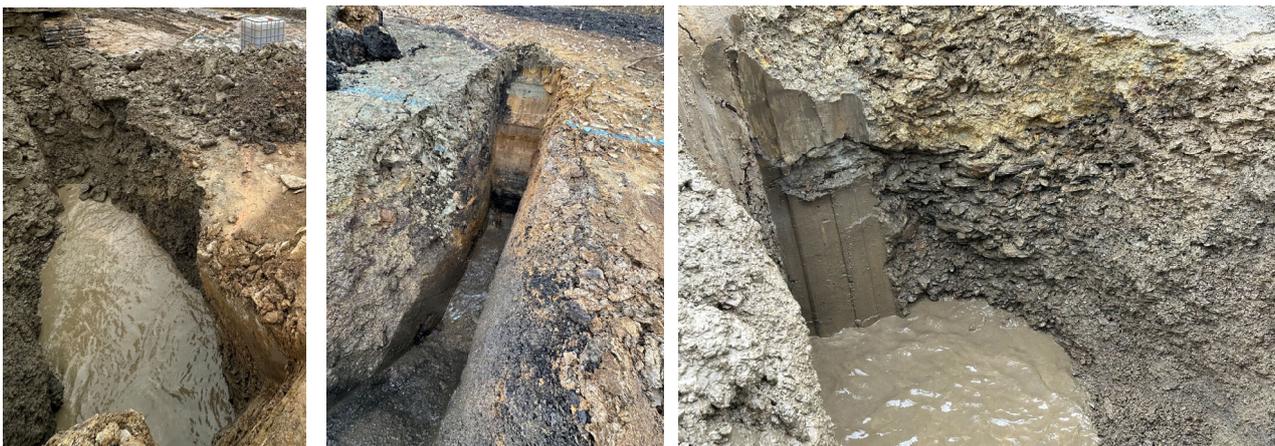
Plates 1 to 3 – Photographic Records of Trial Trenches TT101, TT102 & TT103

3 no. mechanically excavated trial trenches were attempted through selected bell pits but were terminated at shallow depths due to significant water ingress and trench instability.

Significant water ingress was noted inside the backfilled bell pits (trial trenches and windowless sampling boreholes) from c.1.00m to c.2.00m bgl.

Following the bell pit investigations where boreholes / trenches were undertaken these features appear to have been adequately backfilled with typically firm clays with no evidence of voids or significant deleterious materials. As such it may be possible to support new dwellings in this area using piled foundations and suspended floor slabs with piles taken beyond the base of the bell pits which were noted to be up to c.7.40m deep. Confirmation should be sought from the appointed specialist drilling and grouting contractor with regards any minimum pre-treatment requirements of bell pits before piling (if any).

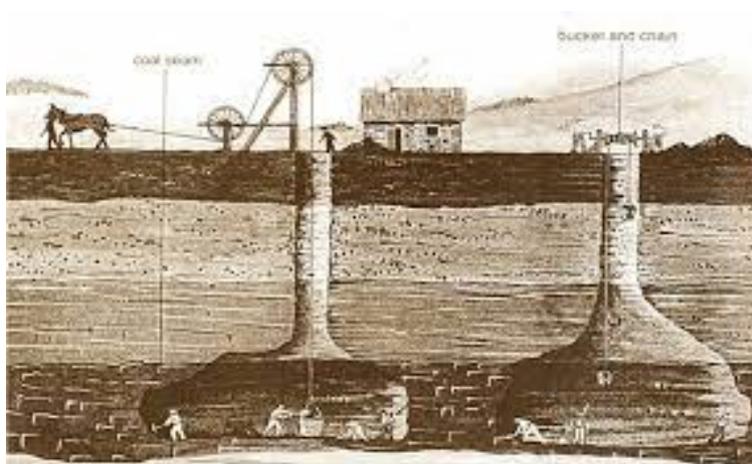
Figure 5 - Typical example of historical bell pitting for illustration purposes

Given the northeast of the site was not fully stripped at the time of the investigation there is high a risk of further unrecorded historical bell pitting and a 'watching brief' is recommended during further site strip / ground preparation works both in the northeast and site wide to check for circular features which could represent potential mine entries and require remedial works or piled foundations.

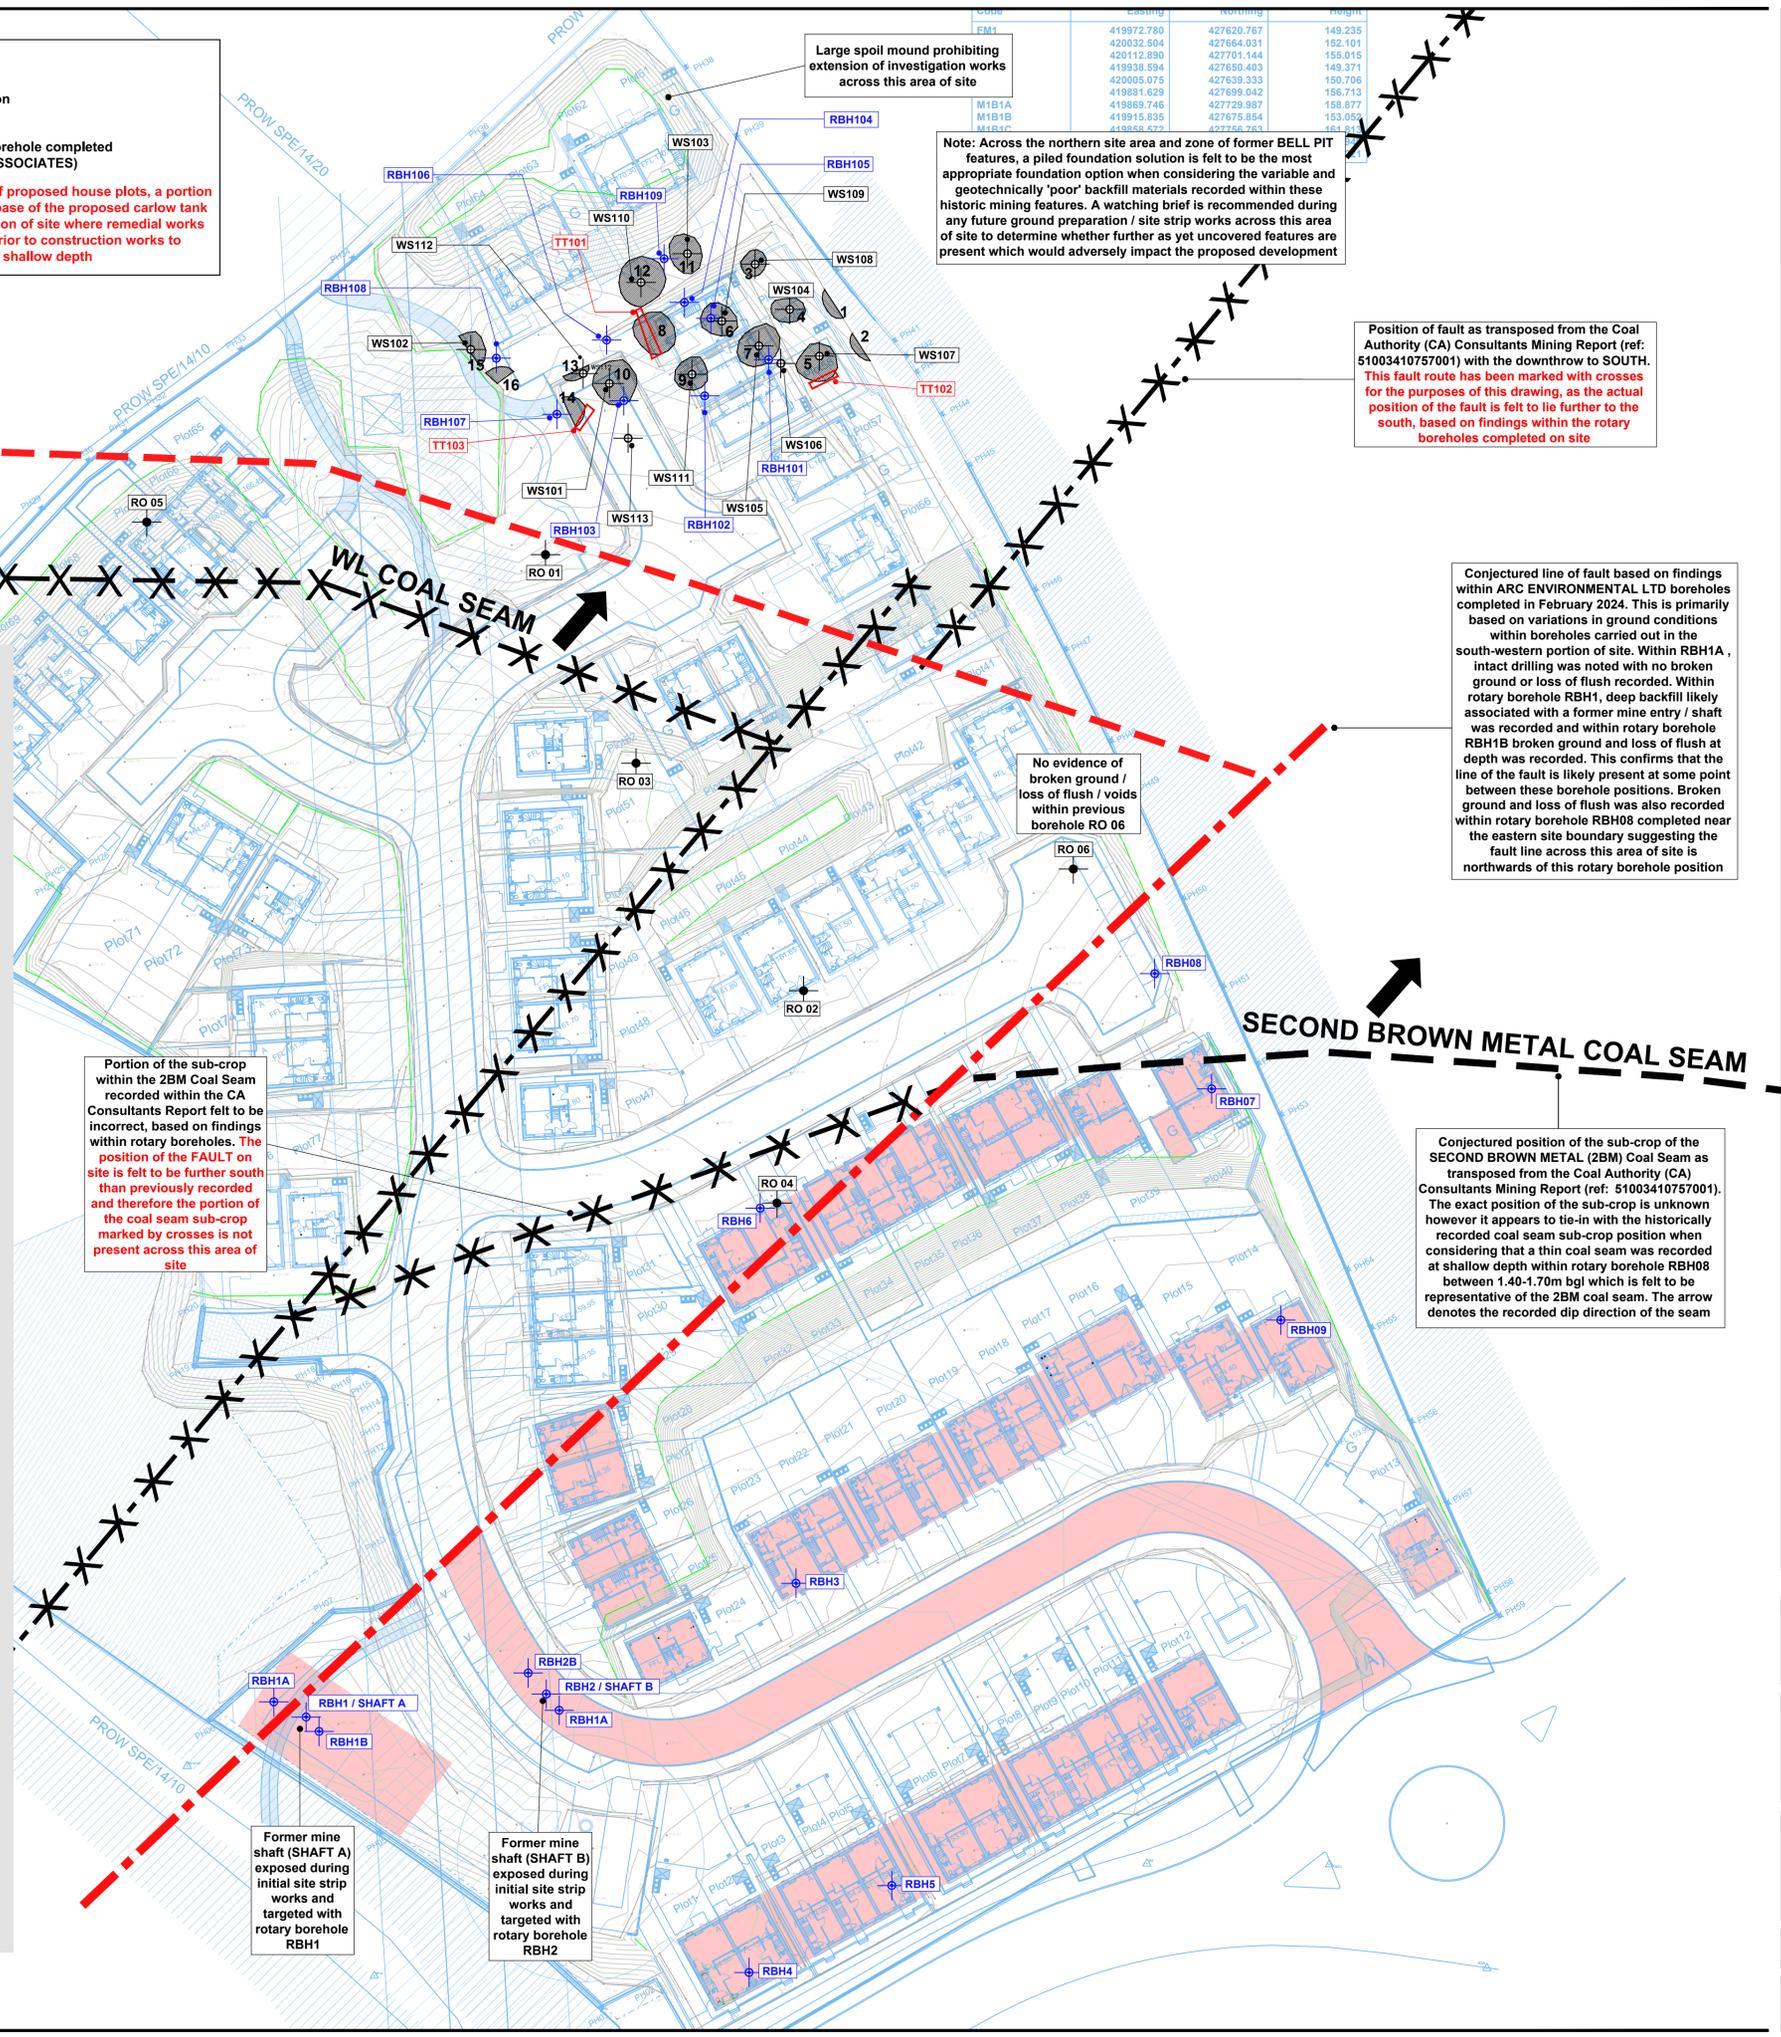
Rotary Boreholes RBH1 and RBH2 targeted the two suspected boreholes (SHAFT A & SHAFT B) in the southwest of the site which were noted to be c.10.50m (SHAFT A) and c.13.00m deep (SHAFT B) respectively.

- RBH1 recorded c.10.50m of clay and ash backfill materials with no evidence of significant voiding (i.e., water flush maintained throughout) then intact light grey mudstone to at least 15.00m.
- RBH2 recorded c.13.00m of made ground comprising clay with brick and mudstone fragment to c.6.50m after which there was loss of flush with 'soft drilling' to c.10.50m then broken ground with small voids to c.13.00m which is considered to be the base of the shaft. 'Steady drilling' was then noted to at least 16.00m.

Former mine shaft (SHAFT A) exposed during initial site strip works and targeted with rotary borehole RBH1

Former mine shaft (SHAFT B) exposed during initial site strip works and targeted with rotary borehole RBH2

The two shafts recorded below a proposed Carlow Tank and proposed highway (estate road) and shallow workings should be fully consolidated by drilling and grouting which would fully dismiss the risk of future ground instability in these workings. Similarly, the effected highway and 32 no. housing plots south of or straddling the revised fault line will require treatment including plots with traditional and piled foundations. This report should be passed on to a specialist drilling and grouting contractor to design and price a suitable scheme. Any treatment scheme will need to be agreed with Kirklees planning & highways departments, the Coal Authority (under permit), and the warranty providers.
