22-110.01L

## **Re: Validation of Hotspot Removal for a Land at Blue Hills Farm, Birkenshaw, BD11 2DU**

Project Title:  
 Proposed Residential Development  
 Blue Hills Estate Farm  
 Birkenshaw

Drawing Title:  
 Validation Sampling Record Sheet 1

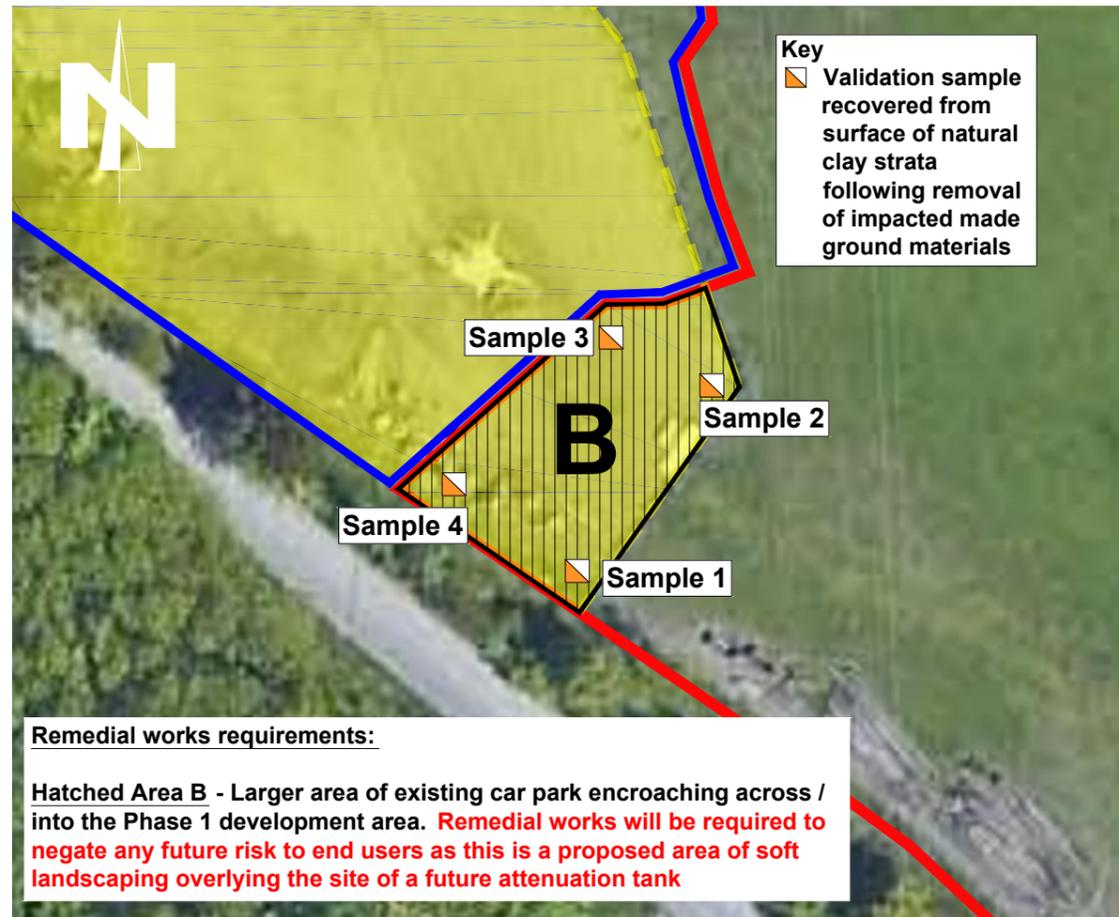
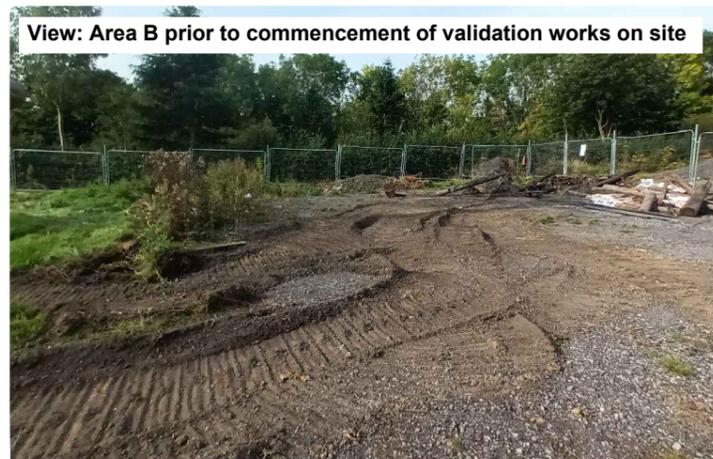
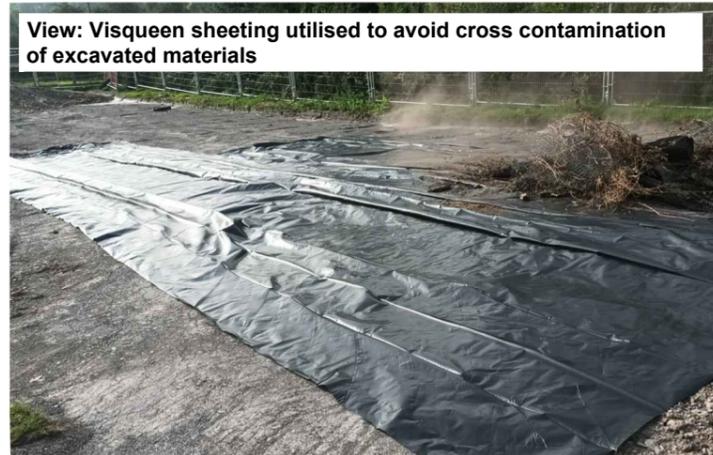
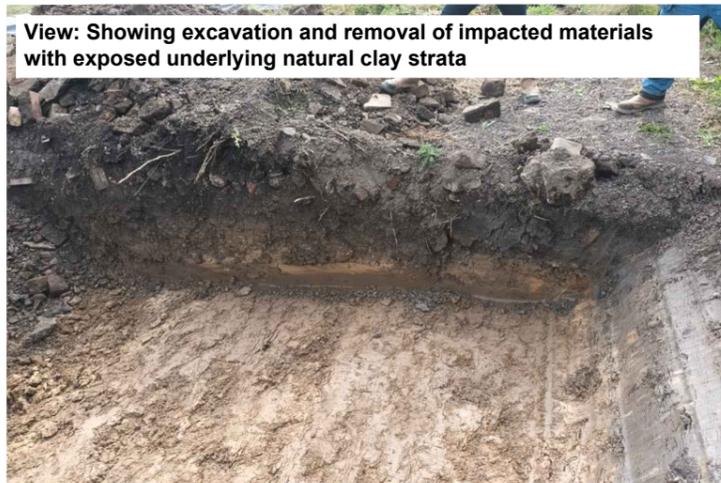
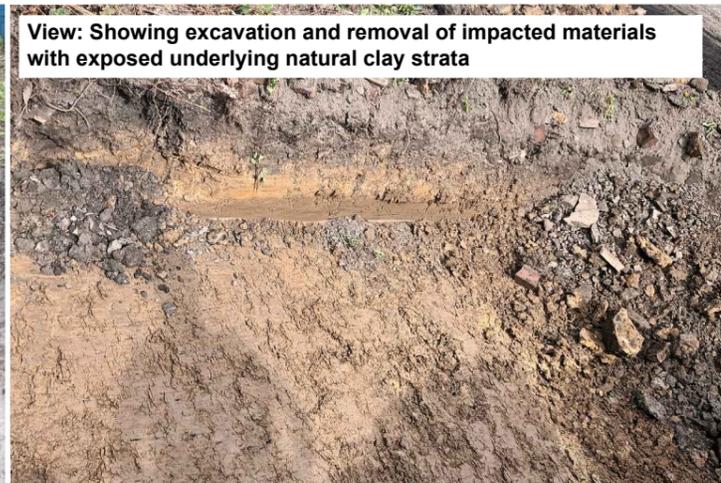
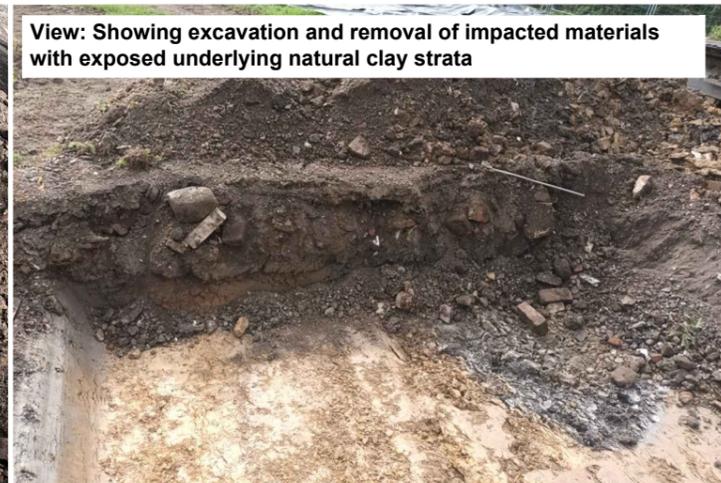
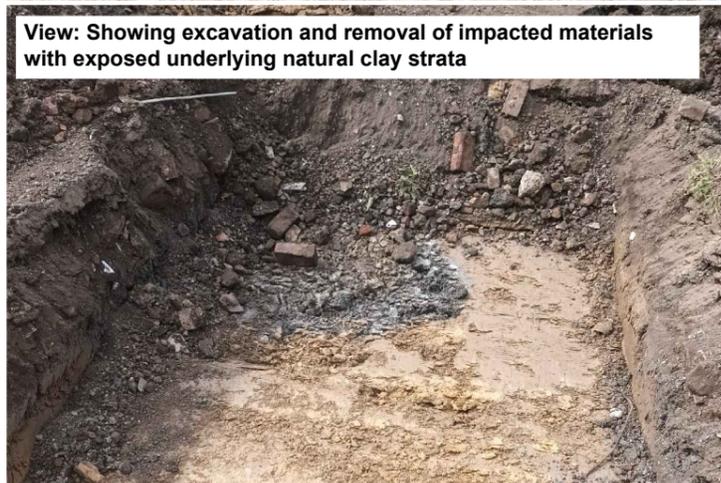
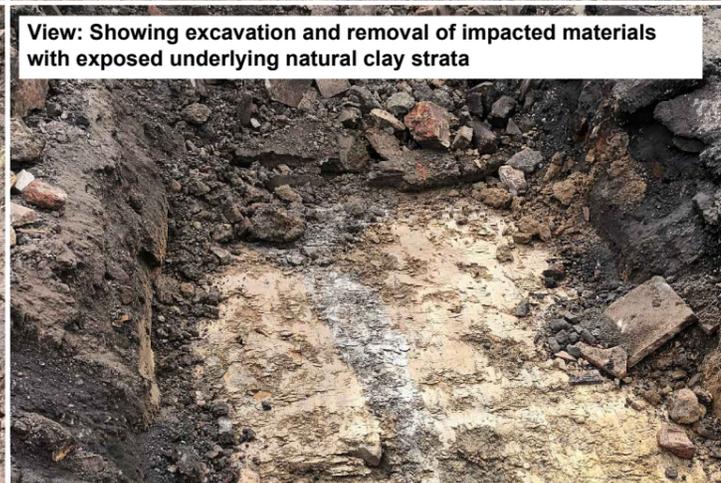
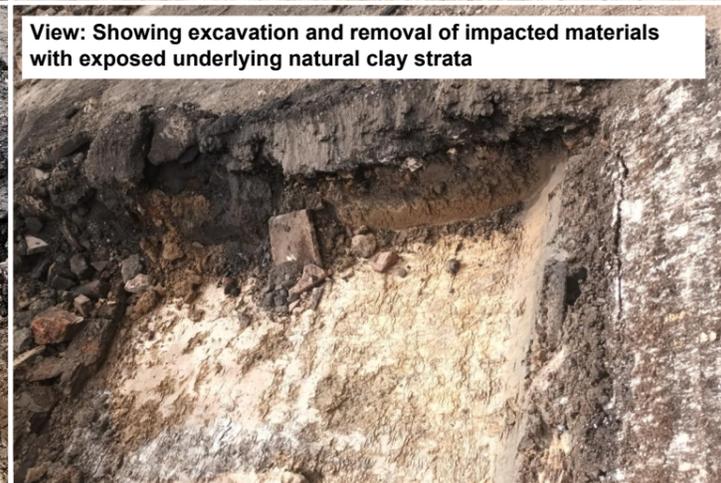
Following the made ground material in Area B the resultant formation comprised a firm yellow / orange mottled brown sandy clay which was carefully inspected to confirm no obvious signs or remains of any anthropogenic debris. 4 no. representative samples of the formation were recovered and forwarded to Chemtech (UKAS & MCERTS Accredited) for subsequent testing. The results of these additional tests are summarised in Table 1 and are included in the Chemtech Environmental Analytical Test Report (ref. 121691) attached to this letter report. A Photographic Record Sheet showing the above works and formation sample locations is attached.

From the additional work and testing undertaken, it is the opinion of Arc Environmental Limited that as the impacted made ground has been removed to a natural clay formation no formal cover system should be required within Area B just an adequate depth of suitable clean topsoil to act as a growing medium to achieve final design levels.

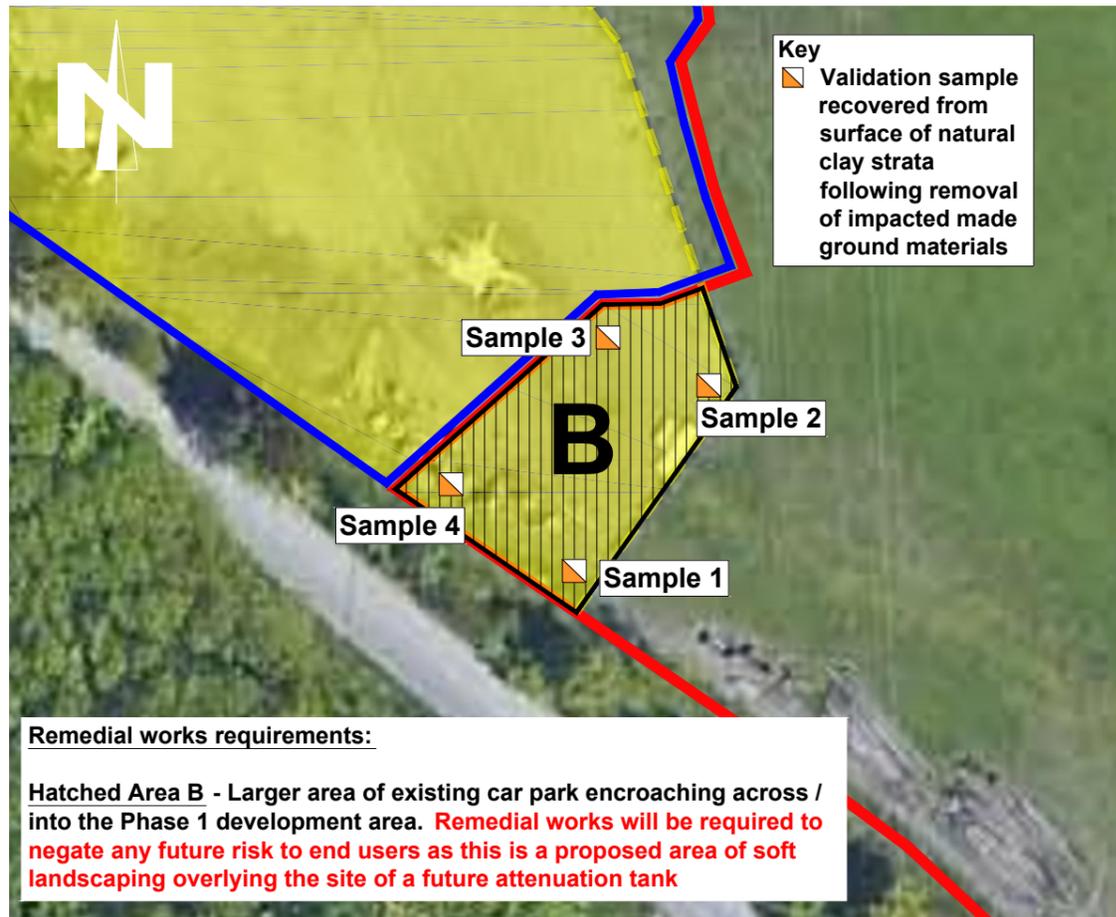
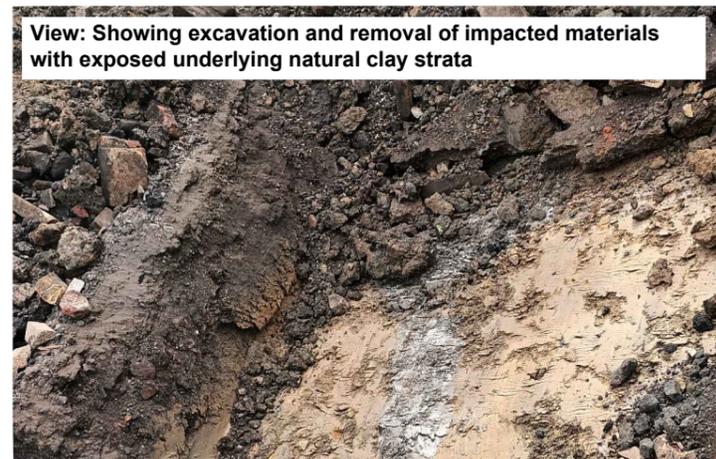
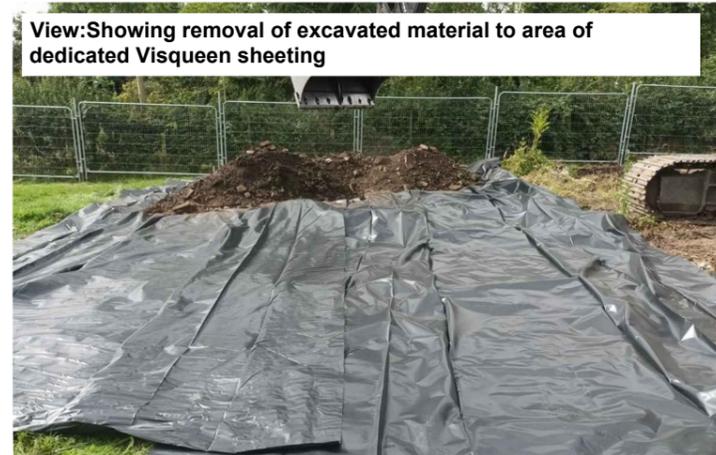
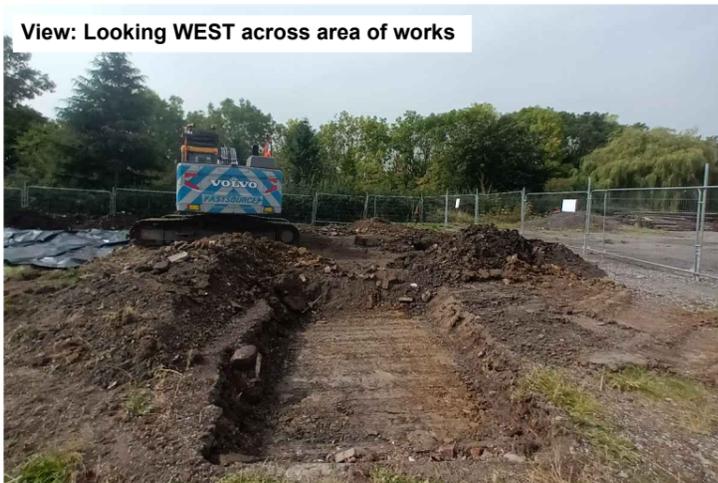
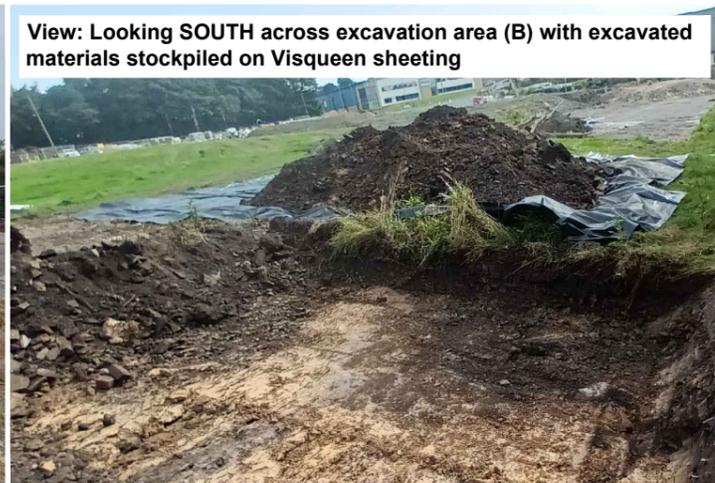
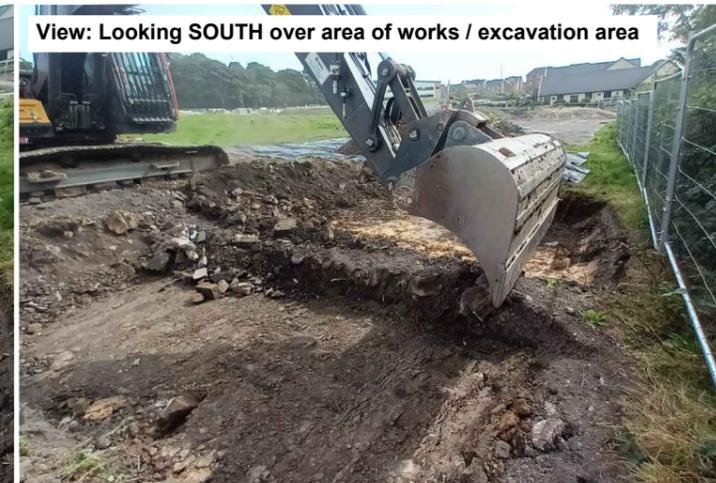
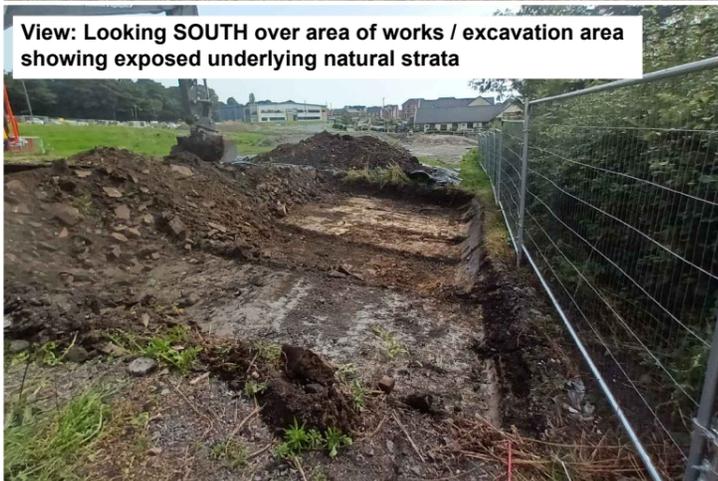
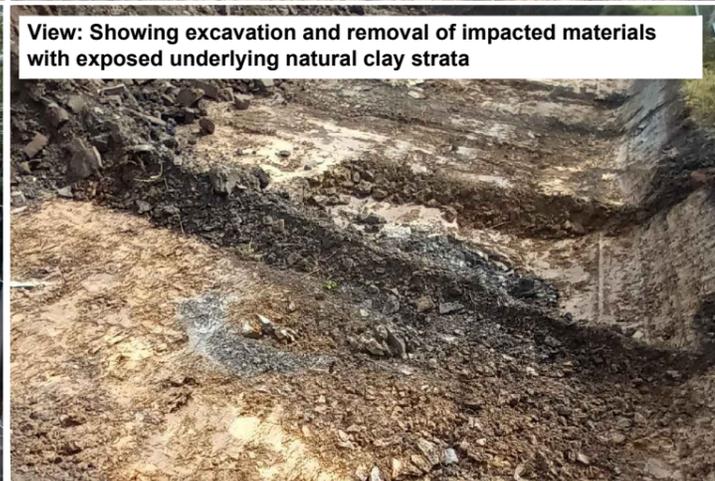
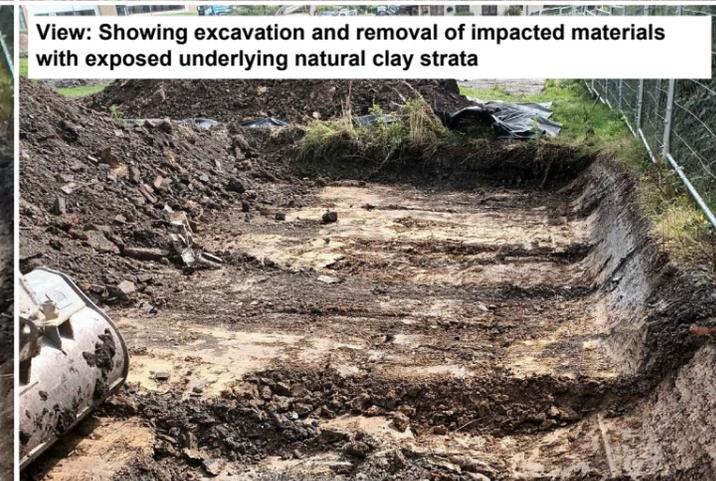
Drawing Title:  
 Validation Sampling Record Sheet 2

During the removal of the made ground materials a dark 'circular' feature was recorded within the natural superficial deposits to the western portion of Area B, which may possibly be associated with historic coal mining activities, such as a 'bell pit' or a mine entry. Further investigation of this feature might be required prior to the construction of the proposed attenuation tank within this area of the site / air shaft.
