**COMPLETION REPORT FOR THE PROOF
DRILLING OF POTENTIAL SHALLOW MINE
WORKINGS**

Former Greenside Mills, Skelmanthorpe
for Lovell Partnerships Ltd

Report reference: C9297C/D&G

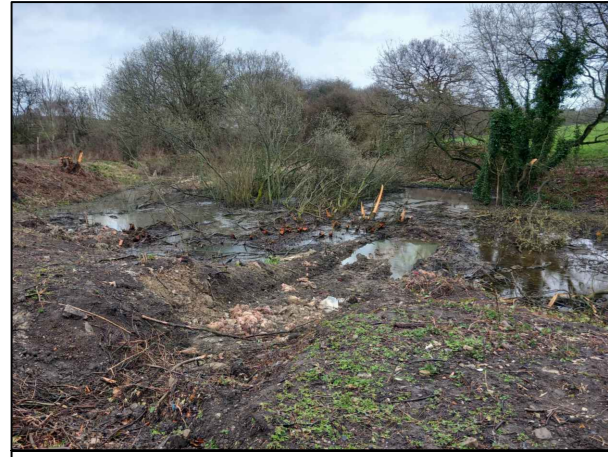
1. Photo of pond within east of the site, looking southeast.

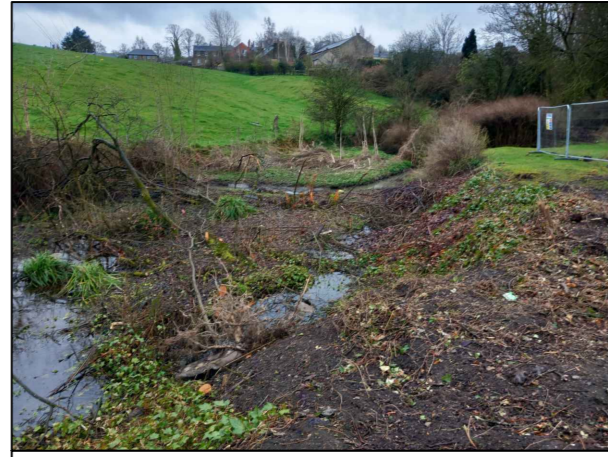
2. Photo of pond and surface water feature looking south.

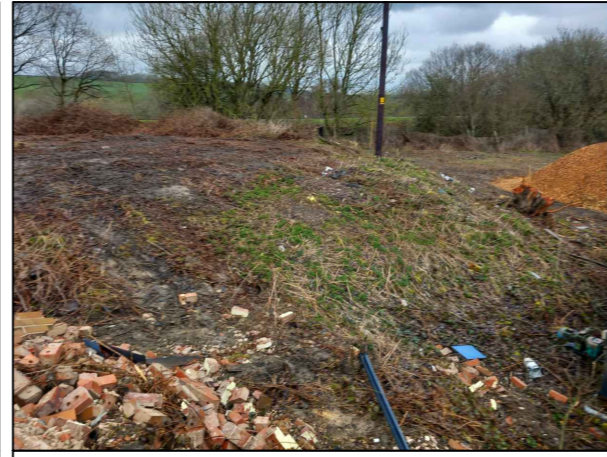
3. Photo of stockpile within east of site, including wooden pole, with area of former infilling and pond beyond to the east.

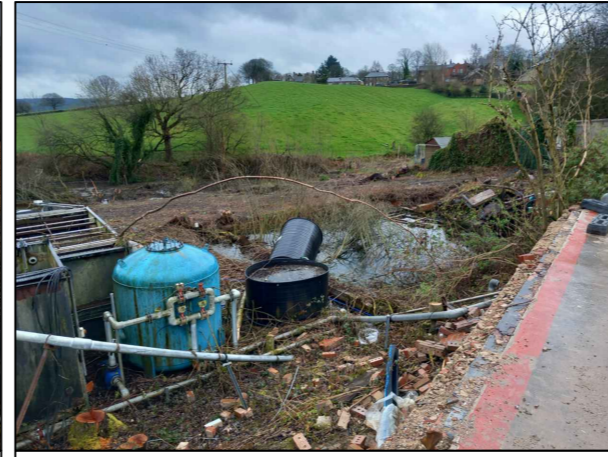
4. Evidence of former brick lined mill pond and adjacent structures prior to backfilling / clearance.

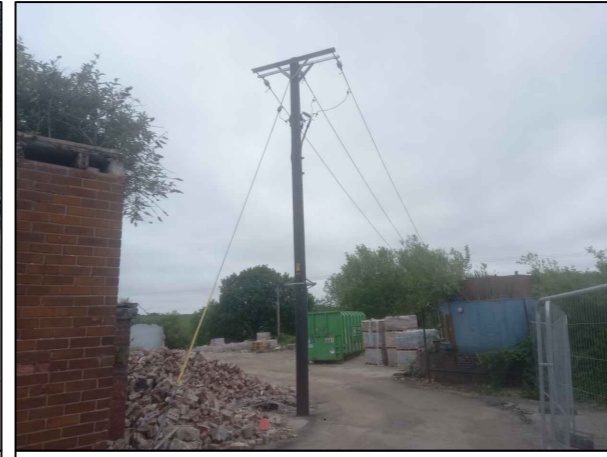
5. Newly constructed overhead cables and wooden pole, located in close proximity to former AST and sub-station.

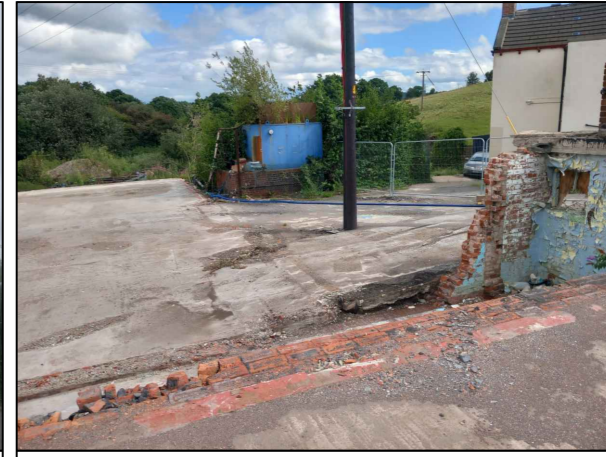
6. View of former AST, prior to demolition and clearance.

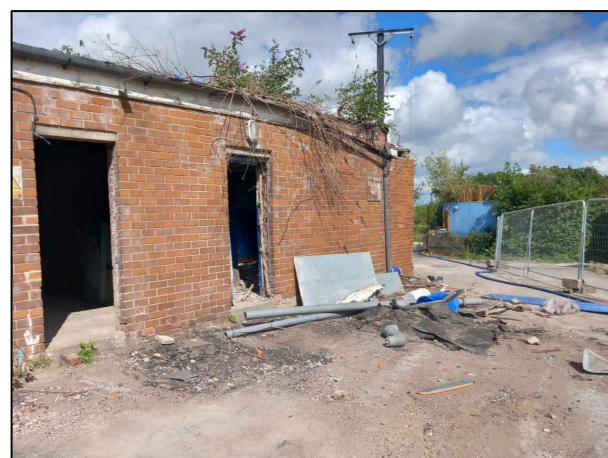
7. View of former sub-station prior to demolition and clearance.

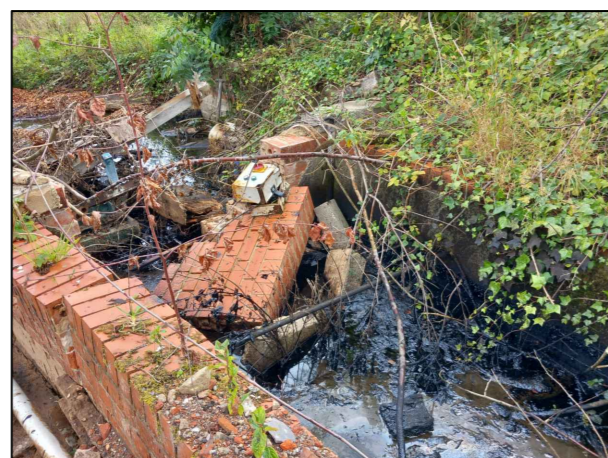
8. Surface water culvert located in southeast, with black oily substance noted.

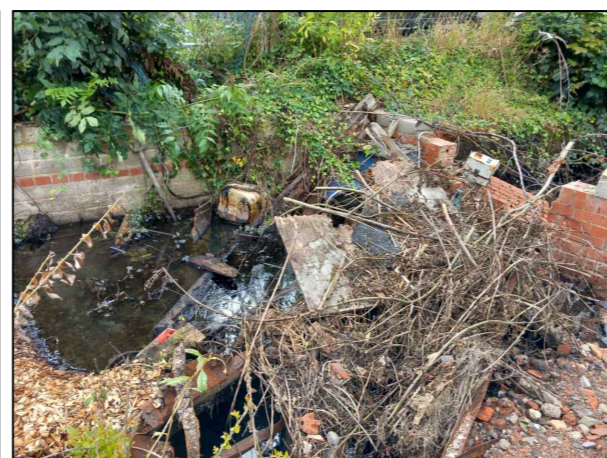
9. View of surface water culvert with discarded containers.

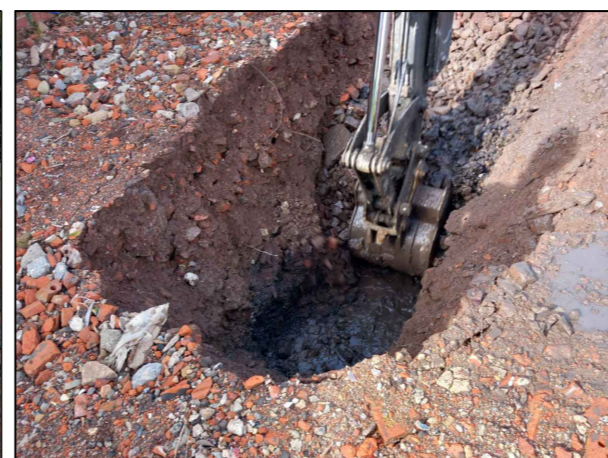
10. Evidence of hydrocarbon staining within backfilled mill pond (trial pit TP218).

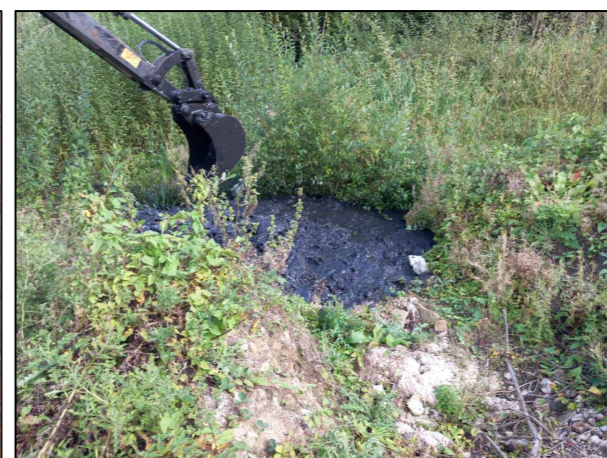
11. View of black saturated pond sediments during trial pitting.

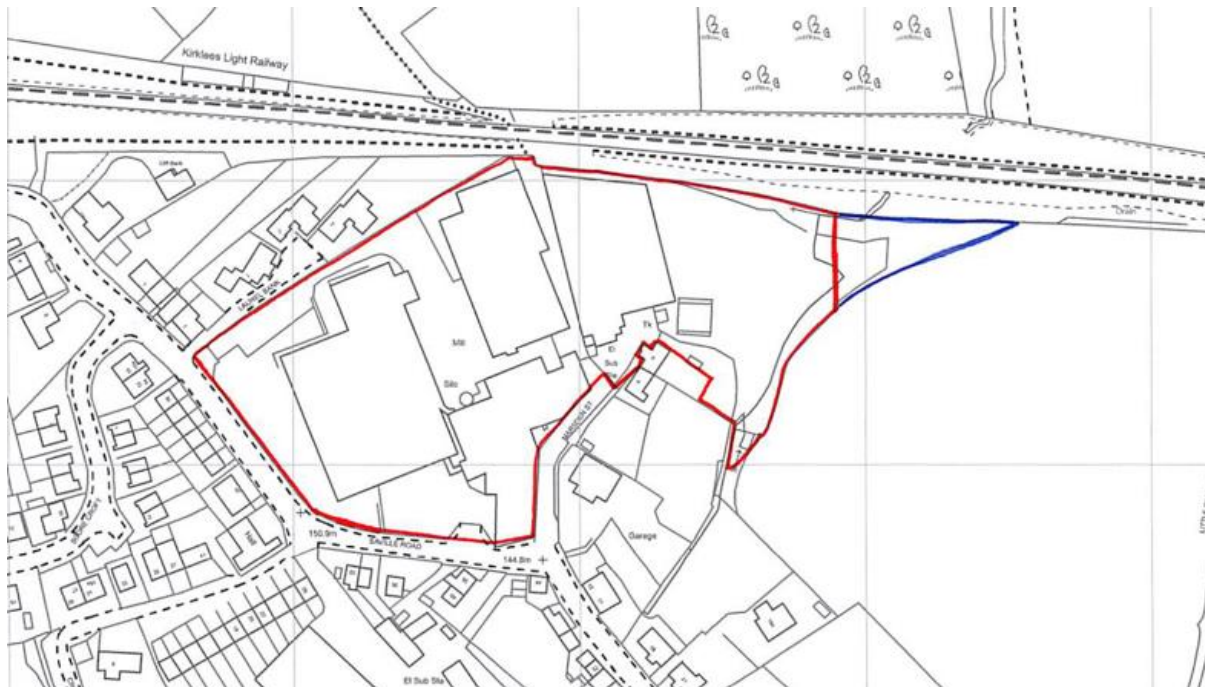
Figure 1.1 Plan showing Development and Ownership Site Boundaries

The red line site boundary shown in Figure 1.1 below indicates the proposed development area, whilst the blue line boundary indicates an extended area of ownership.

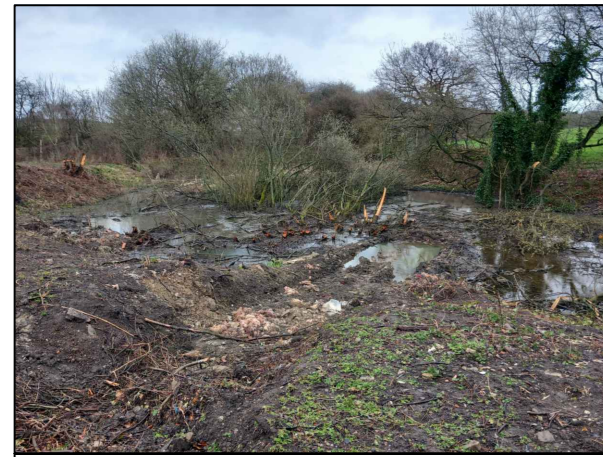
1. Photo of pond within east of the site, looking southeast.

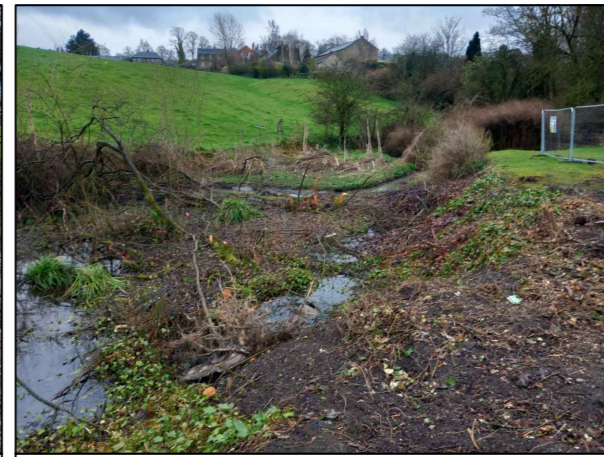
2. Photo of pond and surface water feature looking south.

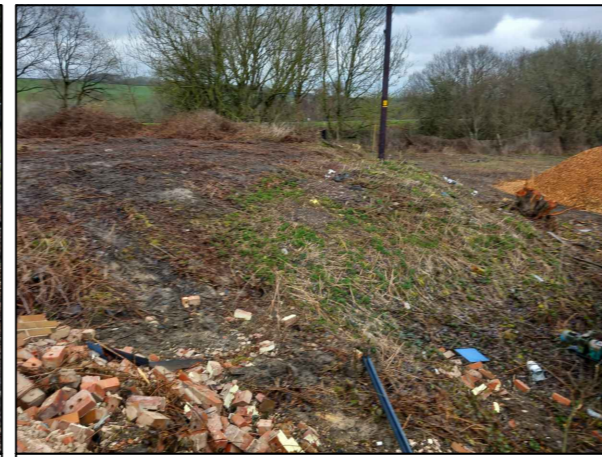
3. Photo of stockpile within east of site, including wooden pole, with area of former infilling and pond beyond to the east.

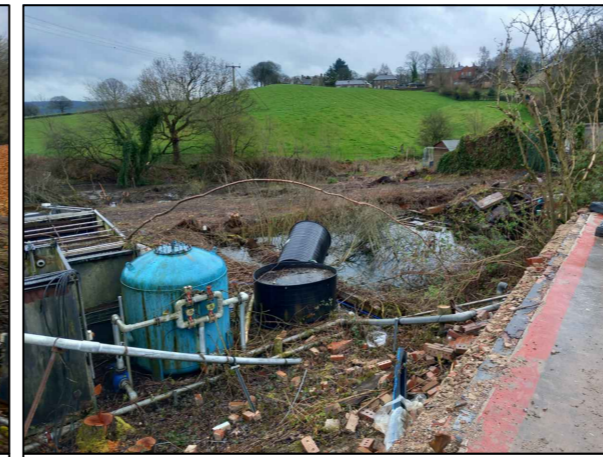
4. Evidence of former brick lined mill pond and adjacent structures prior to backfilling / clearance.

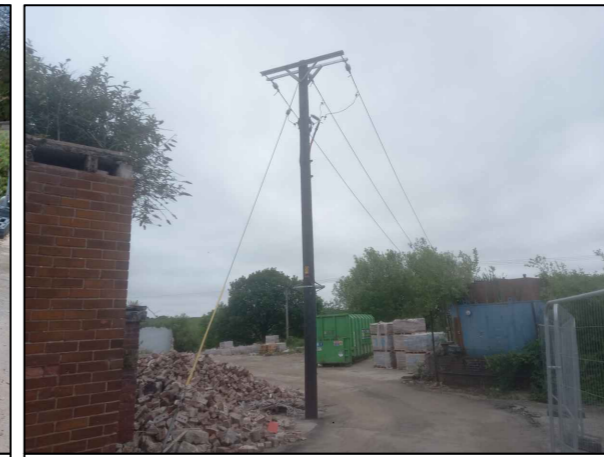
5. Newly constructed overhead cables and wooden pole, located in close proximity to former AST and sub-station.

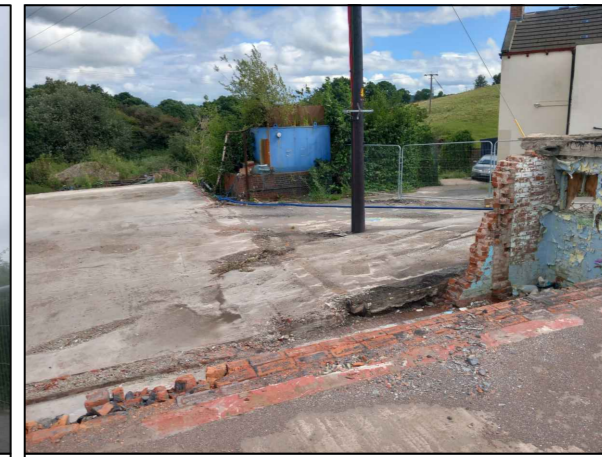
6. View of former AST, prior to demolition and clearance.

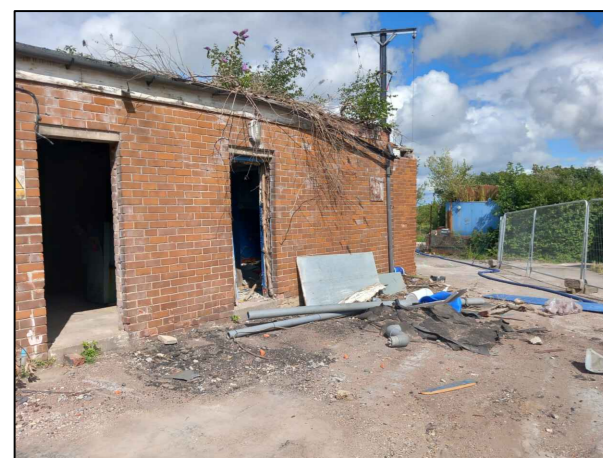
7. View of former sub-station prior to demolition and clearance.

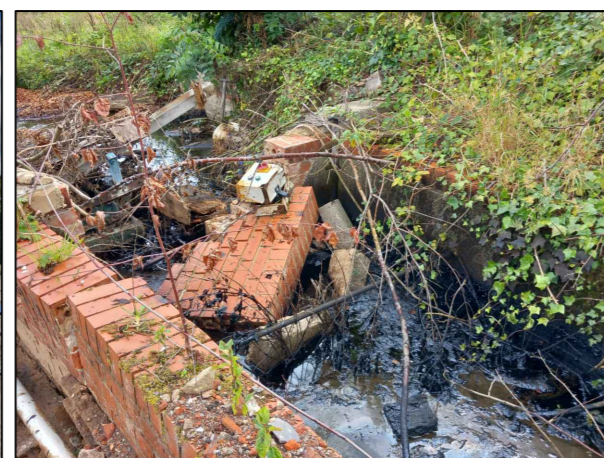
8. Surface water culvert located in southeast, with black oily substance noted.

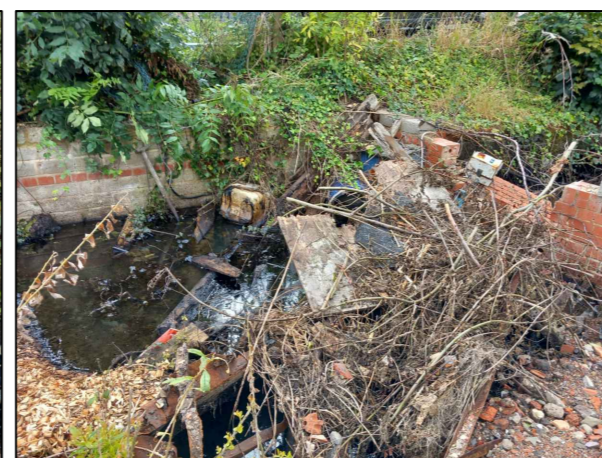
9. View of surface water culvert with discarded containers.

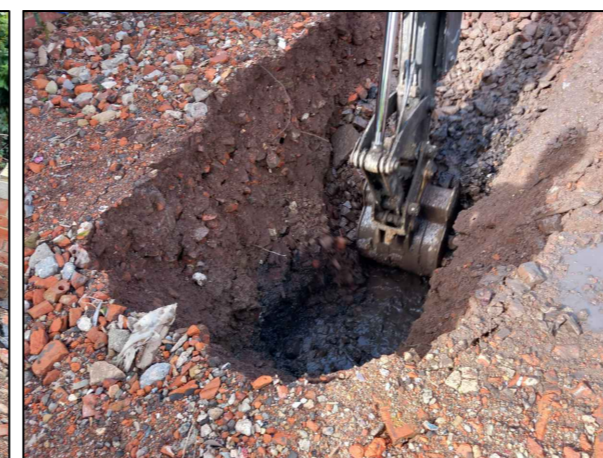
10. Evidence of hydrocarbon staining within backfilled mill pond (trial pit TP218).

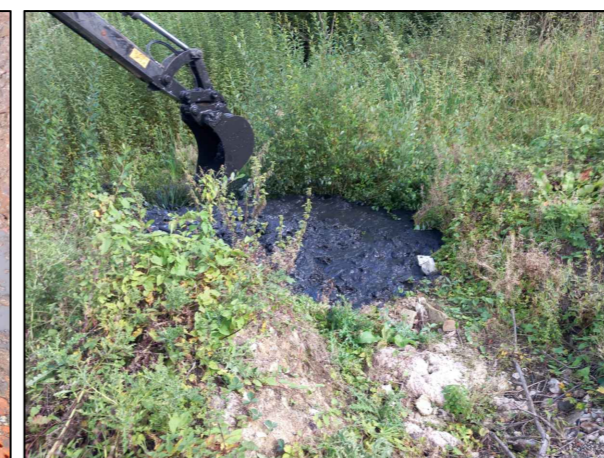
11. View of black saturated pond sediments during trial pitting.

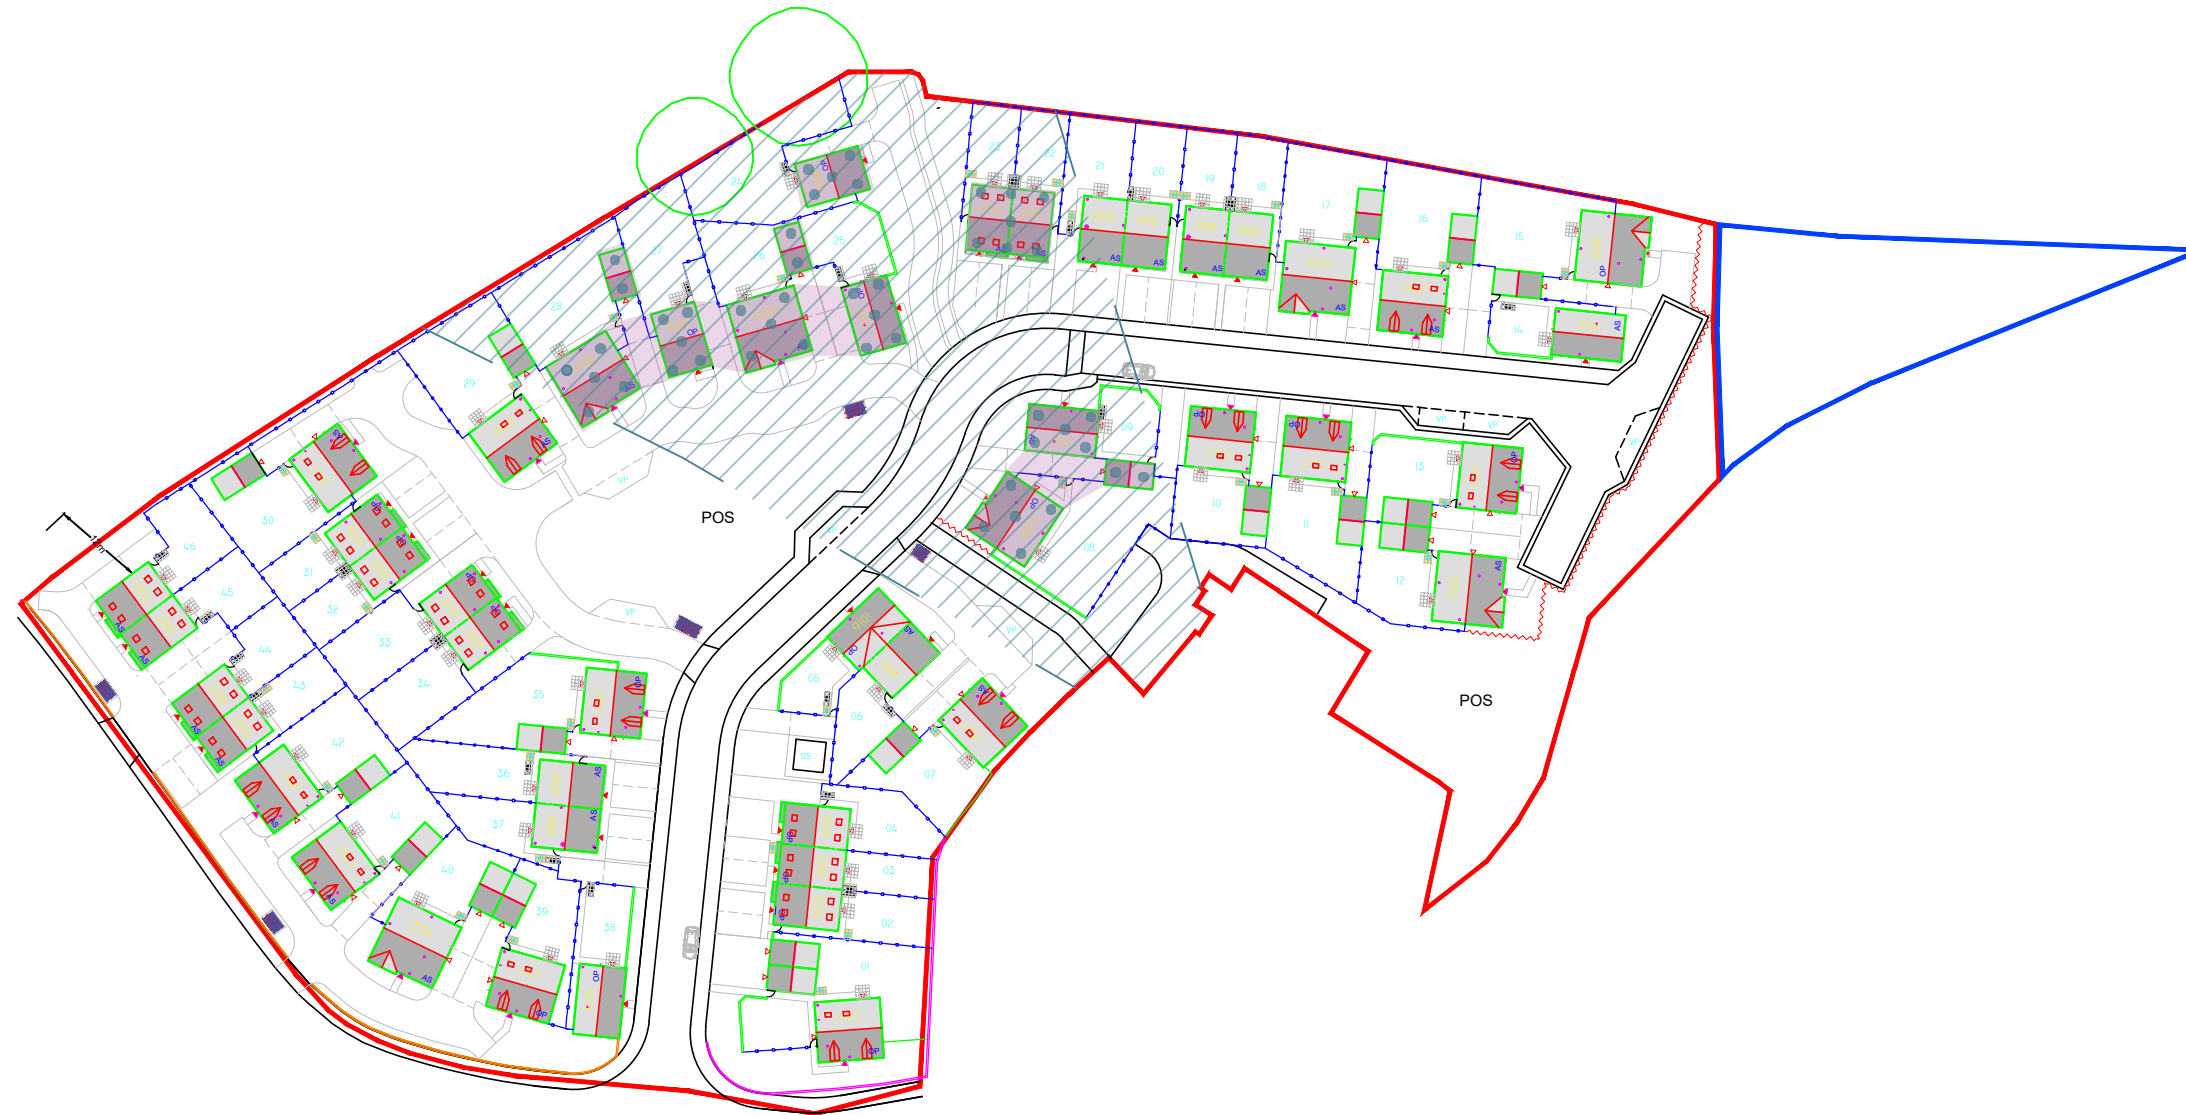
- Development site boundary
- Proposed borehole grid pattern
- Proposed plots for drill and subsequent grout stabilisation, where necessary.
- Proposed extent of site for stripping of unrecorded mine entries (such as bell pits / crop workings etc).

Due to the uncertainty regarding the extent of potential shallow mining at the site, the works will be undertaken in a staged manner, with treatment only undertaken where the initial probe drilling proves it is required. Boreholes will be drilled on a domino-5 pattern across building footprints within central site areas. Should evidence of shallow mine workings exhibiting inadequate competent rock cover be encountered then treatment will be undertaken utilising a 3m x 3m grid of holes extending across the nominal zone of consolidation i.e. up to 3m beyond the plot and / or beyond the fault lines once confirmed. Treatment of any retaining walls/structures greater than 1.5m in height (or where the retaining feature is considered integral to supporting
