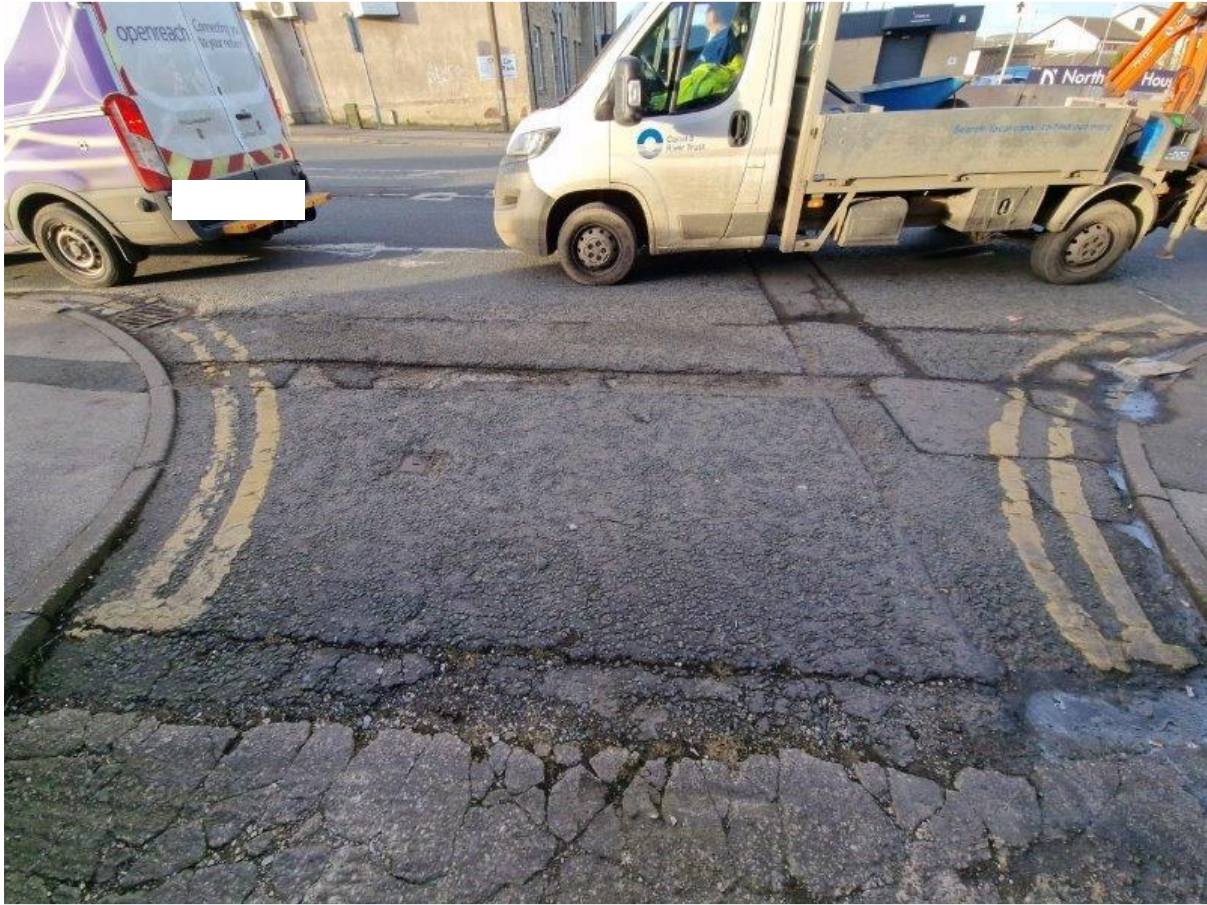
Lower Fitzwilliam Street 22m from lights

Surface damage and scarring to footpath and carriageway from utilities works. Yellow and white lining faded.

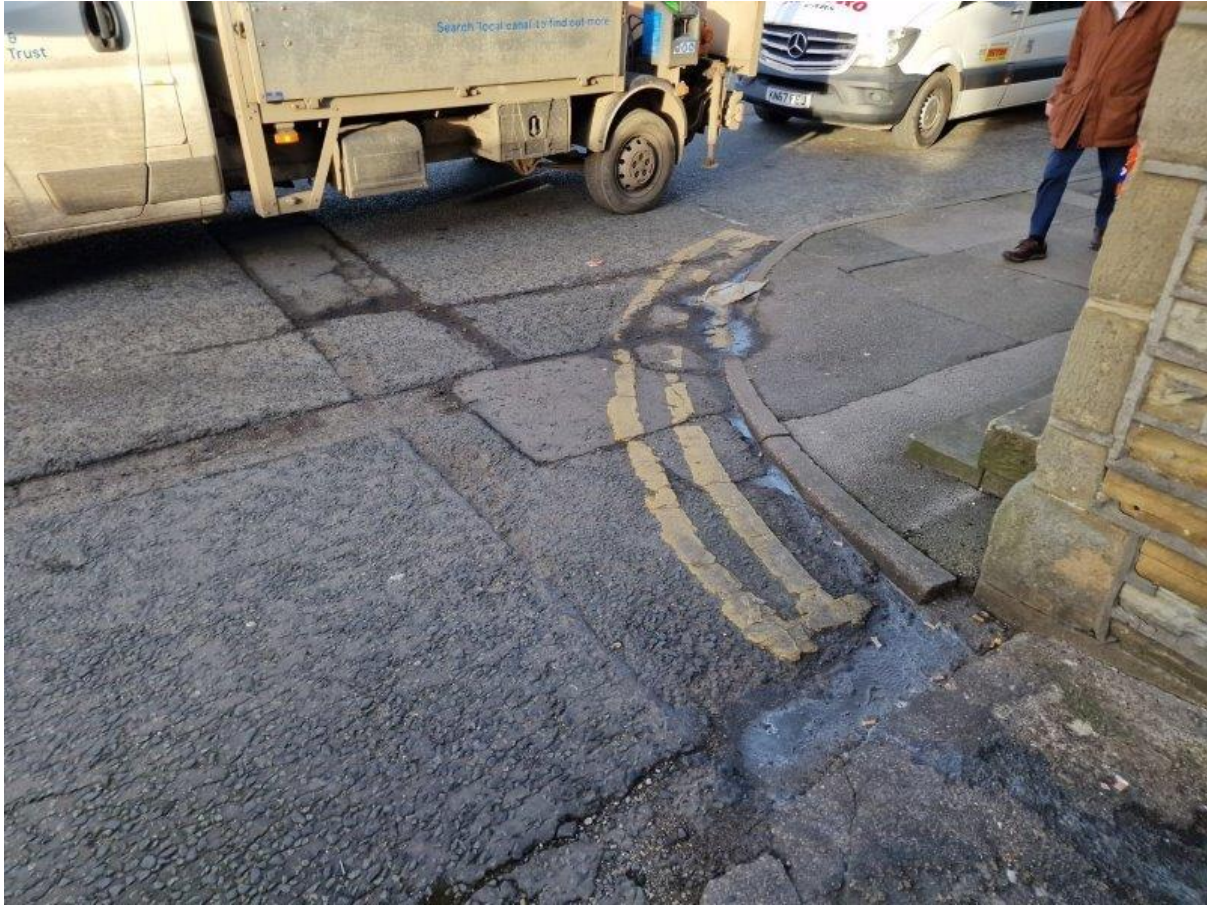
Lower Fitzwilliam Street 22m from lights

Surface damage and scarring to footpath and carriageway from utilities works. Yellow and white lining faded.

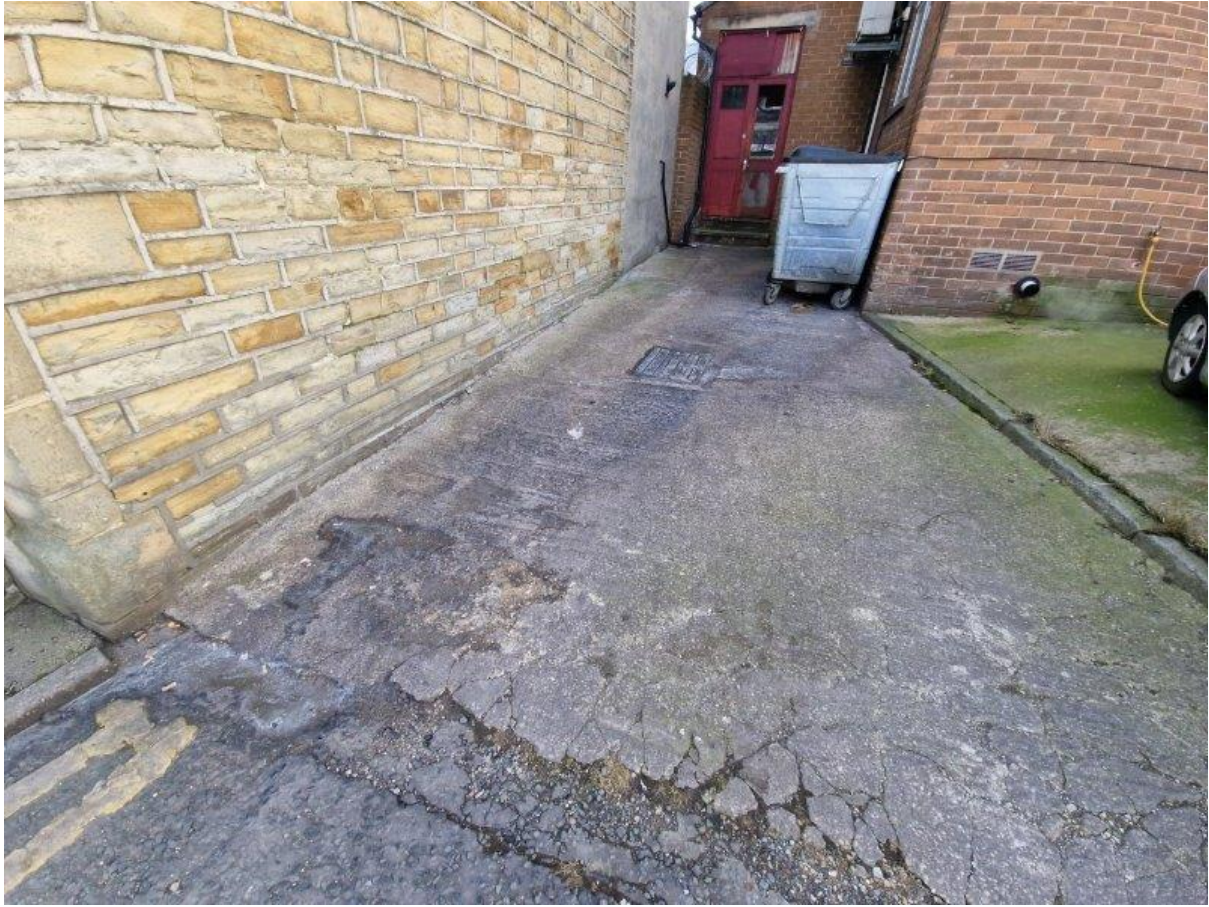
Lower Fitzwilliam Street 22m from lights

Surface damage and scarring to footpath and carriageway from utilities works. Yellow and white lining faded.

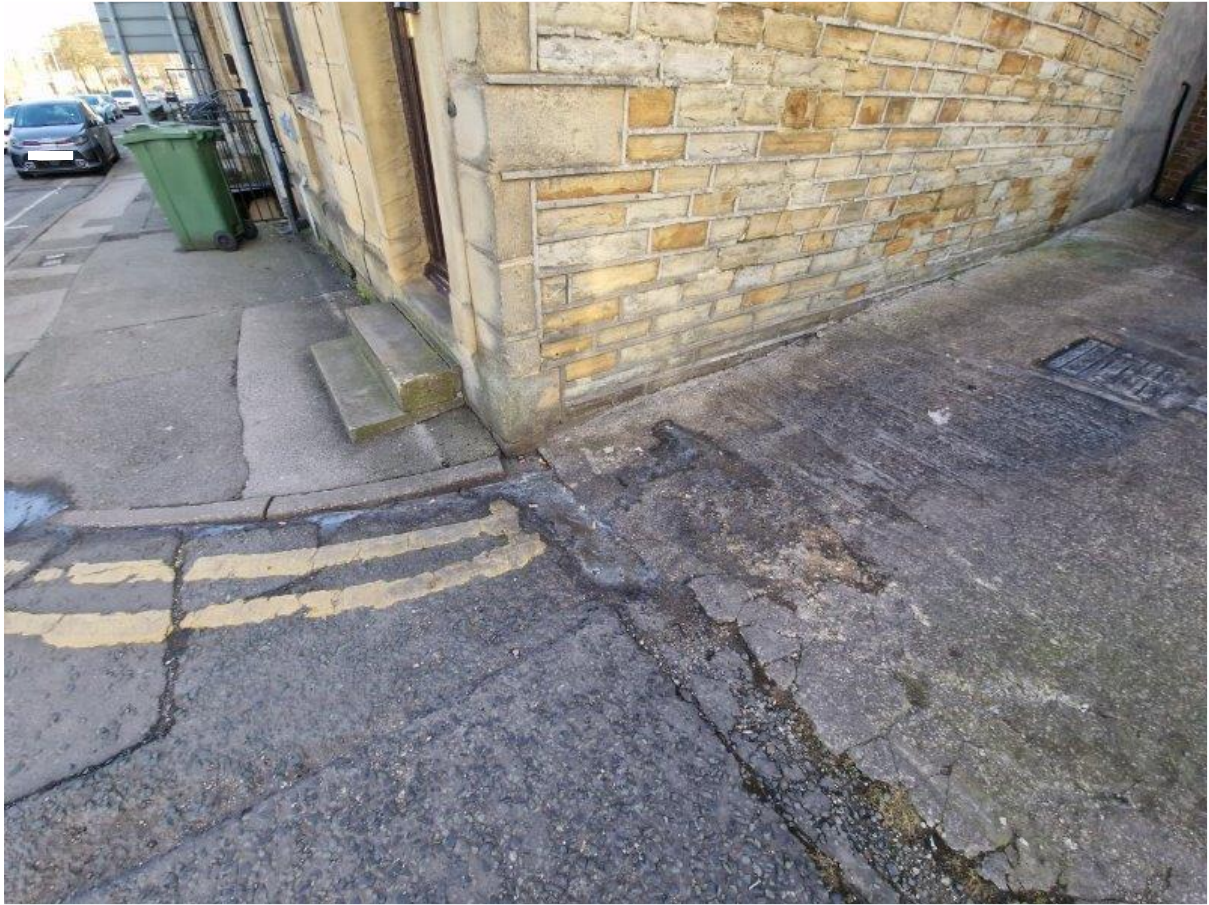
Lower Fitzwilliam Street 22m from lights

Surface damage and scarring to footpath and carriageway from utilities works. Yellow and white lining faded.

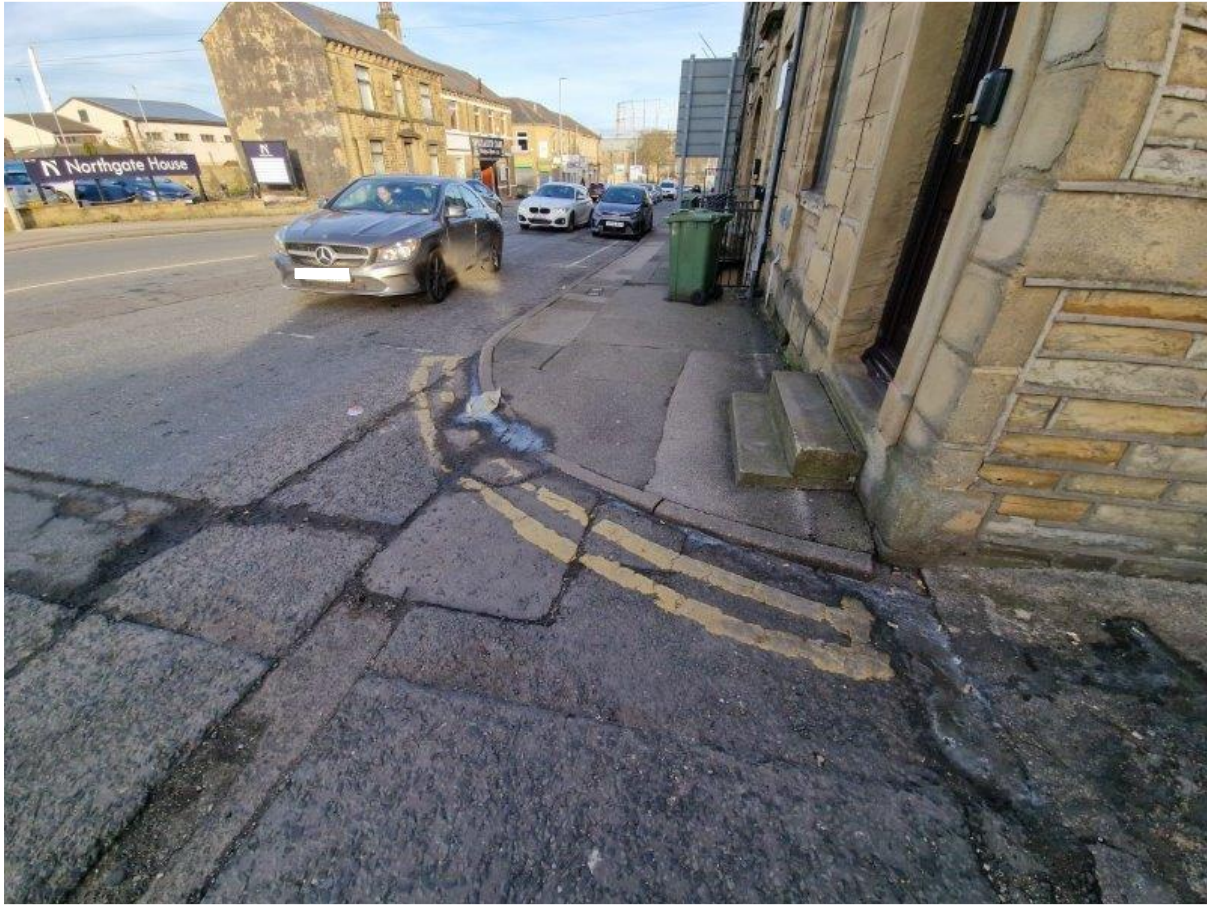
Lower Fitzwilliam Street 22m from lights

Surface damage and scarring to footpath and carriageway from utilities works. Yellow and white lining faded.

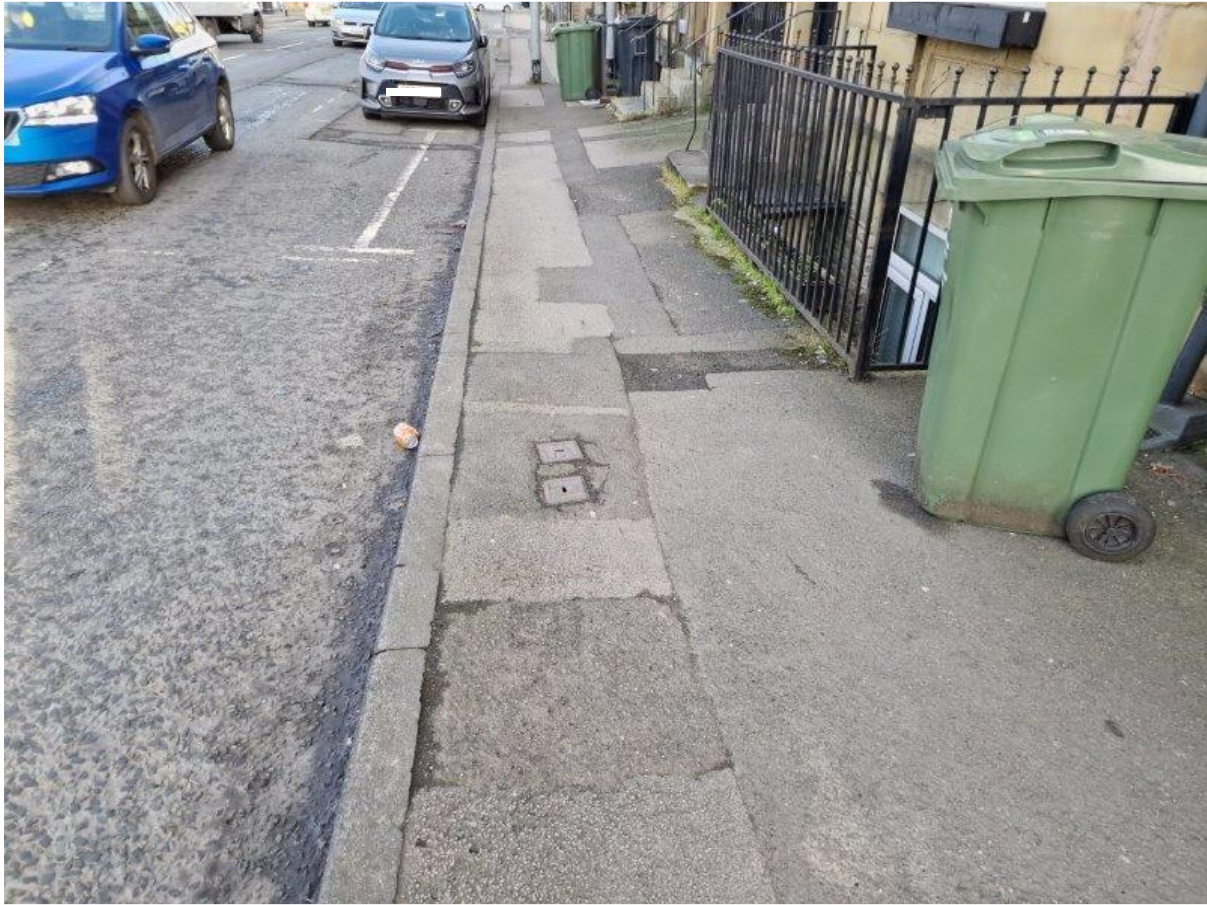
Lower Fitzwilliam Street 30m from lights

Surface damage and scarring to footpath and carriageway from utilities works. Yellow and white lining faded.

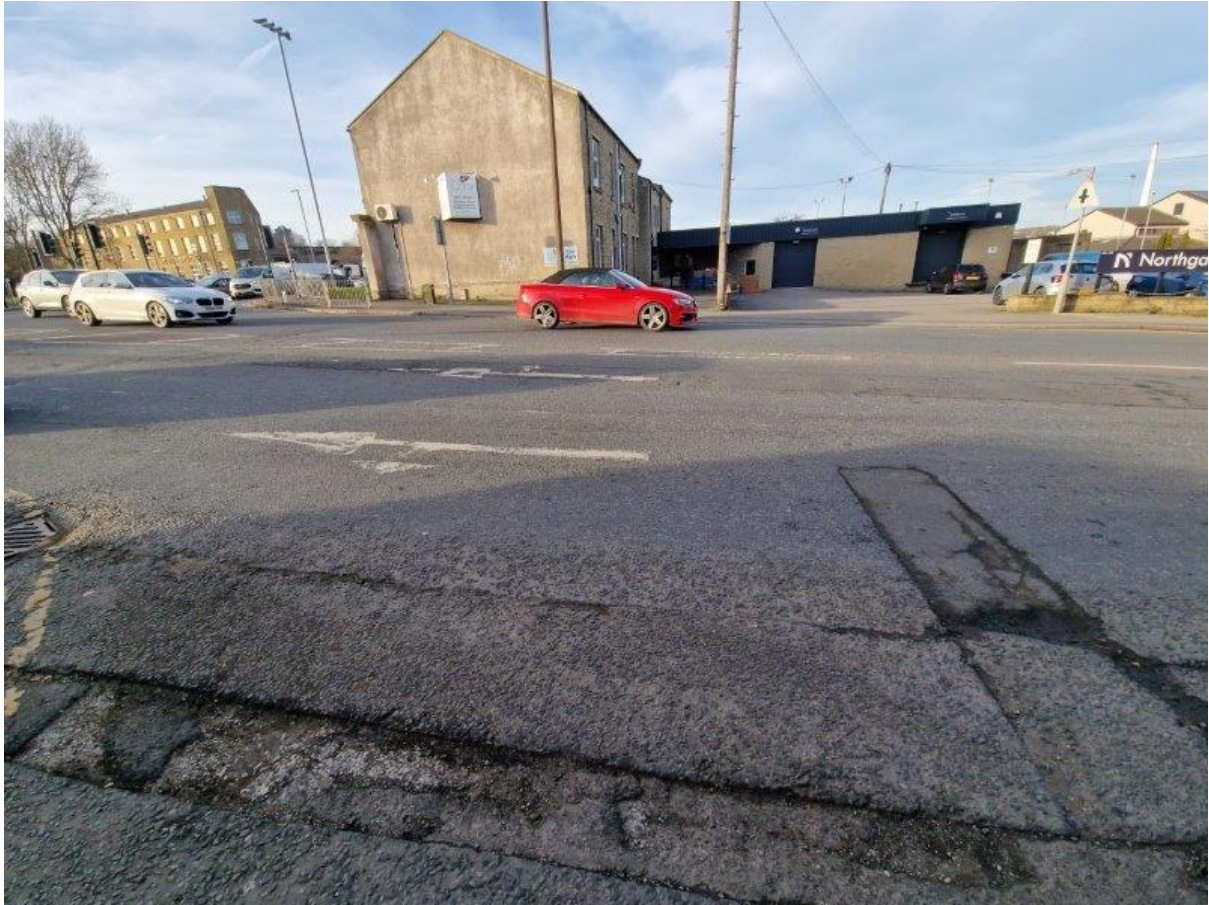
Lower Fitzwilliam Street 22m from lights

Surface damage and scarring to footpath and carriageway from utilities works. Yellow and white lining faded.

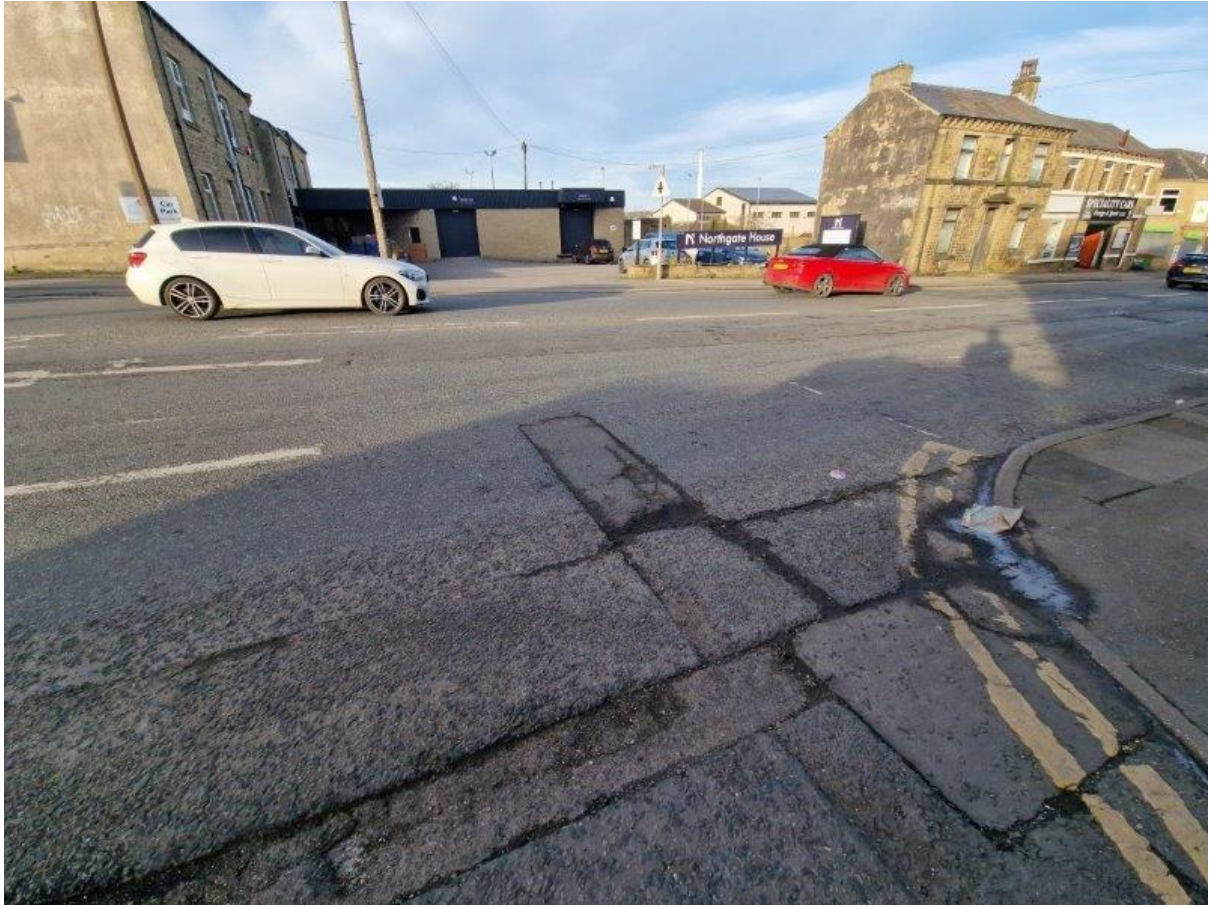
Lower Fitzwilliam Street 22m from lights

Surface damage and scarring to footpath and carriageway from utilities works. Yellow and white lining faded.

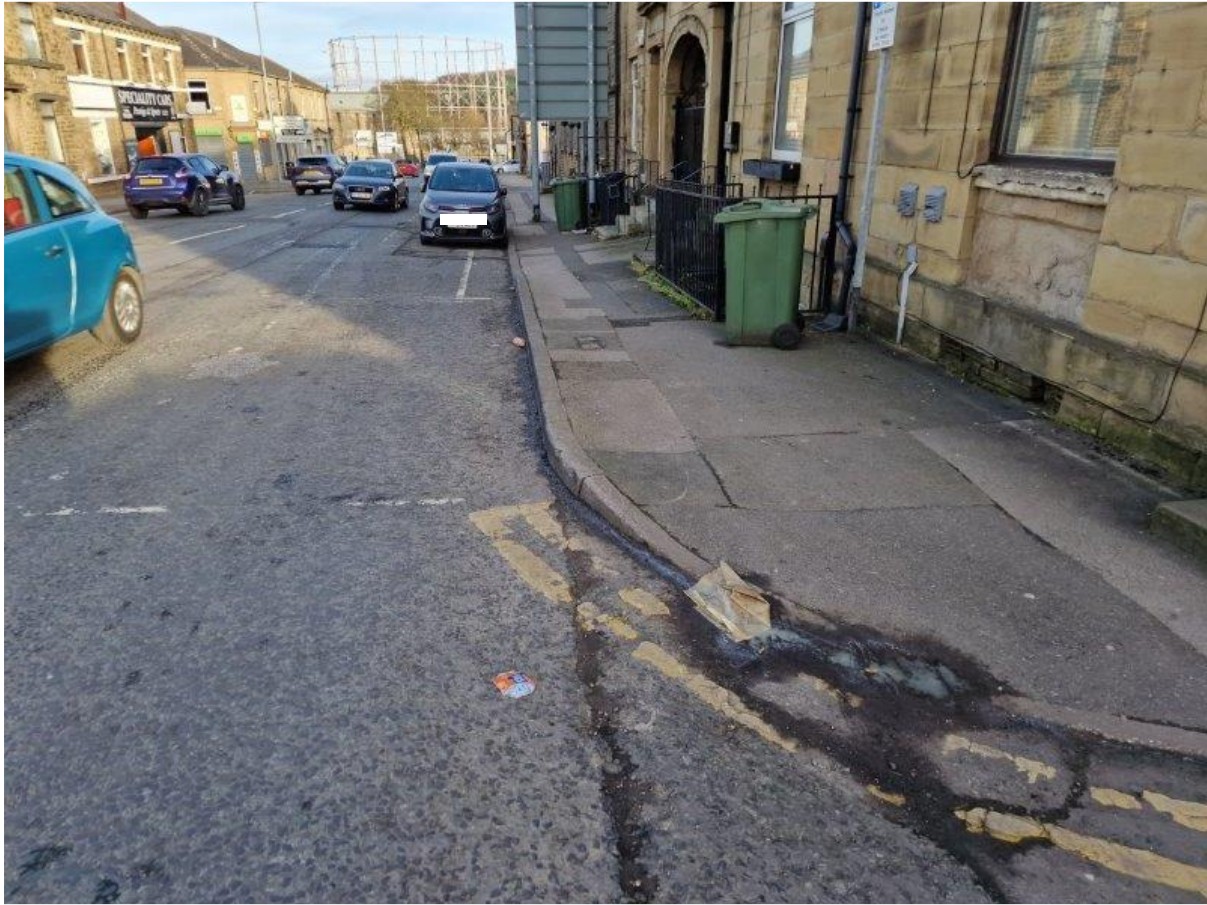
Lower Fitzwilliam Street 22m from lights

Surface damage and scarring to footpath and carriageway from utilities works. Yellow and white lining faded.

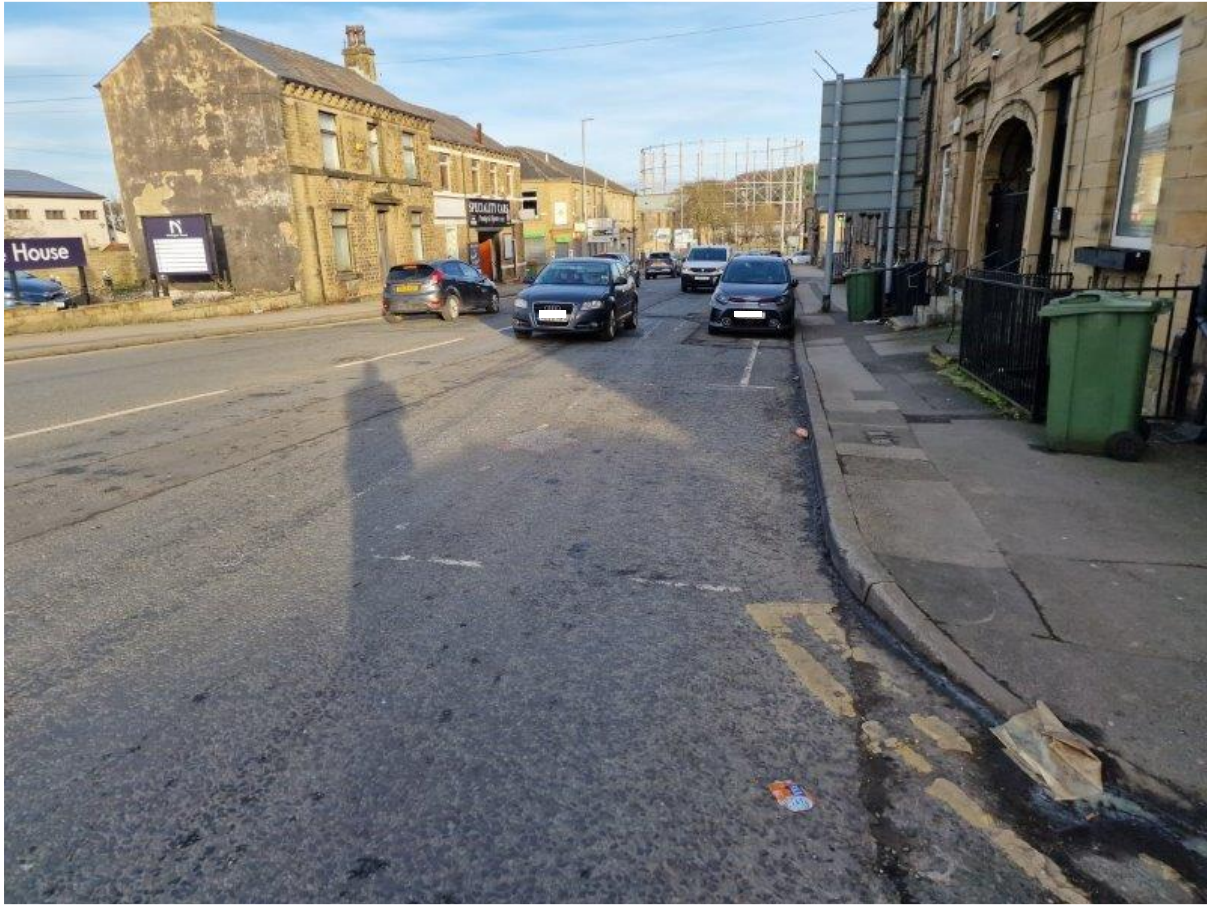
Lower Fitzwilliam Street 22m from lights

Surface damage and scarring to footpath and carriageway from utilities works. Yellow and white lining faded.

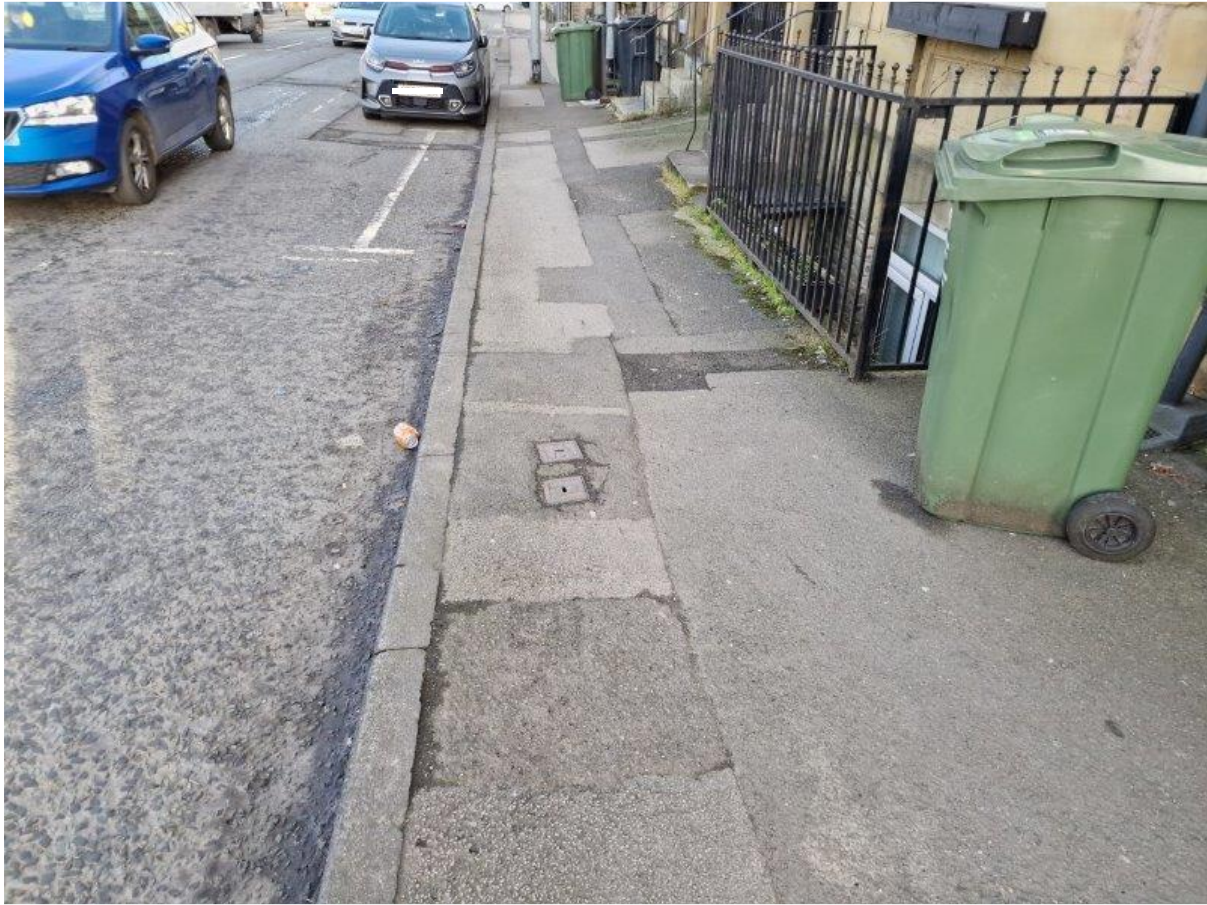
Lower Fitzwilliam Street 30m from lights

Surface damage and scarring to footpath and carriageway from utilities works. Yellow and white lining faded.

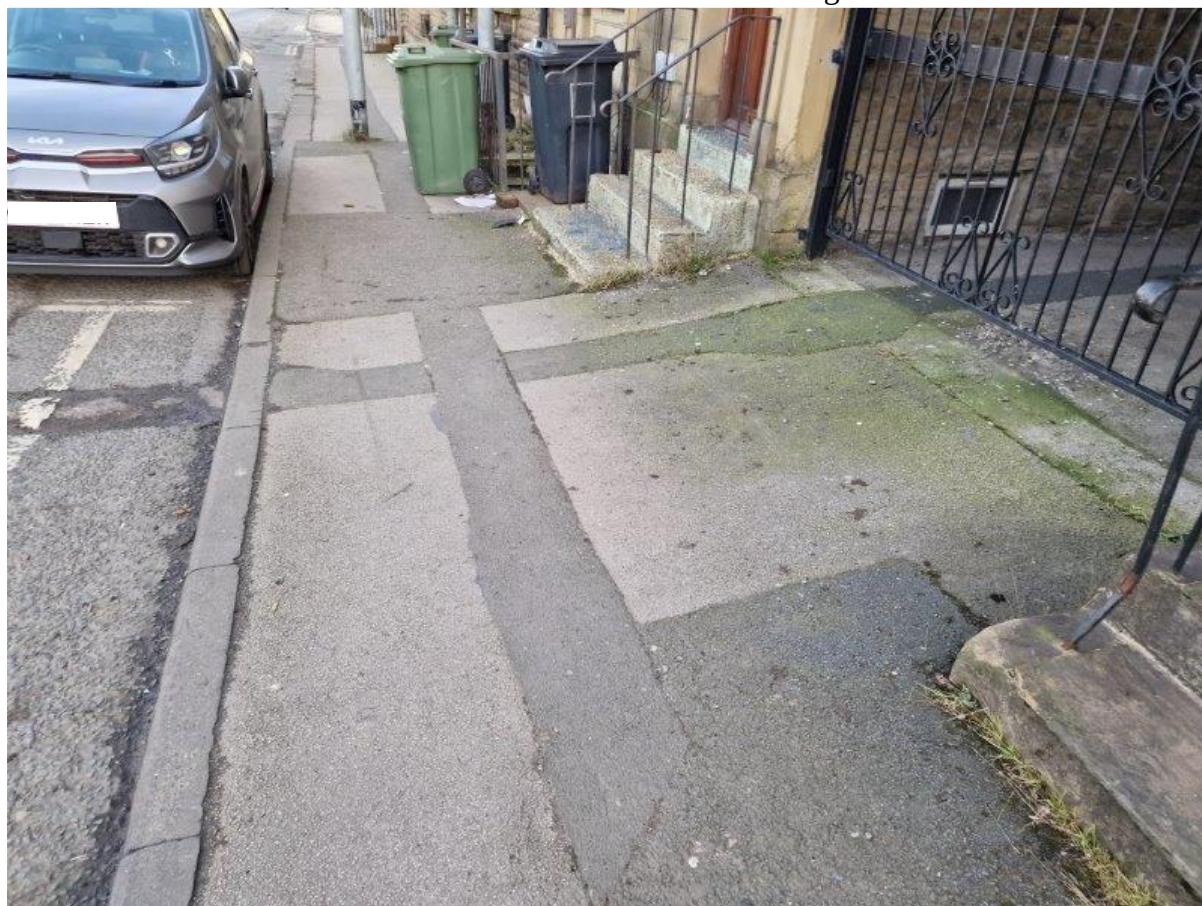
Lower Fitzwilliam Street 30m from lights

Surface damage and scarring to footpath and carriageway from utilities works. Yellow and white lining faded.

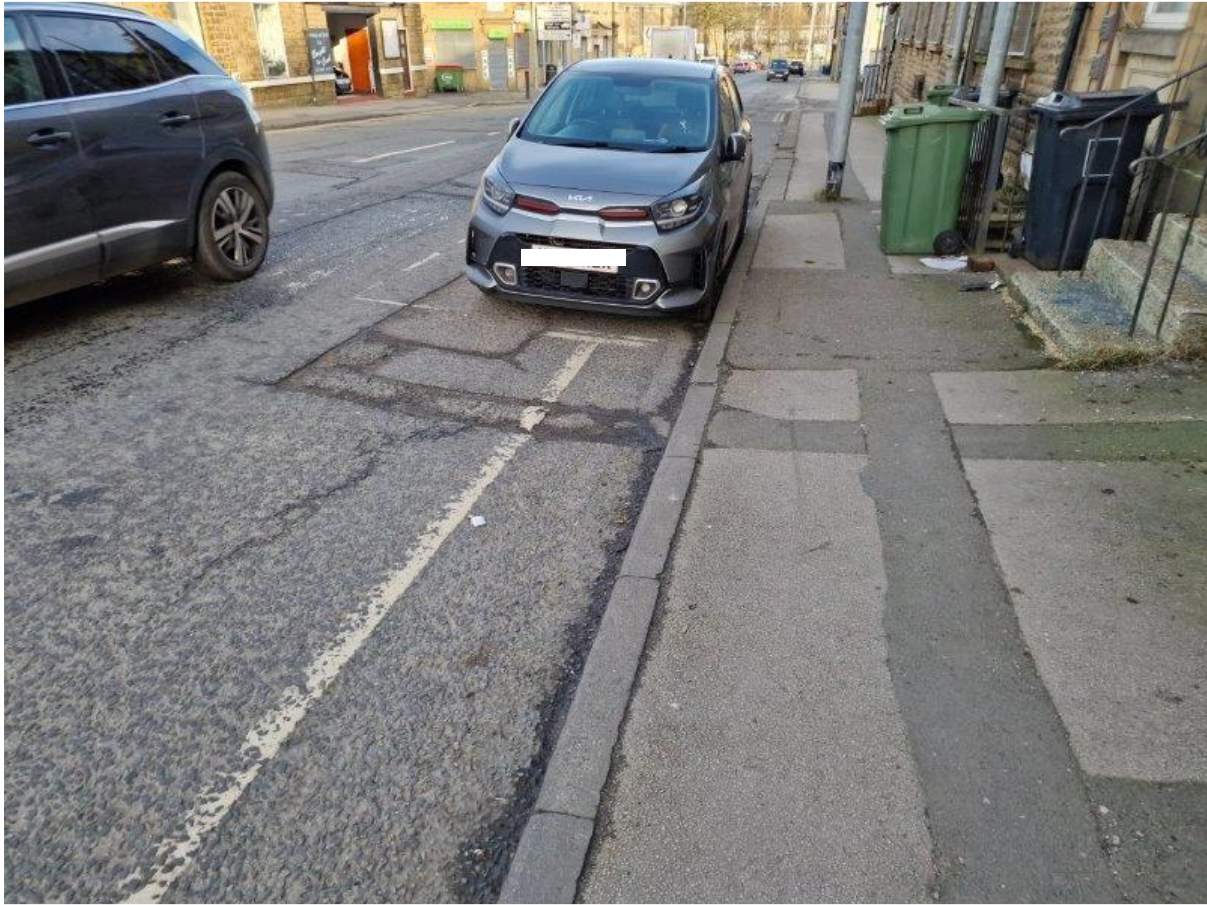
Lower Fitzwilliam Street 30m from lights

Surface damage and scarring to footpath and carriageway from utilities works. Yellow and white lining faded.

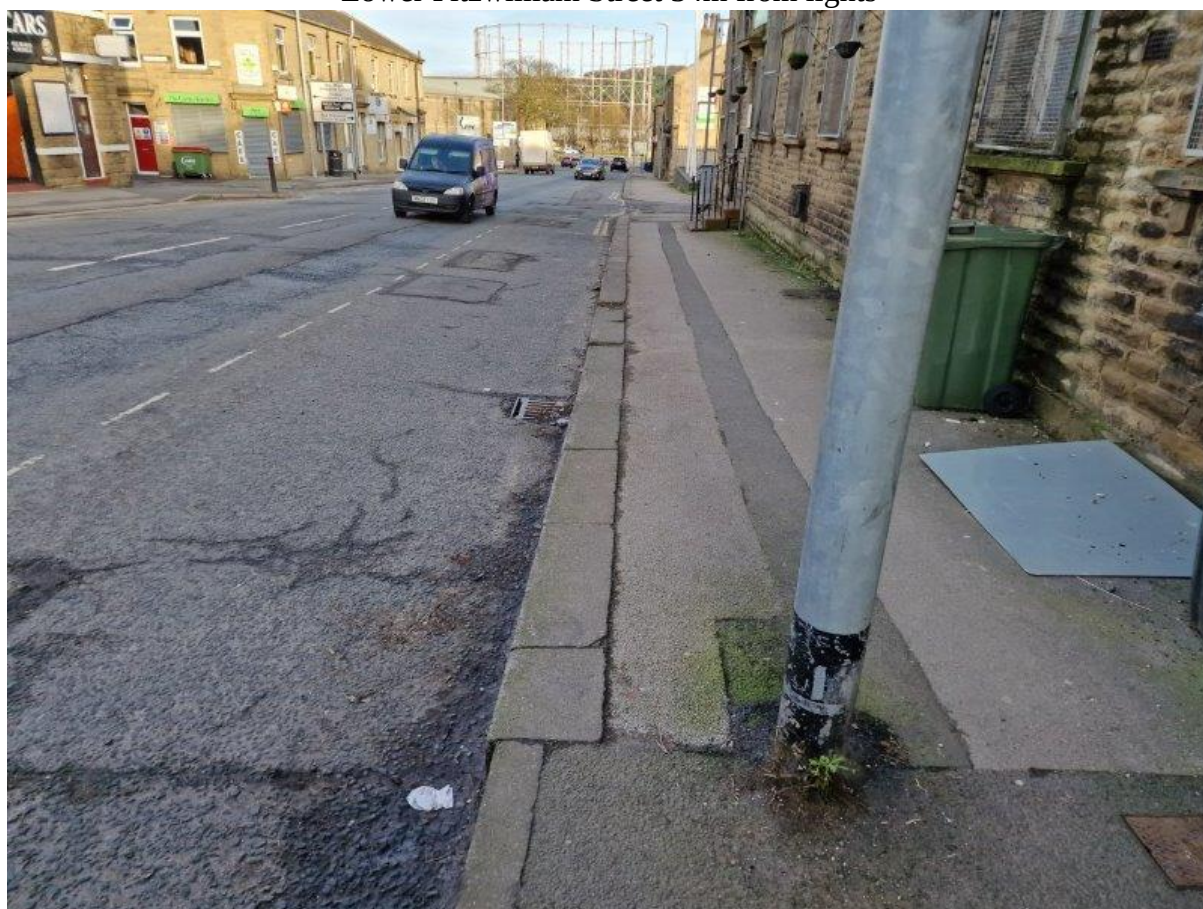
Lower Fitzwilliam Street 34m from lights

Surface damage and scarring to footpath and carriageway from utilities works. Yellow and white lining faded. Kerbs damaged and misaligned.

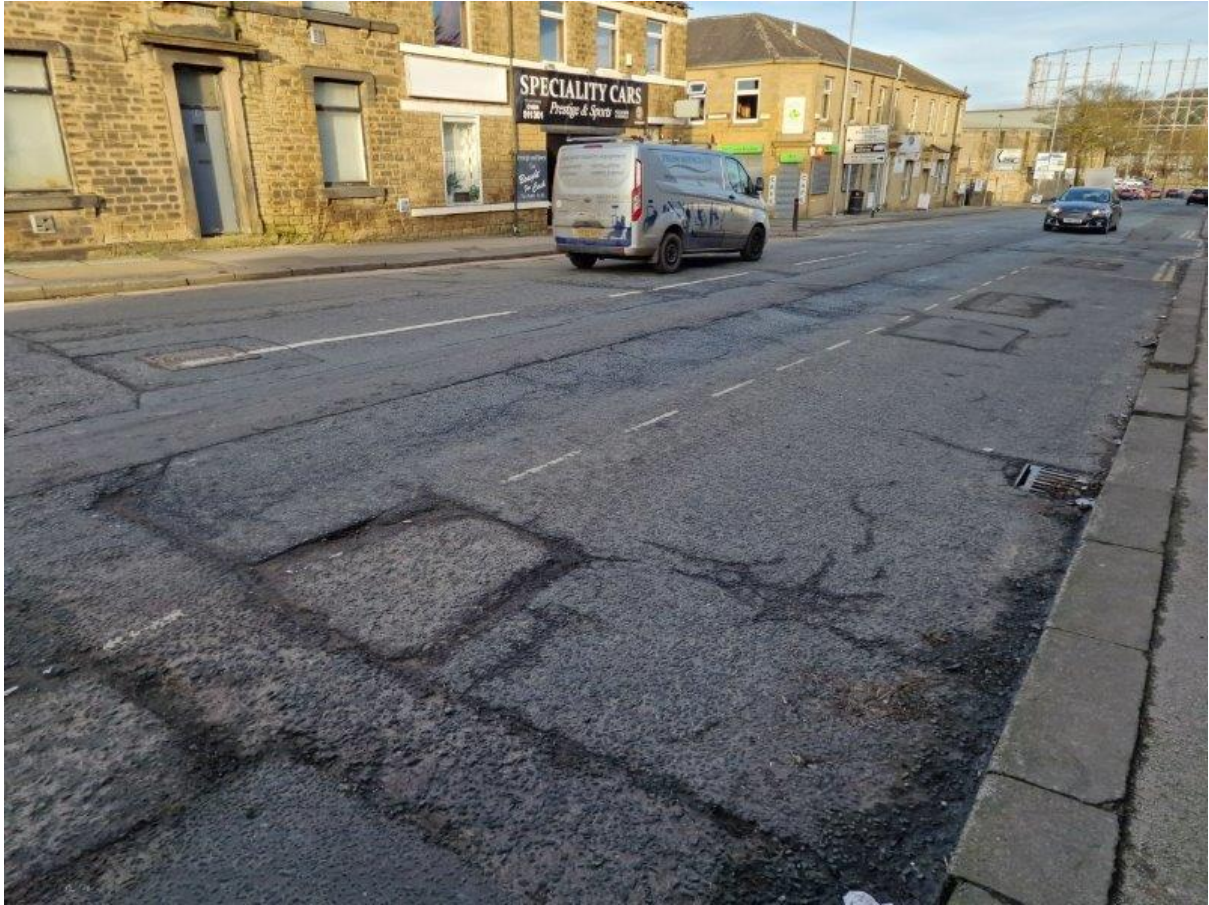
Lower Fitzwilliam Street 45m from lights

Surface damage and scarring to footpath and carriageway from utilities works. Yellow and white lining faded. Kerbs damaged and misaligned.

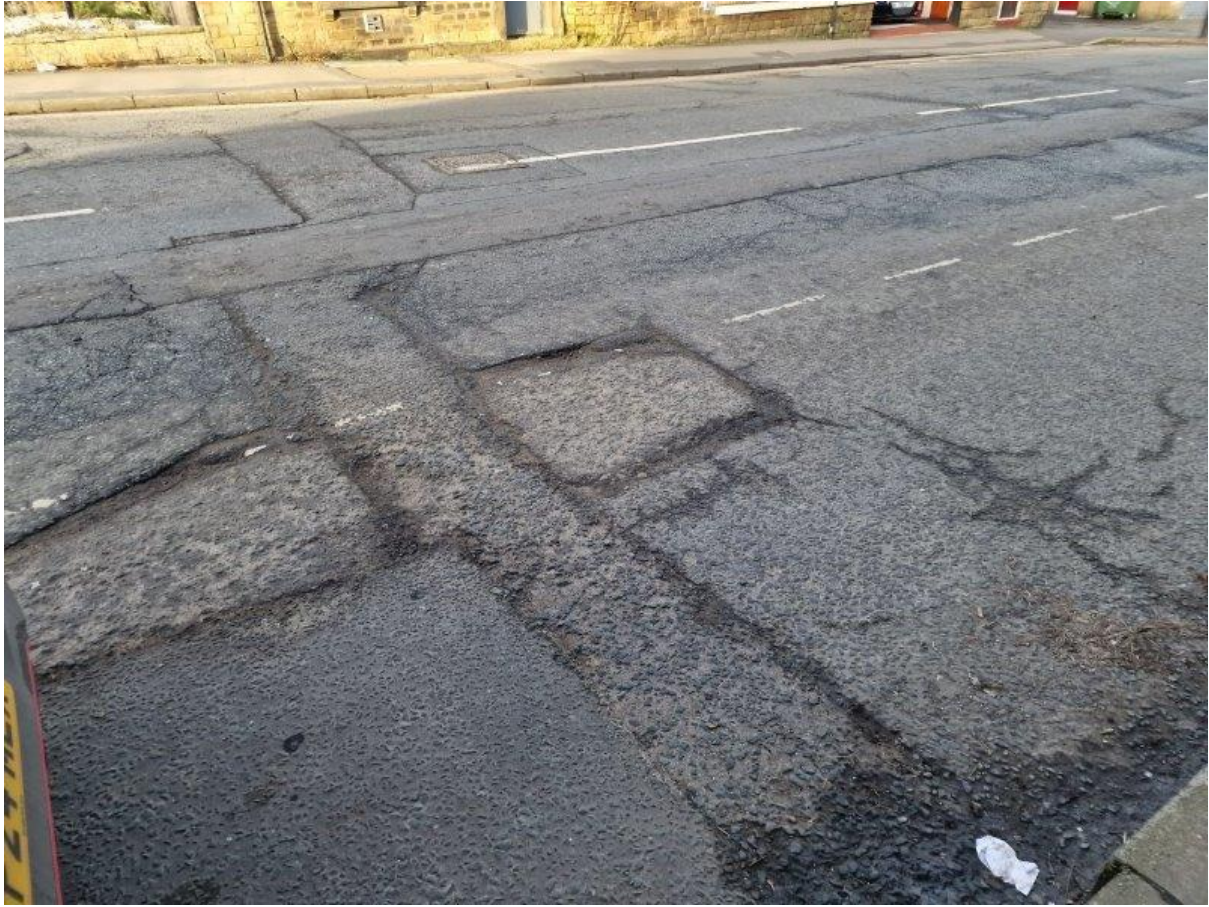
Lower Fitzwilliam Street 45m from lights

Surface damage and scarring to footpath and carriageway from utilities works. Yellow and white lining faded.

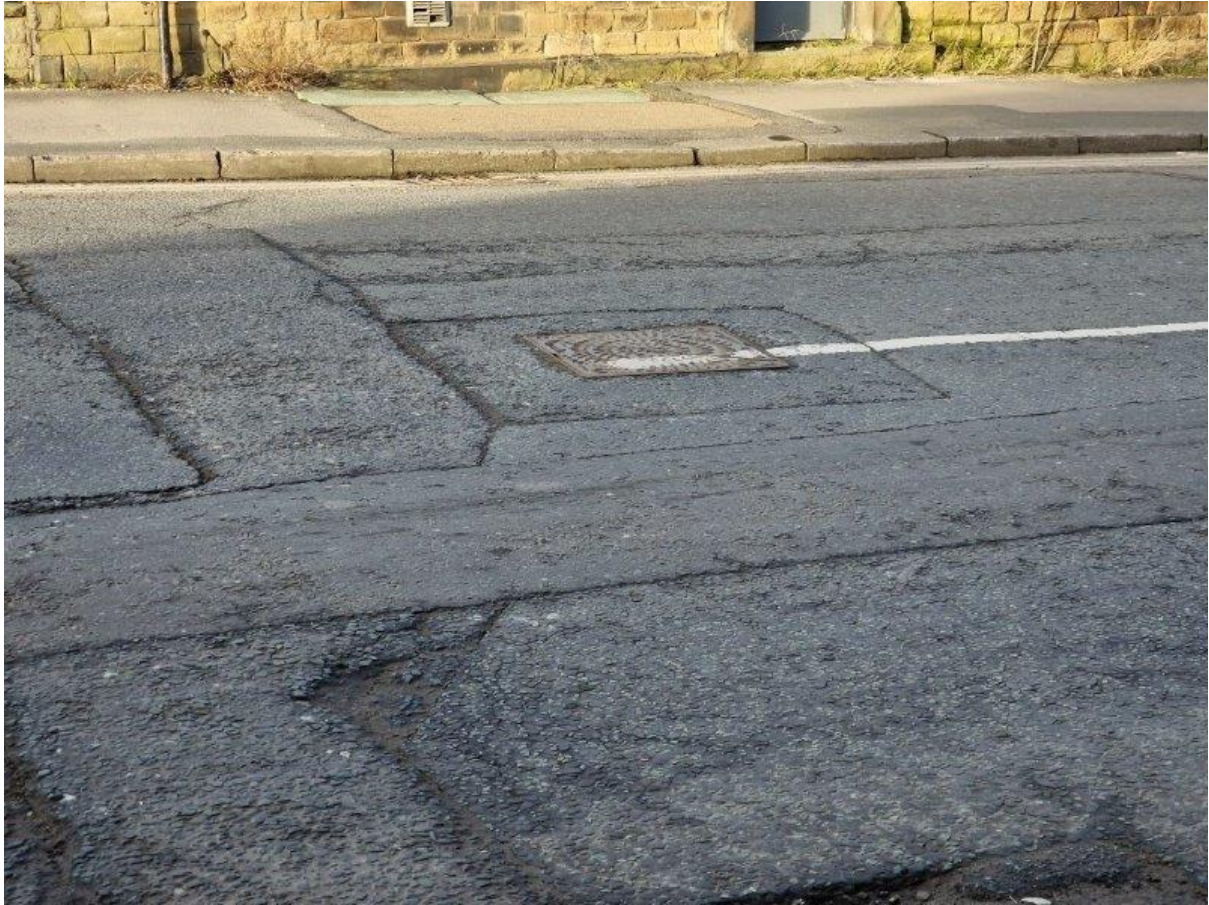
Lower Fitzwilliam Street 45m from lights

Surface damage and scarring to footpath and carriageway from utilities works. Yellow and white lining faded.

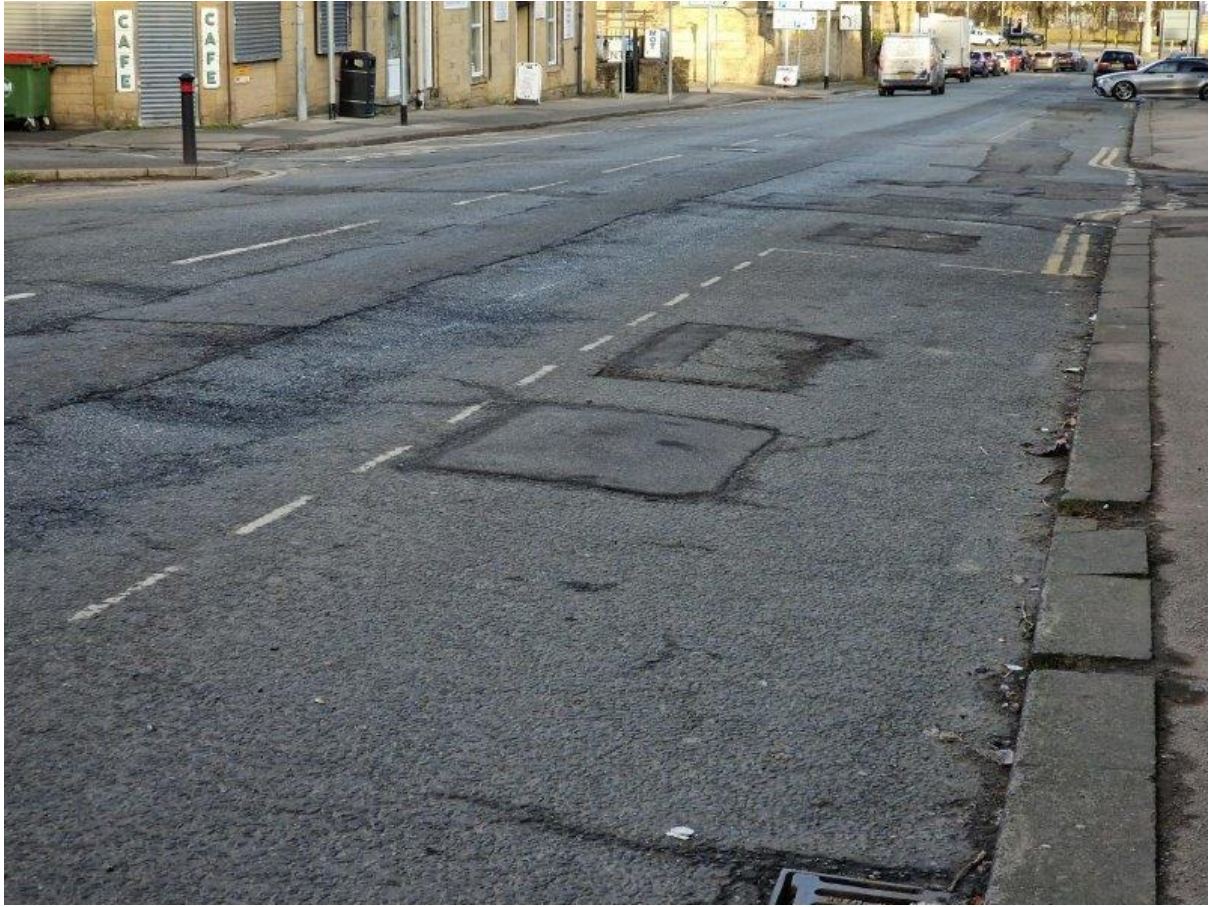
Lower Fitzwilliam Street 52m from lights

Surface damage and scarring to footpath and carriageway from utilities works. Yellow and white lining faded. Kerbs damaged and misaligned.

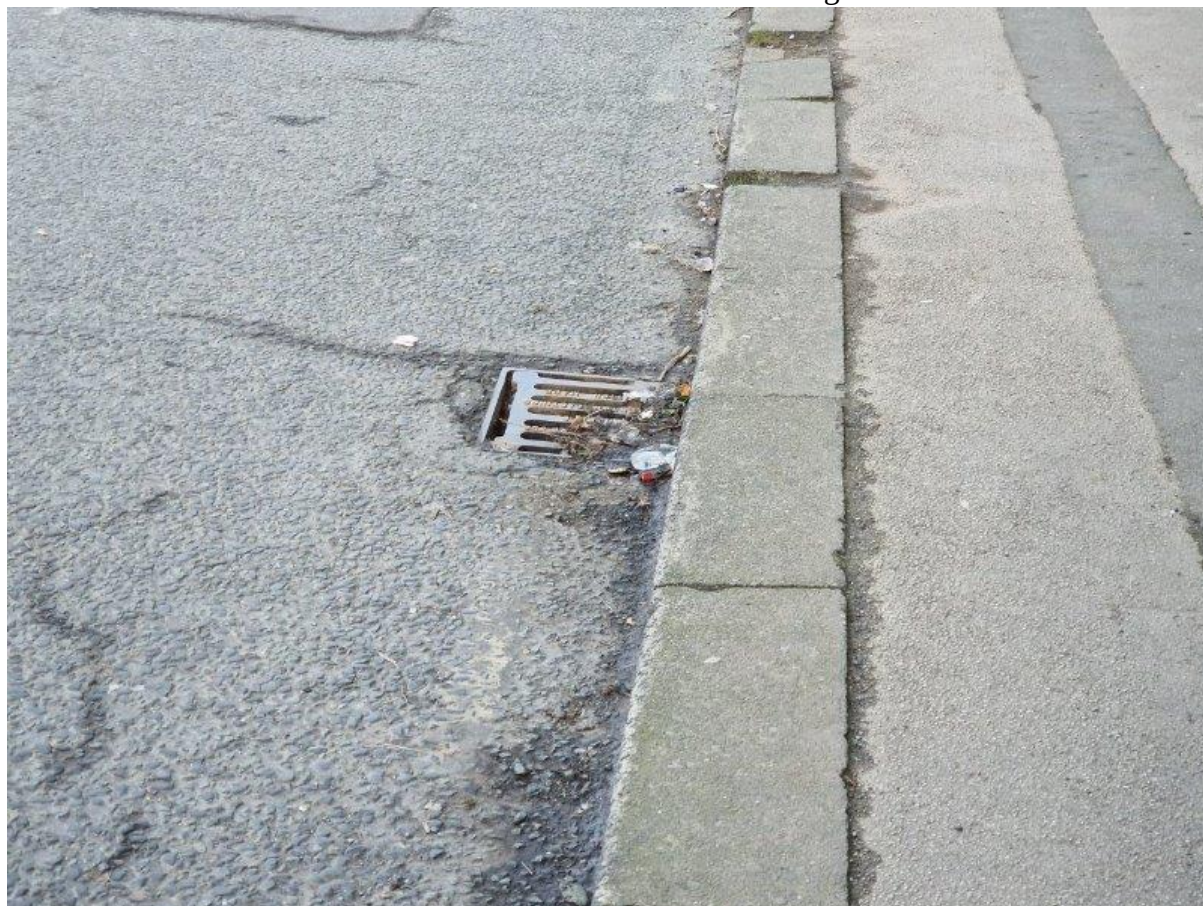
Lower Fitzwilliam Street 52m from lights

Surface damage and scarring to footpath and carriageway from utilities works. Yellow and white lining faded. Drain partially blocked. Kerbs damaged and misaligned.

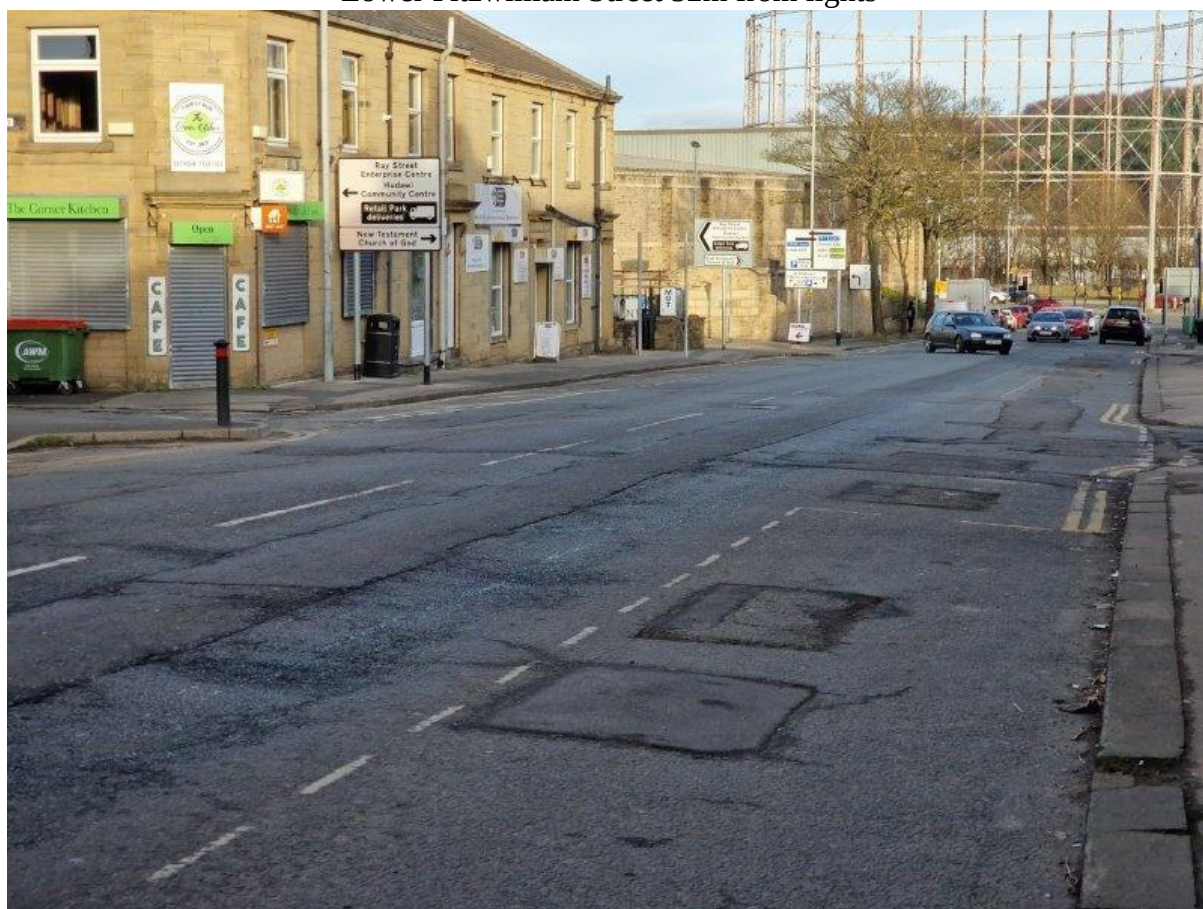
Lower Fitzwilliam Street 52m from lights

Surface damage and scarring to footpath and carriageway from utilities works. Yellow and white lining faded. Kerbs damaged and misaligned.
