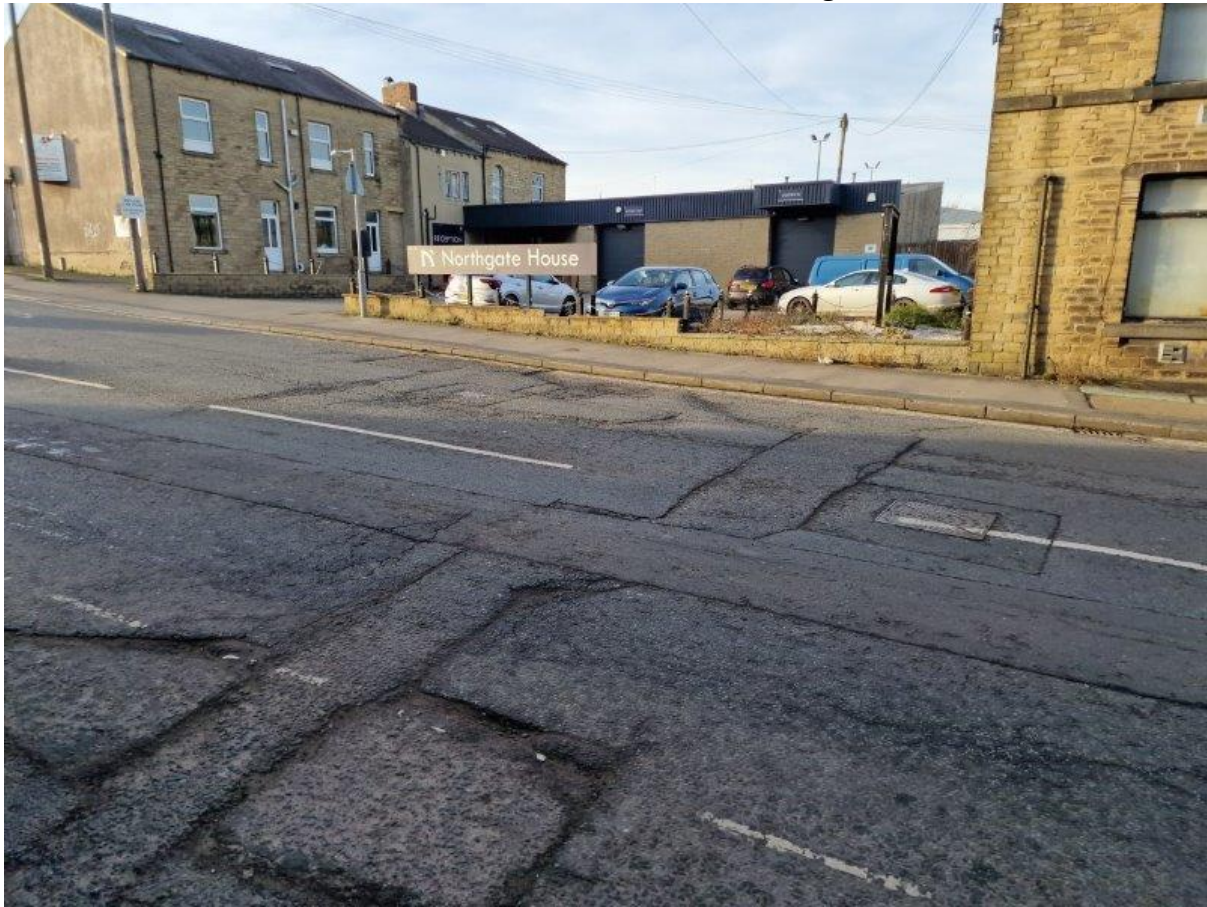
Lower Fitzwilliam Street 50m from lights

Surface damage and scarring to footpath and carriageway from utilities works. Yellow and white lining faded.

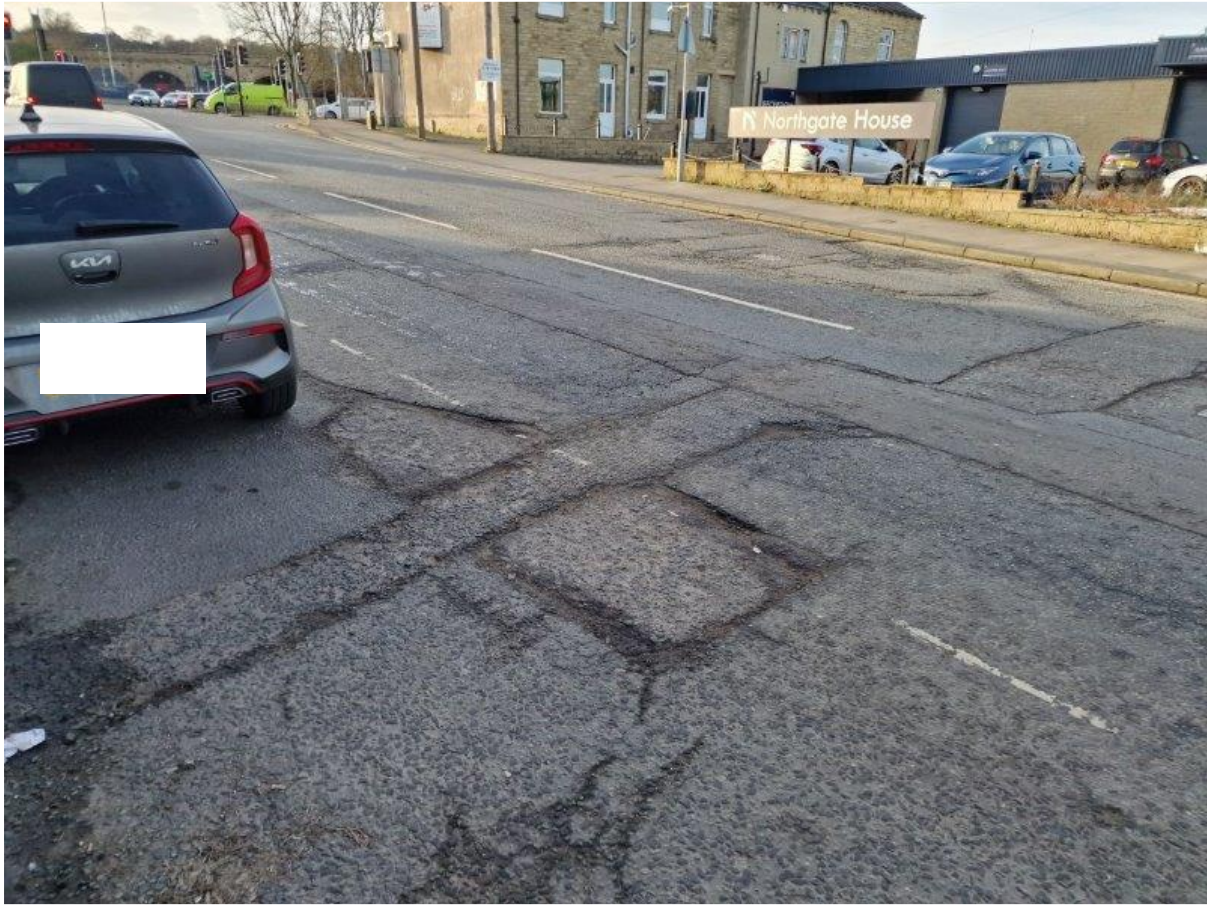
Lower Fitzwilliam Street 50m from lights

Surface damage and scarring to footpath and carriageway from utilities works. Yellow and white lining faded.

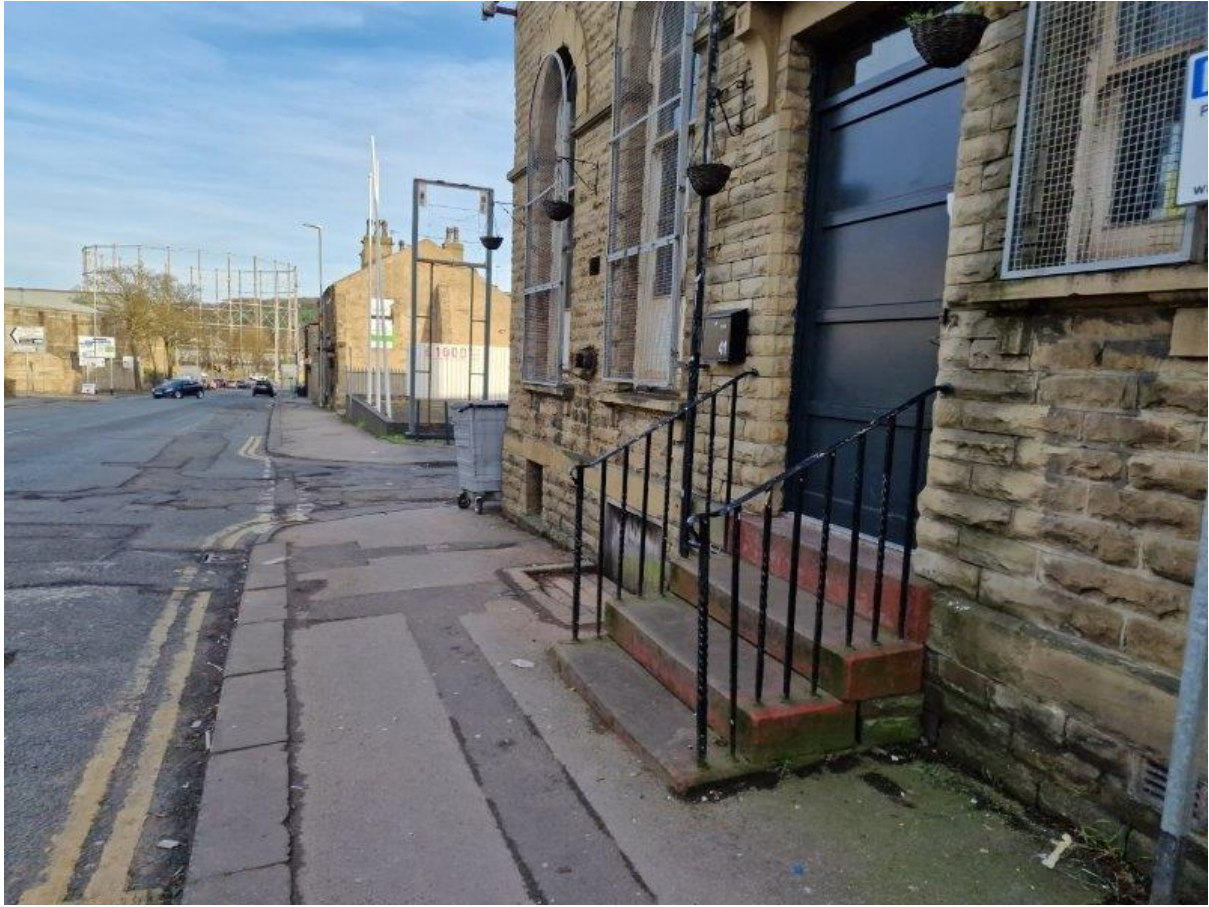
Lower Fitzwilliam Street 57m from lights

Surface damage and scarring to footpath and carriageway from utilities works. Yellow and white lining faded.

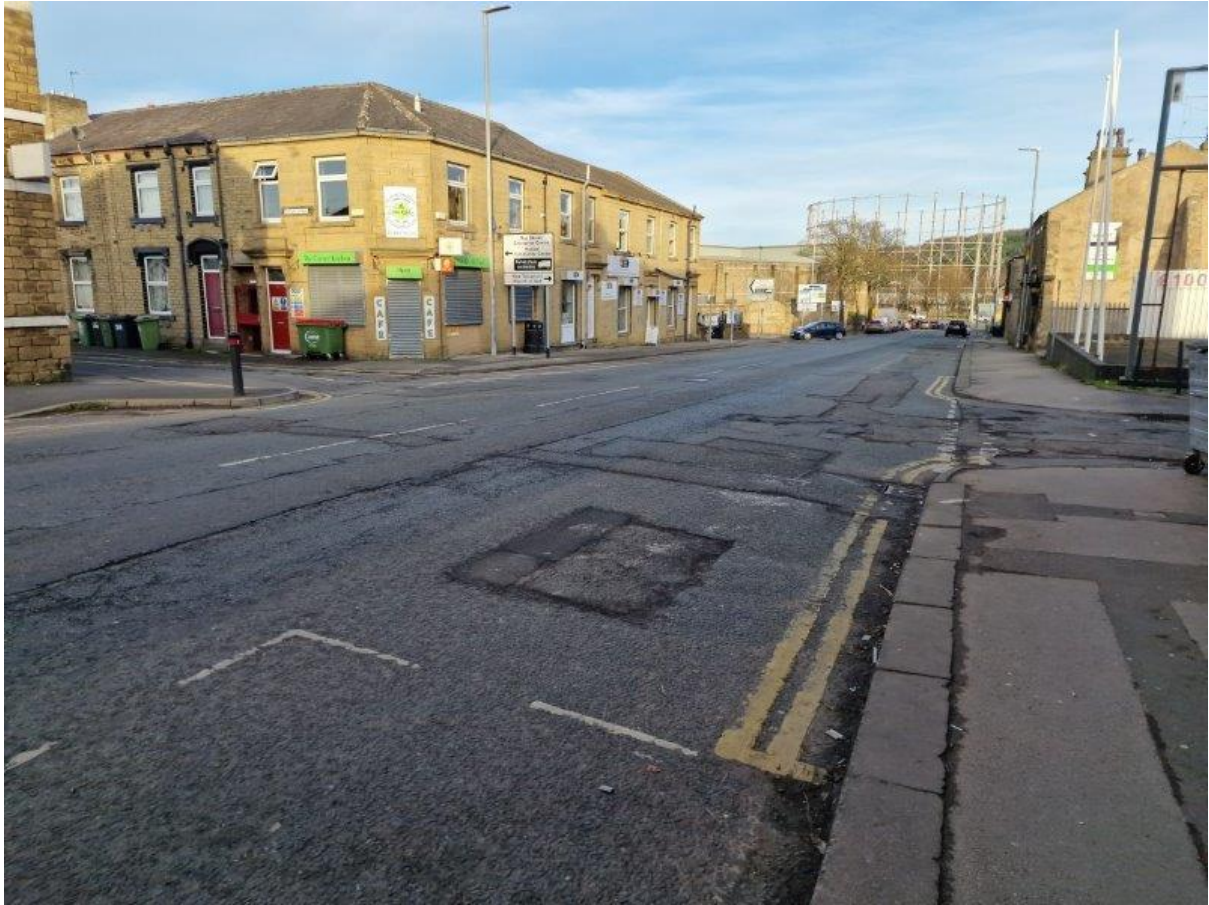
Lower Fitzwilliam Street 57m from lights

Surface damage and scarring to footpath and carriageway from utilities works. Yellow and white lining faded. Kerbs damaged or misaligned.

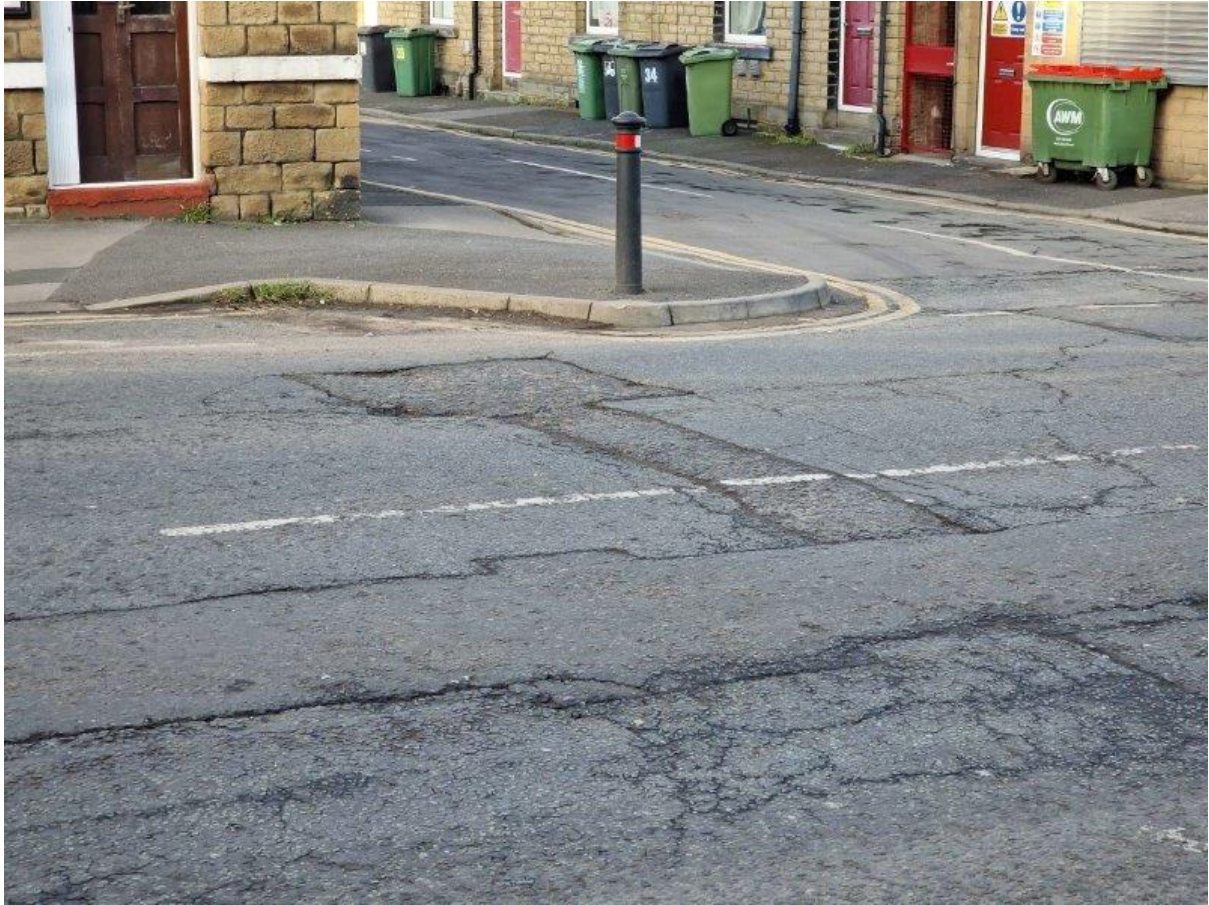
Lower Fitzwilliam Street/ Southgate junction (west side at the lights)

Surface damage and scarring to footpath and carriageway from utilities works. Yellow and white lining faded.

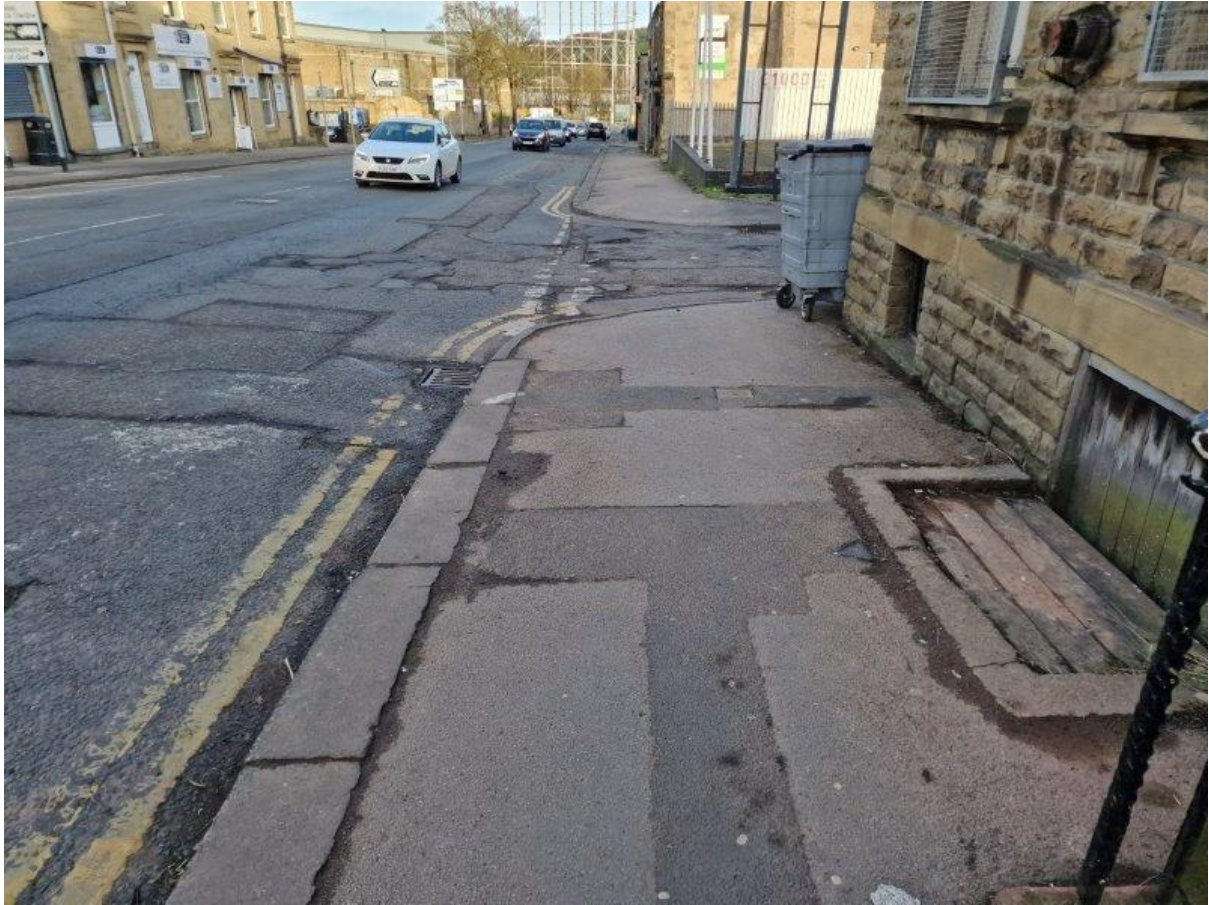
Lower Fitzwilliam Street/ Southgate junction (west side at the lights)

Surface damage and scarring to footpath and carriageway from utilities works. Yellow and white lining faded. Kerbs damaged or misaligned.

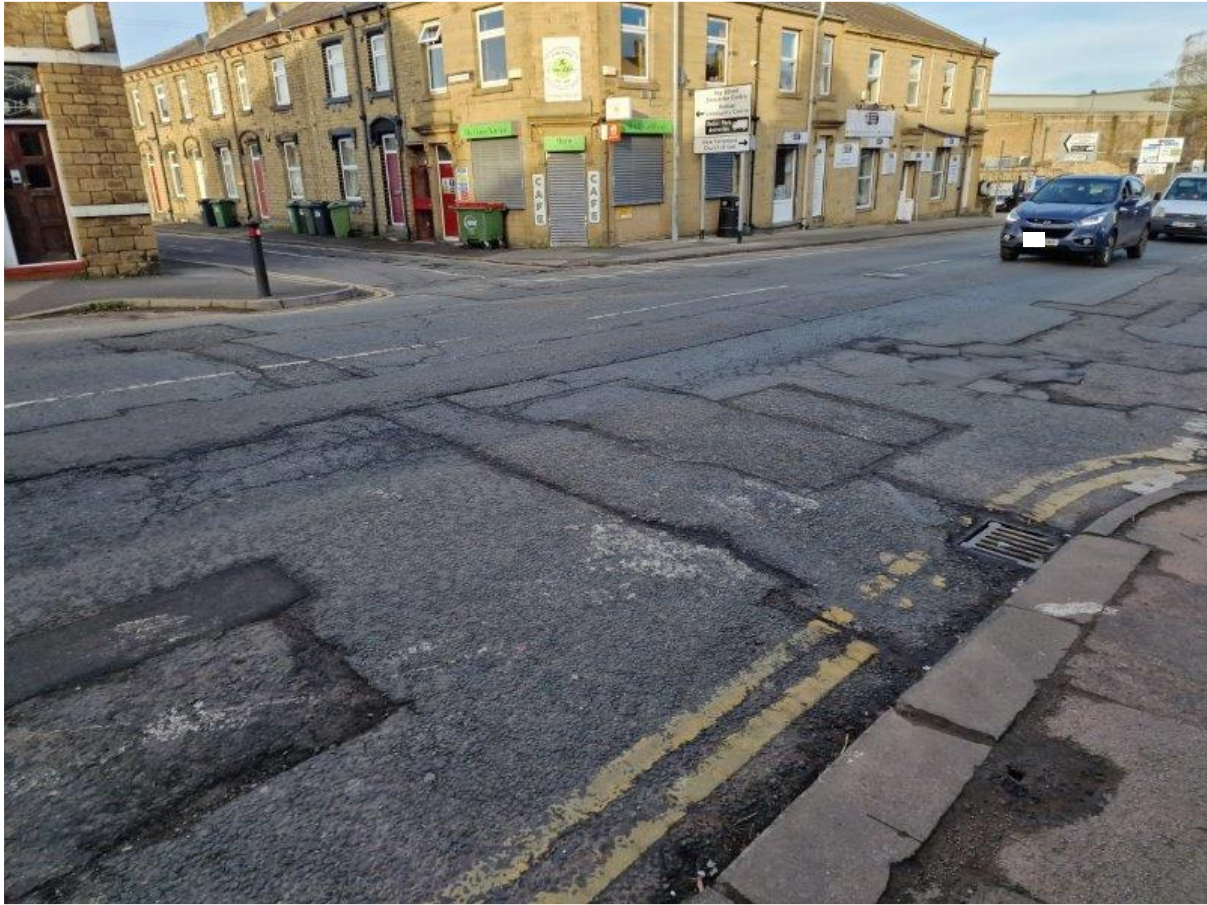
Lower Fitzwilliam Street 62m from lights

Surface damage and scarring to footpath and carriageway from utilities works. Yellow and white lining faded. Kerbs damaged or misaligned.

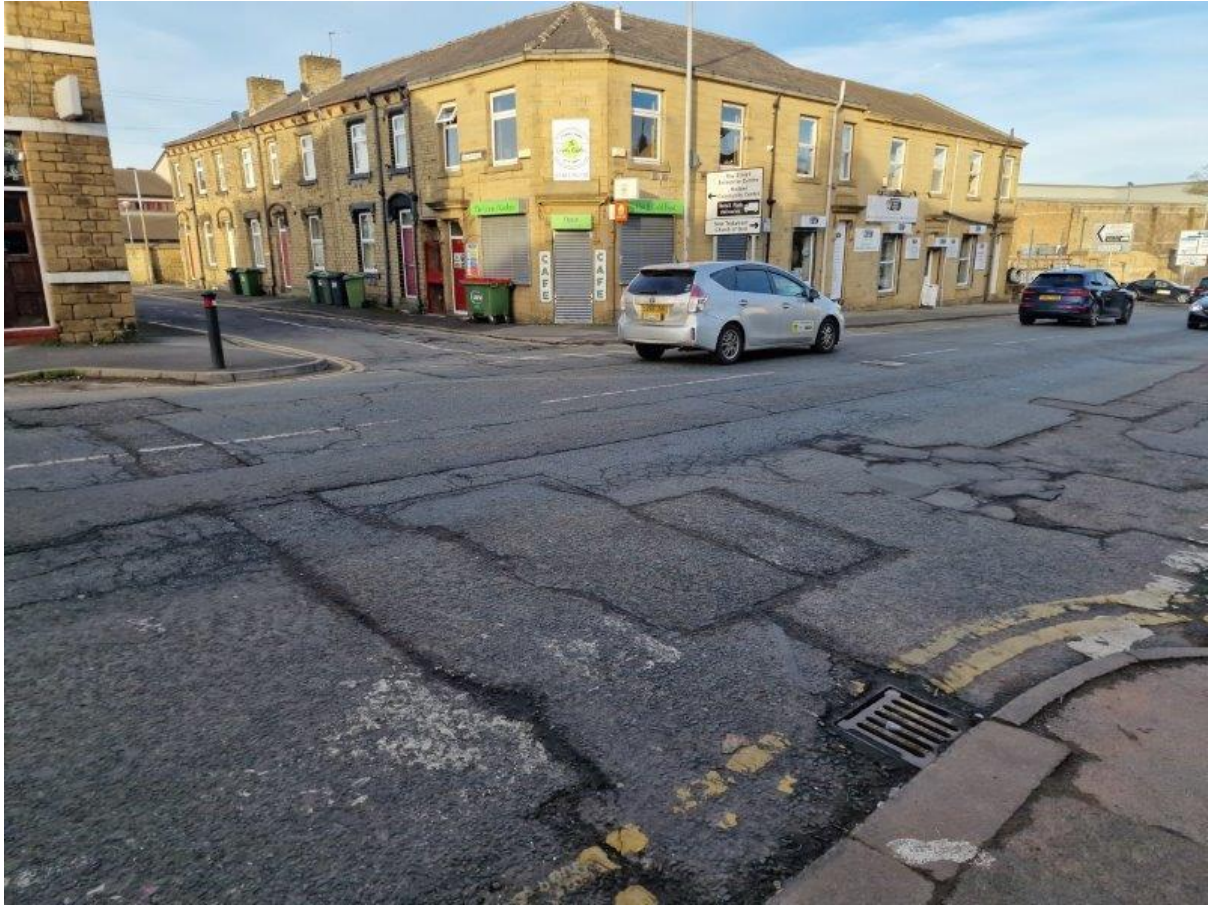
Lower Fitzwilliam Street 62m from lights

Surface damage and scarring to footpath and carriageway from utilities works. Yellow and white lining faded. Kerbs damaged or misaligned.

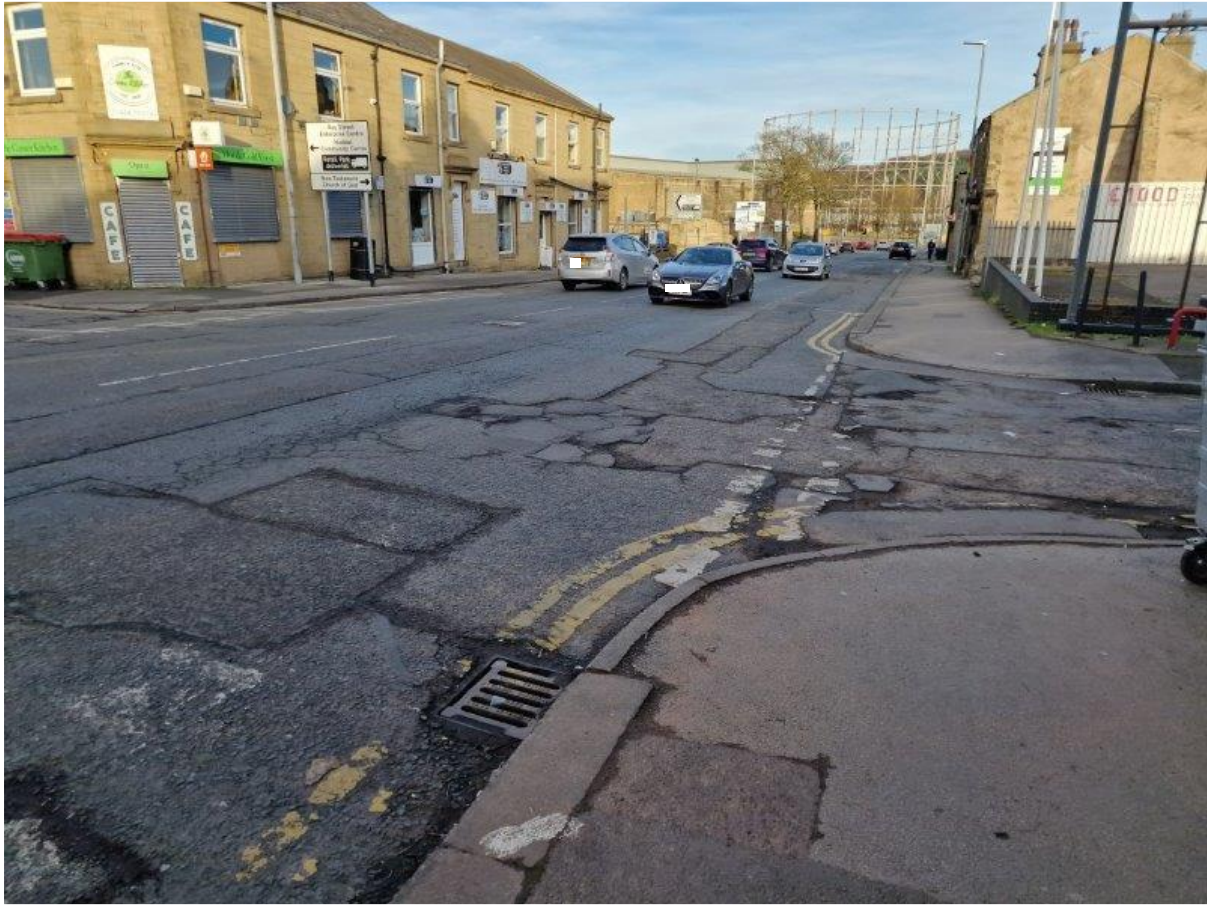
Lower Fitzwilliam Street/ William Street (south west side) corner

Surface damage and scarring to footpath and carriageway from utilities works. Yellow and white lining faded. Kerbs damaged or misaligned.

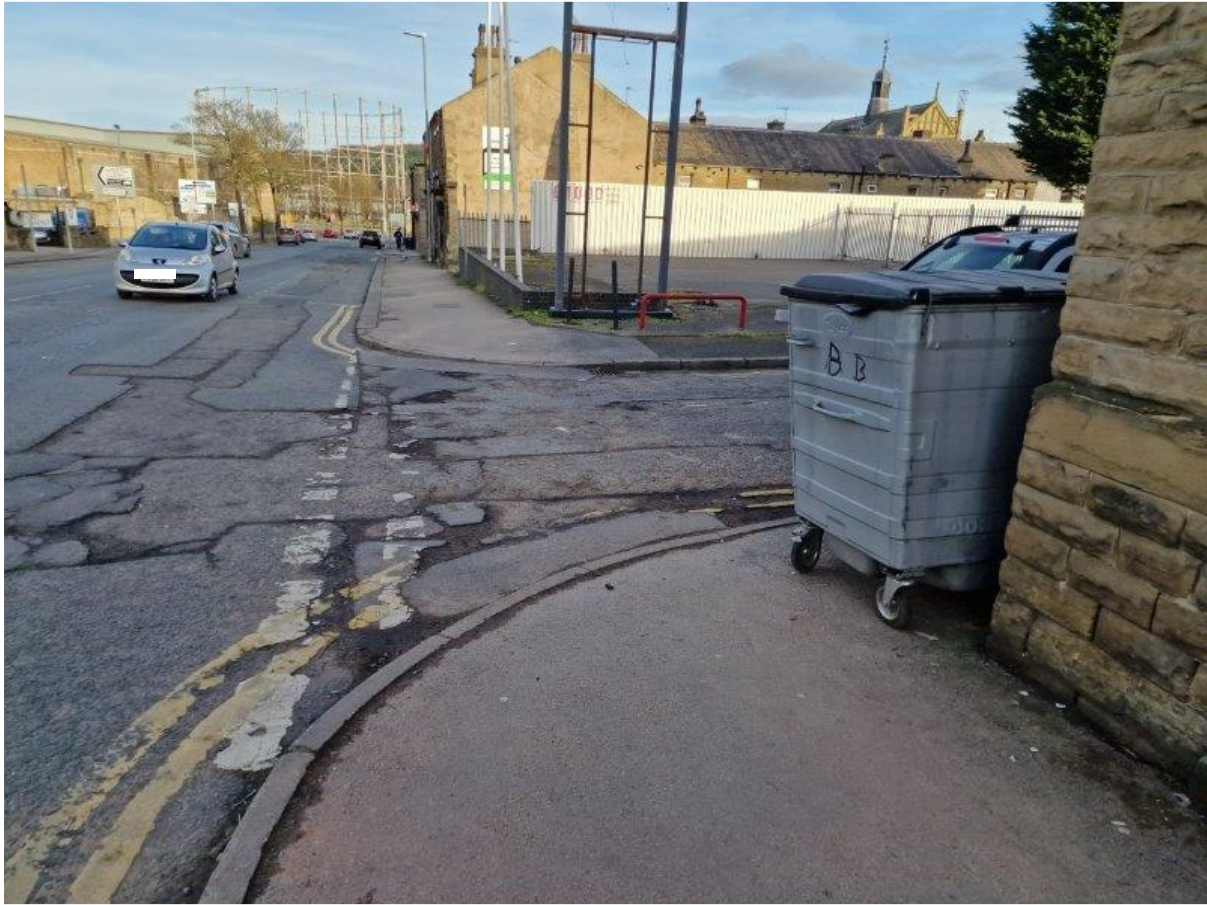
Lower Fitzwilliam Street/William Street (south west side) corner

Surface damage and scarring to footpath and carriageway from utilities works. Yellow and white lining faded. Kerbs damaged or misaligned.

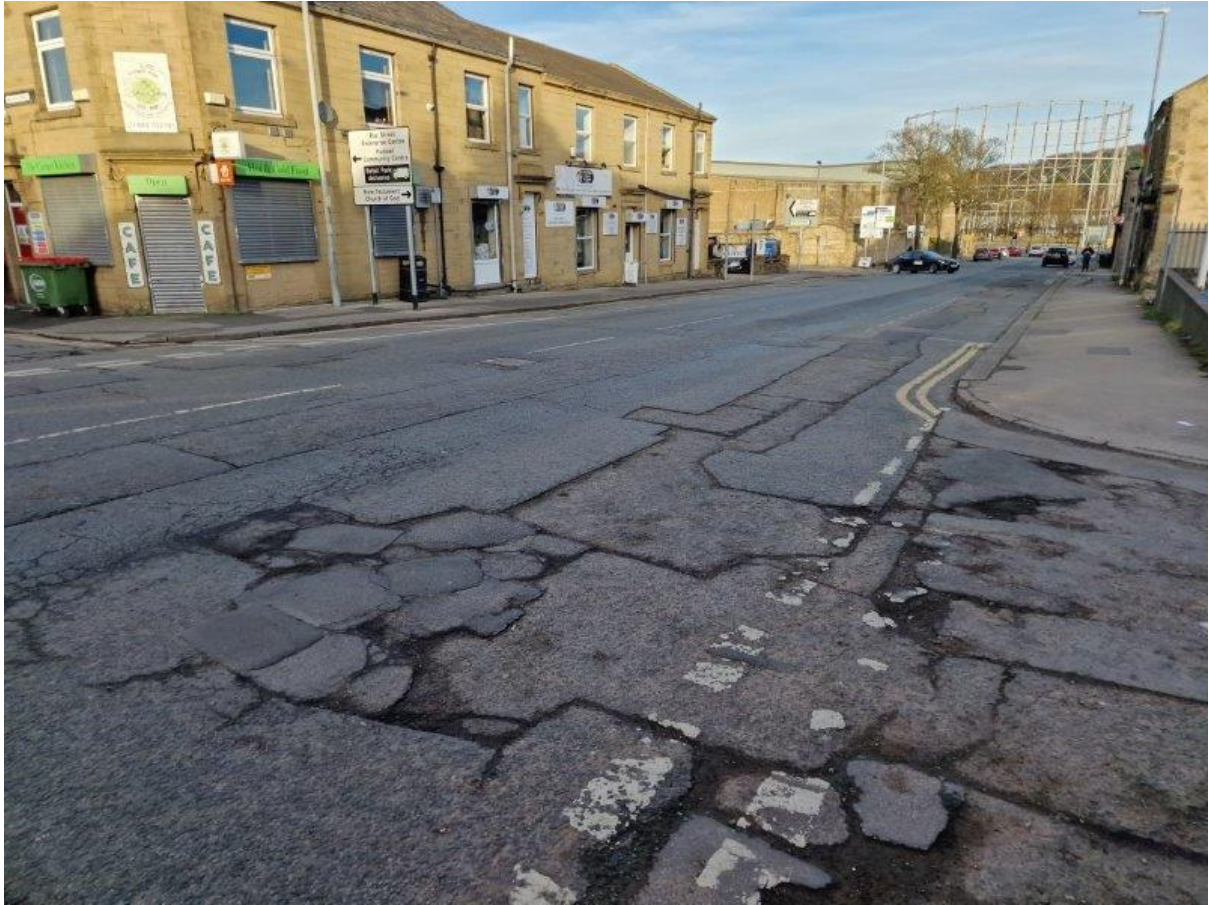
Lower Fitzwilliam Street / William Street (south west side) corner

Surface damage and scarring to footpath and carriageway from utilities works. Yellow and white lining faded.

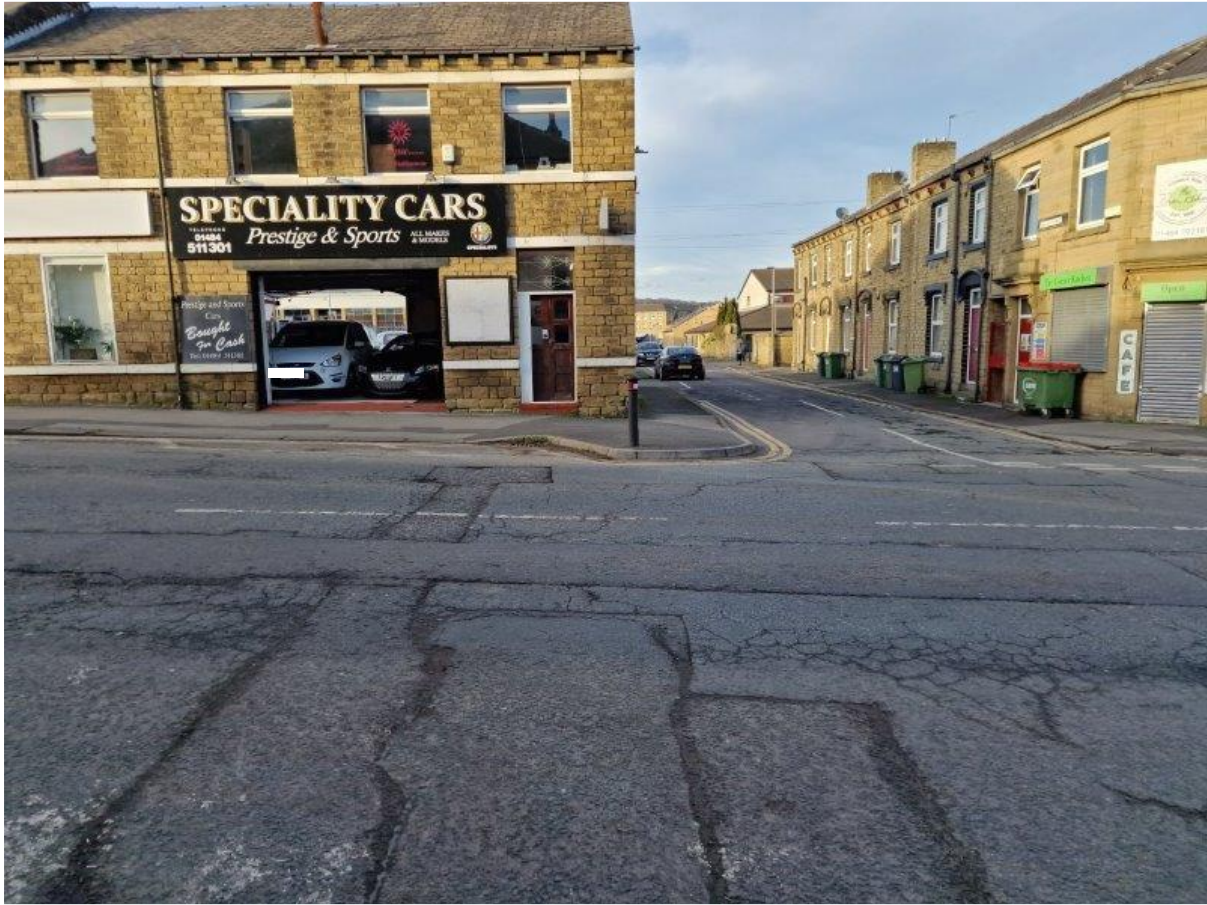
Lower Fitzwilliam Street / William Street (south west side) corner

Surface damage and scarring to footpath and carriageway from utilities works. Yellow and white lining faded.

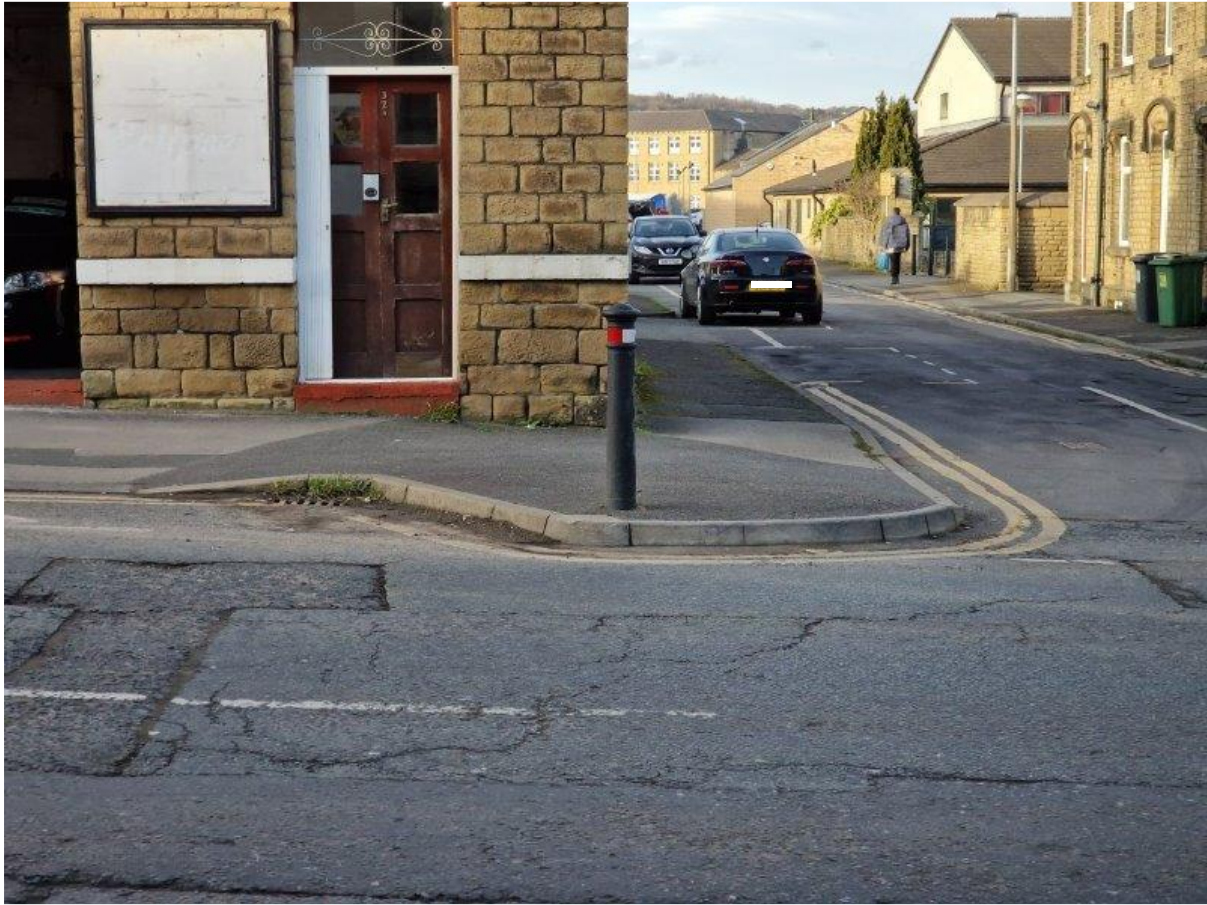
Lower Fitzwilliam Street/ William Street (south west side) corner

Surface damage and scarring to footpath and carriageway from utilities works. Yellow and white lining faded. Kerbs opposite appear in good order.

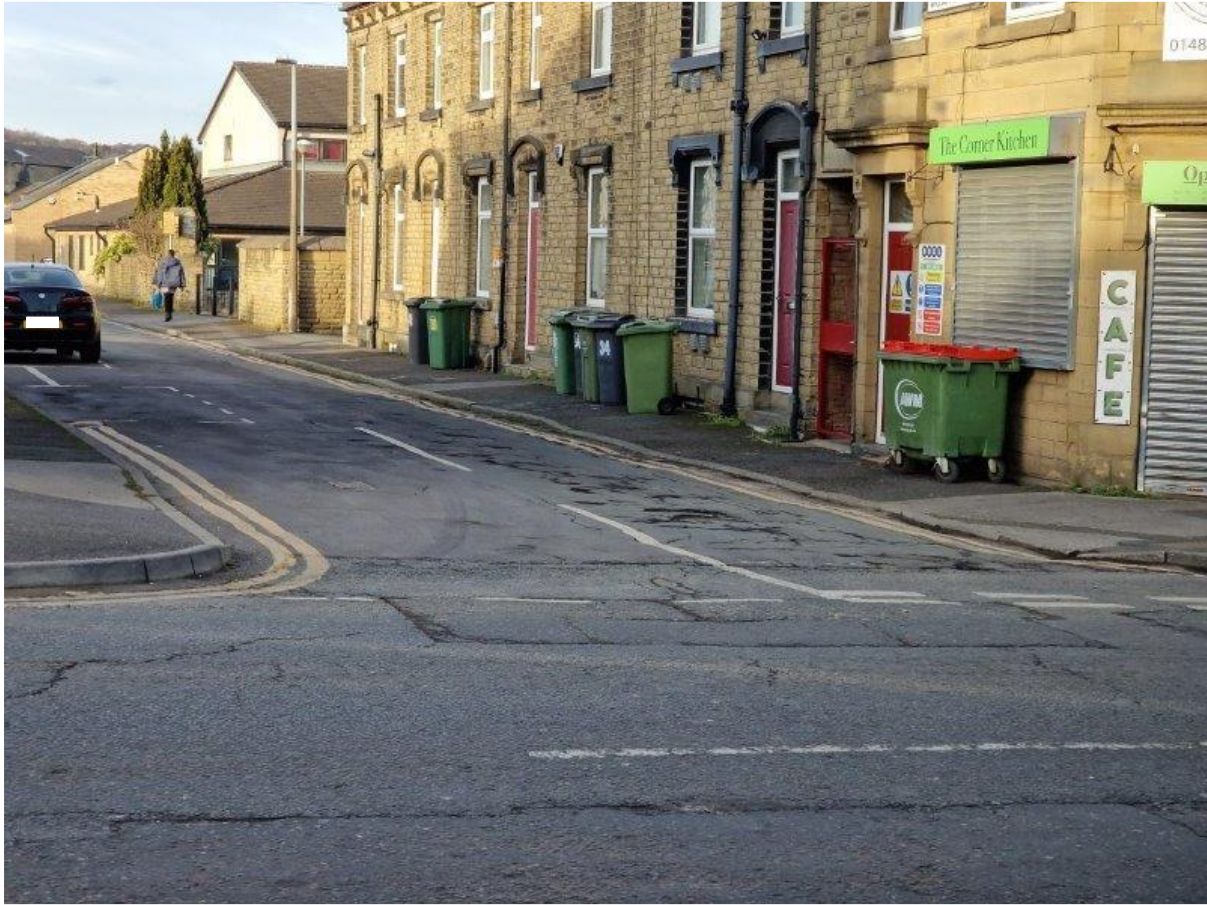
Lower Fitzwilliam Street / William Street (south west side) corner

Surface damage and scarring to footpath and carriageway from utilities works. Yellow and white lining faded. Kerbs opposite appear in good order.

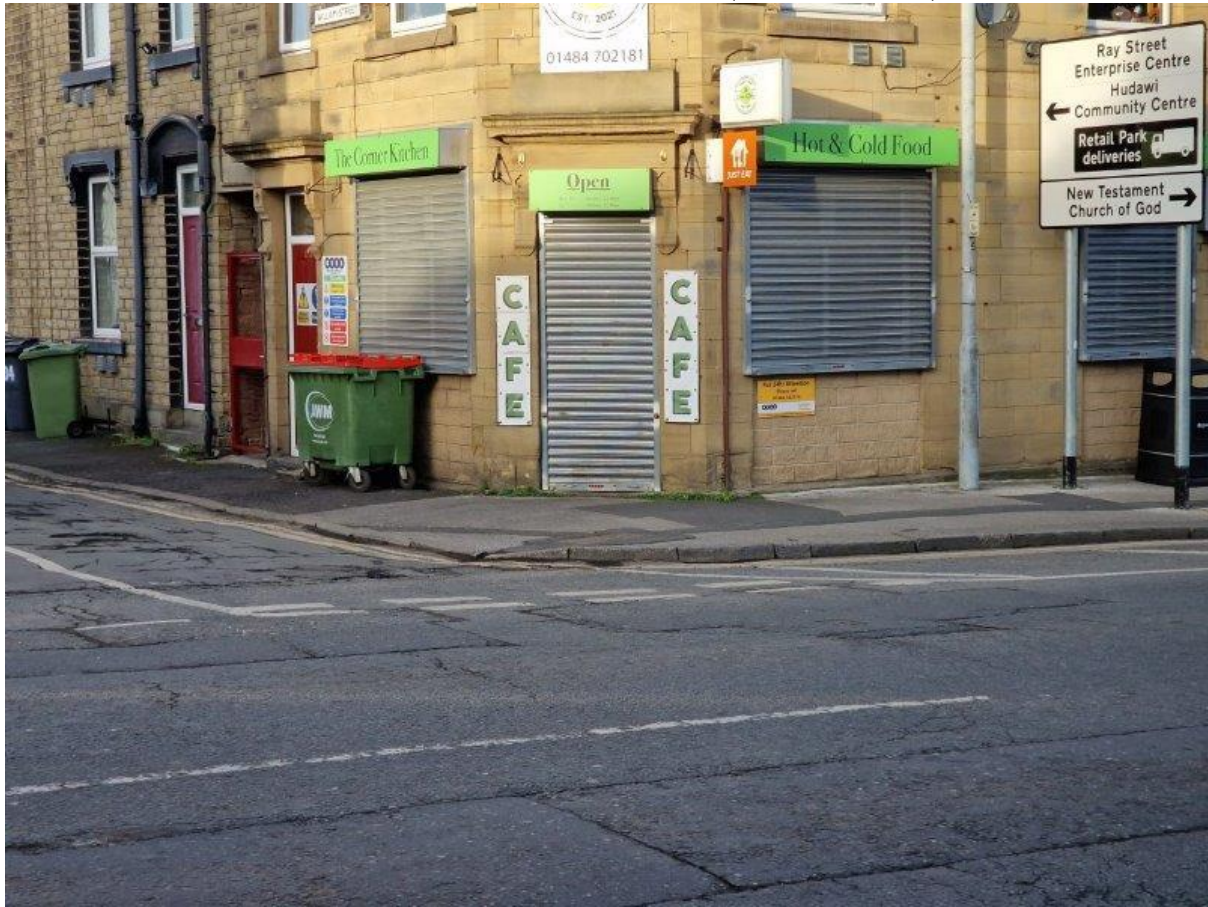
Lower Fitzwilliam Street / William Street (south west side) corner

Surface damage and scarring to footpath and carriageway from utilities works. Yellow and white lining faded. Kerbs opposite are damaged and misaligned

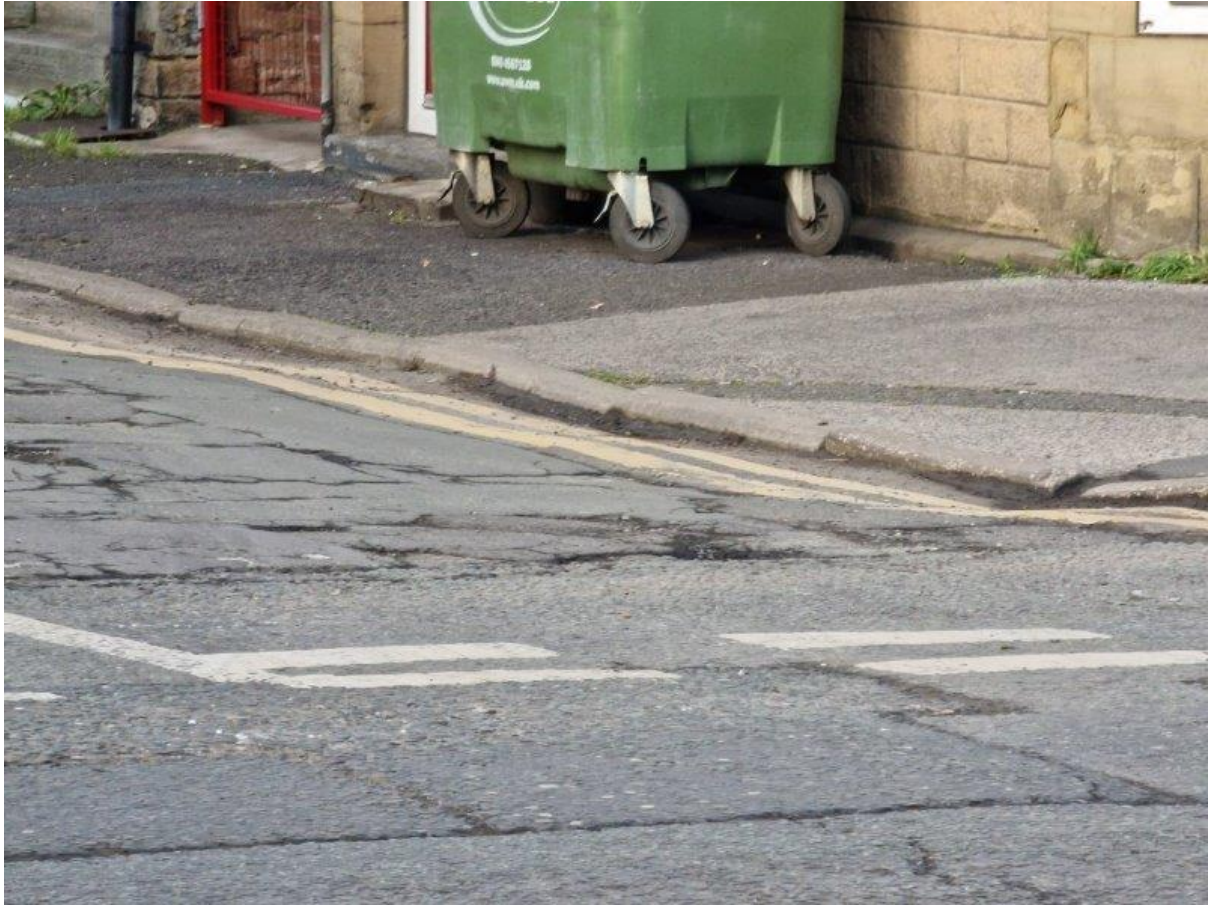
Lower Fitzwilliam Street / William Street (south west side) corner

Surface damage and scarring to footpath and carriageway from utilities works. Yellow and white lining faded. Kerbs opposite are damaged and misaligned

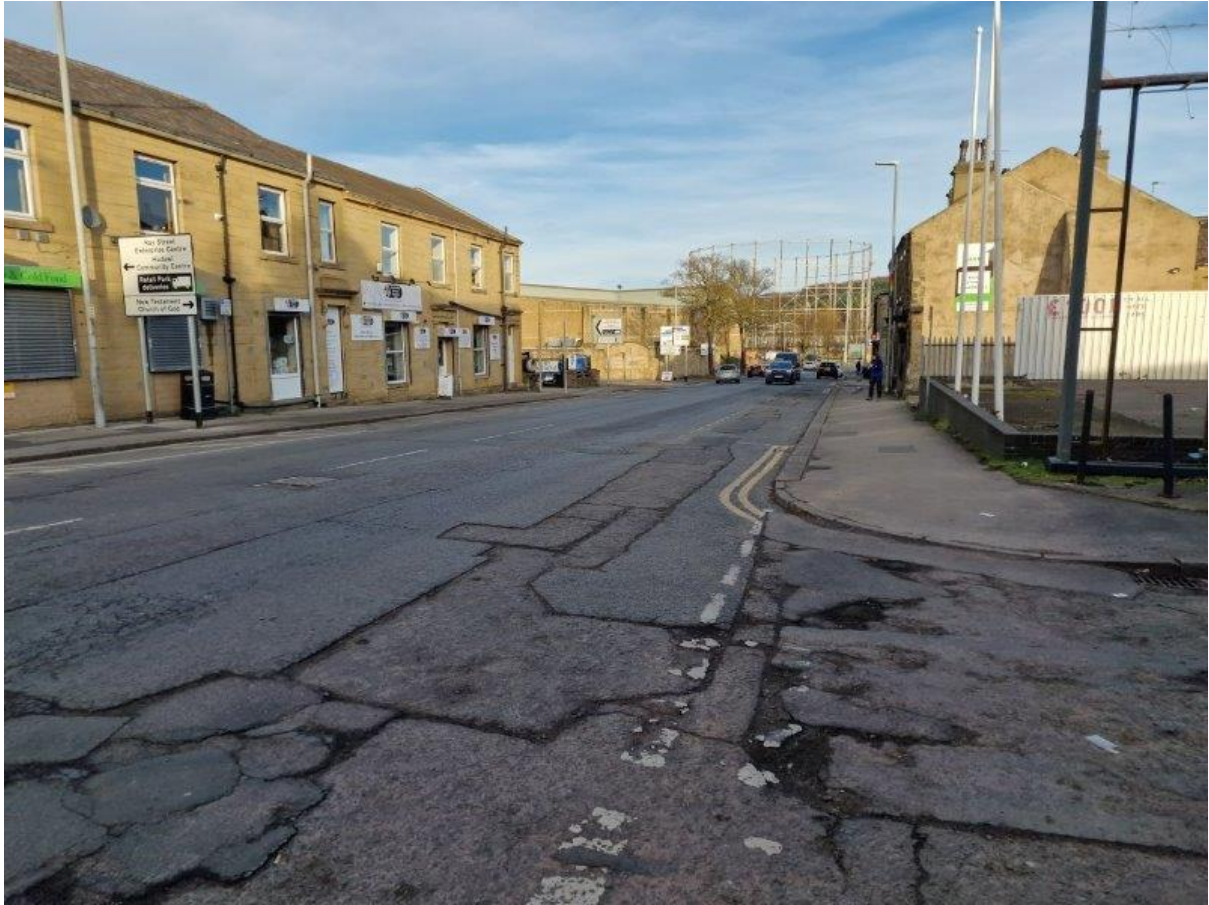
Lower Fitzwilliam Street / William Street (south west side) corner

Surface damage and scarring to footpath and carriageway from utilities works. Yellow and white lining faded. Kerbs opposite are damaged and misaligned

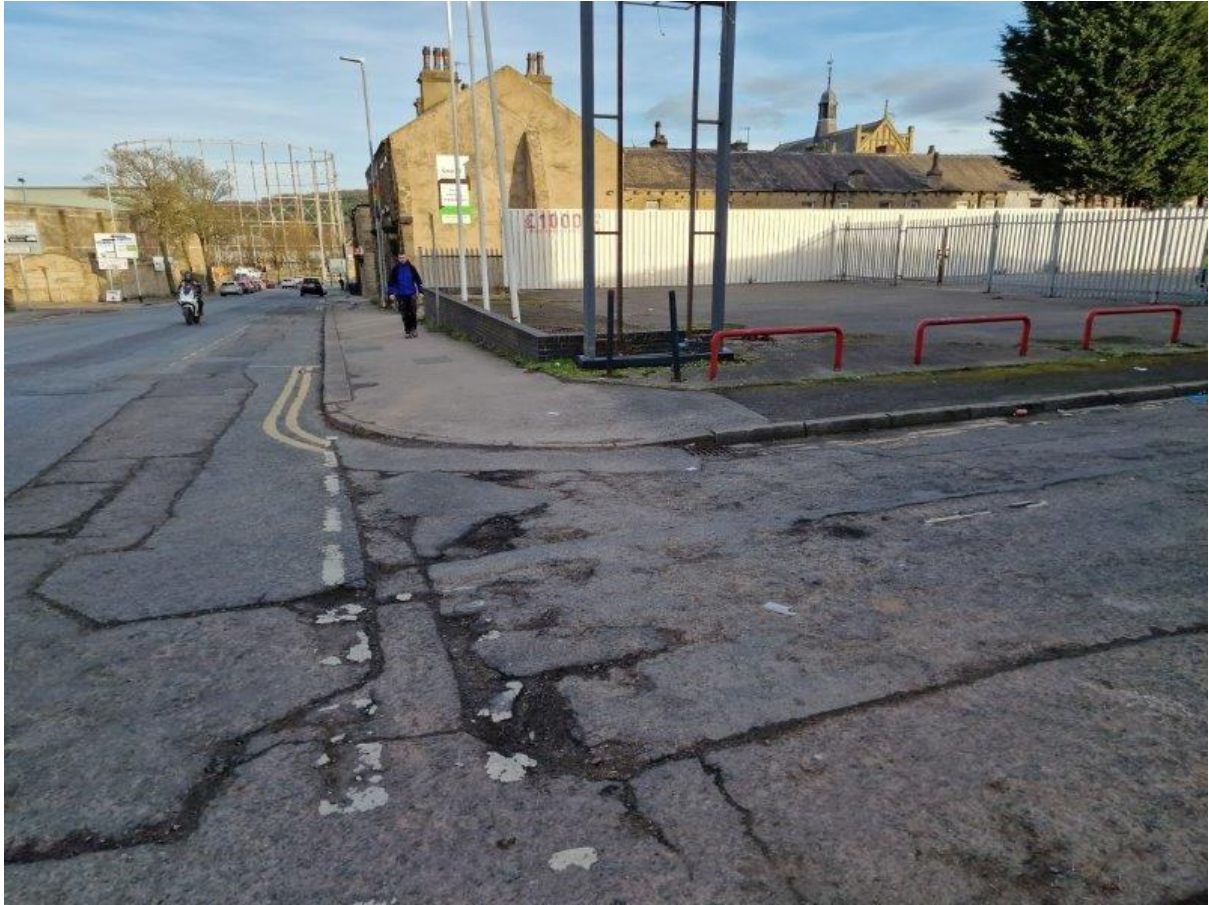
Lower Fitzwilliam Street / William Street (south west side) corner

Surface damage and scarring to footpath and carriageway from utilities works. Yellow and white lining faded. Kerbs showing signs of wear and minor damage.

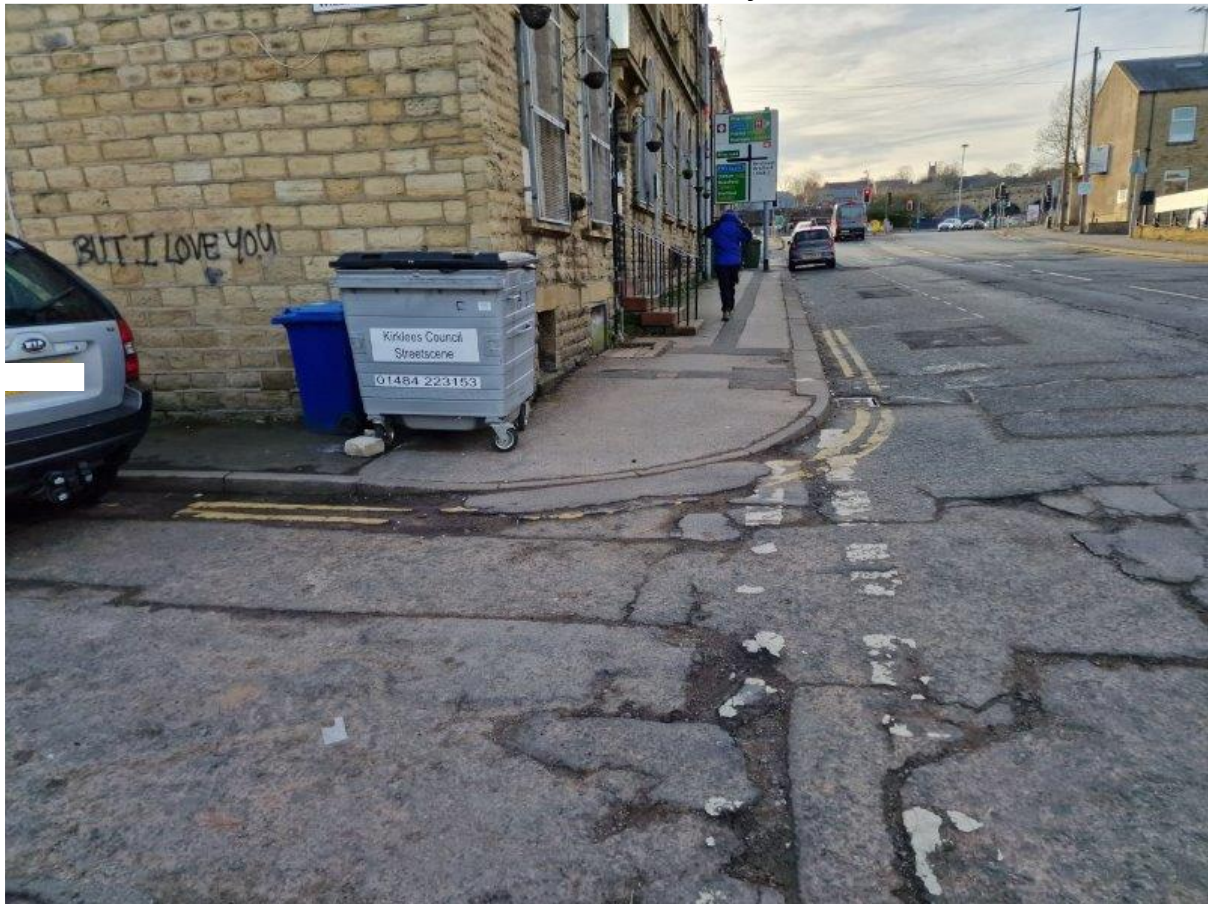
Lower Fitzwilliam Street/William Street junction south side

Surface damage and scarring to footpath and carriageway from utilities works. Yellow and white lining faded. Kerbs showing signs of wear and minor damage.

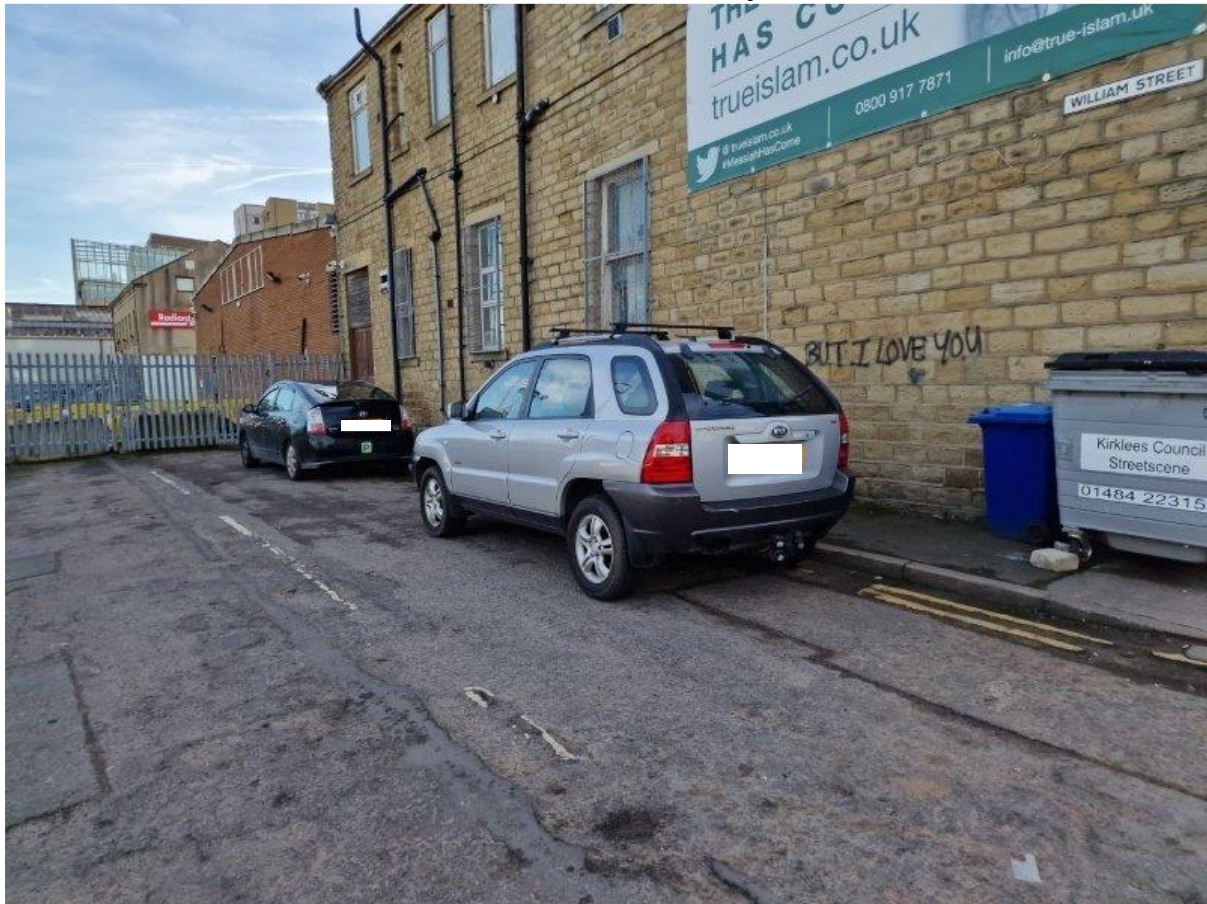
Lower Fitzwilliam Street/William Street junction south side

Surface damage and scarring to footpath and carriageway from utilities works. Yellow and white lining faded. Kerbs showing signs of wear and minor damage.
