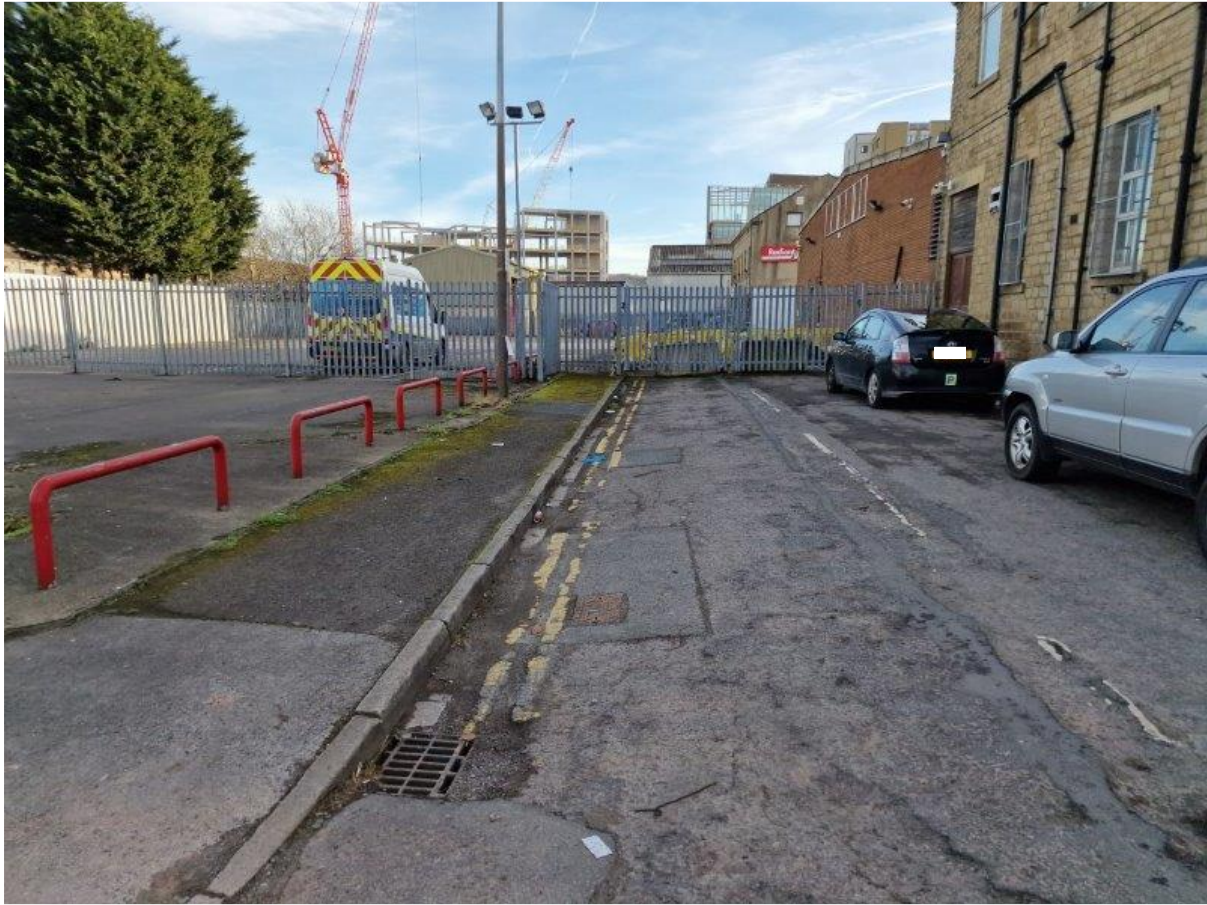
Lower Fitzwilliam Street/William Street junction south side

Surface damage and scarring to footpath and carriageway from utilities works. Yellow and white lining faded. Kerbs showing signs of wear and minor damage. Drain has minor debris build up inside.

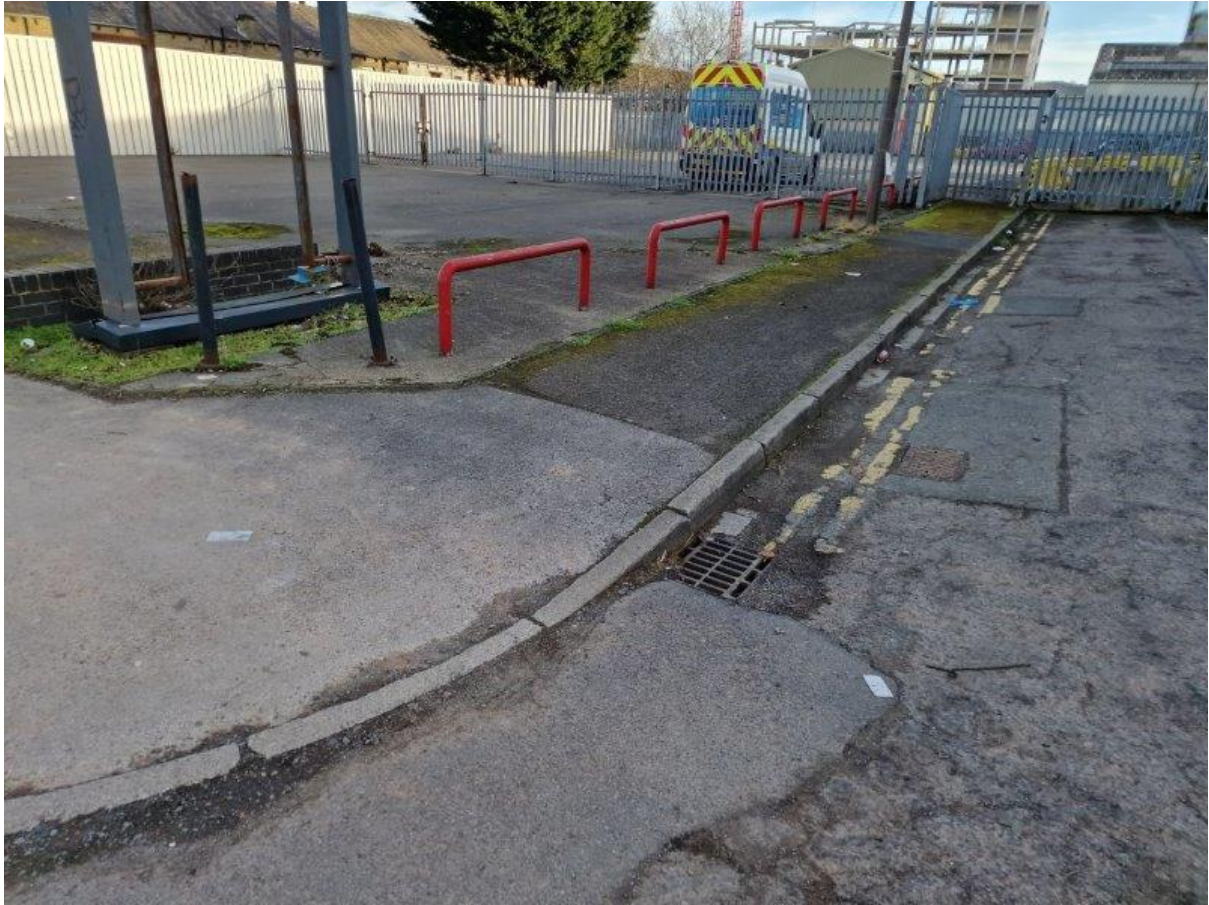
Lower Fitzwilliam Street/William Street junction south side

Surface damage and scarring to footpath and carriageway from utilities works. Yellow and white lining faded. Kerbs showing signs of wear and minor damage. Drain has minor debris build up inside. Vegetation growth to walkway.

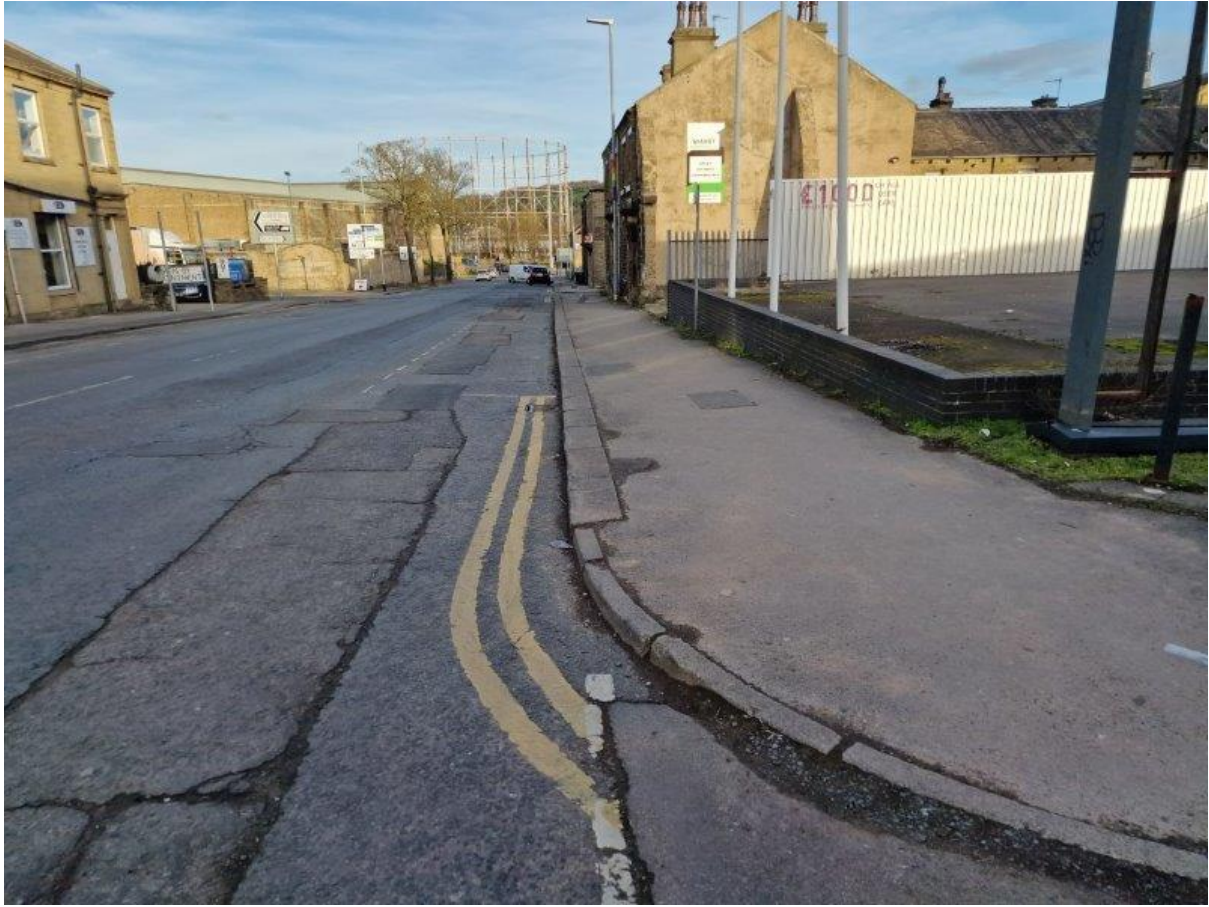
Lower Fitzwilliam Street/William Street junction south side

Surface damage and scarring to footpath and carriageway from utilities works. Yellow and white lining faded. Kerbs showing signs of wear and minor damage.

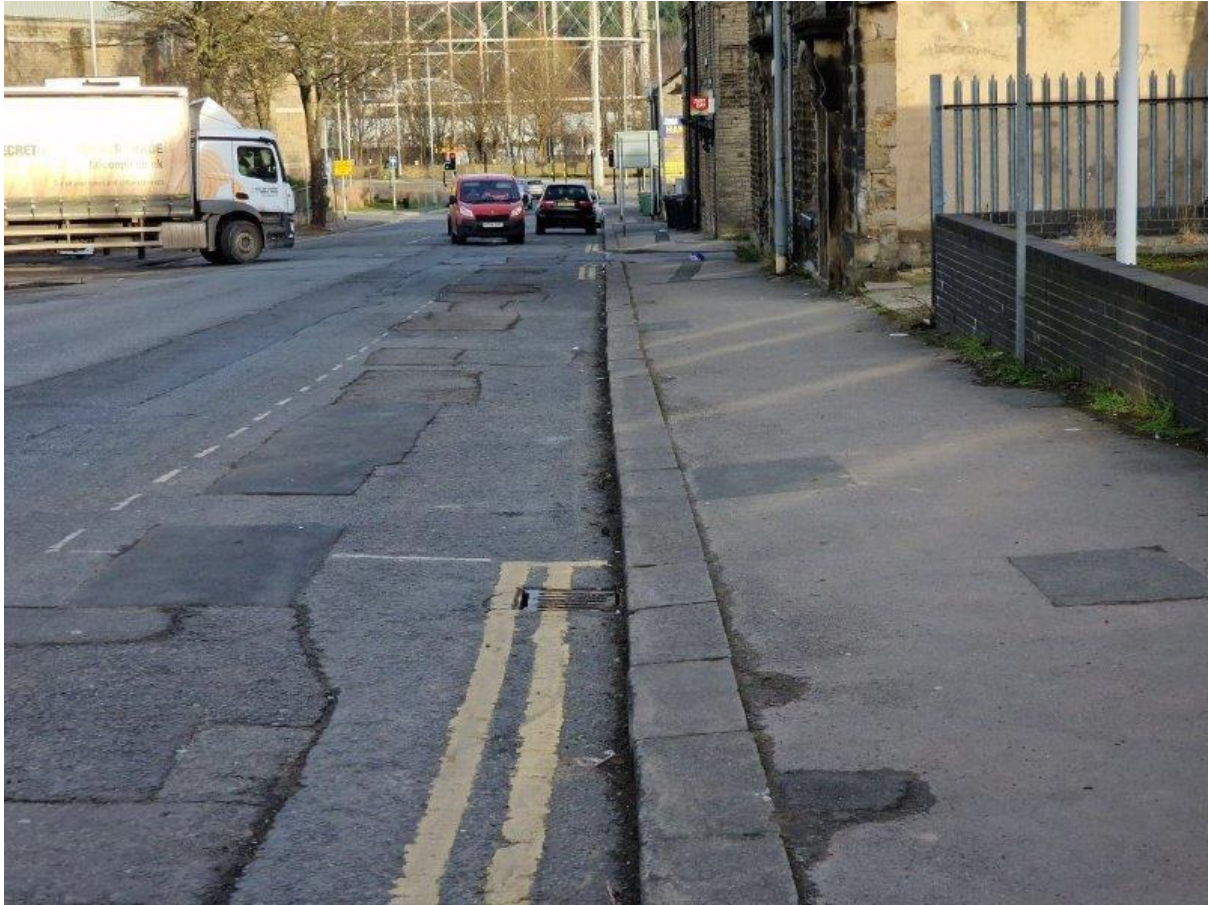
Lower Fitzwilliam Street/William Street junction south east side

Surface damage and scarring to footpath and carriageway from utilities works. Yellow and white lining faded. Kerbs showing signs of wear and minor damage.

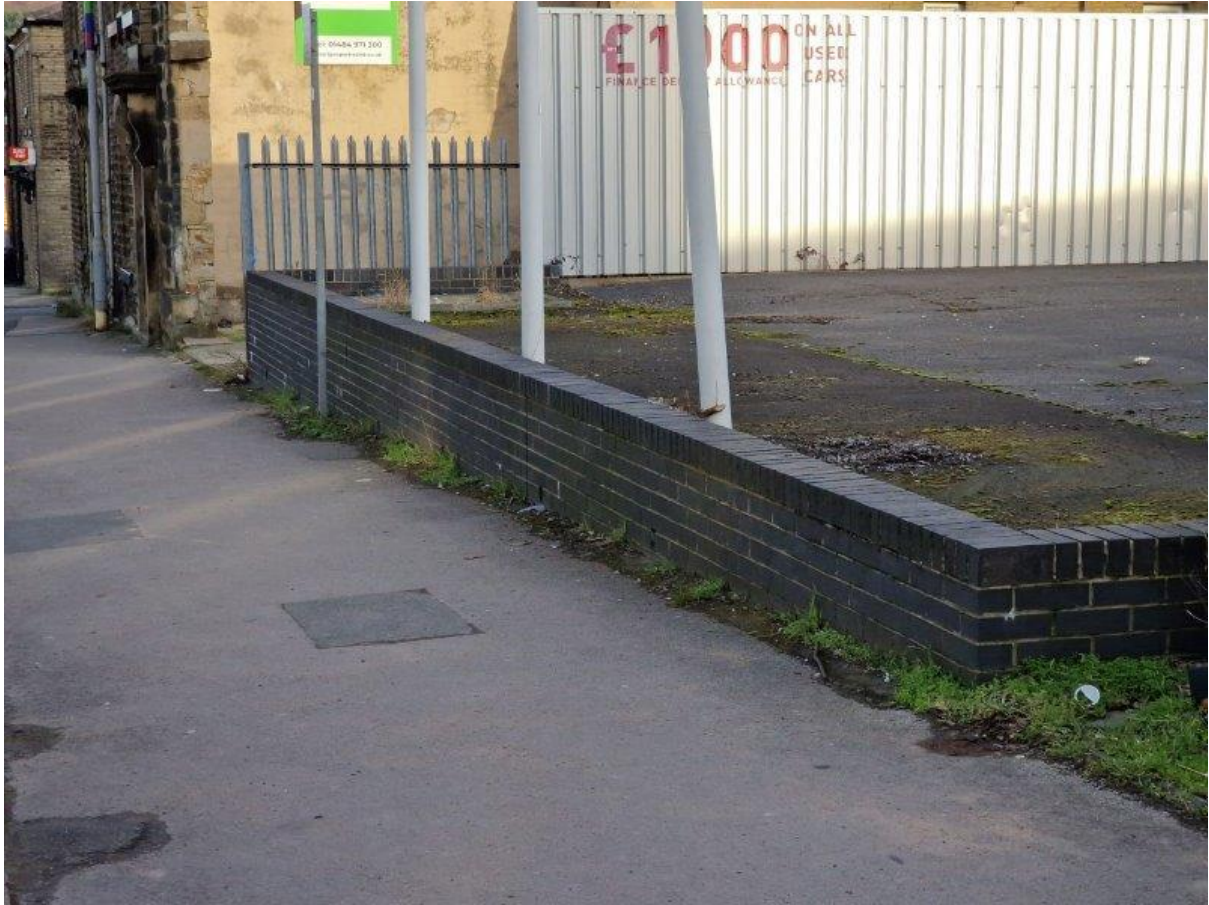
Lower Fitzwilliam Street/William Street junction south east side

Surface damage and scarring to footpath and carriageway from utilities works. Vegetation growth to base of wall/path edge.

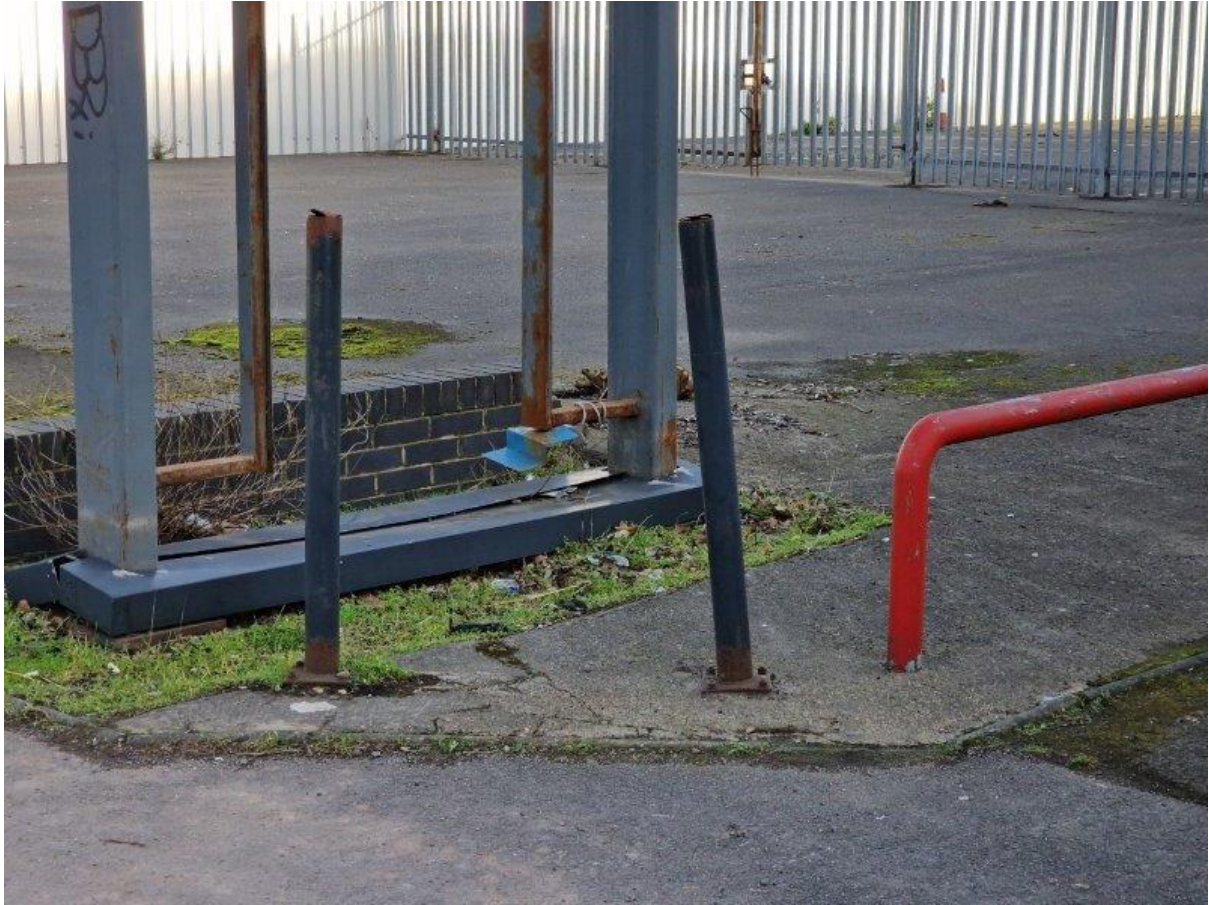
Lower Fitzwilliam Street/William Street junction south east side

Surface damage and scarring to footpath and carriageway from utilities works. Vegetation growth to base of wall/path edge.
