**REMEDIATION STRATEGY AND VERIFICATION PLAN
JOSEPH NORTON SEMH SCHOOL
HUDDERSFIELD
WATES CONSTRUCTION LTD
RSVP-25049-25-94 REV A
APRIL 2025**

Rev	Prepared	Approved	Date of Issue	Reason(s) for Revision
A	KRP	LGS	15/04/25	Inclusion of further ground investigation. Updated ground gas monitoring and assessment.

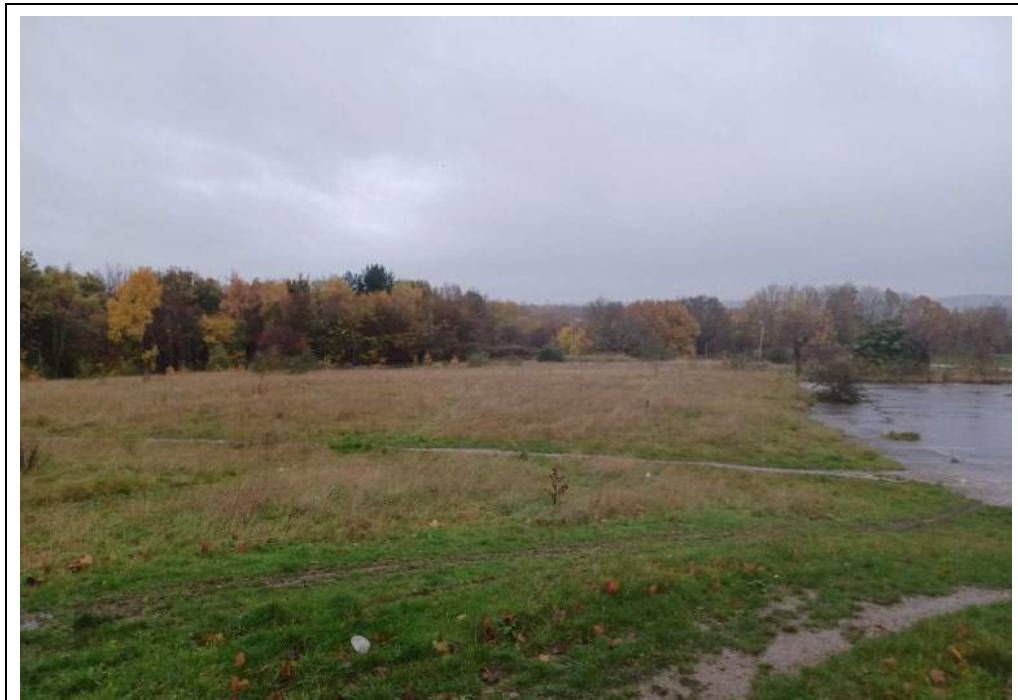
Figure 4: Site as photographed during walkover undertaken by HSP Consulting in 2022.

2.1.6 Figure 4 below presents an extract taken from a site walkover conducted by HSP Consulting.

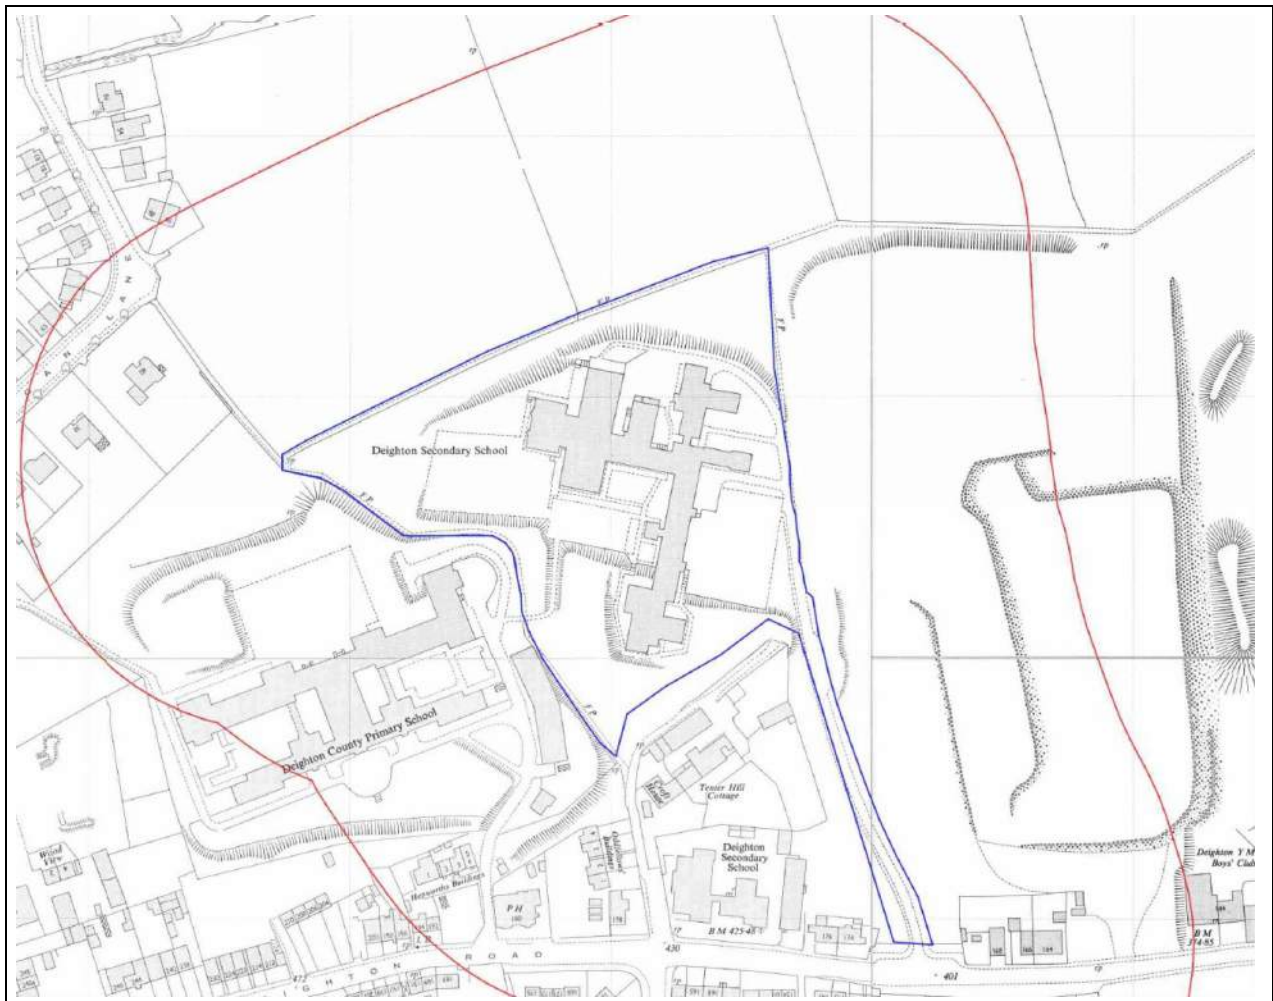
Figure 6: 1957 1:1,250 map showing development of Deighton Secondary School on the site and map symbols indicating filling on adjacent site to the east

reproduced from Phase I Geo-Environmental Desk Study produced by HSP Consulting.

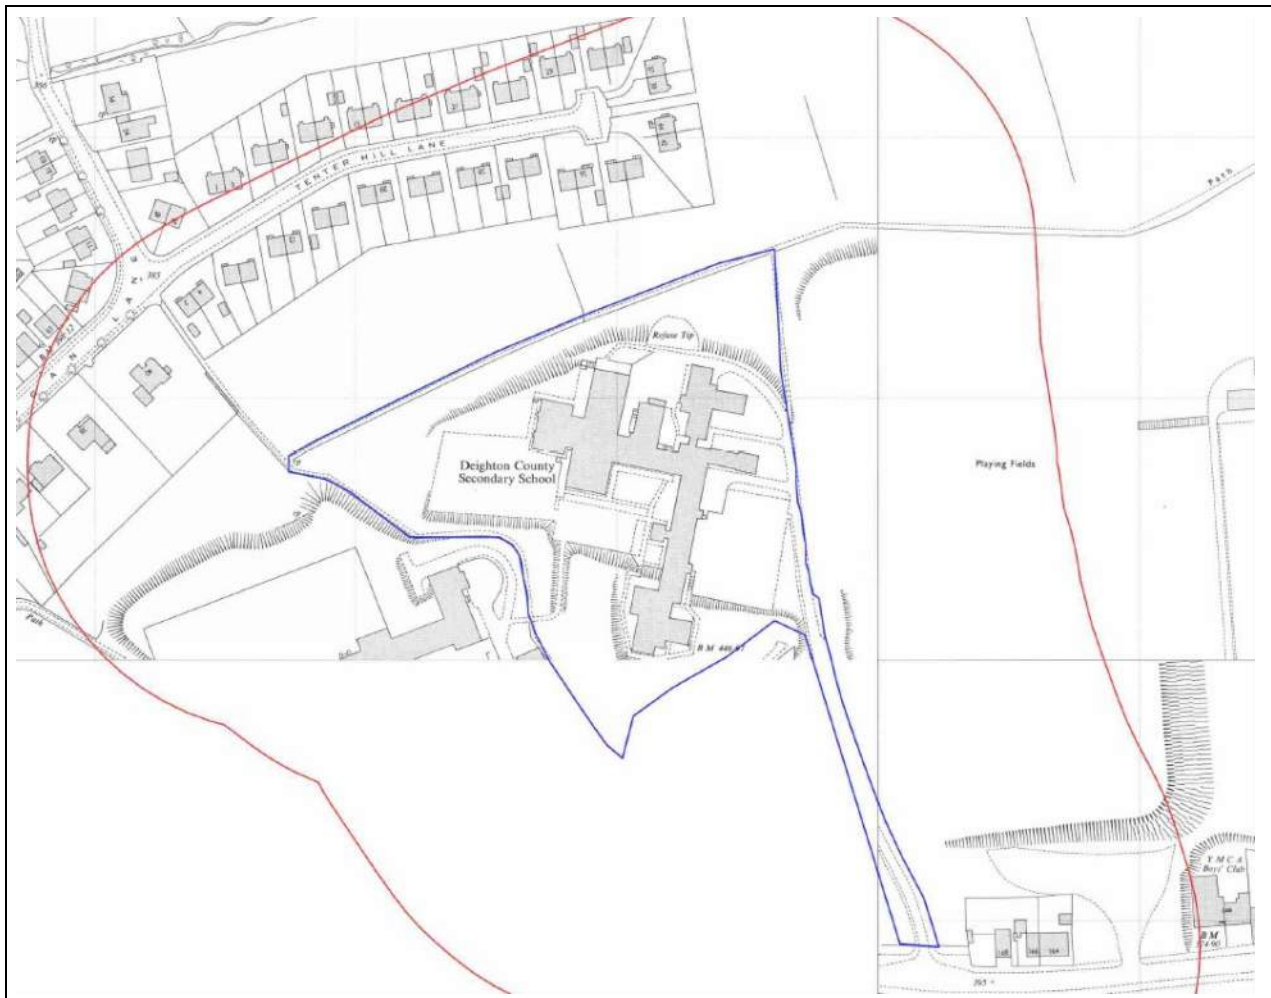
Figure 8: 1966 1:1,250 map showing refuse tip on site (landfill 2 on Groundsure map) within embankment and completed playing fields to the east

reproduced from Phase I Geo-Environmental Desk Study produced by HSP Consulting.

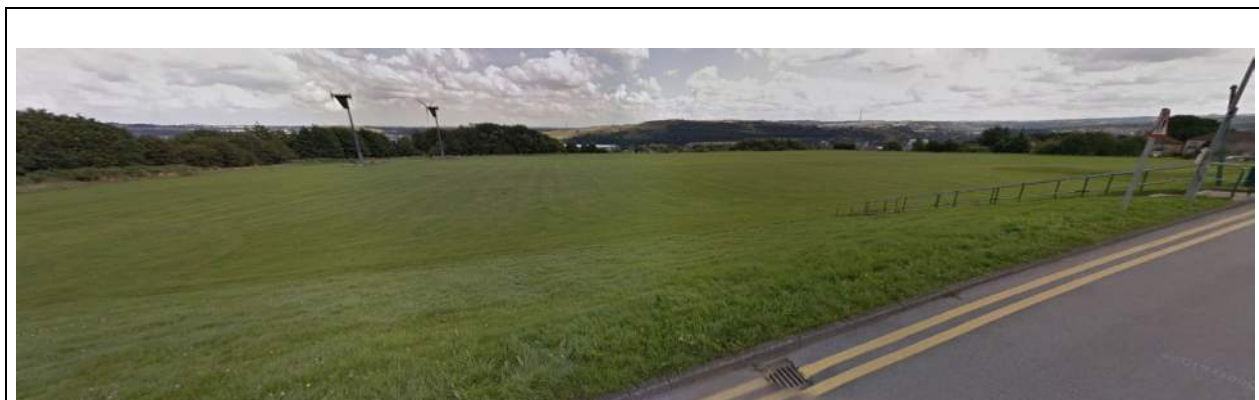
Figure 9: 2012 view of playing fields with level topography

- 3.2.6 The playing fields to the east appear to have been formed to give a level playing surface set at a lower elevation than the former school land (see Figure 9). Very little information is available on potential filling activities, with historic landfill data only limited to the waste type as household. Assuming the site has been correctly identified as a historical landfill, then, based on our experience of sites of similar age and context (formation of public playing fields), anticipated fill could include mixed soils, mostly black silty soils formed from ash and cinders from domestic fires, with subfractions of bottles, ceramics, animal bones, some plastic and similar discarded household items. Potential putrescible material beneath the playing fields would have largely degraded, as suggested by the more recent spike data.

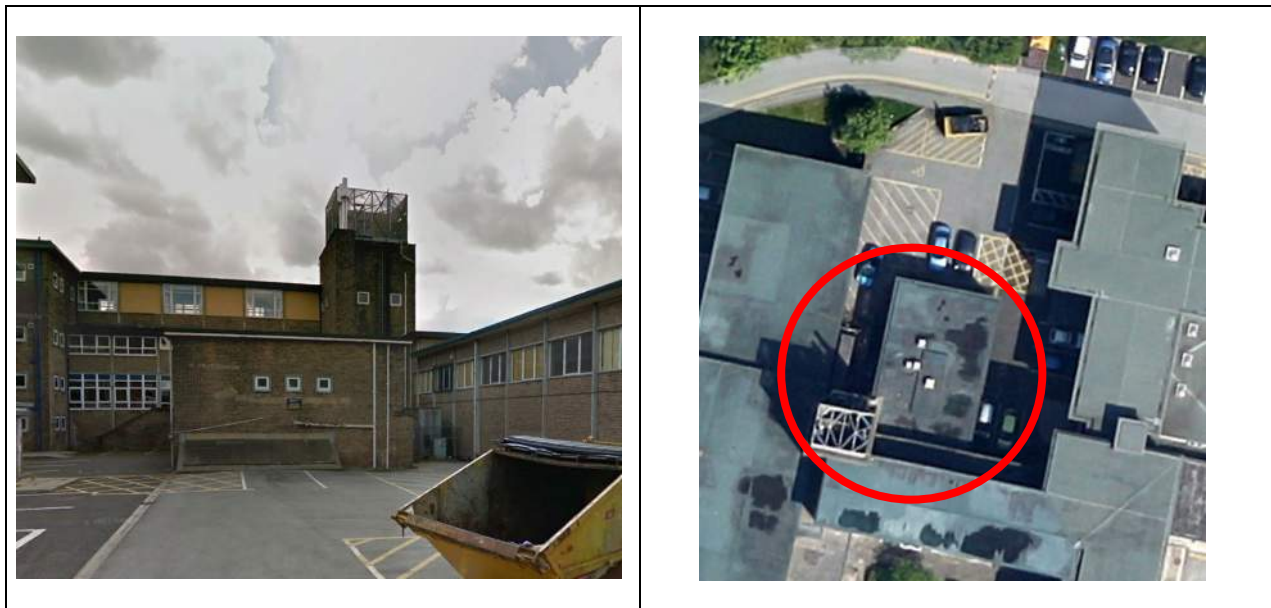
Figure 12: Former plant / boiler room location

3.8.4 Location TP01 positively located the former plant/boiler room basement that had been infilled during demolition (Figure 12), however the full depth of fill was not determined due to the sides of the trial pit spalling with loose demolition fill. The depth was later estimated to be approximately 5 m from observations of the flush water from a rotary borehole located adjacent to TP01. Approximately 2 m of rubble fill was also recorded in nearby location WS08. The fill in WS08 and TP01 was reported to contain:

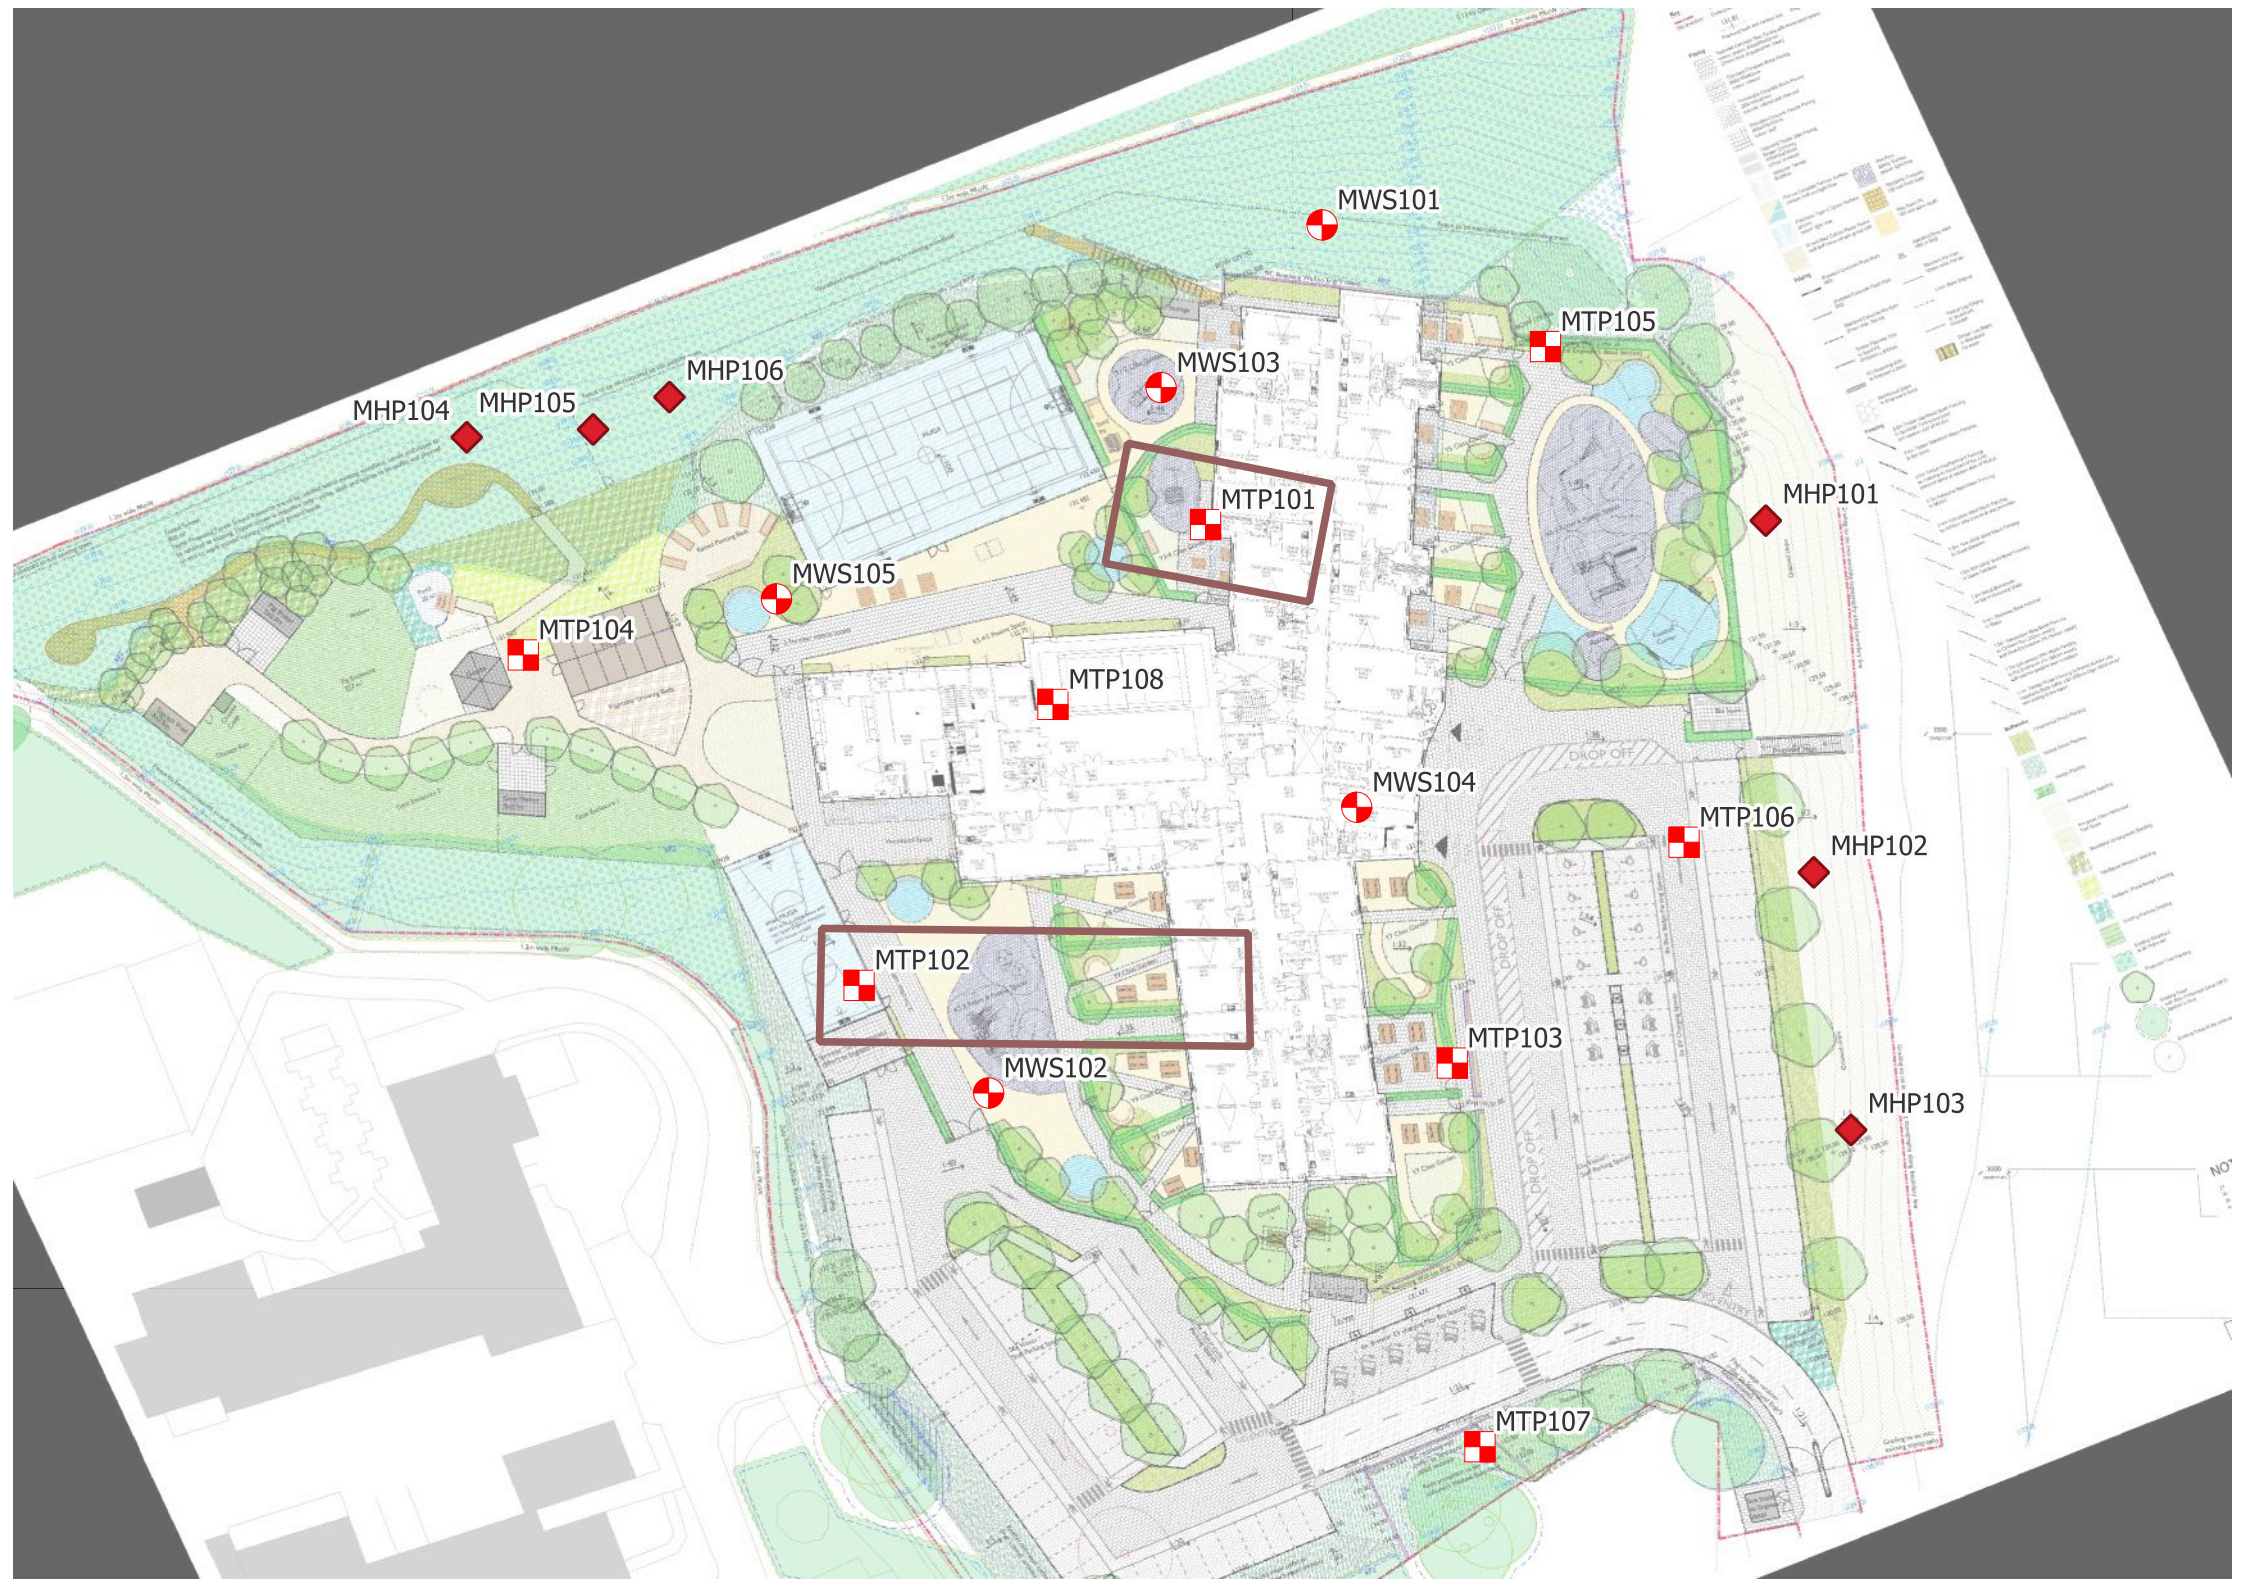
- APPENDIX 3**
- IDOM Merebrook Exploratory Hole & Sampling Locations – March 2025
 - IDOM Merebrook Exploratory Hole Logs – March 2025
