Harron Homes Ltd  
Merchant Fields, Cleckheaton  
Specification for Treatment of Mineworkings

**REPORT TITLE:** **Specification for Treatment of Mineworkings**

**REPORT NUMBER:** **001 Rev B**

**CLIENT NAME:** **Harron Homes Ltd**

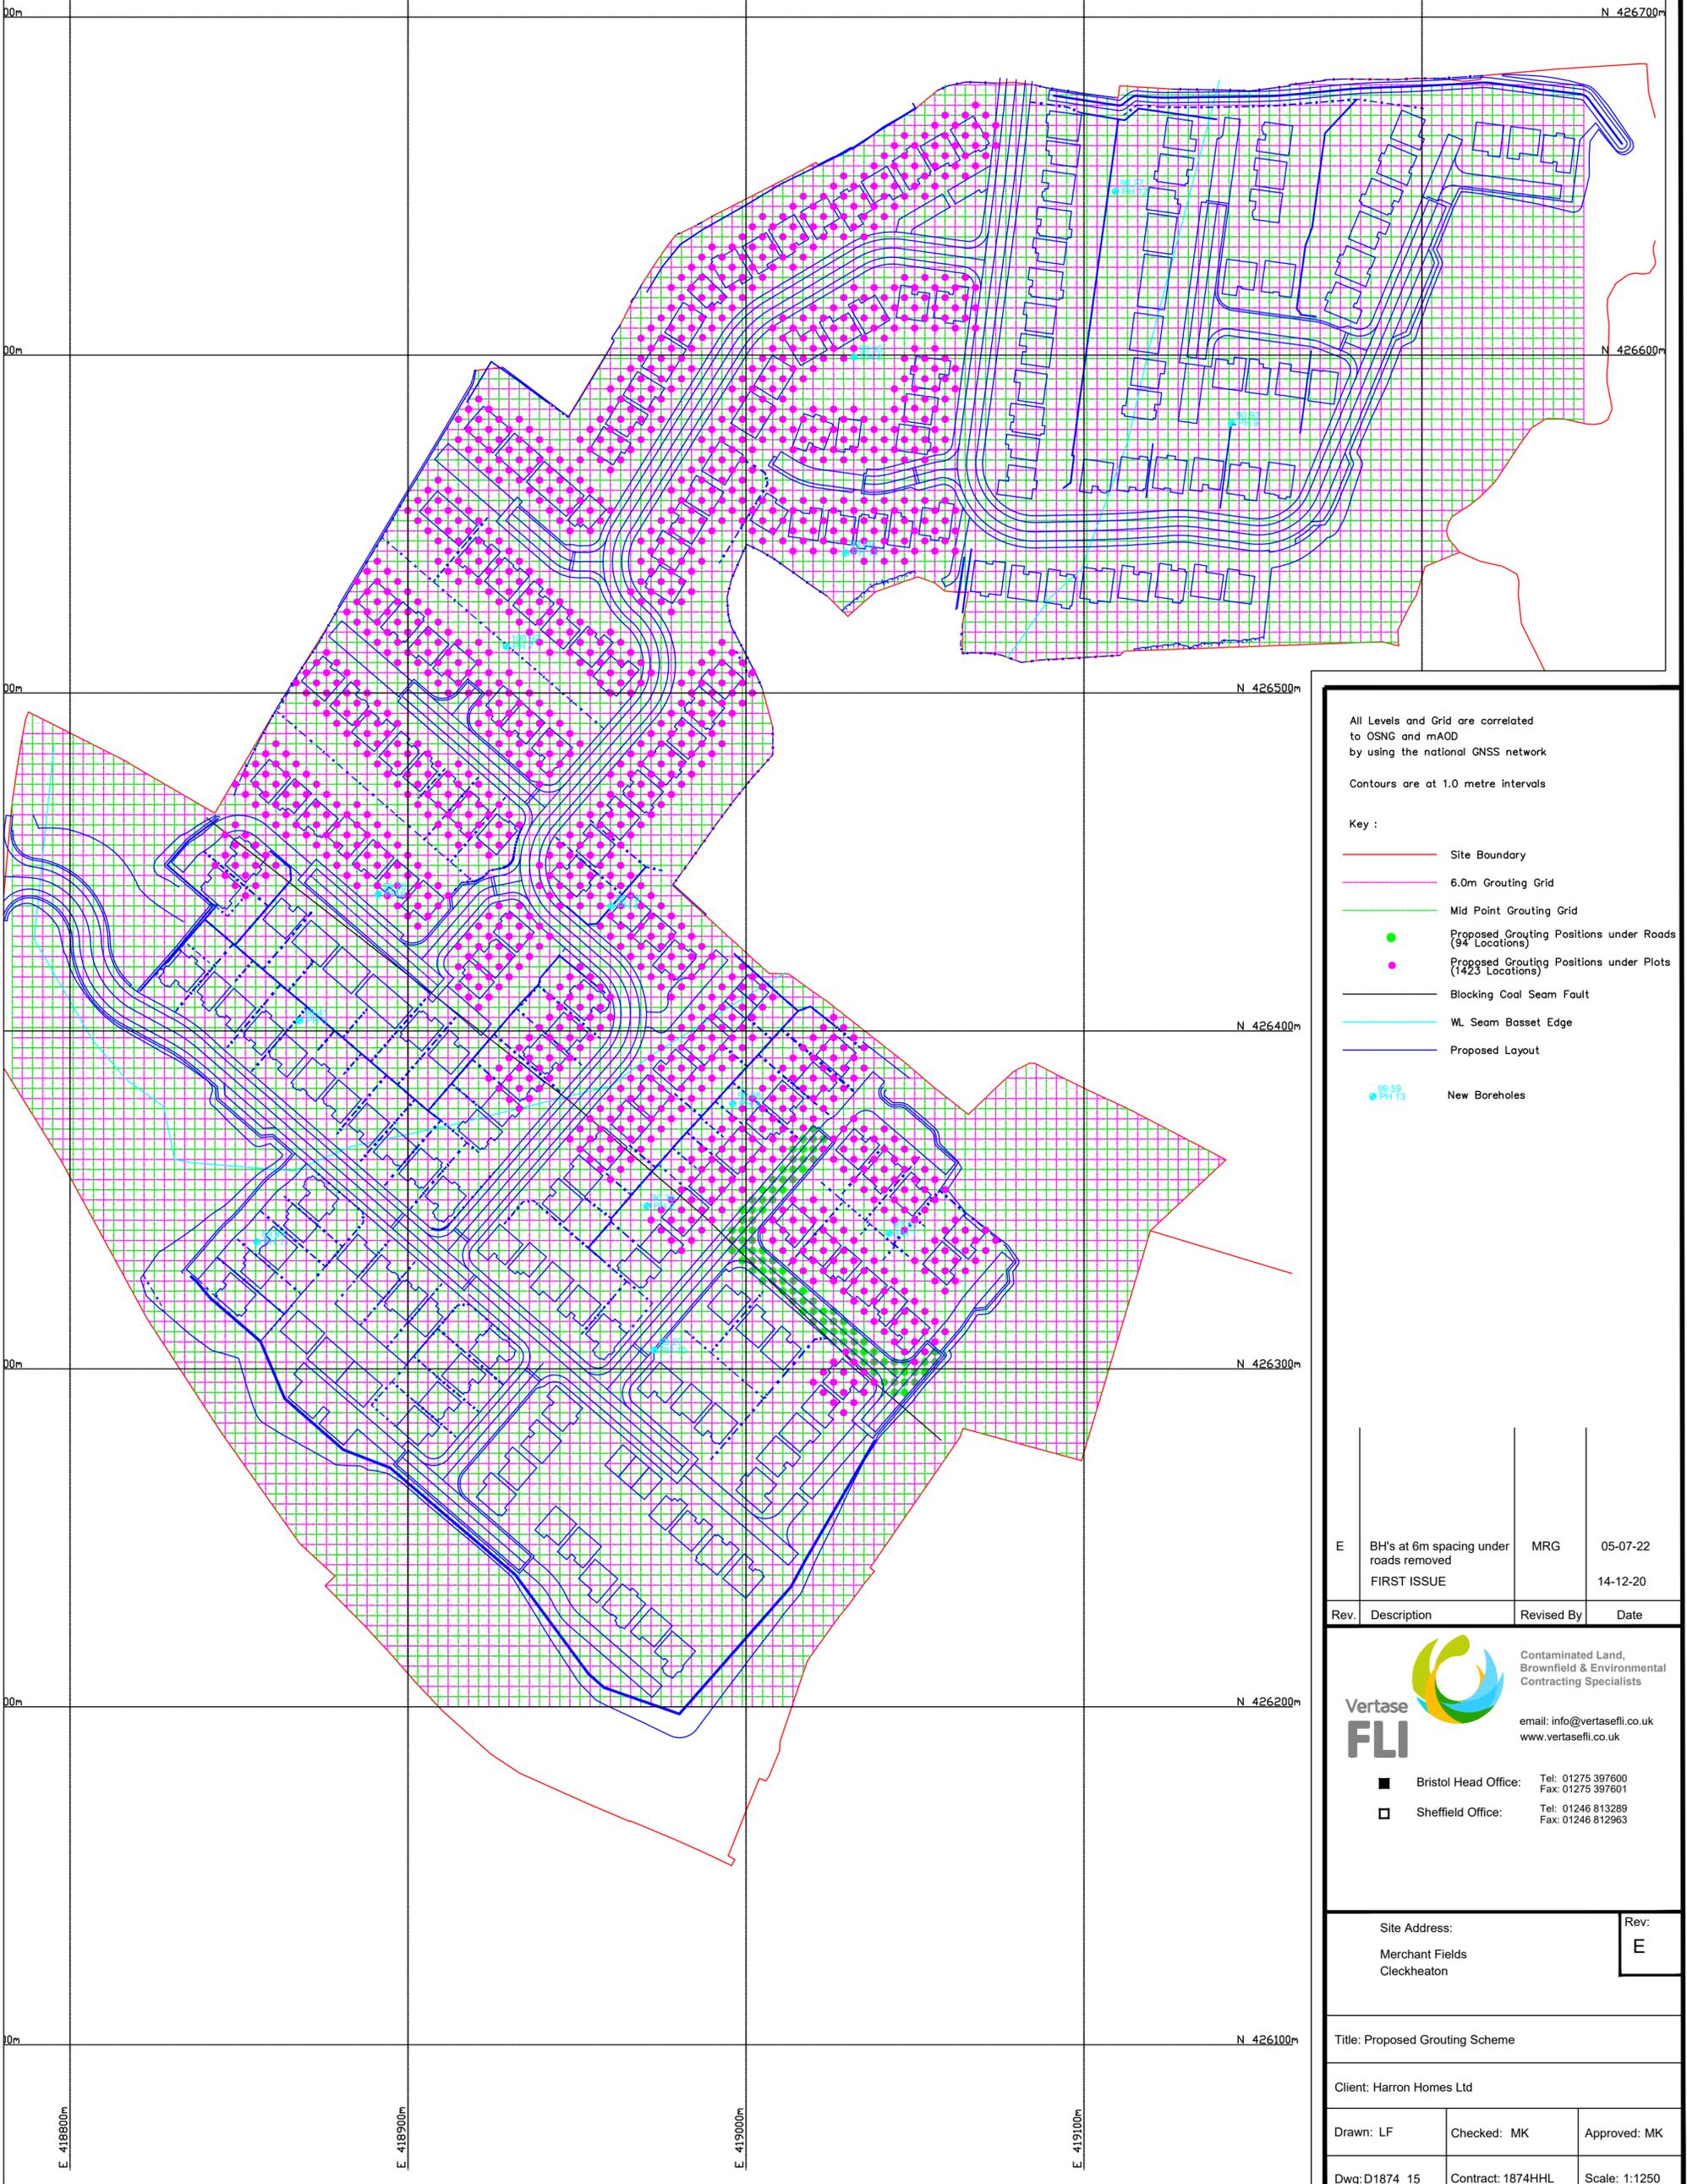
Site Address: Merchant Fields Cleckheaton	Rev: <b>E</b>	
Title: Proposed Grouting Scheme		
Client: Harron Homes Ltd		
Drawn: LF	Checked: MK	Approved: MK
Dwg: D1874_15	Contract: 1874HHL	Scale: 1:1250
