# Geoenvironmental Appraisal

## Land at Merchant Fields, Cleckheaton For Harron Homes

Report no: 2828/1A

Date: July 2019

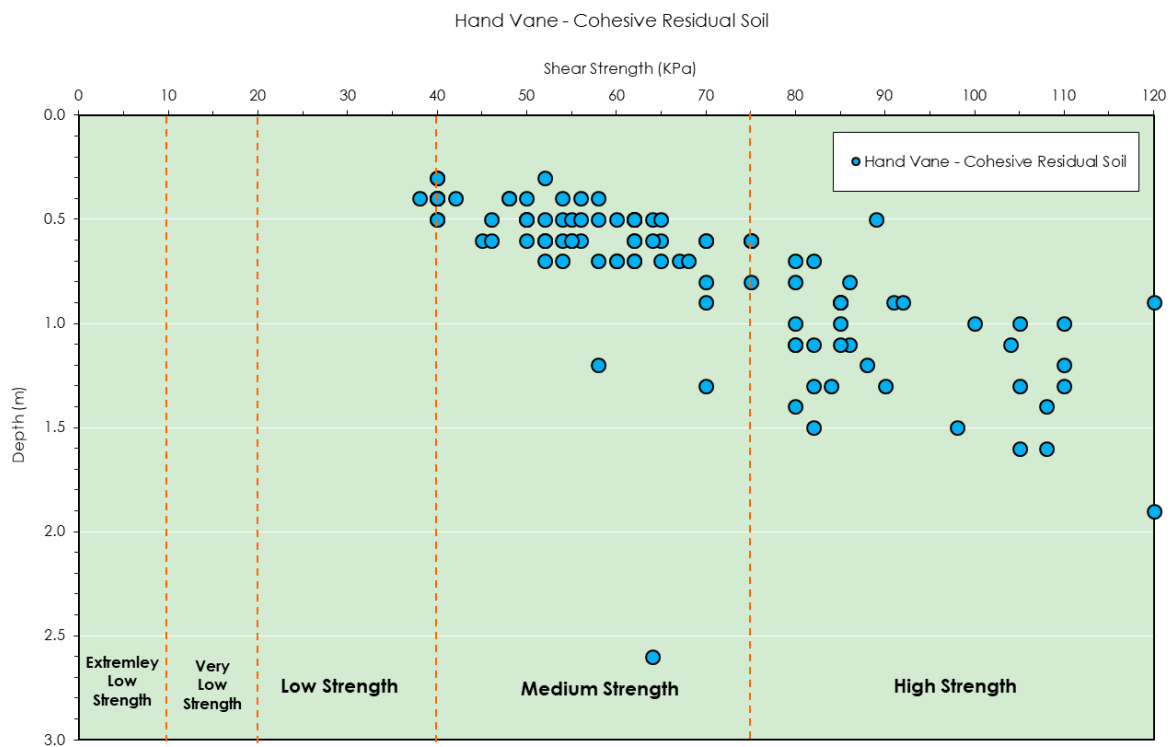
- 12.5.1 Hand shear vane testing was undertaken within trial pits in-situ to around 1.2m depth and from larger blocks of excavated clay below that depth.
- 12.5.2 The results are summarised within the plot below and illustrate a broad linear increase in undrained shear strength ( $S_u$ ) with depth within the Cohesive Residual Soil. Below approximately 0.9m depth  $S_u$  is typically greater than 70kPa.
- 12.5.3 The plot below provides a summary of undrained shear strengths.

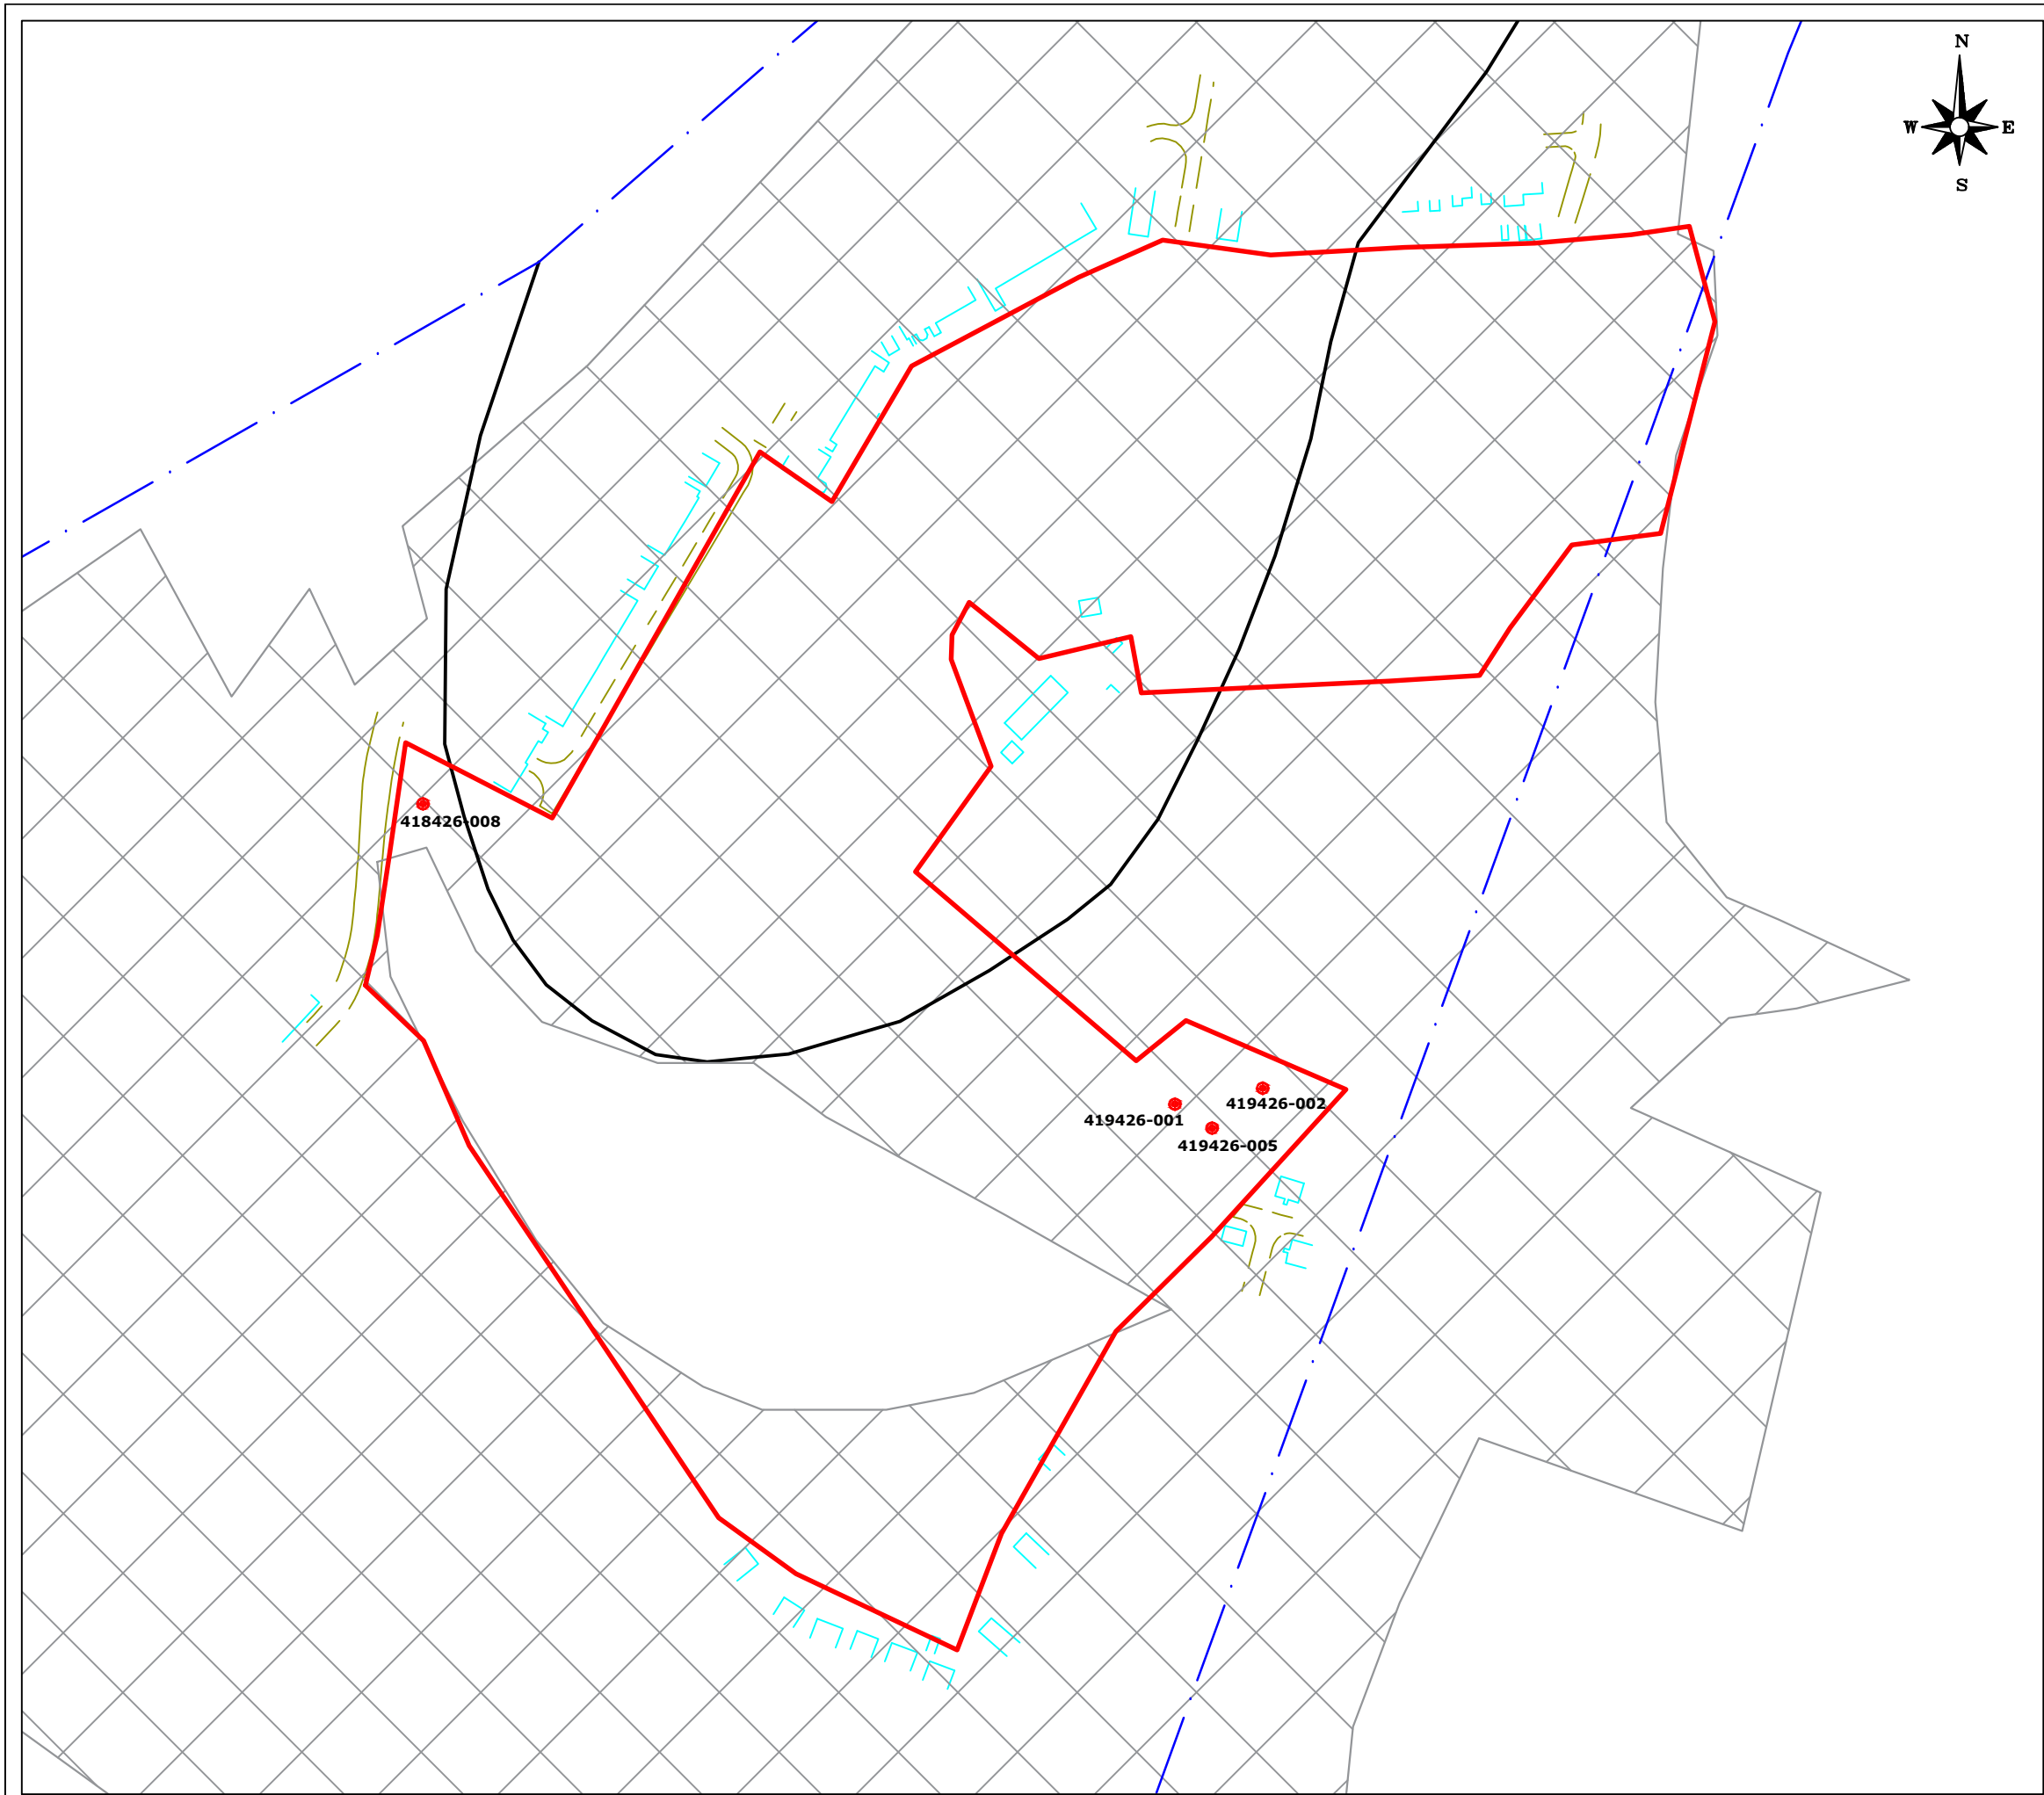
| SCALE | 1:2500 | SHEET | A3 | DRAWING NO. | 2828/8 | REVISION | |

- NOTES
- COAL AUTHORITY DEVELOPMENT HIGH RISK AREA (FROM CA)
  - CA RECORDED SHAFT
  - MAPPED OUTCROP OF WHEATLEY LIME COAL
  - MAPPED FAULT LINE
  - APPROXIMATE SITE BOUNDARY

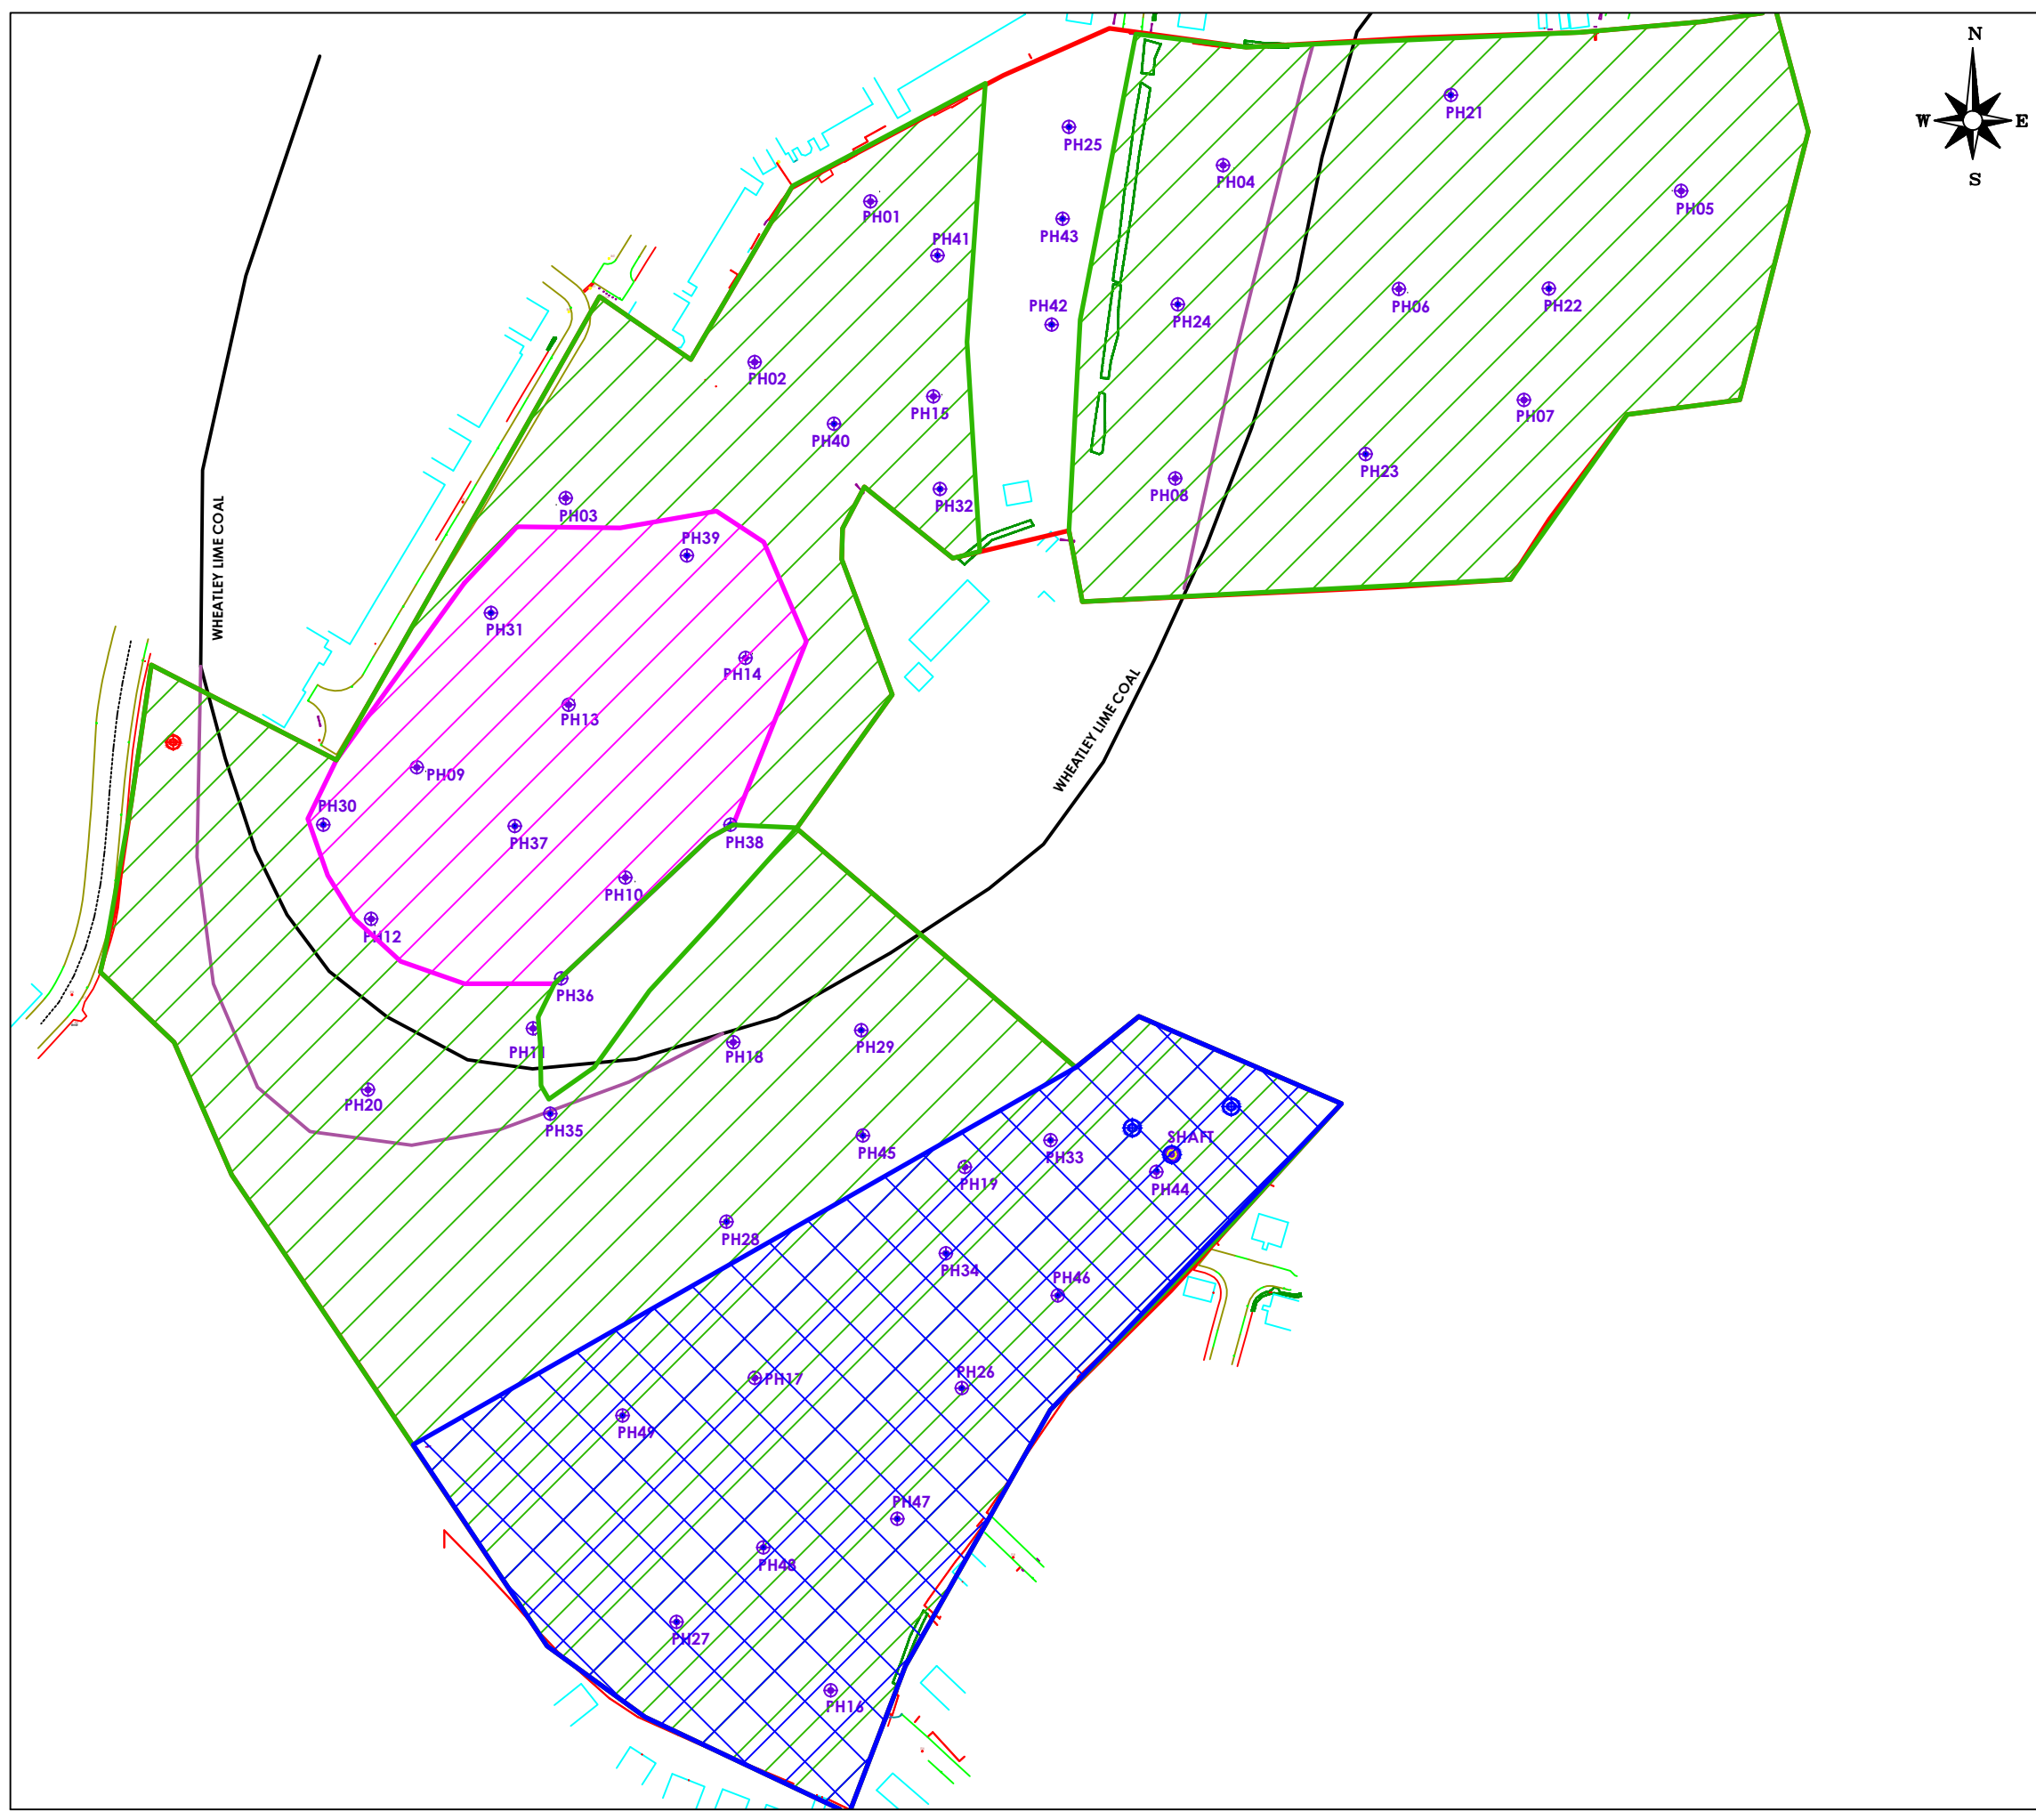
- NOTES
- PROBEHOLE LOCATION
  - CA RECORDED SHAFT (NOT LOCATED)
  - SHAFT LOCATION (AS SURVEYED)
  - AREA REQUIRING GROUTING - MIDDLETON 11 YARD COAL
  - AREA REQUIRING PROOF DRILLING - MIDDLETON 11 YARD COAL
  - AREA REQUIRING GROUTING - BLOCKING COAL
  - MAPPED OUTCROP OF WHEATLEY LIME COAL (FROM PUBLISHED BGS PLANS)
  - INFERRED OUTCROP OF WHEATLEY LIME COAL (FROM LITHOS EXPLORATORY HOLES)

| A | UPDATED WITH SUPPLEMENTARY PH FINDINGS (MJT) | 28/06/2019 |
