# GEO-ENVIRONMENTAL REPORT

| job number | C4137/24/E/6329 | date | 26/04/24 |
| site address | Cummins Turbo Proposed Footbridge,<br>Saint Andrew's Road,<br>Huddersfield,<br>HD1 6RA. | | |

## Report on a Phase 2 Geo-environmental Investigation

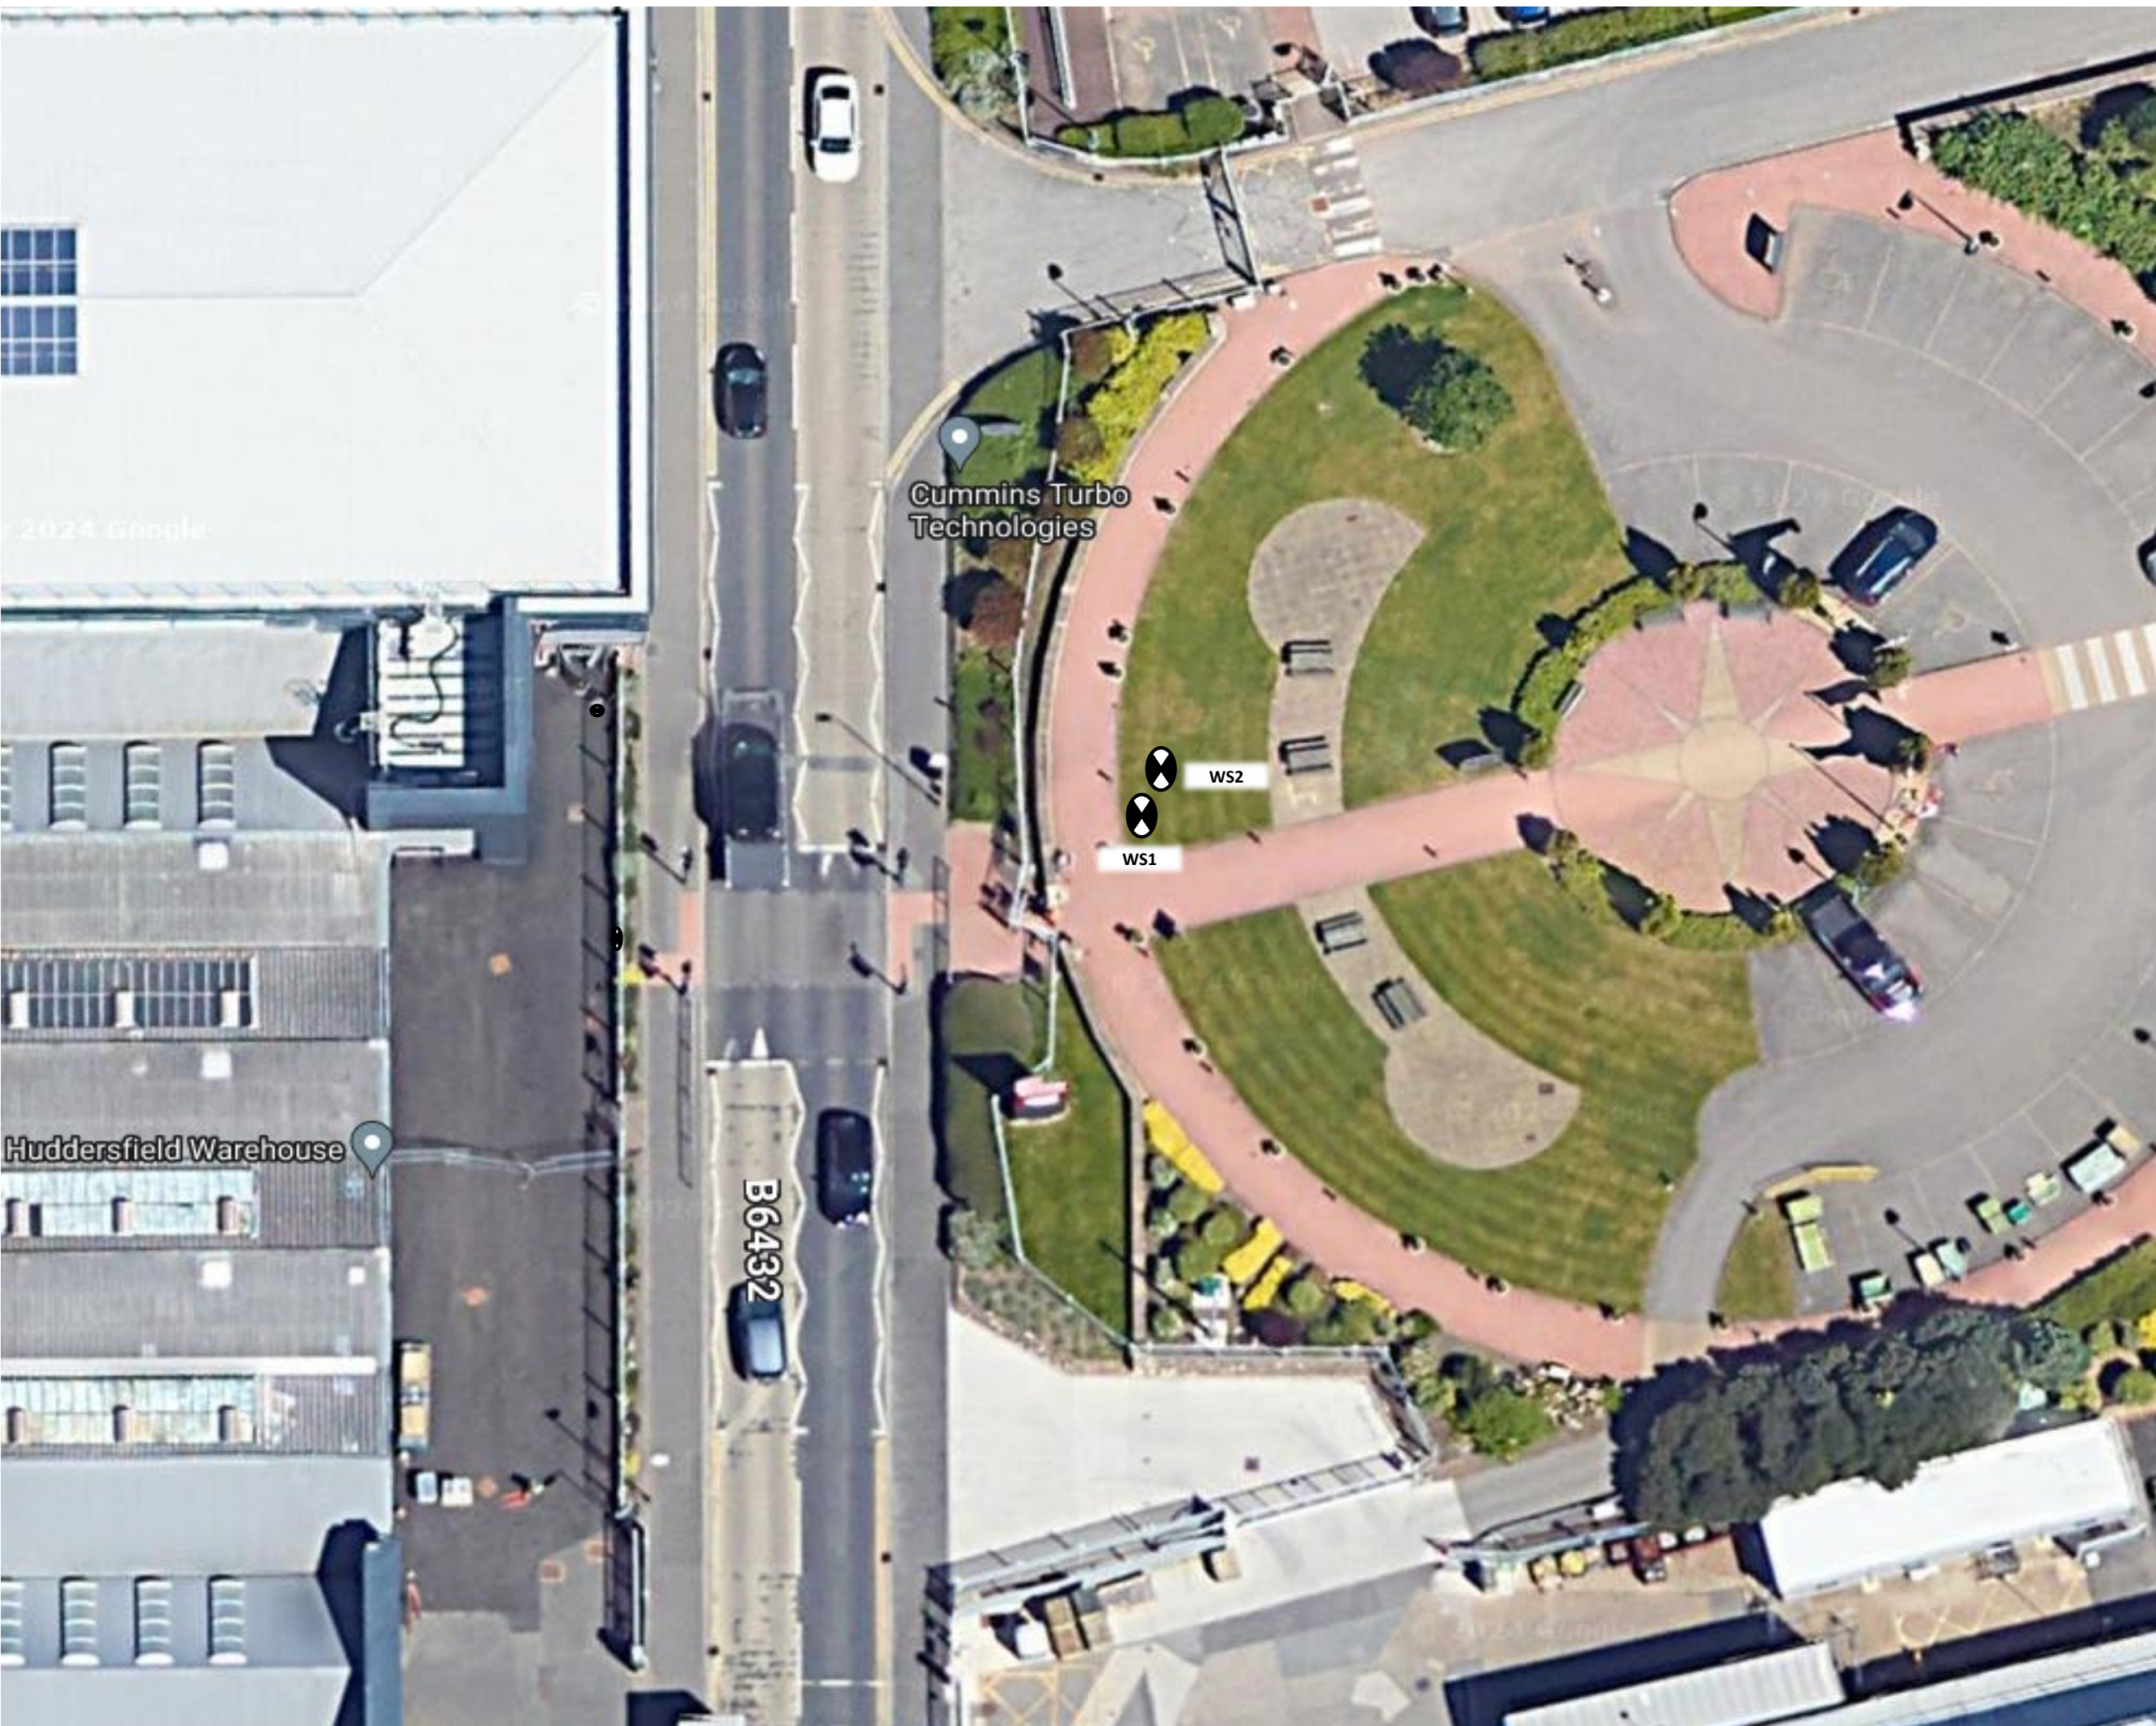
### Site Plan

The investigatory locations are shown on the site plan which is presented in Appendix 1 to this report.

**Notes:**  
Investigation positions approximated from site operative's notes.
