# GEO-ENVIRONMENTAL REPORT

# Report on a Phase 2 Geo-environmental Investigation

| Location: | 176 Almondbury Bank<br>Huddersfield, West Yorkshire, HD5 8EX | |
| Report No. | C4722/24/E/7215 | Report date: December 2024 |

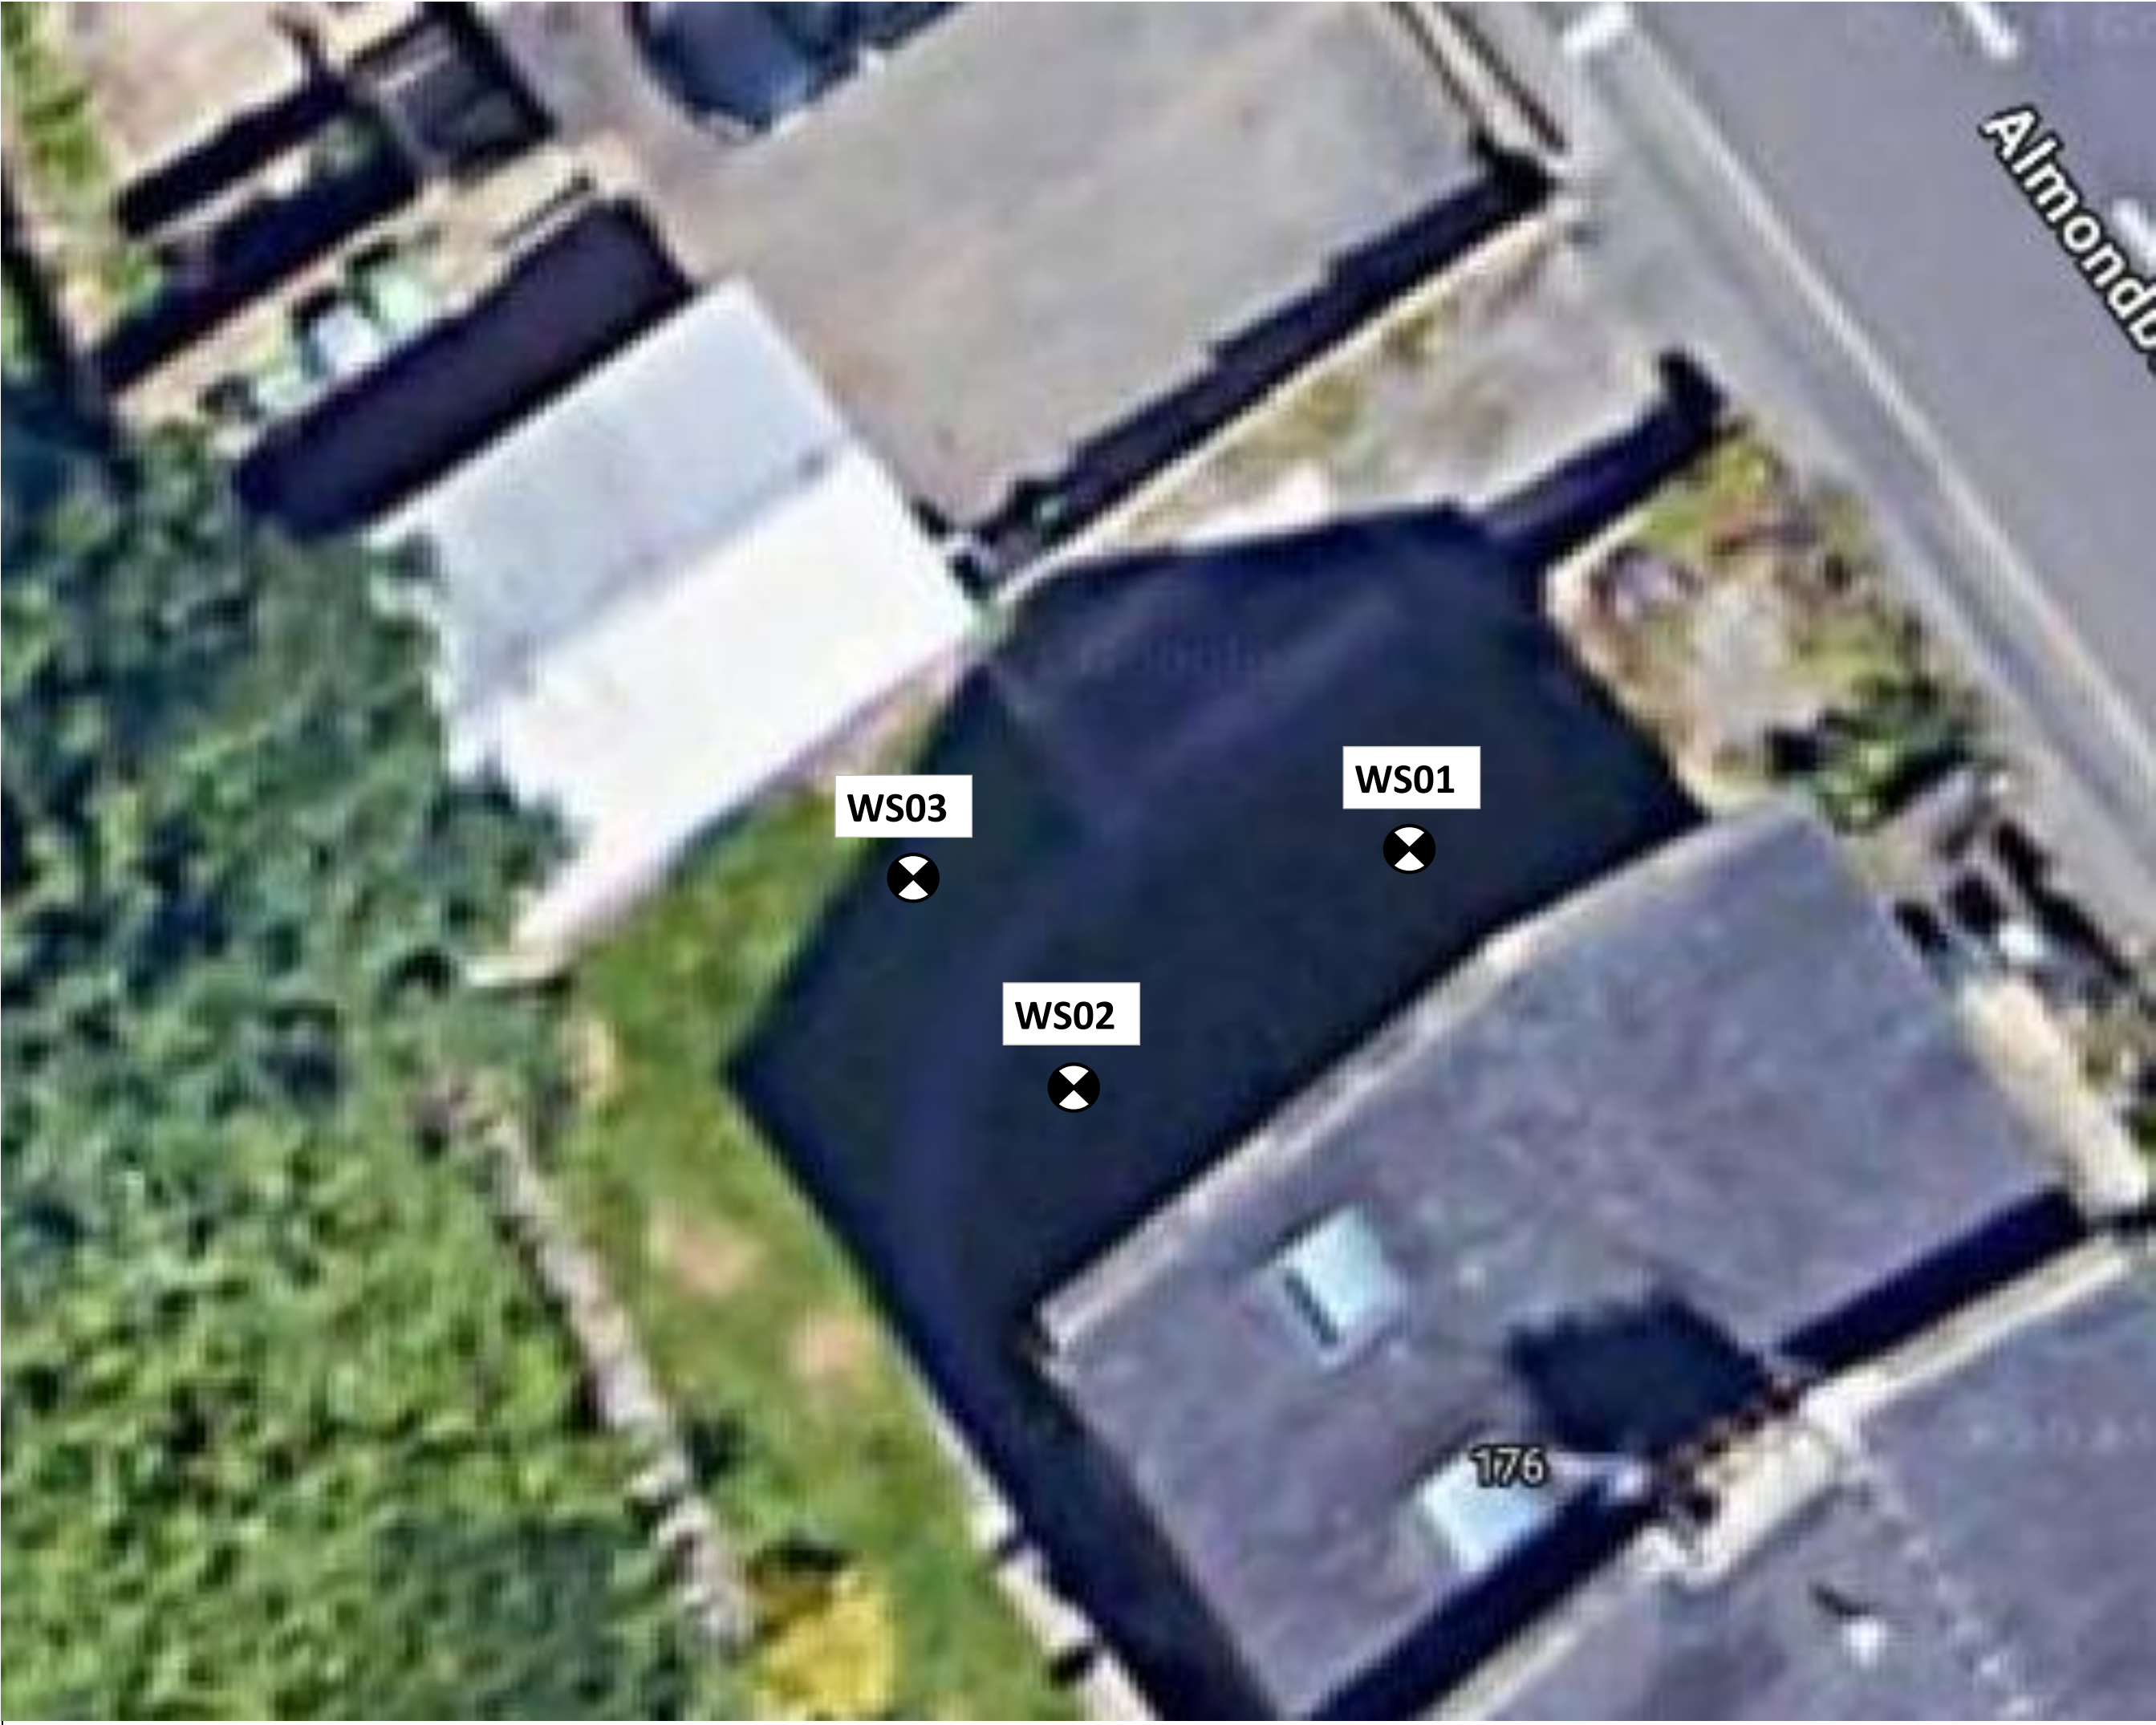
### Site Plan

The investigatory locations are shown on the site plan which is presented in Appendix 1 to this report.
