## **Phase II Geo-environmental Report**

**Project:** Yew Tree Road,  
Birchcliffe,  
Huddersfield

**Client:** Newett Homes

**Reference:** S12597-JNP-XX-XX-RP-G-1001 P01

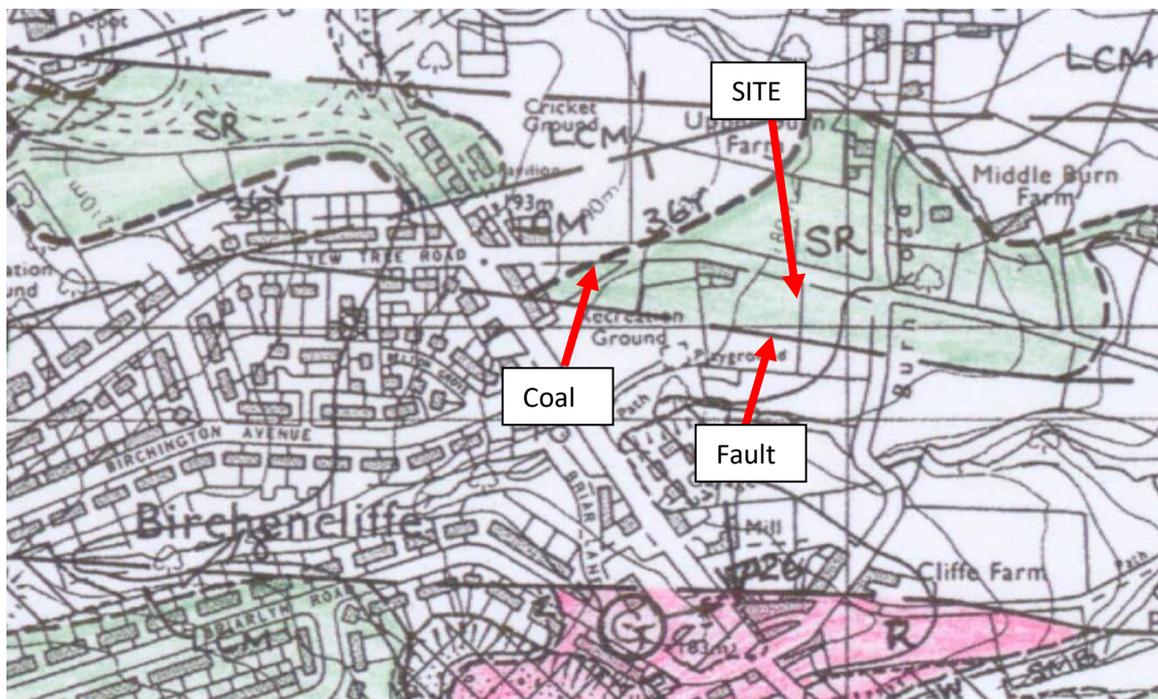
**Figure 3.1** Extract of the BGS 1:10,000 Map SE11NW

- 3.1.7 A fault is present along the boundary of the Stanningley Rock and strata of the Pennine Lower Coal Measures Formation.
- 3.1.8 The 36 Yars and Hard Bed Band Coal Seams are indicated to outcrop approximately 80m to the northwest of the site.

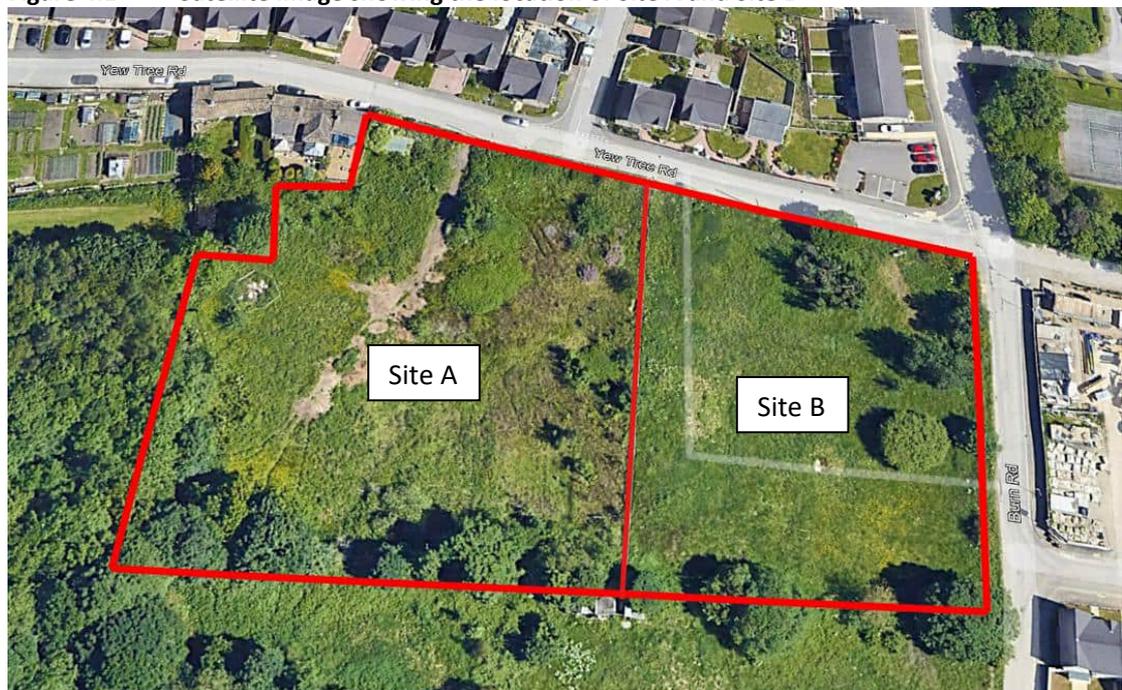
**Figure 4.1** Satellite image showing the location of Site A and Site B

4.2.1 The site was separated into Site A (in the west) and Site B (in the east) by RGS as shown on Figure 4.1.

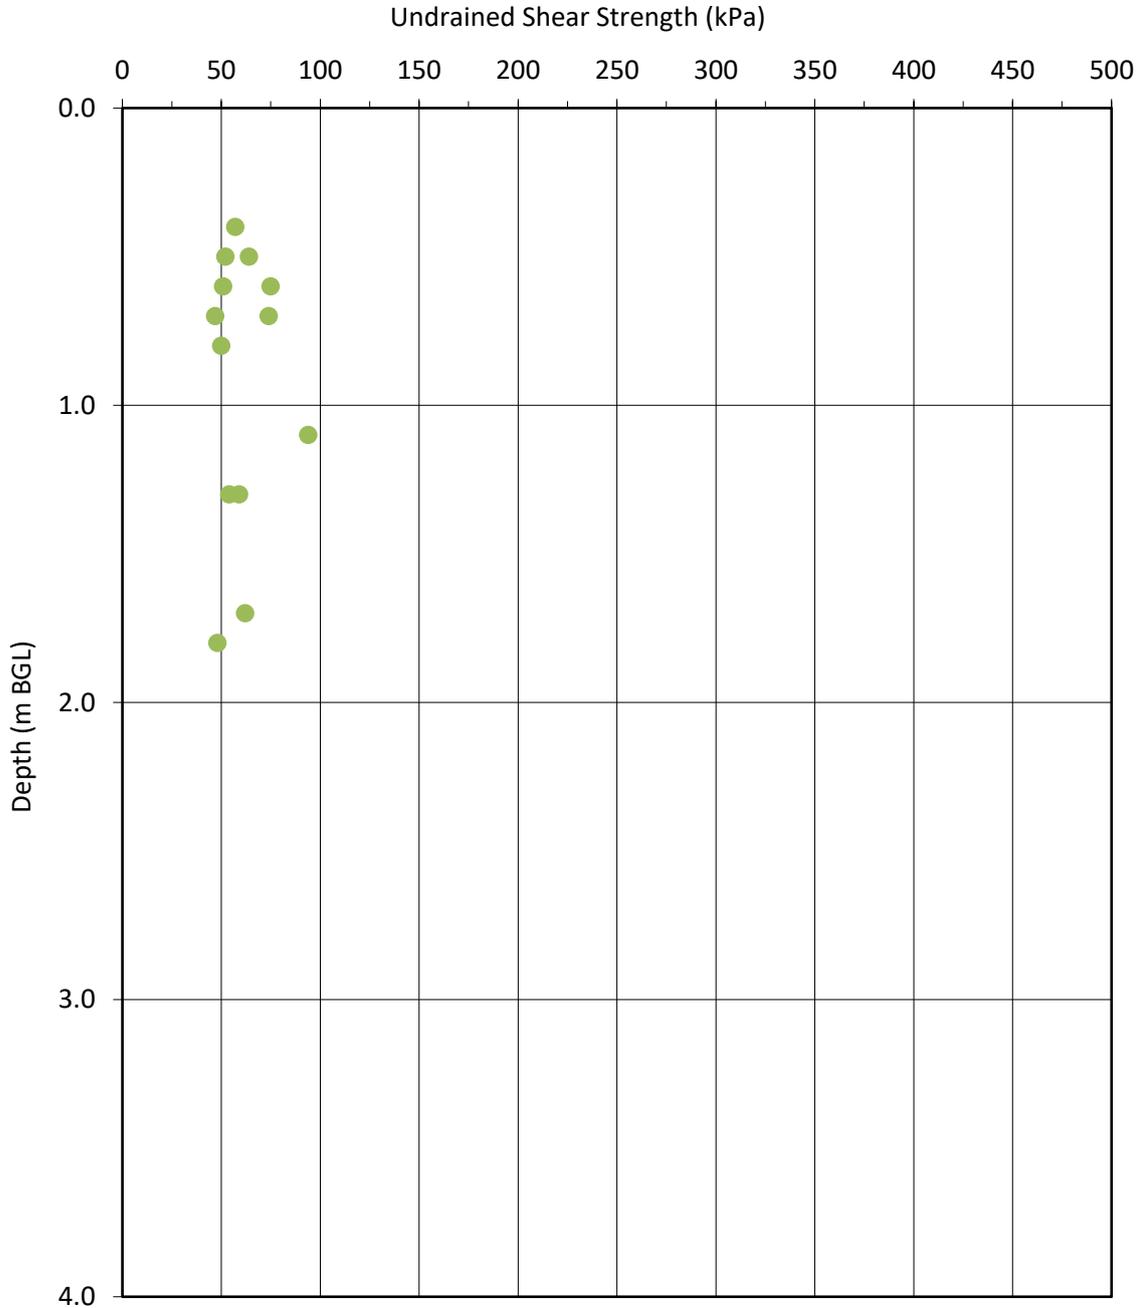
**Figure 3**

**Undrained Shear Strength / Depth Relationship**

- Cohesive Soil
- strata1 (4.5 x SPT N Value)
- strata1 (Triaxial Test)
- strata2 (Hand Shear Vane)
- strata2 (4.5 x SPT N Value)
- strata2 (Triaxial Test)
- Trial Pit (Hand Shear Vane)
- strata3 (4.5 x SPT N Value)
- strata3 (Triaxial Test)
- strata4 (Hand Shear Vane)
- strata4 (4.5 x SPT N Value)
- strata4 (Triaxial Test)

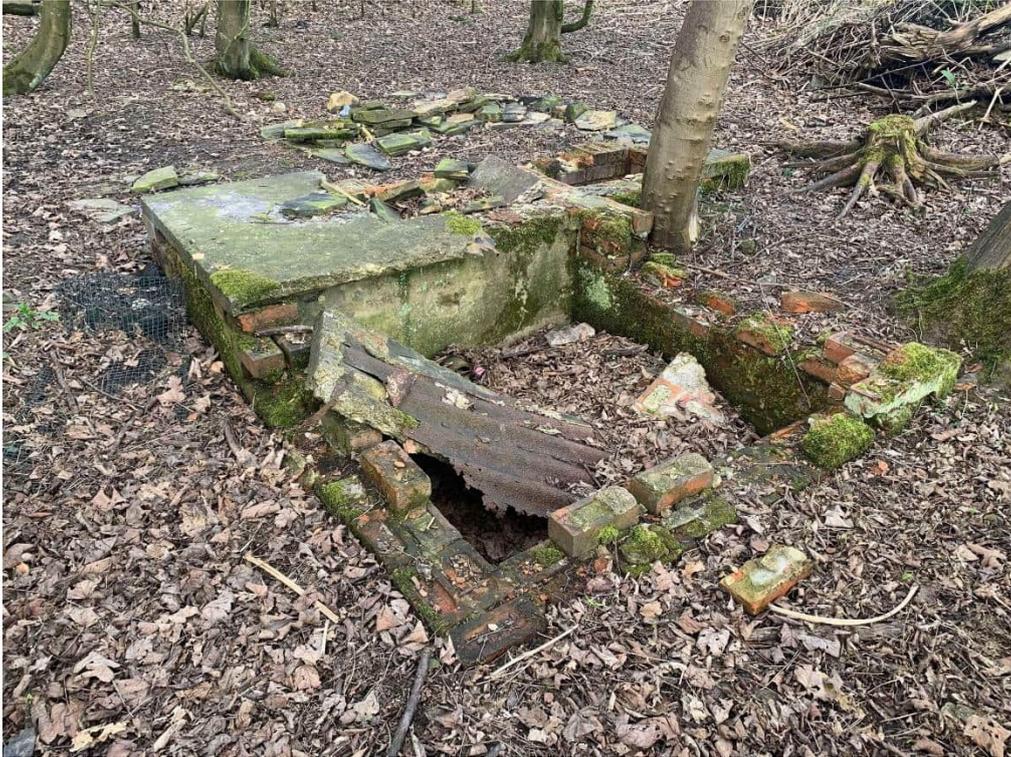
View of the demolished structure to the central south of the western side of the site, facing east.

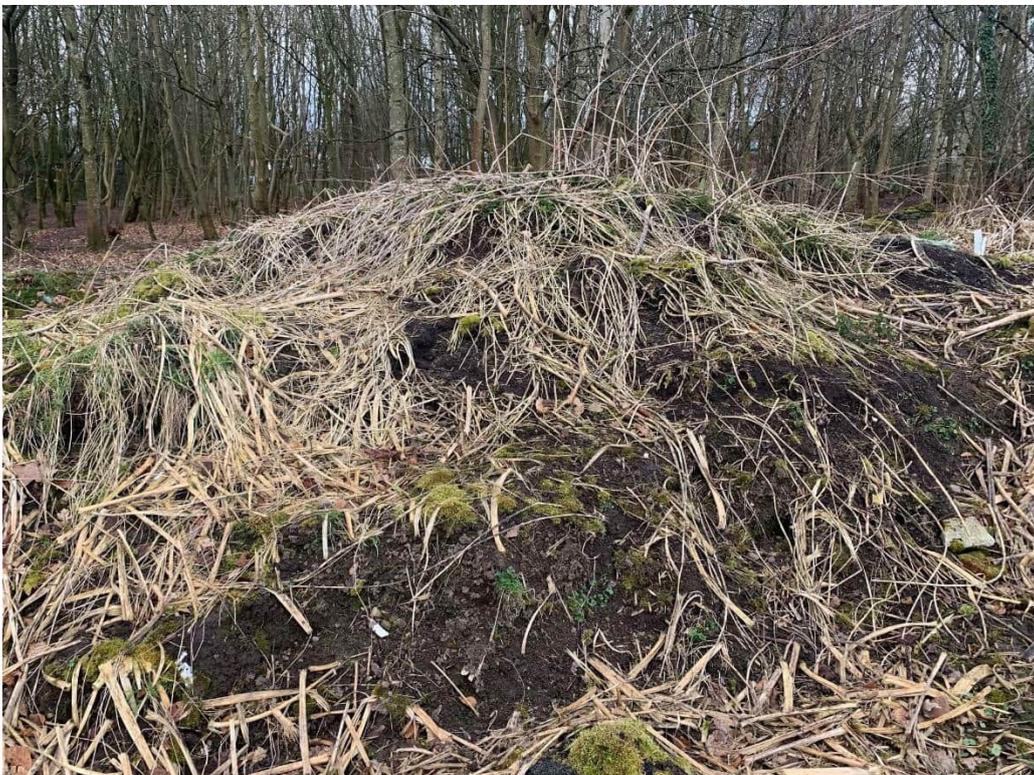
View of the stockpile to the central south of the western side of the site, facing south

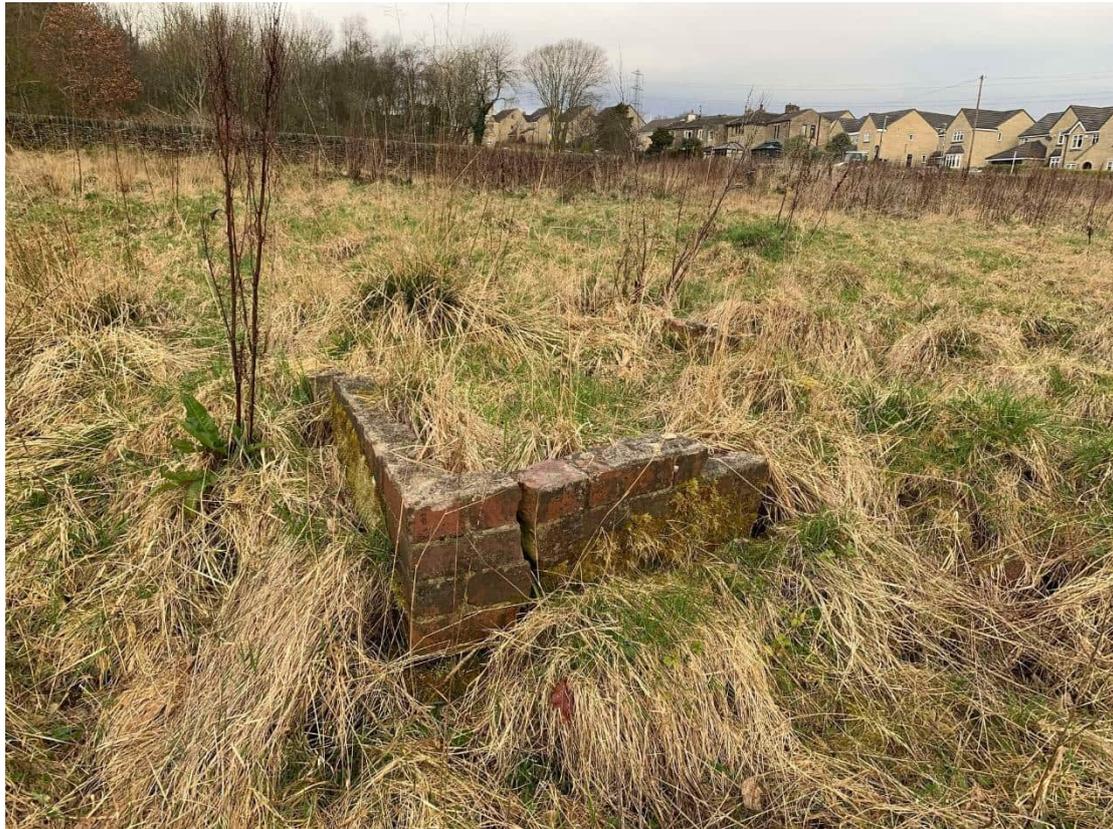
View of the demolished structure to the central south of the eastern side of the site, facing west.

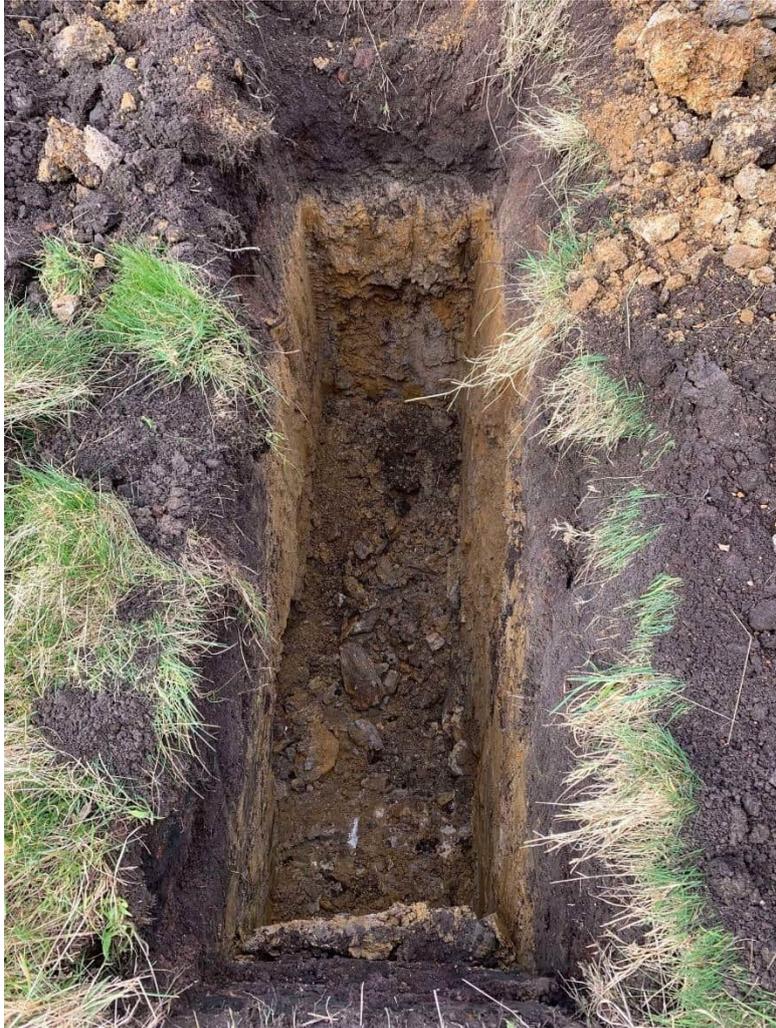
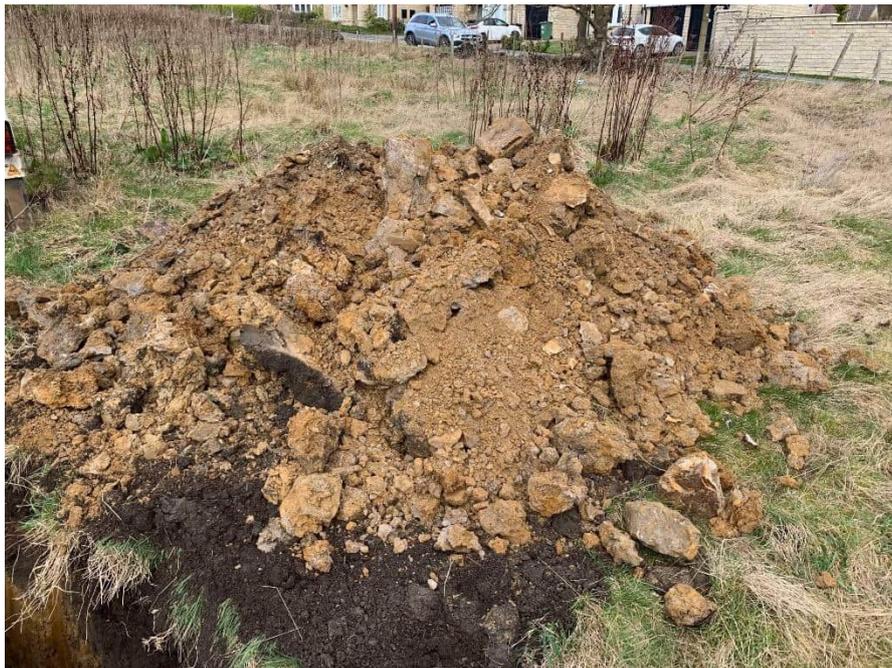
TP205

7.7.1 Fragments of broken glass, clinker and plastic detritus were observed in the made ground associated with TP205, TP206 and TP207.

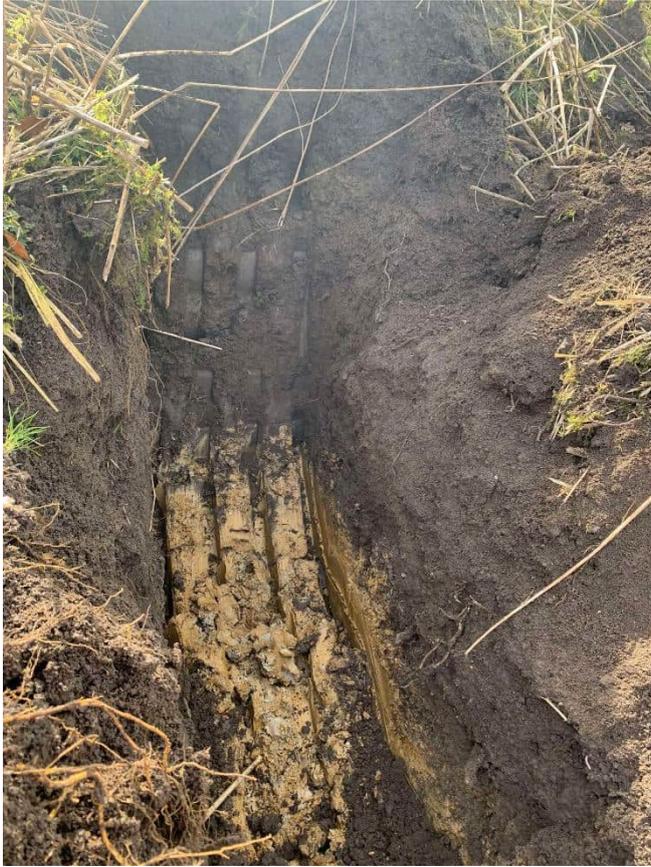
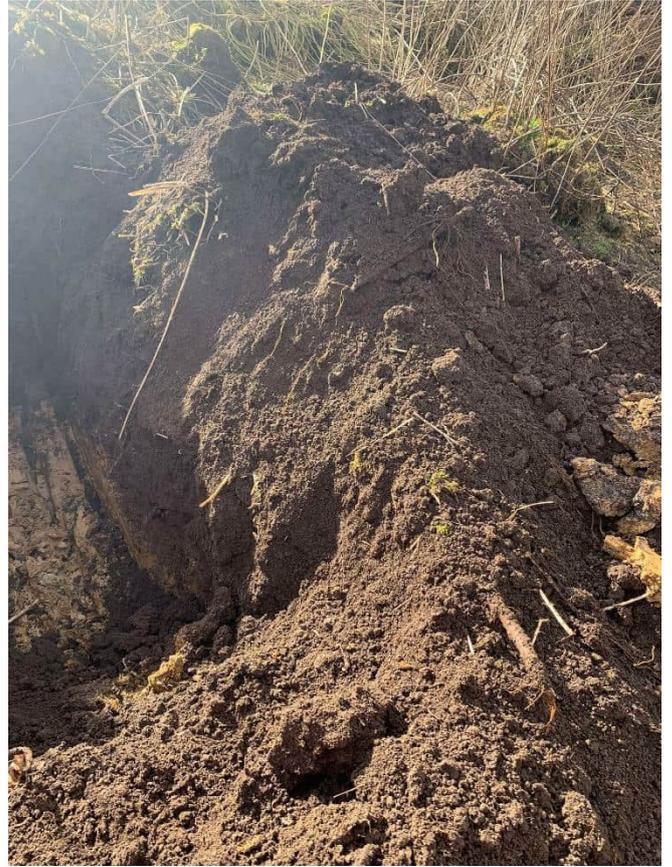
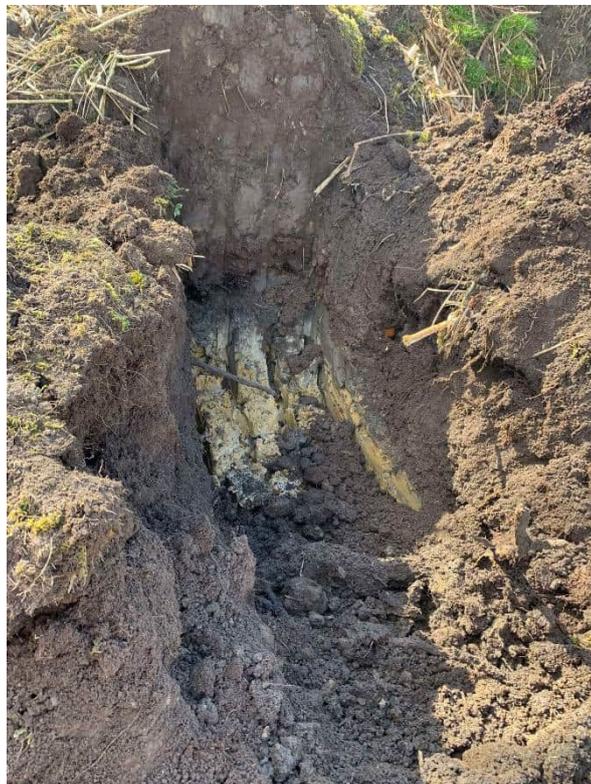
Stockpile in the central south of the eastern field and arisings

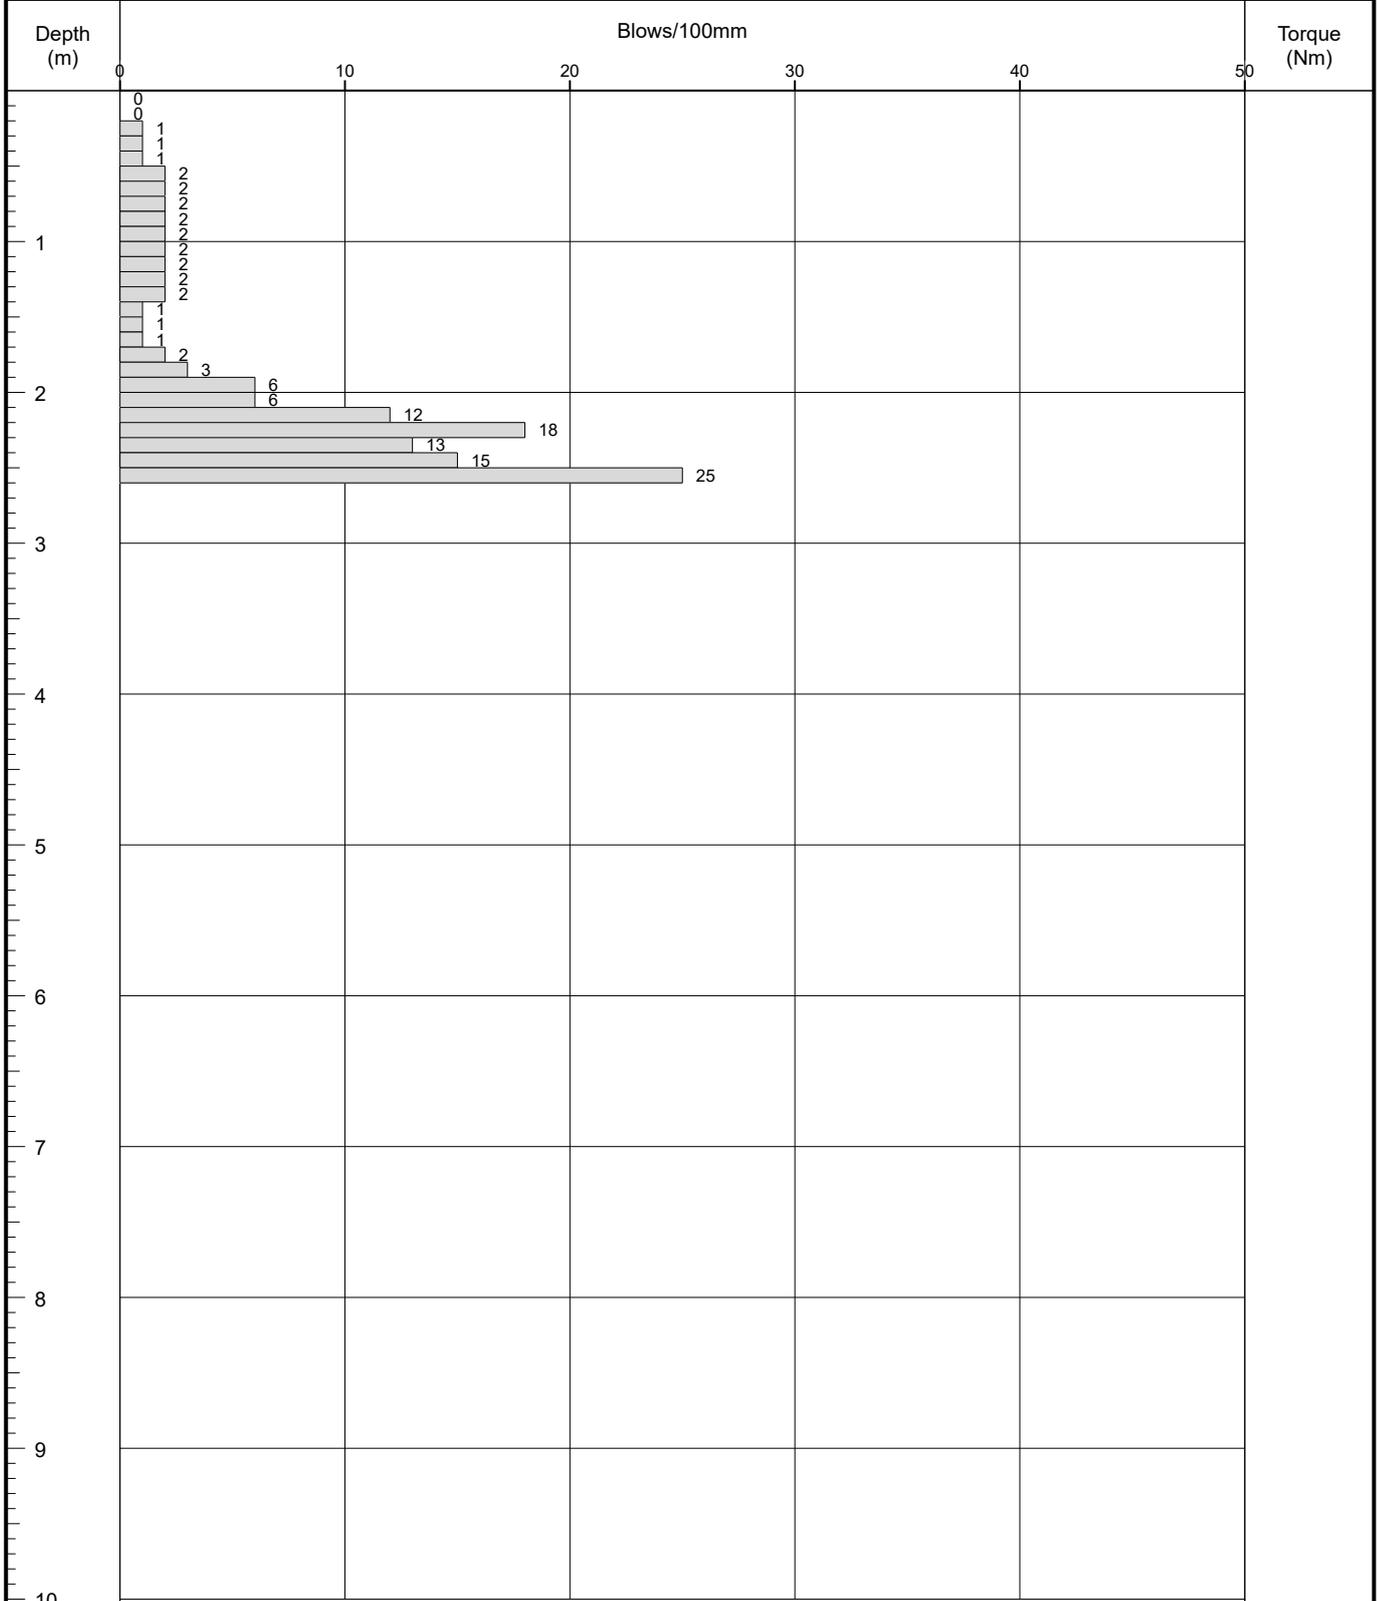
Remarks:	Fall Height	750mm	Cone Base Diameter	50.5mm
	Hammer Wt	63.5kg	Final Depth	2.6m
	Probe Type	DPSH-B

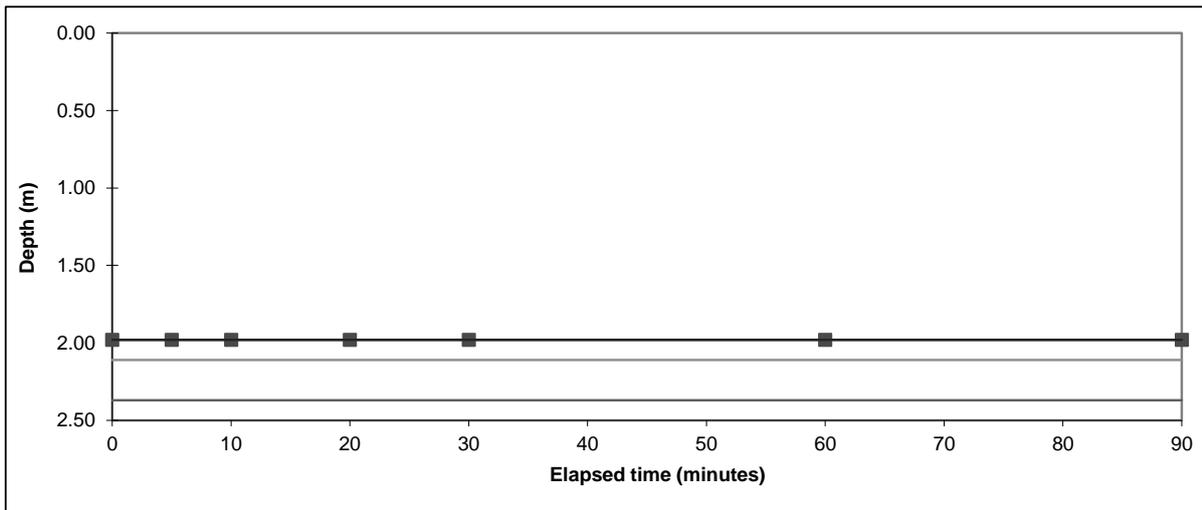
Trial Pit No:	TPSA01	Test No:	1	Date:	07/06/2022
Length (m):	2.200	Datum Height:		0.00 m agl	
Width (m):	1.70	Granular infill:	None		
Depth (m):	2.50	Porosity of infill:	1	(assumed)

Start water depth for analysis (mbgl):	1.98		
75% effective depth (mbgl):	2.11	Elapsed time (mins):	#N/A
50% effective depth (mbgl):	2.24		
25% effective depth (mbgl):	2.37	Elapsed time (mins):	#N/A
Base of soakage zone (mbgl):	2.50		
Volume outflow between 75% and 25% effective depth (m <sup>3</sup> ):			
Mean surface area of outflow (m <sup>2</sup> ):			5.77
(side area at 50% effective depth + base area)			
Time for outflow between 75% and 25% effective depth (mins):

<b>Soil infiltration rate (m/s):</b>	<b>Test incomplete as 25% effective depth not achieved. Unable to reliably determine soil infiltration rate.</b>
--------------------------------------	--

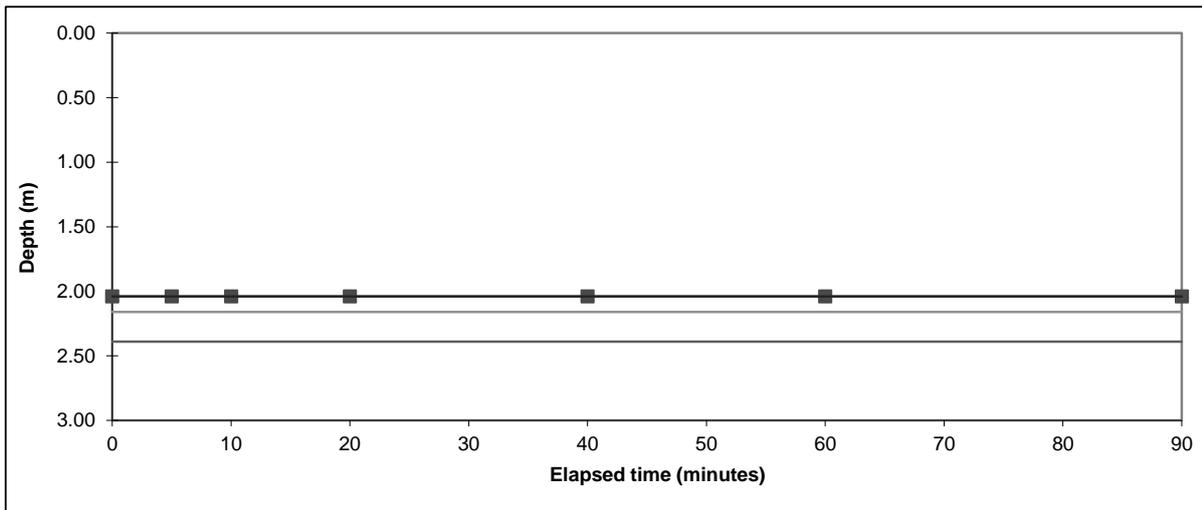
Trial Pit No:	TPSA02	Test No:	1	Date:	07/06/2022
Length (m):	2.500	Datum Height:		0.00 m agl	
Width (m):	1.60	Granular infill:	None		
Depth (m):	2.50	Porosity of infill:	1	(assumed)

Start water depth for analysis (mbgl):	2.04	Elapsed time (mins):	#N/A
75% effective depth (mbgl):	2.16	Elapsed time (mins):	#N/A
50% effective depth (mbgl):	2.27		
25% effective depth (mbgl):	2.39	Elapsed time (mins):	#N/A
Base of soakage zone (mbgl):	2.50		
Volume outflow between 75% and 25% effective depth (m <sup>3</sup> ):			
Mean surface area of outflow (m <sup>2</sup> ):			5.89
(side area at 50% effective depth + base area)			
Time for outflow between 75% and 25% effective depth (mins):

<b>Soil infiltration rate (m/s):</b>	<b>Test incomplete as 25% effective depth not achieved. Unable to reliably determine soil infiltration rate.</b>
--------------------------------------	--

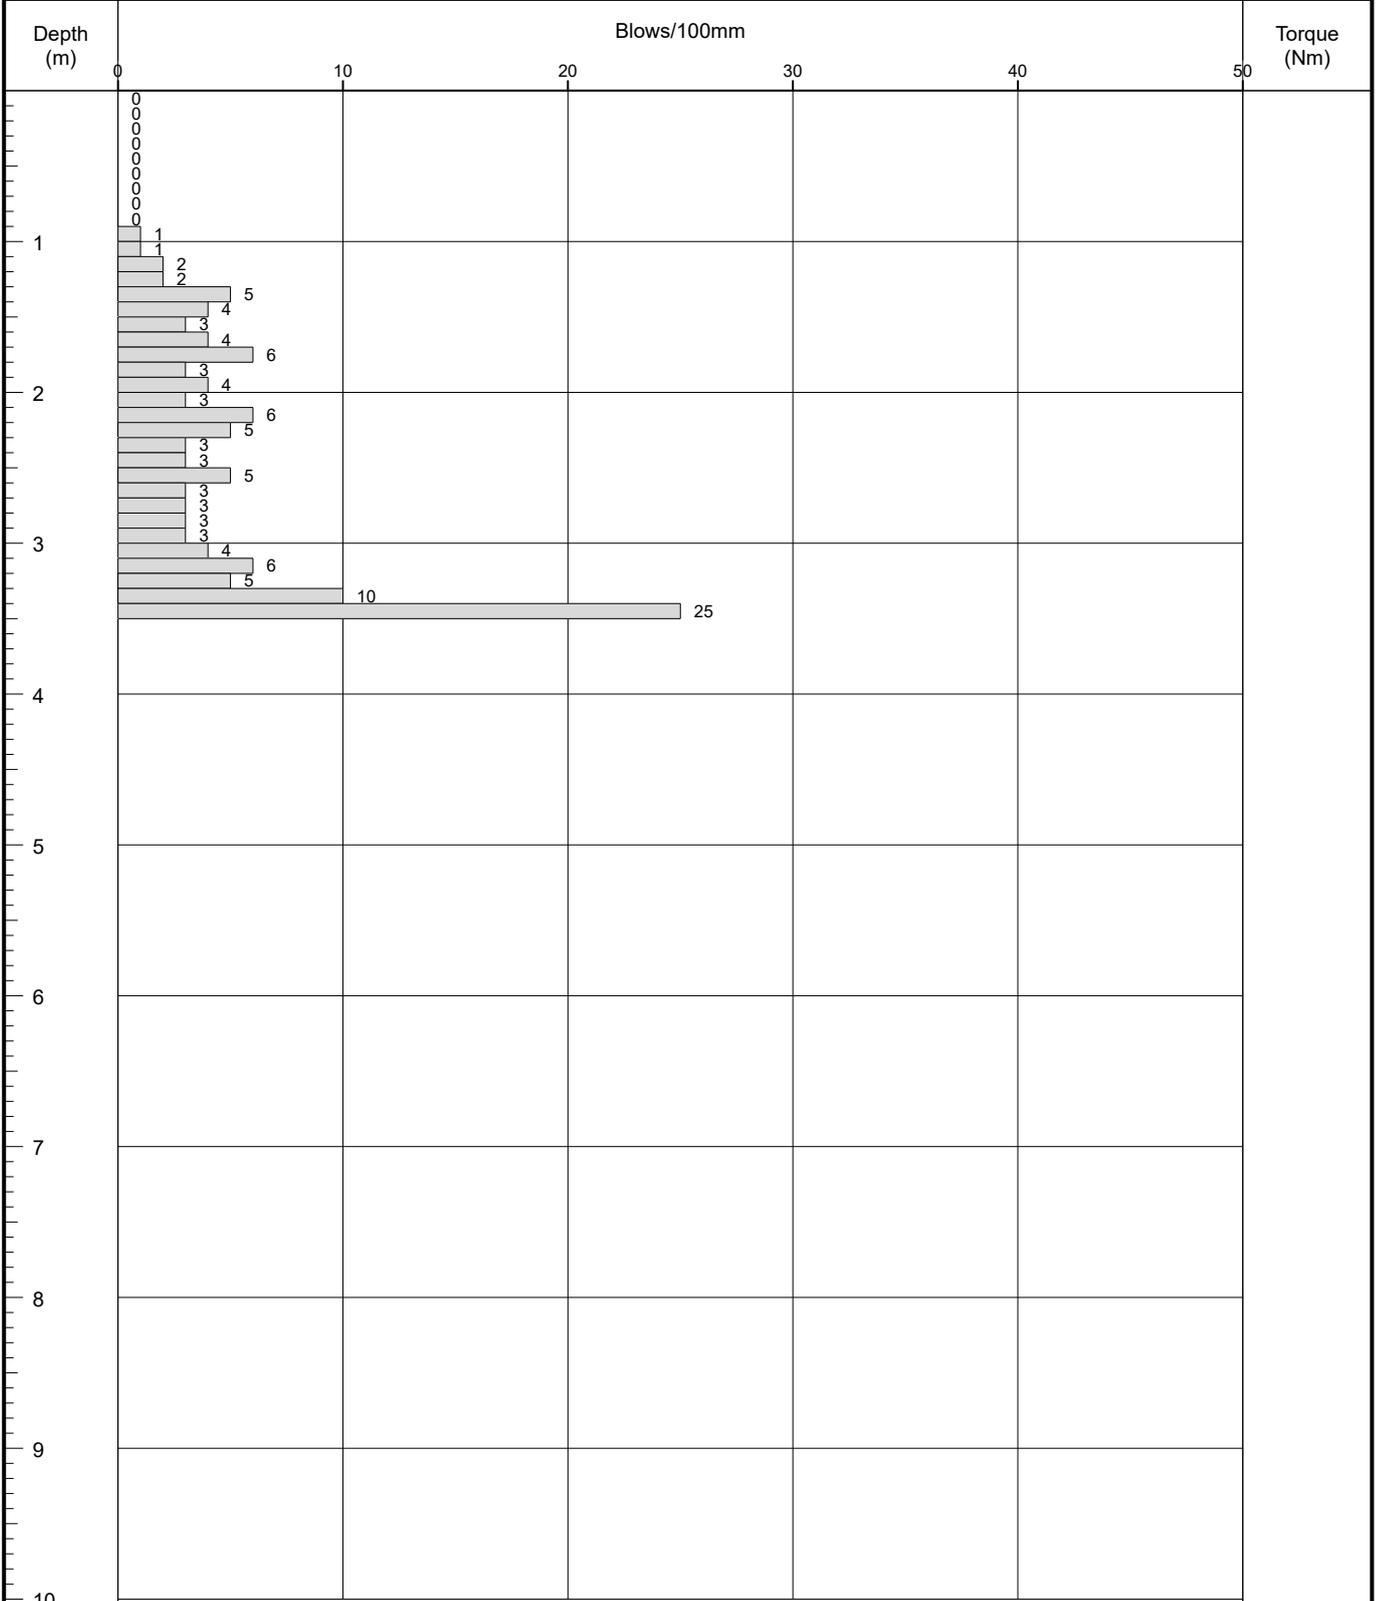
Remarks: 1) CAT scan prior to breaking ground - no services identified.	Fall Height	750mm	Cone Base Diameter	50.5mm
	Hammer Wt	63.5kg	Final Depth	3.33m
	Probe Type	DPSH-B

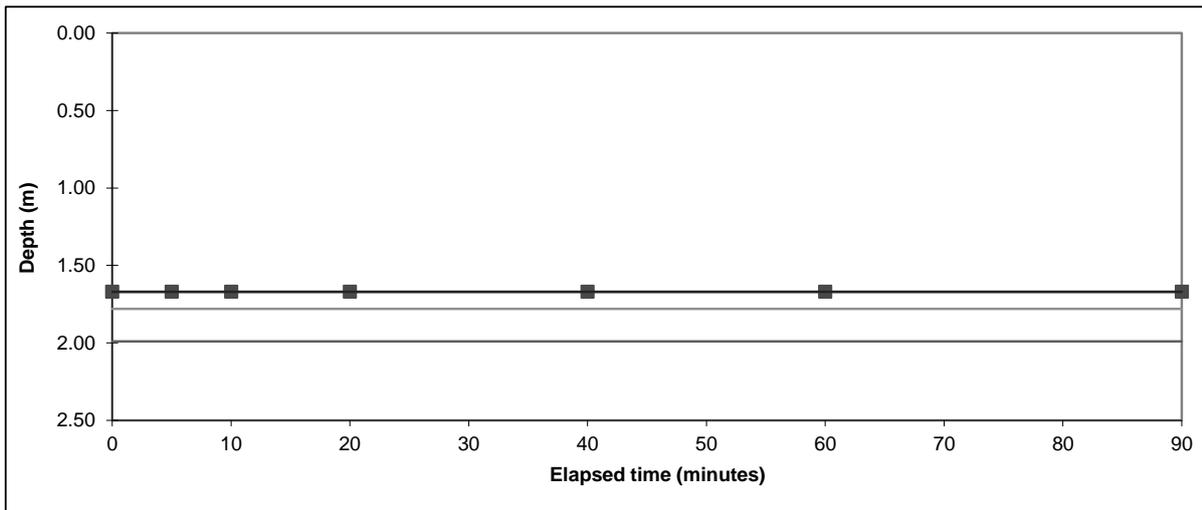
Elapsed time (minutes)	Water Depth (m below datum)	Elapsed time (minutes)	Water Depth (m below datum)
0	1.670		
5	1.670		
10	1.670		
20	1.670		
40	1.670		
60	1.670		
90	1.670

Start water depth for analysis (mbgl):	1.67		
75% effective depth (mbgl):	1.78	Elapsed time (mins):	#N/A
50% effective depth (mbgl):	1.89		
25% effective depth (mbgl):	1.99	Elapsed time (mins):	#N/A
Base of soakage zone (mbgl):	2.10		
Volume outflow between 75% and 25% effective depth (m <sup>3</sup> ):			
Mean surface area of outflow (m <sup>2</sup> ):			4.09
(side area at 50% effective depth + base area)			
Time for outflow between 75% and 25% effective depth (mins):

<b>Soil infiltration rate (m/s):</b>	<b>Test incomplete as 25% effective depth not achieved. Unable to reliably determine soil infiltration rate.</b>
--------------------------------------	--

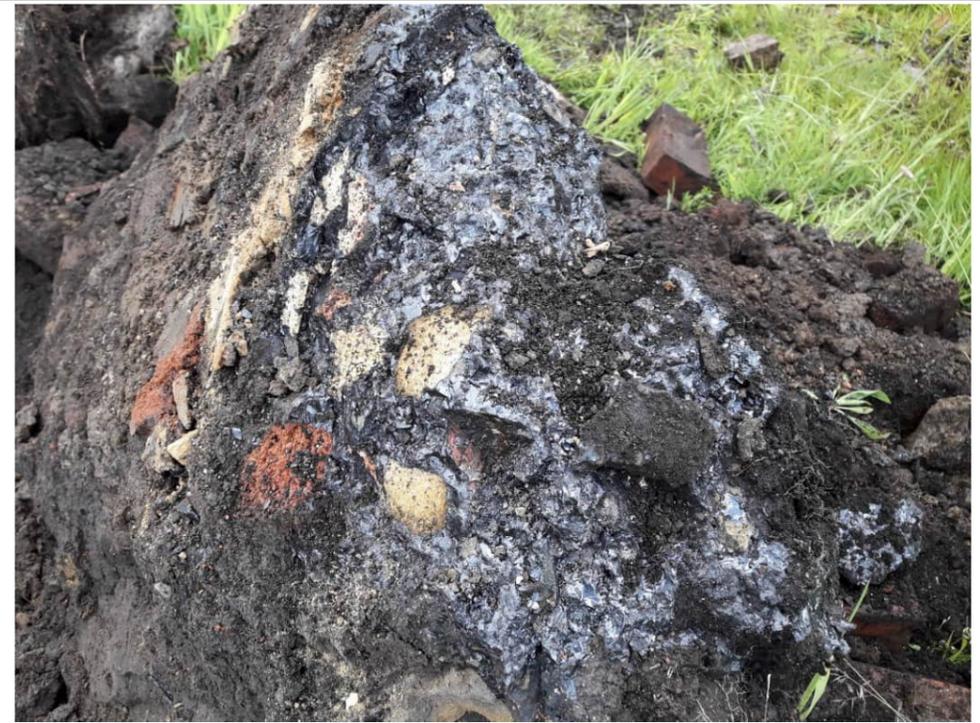
Photo 2: Bound macadam material recovered in TP06A.

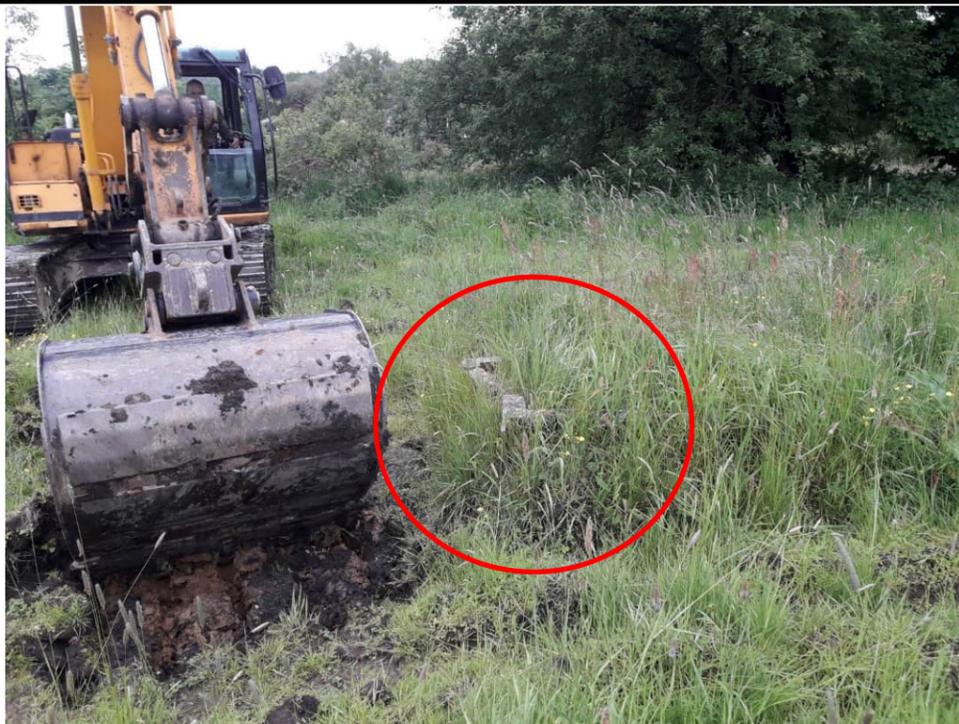
Photo 3: Brick lined feature.

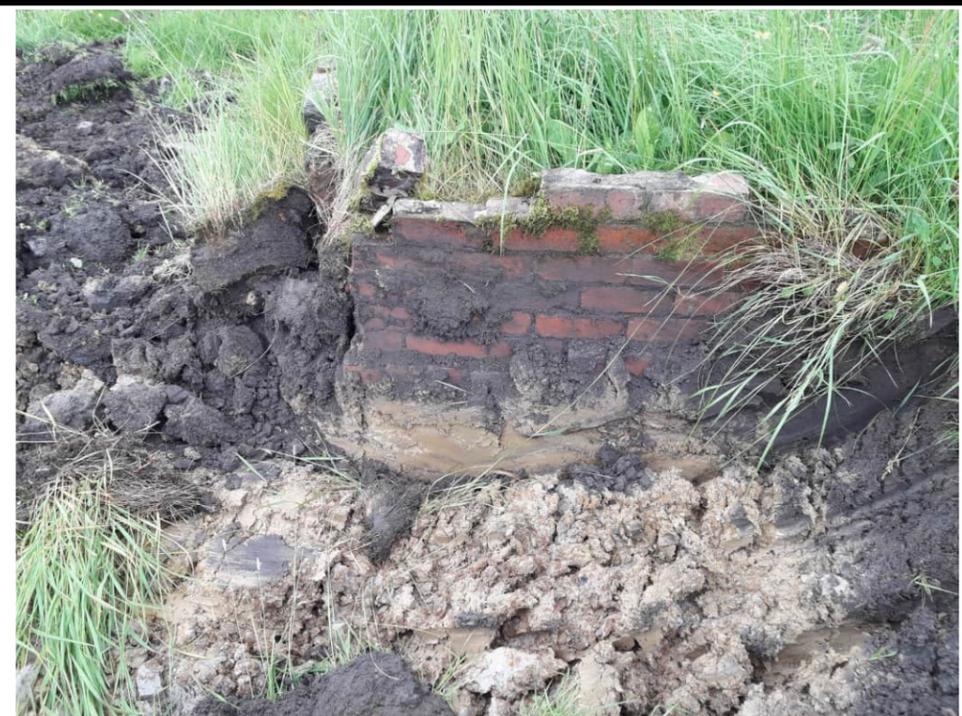
Photo 4: Feature had no distinct foundation and the inside was filled with soil.
