Residential Development

Erection of 2 pairs Semi-detached Dwellings (4no.)

Land Adjacent to Caledonian Road,

## Coal Mining Report

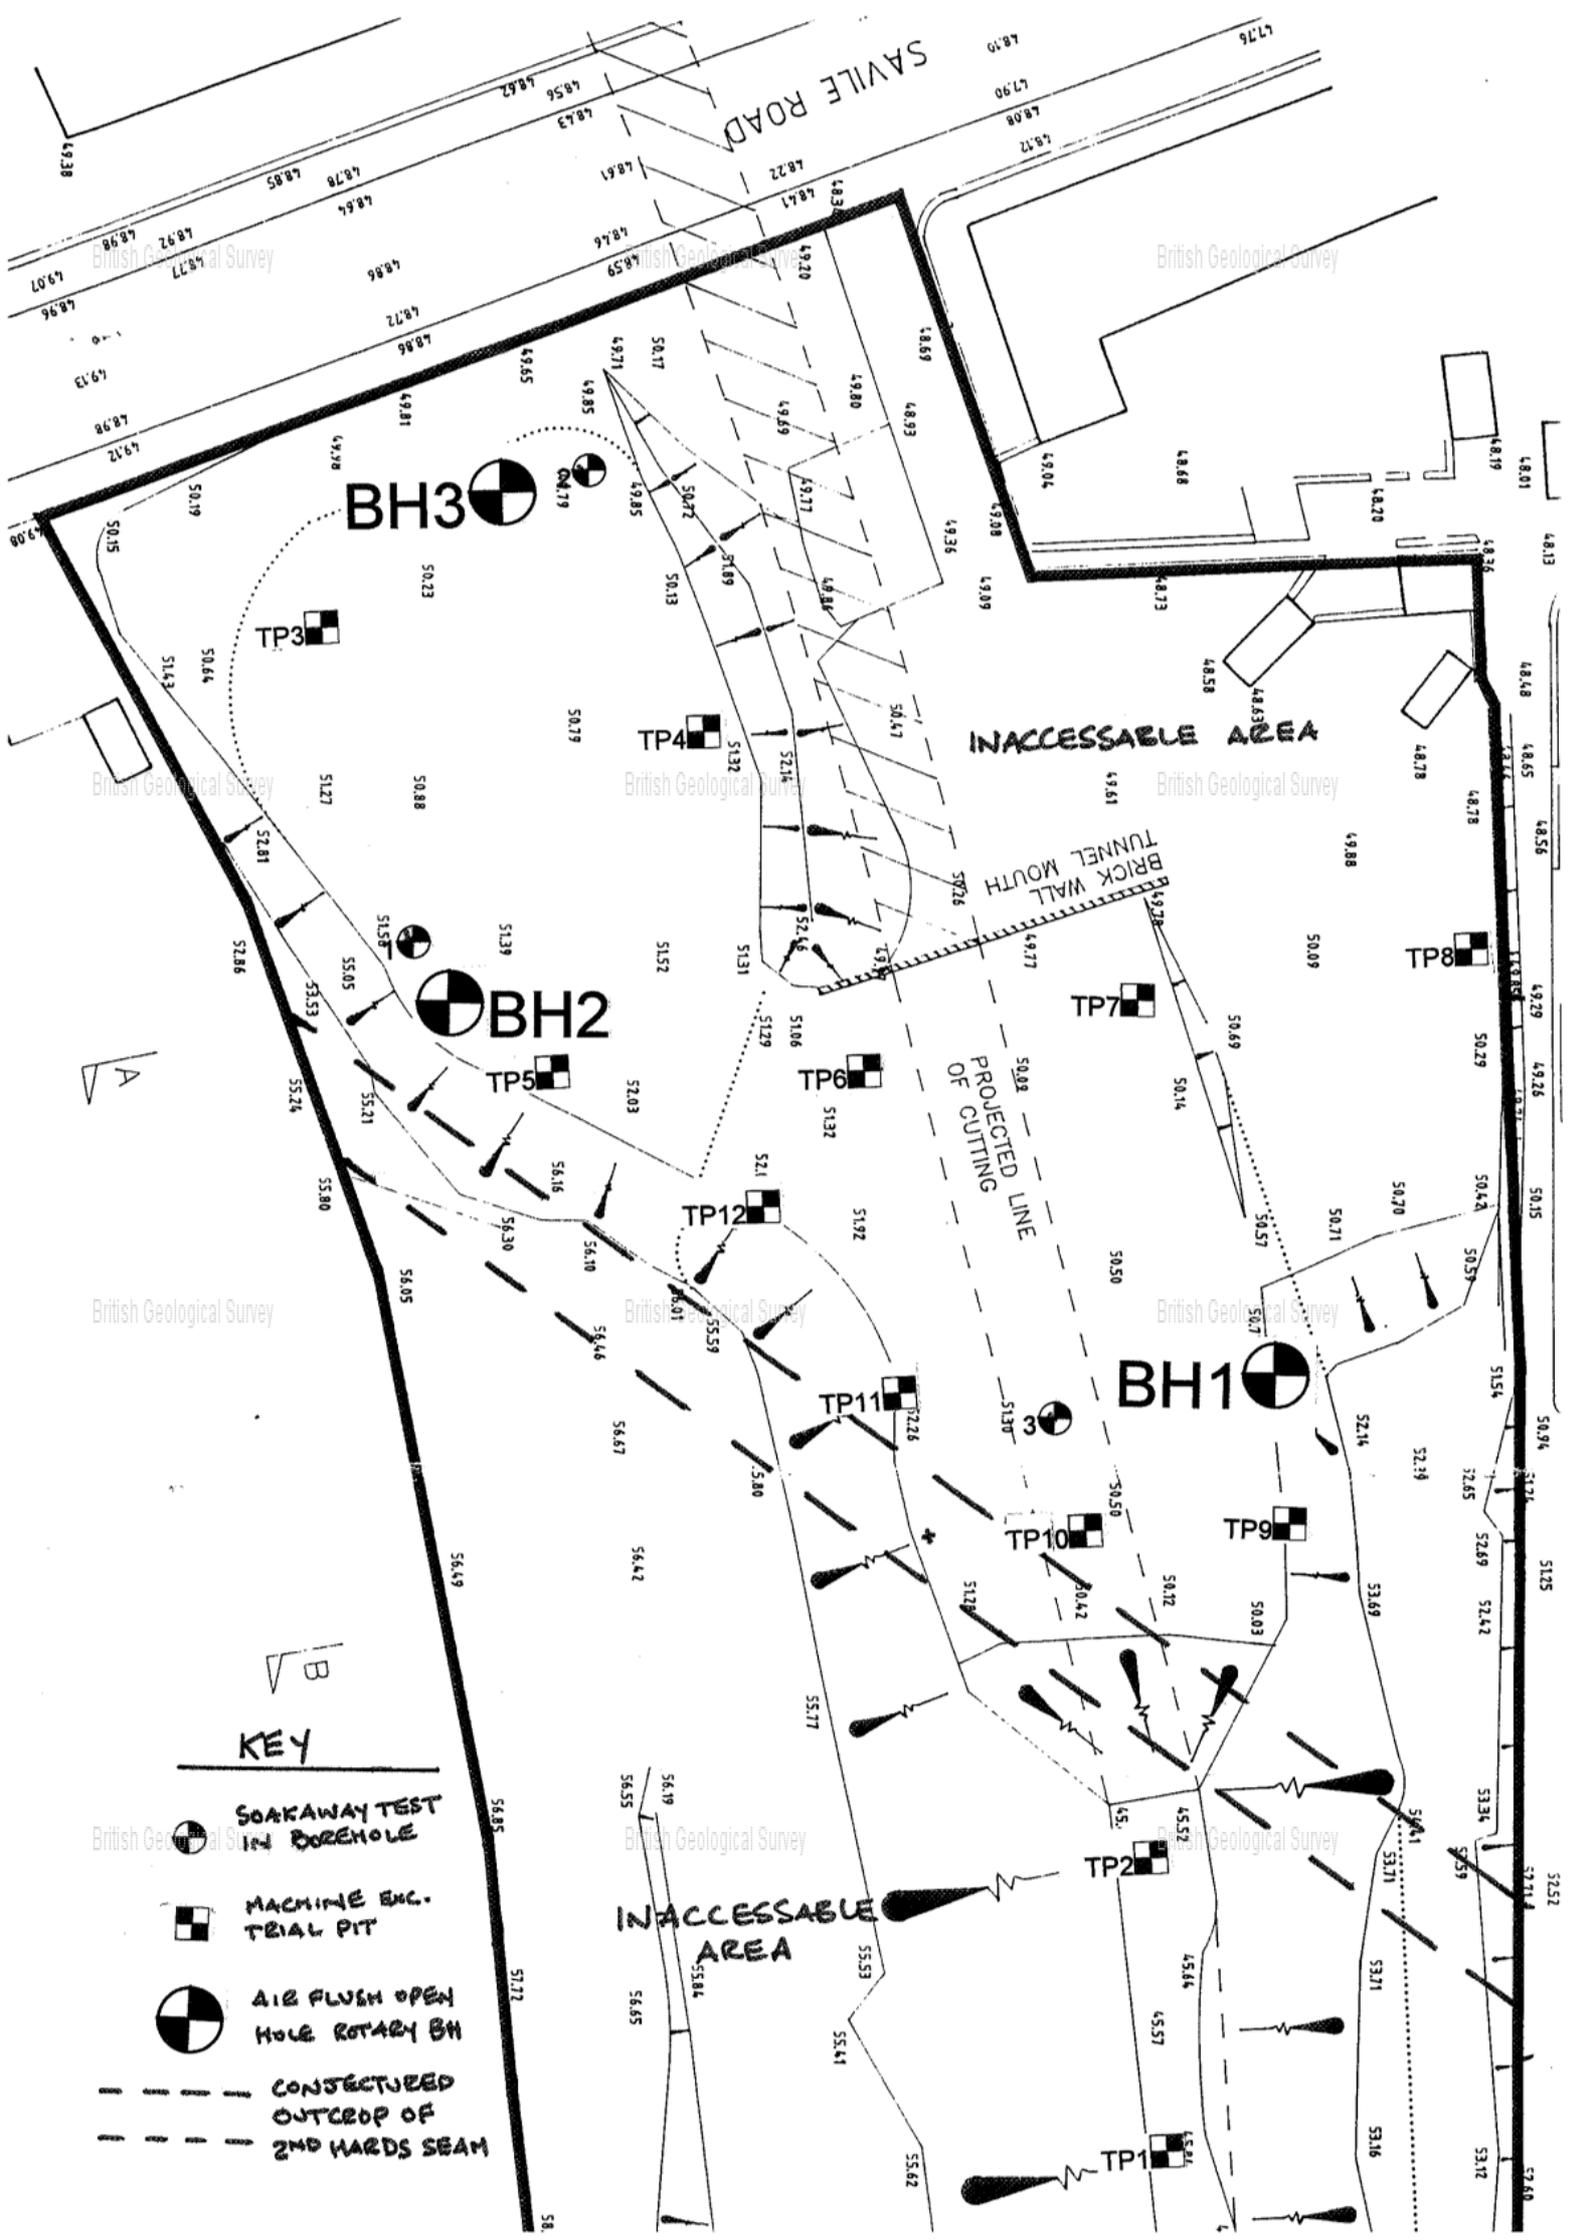
AIR FLUSH OPEN HOLE ROTARY BH

CONJECTURED OUTCROP OF 2ND HARDS SEAM

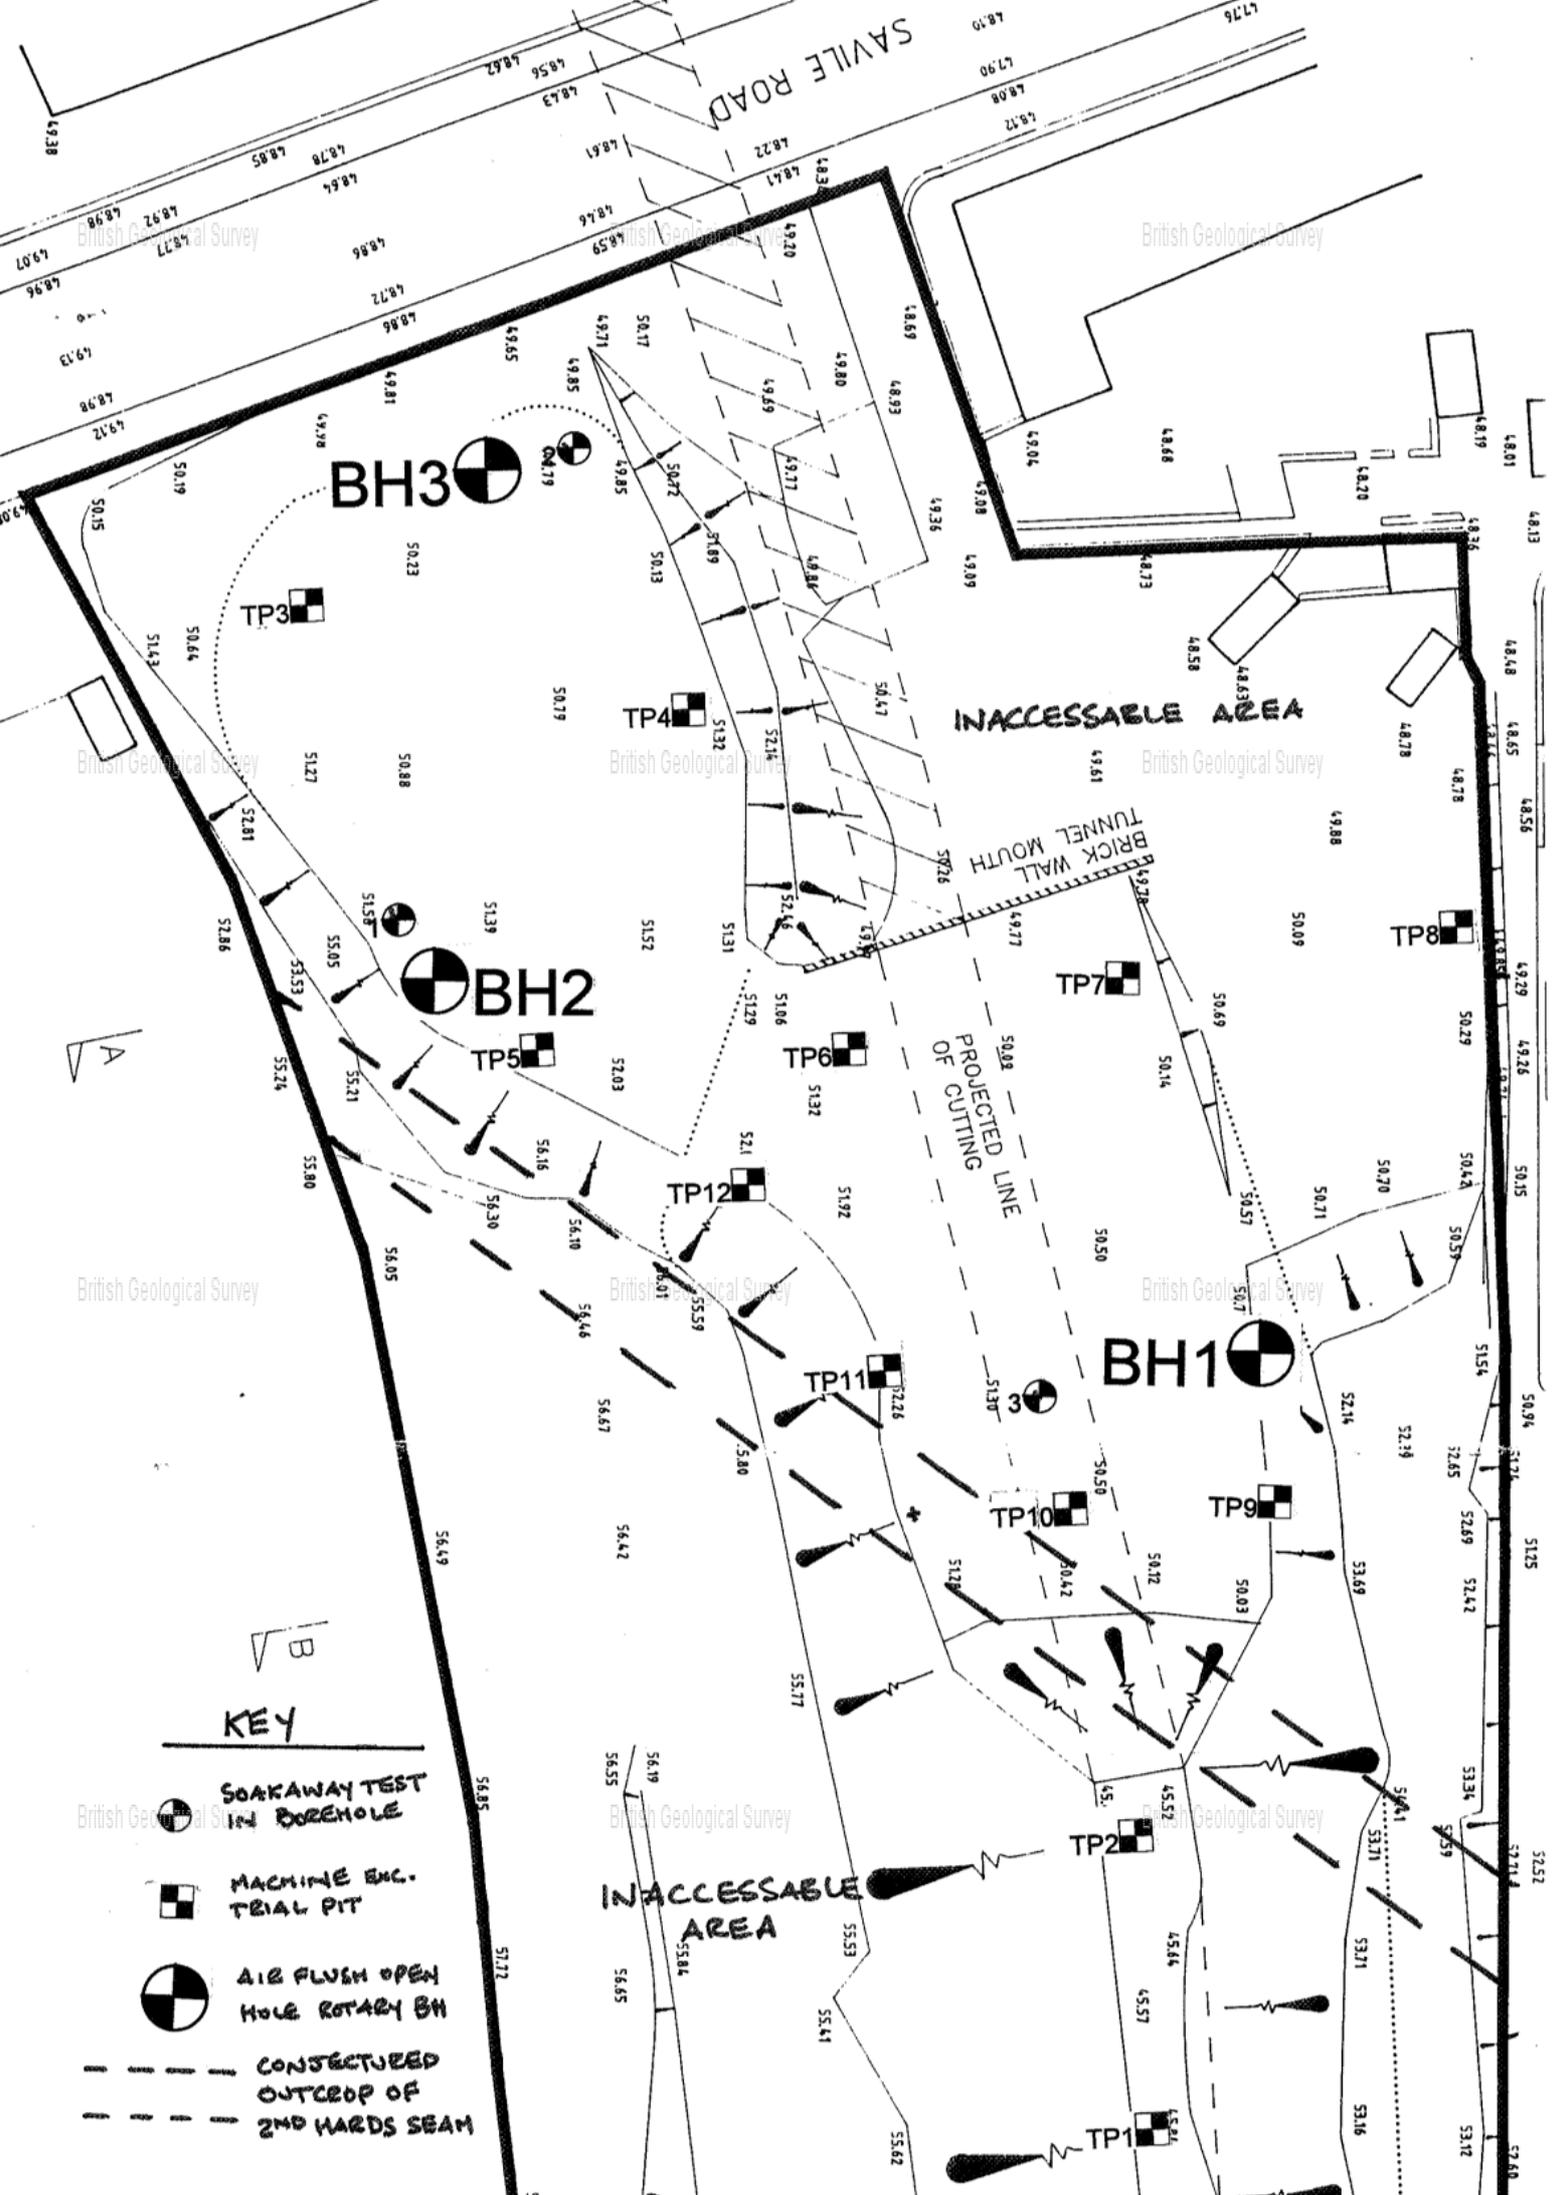
CLIENT ROBINSON CONSULTING ENGS		JOB NO CB761	LOCATION LAND OFF SAVILE ROAD, DEWSBURY		BOREHOLE NO <b>RBH1</b>		
DATE NOVEMBER 1996		SCALE 1 to 100	BORING METHOD OPEN HOLE AIR FLUSH ROTARY		Sheet: 1		
Drilling & Casing Progress	SAMPLE/TEST		SPT N - value or COHESION	DESCRIPTION	O D LEVEL	LEGEND	DEPTH
	Type & No.	Depth(M)					
13TH				MADE GROUND? - Possibly disturbed dark brown and black very "soily" clay.	50.70

18.50
<b>DUNELM DRILLING COMPANY</b> TEL 091-526-2534 FAX 091-517-0085				<b>BOREHOLE LOGSHEET</b>			
Water Observations, Remarks, Etc Water struck at 14.00m. Cased to 3.00m. Descriptions based purely on drillers interpretation of returned cuttings to surface and drilling rates maintained.				No workings recorded. No coal noted. Full air return noted throughout borehole.

As can be seen from two of the three rotary boreholes (RBH’s 2 & 3), rockhead was recorded at between 1.00m and 1.50m bgl and a thin (0.20m to 0.30m) coal seam was recorded at depths of between 23.30m and 24.50m bgl, which is taken as being representative of the 3BM seam. There was no evidence of any unrecorded workings, voiding or broken ground/collapsed workings noted in this seam nor in RBH1.

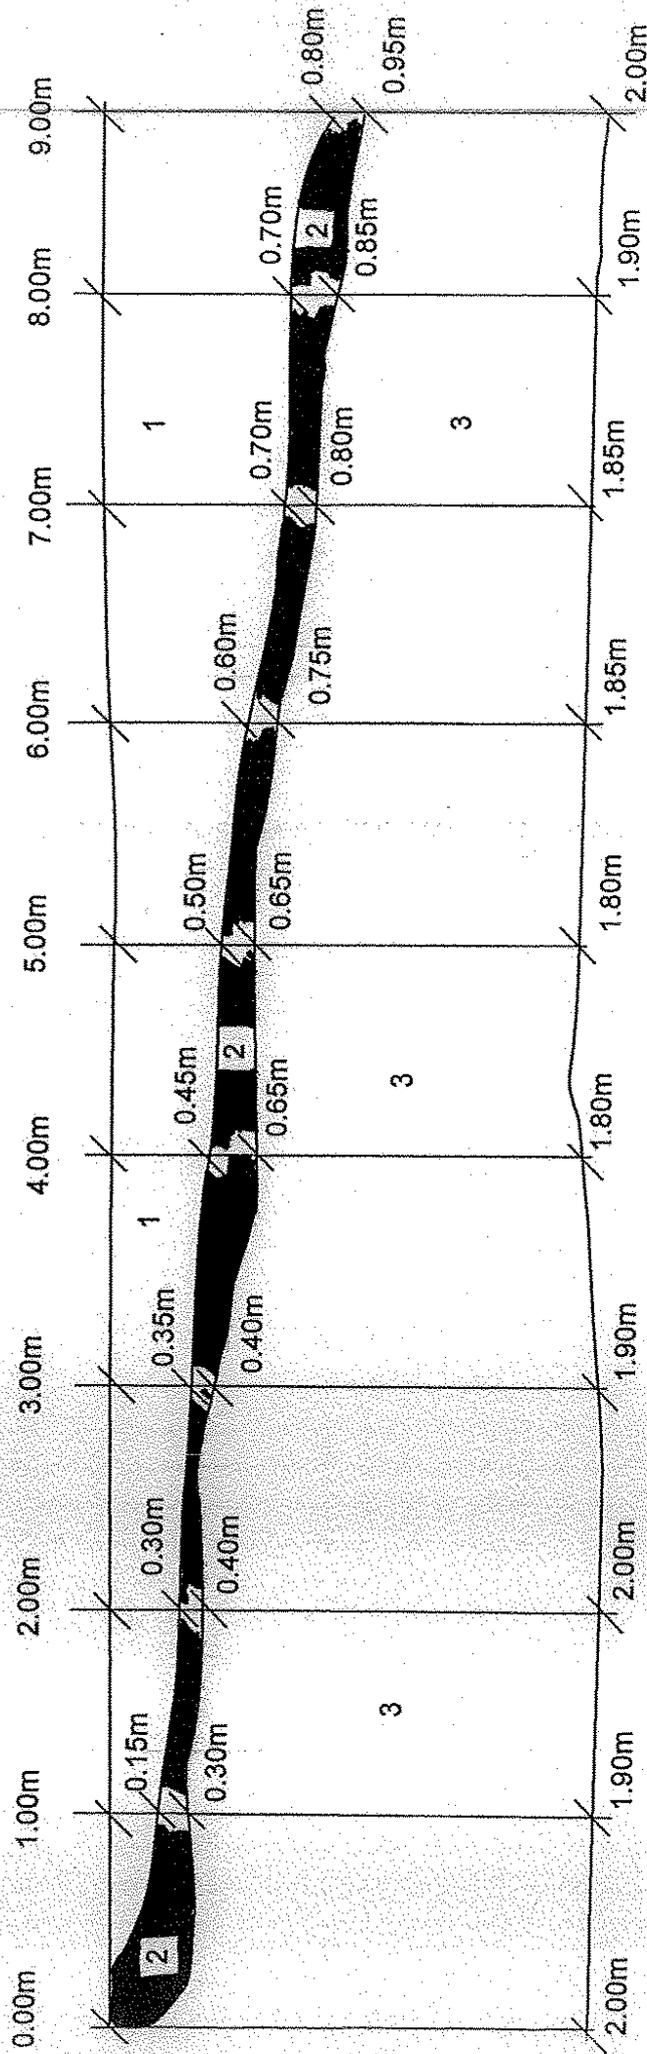
# TRENCH NO. 2 SAVILLE ROAD

- 1 Made Ground / stiff mudstone clay
- 2 Apparent Coal Seam (including seat earth etc)
- 3 Mudstone

From the trench record sheets for trenches 2 and 3, where the subcrop of the 2BM seam has been located, it has been recorded as thin to 0.20m thick and comprising poor to reasonable quality (generally inferior) coal with a seat earth below and no evidence of extraction. The reports concluded that whilst the site was not considered to be at risk from any shallow unrecorded workings in either the deeper 3BM seam noted in RBH's 2 & 3, or within the 2BM seam at subcrop, for those plots affected future foundations would need to be taken down through the subcrop of the 2BM seam and be based in the underlying bedrock materials

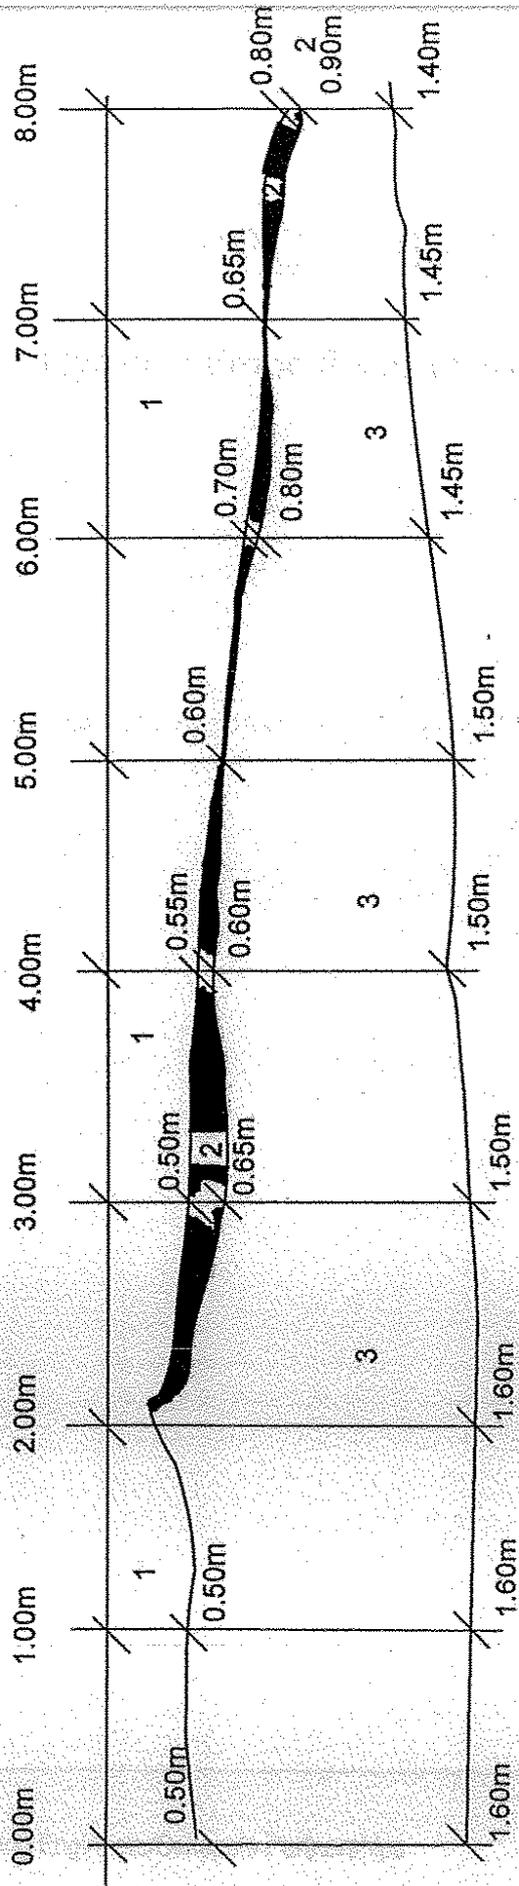
# TRENCH NO. 3 SAVILLE ROAD

- 1 Made Ground / stiff mudstone clay
- 2 Apparent Coal Seam (very poor)
- 3 Mudstone (occasionally very mudstone clays)

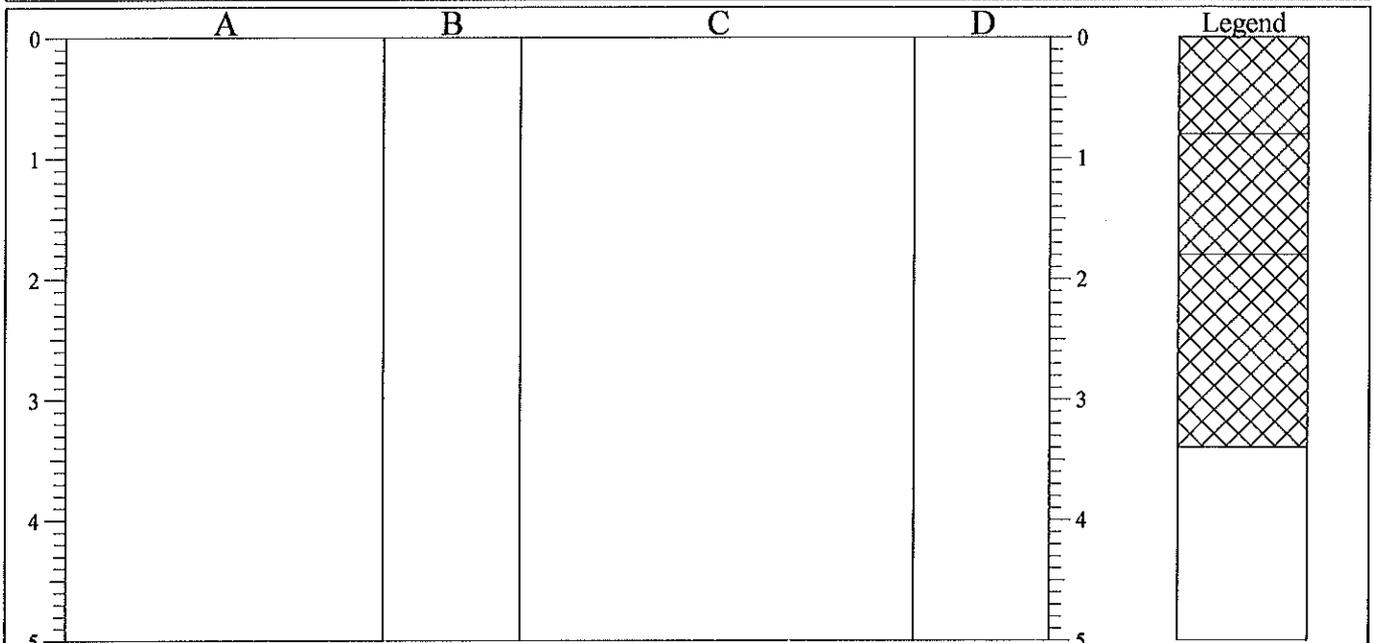
Project <b>Savile Road, Dewsbury</b>				TRIAL PIT No  <b>TP1</b>
Job No <b>05-5648RE</b>	Date <b>05-02-06</b> <b>05-02-06</b>	Ground Level (m)	Co-Ordinates ()	
Contractor <b>HEWDEN</b>				Sheet <b>1 of 1</b>

STRATA			COMMENTS	
Depth	No	DESCRIPTION	Depth	COMMENTS
0.00-0.80		MADE GROUND - Light grey brown slightly sandy slightly gravelly CLAY. Sand is fine-coarse, gravel is angular-sub angular, fine-coarse of Sandstone and Brick. Cobbles noted.	0.30-0.80	B1 Vane 46
0.80-1.80		MADE GROUND - Dark grey very clayey very gravelly SAND. Sand is fine-coarse slightly ashy, gravel is angular-sub angular, fine-coarse of Brick, Concrete, Tarmac and Clinker. Cobbles noted. Some wood fragments.	1.00-1.50	B2
1.80-3.40		MADE GROUND - Mottled greys slightly sandy gravelly CLAY. Sand is fine-coarse, gravel is angular-sub angular, fine-coarse of Concrete, Brick and Sandstone. Boulders noted. Some fragments of wood and plastic piping noted.	2.00-2.50	B3 Vane 35
			3.00-3.40	B4 Vane 46

Shoring/Support: Stability:  	<b>GENERAL REMARKS</b>  No groundwater encountered.
--	---

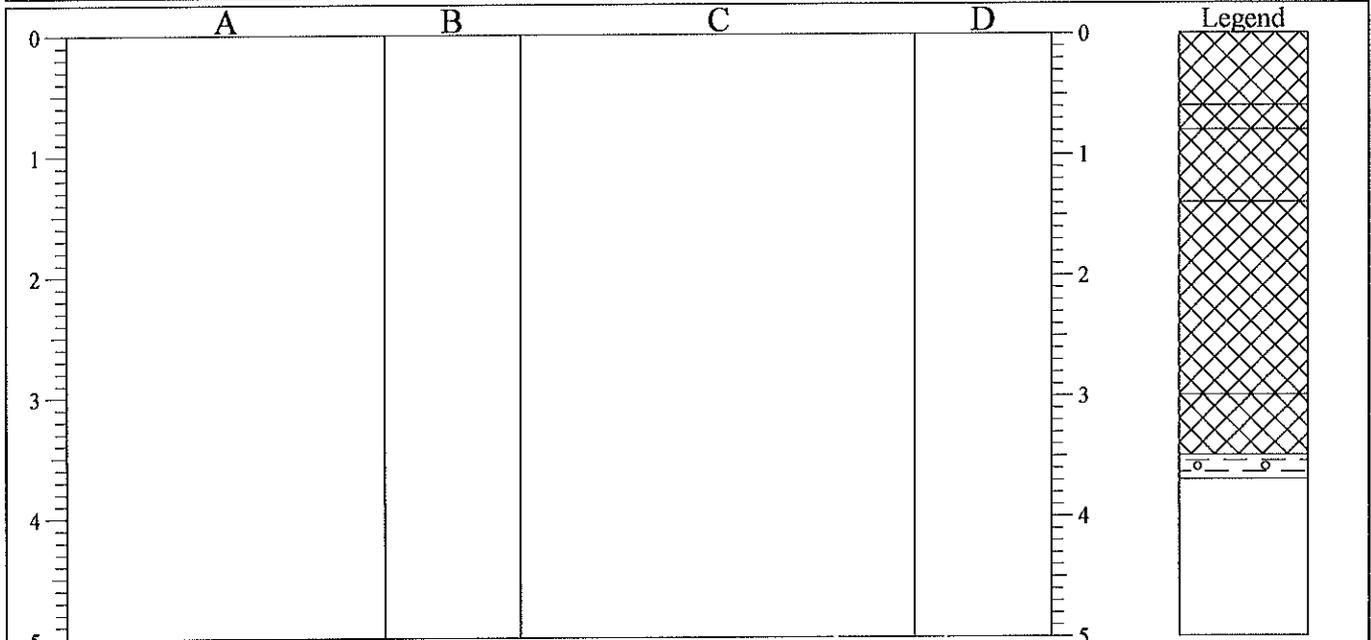
Project Savile Road, Dewsbury				TRIAL PIT No <b>TP2</b>	
Job No 05-5648RE	Date 05-02-06 05-02-06	Ground Level (m)	Co-Ordinates ()		
Contractor HEWDEN				Sheet 1 of 1

STRATA			COMMENTS	
Depth	No	DESCRIPTION	Depth	COMMENTS
0.00-0.60		MADE GROUND - Dark grey very clayey very gravelly SAND. Sand is fine-coarse slightly ashy, gravel is angular-sub angular, fine-coarse of Brick, Sandstone and Clinker. Some rootlets noted.

0.60-0.80		MADE GROUND - Brown slightly sandy slightly gravelly CLAY. Sand is fine-coarse, gravel is angular-rounded, fine-medium of Sandstone and Brick.	0.60-0.80	B1 Vane 71

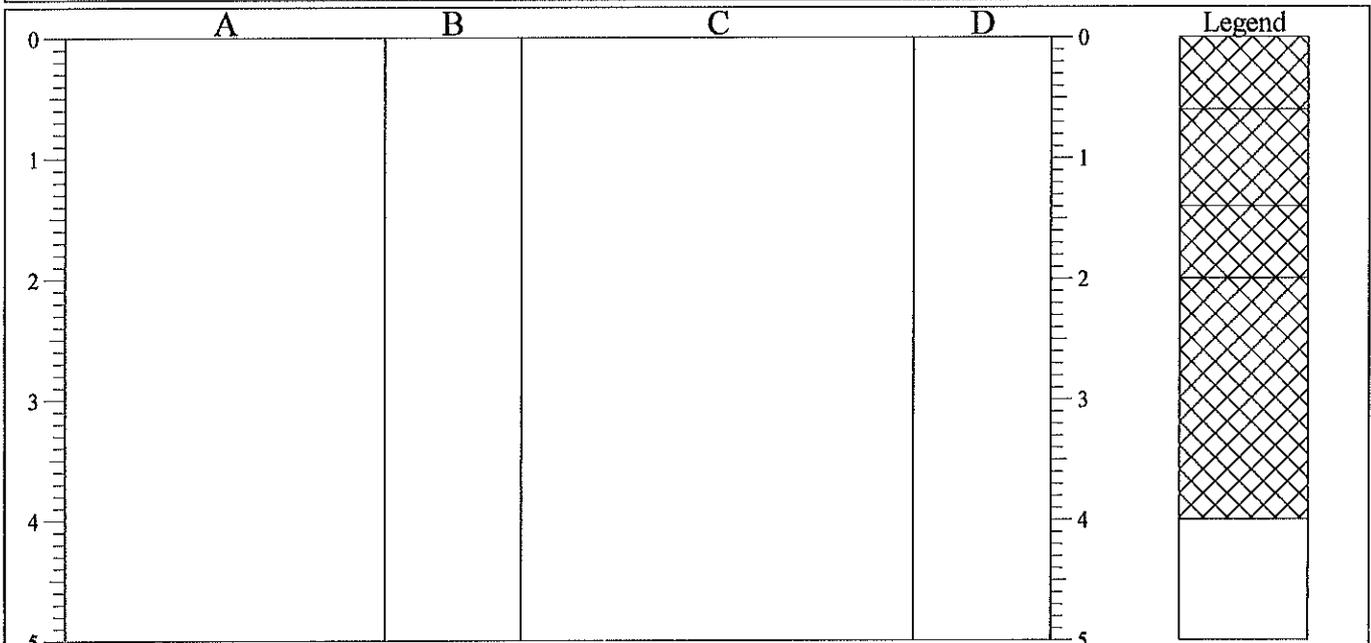
Project <b>Savile Road, Dewsbury</b>				TRIAL PIT No  <b>TP3</b>
Job No <b>05-5648RE</b>	Date <b>05-02-06</b> <b>05-02-06</b>	Ground Level (m)	Co-Ordinates ( )	
Contractor <b>HEWDEN</b>				Sheet <b>1 of 1</b>

STRATA			COMMENTS	
Depth	No	DESCRIPTION	Depth	COMMENTS
0.00-0.60		MADE GROUND -Brown sandy gravelly CLAY. Sand is fine-coarse, gravel is angular-sub rounded, fine-coarse of Sandstone and Brick. Cobbles noted.		
0.60-1.40		MADE GROUND - Dark grey slightly clayey very gravelly SAND. Sand is fine-coarse slightly ashy, gravel is angular-sub rounded, fine-coarse of Brick and Sandstone. Boulders noted.	0.50-0.60	B1 Vane 47
			1.00-1.40	B2
1.40-2.00		MADE GROUND - Dark grey slightly sandy gravelly CLAY. Sand is fine-coarse, gravel is angular-sub rounded, fine-coarse of Brick, Tarmac, Coal, Sandstone and Clinker.	1.50-2.00	B3 Vane 35
2.00-4.00		MADE GROUND - Dark grey clayey very gravelly SAND. Sand is fine-coarse slightly ashy, gravel is angular-sub rounded, fine-coarse of Sandstone, Brick and Clinker.	2.00-2.50	B4

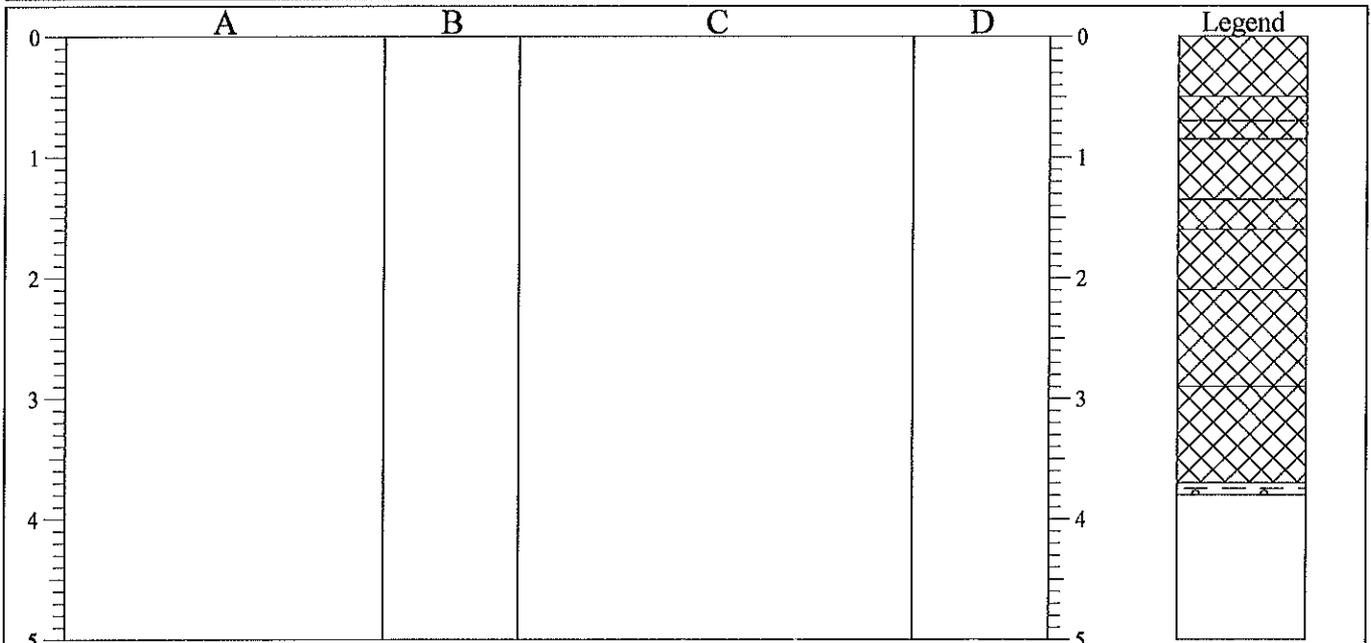
Project <b>Savile Road, Dewsbury</b>				<b>TRIAL PIT No</b>  <b>TP4</b>
Job No <b>05-5648RE</b>	Date 05-02-06 05-02-06	Ground Level (m)	Co-Ordinates ( )	
Contractor <b>HEWDEN</b>				Sheet <b>1 of 1</b>

STRATA			COMMENTS	
Depth	No	DESCRIPTION	Depth	COMMENTS
0.00-0.50		MADE GROUND - Brown slightly sandy slightly gravelly CLAY. Sand is fine-coarse, gravel is angular-sub rounded, fine-coarse of Sandstone and Brick.	0.30-0.50	B1 Vane 53 B2

0.50-0.70		MADE GROUND - Dark grey slightly sandy slightly gravelly CLAY. Sand is fine-coarse, gravel is angular-sub rounded, fine-coarse of Brick, Concrete and Sandstone. Plastic piping, rope and metal noted.	0.50-0.70

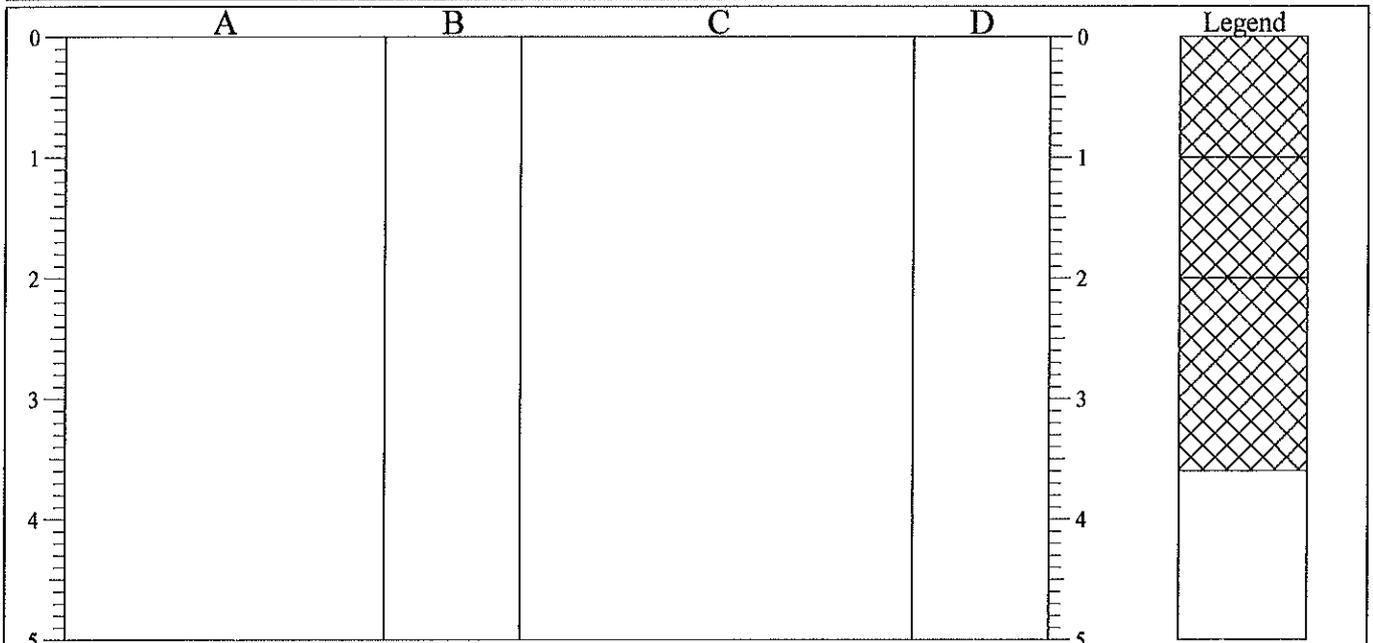
Project Savile Road, Dewsbury				TRIAL PIT No <b>TP5</b>	
Job No 05-5648RE	Date 05-02-06 05-02-06	Ground Level (m)	Co-Ordinates ()		
Contractor HEWDEN				Sheet 1 of 1

STRATA			COMMENTS	
Depth	No	DESCRIPTION	Depth	COMMENTS
0.00-1.00		MADE GROUND - Brown sandy gravelly CLAY. Sand is fine-coarse, gravel is angular-sub rounded, fine-coarse of Sandstone, Brick and Concrete. Old plastic piping noted.	0.50-1.00	B1
1.00-2.00		MADE GROUND - Dark grey clayey very gravelly SAND. Sand is fine-coarse slightly ashy, gravel is angular-sub rounded, fine-coarse of Brick and Concrete. Wood fragments noted..	1.00-1.50	B2
2.00-3.60		MADE GROUND - Mottled dark greys slightly sandy gravelly CLAY. Sand is fine-coarse, gravel is angular-rounded, fine-coarse of Sandstone, Brick, Tarmac, Clinker and Burnt Shale. Wood fragments noted.	2.50-3.00	B3 Vane 53

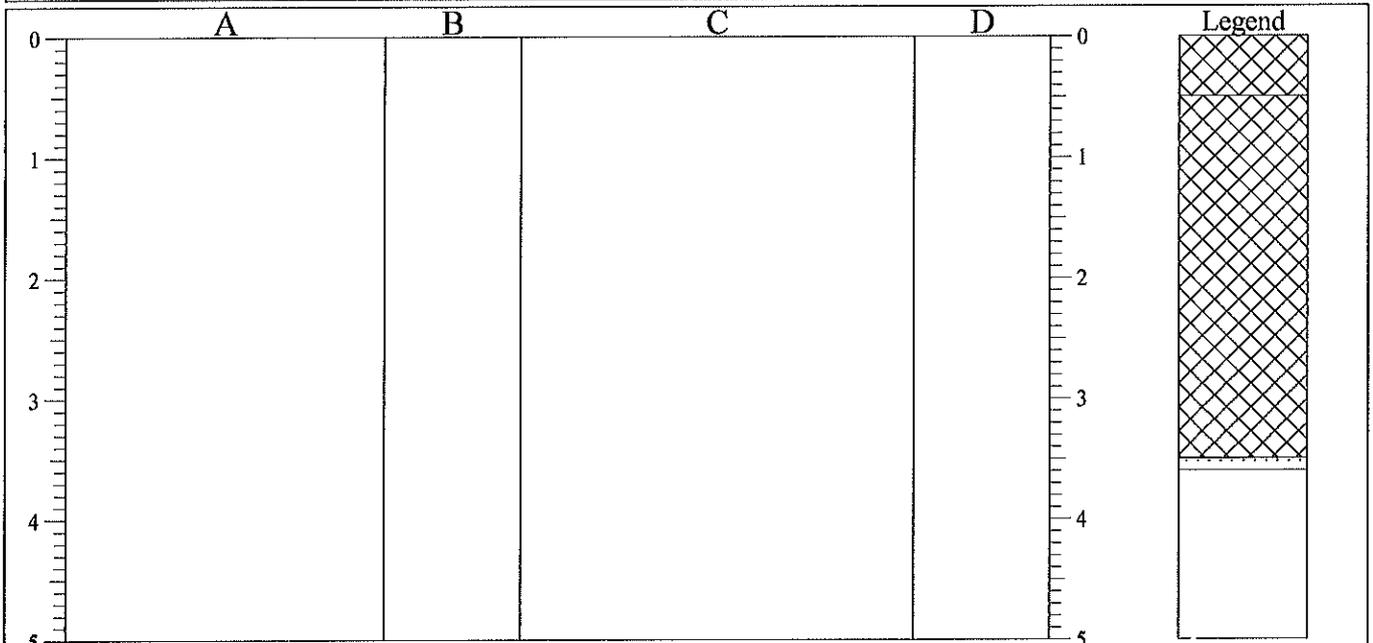
Project Savile Road, Dewsbury				TRIAL PIT No <b>TP6</b>	
Job No 05-5648RE	Date 05-02-06 05-02-06	Ground Level (m)	Co-Ordinates ()		
Contractor HEWDEN				Sheet 1 of 1

STRATA			COMMENTS	
Depth	No	DESCRIPTION	Depth	COMMENTS
0.00-0.50		MADE GROUND -Brown sandy gravelly CLAY. Sand is fine-coarse, gravel is angular-sub angular, fine-coarse of Sandstone, Brick and Concrete.		
0.50-3.50		MADE GROUND - Dark brown progressing to dark grey with depth clayey very gravelly SAND. Sand is fine-coarse, gravel is angular-sub angular, fine-coarse of Tarmac, Concrete and Brick.	1.00-1.50	B1
			2.00-2.50	B2
			3.00-3.50	B3
3.50-3.60		Weathered Sandstone Bedrock. Recovered as SAND and GRAVEL. Sand is fine-coarse. gravel is angular, fine-coarse of Sandstone. Cobbles noted.

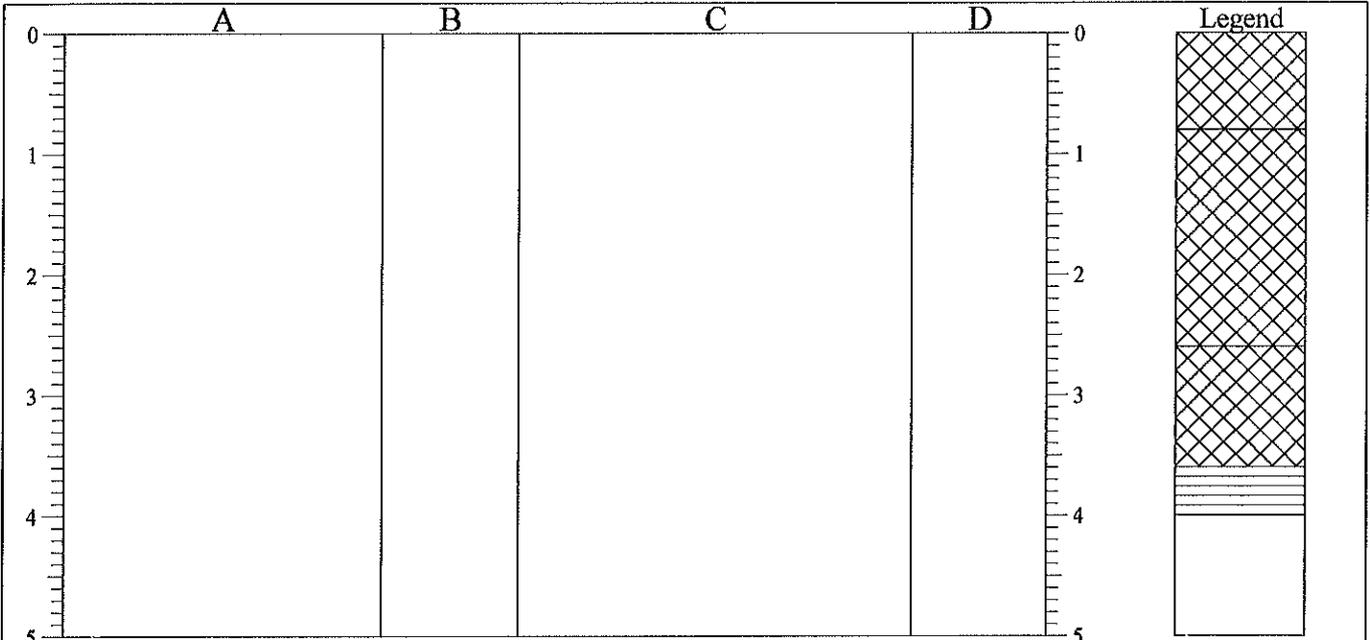
Project Savile Road, Dewsbury				TRIAL PIT No <b>TP7</b>
Job No 05-5648RE	Date 05-02-06 05-02-06	Ground Level (m)	Co-Ordinates ()	
Contractor HEWDEN				Sheet 1 of 1

STRATA			COMMENTS	
Depth	No	DESCRIPTION	Depth	COMMENTS
0.00-0.80		MADE GROUND - Brown clayey very gravely SAND. Sand is fine-coarse, gravel is angular-sub angular, fine-coarse of Brick, Sandstone, concrete and Pottery. Boulders noted.	0.50-0.80	B1
0.80-2.60		MADE GROUND - Dark grey clayey very gravely SAND. Sand is fine-coarse slightly ashy, gravel is angular-sub rounded, fine-coarse of Brick, Sandstone and Concrete.	1.00-1.50	B2
2.60-3.60		MADE GROUND - Mottled greys sandy gravely CLAY. Sand is fine-coarse, gravel is angular-sub rounded, fine-coarse of Sandstone, Brick, Clinker and Concrete.	3.00-3.50	B3 Vane 15
3.60-4.00		Highly weathered mottled yellow and black Siltstone and coal recovered as sandy GRAVEL. Sand is fine-coarse, gravel is angular, fine-coarse of Siltstone, Mudstone and Coal.	3.80-4.00	B4

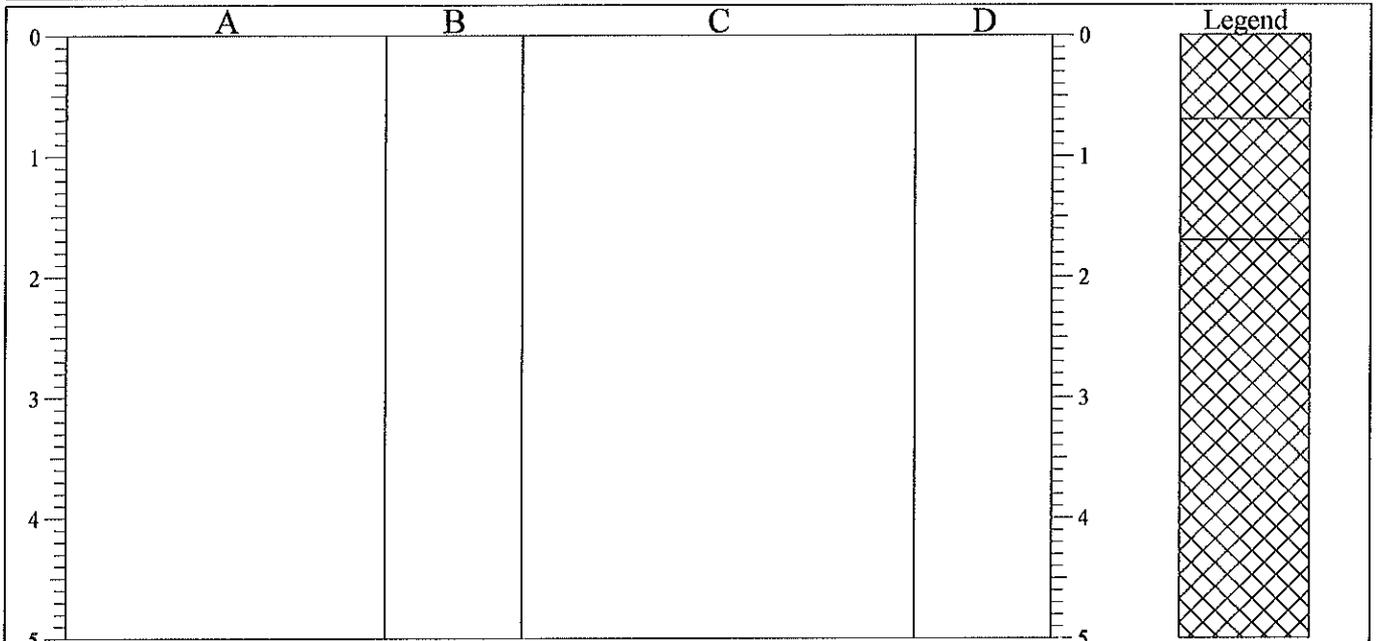
Project <b>Savile Road, Dewsbury</b>				TRIAL PIT No <b>TP8</b>	
Job No <b>05-5648RE</b>	Date <b>05-02-06</b> <b>05-02-06</b>	Ground Level (m)	Co-Ordinates ()		
Contractor <b>HEWDEN</b>				Sheet <b>1 of 1</b>

STRATA			COMMENTS	
Depth	No	DESCRIPTION	Depth	COMMENTS
0.00-0.70		MADE GROUND - Greyey brown sandy gravelly CLAY. Sand is fine-coarse, gravel is angular-sub rounded, fine-coarse of Sandstone and Brick. Boulders noted. Wood fragments and metal wire also noted.	0.30-0.70	B1 Vane 57
0.70-1.70		MADE GROUND - Brown very clayey very gravelly SAND. Sand is fine-coarse, gravel is angular-sub angular, fine-coarse of Brick, Concrete and Sandstone. Cobbles noted.	1.00-1.50	B2
1.70-5.00		MADE GROUND - Dark grey very clayey very gravelly SAND. Sand is fine-coarse, gravel is angular-sub angular, fine-coarse of Brick, Tarmac, Pottery, Clinker and Sandstone. Metal chain, wood and plastic piping also noted.	2.00-2.50	B3
			3.00-3.50	B4
			4.50-5.00	B5

Shoring/Support: Stability:  	GENERAL REMARKS
	Water noted seeping in at 4.10 metres.

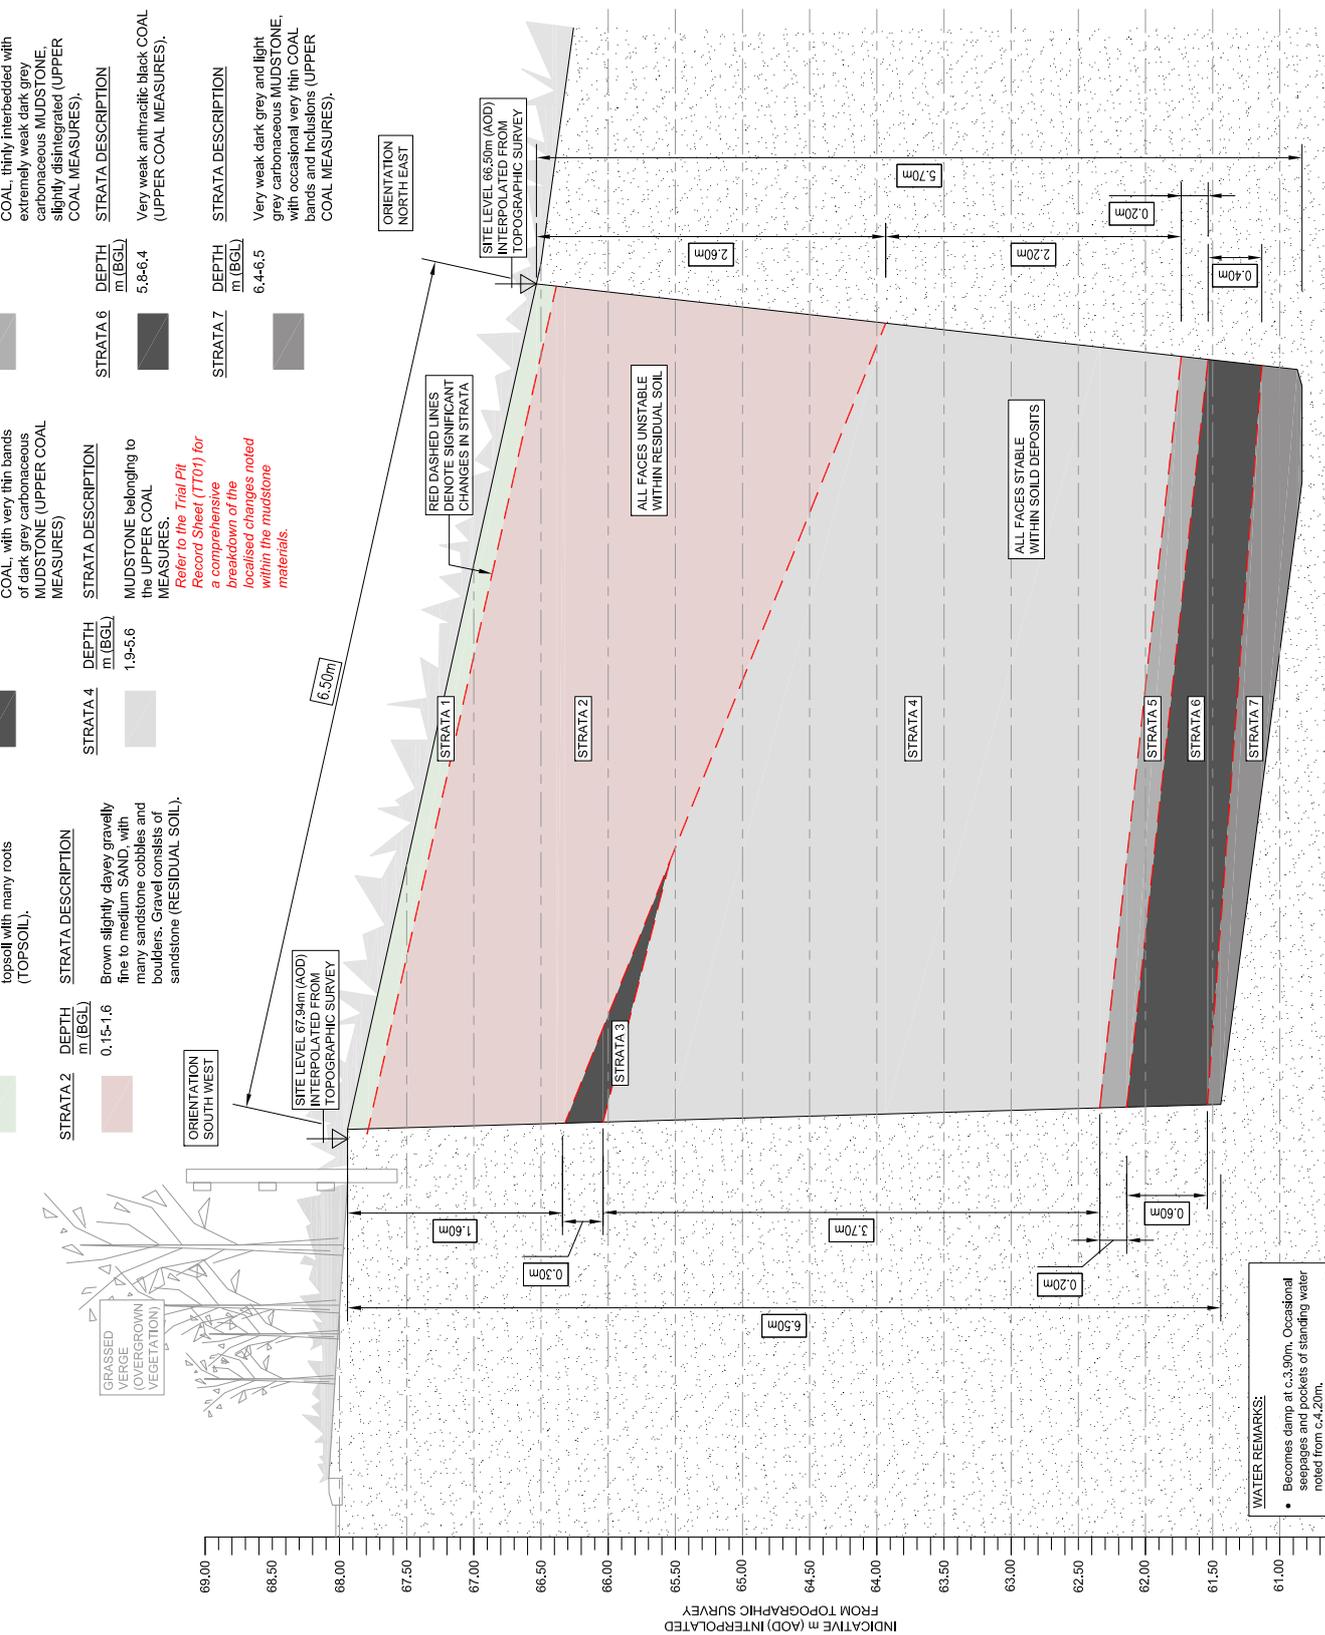
**TRIAL TRENCH CROSS SECTION (TT01)**

**WATER REMARKS:**  
• Becomes damp at c.3.90m. Occasional seepages and pockets of standing water noted from c.4.20m.

At the locations of TT01 and TT02 bands of anthracitic black coal, with bands of inter-bedded coal and carbonaceous mudstone, were noted within the initial mudstone deposits, at depths of between 2.50m to 3.50m (TT02) and 5.60m to 6.40m bgl (TT01). In addition, at the location of TT01 an initial shallow band of very weak black weathered coal was also noted at rock head, from 1.60m to 1.90m bgl, with this band noted to be tapering in thickness and was no longer evident 2.00m from the site boundary. Similarly, a thin layer of inter-bedded carbonaceous mudstone and extremely weak weathered coal was noted in TT03 at depths of between 1.90m to 2.00m bgl, within the initial mudstone bedrock materials.
