Residential Development

Erection of 2 pairs Semi-detached Dwellings (4no.)

Land Adjacent to Caledonian Road,

## Coal Mining Report

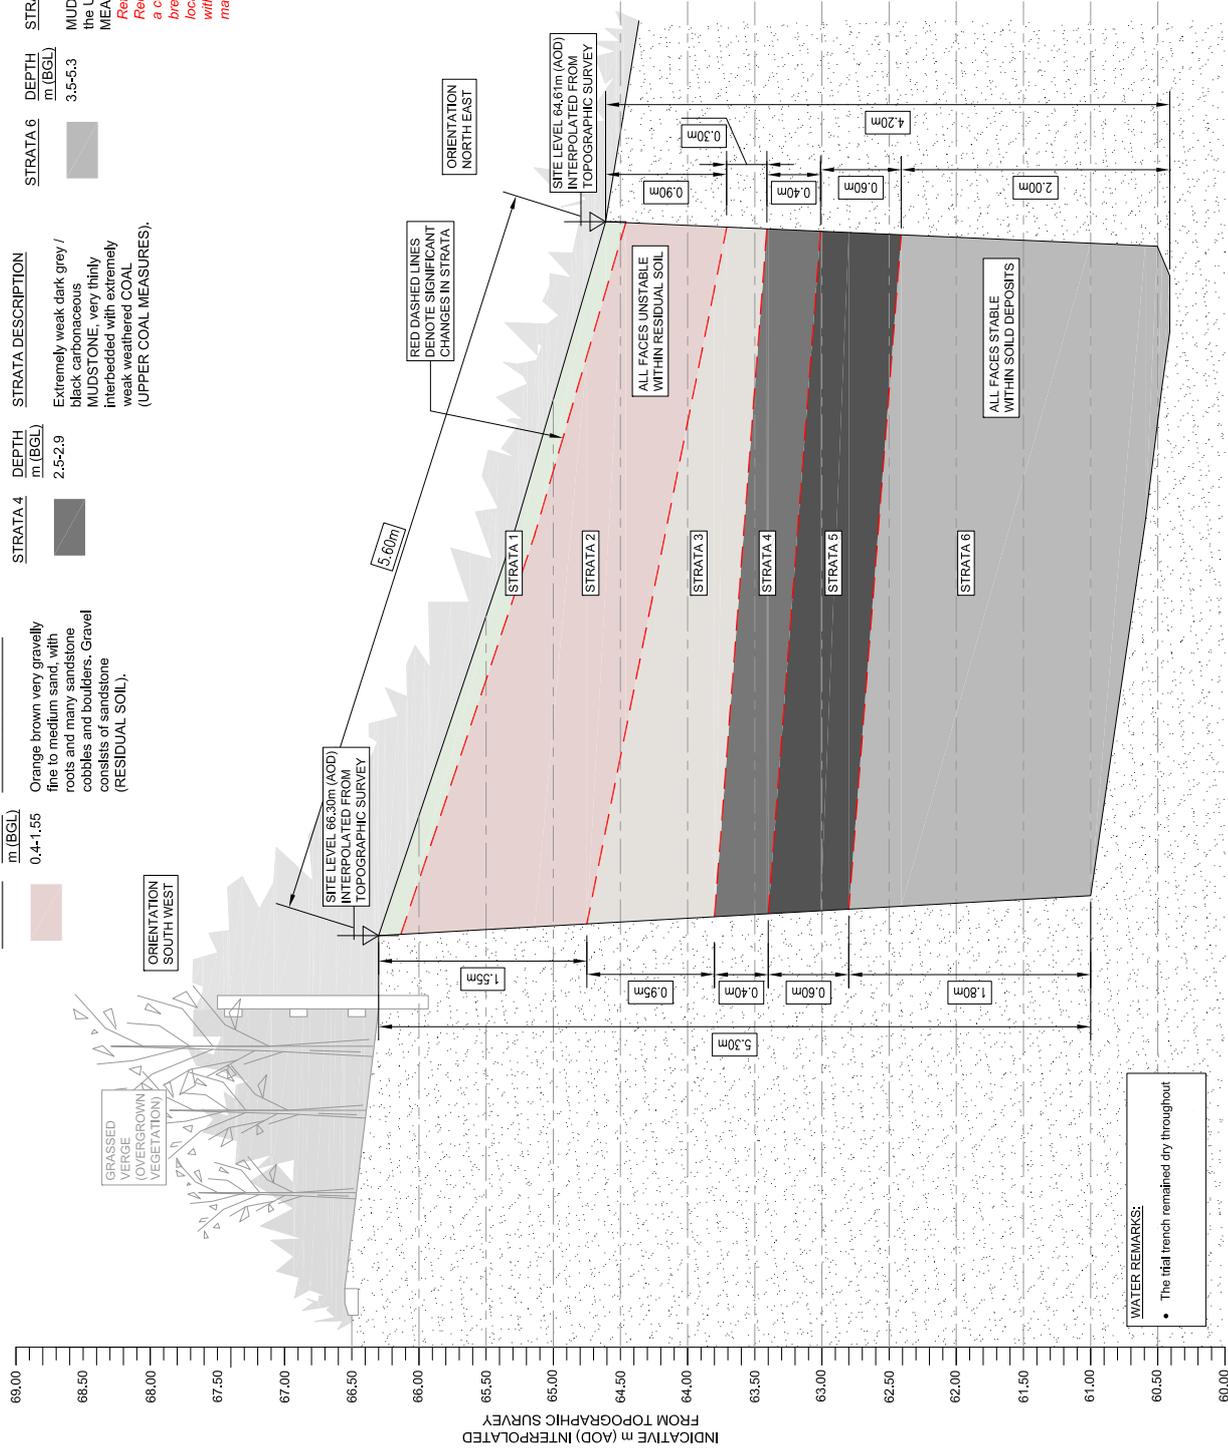
**TRIAL TRENCH CROSS SECTION (TT02)**

**WATER REMARKS:**

- The trial trench remained dry throughout

At the locations of TT01 and TT02 bands of anthracitic black coal, with bands of inter-bedded coal and carbonaceous mudstone, were noted within the initial mudstone deposits, at depths of between 2.50m to 3.50m (TT02) and 5.60m to 6.40m bgl (TT01). In addition, at the location of TT01 an initial shallow band of very weak black weathered coal was also noted at rock head, from 1.60m to 1.90m bgl, with this band noted to be tapering in thickness and was no longer evident 2.00m from the site boundary. Similarly, a thin layer of inter-bedded carbonaceous mudstone and extremely weak weathered coal was noted in TT03 at depths of between 1.90m to 2.00m bgl, within the initial mudstone bedrock materials.

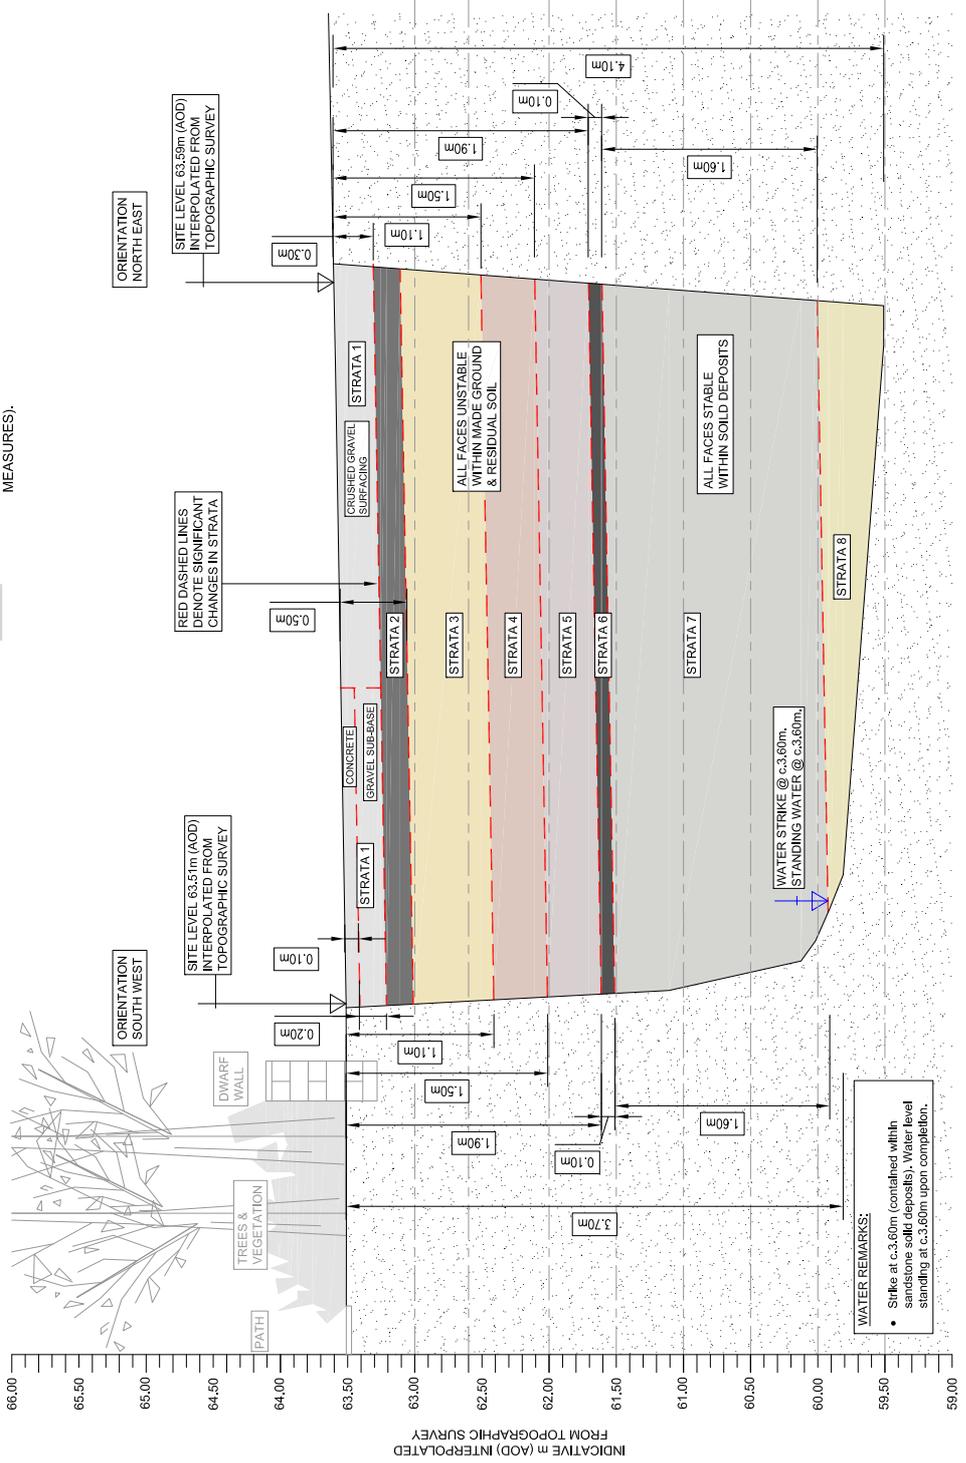
**TRIAL TRENCH CROSS SECTION (TT03)**

**NOTES:**

- SEE DRAWING '11-183-TRIAL TRENCH CROSS SECTION (TT03) - SHEET 2' FOR A PHOTOGRAPHIC RECORD OF THE TRIAL TRENCH EXCAVATION

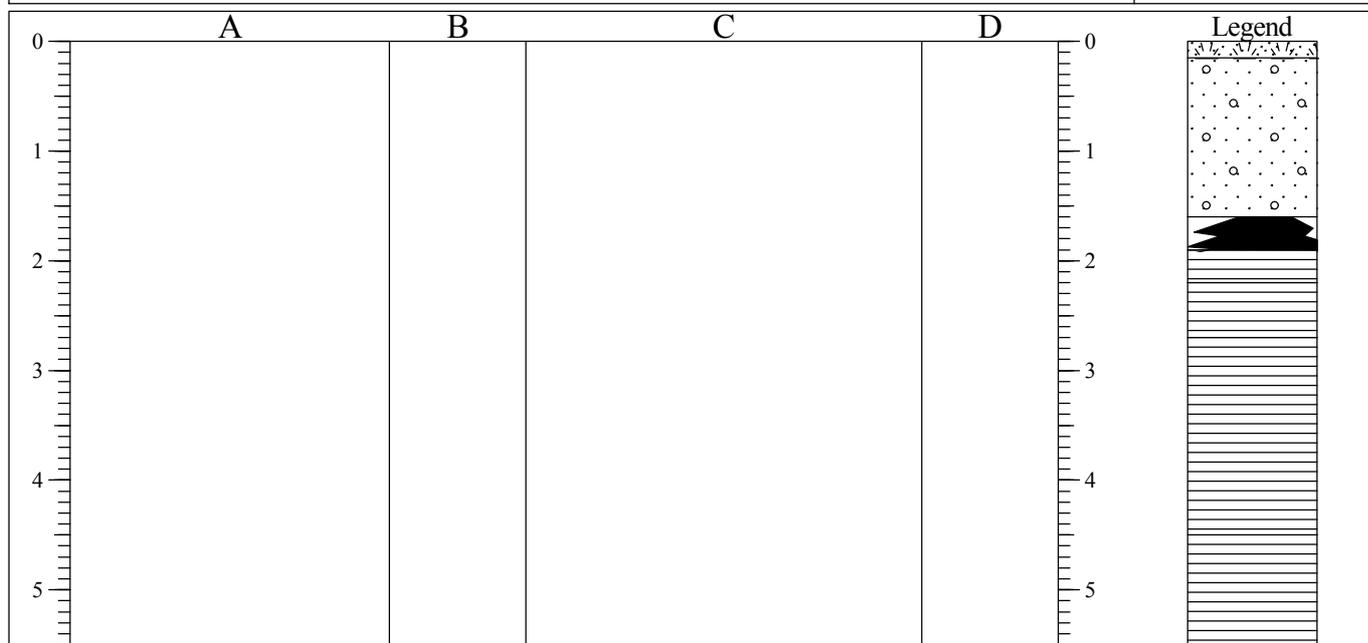
Project Land adjacent to Caledonian Road, Savile Town, Dewsbury				<b>TRIAL PIT No</b>  <b>TT01</b>
Job No 11-183	Date 05-05-11	Ground Level (m) 67.94	Co-Ordinates ()	
Contractor Arc Environmental Limited				Sheet 1 of 2

STRATA			SAMPLES & TESTS		
Depth	No	DESCRIPTION	Depth	No	Remarks/Tests
0.00-0.15		Unmanaged vegetation over TOPSOIL, with many roots (TOPSOIL).			
0.15-1.60		Brown slightly clayey gravelly fine to medium SAND, with many sandstone cobbles and boulders. Gravel consists of sandstone (RESIDUAL SOIL).	0.40-0.80	B1

1.60-1.90		Very weak black weathered COAL, with very thin bands of dark grey carbonaceous MUDSTONE (UPPER COAL MEASURES).	1.70-1.90	B2	
1.90-2.20		Extremely weak light grey silty MUDSTONE, slightly disintegrated (UPPER COAL MEASURES).	1.90-2.20	B3

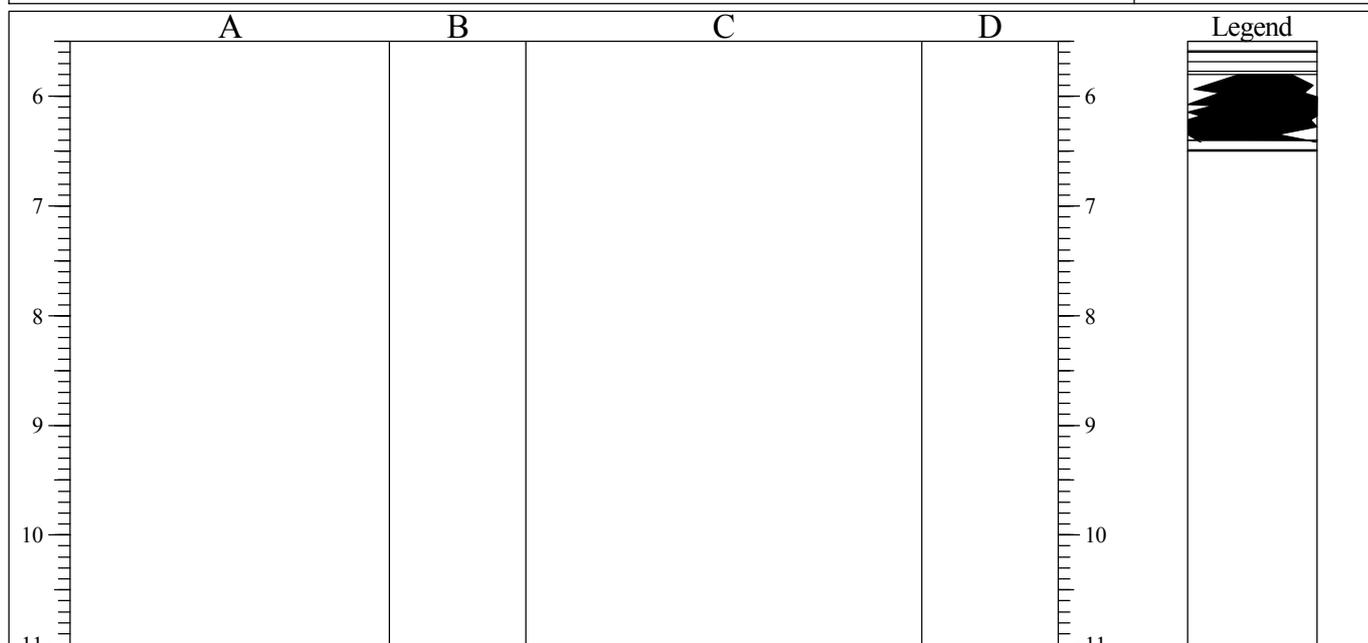
Project Land adjacent to Caledonian Road, Savile Town, Dewsbury				TRIAL PIT No  <b>TT01</b>
Job No 11-183	Date 05-05-11	Ground Level (m) 67.94	Co-Ordinates ()	
Contractor Arc Environmental Limited				Sheet 2 of 2

STRATA			SAMPLES & TESTS		
Depth	No	DESCRIPTION	Depth	No	Remarks/Tests
5.60-5.80		Extremely weak weathered black COAL, thinly interbedded with extremely weak dark grey carbonaceous MUDSTONE, slightly disintegrated (UPPER COAL MEASURES). Very weak anthracitic black COAL (UPPER COAL MEASURES).	5.60-5.80	B9	
5.80-6.40			6.00-6.20	B10	
6.40-6.50		Very weak dark grey and light grey carbonaceous MUDSTONE, with occasional very thin COAL bands and inclusions (UPPER COAL MEASURES). Trial trench complete at 6.50m.	6.40-6.50	B11	
6.50

<p>Shoring/Support: None          Stability: All faces unstable in residual soil. Stable in solid deposits.</p> <div style="text-align: center; margin-top: 10px;"> </div>	<p style="text-align: center;"><b>GENERAL REMARKS</b></p> <p>WATER: Becomes damp at 3.90m. Occasional seepages and pockets of standing water noted from c.4.20m.          ORIENTATION: NE-SW.</p>
--	---

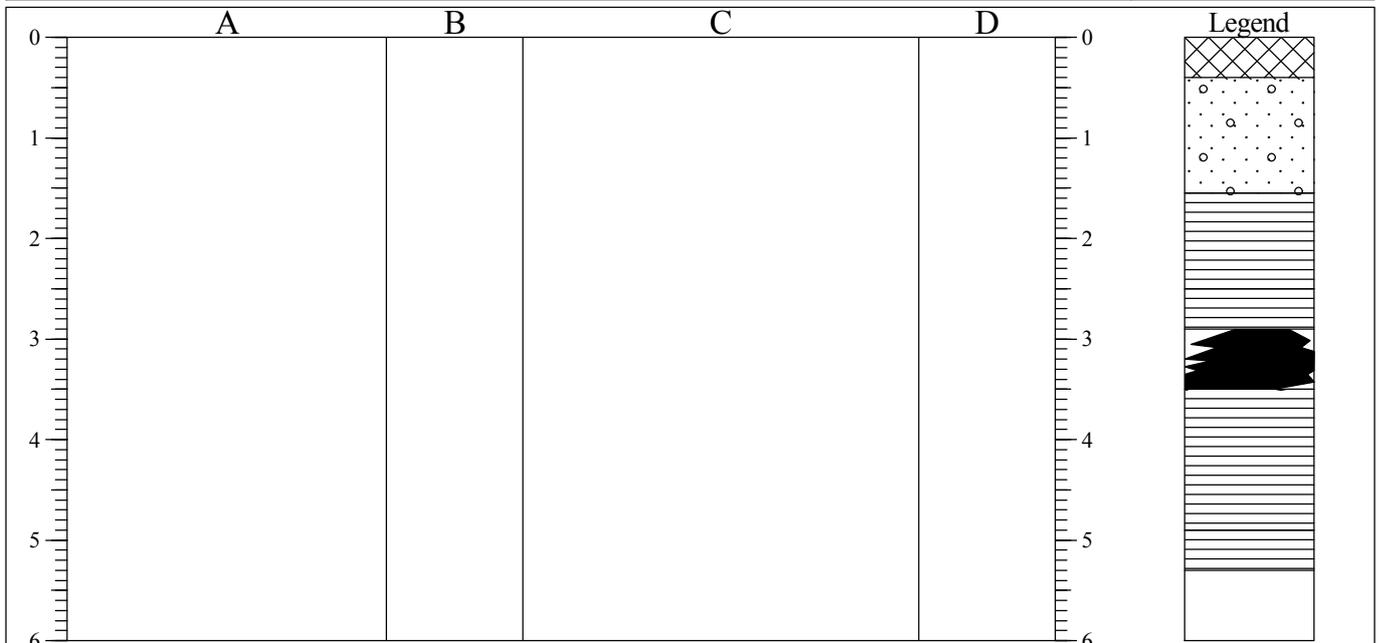
Project Land adjacent to Caledonian Road, Savile Town, Dewsbury				<b>TRIAL PIT No</b>  <b>TT02</b>
Job No 11-183	Date 05-05-11	Ground Level (m) 66.31	Co-Ordinates ()	
Contractor Arc Environmental Limited				Sheet 1 of 1

STRATA			SAMPLES & TESTS		
Depth	No	DESCRIPTION	Depth	No	Remarks/Tests
0.00-0.40		Unmanaged vegetation over topsoil, with conglomerated mudstone pockets, many roots and occasional plastic fragments (MADE GROUND).	0.10-0.30	B1

0.40-1.55		Orange brown very gravelly fine to medium SAND, with roots and many sandstone cobbles and boulders. Gravel consists of sandstone (RESIDUAL SOIL).	0.80-1.20	B2

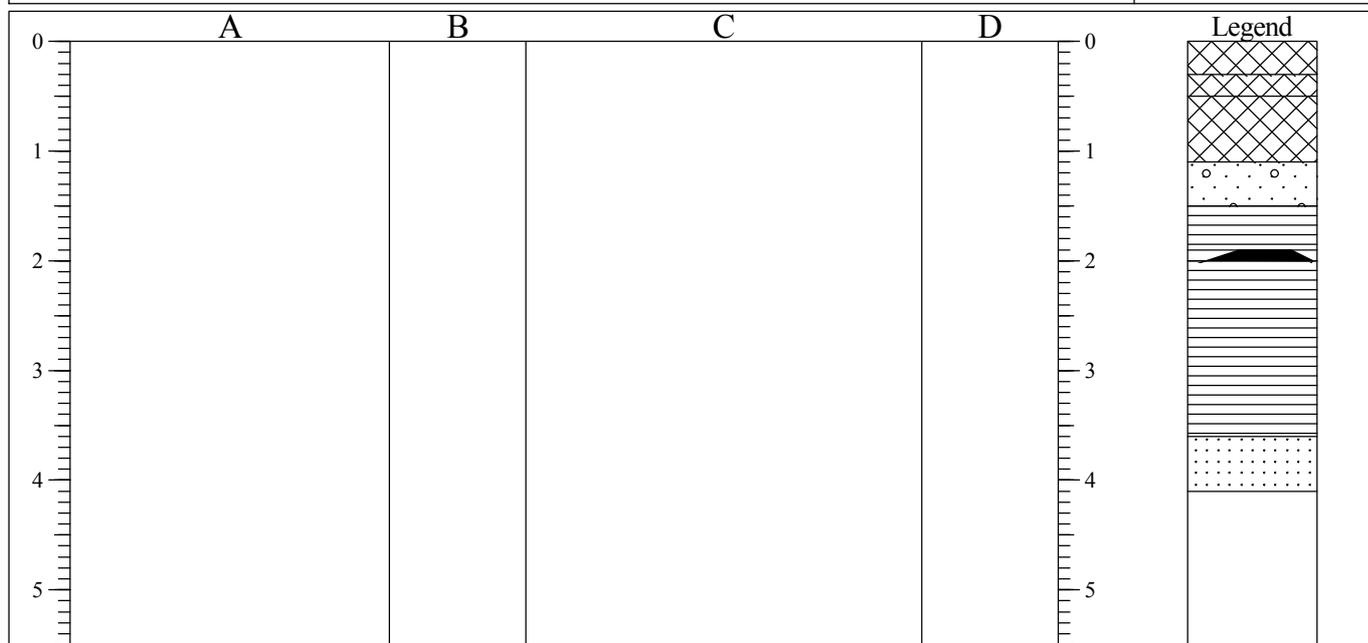
Project Land adjacent to Caledonian Road, Savile Town, Dewsbury				<b>TRIAL PIT No TT03</b>
Job No 11-183	Date 05-05-11	Ground Level (m) 63.59	Co-Ordinates ()	
Contractor Arc Environmental Limited				Sheet 1 of 1

STRATA			SAMPLES & TESTS		
Depth	No	DESCRIPTION	Depth	No	Remarks/Tests
0.00-0.30		Concrete with underlying gravel sub-base (former access road) and crushed concrete, dolomite and brick surfacing (MADE GROUND).	0.30-0.50	B1

0.30-0.50			0.50-1.10	B2	
0.50-1.10		Dark grey / black carbonaceous mudstone gravel (MADE GROUND).	0.60-0.80	B2	
1.10-1.50		Disturbed yellow brown gravelly sand, with sandstone cobbles and boulders, intermixed with light grey and orange mudstone (MADE GROUND). Disused drain encountered at 1.10m.	1.20-1.40	B3

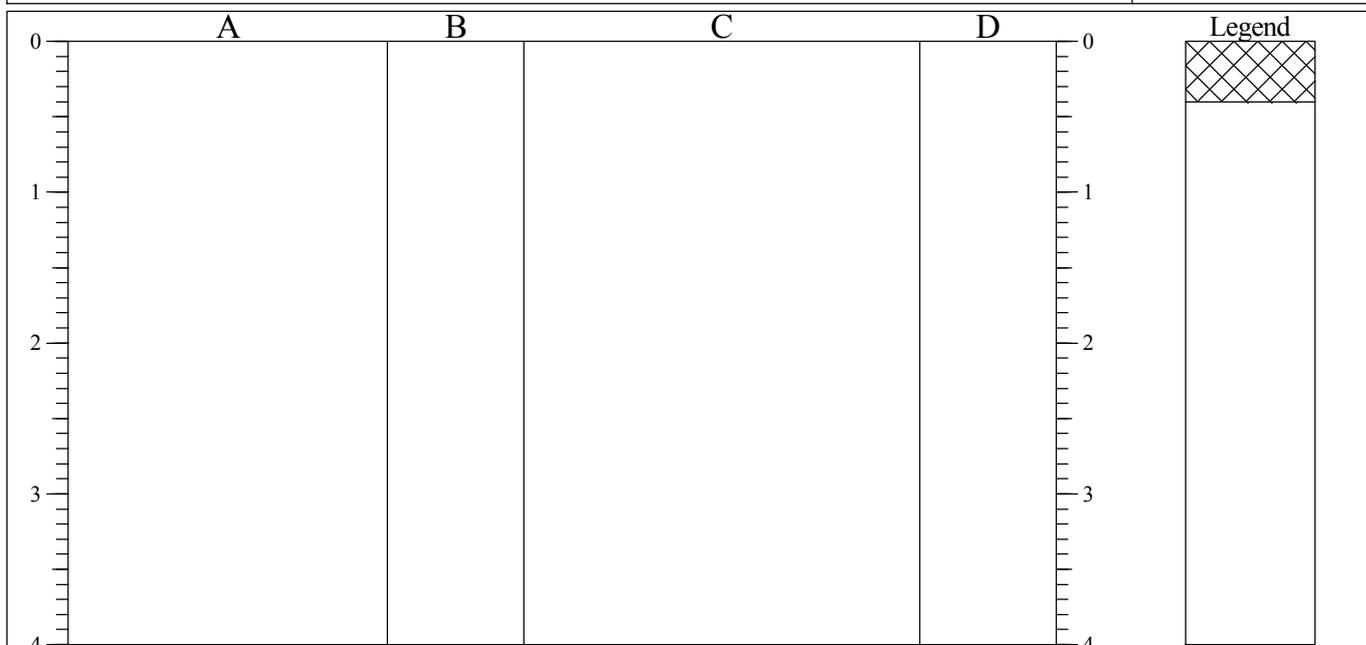
Project Land adjacent to Caledonian Road, Savile Town, Dewsbury				TRIAL PIT No <b>TT03A</b>
Job No 11-183	Date 05-05-11	Ground Level (m) 63.59	Co-Ordinates ()	
Contractor Arc Environmental Limited				Sheet 1 of 1

STRATA			SAMPLES & TESTS		
Depth	No	DESCRIPTION	Depth	No	Remarks/Tests
0.00-0.40		Concrete with underlying gravel sub-base (former access road) and crushed concrete, dolomite and brick surfacing (MADE GROUND).	0.10-0.30	B1	
0.40		Trial trench terminated at 0.40m as uncovered service culvert within western face of trench (cast iron pipe visible at base of culvert) - noted to trend E-W below the existing yard area and also extend below adjacent Caledonian Road. To avoid potential damage trial trench location moved c.1m south - see TT03A for further detail.

Shoring/Support: None Stability: All faces unstable in made ground.  	<b>GENERAL REMARKS</b>  ORIENTATION: NE-SW.
--	---

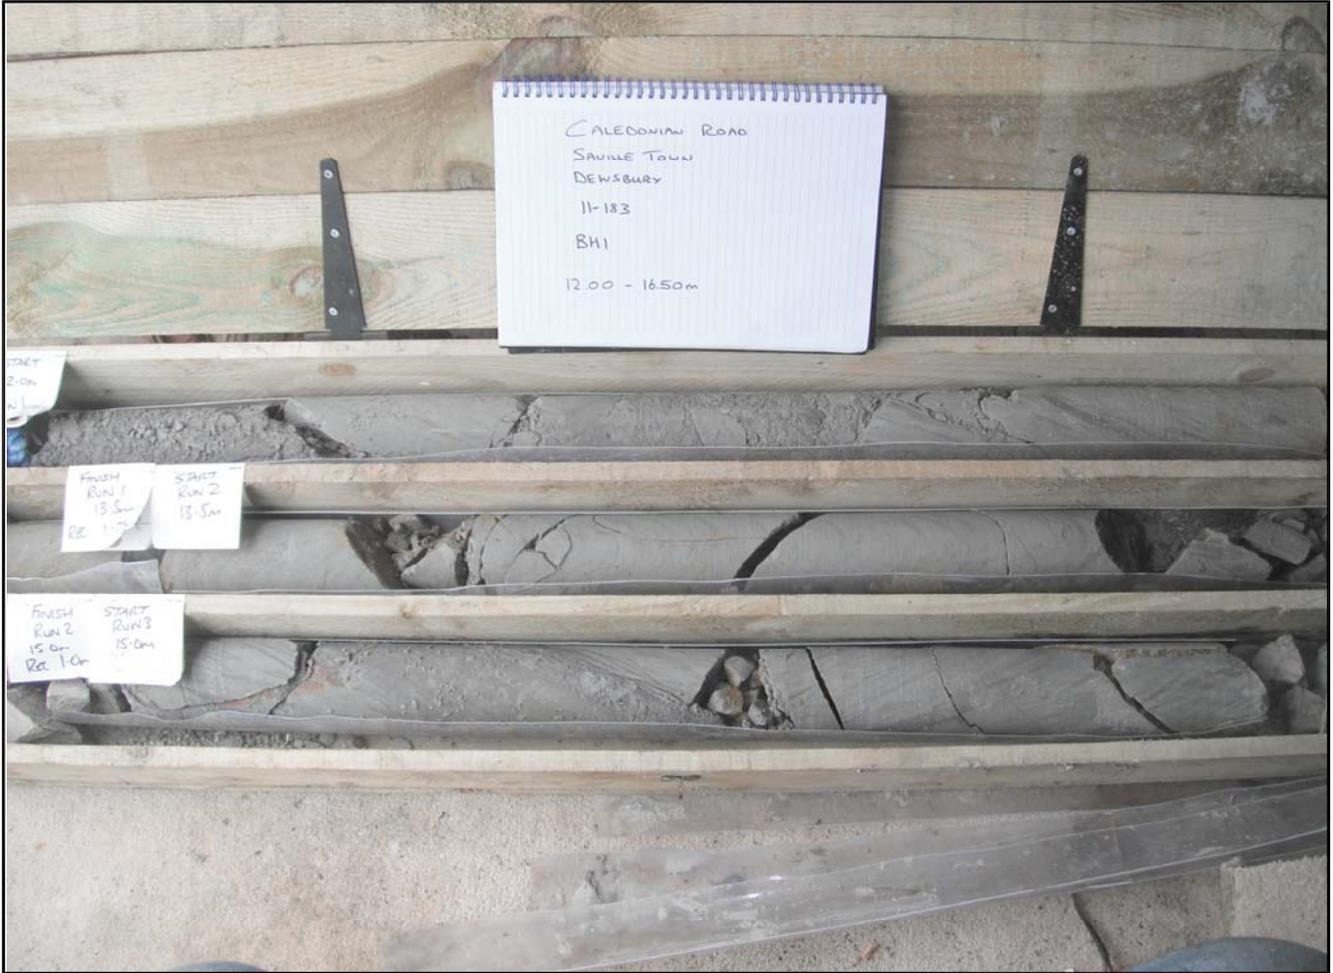
**ROTARY CORE PHOTOGRAPHIC RECORD**

CORE DETAILS	
BOREHOLE REF	BH1
CORE SECTION (DEPTHS)	12.0M to 16.5M
CORE RECOVERY	LESS THAN 100% CORE RECOVERY THROUGH CORE RUN

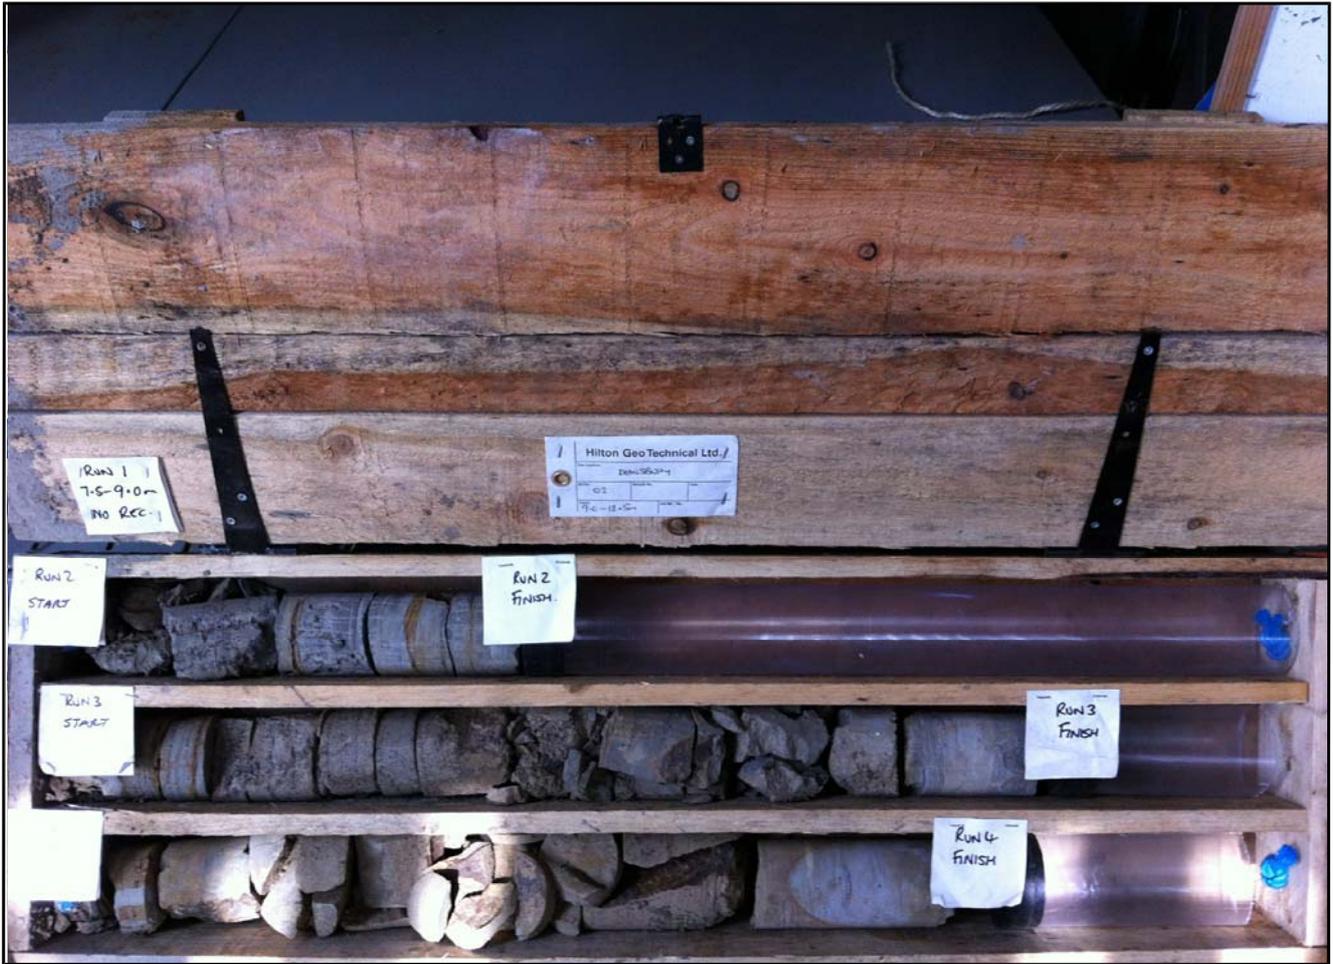
ROTARY CORE PHOTOGRAPHIC RECORD

CORE DETAILS	
BOREHOLE REF	CP6
CORE SECTION (DEPTHS)	7.50M to 12.00M
CORE RECOVERY	LESS THAN 100% CORE RECOVERY THROUGH CORE RUN

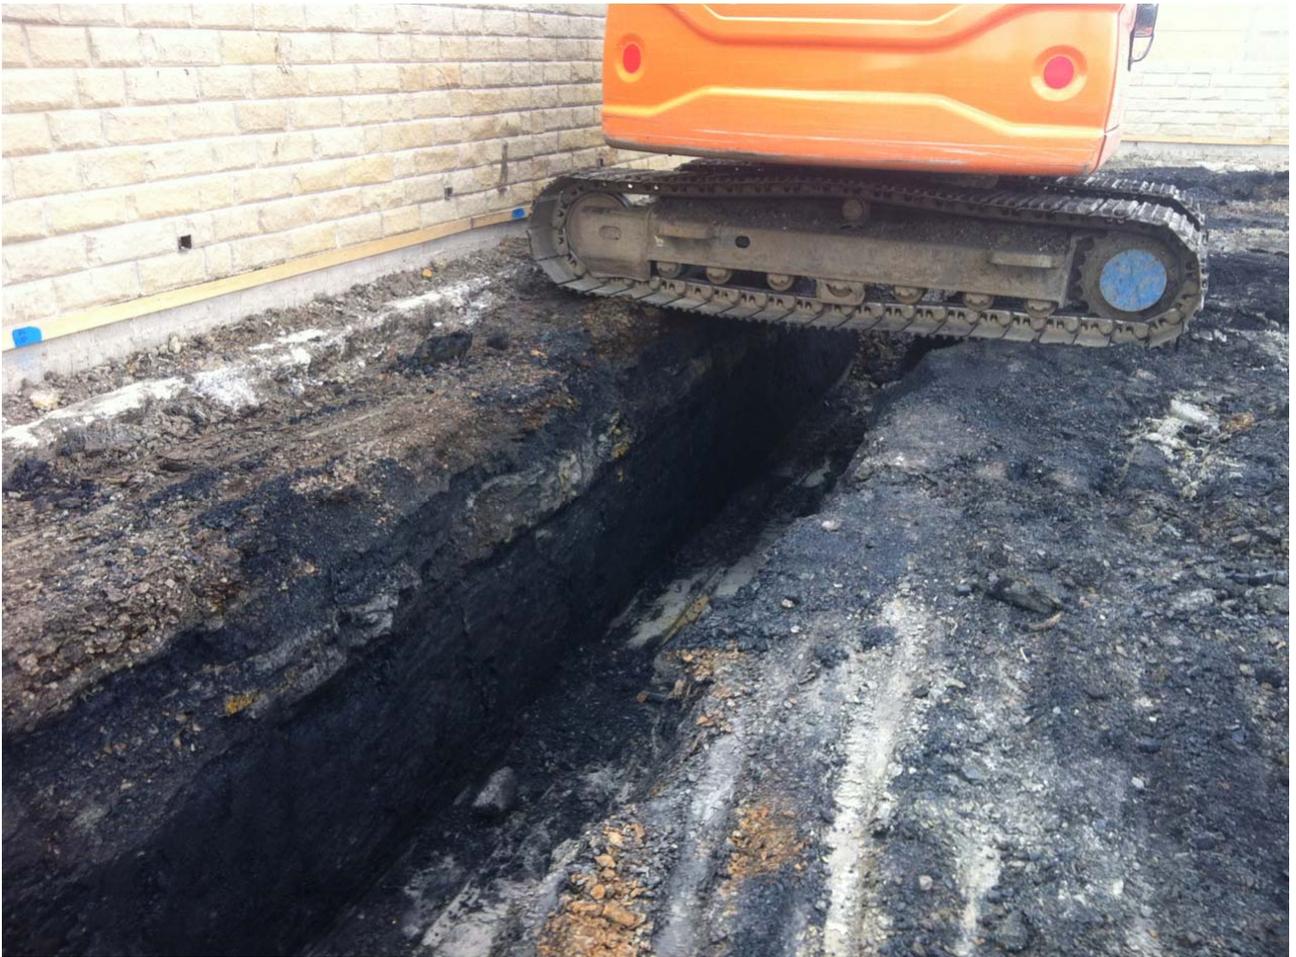
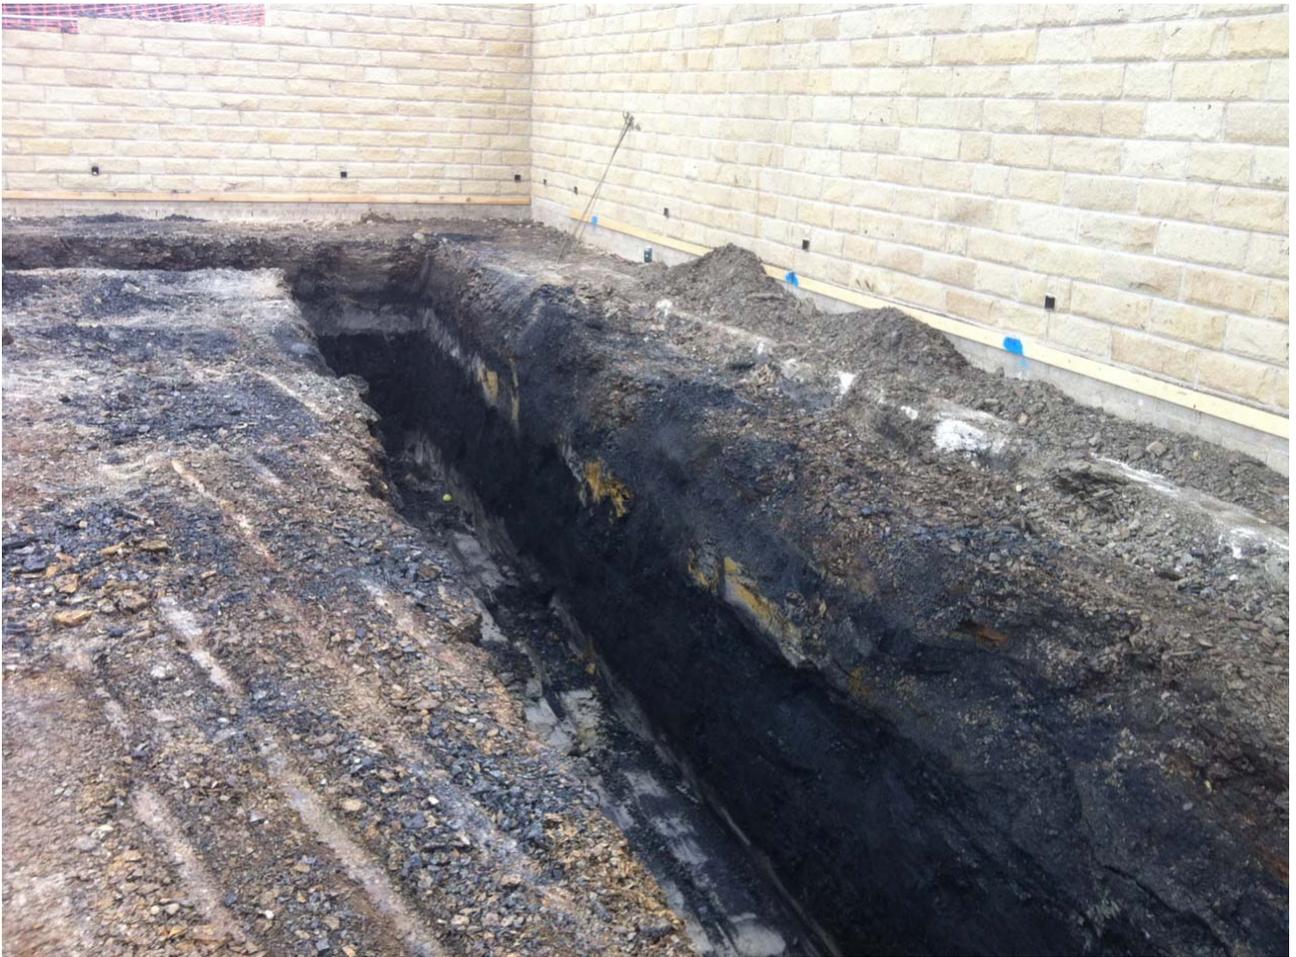
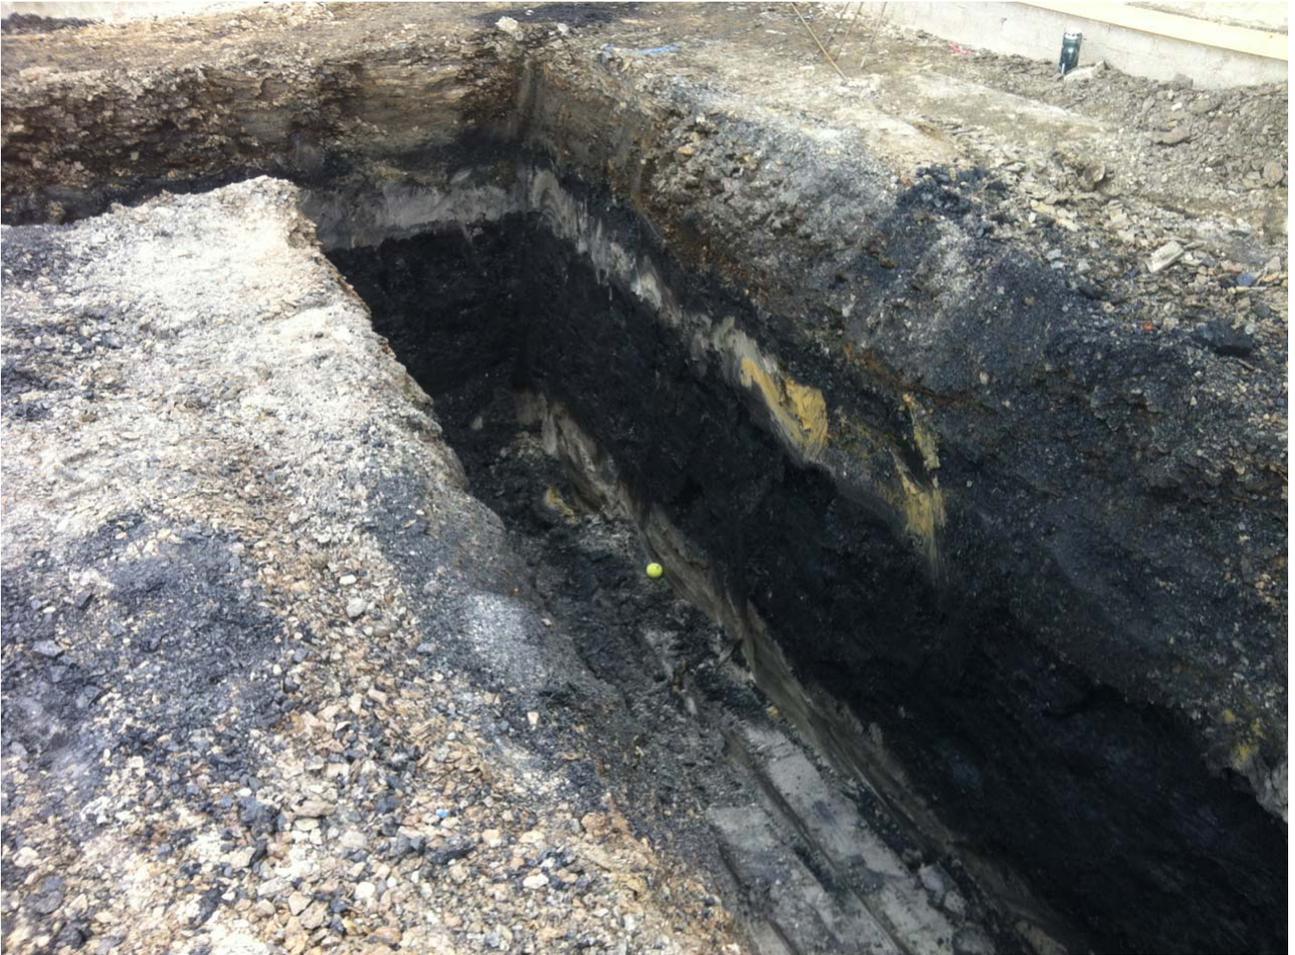
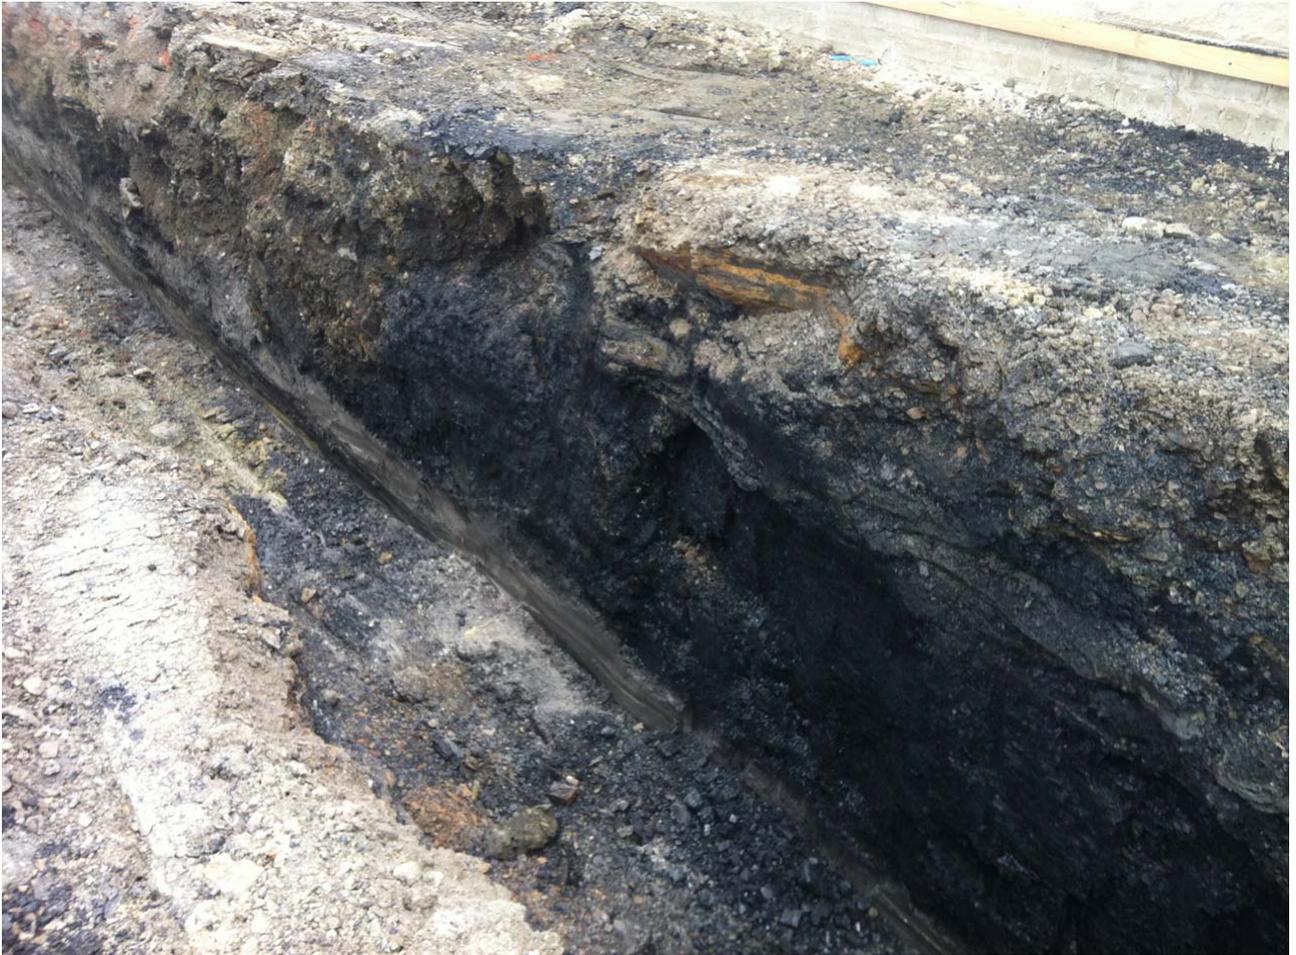
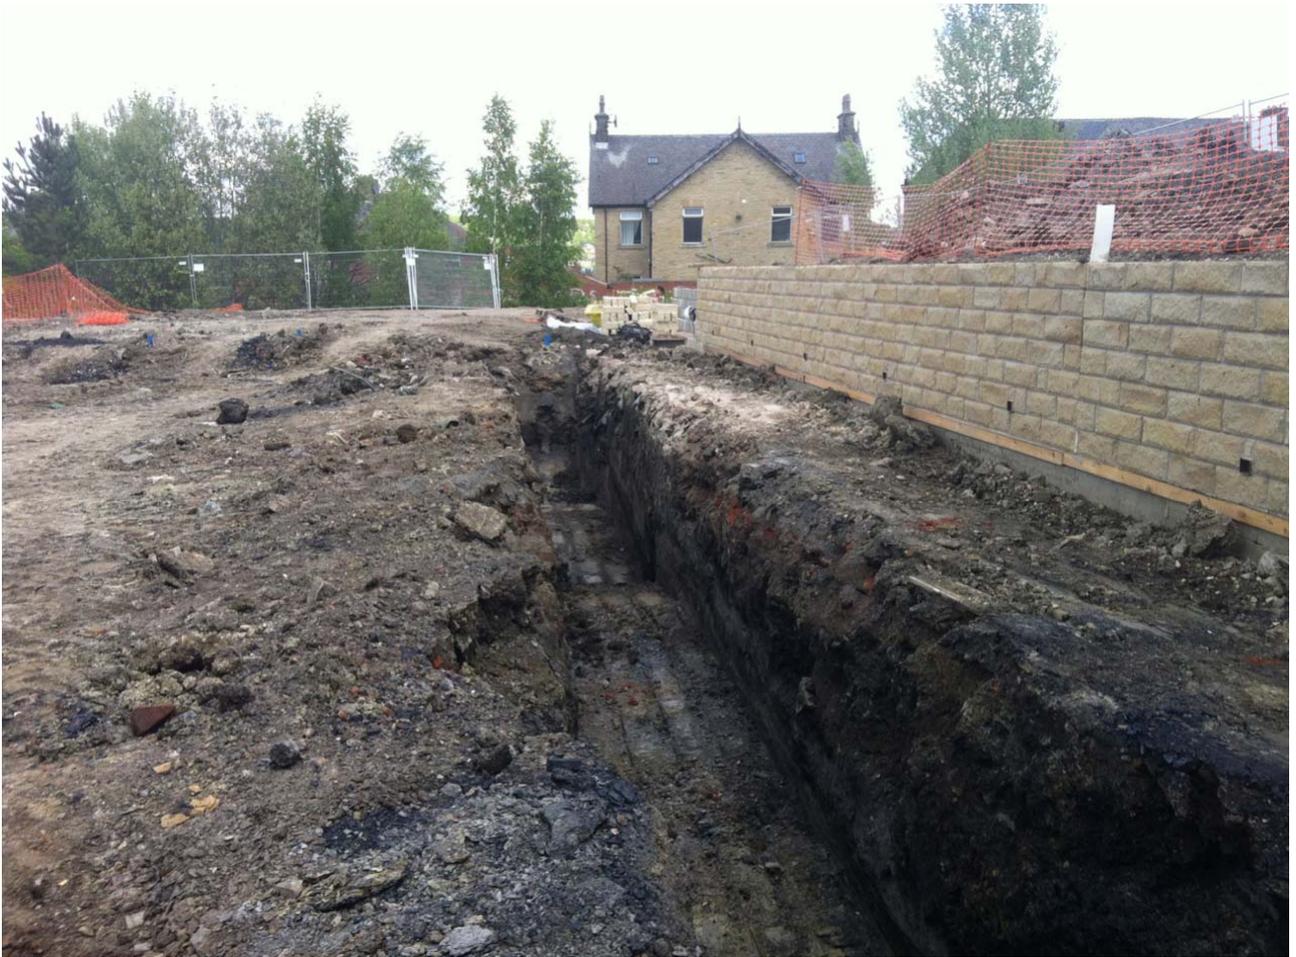
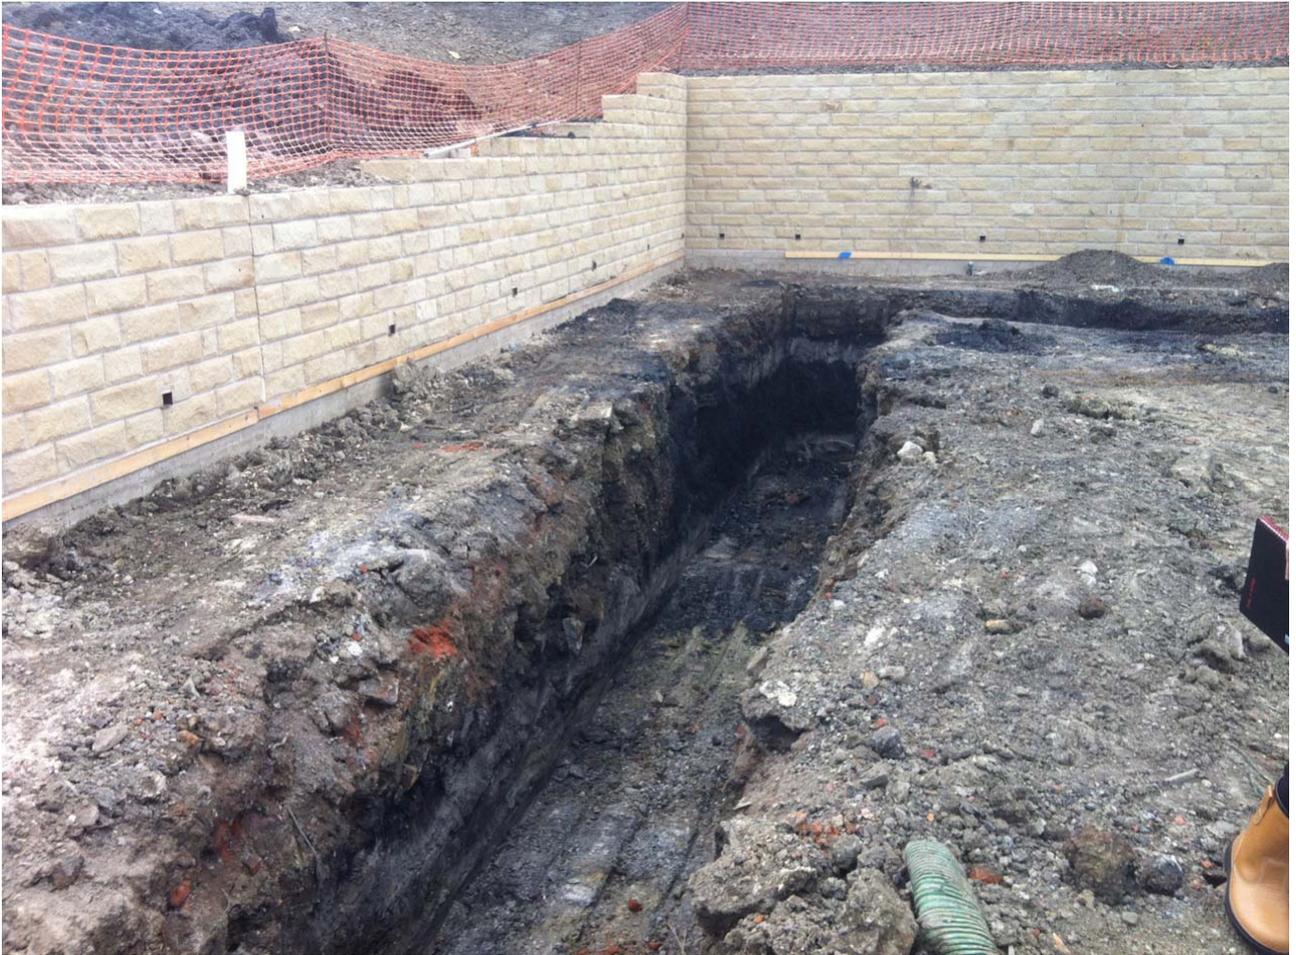
### Photographs of Foundation Excavations (May 2014)

Copies of 6 no. site photographs taken during May 2014 of the foundation excavations for the southern corner of the Sidings Health Centre building have been provided by One 17 Structural Design, copies of which can be seen in Appendix VI. During the foundation excavations for the southern corner of the new health centre building, and as expected from previous intrusive investigation works, the outcrop of the 2BM coal seam was encountered at shallow depths below this portion of the site.

The coal seam was noted to be intact comprising bands of interbedded anthracitic black weak coal, carbonaceous mudstone and weathered mudstone, locally up to c.0.60m in thickness, before being underlain by mudstone bedrock materials within which the new foundations were constructed. There was no evidence of any unrecorded workings, voiding or broken ground/collapsed workings noted in the 2BM seam.
