Bat Survey to  
Moorlands Cricket Club  
Memorial Park  
Huddersfield Road  
Mirfield  
WF14 9NE

11<sup>th</sup> June 2026

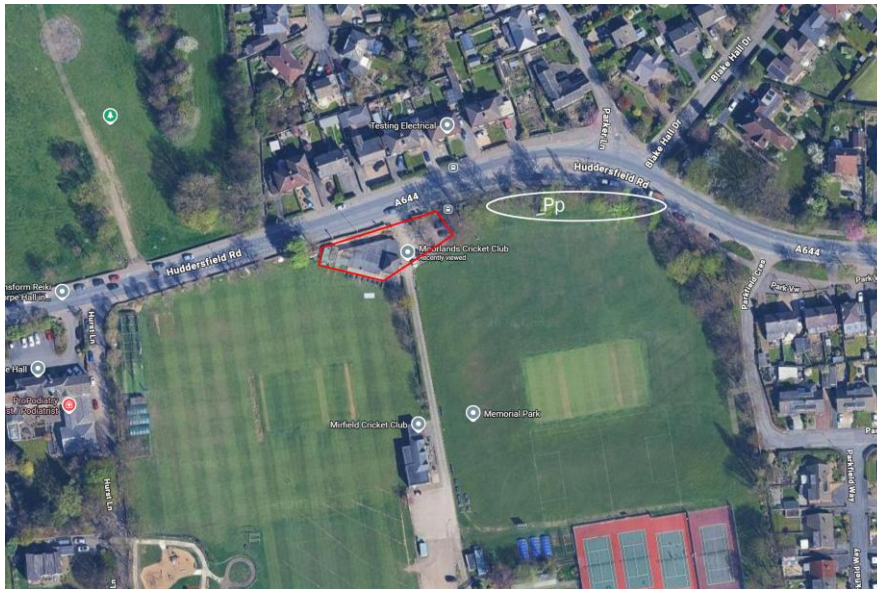
Figure 3. Area of bat activity.

An emergence survey was carried out on Thursday 11<sup>th</sup> June 2026 in favourable conditions with temperatures of 14.5°C and only a gentle breeze which got up towards sunset. Sunset was recorded at 21:35 and the survey commenced 40 minutes prior to that time and lasted until 90 minutes after that time. The first bat was recorded around 20 minutes after sunset and was hunting around trees to the east of the pavilion and this suggests a local emergence. However, no bats emerged from the cricket pavilion and only a small number of bat passes were recorded.
